# JD DANCE CLUB, ROCHDALE

## Nocturnal Bat Survey Report

*August 2023*

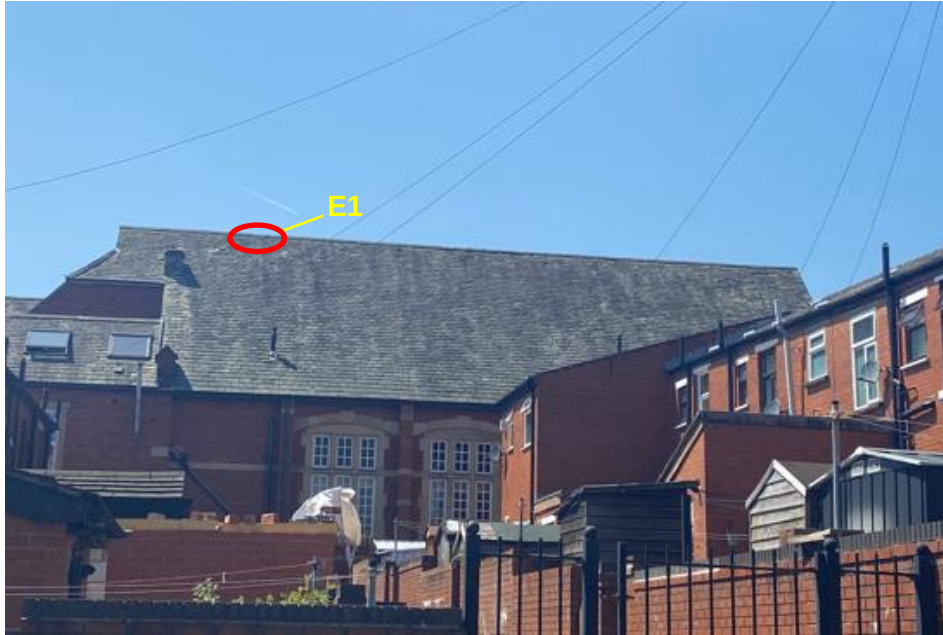
Figure 3.1 – Emergence Location

3.1.3. **One roost location was observed during the survey.** A single common pipistrelle was observed by VP1 at 21:55. This bat emerged from the roof ridge tiles at the top of the eastern aspect of the building. Please refer to Figure 3.1 for the approximate emergence location.

3.2.3. **One roost location was observed during the survey.** A single common pipistrelle was observed by VP1 at 21:57. This bat emerged from the roof ridge tiles at the top of the eastern aspect of the building in the same location as observed during the previous survey. Please refer to Figure 3.1 for the approximate emergence location.

- The ecologist will attend site on the day of the scheduled works to undertake a search for bats in the identified roost locations prior to the works commencing (i.e. supervise removal of hanging tiles at emergence location). Any bats found will be relocated into the roost provisions, already installed on site. The initial stages of the works will occur under the supervision of the ecologist.

4.4.4. Once the selected features have been removed under supervision (i.e. roofing tiles at emergence point), works can proceed in the absence of the licenced ecologist, at their discretion. If a bat is discovered at any unsupervised time, work must cease immediately, and a licenced bat handler must be called for advice. This advice will include leaving the bat to disperse of its own accord or wait for the licenced ecologist to move the bat. Builders and contractors are explicitly forbidden from handling bats except in the case of finding a trapped or injured bat. In which case the bat may be moved into a safe and secure place (e.g. a box) and the ecologist must be contacted immediately.

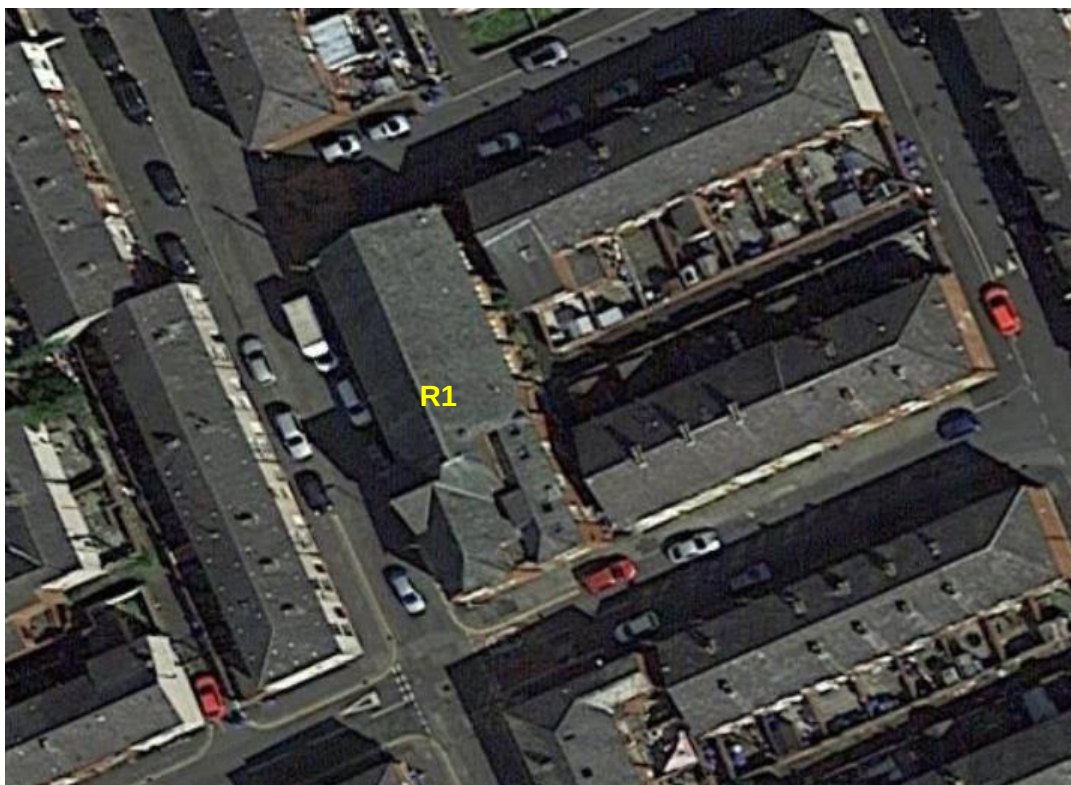
Figure 3.3 – Roost location

- 3.4.2. During the surveys on 13<sup>th</sup> July and 19<sup>th</sup> July 2023 a single non-breeding summer roost for common pipistrelle was observed on the eastern aspect of the building in relation to the roof ridge tiles. The low numbers of bats (i.e. peak count of one bat per roost) recorded using the roost during the survey, indicates that the roost is non-breeding summer roost for low numbers of common and widespread species of bat.

- 3.4.3. Bat roost categorisation was possible as surveys were completed during maternity roost season. As stated in the best practice guidelines (Collins, 2016) to determine the presence of a maternity roost surveys are to be carried out in the months of May to August. A single bat was observed during the first survey, indicating it is a non-breeding, transitional roost.
