Wilson Bowden Developments Ltd  
Plot L Kingsway Business Park  
Rochdale

Phase 1 and Phase 2 Geo-Environmental  
Assessment

June 2017

Project Number: NTT2589

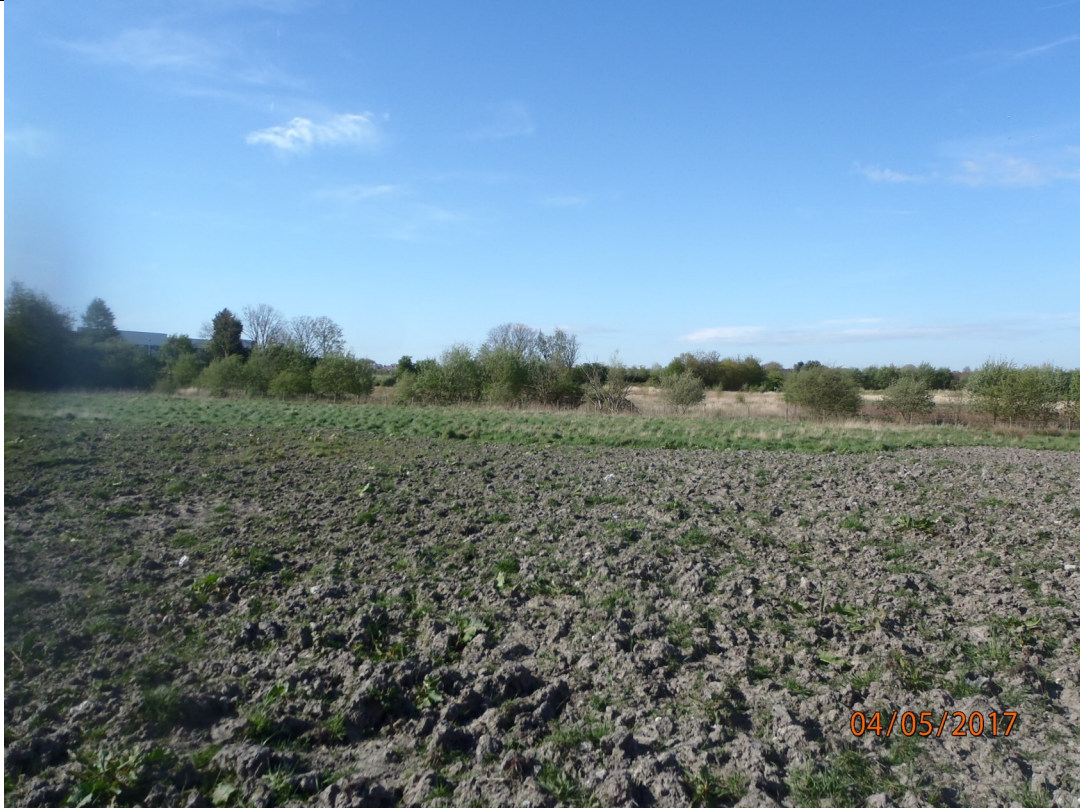
Photo 1—View from the eastern site boundary looking west.

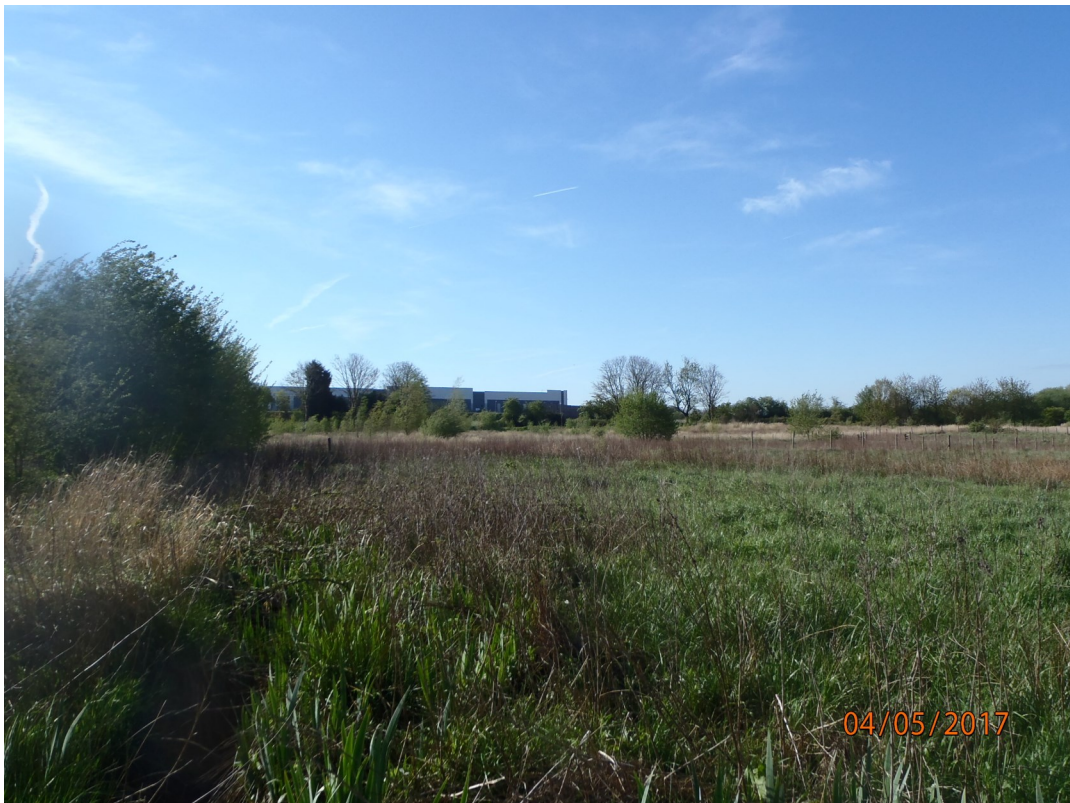
Photo 2— View from the north of the site looking south.
