## GeoEnvironmental Site Investigation Report

Dobfield Road

Rochdale

**Report Ref: A5182/22/SI/V3**

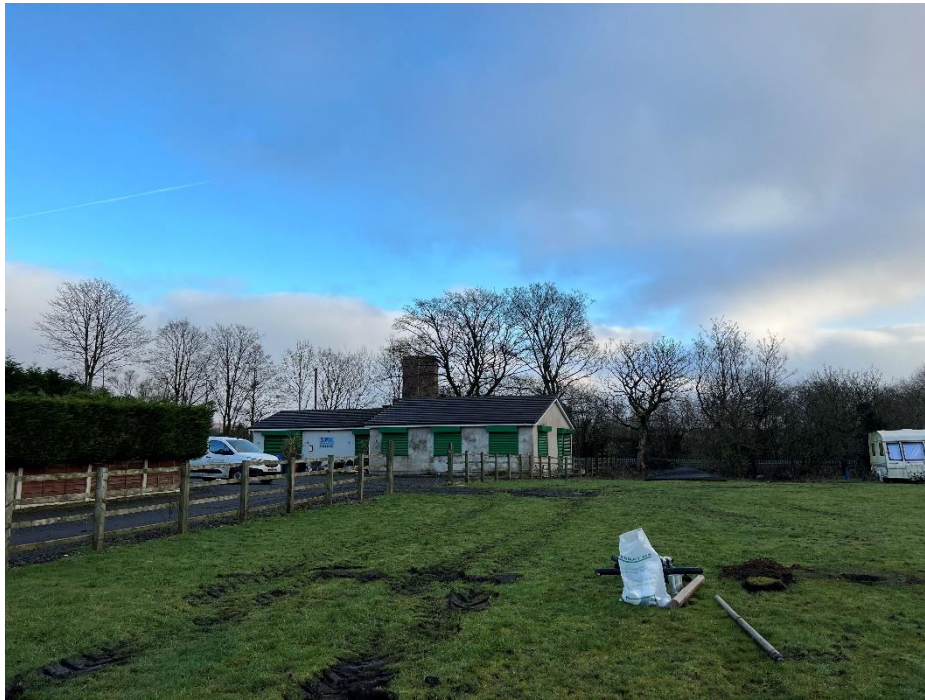
View of the on-site building, owned by PDTL, looking southwest

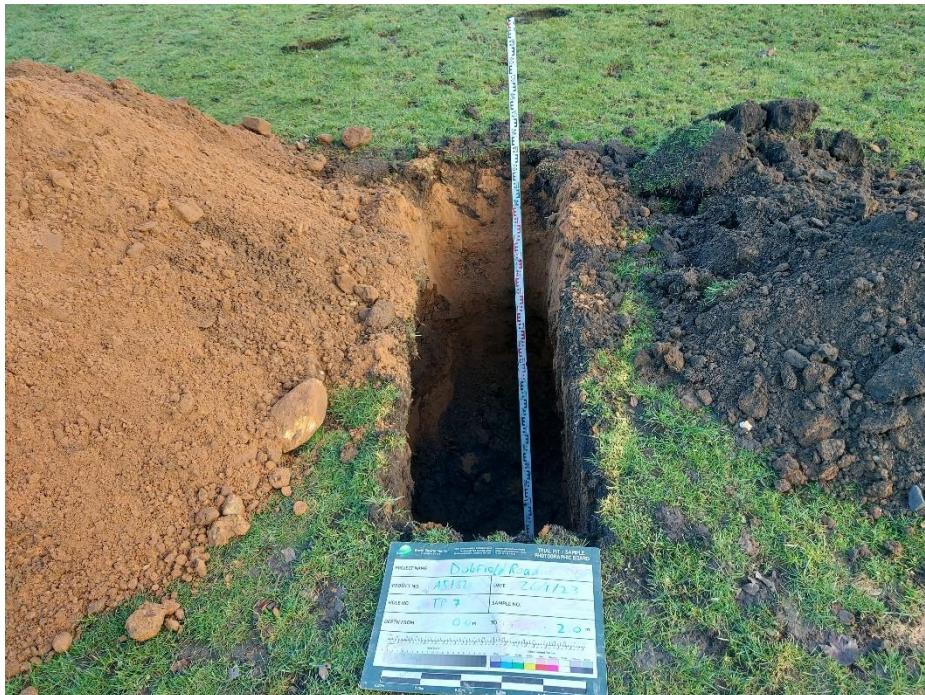
Photograph of representative soils (TP7)

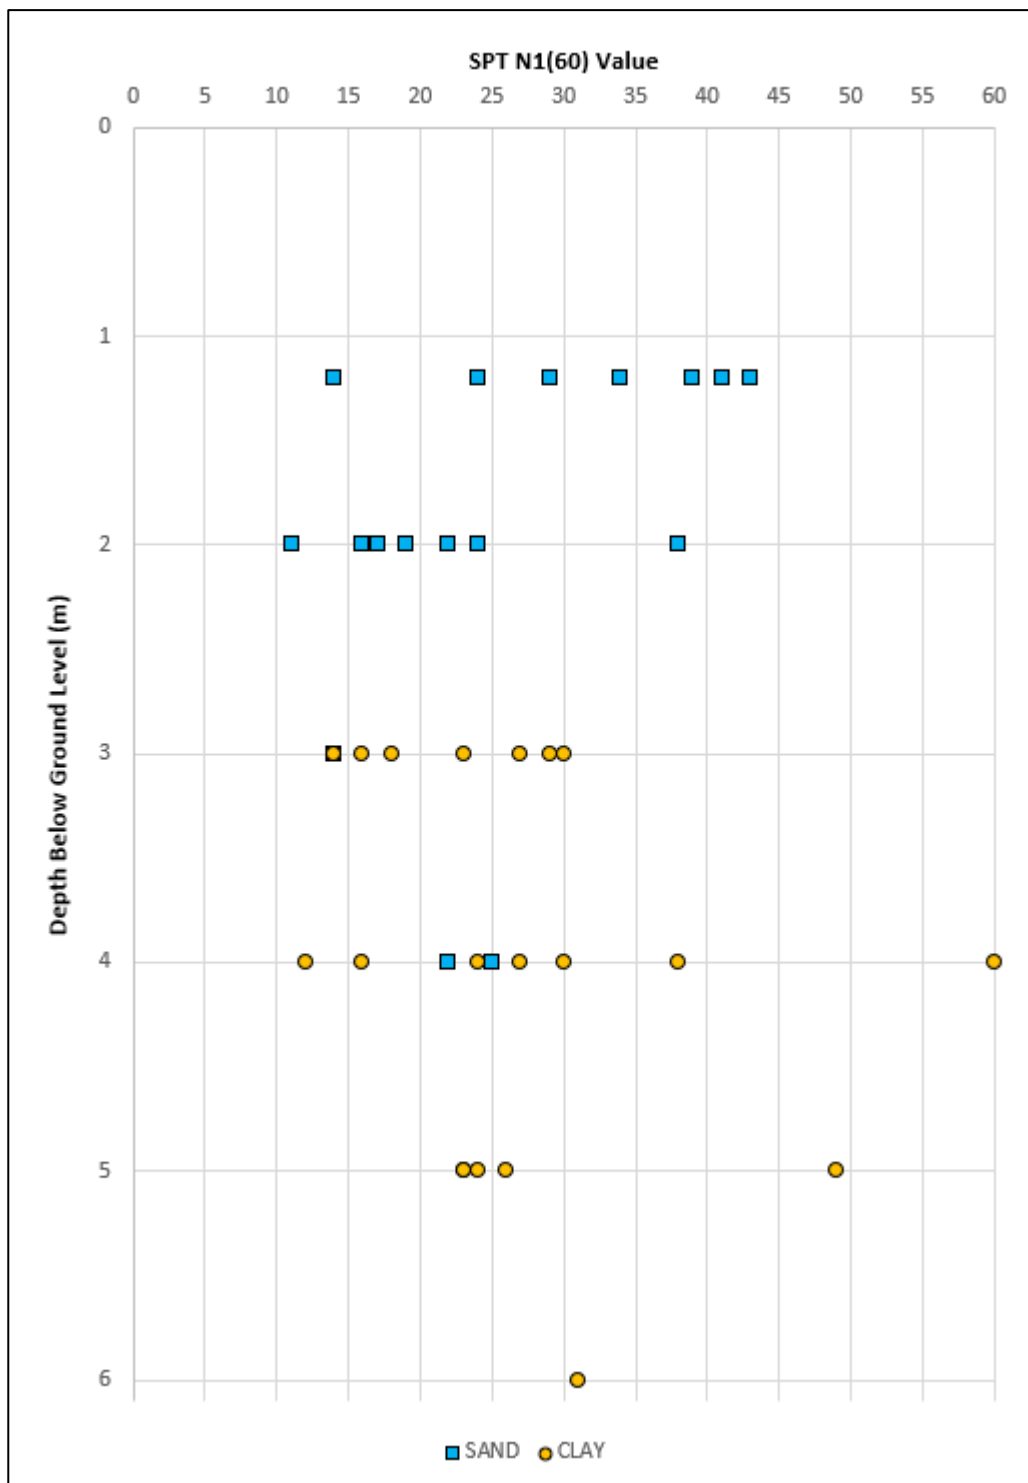
Figure 5 SPT N1(60) v Depth Plot

It is recommended that for assessing ultimate bearing capacities, where the lower values are critical, the lower quartile value of N values is used. Based on the N Values in the above table, the equivalent shear strength values were in the range of 72 - 160 kN/m<sup>2</sup>, suggesting that the clay is of medium to very high strength.

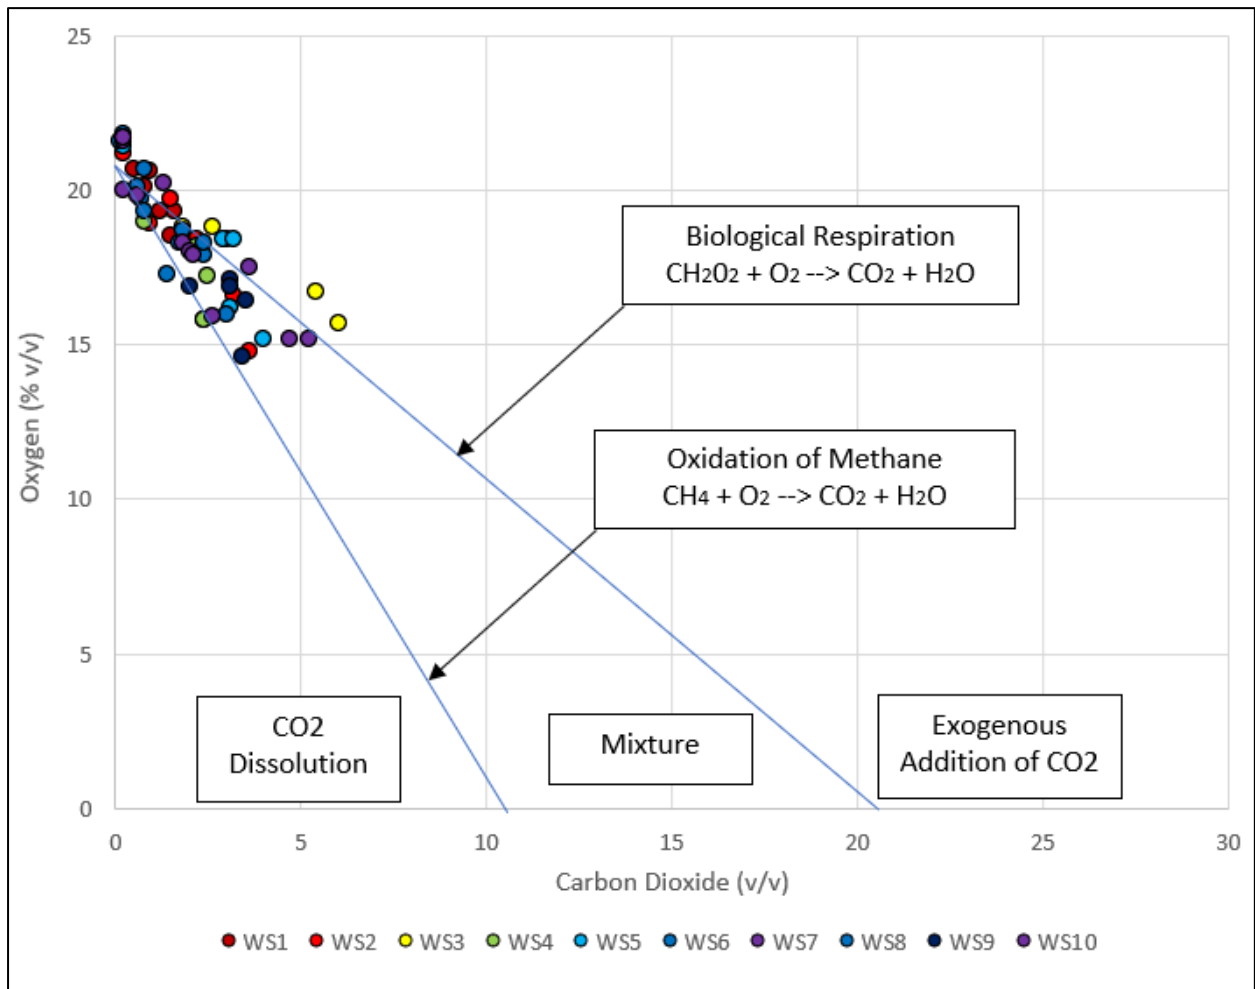
**Figure 9 Carbon Dioxide: Oxygen Ratio Plot**

Figure 9 shows that the points that plot to the left of the biological respiration and oxidation of methane lines are caused by dissolution of gas from the ground (or pore) water and from reaction of rainwater with soil. The points to the right of the biological respiration line are caused by biological respiration (i.e., oxidation of organic material in the soil).

None of the data plots to the left of the oxidation of methane line. The data is roughly split either side of the biological respiration line. The data plotted to the right of the biological respiration line indicates that the source of carbon dioxide is likely to be from the oxidation of organic material in the soil, whereas the data plotted to the left indicates a mixture.

The above results and assessment suggest the site can be given a Characteristic Situation 1, i.e., 'very low risk', in accordance with Table 17 above.

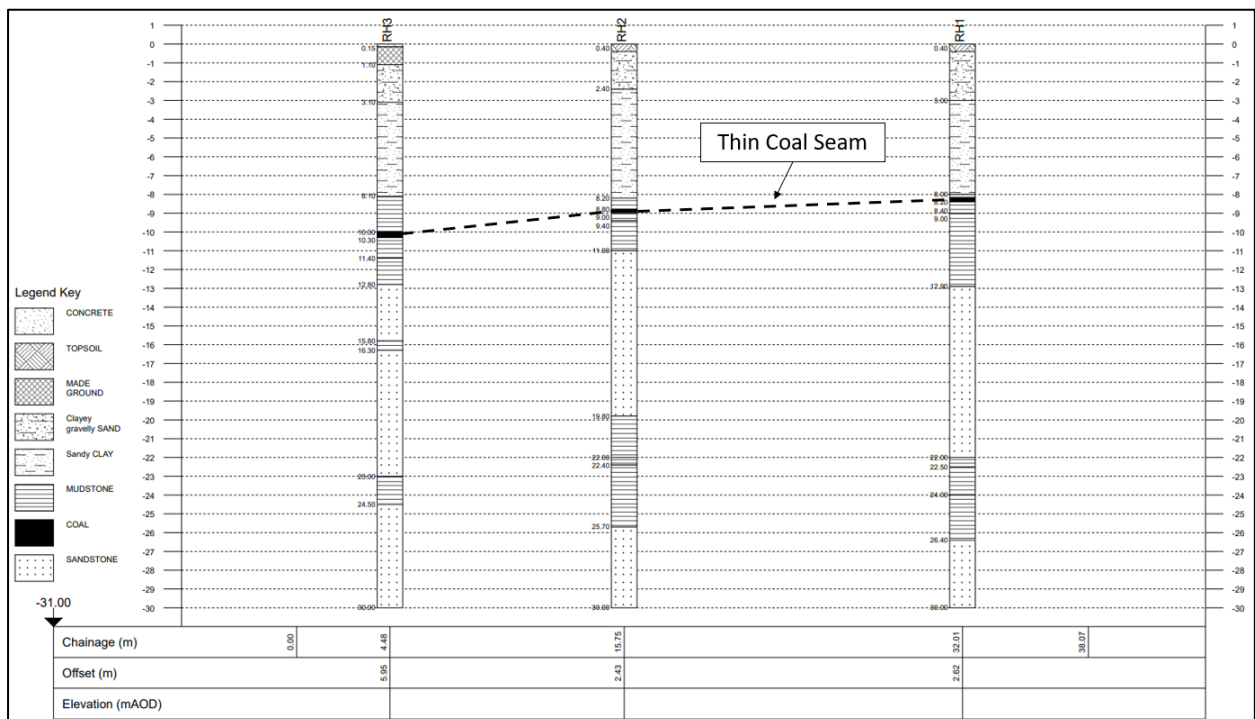
**Figure 12 Cross Section (A - A') of Encountered Coal Seams**

In general, superficial deposits were encountered below the site to approximately 8.00m bgl and were underlain by bedrock comprising a sequence of grey mudstones and sandstones. Occasional thin (<0.10m) bands of competent sandstone were encountered within the mudstones, with thin bands of mudstone encountered within some of the sandstones.

All lithologies were found to be intact. There was no evidence of voiding or broken strata caused by shallow mineworking.

As a result, ground remedial measures such as strengthening of foundations or mine grouting will not be required.
