# BANK TOP FARM, HOLLINGWORTH ROAD, LITTLEBOROUGH

## Phase 1 - Preliminary Risk Assessment

Report Ref: BEK-22019-1 Rev A

August 2022

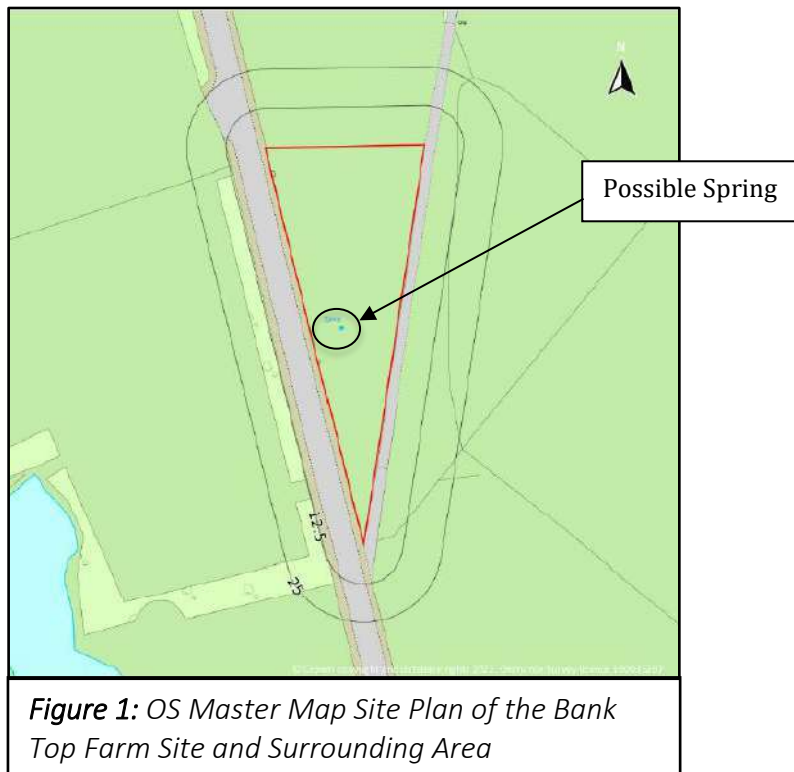
2.2.2 The site is a triangular plot of open grassed agricultural land flanked by dry stone walls on the whole west and the south-east section of the boundary, the rest of the east boundary is open (see Figure 1). Sheep livestock were occupying the site at the time of the walkover. Hollingworth Road runs parallel along the westward boundary and a farm access track along the eastward boundary. The northern site boundary is open to the rest of the field.

- 2.2.3 Two metal gates are located on the west and south-east walls, they were unlocked at the time of the site walkover. The site is unevenly sloped from the east down to the west. A boggy, reeded area encircled a possible spring in the centre of the site.

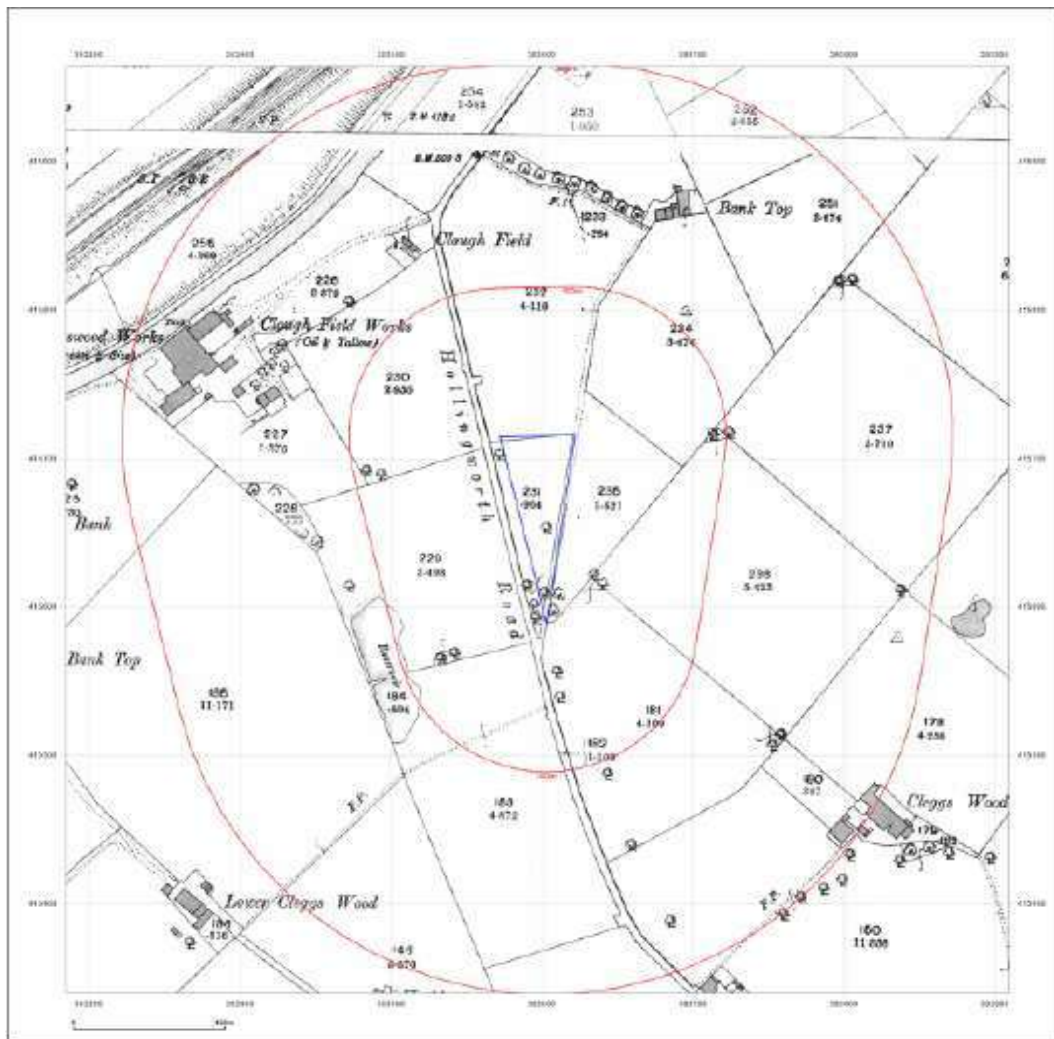
**Figure 2:** OS Map of the Bank Top Farm Site and Surrounding Area in 1891

- 3.1 The history of the site has been established using historical OS maps supplied by Groundsure. A selection of the maps reviewed is presented in Appendix A.
- 3.2 The site has remained virtually unchanged since the earliest OS maps were produced back in 1891 (Figure 2) and 1910. Hollingworth Road runs north-south adjacent to the site up to clough field. A farm track runs along the east side of the site boundary. A reservoir is approximately 100 m south-west of the site and Clough Field Oil and Tallow Works is north-west approximately 200 m away.

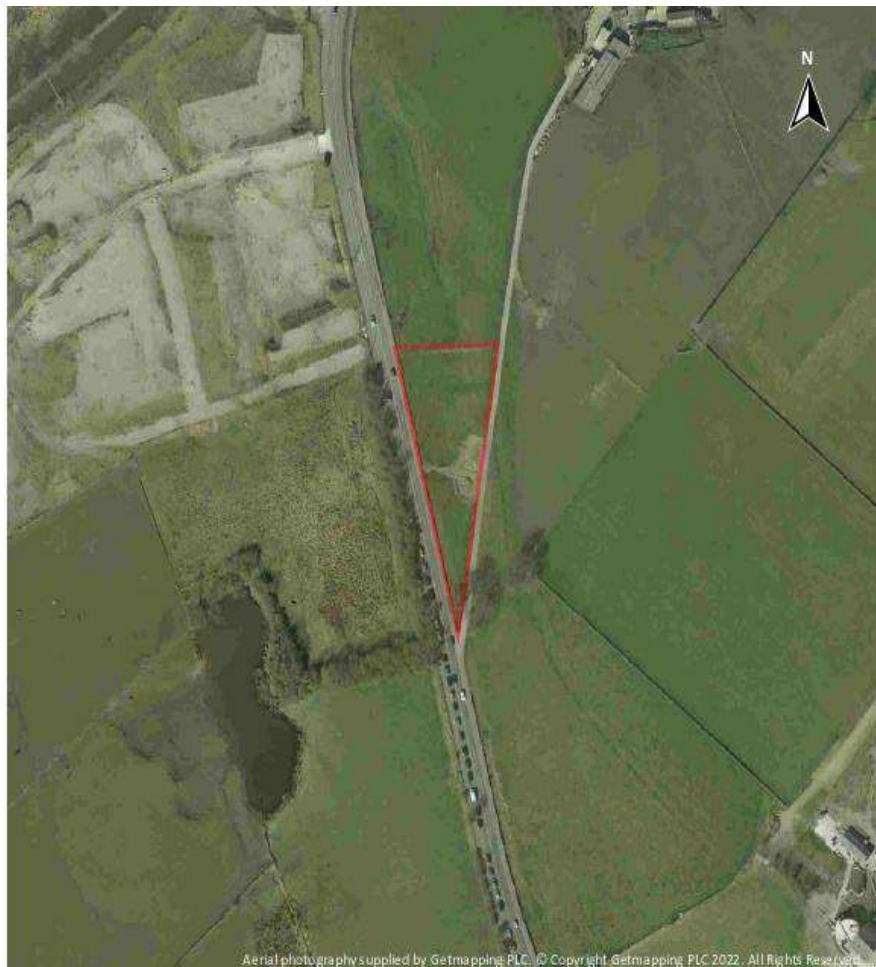
**Figure 3:** Satellite aerial imagery of the Bank Top Farm site and the surrounding area in 2012

- 3.6 The aerial satellite images presented in the Enviro+GeoInsight Report shows a possible track from the access gate has been formed leading to what looks like either excavated ground or a store pile of lime. The commercial complex north-west of the site is absent (Figure 3).

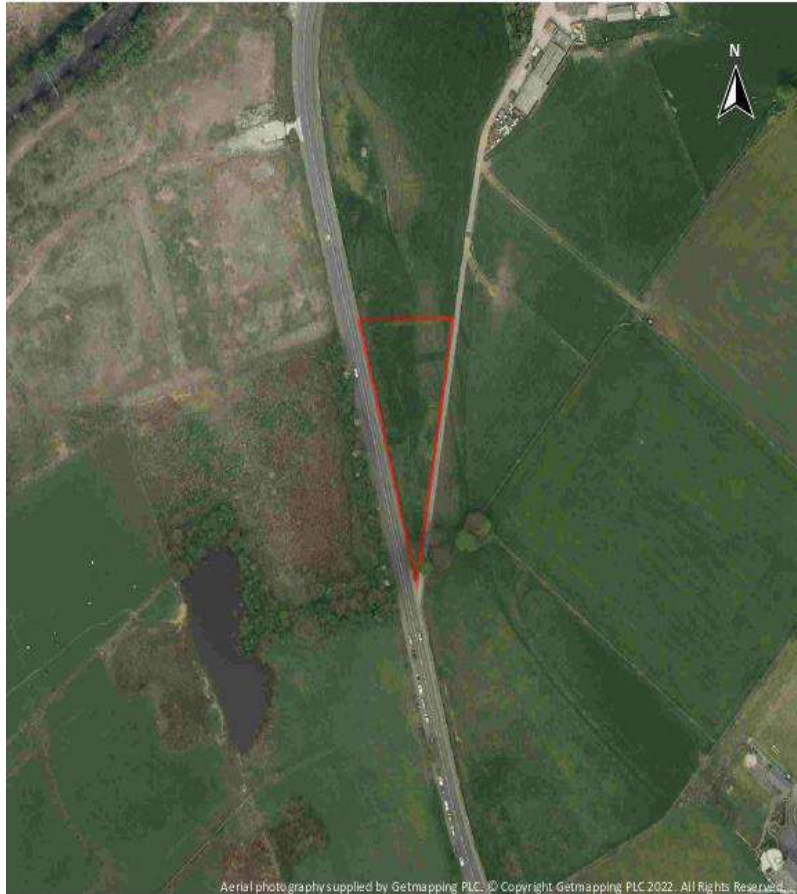
**Figure 4:** Satellite Aerial Imagery of the Bank Top Farm site and the Surrounding Area in 2019

- 3.7 The most recent aerial satellite image (Figure 4), very little change occurred since 2012. The site no longer has a trail leading from the access gate or excavation feature. It is likely the feature seen in 2012 was a lime pile and has subsequently been removed.

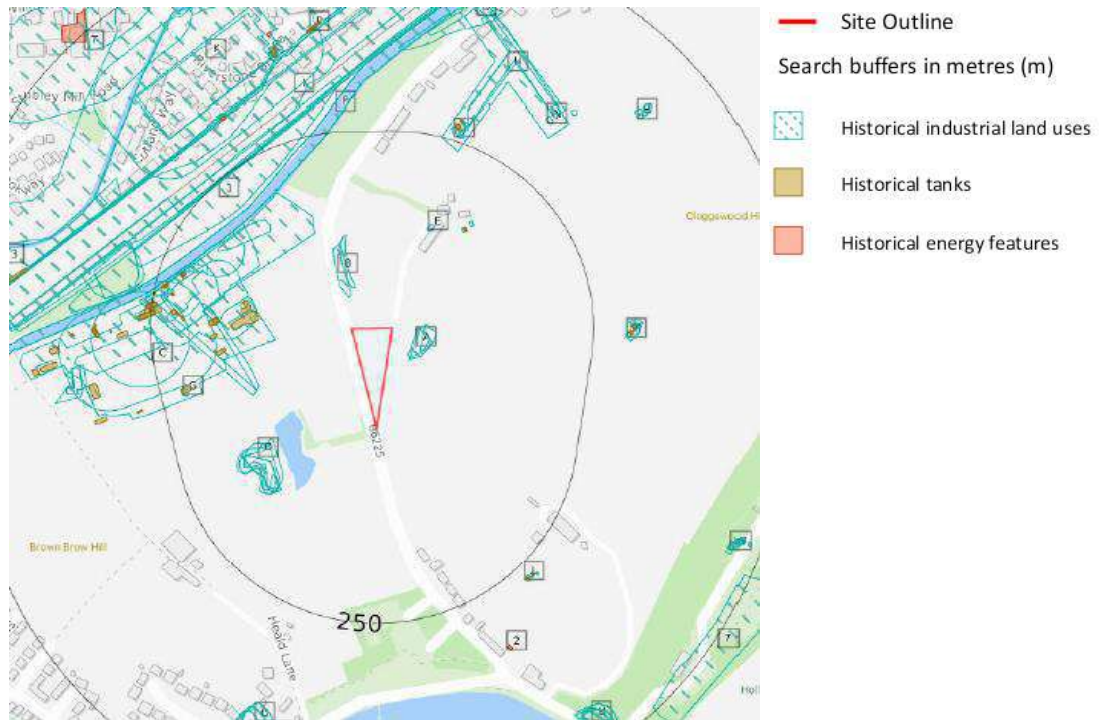
**Figure 5:** Potentially Contaminative Land Use Features Digitized from Historical OS Maps Around the Site Boundary

- 4.5.8 There are no electricity substations located within 250 m of the site noted by Groundsure.
- 4.5.9 There were no historical petrol stations or historical garages located within 250 m of the site.
- 4.5.10 There are 38 potentially contaminative historical industrial sites located within 250 m of the site according to the Enviro+GeoInsight report, with the sites dating from 1851 (Figure 5). There are four unspecified ground workings/pits within 50 m of the site boundary; the closest of which is 25 m east (dated 1928), 27 m east (dated 1938), 39 m east (dated 1949) and 41 m north (dated 1949). The ground workings are unspecified but are likely to be quarries suggested from satellite observation.
