# **GEO-ENVIRONMENTAL AUDIT**

## **PHASE 1 Preliminary Risk Assessment**

## **PHASE 2 Site Investigations**

## **PHASE 3 Remediation Statement**

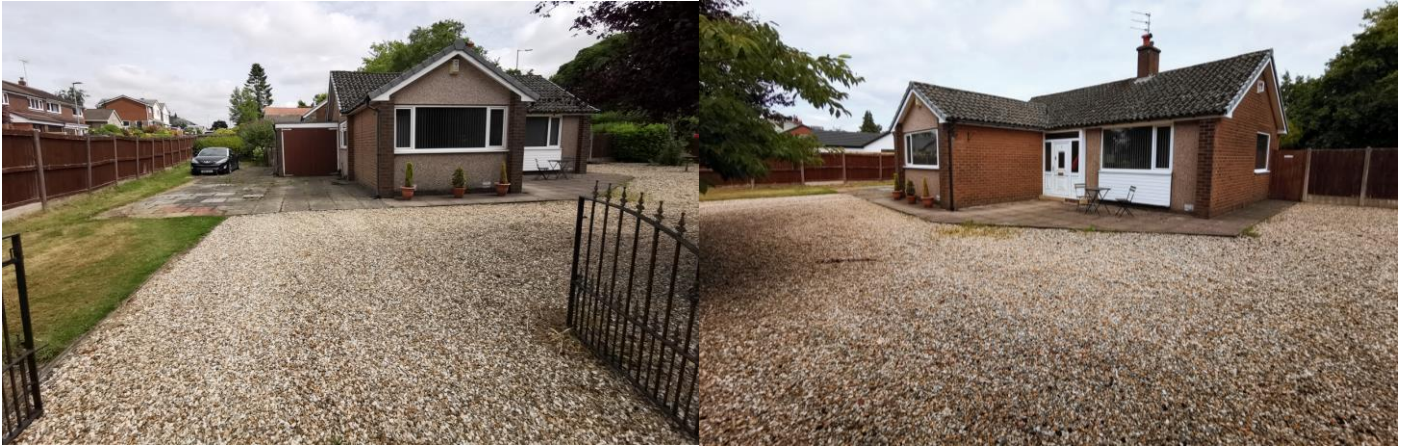
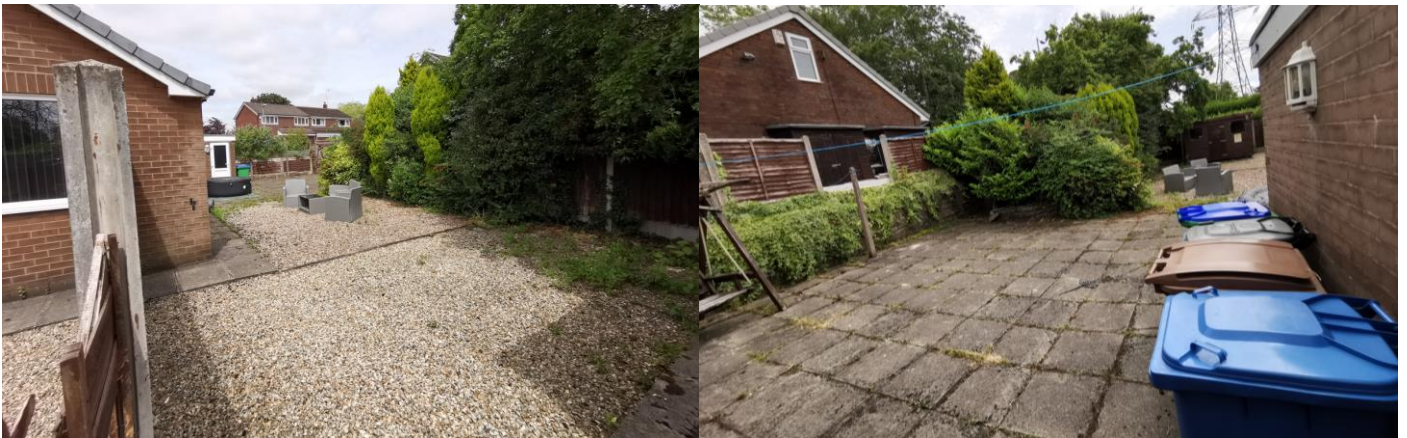
| Details of Existing Structures & Features: | <p>The Site was accessed via the west driveway entrance off War Office Road.</p> <p>The Site was generally enclosed by timber fencing, dwarf walls and shrubbery around the perimeter, with a higher retaining wall to the east boundary.</p> <p>The existing bungalow is nominally central to the Site, with the surrounding area comprising patio/paths made up of PCC pavements, and other areas generally comprising stone chippings. There were some soft verges around the perimeter in places, and a timber shed in the back garden area.</p> <p>Some small juvenile trees were noted around the Site perimeter such as cherry, copper beech, leylandii amongst others.</p> |

Reconnaissance photos July 2022.

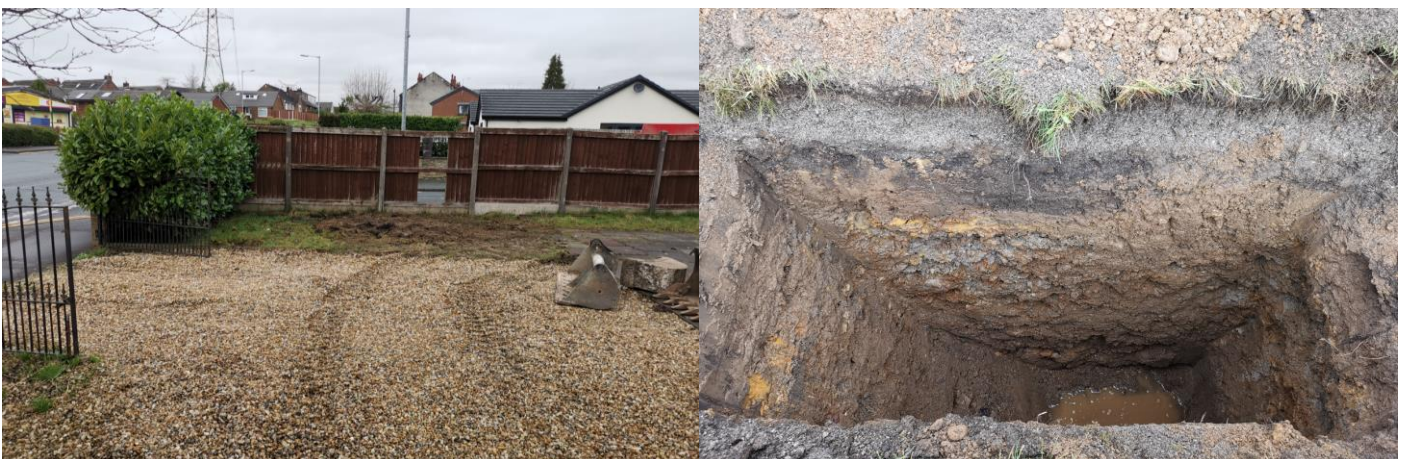
| Trial Hole/Soil Sample | Made ground horizon | Mitigation/Action |
|---|---|---|
| TH1/S1 | No exceedances. | PASS |

Site investigation photos February 2024 - Trial Hole TH1.

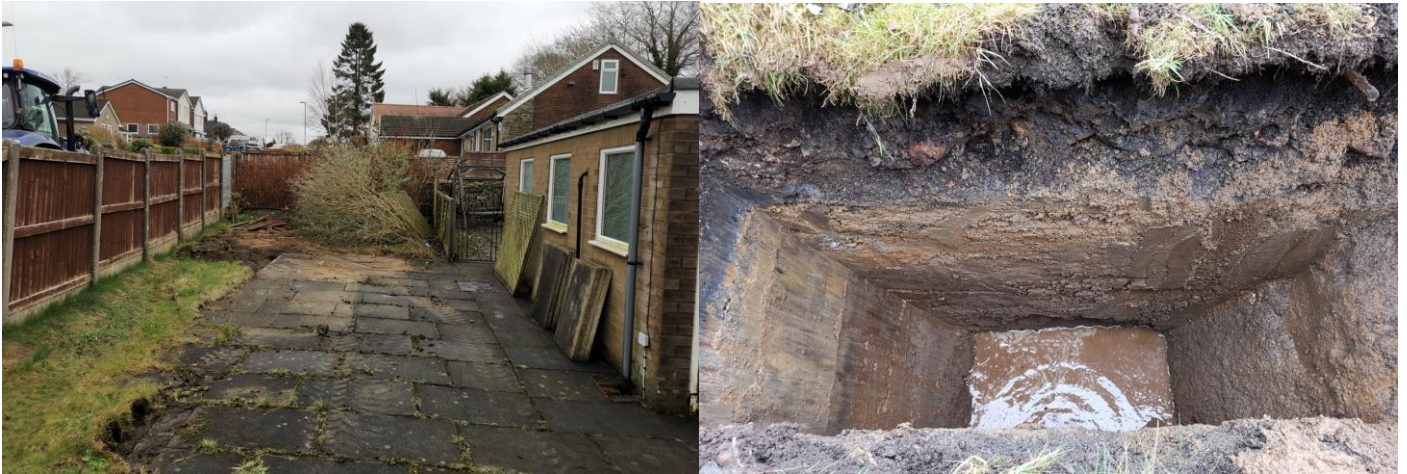
| Trial Hole/Soil Sample | Made ground horizon | Mitigation/Action |
|---|---|---|
| TH2/S2 | Lead, benzo[a]anthracene, benzo[a]pyrene, benzo[b]fluoranthene, chrysene, dibenz[ah]anthracene. | FURTHER ACTION |

Site investigation photos February 2024 - Trial Hole TH2.

The existing soils will not be suitable for reuse with regard to human receptors, and a suitable cover system will need to be employed.

Dependent on the final finished levels, existing made ground within proposed soft landscaping areas, should either be covered with 600mm of imported soil, or excavated to 600mm from finish levels (or to clean virgin material if shallower than this) and replaced with imported soil to suit finishes. The 600mm cover system is adopted for the following reasons:

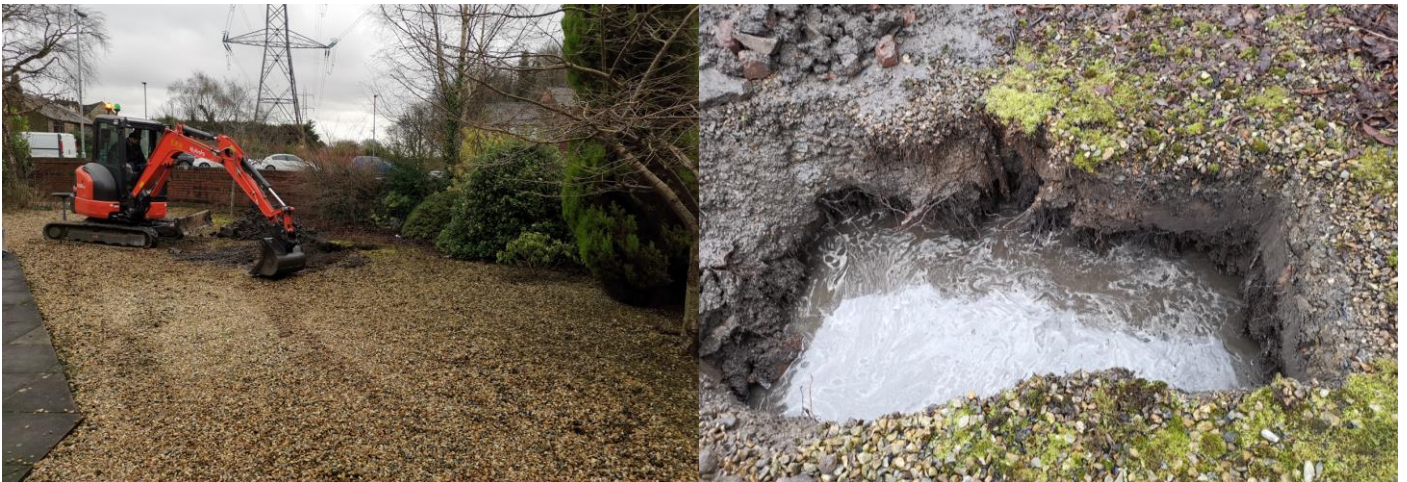
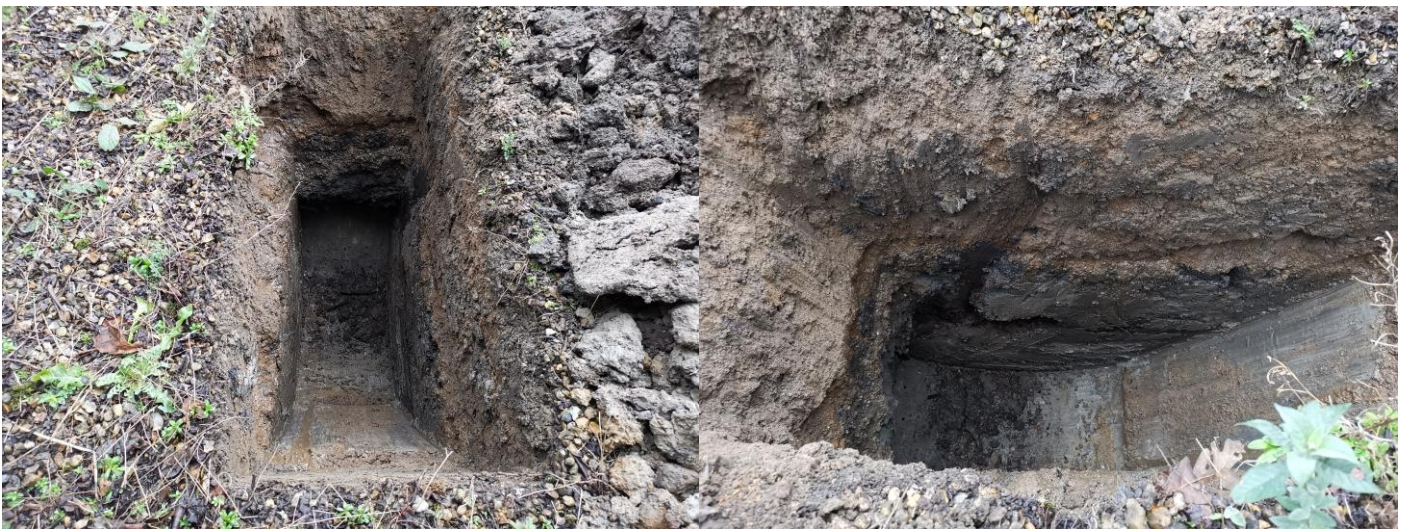
| Trial Hole/Soil Sample | Made ground horizon | Mitigation/Action |
|---|---|---|
| TH3/S3 | Lead, benzo[b]fluoranthene, dibenz[ah]anthracene. | FURTHER ACTION |

Site investigation photos February 2024 - Trial Hole TH3.
