**Chicken Shed,  
Higher Moorgate Cottage,  
Gristlehurst Lane, Heywood,  
Manchester.  
OL10 4BJ**

**Survey & Assessment in Respect of Bat Species  
and Nesting Birds (including Barn Owl).**

**12<sup>th</sup> March 2022**

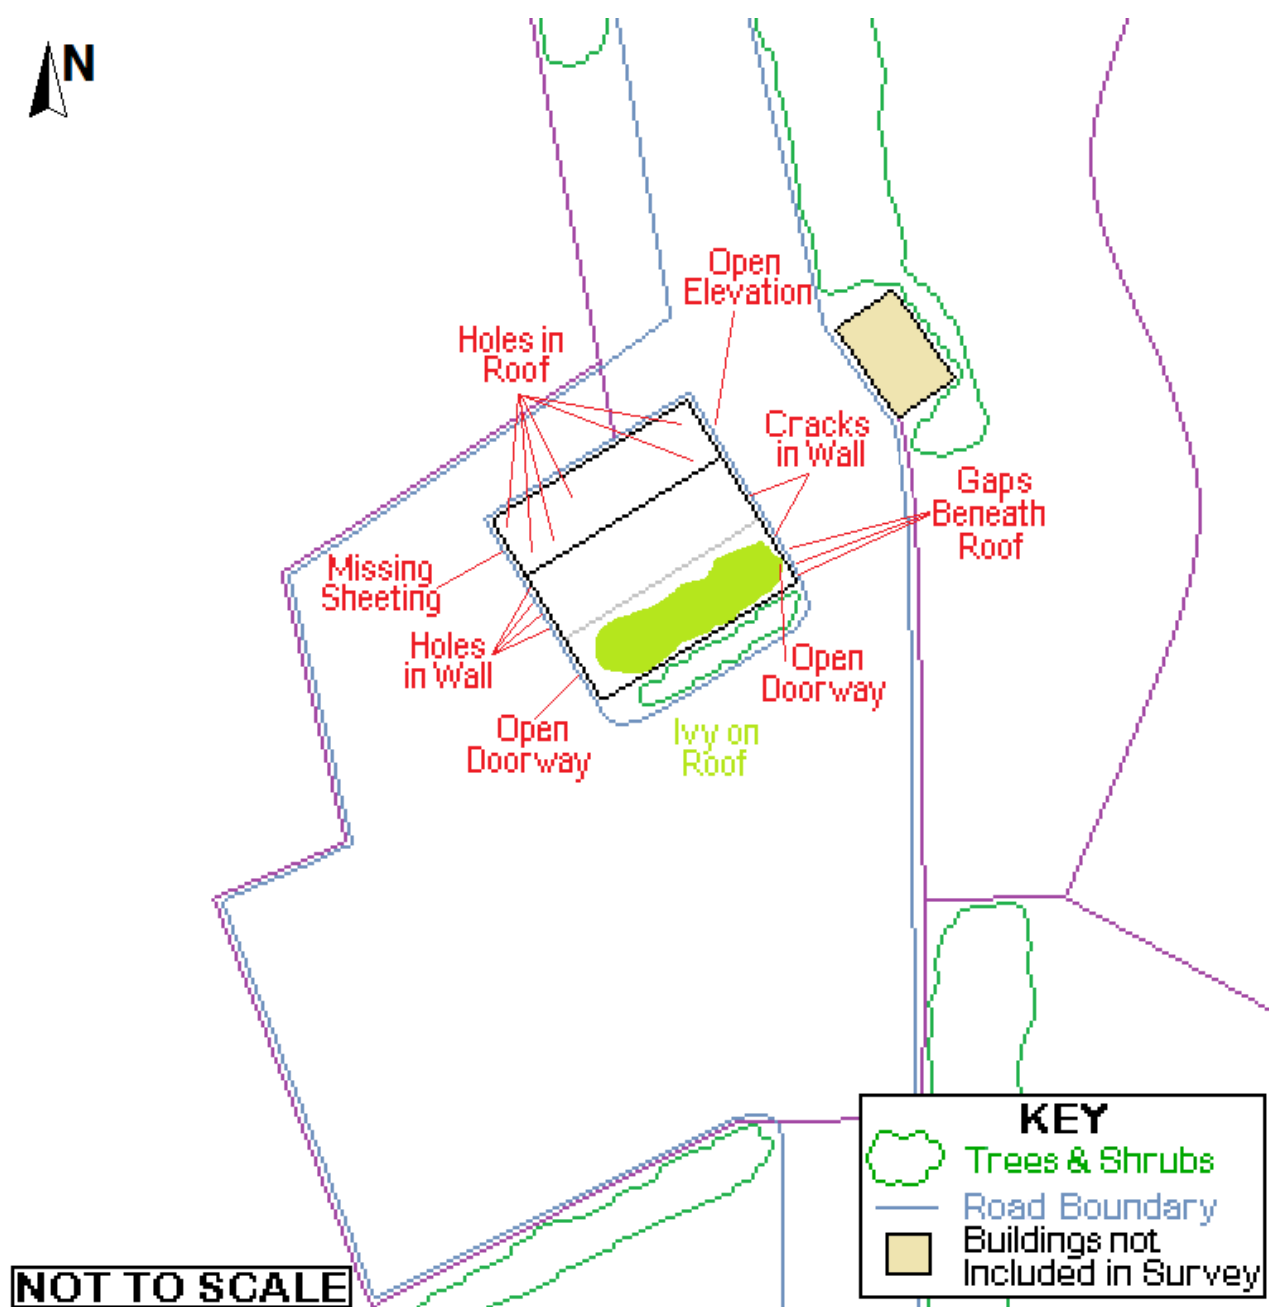
Fig 5 – Plan of Daylight Evidence and Opportunity Survey Results.

The chicken shack was unused and in a very poor condition. It was unheated, uninsulated, and would be draughty, damp and cold throughout most of the year, and as such, was deemed unsuitable for breeding bats. Also, as frost and bad weather was likely to penetrate the interior of the shack in the colder months, it was felt that the building did not offer the optimum humidity, and stable low temperatures that are required by hibernating bats. The resulting conclusion was that the building was deemed to offer extremely low roosting potential for bats of any type. It was also thought that copious amounts of daylight would enter into the inside of the barn and lean-to through the large open areas in both the structure, and through the clear corrugated roof panels, and this would further reduce the internal dark corners that are essential for daytime roosting bats, (refer to **Appendix 2**), (refer to **figs 3, 4 and 5**, and **photos 1 to 15**).

**4.1** In summary during the current surveys undertaken on 2<sup>nd</sup> March 2022, no current, or historic evidence of roosting bats was found anywhere within in the two parts of the chicken shack, nor anywhere else in the nearby site.

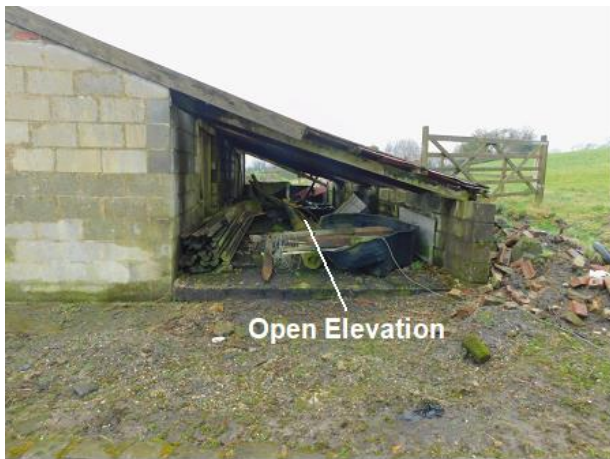
**PHOTO 1**  
**North-eastern Corner of Lean-to**

- The north-eastern elevation of the lean-to was completely open, as was the main doorway within the eastern elevation, but during a careful internal search of the main building and the lean-to, the walls, the floor together with the accumulated piles of debris, found neither droppings, invertebrate prey remains, or any other form of evidence of bat occupancy was found, and the interior of the building was deemed to offer low roost suitability, (refer to **figs 3, 4 and 5** and **photos 1 to 4**).

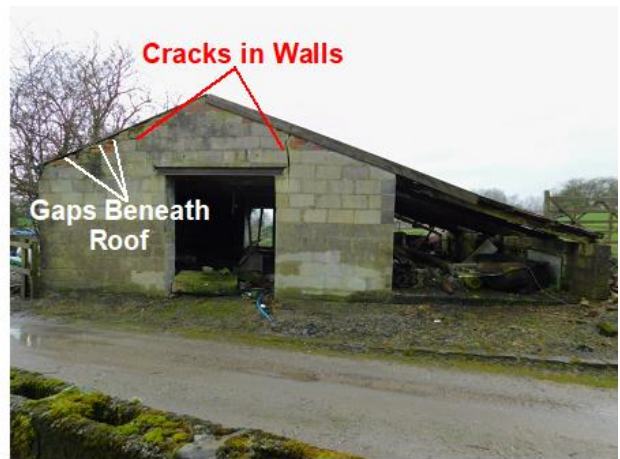
**PHOTO 2**  
**Eastern Elevation of Lean-to**

- Two vertical cracks were found, one either side of the eastern gable, and also there was a line of holes at the top of the wall, just beneath the line of the south-eastern roof, all offering potential for bat use, and these were all internally inspected using an endoscope. Also, a visible search of the wall and floor beneath them, found neither droppings, urine staining, invertebrate prey remains, nor any fur staining from continued passage of bats through the holes, (refer to **figs 3, 4 and 5** and **photos 2 and 3**).

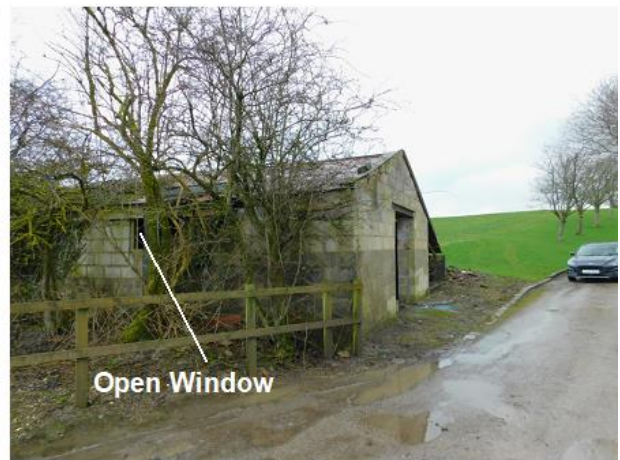
**PHOTO 4**  
**South-eastern Corner of Chicken Shack**

- Positioned within the southern elevation, a window was missing, however it was thought that due to the nearness and denseness of the nearby growing trees, that flight paths for bats amongst the trees and their branches, would be extremely unlikely, (refer to **figs 3, 4 and 5** and **photo 4**).

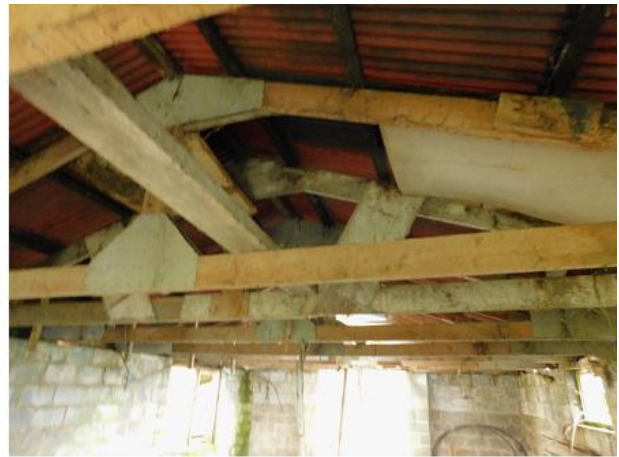
**PHOTO 14**  
**Underside of Main Building Roof**

The main building was a tall, single-story barn, constructed from concrete block, with a pitched roof covered in metal corrugated sheeting, mounted upon wooden purlins and trusses, but there was no roof void.

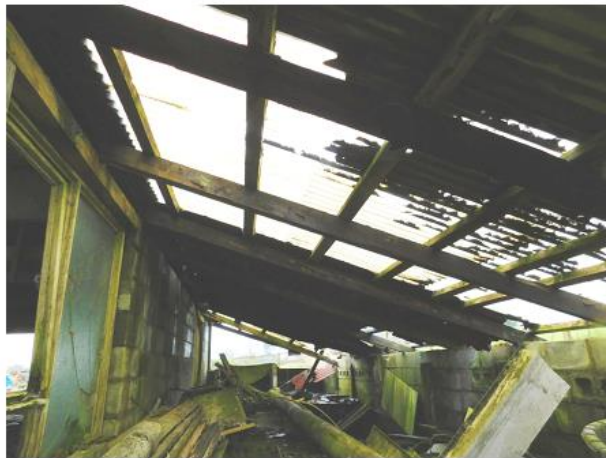
**PHOTO 15**  
**Underside of Lean-to Roof**

Attached externally along the northern elevation was a triangular sectioned lean-to, constructed from similar materials as the main building, and with a sloping roof covered in a mixture of clear plastic and metal corrugated sheeting, all mounted upon wooden purlins and trusses, but again with no roof void.

- Large areas of the corrugated sheeting along the northern part or the lean-to roof were missing, allowing both light and possible birds and bats to enter, but once again internal inspection found nothing to suggest that they were in fact being used, (refer to **figs 3, 4 and 5** and **photos 9 to 12 and 15**).
