SA/2024/25

# Tack Lea Works, Greenbooth Road, Norden, Rochdale

Archaeological Evaluation and Mitigation  
Built / Historic / Natural

| <b>Document:</b> | Archaeological Evaluation and Mitigation Report |

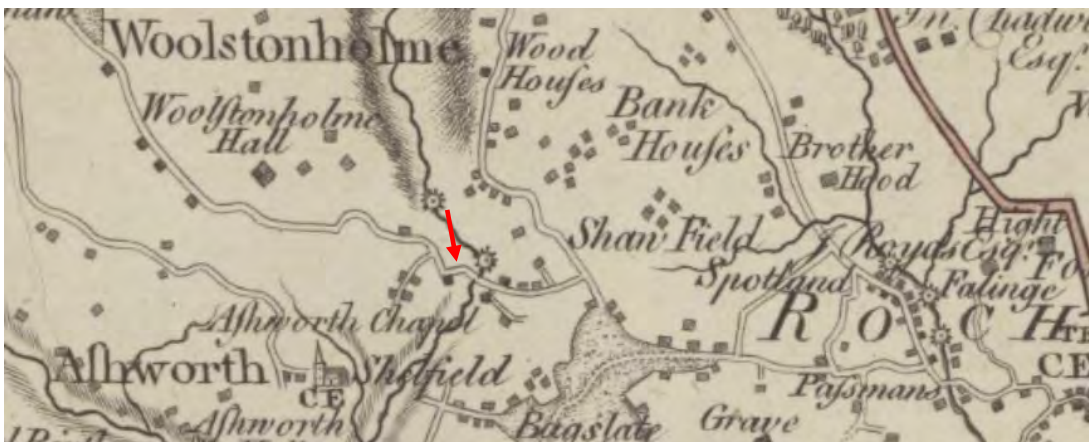
*Plate 1 Yates' map of Lancashire 1786, showing the approximate Site area*

- 4.5.1 The Site lies within Norden, Rochdale. Norden does not appear on 18<sup>th</sup>-century mapping, although Wolstenholme is captured on Yates's map of 1786 (Plate 1), which lies a short distance to the north-east of the Site. Ribbon development had taken place along the main lanes that connected to Rochdale to the surrounding settlements. This included Edenfield Road, which led to 'Wolstenholme'. Several watermills (or / and engines) had been erected along the various brooks and watercourses surrounding Wolstenholme, particularly Naden Brook that ran through the Site. A watermill may have fallen within the Site by the late 18<sup>th</sup> century however the map is produced at too small a scale to accurately determine. Furthermore, later maps show that the course of Naden Brook was altered to feed multiple reservoirs that were established within the Site.

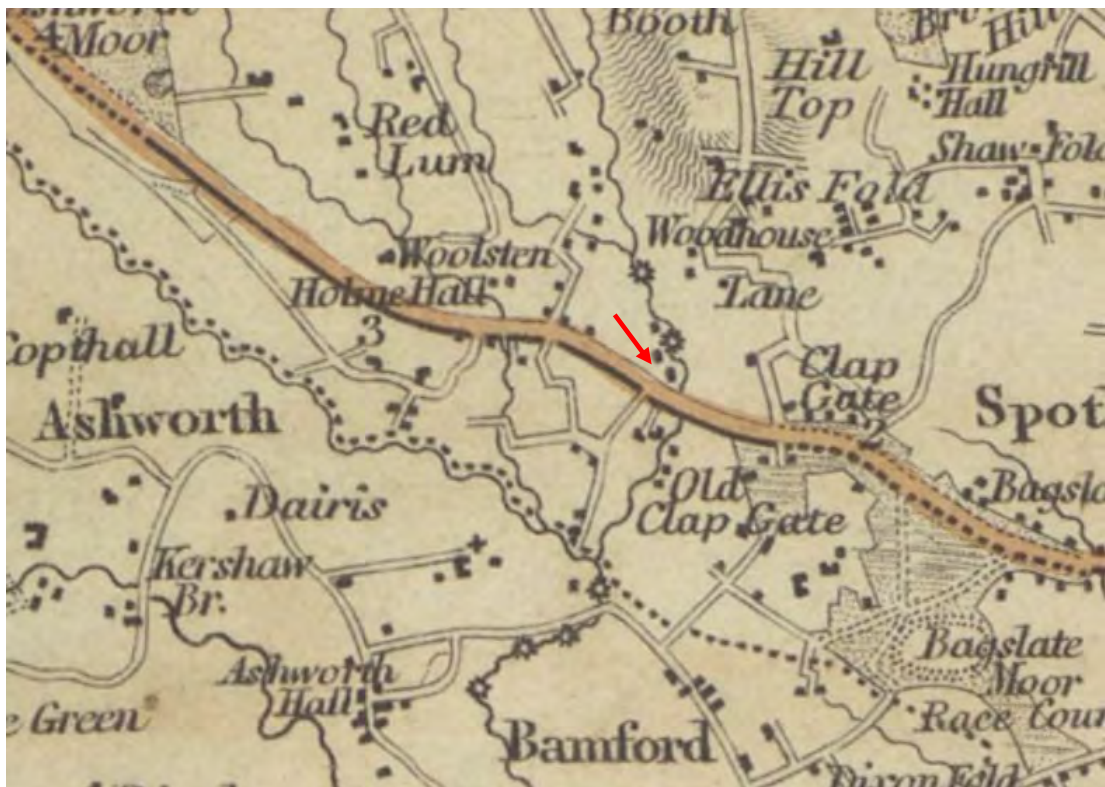
*Plate 2 Hennet and Bingley's map of 1830, showing the approximate Site location*

4.5.2 The next available map is Hennet and Bingley's plan of Lancashire, 1830 (Plate 2). Again, the map is produced at too small a scale to accurately pinpoint the Site location. However, buildings and a watermill are shown on the map and could represent Shepherd Mill. A fulling mill, commonly called Shepherd Mill, Spotland was advertised for sale in 1835, together with a mill dam, kiln, drying house, cottages and dwelling houses near Woodhouse Lane and closes lands and grounds known as Little Field, Mill Croft and Pitt-Hole, together with further plots of land (Manchester Courier, 12<sup>th</sup> September 1835). The property was owned by Elizabeth Barlow.

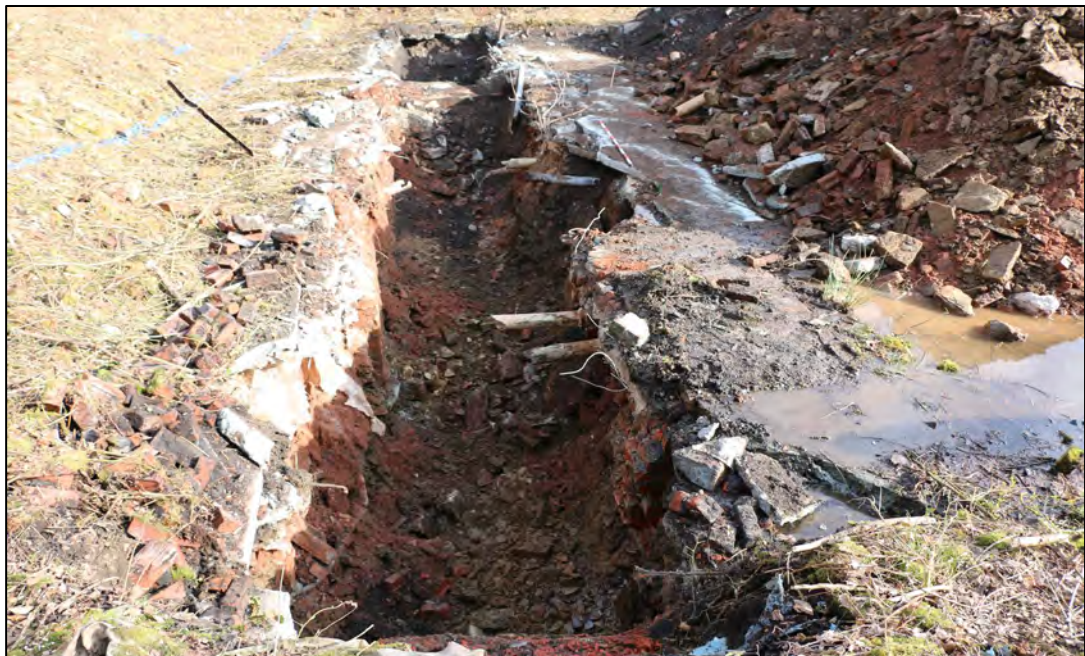
*Plate 7 General shot of Trench 1, looking south-east. Scale = 1 x 2m.*

- 6.3.4 The remnants of machine-made brick walls were partly visible in the north-east and south-west facing sections of the trench (Plate 7). The wall stubs seemed to have been bonded with hard grey mortar. The walls were not recorded due to health and safety constraints. The walls likely represented the foundations of an extension to the building in the north-west of the Site first shown on the 1929 plan (Figure 6).

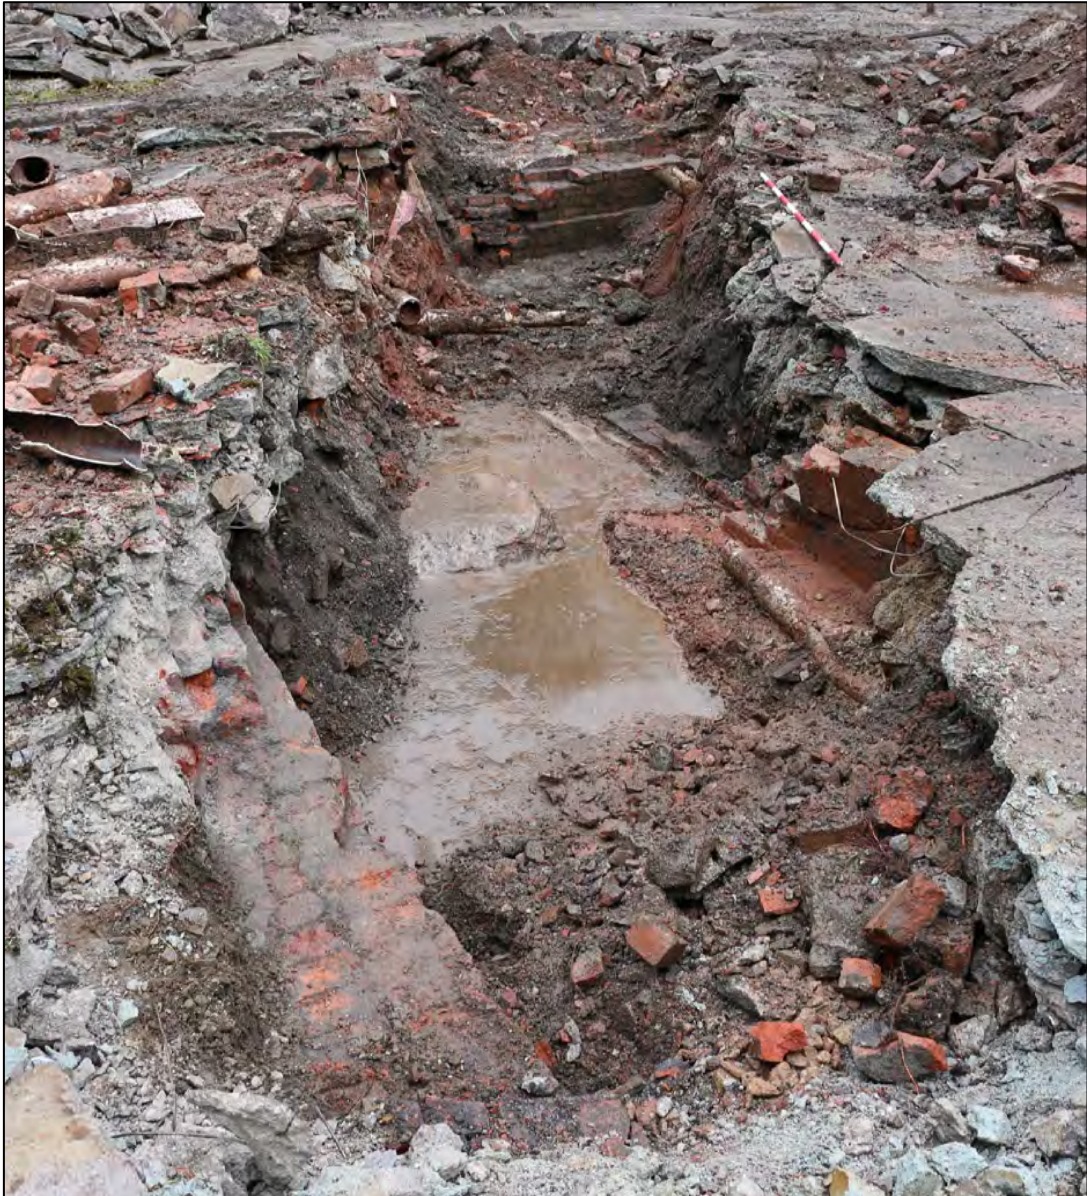
*Plate 8 General shot of Trench 2, looking north-east. Scale = 1 x 2m.*

- 6.4.4 The earliest structures observed in Trench 2 comprised walls [203], [205], and [207]. These structures likely represented remains of a building first shown on the 1910 plan (see Figure 5).
- 6.4.5 The remains of a wall [203] that was aligned north/north-east to south/south-west was excavated in the south-west end of the trench. The wall measured an observed length of 2.88m, continuing beyond the limit of excavation. The wall was 0.47m wide and survived up to c 1m high (Plate 9). The wall was constructed of red wire-cut bricks laid in English Garden Wall bond and bonded

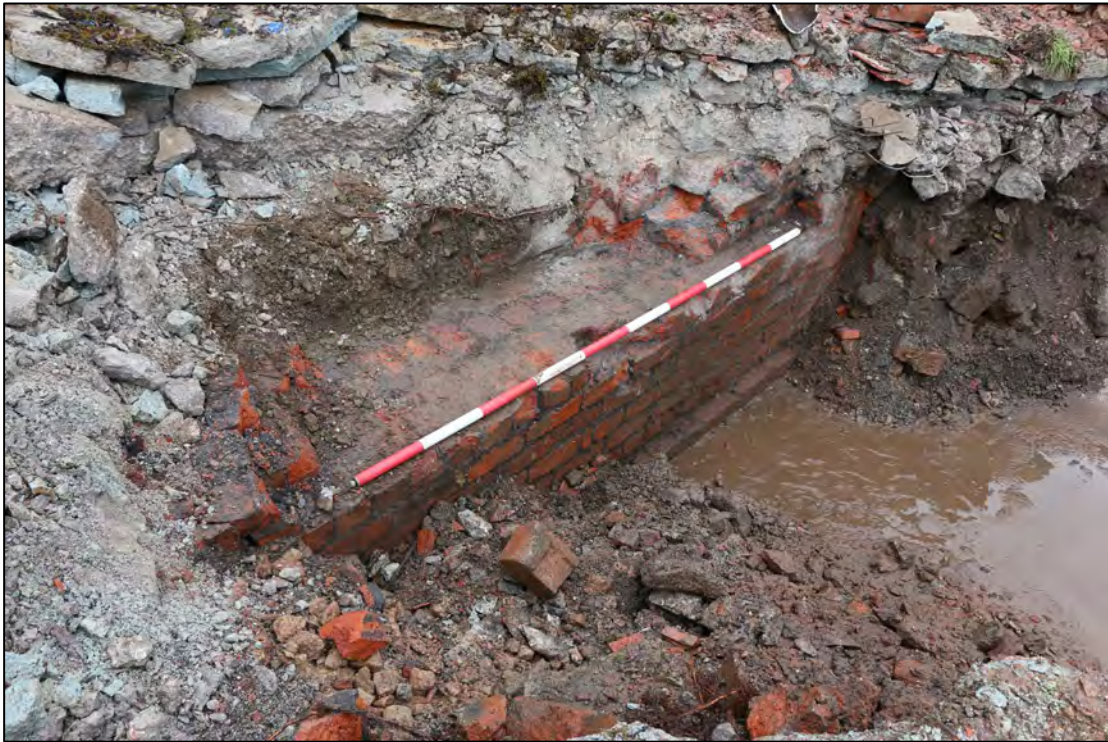
with a hard, dark grey, ashy mortar. The wall likely formed the west external wall of the building (see Figure 5).

*Plate 9 Shot of Wall [203] in Trench 2, looking south-west. Scale = 1 x 2m.*

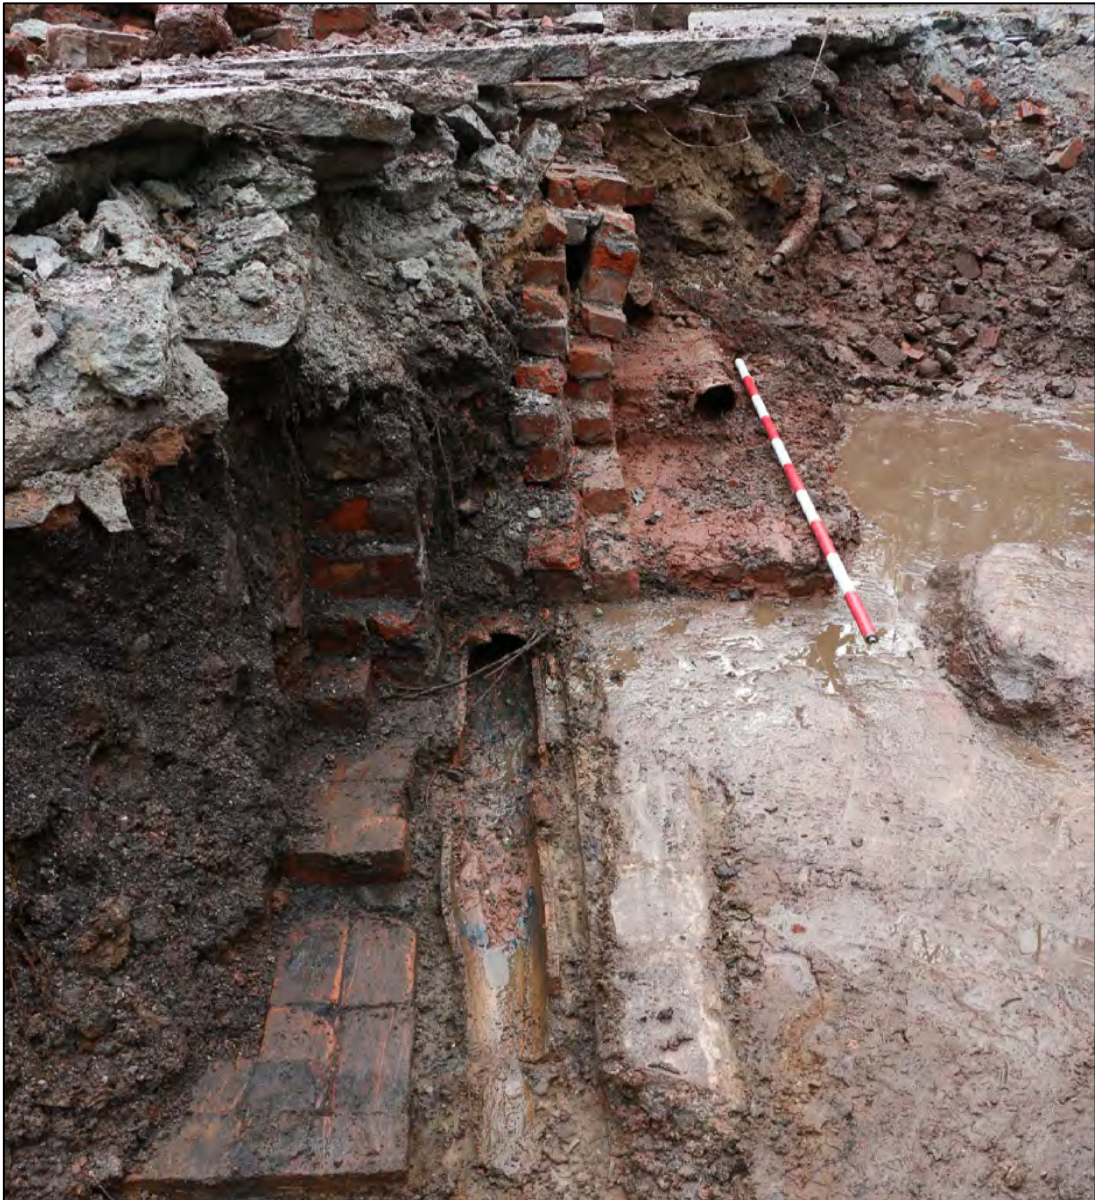
- 6.4.7 Poured concrete formed a surface [206] between walls [203] and [205], which measured 3.4m by 1.8m wide and was 0.09m thick (see Plate 10). The surface continued past the limit of excavation. A large square shaped concrete moulded rise was within the concrete surface. The concrete floor surface was likely a later addition, potentially post-dating the 1930s.

*Plate 10 Shot of Walls [205] (with ceramic pipe running alongside it) and [204], sand deposit (202) around a plastic pipe, and concrete surface [206] in Trench 2, looking south. Scale = 1 x 2m.*

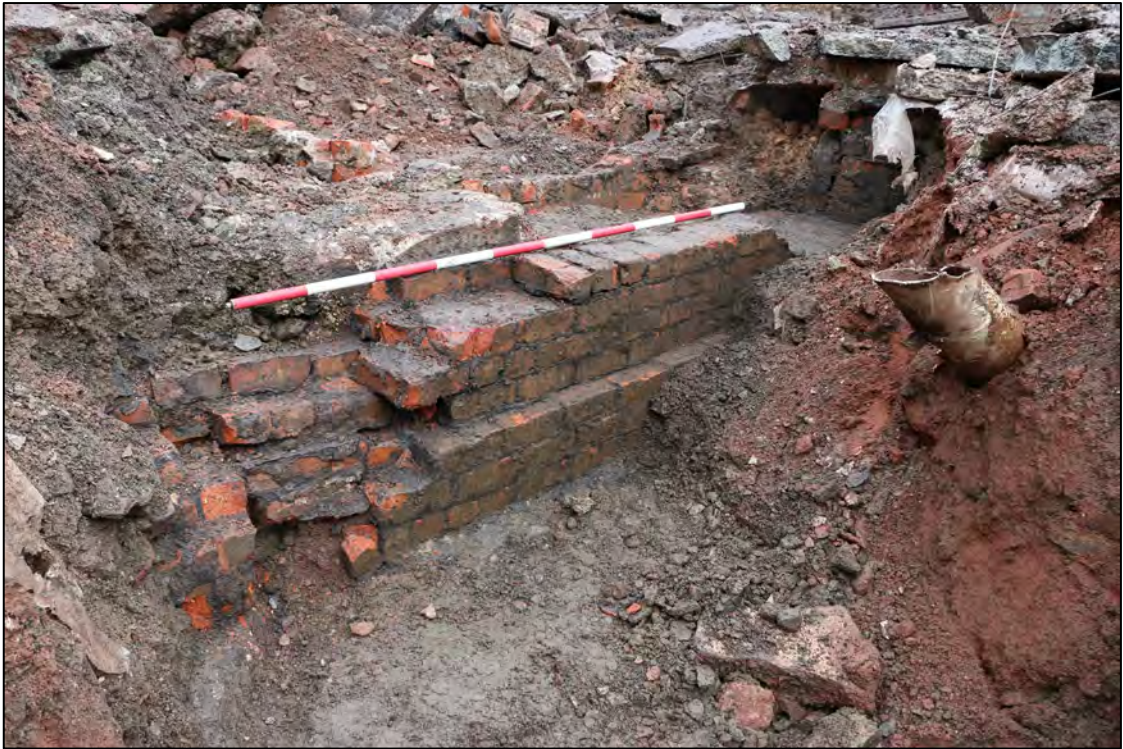
- 6.4.8 Wal [207] was aligned west/north-west to east/south-east and measured an observed maximum of 2.93m long, 0.65m wide and 0.68m high (Plate 11). Wall [207] was constructed of wire-cut red bricks laid in alternative header and stretcher bond and bonded with a hard, dark blackish grey, ashy mortar.

*Plate 11 Shot of Wall [207] in Trench 2, looking east. Scale = 1 x 2m.*

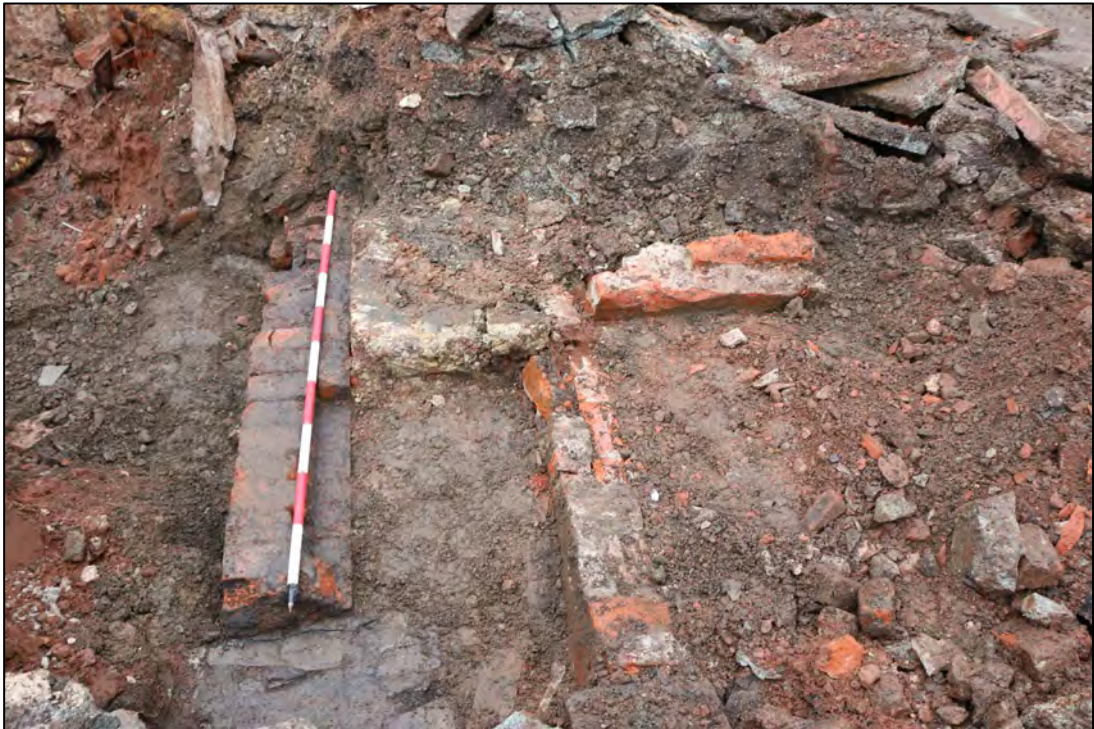
frogged red bricks laid in stretcher bond and bonded with a modern cement mortar.

*Plate 12 Shot of Wall [208] (right of concrete) in Trench 2, looking north-west. Scale = 1 x 2m.*

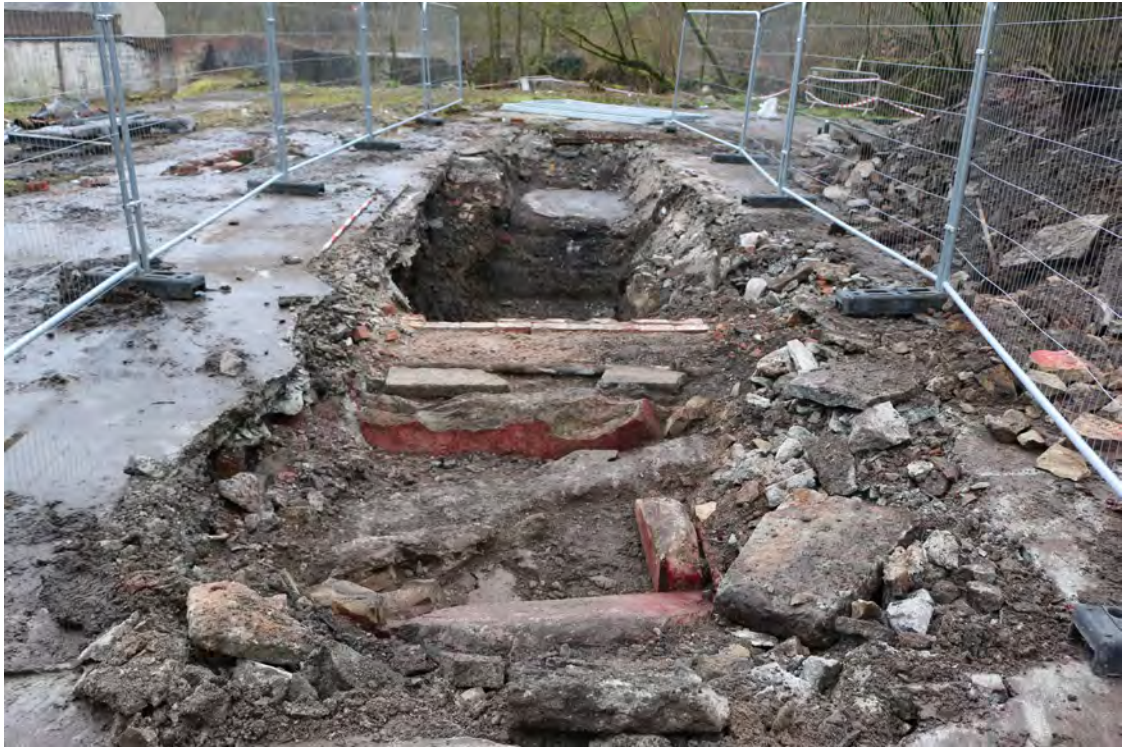
- 6.5.1 Trench 3 was located to the south-east of Trench 2 and was positioned over the potential location of the original engine house in the block that was first shown on the Ordnance Survey map of 1910 (Figure 5; Lanpro 2024).
- 6.5.2 Trench 3 measured a maximum of 13.7m long, 3m wide and 1.9m deep (Plate 13). The southern end of the trench could not be excavated due to a false floor covering a c 2.5m drop.

*Plate 13 General shot of Trench 3, looking north-east. Scale = 1 x 2m.*

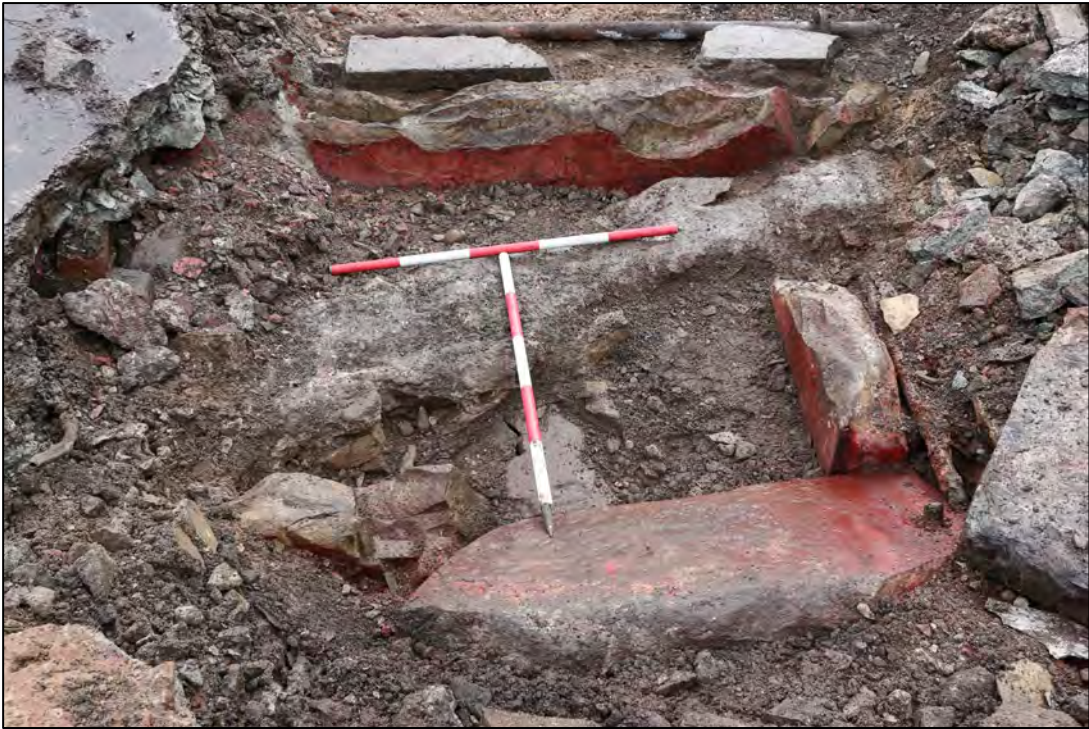
- 6.5.4 The upper remains of a stone-lined tank [305] was exposed in the north-east end of Trench 3 (Plate 14). The potential tank was constructed from three large gritstone slabs (the fourth wall of the tank likely lay beyond the trench edge) that were held into position by iron rods. The tank had an exposed area of 2.6m by 1.8m, though it appeared to continue beyond the trench edges. The inner and outer faces of the stonework were stained red, potentially from dye. The tank had been truncated by the installation of a ceramic drainpipe encased in modern concrete, aligned broadly east to west.

*Plate 14 Shot of Tank [305] in Trench 3, looking south-west. Scale = 2 x 1m.*

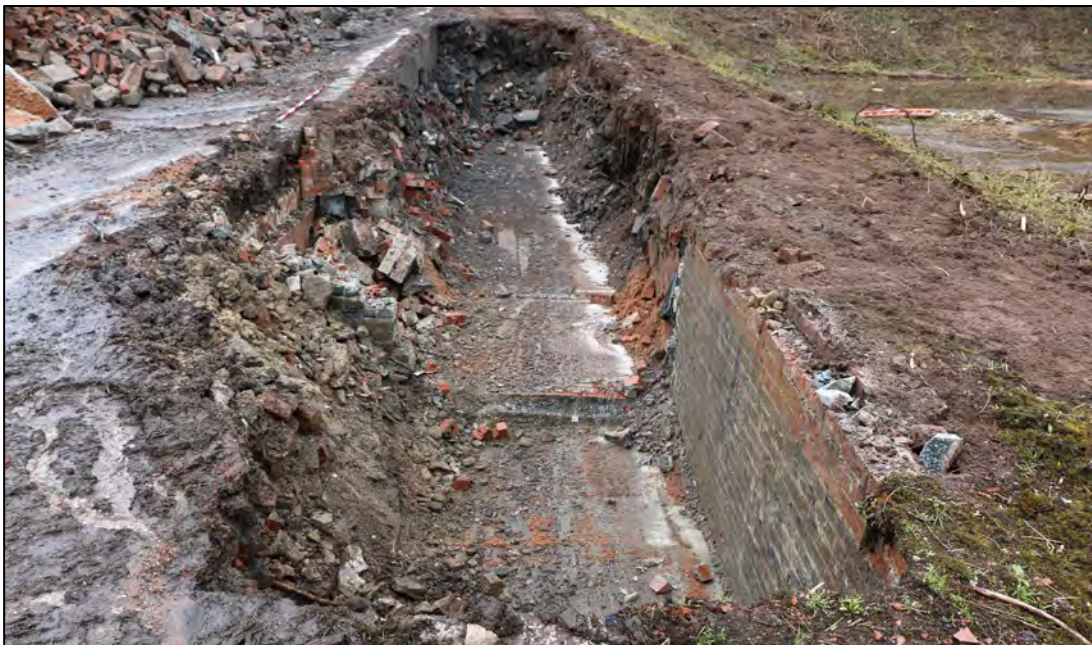
*Plate 15 General shot of Trench 4, looking north-east. Scale = 1 x 2m.*

- 6.6.1 Trench 4 targeted a rectangular building that formed part of the main mill block at Woodhouse Mill. The building was first shown on the 1893 plan (Figure 4). The 1910 plan (Figure 5) shows that the building was a separate structure potentially associated with the bleaching croft (Lanpro 2024).
- 6.6.2 The trench was aligned north-east to south-west and measured a maximum of 17.8m long, 3.1m wide and 2.2m deep (Plate 15). Site access prevented the trench from being fully excavated. The trench could not be entered due to health and safety constraints, therefore, all measurements were taken from ground level and were approximate.

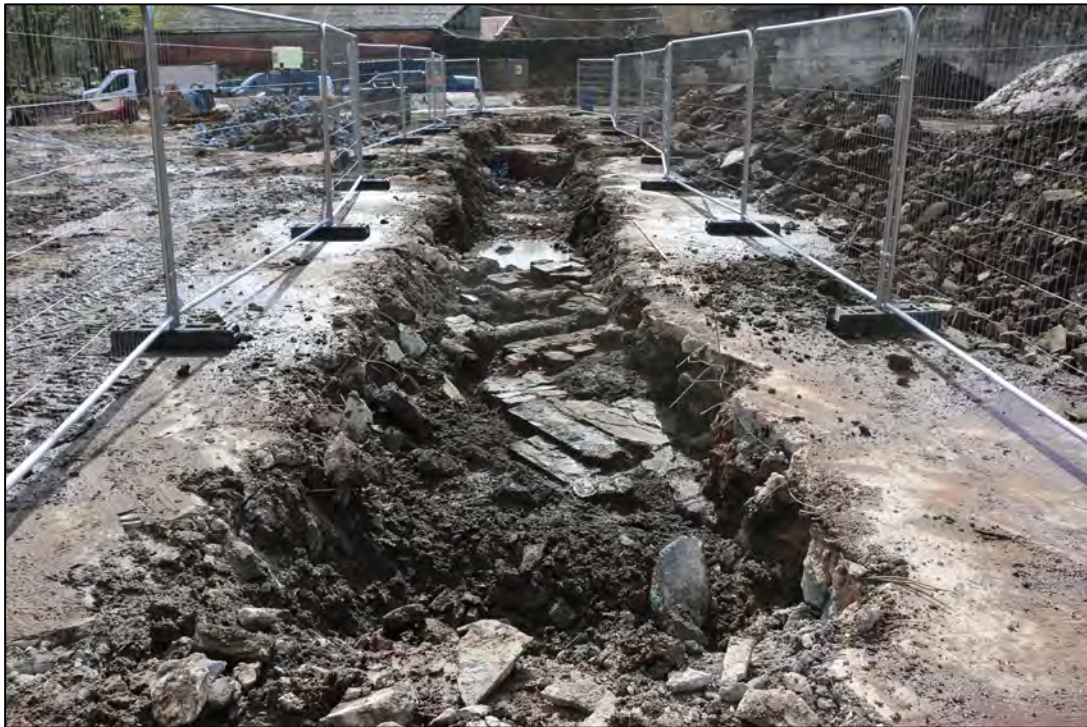
- 6.7.2 The presence of large earthen bunds that surrounded the Site prevented the trench from being fully excavated. Furthermore, health and safety constraints prevented the trench from being entered therefore, all measurements were taken from the current ground level.

*Plate 16 General shot of Trench 5, looking south-east. Scale = 1 x 2m.*

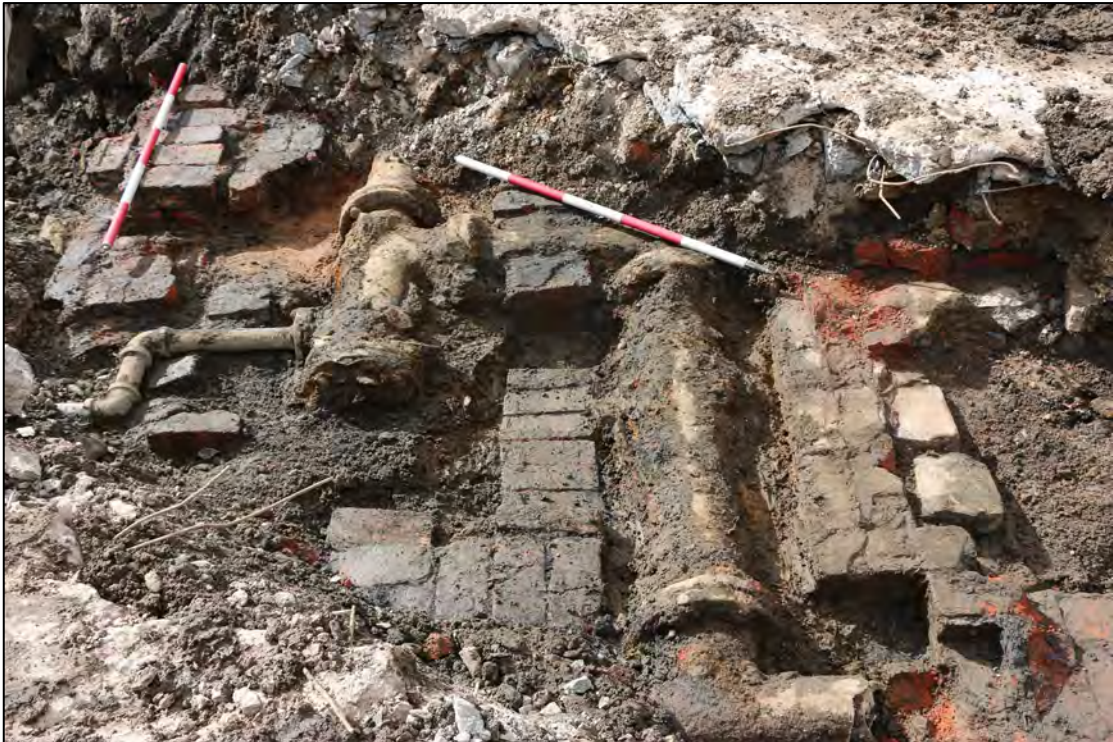
*Plate 17 From left to right, wall [508], pipework [510], wall [511] and wall [512] in Trench 5, looking north-west. Scales = 2 x 1m.*

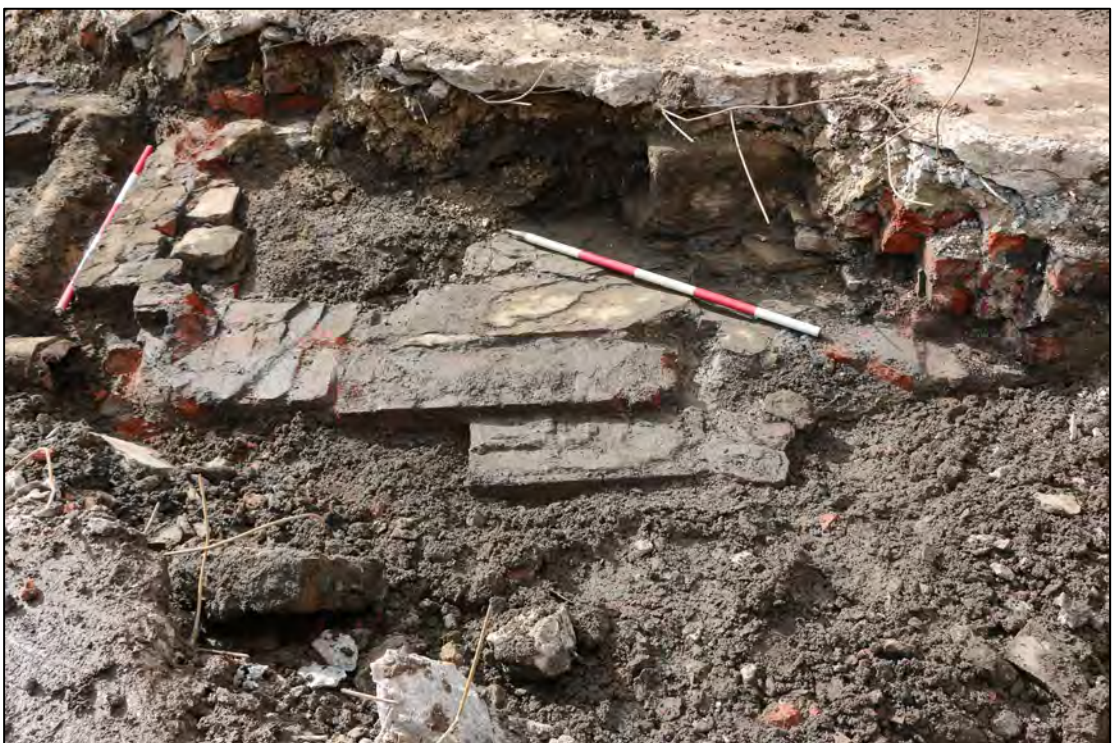
- 6.7.7 The north-east corner of a room was exposed in the north-west end of the trench (Plate 18). The room was demarcated by wall [512] that ran parallel to wall [511] for c 2.4m before returning to the north-west (measuring c 2.9m). The walls of the room were mostly c 0.48m wide and survived between 0.56m to 0.67m high (in the north-east facing section of the trench edge). The fabric of the wall consisted of a mixture of reused handmade bricks and machine-made bricks bonded with hard dark greyish black mortar. Modern cement had been used to repair some of the brickwork. Stone blocks had been incorporated into the north-west facing side of the wall. These may have been reused from an earlier phase of activity. A large stone slab abutted the north-west return and may have paved the room.

*Plate 18 View of potential north-east corner of a room demarcated by wall [512], showing stone inserts, looking north-west/west*

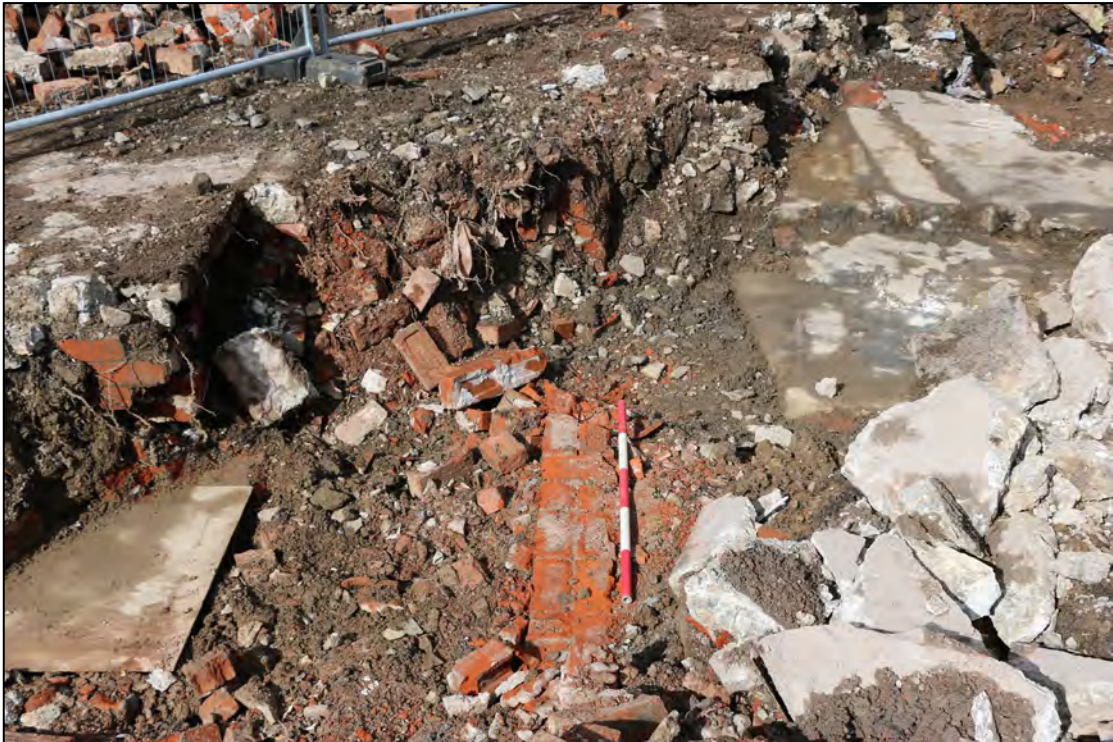
- 6.7.9 The remains of a modern frogged brick wall bonded with a modern cement [503] were excavated to the north of the concrete slabs [502] (Plate 20). The wall was laid in stretcher bond and was aligned west/north-west to east/south-east. The wall measured 2.62m long, 0.23m wide and survived up to 0.15m high and continued beyond the limit of excavation.
- 6.7.10 A modern concrete floor surface [504] was excavated to the north-east of the wall [503] (Plate 20), covering an exposed area of 3.89m by 1.83m that extended beyond the trench edges. The concrete was 0.32m thick.

*Plate 20 Shot of wall [503] and concrete [504] in Trench 5, looking west-north-west. Scale = 1 x 1m.*

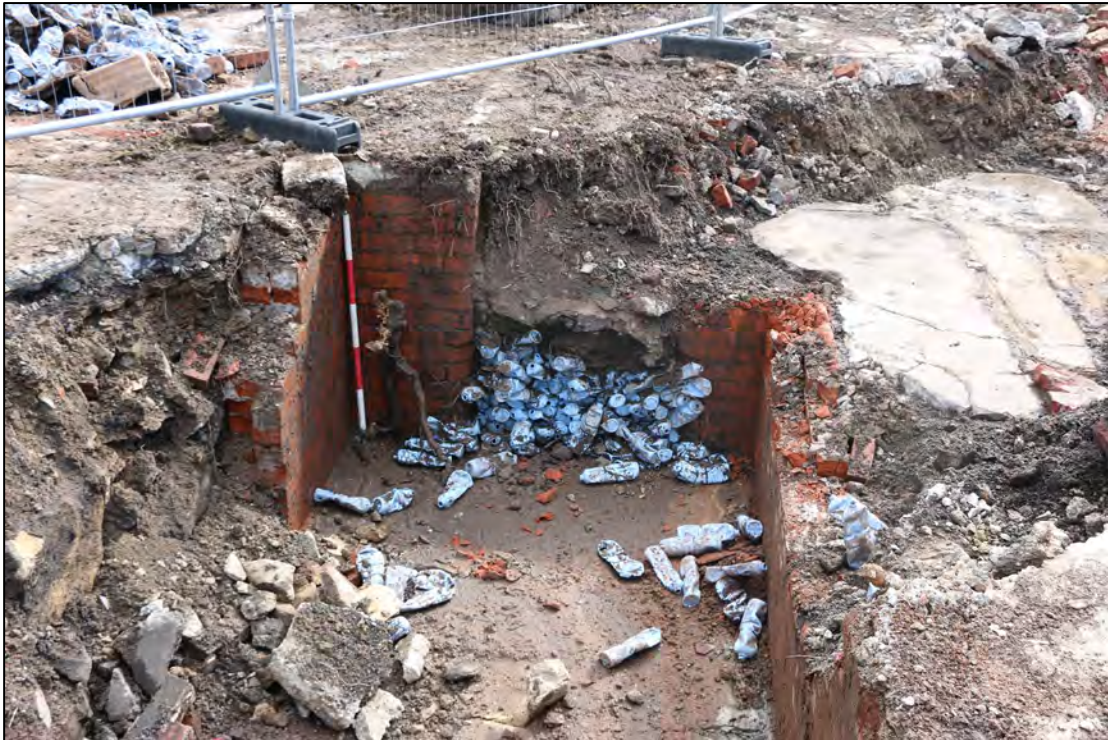
- 6.7.13 The surface of the room was paved with rectangular sandstone flags [506] (Plate 21). Each flag measured approximately 0.5m long, 0.3m wide and 0.03m thick. Mortar did not survive between the stone slabs. The surface measured 3m by 2m, continuing past the limit of excavation.

*Plate 21 Shot of walls [505] and [509] and surface [506] in Trench 5, looking east. Scale = 1 x 1m.*

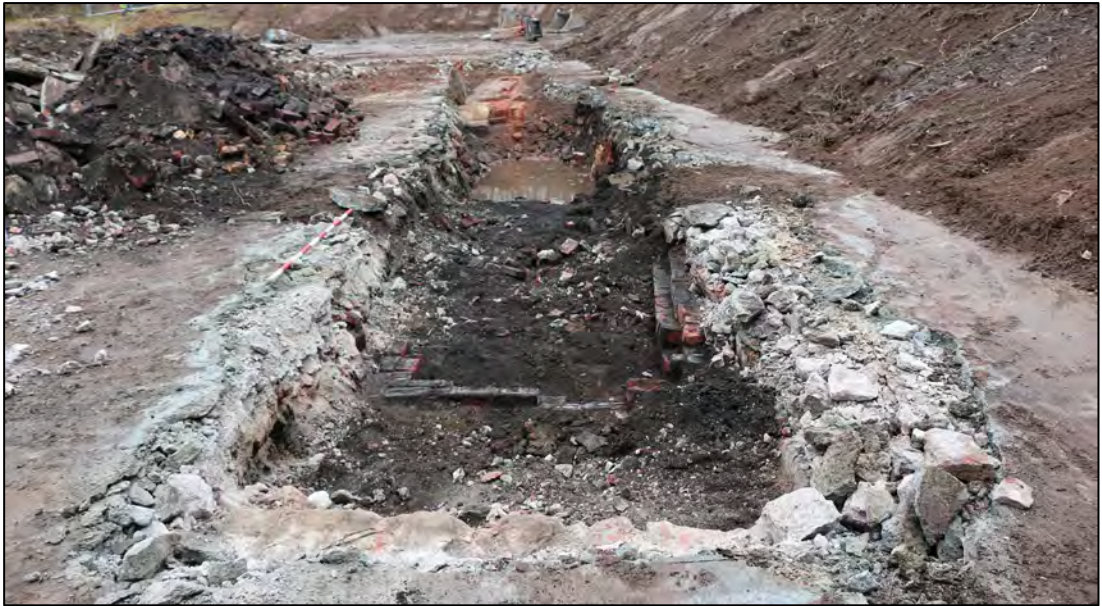
*Plate 22 General shot of Trench 6, looking north-west, showing concrete [606] and modern wall [605] in the foreground. Scale = 1 x 2m.*

6.8.1 Trench 6 was aligned north-west to south-east and measured 21.7m long, 2.6m wide and 1.05m deep (Plate 22). Trench 6 targeted the main mill building first shown on mid-19<sup>th</sup>-century mapping (Figure 3; Lanpro 2024).

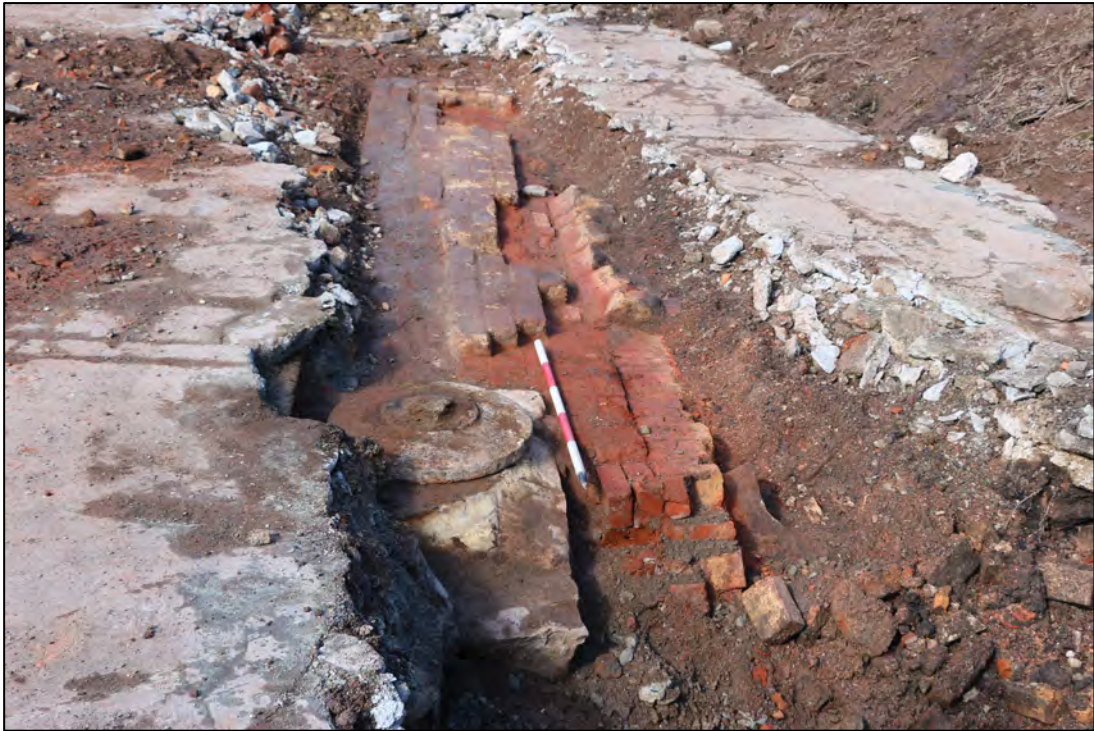
*Plate 23 Shot of Boiler Bed [602] in Trench 6, looking north-west. Scale = 1 x 1m.*

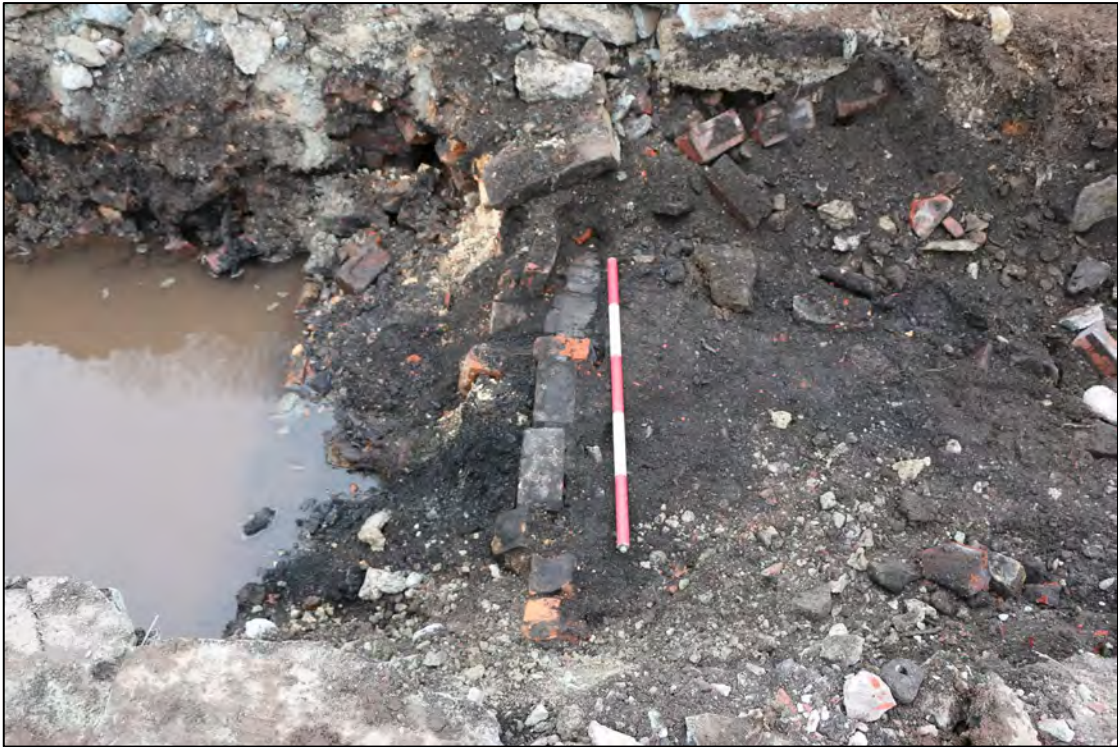
- 6.8.5 The remains of a brick surface [607] were excavated within broadly the centre of the trench however, as soon as this was uncovered, the trench quickly filled with water (Plate 24). The surface was constructed of handmade red brick and yellow fire brick laid in an irregular bonding pattern and bonded with a sandy lime mortar. The surface had an exposed length of 1.21m and a width of 1.5m, which continued beyond the limit of excavation.
- 6.8.6 At the south-eastern edge of brick surface [607], a north-west to south-east aligned brick wall [604] was excavated (Plate 24). The wall [604] was heavily truncated and was constructed from red wire-cut bricks bonded with a hard black ashy mortar and laid in stretcher bond. The wall measured an exposed length of 1.65m, continuing beyond the trench edge. The wall was 0.11m wide and survived up to c 0.15m high.

*Plate 24 Shot of poorly preserved wall [604], also showing flooded area that covered surface [607]*

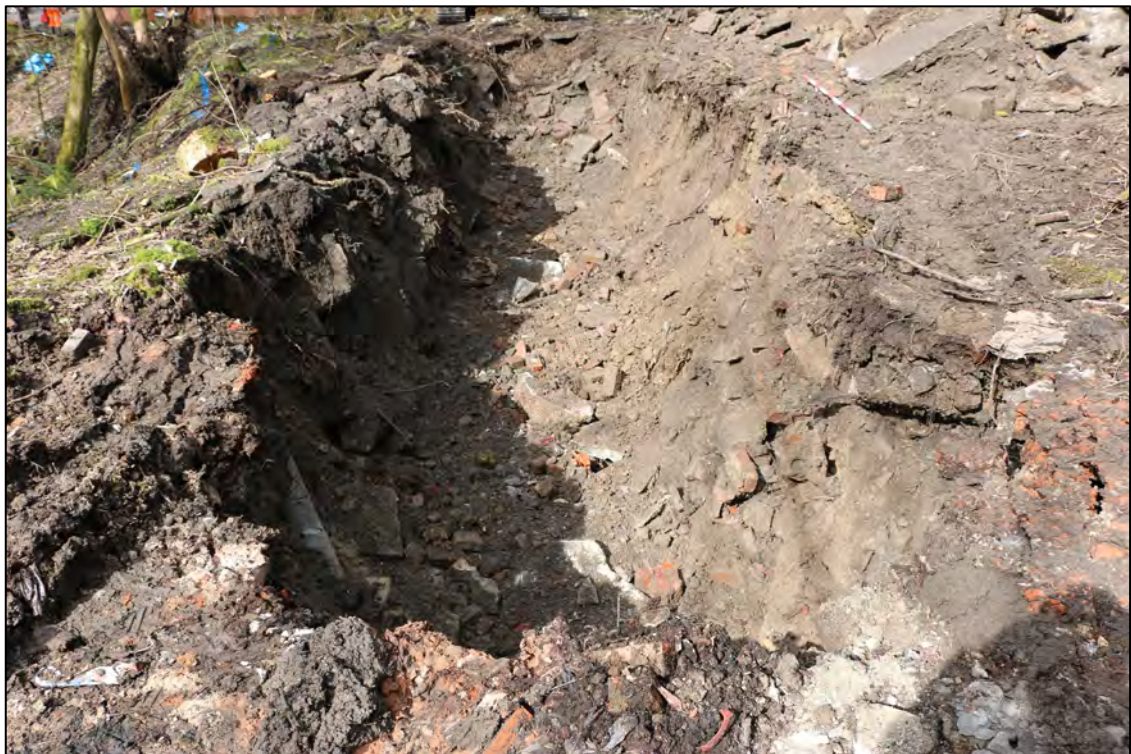
- 6.9.3 A layer of greyish brown silty sand with frequent stone and brick rubble (700) was observed throughout the excavation of Trench 7, measuring 2.6m thick. This layer was likely created during the demolition of the pre-existing mill buildings on the Site.

- 6.9.4 Trench 7 was devoid of archaeological remains.

*Plate 25 General shot of Trench 7, looking north-west. Scale = 1 x 2m.*

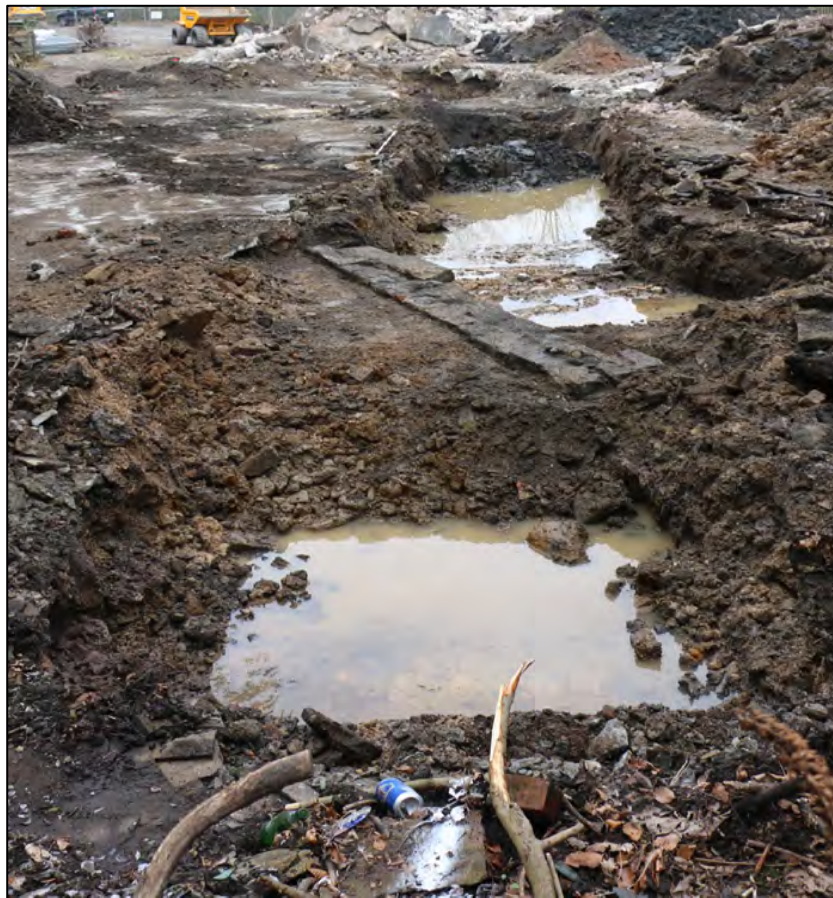
6.10.1 Trench 8 targeted the north-western end of a building that was associated with Shepherds Mill, first captured on the 1851 map (Figure 3). The building lay close to a large weir that had been extended by the 1890s (Figure 4), potentially to include a chimney and stair tower (Lanpro 2024). The purpose of this trench was to ascertain whether the building was associated with the mill's water management system. The trench measured a maximum of 30.2m long, 3m wide and 2.65m deep (Plate 26).

*Plate 26 General shot of Trench 8, looking south-south-east. Scale = 1 x 2m.*

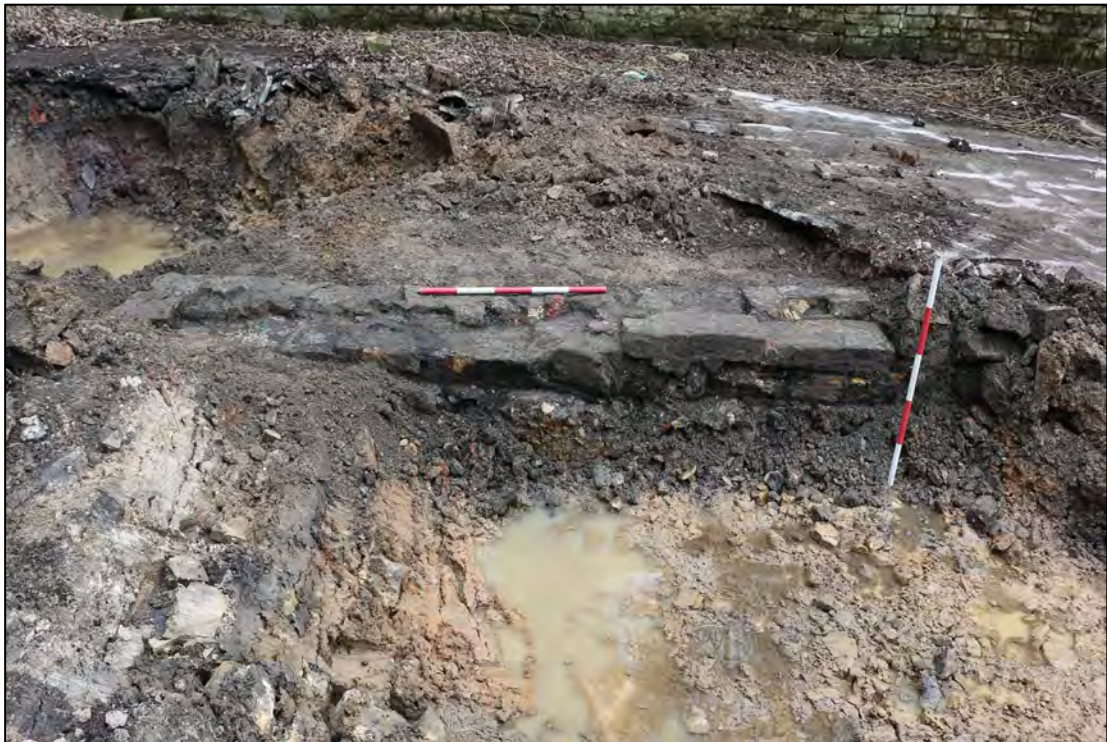
- 6.10.4 The remains of a stone wall were excavated in the north-west end of the trench. The stone wall [803] was constructed above foundation deposit (807). The wall was aligned north-west to south-east and measured a maximum exposed length of 4.3m, continuing beyond the east edge of the trench. The wall was 0.6m wide and survived up to 0.34m high. The wall was constructed of roughly hewn sandstone and gritstone blocks that measured between 0.36m to 0.7m long, 0.26m to 0.33m wide and 0.08m to 0.1m thick (Plate 27). The wall included reused handmade bricks bonded with a hard black ashy mortar, which may have been used to repair the wall. The section of the wall that included bricks measured 0.39m long and was 0.11m high.

*Plate 27 South-west facing elevation of foundation deposit (807) and wall [803], looking north-east. Scales = 2 x 1m.*

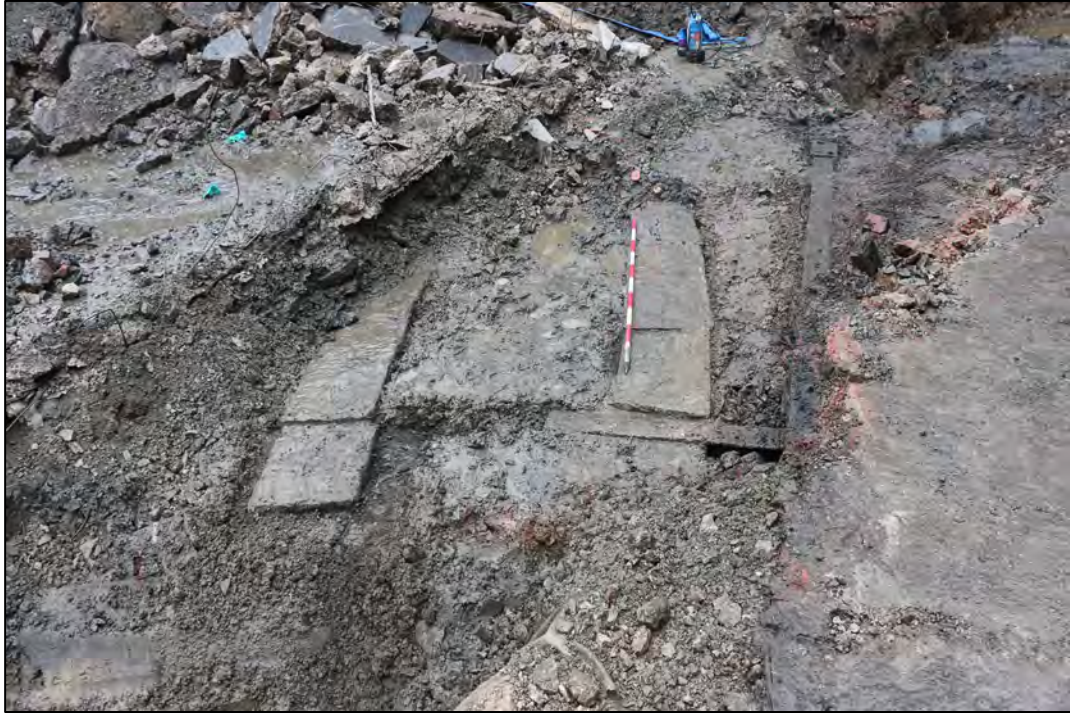
measured an exposed length of 5.4m, continuing beyond the limit of excavation. The walls were 0.36m wide and were constructed of roughly hewn gritstone blocks measuring between 0.36m to 0.8m long, 0.3m to 0.33m wide and 0.08m to 0.1m thick.

*Plate 28 Walls [806], looking north-west. Scale = 1 x 2m.*
