SA/2024/25

# Tack Lea Works, Greenbooth Road, Norden, Rochdale

Archaeological Evaluation and Mitigation  
Built / Historic / Natural

| <b>Document:</b> | Archaeological Evaluation and Mitigation Report |

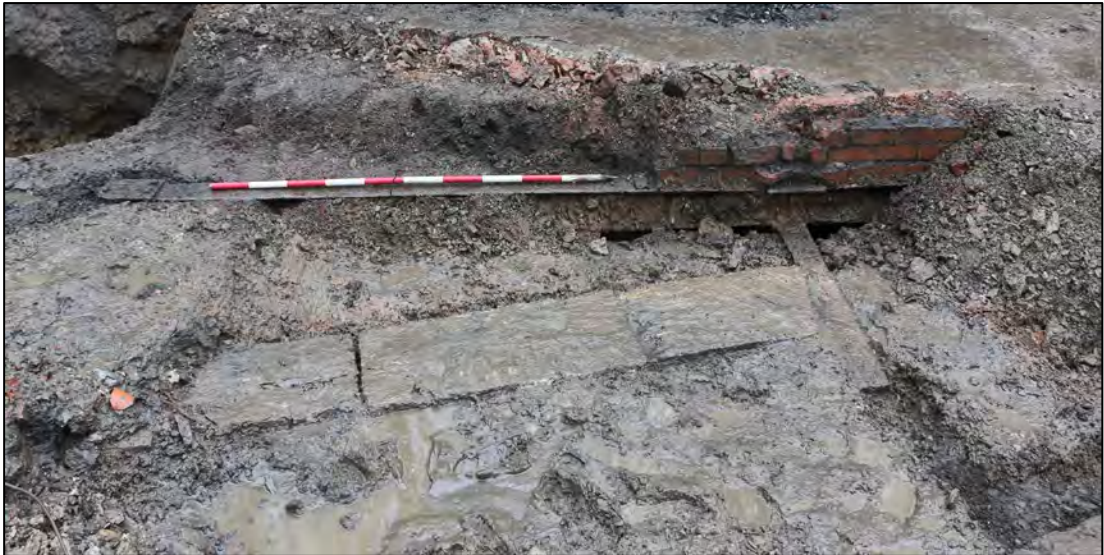
6.10.6 A large north-west to south-east aligned modern slipped red brick, and gritstone-built drain [805] lay in the south-east end of the trench (Plate 29). The drain was bounded by a modern red brick wall that was exposed in the east trench edge. The drain [805] measured 9.7m long, 0.7m wide and 2.16m high, continuing beyond the limit of excavation. The drain truncated earlier remains in this part of the Site.

*Plate 29 Shot of Drain [805], looking north-east. Scale = 1 x 2m.*

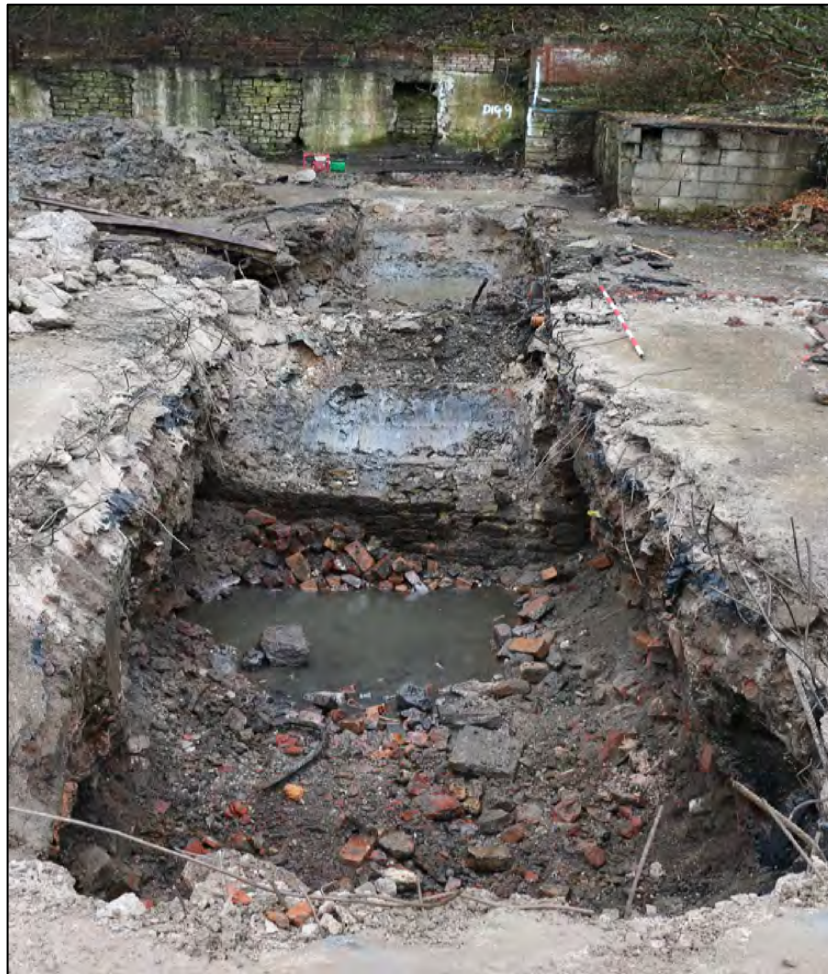
- 6.11.2 Trench 8 was aligned north-east to south-west and measured a maximum of 20.1m long, 2.7m wide and 2.4m deep (Plate 30).
- 6.11.3 The north-eastern half of the trench was excavated between 1.29m and 1.8m deep due to the water table. Therefore, the geological natural substrate (905) was not exposed in this part of the trench.

*Plate 30 General shot of Trench 9, looking north-east. Scale = 1 x 2m.*

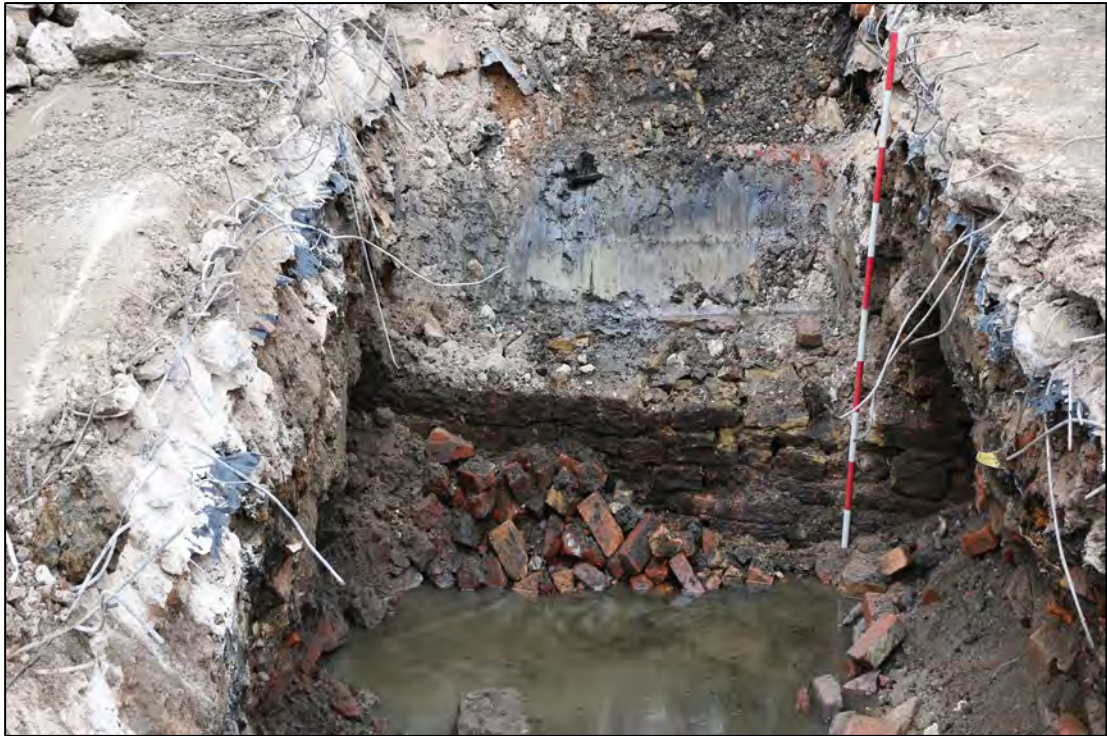
- 6.11.4 A very compacted light yellowish-brown buff clay with occasional gritstone inclusions (905) was excavated in the south-west end of the trench and represented the natural geology. The natural geology (905) was excavated at a depth of 1.83m below the current ground surface.
- 6.11.5 The earliest structure observed in Trench 9 was excavated in the south-western half of the trench and consisted of a stone-built wall [904] that was cut into the natural geology (905). The wall [904] ran through the width of the trench (c 2.7m), continuing beyond the trench edges (Plate 31). The wall survived between 0.62m high and 1.10m high (in the south-west trench edge). The wall was c 1m wide and was constructed of roughly hewn gritstone blocks. The wall likely represented the north wall of a reservoir or an associated channel that fed the reservoirs.

*Plate 31 South-west elevation of reservoir wall [904], looking north-east. Scale = 1 x 2m.*

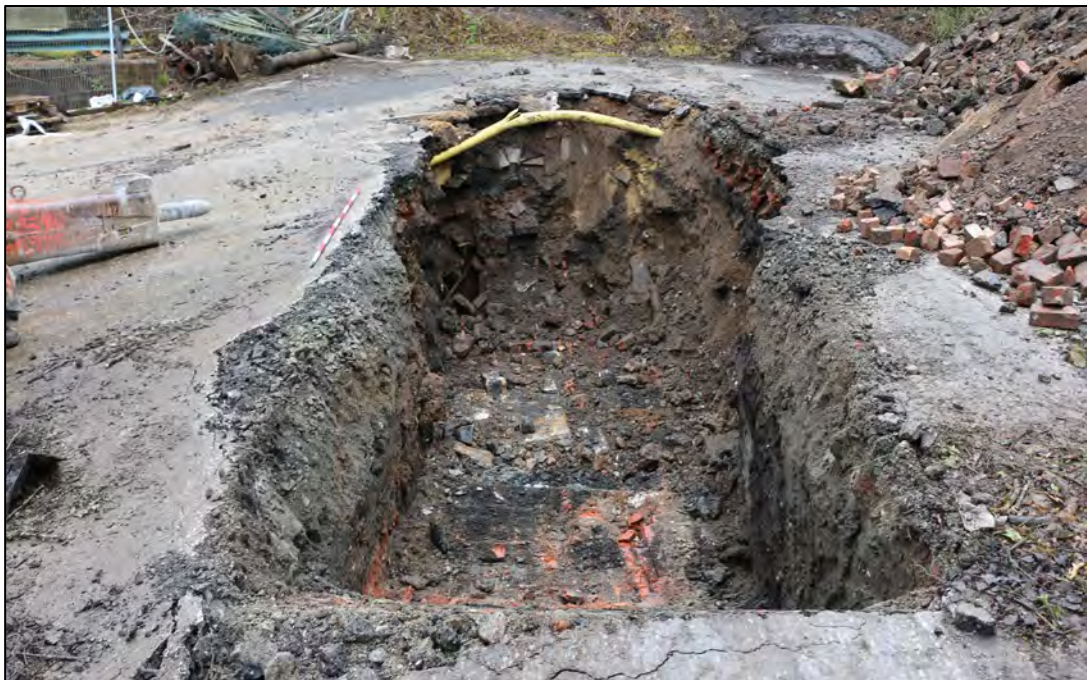
6.12.2 Trench 10 was aligned north-east to south-west and measured a maximum of 10.4m long, 3.8m wide and 2.4m deep (Plate 32). The trench had to be shortened due to its proximity to a metal fence that separated the Site from the brook.

*Plate 32 General shot of Trench 10, showing wall [1003] in the foreground, looking north-east.*

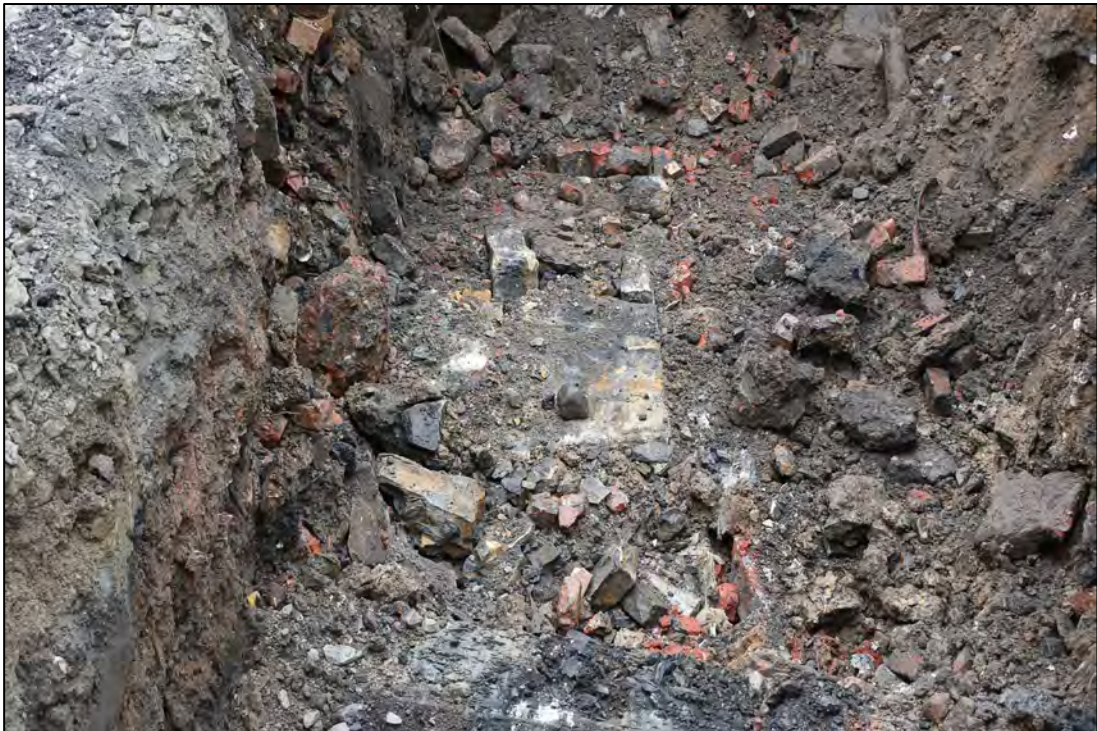
*Plate 33 General shot of machine bed [1004], looking north-east.*

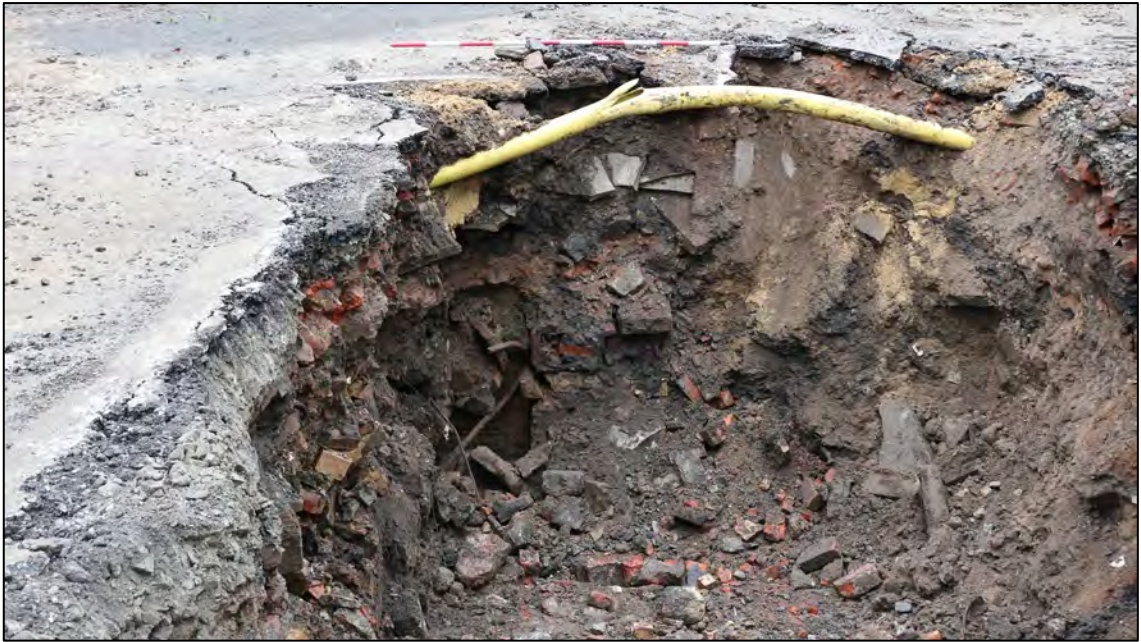
- 6.12.6 A stone-built wall [1005] aligned west/south-west to east/north-east was excavated in the north-east end of the trench, temporarily visible within the south-west facing section of the trench (Plate 34). The wall was likely an external wall of a building associated with Shepherds Mill and was constructed of roughly hewn stone blocks bonded with a hard black ashy mortar. The wall had a buttress that measured 0.9m wide. No further measurements could be obtained due to the trench edges collapsing.

*Plate 34 Shot of wall [1005] partly visible in the north-east end of the trench, looking south-west*

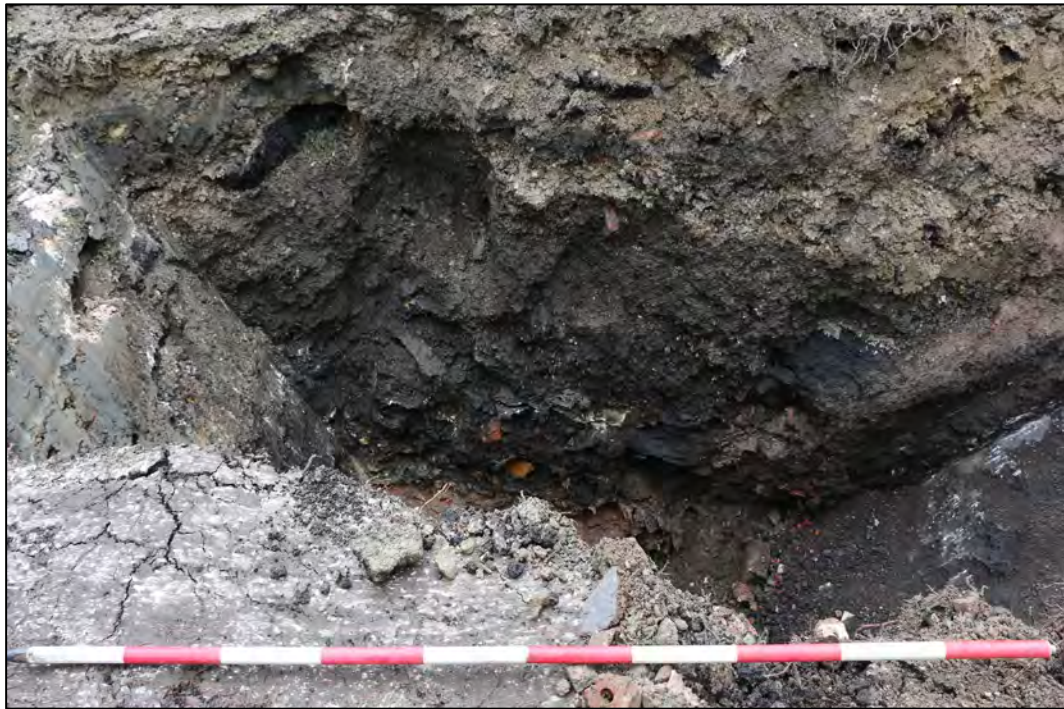
- 6.13.5 No archaeological features or structures were observed in Trench 11.
- 6.13.6 A silty clay with frequent brick and stone rubble (1101) filled Trench 11 (Plate 35), measuring c 3.06m deep. This was likely created by the demolition of buildings on the Site.
- 6.13.7 A modern asphalt surface [1100] overlay the demolition layer (1101) and measured 0.14m thick.

*Plate 35 South-west facing section of Trench 11, looking north-east. Scale = 1 x 2m.*

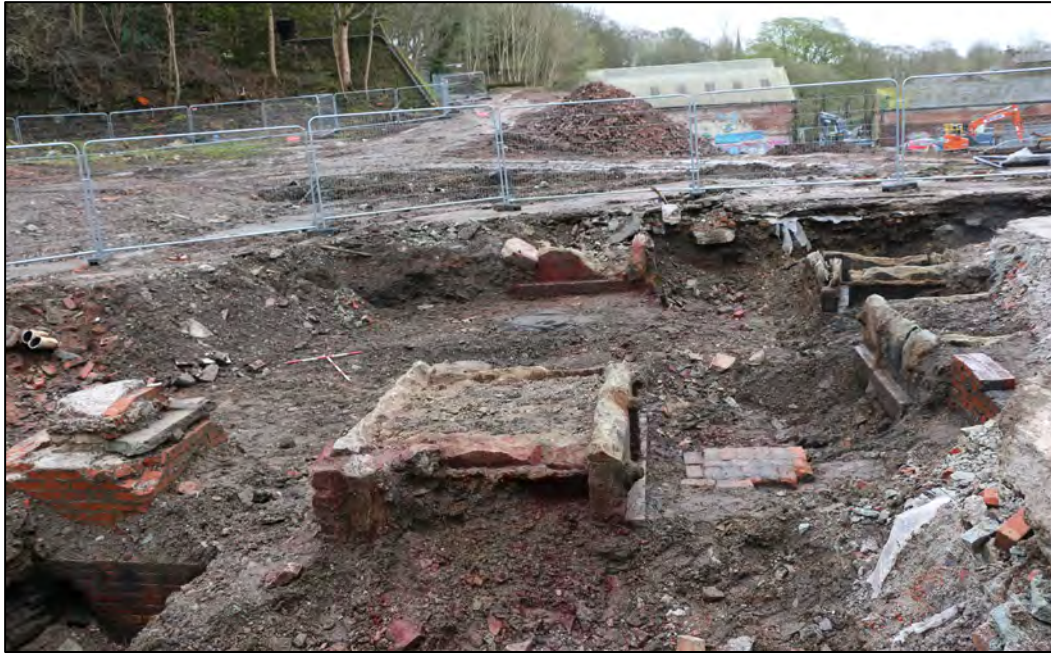
- 6.15.1 Area A lay between evaluation trenches 2 and 3 (Plate 36) targeting an area that contained stone-lined tanks that likely correlated with a building that was first shown on the 1910 plan (Figure 5) and extended by 1929 (Figure 6) that may have undertaken the dyeing process.

*Plate 36 General shot of Area A, showing a series of stone-lined tanks looking south-east.*

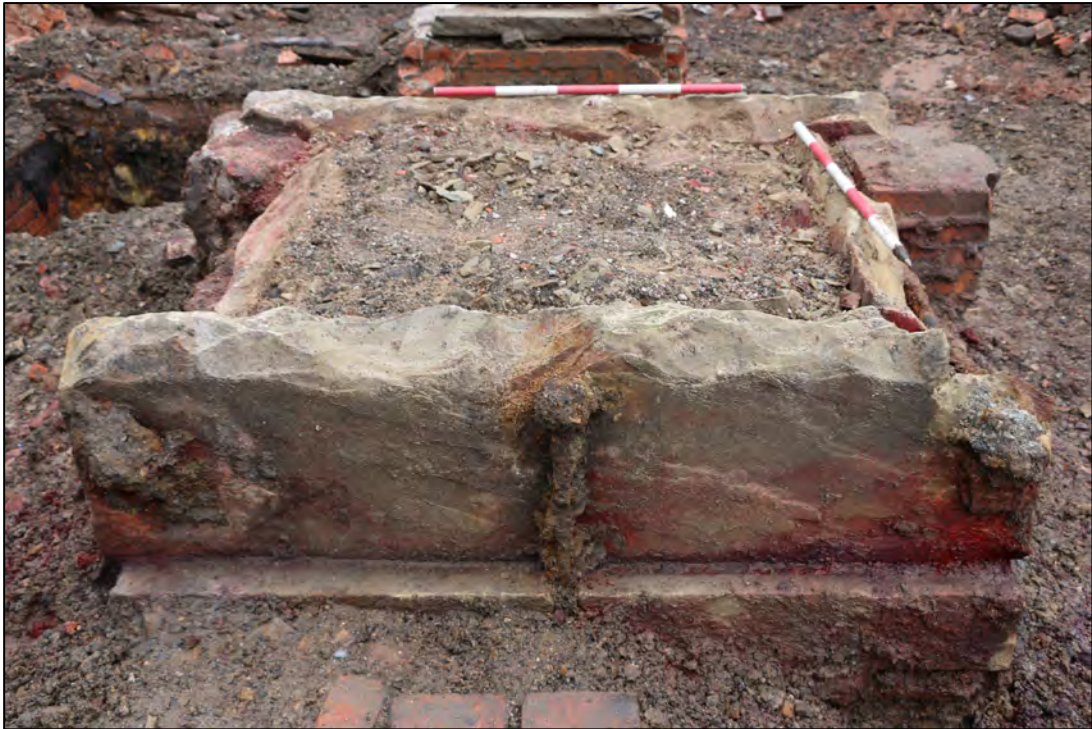
6.15.4 In total, four stone-built tanks were partly or fully exposed within the excavation area. A stone-built dye tank [2004] was excavated in the north-west of the excavation area (Plate 37). The stone-built tank was aligned north-west to south-east and measured 2.51m by 1.96m wide. The tank had an exposed height of 0.75m. The fabric of the tank consisted of roughly hewn gritstone slabs that varied in size between 1.54m to 2.54m long, 0.55m to 0.56m wide and 0.18m to 0.22m thick. The stone walls of the structure were pinned together using long iron rods and pins. Red dye stained the exterior faces of the stone tank. The tank was heavily truncated.

*Plate 37 Shot of dye tank [2004], looking south-east. Scales = 2 x 1m.*

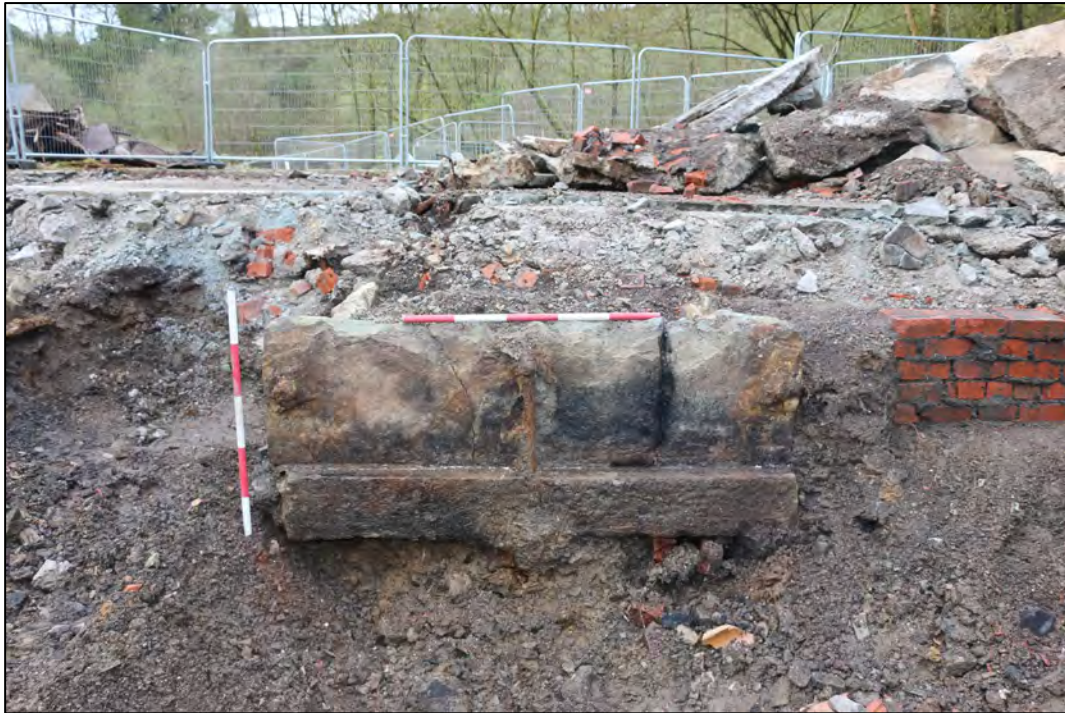
6.15.5 Stone-built dye tank [2005] was partly excavated in the south-west edge of the trench (Plate 38). The dye tank was also aligned north-west to south-east and measured an exposed area of 2.1m by 1.22m. The tank continued beyond the limit of excavation. The tank had an exposed height of 0.83m formed from two courses of stone slabs. The tank was of the same construction as tank [2004]. The exterior stone faces of the tank were stained black. The tank was also heavily truncated.

*Plate 38 Shot of dye tank [2005], looking south-west. Scales = 2 x 1m.*

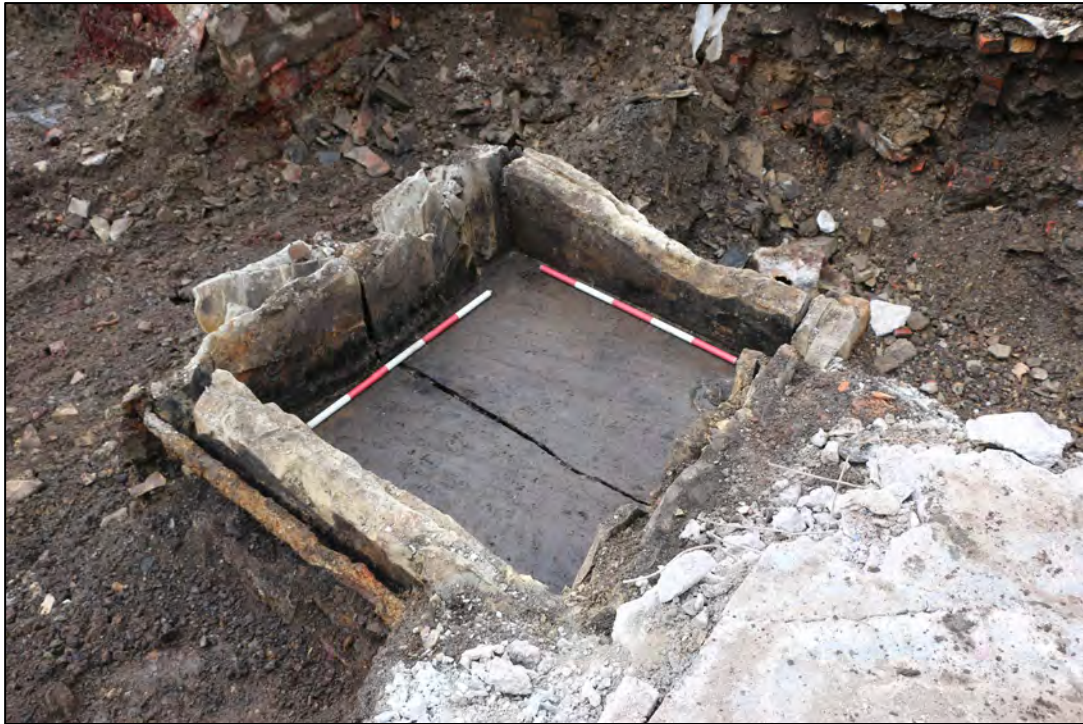
6.15.6 A third stone-built dye tank [2006] was located south-east of tank [2005]. The tank was roughly square measuring 2.16m by 2.04m and had an exposed height of 0.67m (Plate 39). The tank [2006] was of the same construction as dye tanks [2004] and [2005]. Each stone slab measured between 2.16m to 1.4m long, 0.48m to 0.5m wide and 0.22m thick. The internal stone faces were stained by black dye. The interior of the tank was also excavated revealing the stone base of the tank. The stone slab base had a sub-circular plug hole cut into the corner that was plugged with a metal stopper.

*Plate 39 Shot of stone-built tank [2006], looking east. Scales = 2 x 1m.*

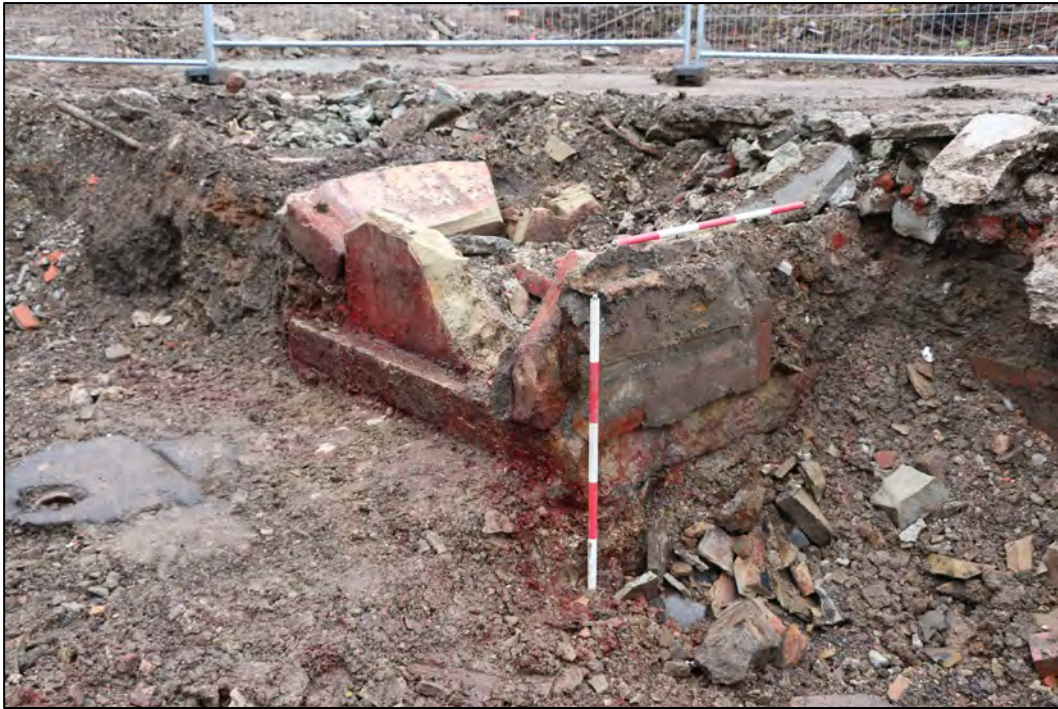
6.15.7 A fourth stone-built tank [2007] (recorded as [305] during the evaluation) was located north-east of tank [2006] (Plate 40). The tank was also aligned north-west to south-east and measured a maximum exposed area of 1.96m by 1.76m, continuing beyond the south-east trench edge. The tank survived up to 0.78m high. Tank [2007] was of the same construction as the other three tanks described above. Each stone slab measured between 1.4m to 1.76m long, 0.55m wide and 0.2m to 0.26m thick. Red dye stained the external faces of the stonework. The stone tank was heavily truncated by a modern drainpipe set in concrete (as described above, Trench 3, p37).

*Plate 40 Shot of dye tank [2007], looking east. Scales = 2 x 1m.*

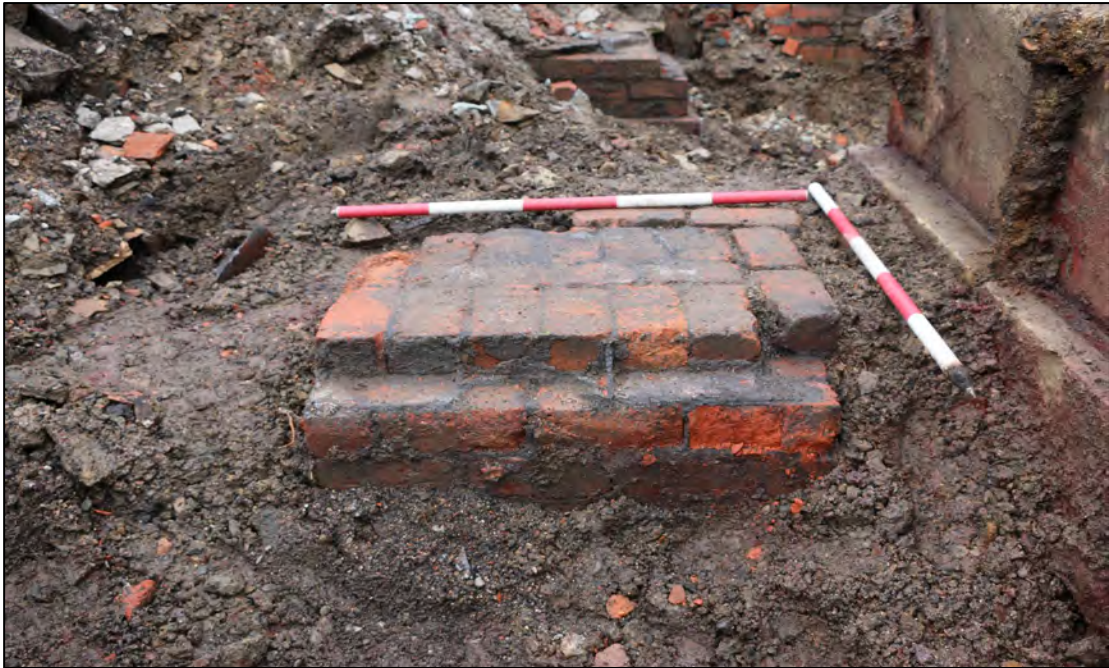
- 6.15.10A square brick-built base [2011] was located immediately south-west of dye-tank [2004]. The brick base measured 0.82m by 0.82m and had an exposed height of 0.3m (Plate 41). The brick base was constructed of wire-cut bricks laid in an irregular bonding pattern and bonded with a hard black ashy mortar.

*Plate 41 Shot of brick-built base [2011], looking north-west. Scales = 2 x 1m.*

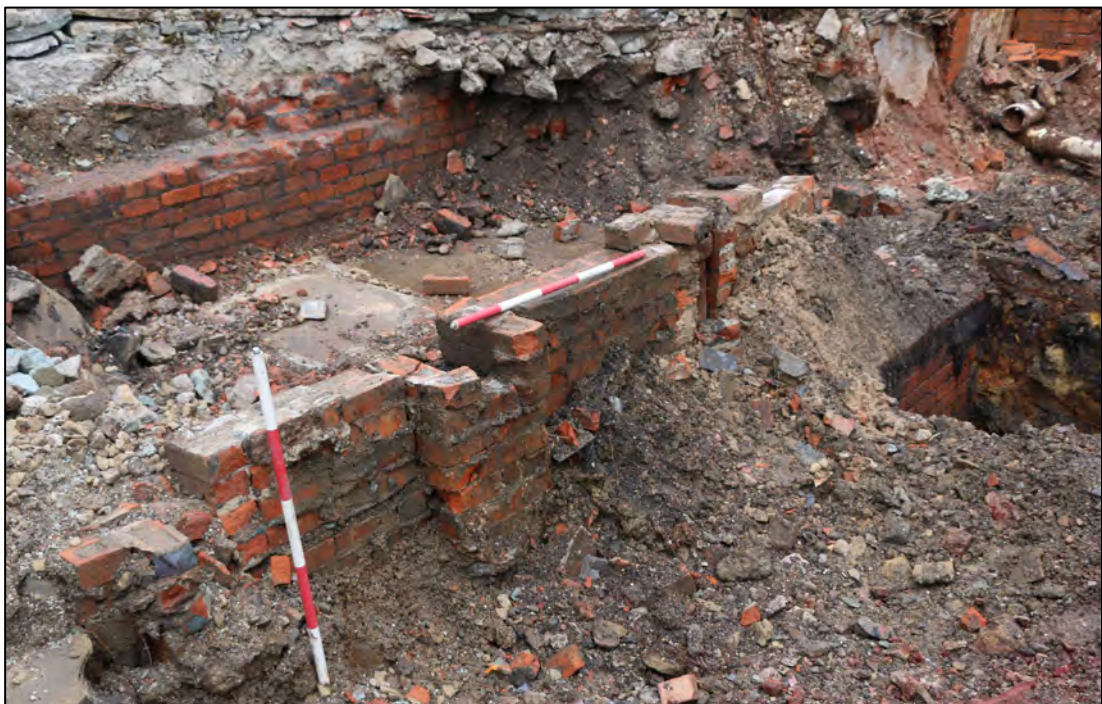
*Plate 42 Shot of wall [2000], looking north-west. Scales = 2 x 1m.*

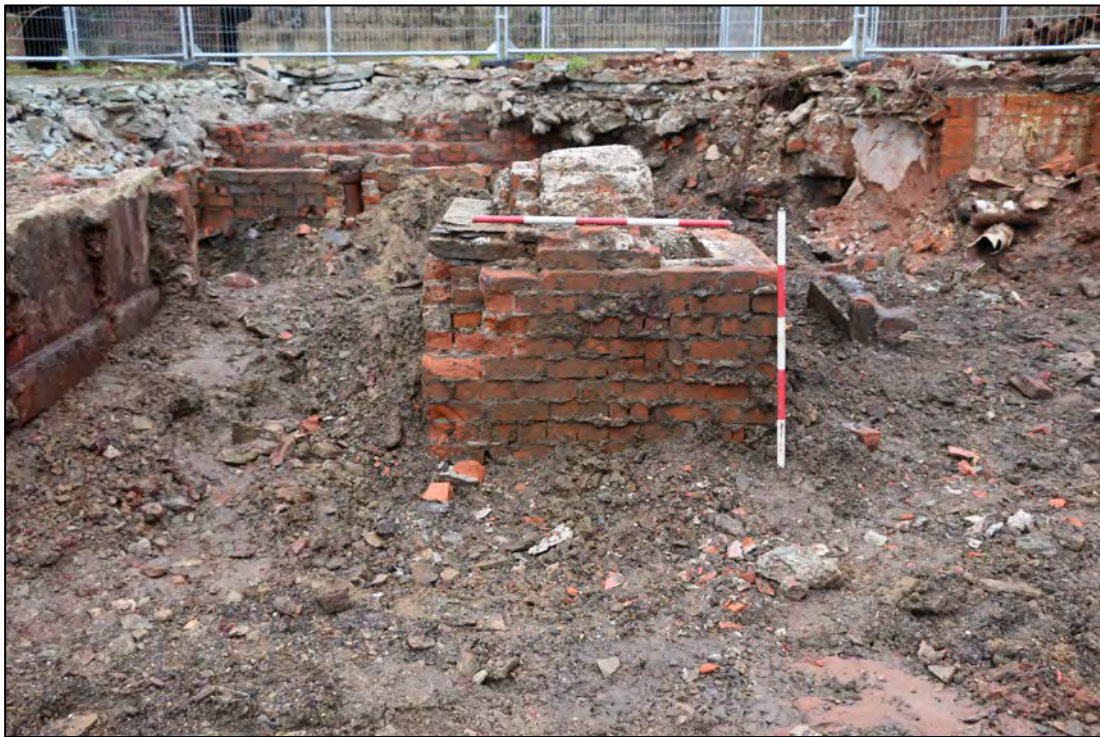
*Plate 43 Shot of stanchion base [2002], looking north-west. Scales = 2 x 1m.*

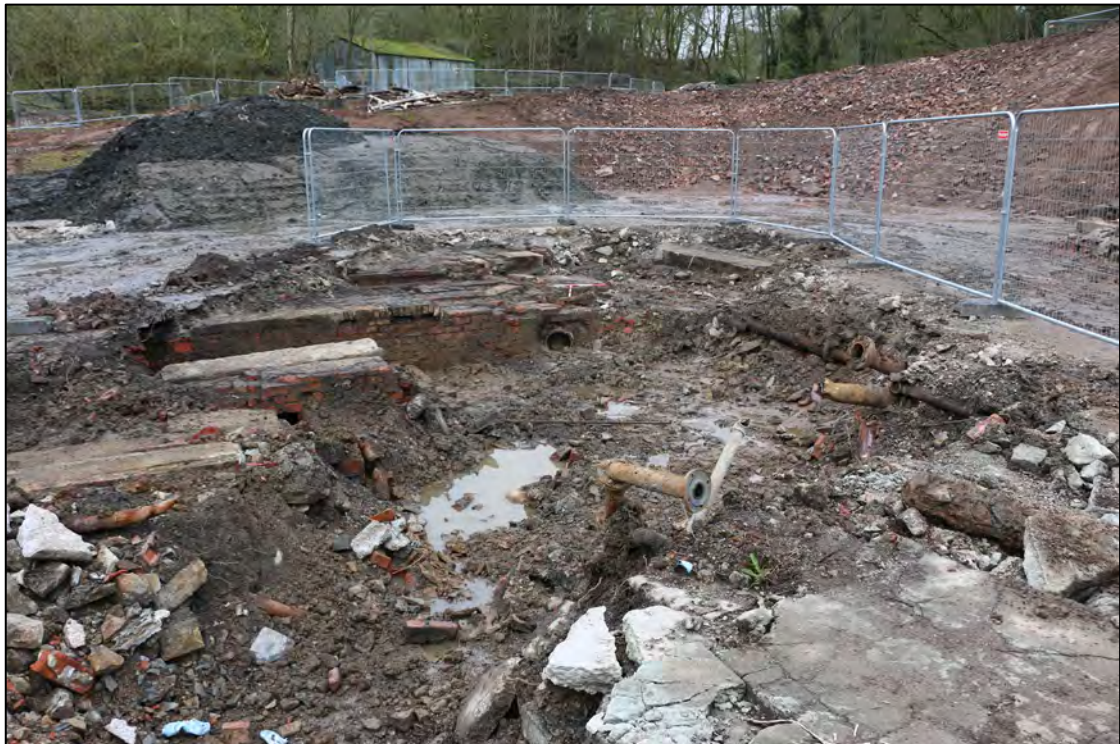
6.16.1 Area B extended the north-east end of evaluation Trench 5, targeting the interior of the main building at Woodhouse Mill (Plate 44)

*Plate 44 General shot of Area B, looking north-west. Scales = 2 x 1m.*

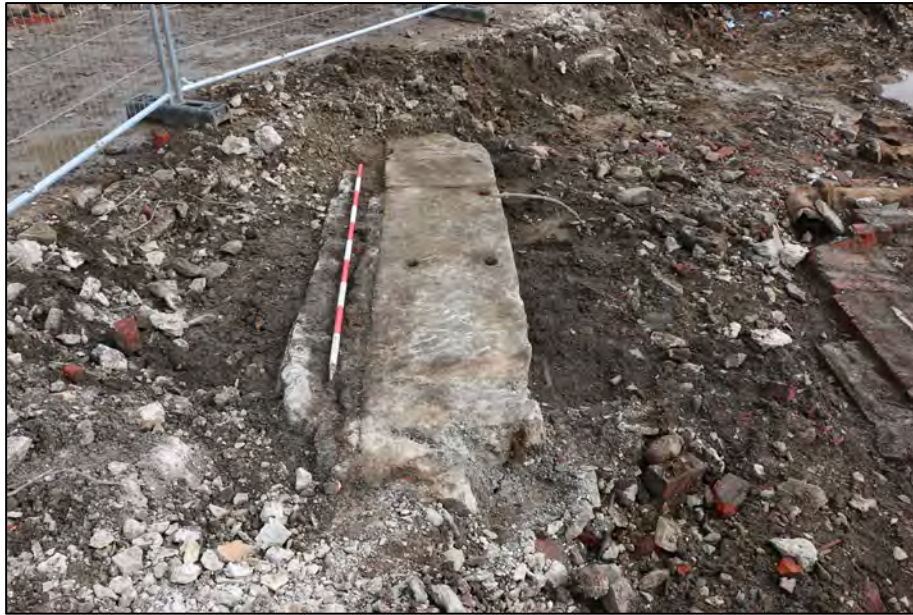
*Plate 45 Shot of Machine bed [4002], looking east. Scale = 1 x 2m.*

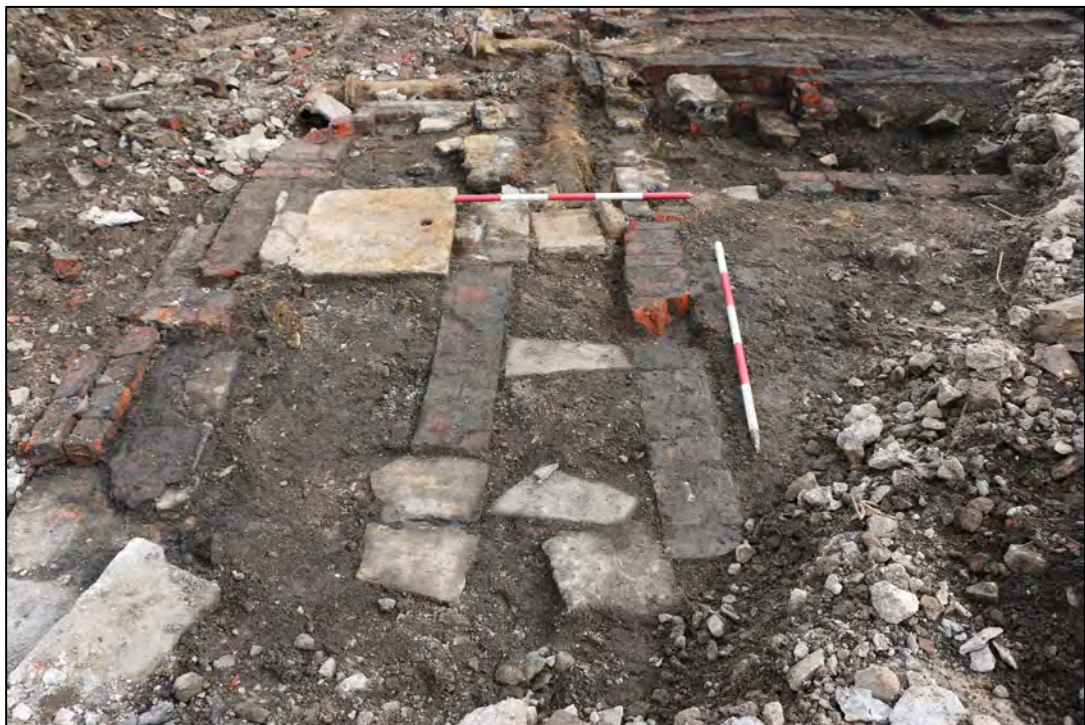
- 6.16.3 The remains of a series of poorly preserved brick walls and stone blocks survived to the south-east of the machine bed (Plate 46). An east to west aligned sandstone foundation block [4003] was excavated to the south-west of the machine bed. The sandstone block measured 1.4m long by 0.55m and 0.3m thick.

- 6.16.4 The remnants of an L-shaped wall [4004] were constructed above the stone block [4003] (Plate 46). Wall [4004] was constructed of handmade red bricks laid in stretcher bond and bonded with a hard black ashy mortar. Modern frogged red brick had been used to repair part of the wall. The wall measured 0.64m long, 0.25m wide and survived up to 0.1m high along its north-east to south-west alignment, before returning to the south-west. The south-west to north-east return of the wall measured 0.36m long.

*Plate 46 From left to right, shot of walls [4004], stone block [4005], walls [4006] and [4007], looking east. Scales = 2 x 1m.*

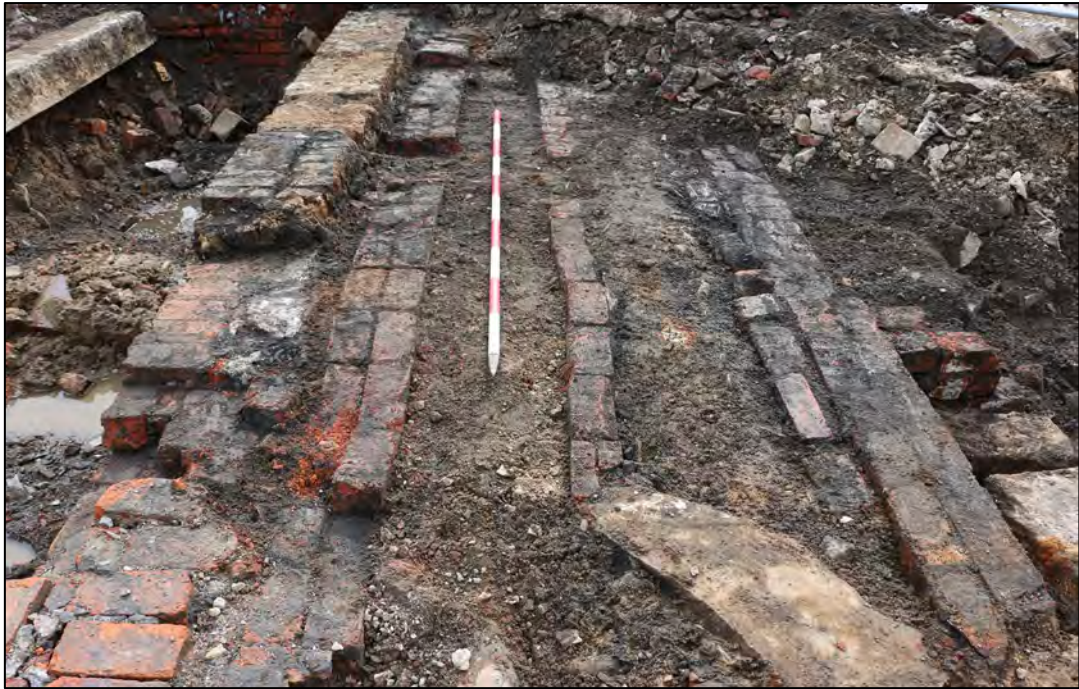
*Plate 47 From left to right, walls [4013], [4012] and [4011], looking south. Scale = 1 x 2m.*

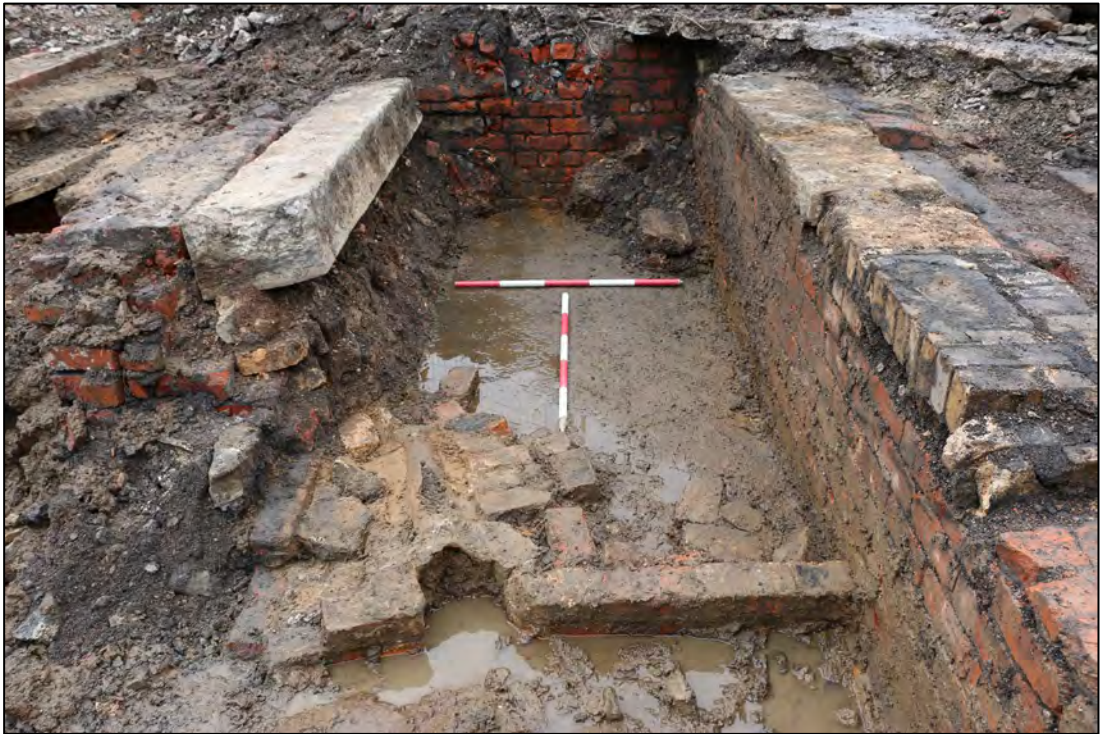
6.16.18 The truncated remains of a pipe overlay the concrete surface [4019] and ran through single skin wall [4020] (Plate 48). The pipe seemed to have been bounded by a mixture of firebrick and wire-cut bricks that survived in poor condition.

*Plate 48 Shot of walls [4015] (left), [4020] in the foreground, [4014] in the background and [4013] (right), and surface [4019], looking south. Scales = 2 x 1m.*

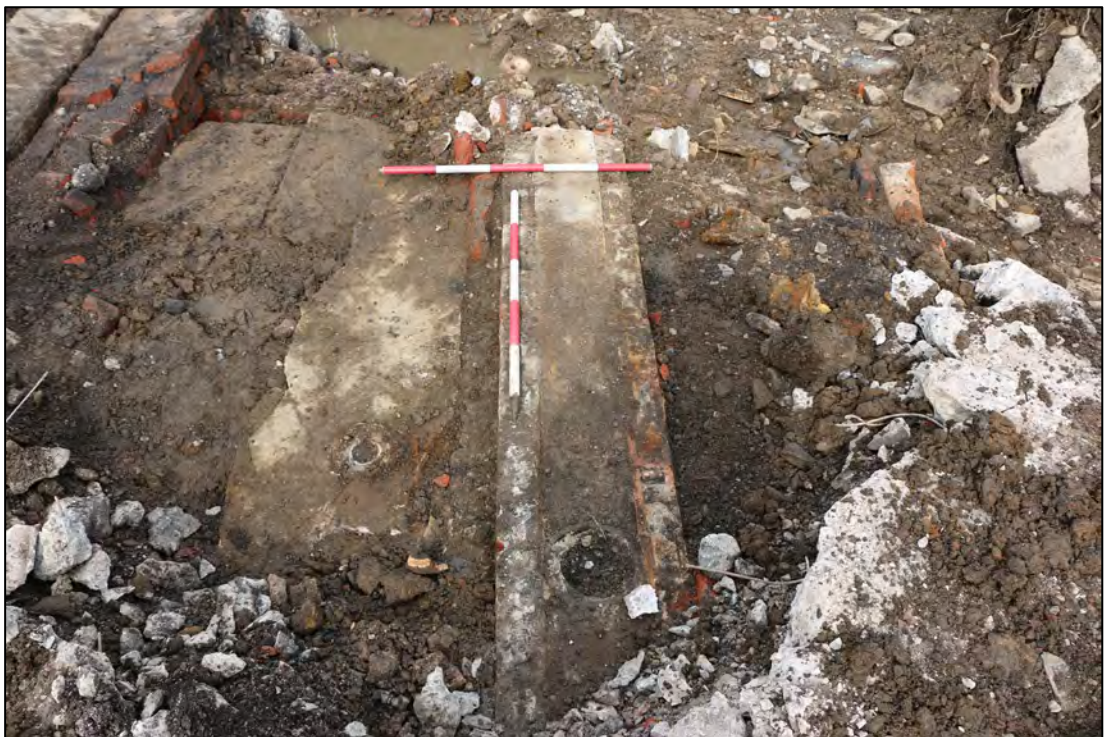
*Plate 49 From left, manhole [4016], and concrete and brick features [4017] and [4018], looking north. Scales = 2 x 1m.*

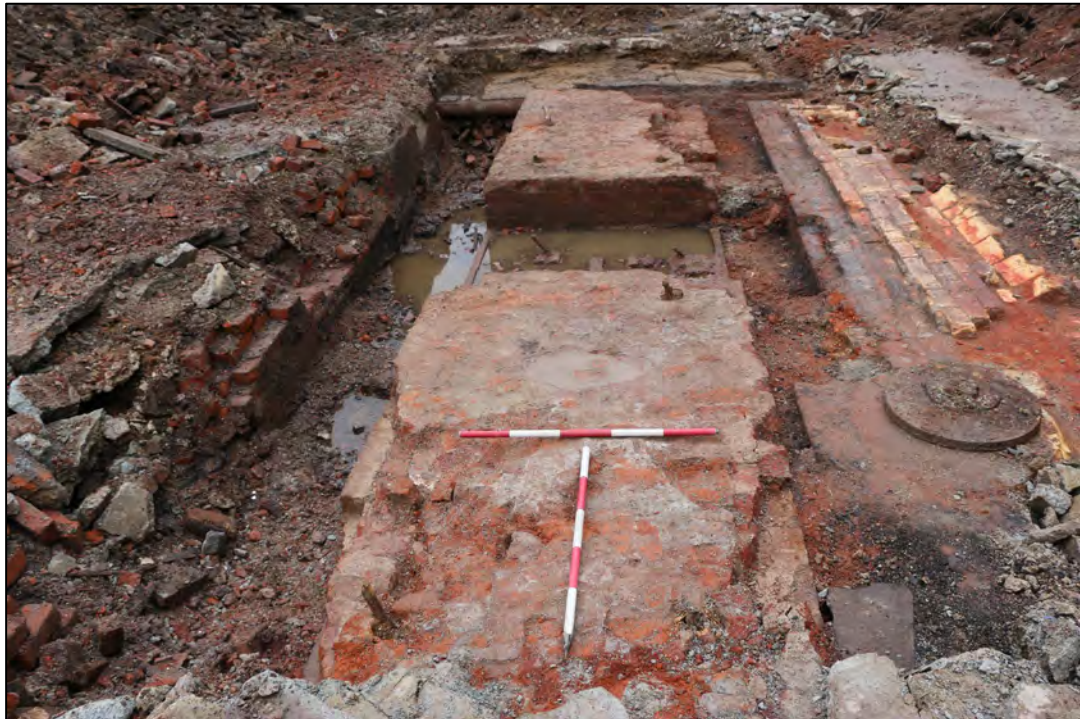
6.17.1 Area C extended evaluation Trench 6 to the north-west, targeting Woodhouse Mill's steam power plant, first shown on the 1851 map (Figure 3; Plate 50).

*Plate 50 General shot of Area C, looking north-west. Scales = 2 x 1m.*

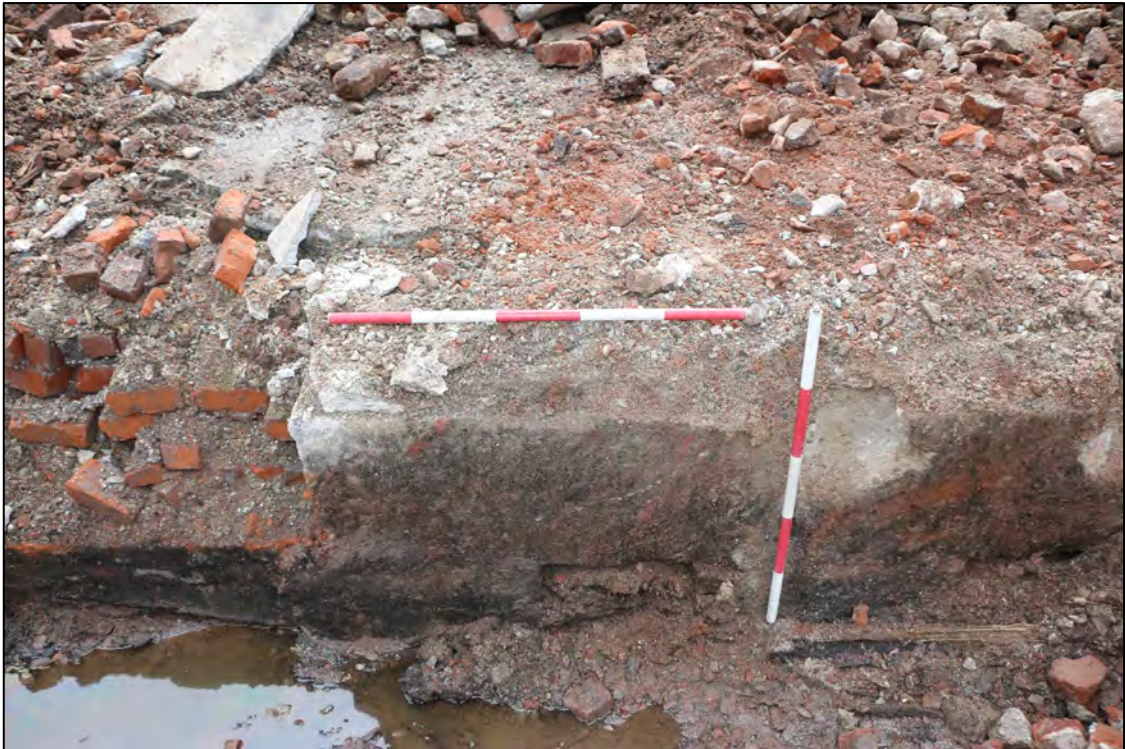
*Plate 51 Shot of sandstone block [3008], at the north-western end of wall [3003] looking south-west. Scales = 2 x 1m.*

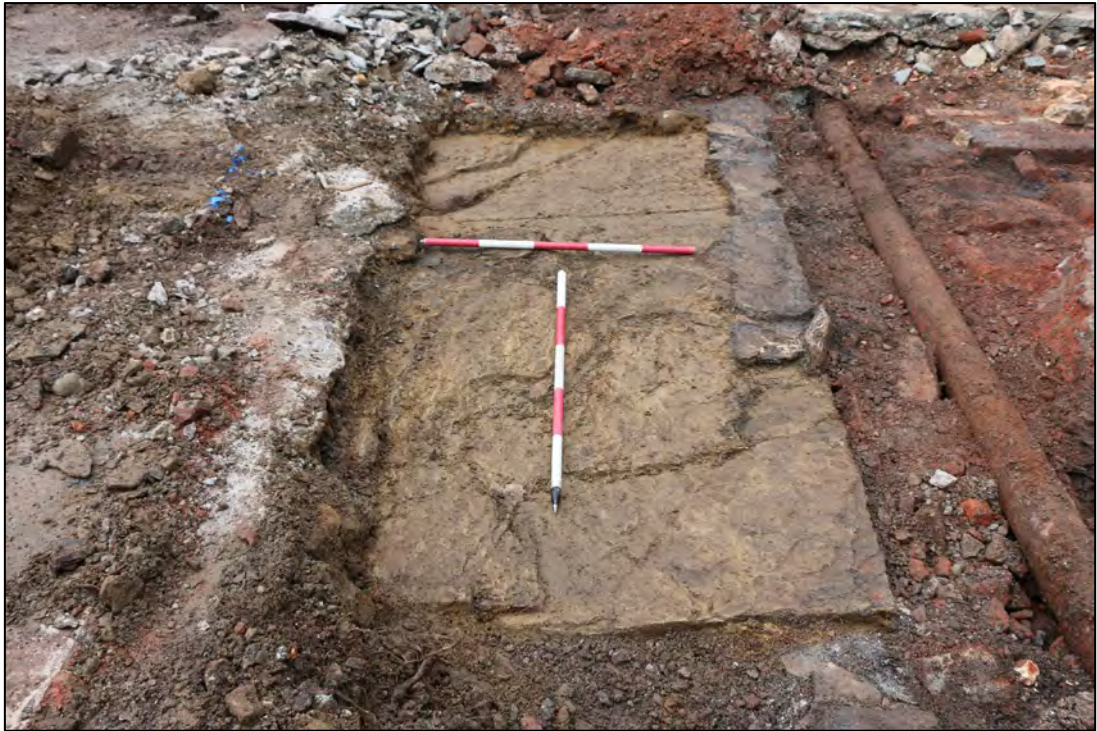
*Plate 52 Shot of gritstone block [3004], looking south-west. Scales = 2 x 1m.*

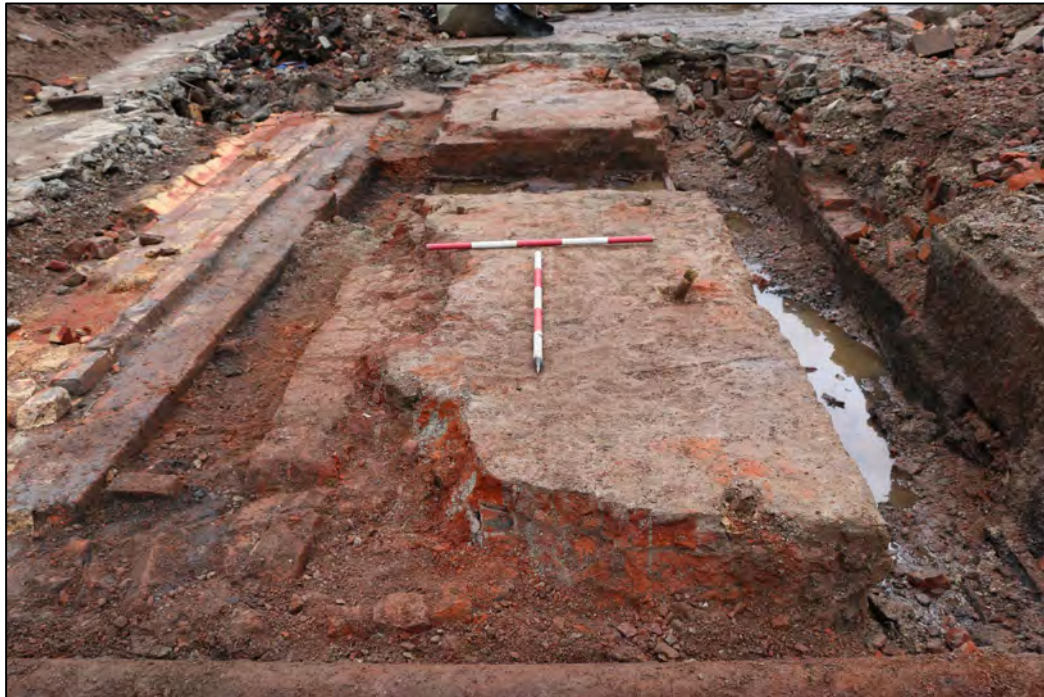
*Plate 53 Shot of engine bed [3005], looking south-east. Scales = 2 x 1m.*

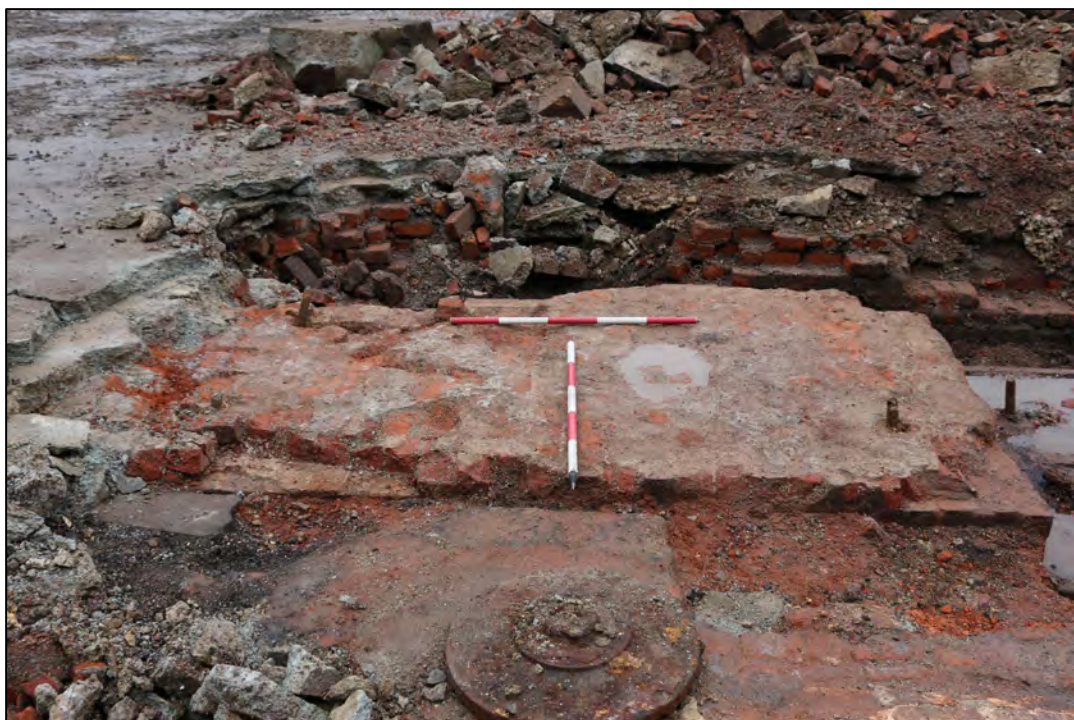
*Plate 54 Shot of engine bed [3006] bordering boiler bed [602], looking south-west. Scales = 2 x 1m.*
