SA/2024/25

# Tack Lea Works, Greenbooth Road, Norden, Rochdale

Archaeological Evaluation and Mitigation  
Built / Historic / Natural

| <b>Document:</b> | Archaeological Evaluation and Mitigation Report |

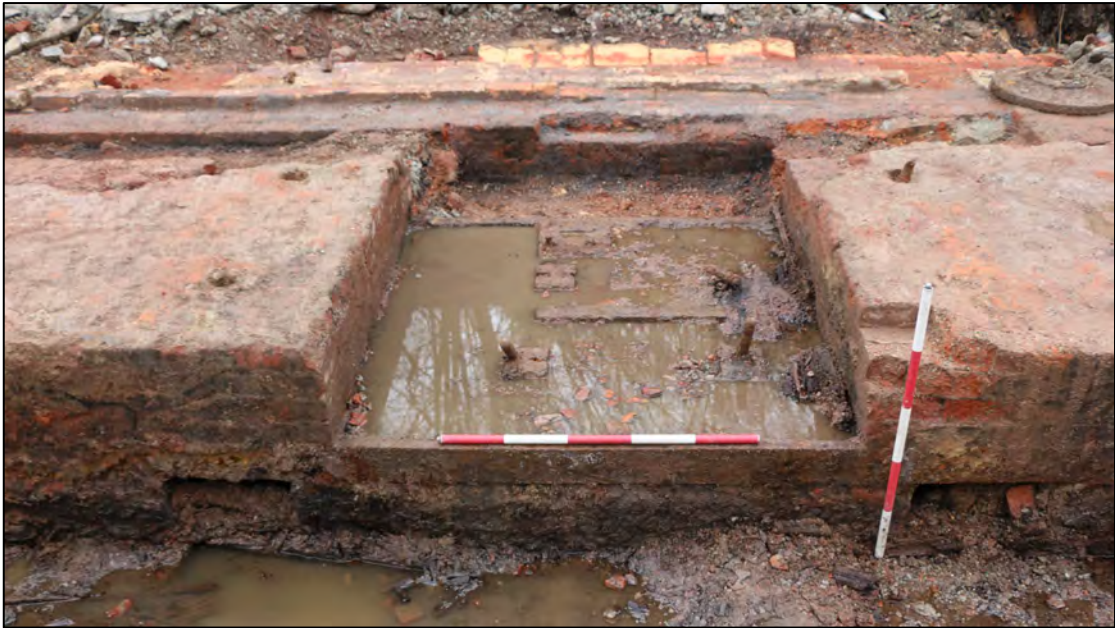
- 6.17.8 The engine beds were separated by a stone slab, which had a series of rectangular depressions and iron fastenings or restraining bolts visible on the surface of the slab [3007] (Plate 55). The iron fixings were fastened to the stone slab [3007], which was situated 0.37m lower than the surface of the engine beds (which were excavated 0.23m below the current ground surface). The

area measured 1.65m by 1.7m wide and was 0.16m high. The remains of timber were also recorded though they were very badly preserved.

*Plate 55 Shot of machine fixings, slab and brickwork [3007] connecting the engine beds, looking south-west. Scales = 2 x 1m.*

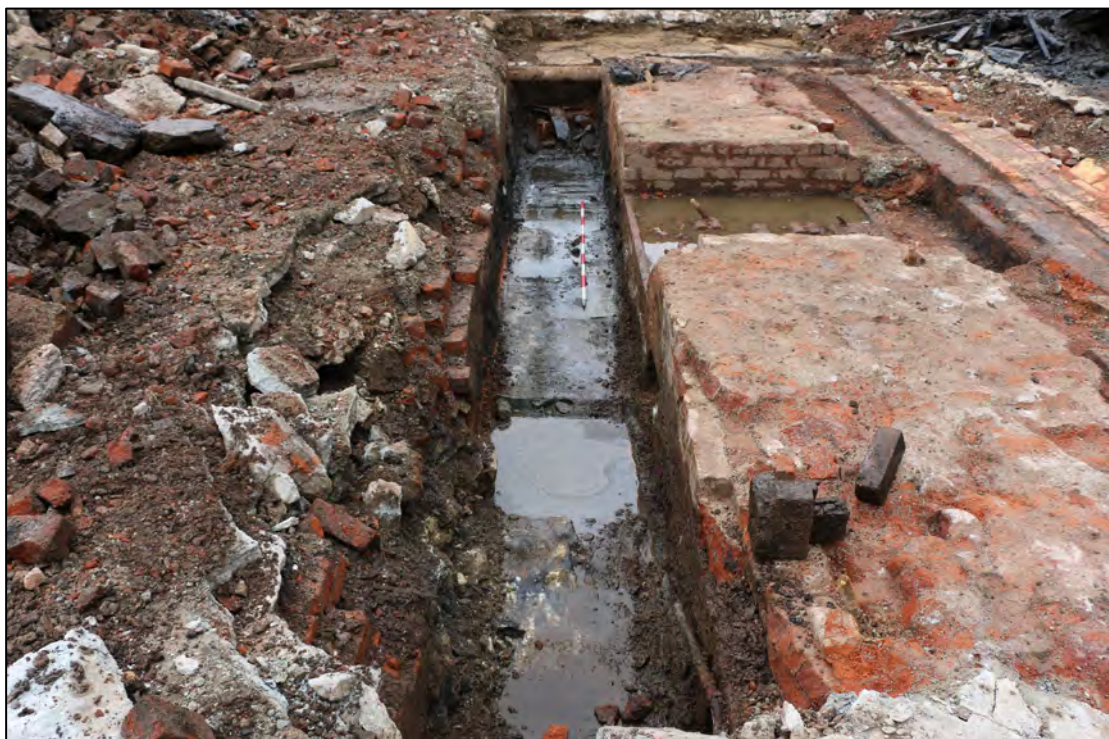
*Plate 56 Shot of asphalt channel [3009], looking north-west. Scale = 1 x 2m.*

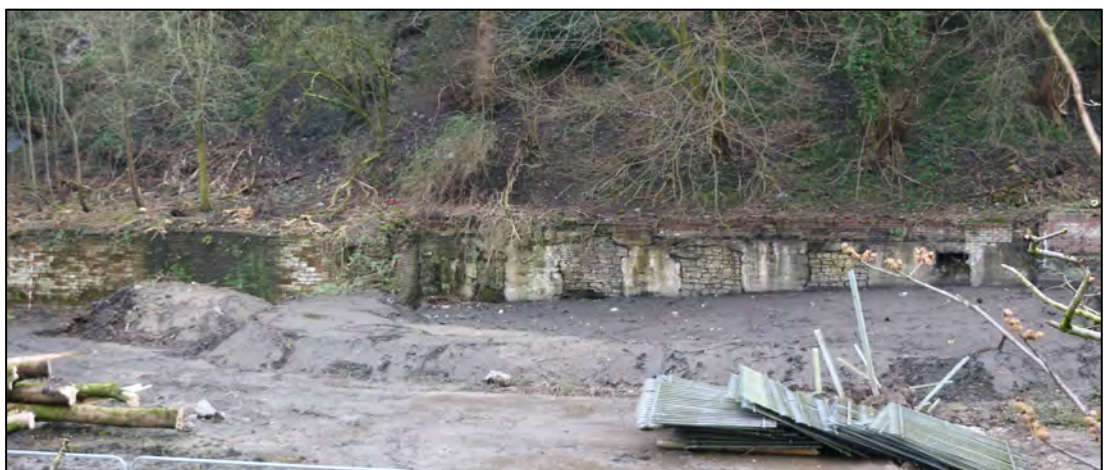
- 7.7.1 The above ground remains of walls associated with Shepherds Mill bordered the northern edge of the Site boundary, surviving up to c 2m (Plate 57). Several materials and phases of construction were evident within the wall including stone, reused stone blocks, concrete and bricks. The phasing sequence is likely to span the mid-19<sup>th</sup> century to mid-20<sup>th</sup> century. These walls were not recorded as part of the excavation or evaluation.

*Plate 57 Shot of extant 19<sup>th</sup> century walls in southern area of Site, looking north. Scale = 1 x 2m*

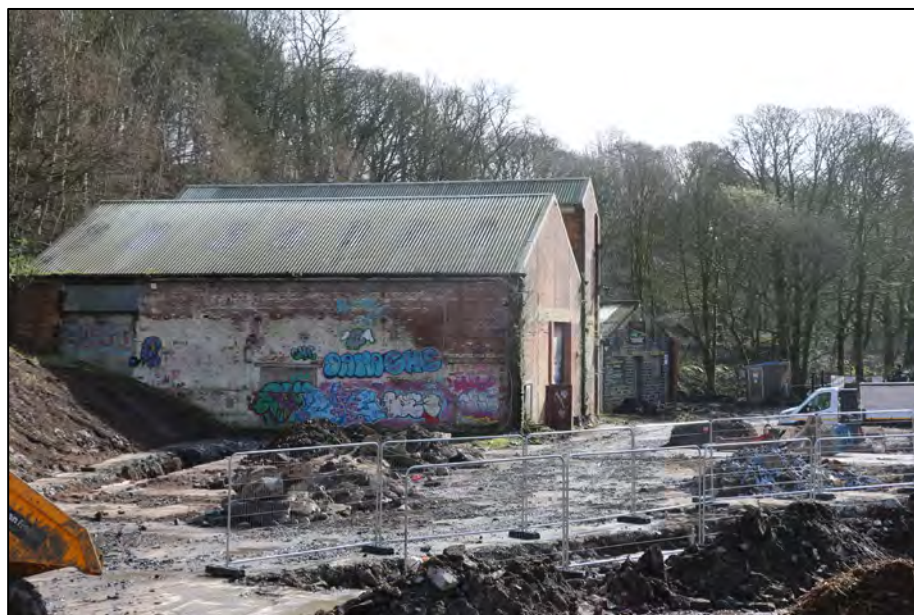
10.2.2 The site comprises the ancillary buildings of a former vehicle accident repair centre, the oldest of which likely date to the mid-20<sup>th</sup> century, although later 20<sup>th</sup> century additions have been constructed in and around the building spaces (Photograph 1). These buildings are composed of a variety of materials and differ in style depending upon the date of construction.

*Photograph 1: Buildings 1 and 2, looking north-east.*

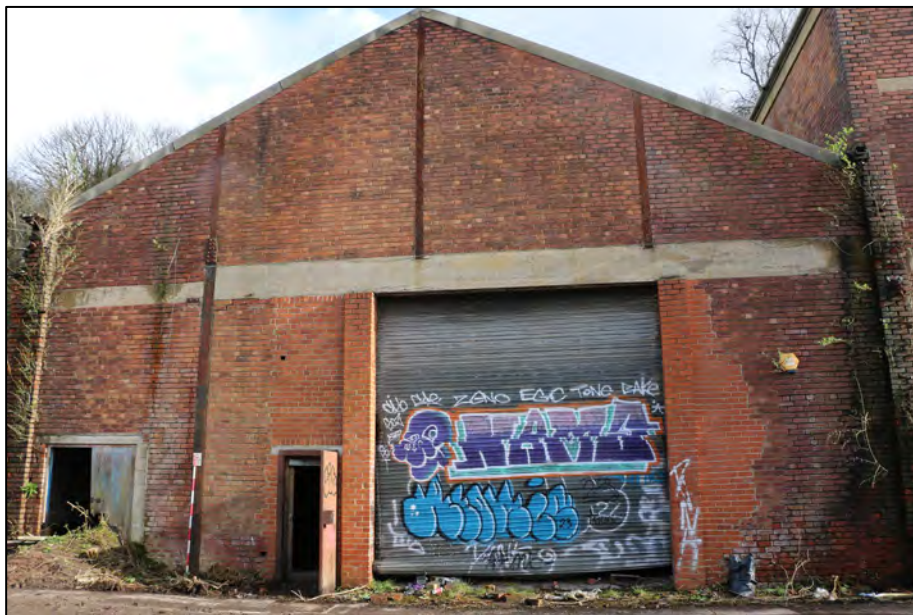
10.4.1 Building 1 was a two-storey tall, large, detached building with an attached tower at its eastern end, constructed of modern, frogged, red brick laid in Common Bond and bonded with a modern cement mortar, and modern concrete blocks. The building had a pitched roof, its longest axis aligned east to west (Photographs 2 and 3). The building was located along the northern perimeter of Site boundary in the north-western area. The building had likely previously been in use as a storage warehouse as evidenced by the large openings that had been blocked up on its southern, western, and eastern elevations and what remained of what appeared to be a metal pulley above the southern elevation opening.

*Photograph 2: Southern elevation of Building 1, looking north. Scale = 1 x 2m.*

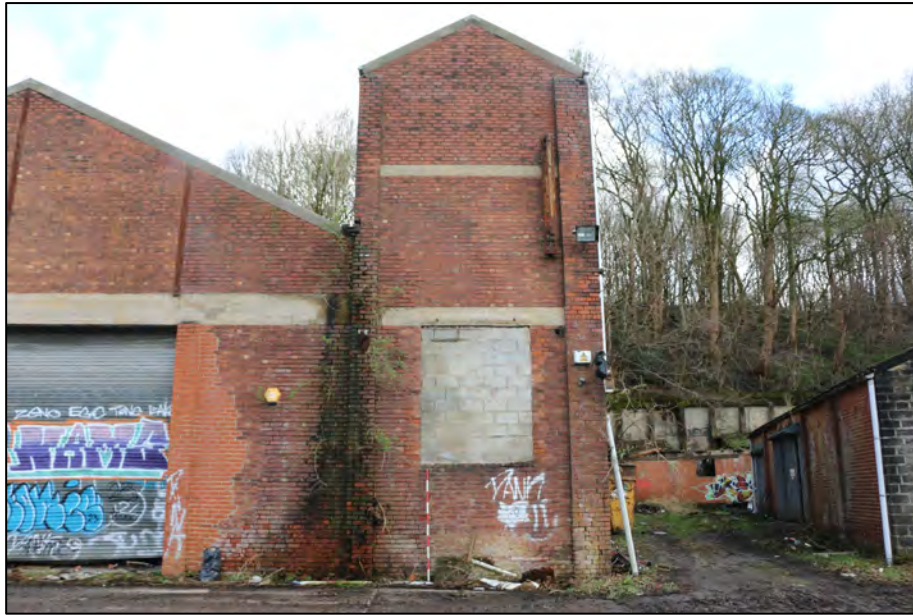
*Photograph 3: Southern elevation of Building 1 tower, looking north. Scale = 1 x 2m.*

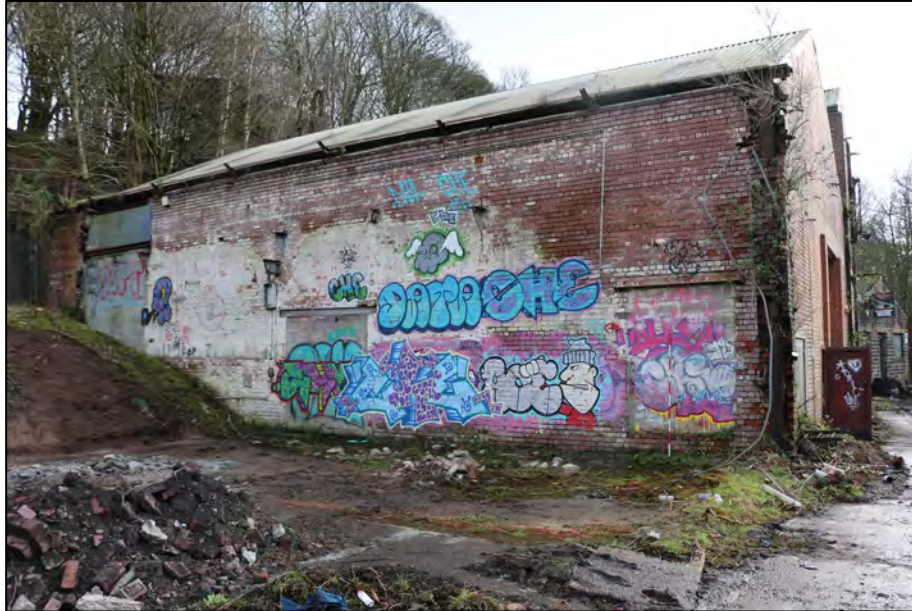
*Photograph 4: Western elevation of Building 1, looking north-east. Scale = 1 x 2m.*

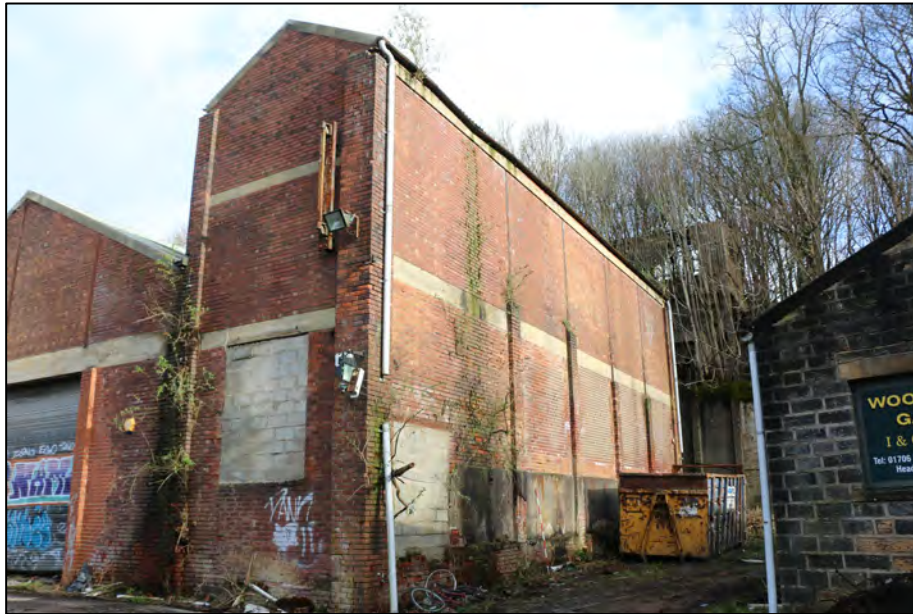
*Photograph 5: Eastern elevation of Building 1 tower, looking north-west. Scale = 1 x 2m.*

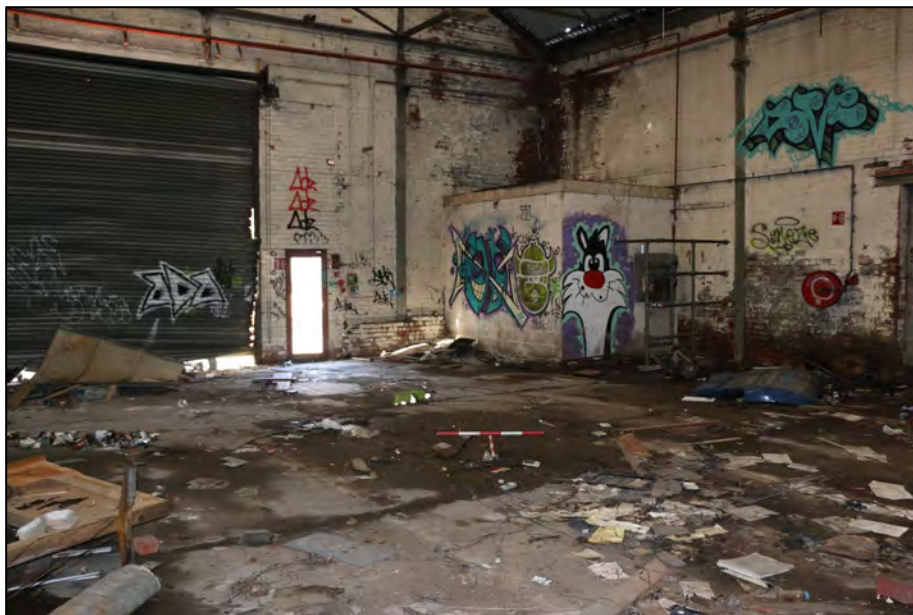
10.5.1 The interior of building 1, accessed from the single doorway and large opening in the southern elevation, constituted one large ground floor room. A second much smaller room was accessed via the double doorway in the southern elevation, with the external brick construction of this smaller room observable in the south-western corner of the main larger interior room of building 1 (see Photograph 6). The larger, northern room retained a brick and concrete-built raised platform along its northern and eastern walls similar to a stage (see Photographs 7, 8 and 9). The interior surfaces of the building's walls were largely painted white (with graffiti) and featureless, aside from a series of vertical steel girders placed at regular intervals and a circular rail running the top of all four walls. A ladder was also observed attached the southern wall which led up to a small walkway in the roof joists of the tower of building 1 (Photograph 10).

*Photograph 6: Internal space of Building 1 showing the construction of smaller room, looking south-west. Scale = 2 x 1m.*

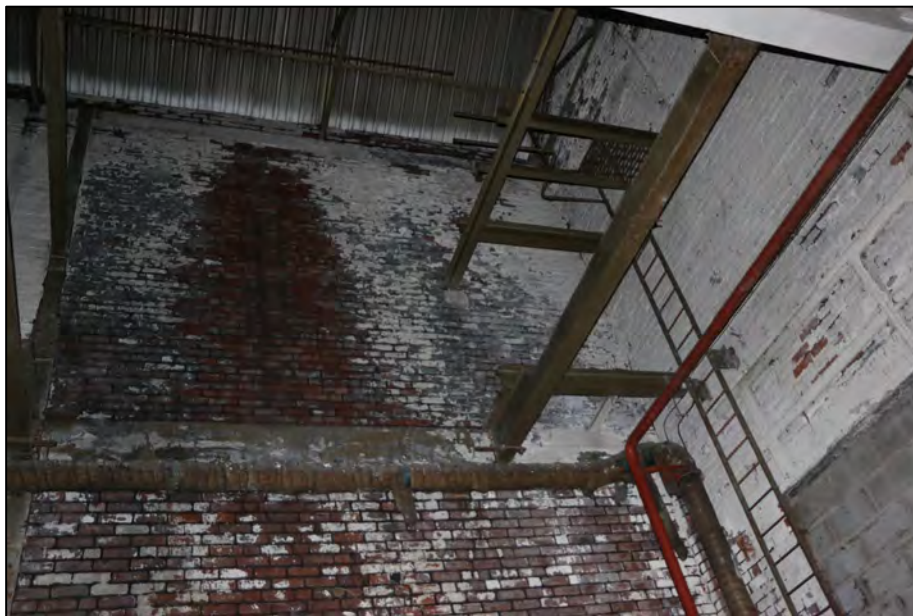
*Photograph 10: Internal space of the tower in Building 1, looking north-west.*

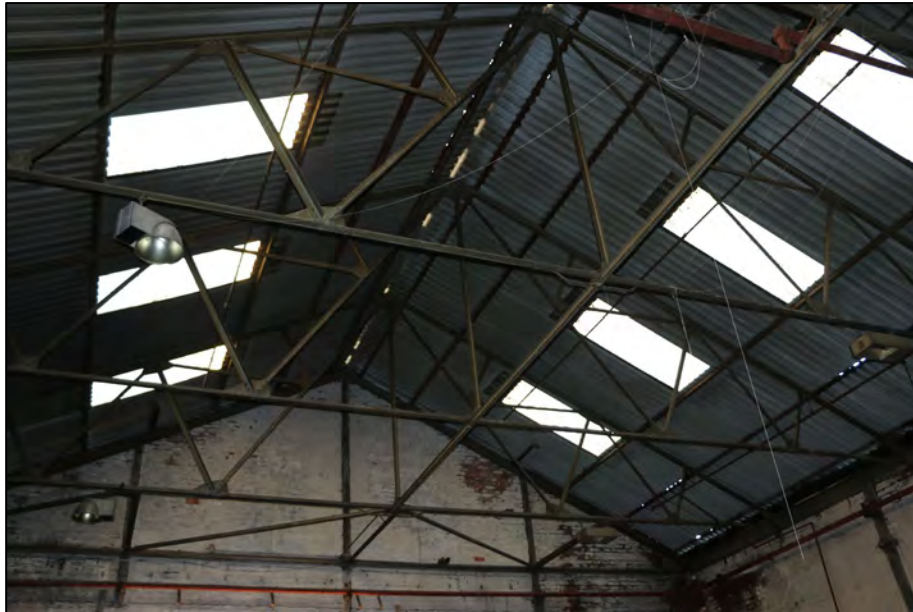
*Photograph 11: Roof joists in Building 1, looking south-west.*

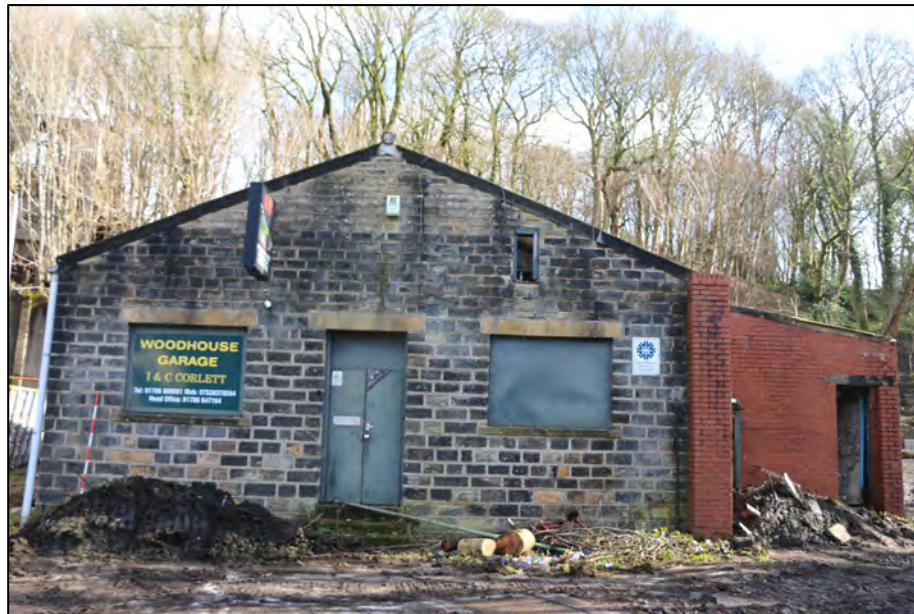
*Photograph 12: Southern elevation of Building 2, looking north. Scale = 1 x 2m.*

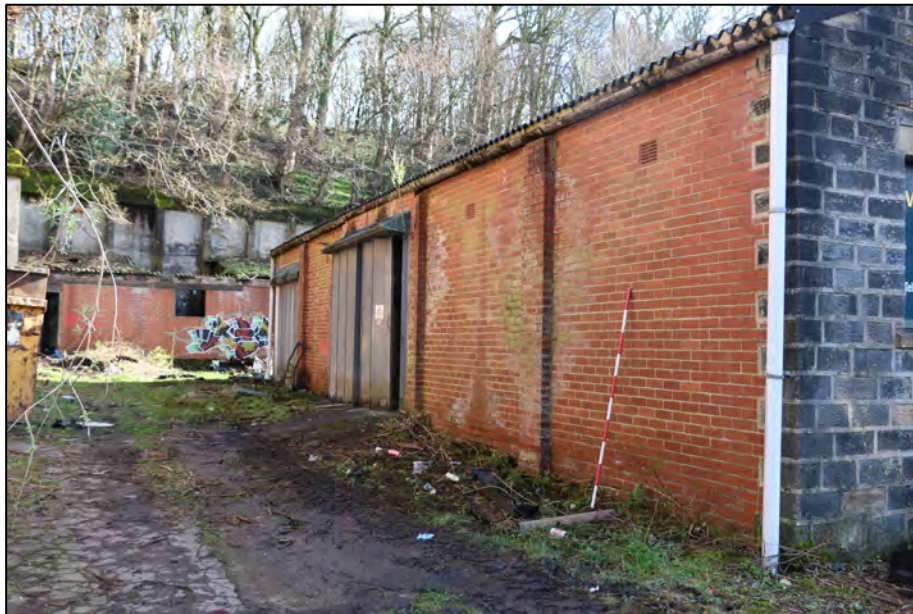
*Photograph 13: Western elevation of Building 2, looking north-east. Scale = 1 x 2m.*

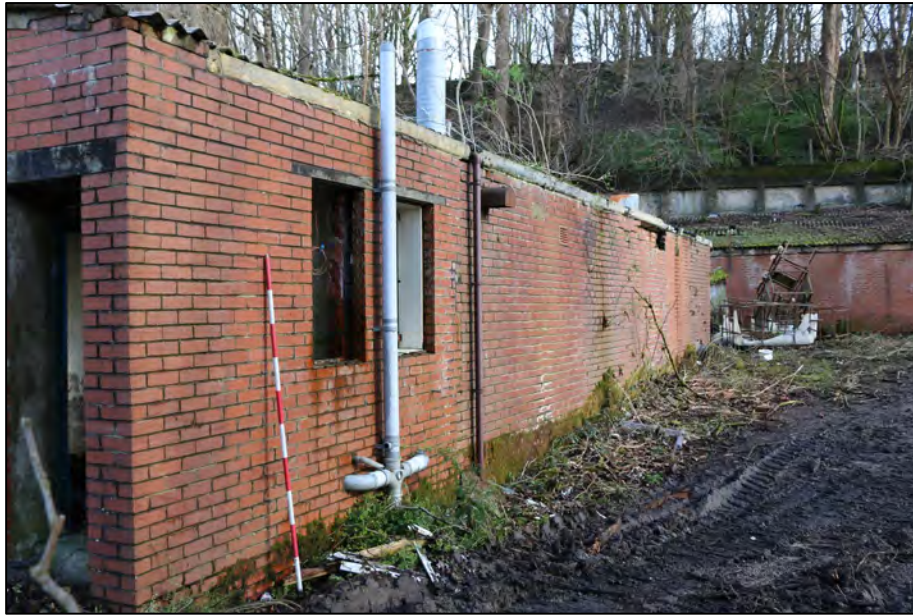
*Photograph 14: Eastern elevation of Building 2, looking north-west. Scale = 1 x 2m.*

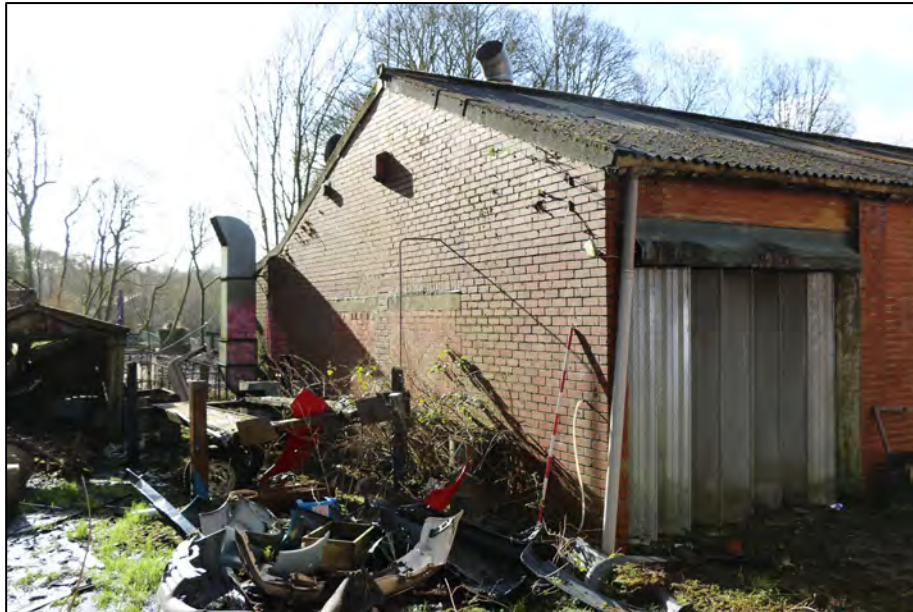
*Photograph 15: Northern elevation of Building 2, looking south-east. Scale = 1 x 2m.*

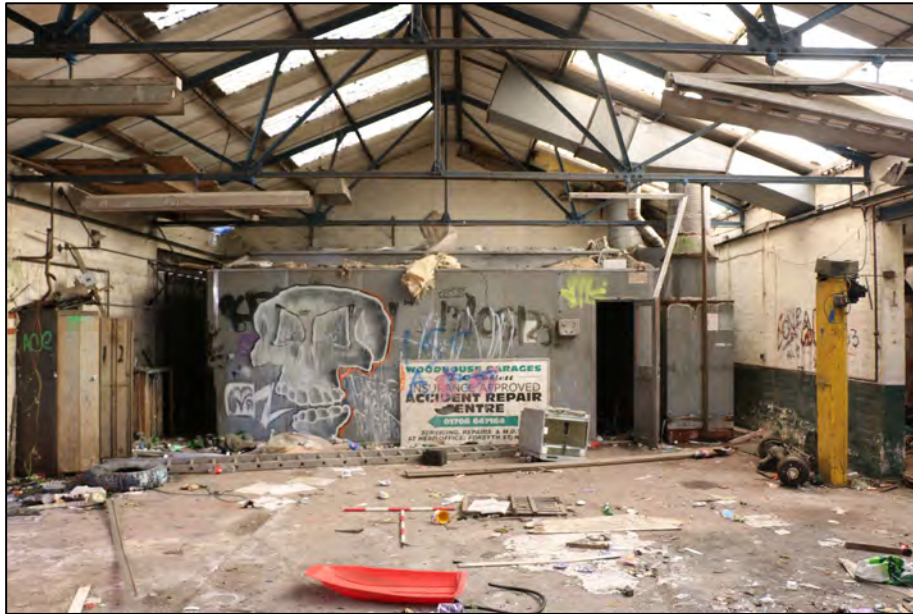
*Photograph 16: Internal space of Building 2 showing the construction of smaller room, looking west. Scale = 2 x 1m.*

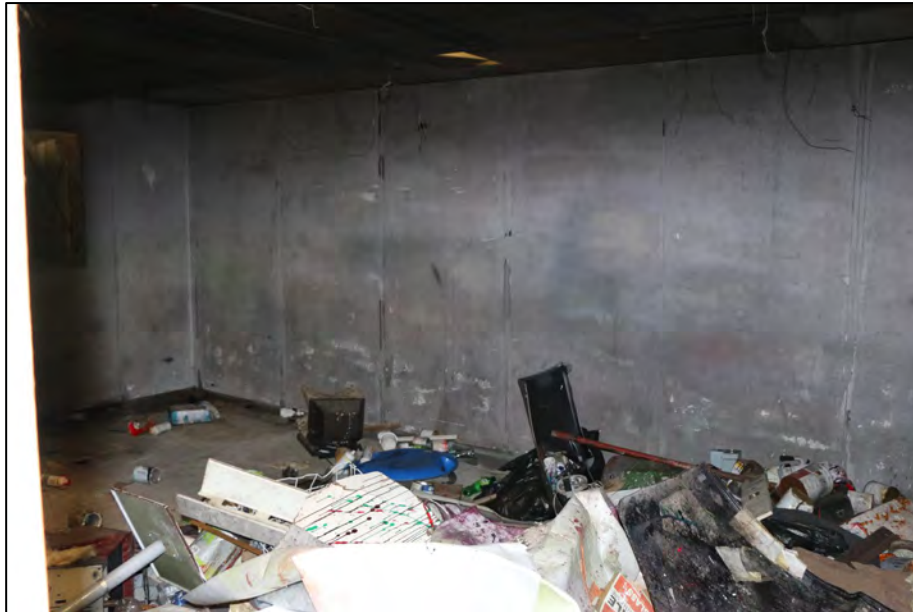
*Photograph 17: Internal space of the metal room in Building 2, looking north-west.*

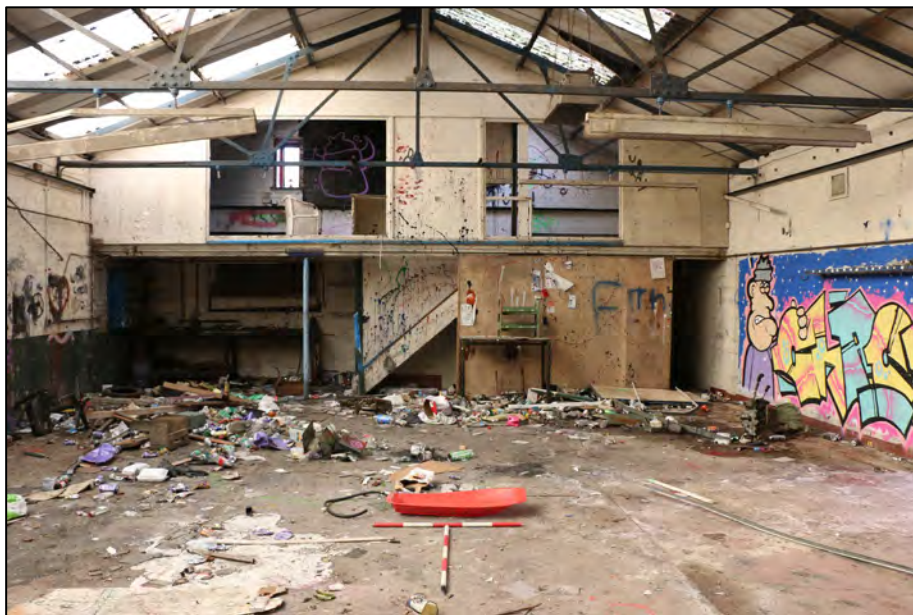
10.8.2 The eastern side of the southernmost ground floor room contained a workbench, and a set of stairs that led to the first-floor room (Photograph 18). The first-floor room was not investigated.

*Photograph 18: Internal space of the southern room and the first-floor room in Building 2, looking east. Scales = 2 x 1m.*

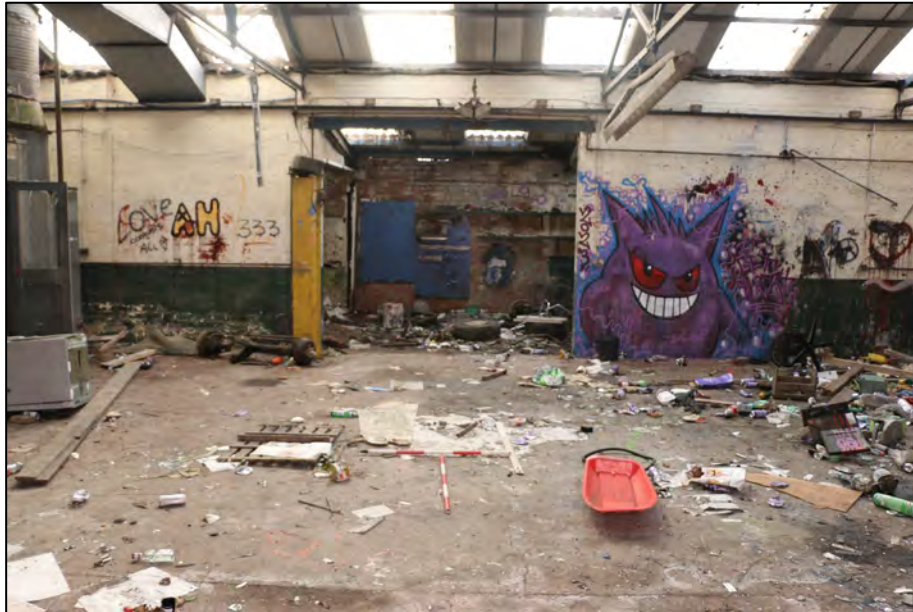
*Photograph 18: Opening from the southern room of Building 2 to the northern room, looking north. Scales = 2 x 1m.*

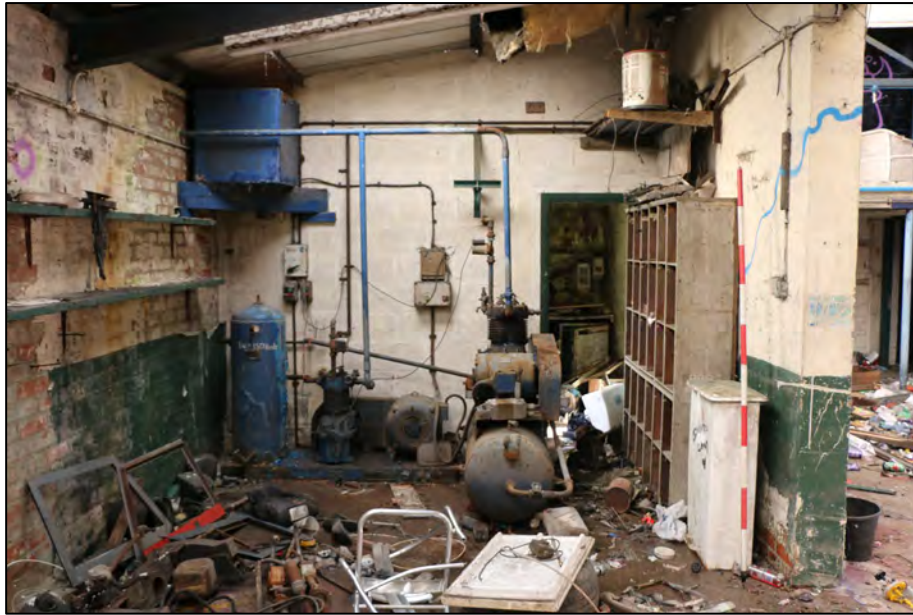
*Photograph 19: Machinery in the eastern end of the northern room of Building 2, looking east.*
