## **Appendix D: Ground Conditions**

## **Hollingworth Road, Littleborough**

### **Coal Mining Risk Assessment**

Project Ref: 332010570/3501/R02 | Rev: 02 | Date: February 2024

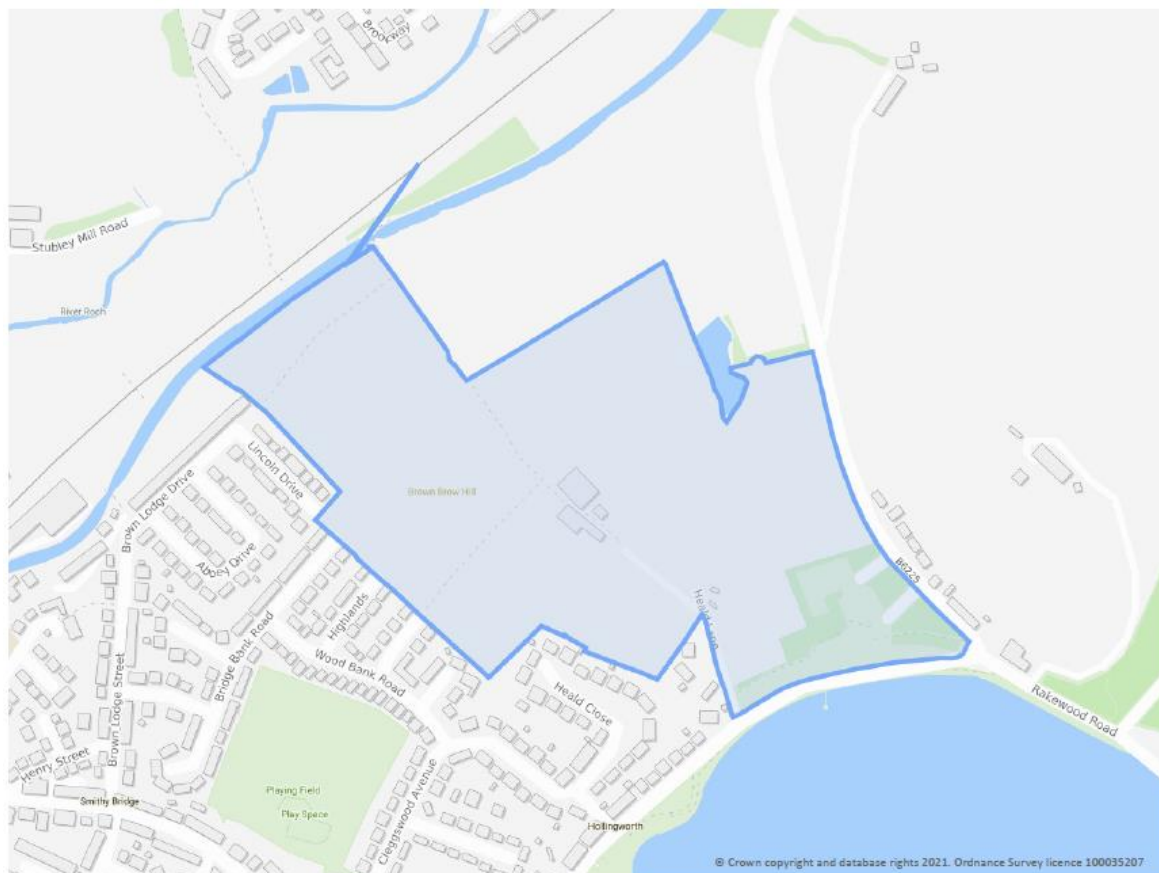
Figure 1-1 General Site Location and Extent

1.4.2 The site is centred approximately at British Grid Reference SD 93341 15448 and its boundary is outlined in blue on the Location Plan shown in **Figure 1-1**.

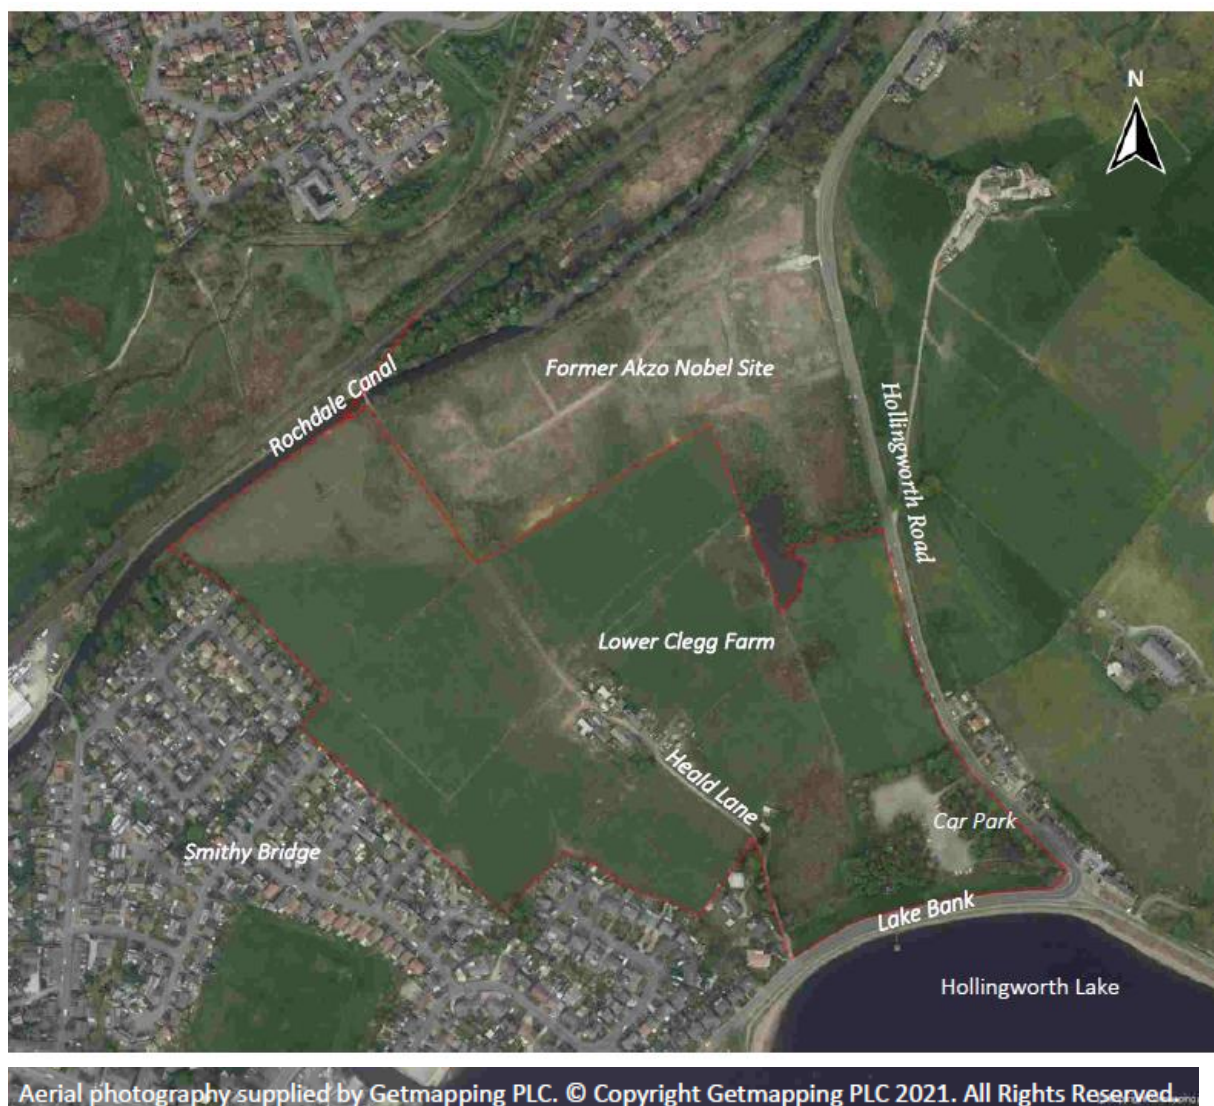
Figure 3-1 Recent aerial imagery

- 3.2.1 The site currently comprises predominantly agricultural or open land with Lower Clegg Farm in the central part and a car park in the south-east corner. The Former Akzo Nobel Site borders the site to the north-east and the Hollingworth Lake is to the south.
- 3.2.2 A recent aerial image of the site taken from the Groundsure report with the site boundary shown highlighted in red and other features annotated is reproduced below as **Figure 3-1**.
