**Phoenix Works,  
Brookes Street,  
Middleton,  
Manchester.  
M24 2WL**

**Preliminary Survey & Assessment  
in Respect of Bat Species, and Nesting Birds.**

**Echo Calls Bat Surveys**

**29<sup>th</sup> October 2023**

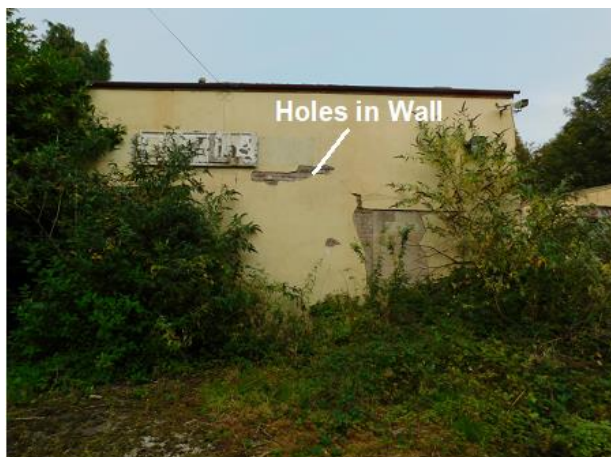
**PHOTO 1**  
**Western Elevation of Building 1**

Building 1 was positioned at the north-western corner of the site, in a north-west to south-easterly orientation, and was attached to the other buildings within the complex. It was a tall rectangular building, constructed from a mixture of concrete block and brick and was covered in render, with a pitched roof covered in uninsulated slates, but with no roof void. The building had deteriorated since the previous survey, and was still in a poor condition, with neither heating nor insulation, and was cold, and very damp, and therefore the building was deemed unsuitable for either daytime roosting bats, or breeding bats. Also, as frost and bad weather was likely to penetrate the interior, the building did not offer the optimum humidity, and stable low temperatures that are required for hibernating bats, and therefore Building 1 was deemed to offer very low suitability for roosting bats, (refer to **figs 3, 4, and 5 and photos 1 to 4, 22, and 31**).

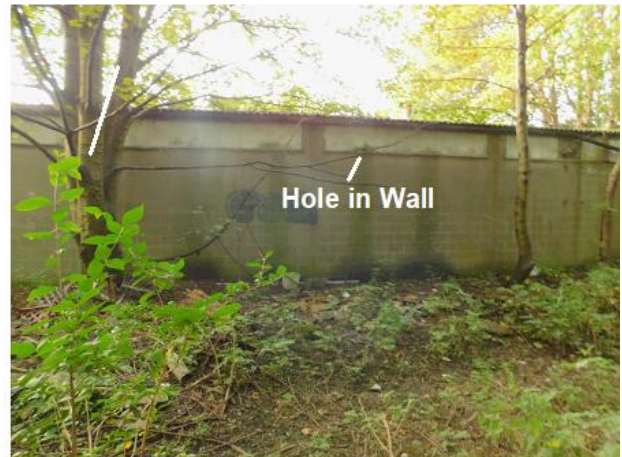
**PHOTO 12**  
**Southern Elevation of Building 4**

- There was a hole in the blockwork, part way along the southern elevation of Building 4, and this was searched internally using an endoscope, and also the wall and floor beneath it were also surveyed, but no signs of bat usage of the hole was found, and therefore they were both deemed to have not been used by roosting bats, (refer to **figs 3, 4 and 5 and photo 12**).

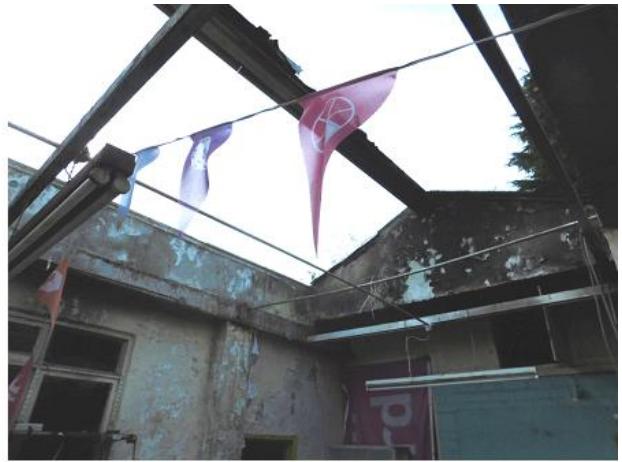
**PHOTO 20**  
**Missing Western Part of Building 2 Roof**

The building was structurally sound, but was unheated, uninsulated, and would be draughty and cold throughout most of the year, and therefore the building was deemed unsuitable for either daytime roosting bats, or breeding bats. It was also concluded that the building would be penetrated by frost and inclement weather in winter, thus making it unsuitable for hibernating bats, Building 2 therefore, was deemed to be of low roosting suitability (refer to **figs 3, 4 and 5 and photos 2, 5 to 8, 18 to 21, 23 to 27, and 31**).

- A large proportion of the glass within the majority of the rooflights was missing, resulting in large areas where cold and inclement weather could enter into the interior of Building 2, however, an internal search of the building beneath these rooflights, found neither droppings, nor any other evidence of either bat usage, or occupation. It was also thought that copious amounts of daylight would enter the building interior through the holes in the roof and the

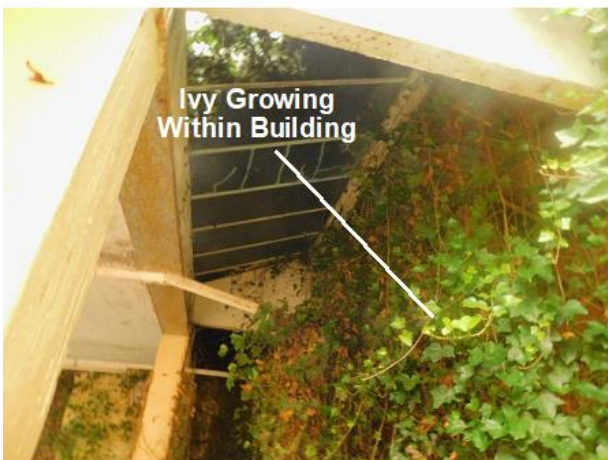
**PHOTO 27**  
**Underside of Eastern Part of Building 2 Roof**

- A dense mat of ivy (*Hedera helix*) was growing into the roof through a hole in the rooflight at the north-eastern corner of Building 2, and dense ivy is considered to have a low, but significant bat roost potential. Where possible therefore, a careful search between the various parts of the ivy plant, initially by hand, torch, or with the use of the endoscope, found no droppings, prey remains, urine staining, fur staining from continual passage between the leaves and plant stems, or bats themselves, nor was any evidence of past bird nesting found within the ivy, (refer to **figs 3, 4 and 5 and photos 27 and 31**).

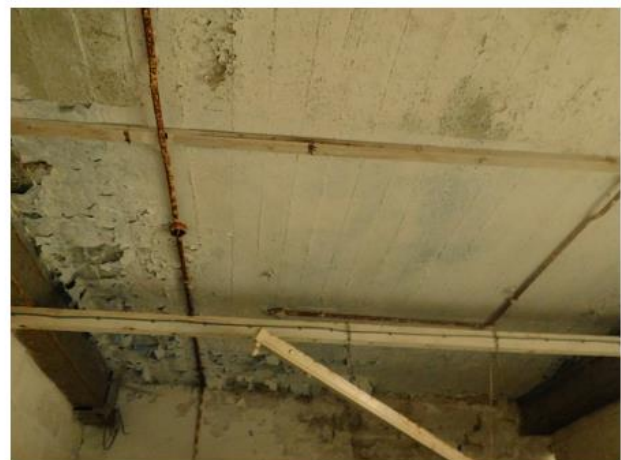
**PHOTO 28**  
**Underside of Building 3 Eastern Roof**

- Some of the glass panels within the rooflights were missing, but again an examination around the openings, and on the floor and walls between them, found no evidence of any type of bat roosting behaviour, (refer to **figs 3, 4 and 5 and photos 28 and 31**).
