## Controlled Waters Risk Assessment

Sladen Mill, Littleborough

Controlled Waters Risk Assessment

| Project Number | 20403 |

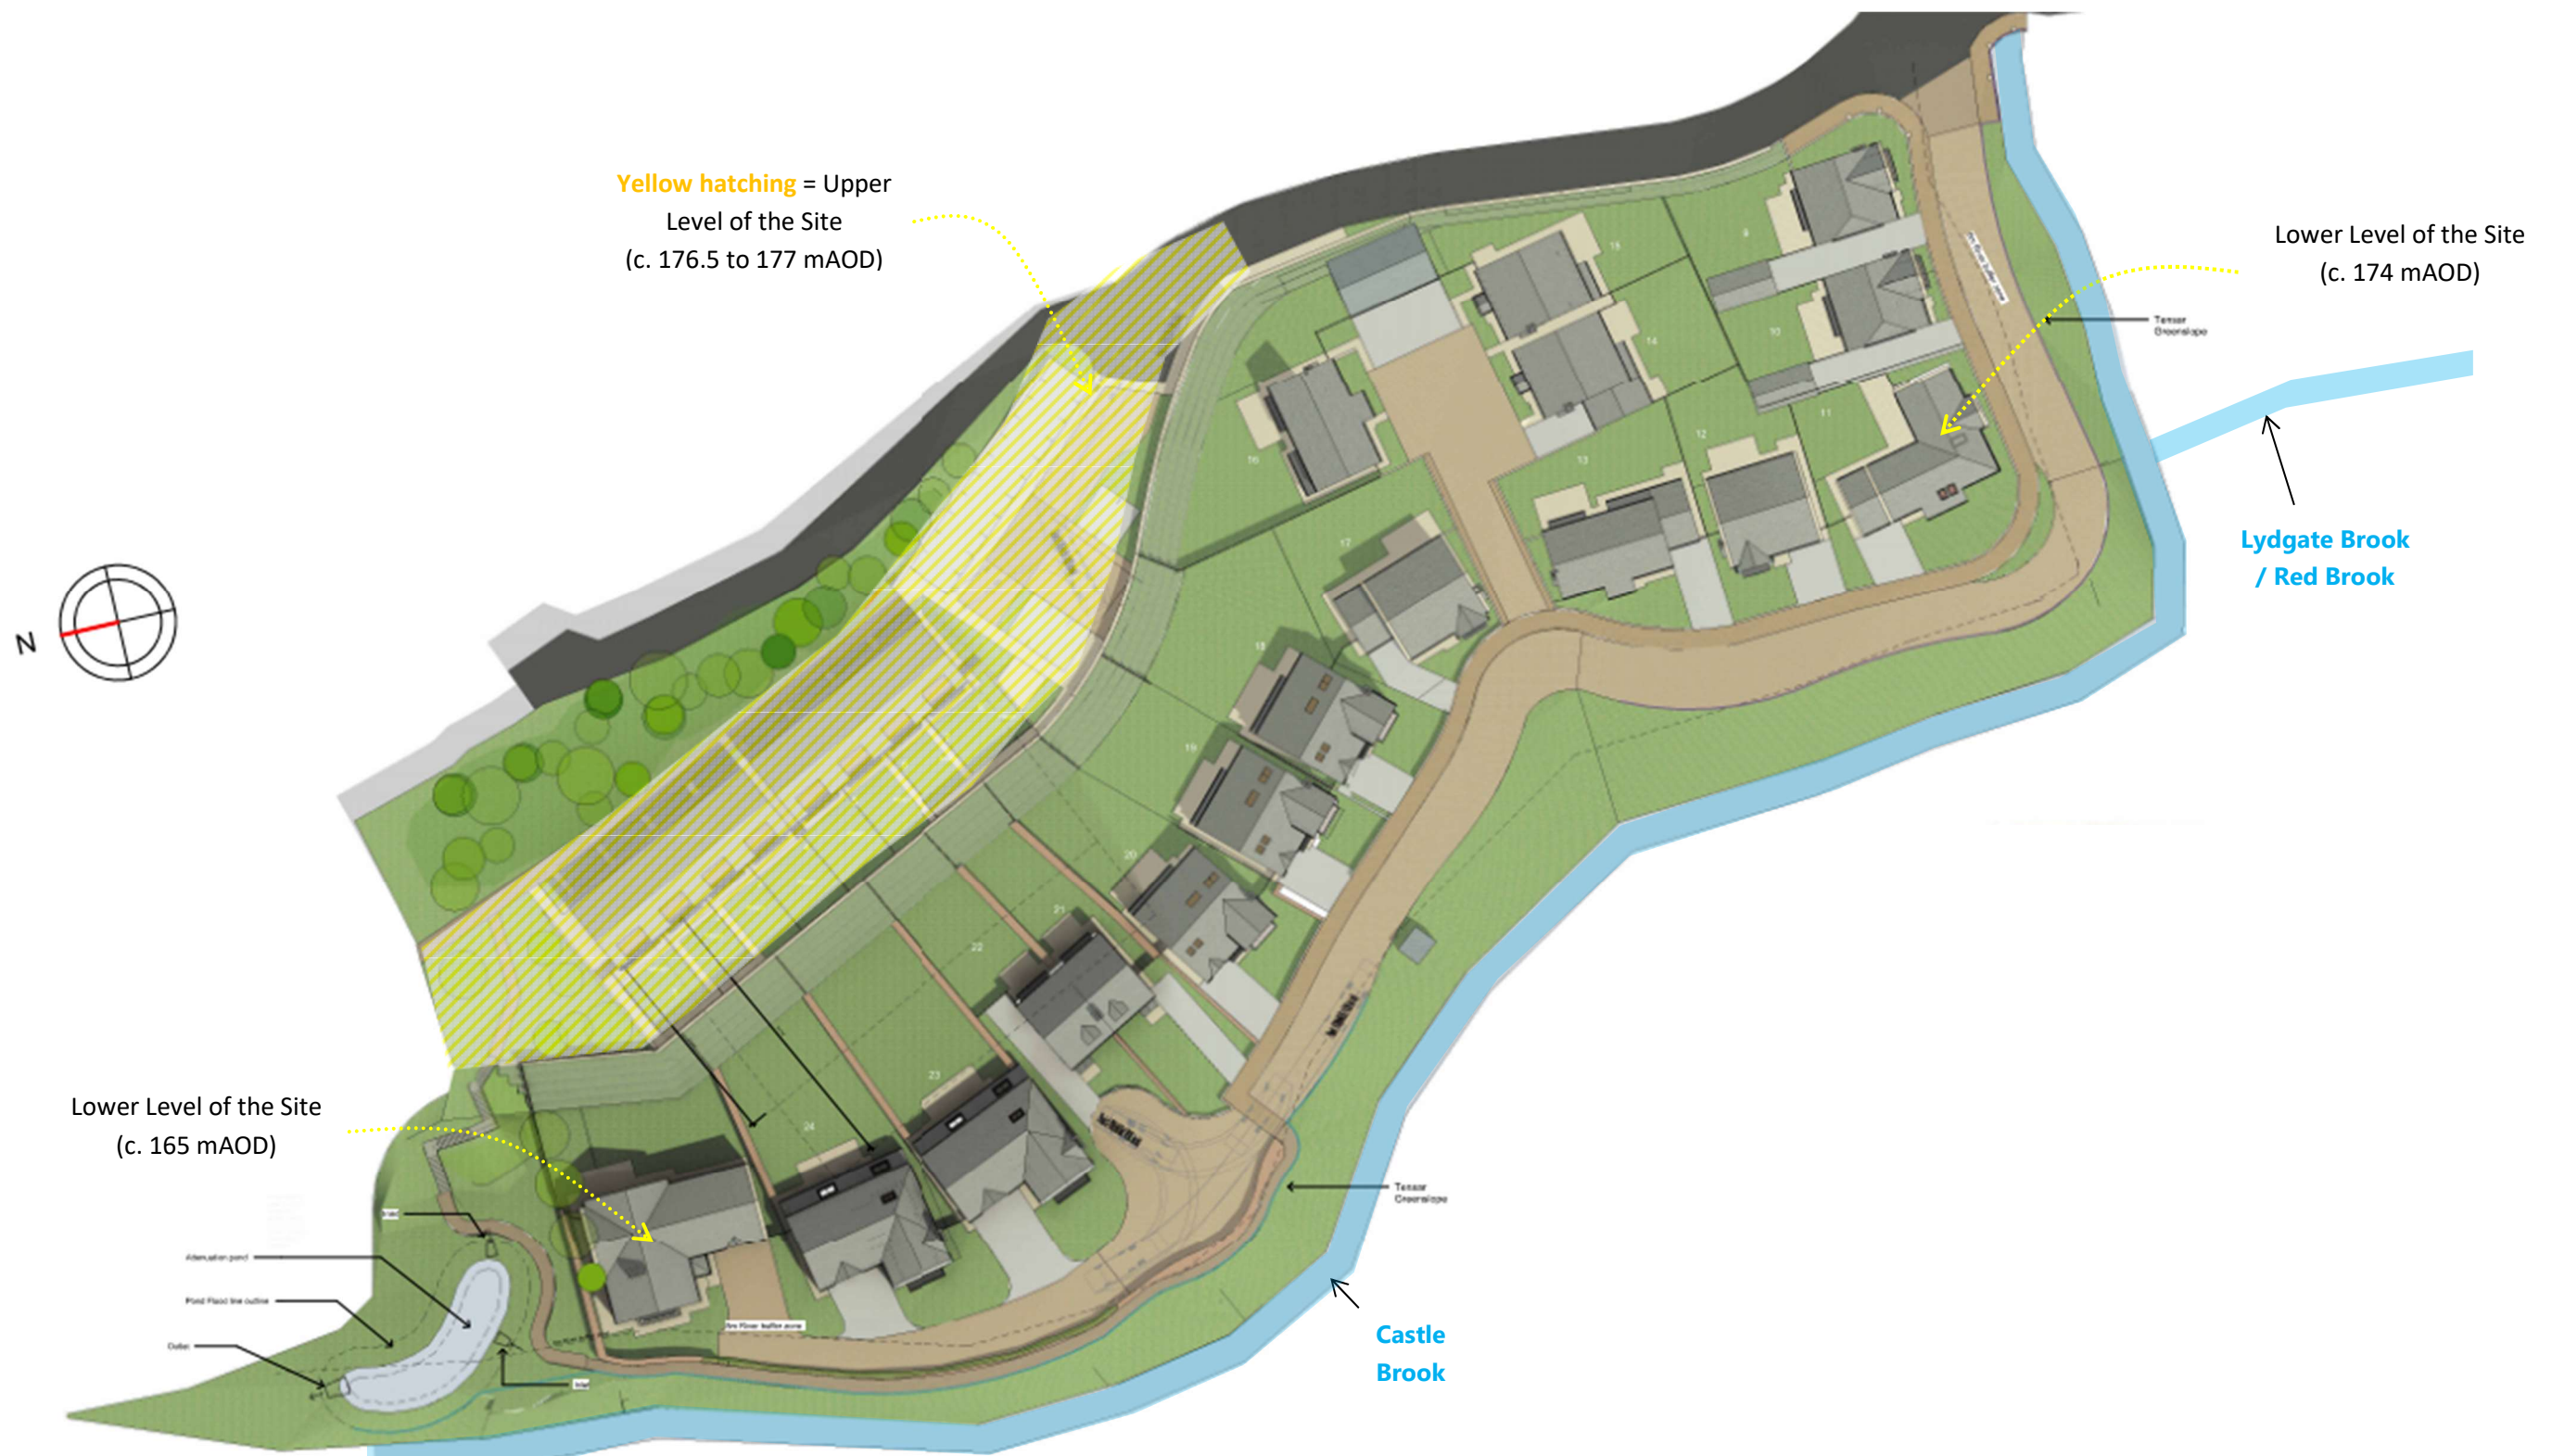
**Figure 2** – Development Plan  
> Extract from appended drawing

As noted within Section 3.0, the scope of the additional fieldwork was developed following a review of the existing reports prepared for the Site (Figure 2) and to address ‘data gaps’, as necessary and discussed within Section 4.0.

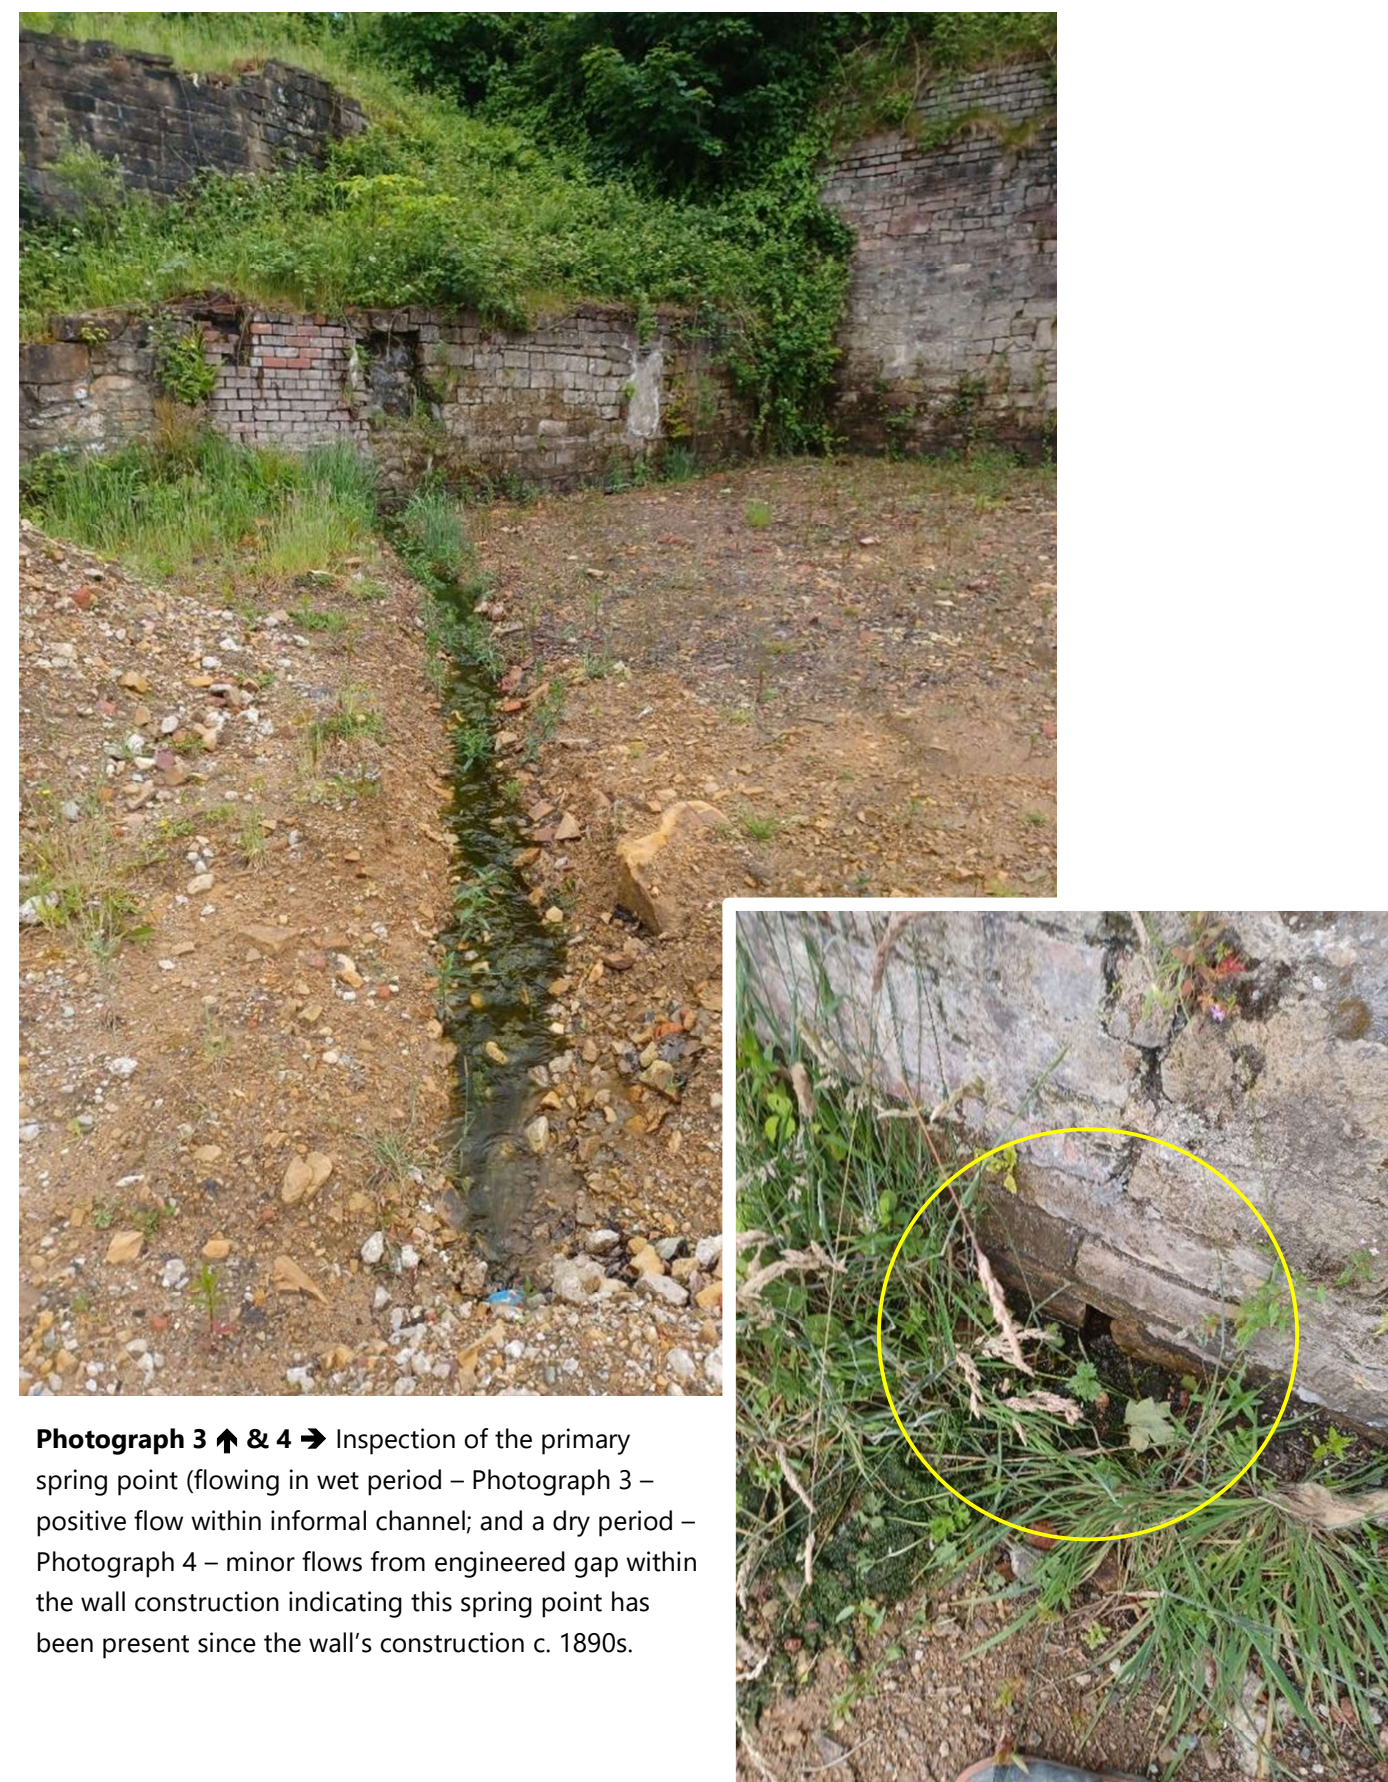
**Photograph 3 ↑ & 4 →** Inspection of the primary spring point (flowing in wet period – Photograph 3 – positive flow within informal channel; and a dry period – Photograph 4 – minor flows from engineered gap within the wall construction indicating this spring point has been present since the wall’s construction c. 1890s.

Inspection of the springs occurred on two occasions following both wet (05 June 2024) and dry (08 July 2024) spells in the local weather (48 hrs prior to visit) noting that water flow rates drop off markedly following periods of dry weather with continued flow only evident from one of the spring points (Photograph 3).

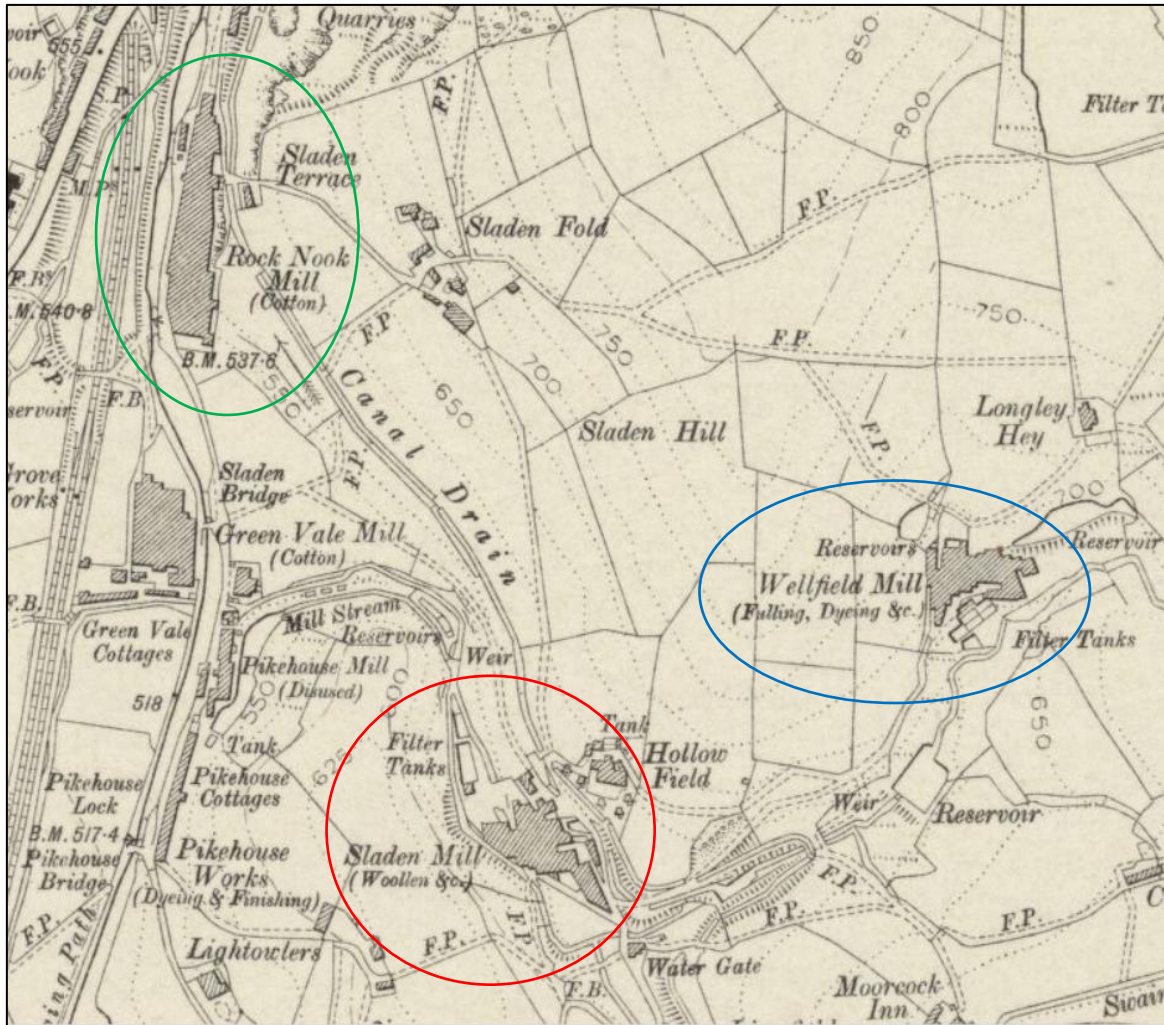
**Plate 3:** Sladen Mill on the OS Map of 1911, indicated in red. Wellfield Mill indicated in blue, and Rock Nook Mill in green. Reproduced with the permission of the National Library of Scotland (2024)
