PROPOSED TRAVIS COURT RESIDENTIAL DEVELOPMENT AT  
FORMER TAPIOS, 342 HEYWOOD OLD ROAD,  
MIDDLETON M24 4QG

PHASE 2 SITE INVESTIGATION REPORT

Client:  
TEC Services Ltd.  
Unit 6  
3a Eagar Street  
Manchester  
M24 1LR

Consultant:  
Build Vision Ltd  
Consulting Engineers  
Middle Cottage  
Ben Kaye Row  
Holmfirth  
HD9 1EF

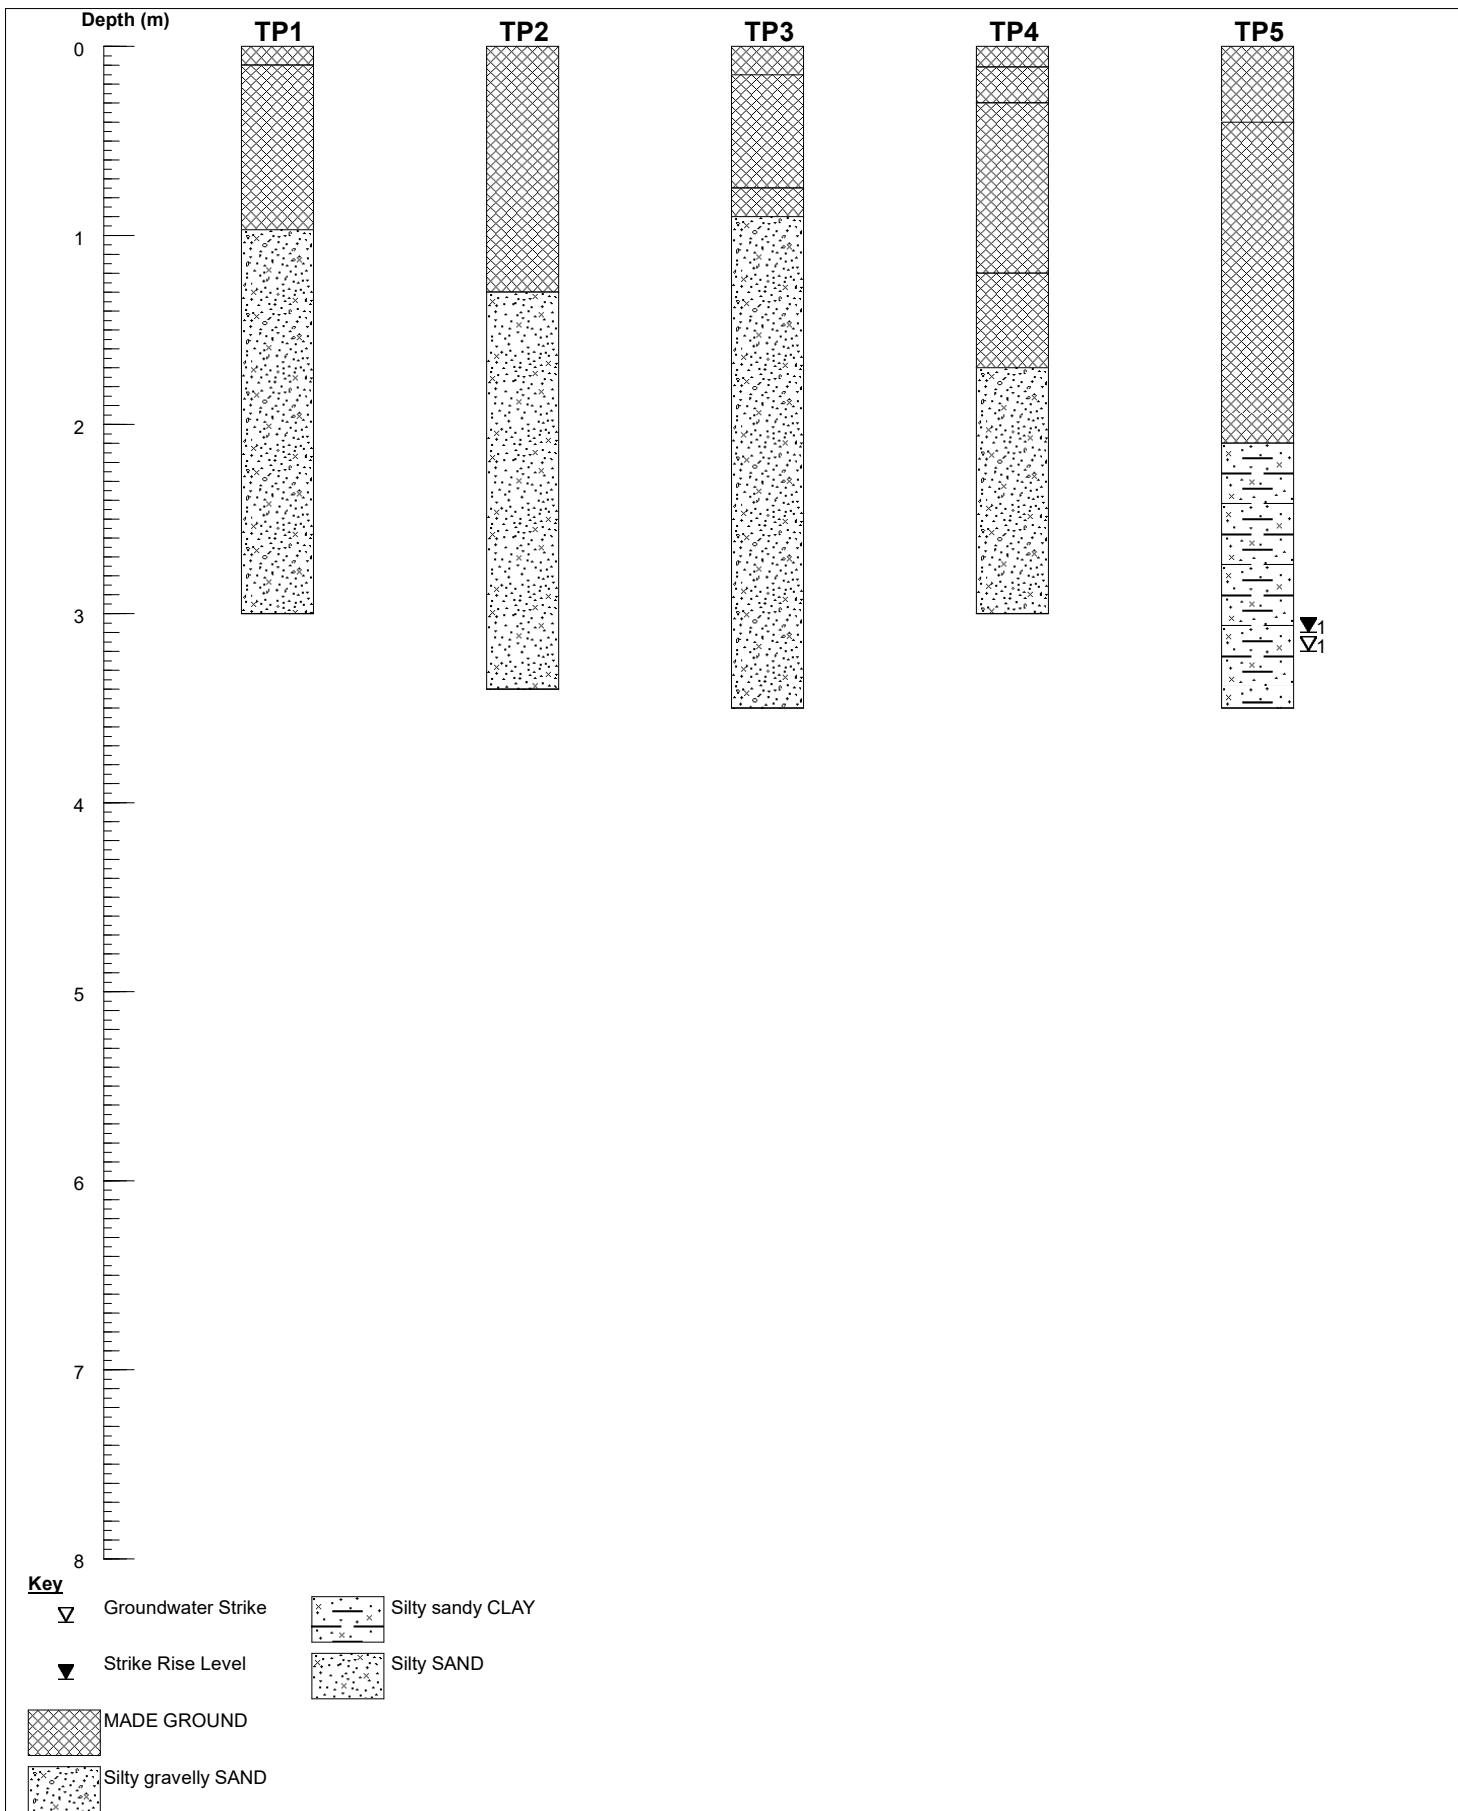
| 0.35 | D | | | | 0.40 | Possible MADE GROUND: loose light brown and orangush brown slightly gravelly clayey fine to coarse sand. Gravel is subangular to subrounded fine to coarse sandstone and siltstone with high cobble and boulder content of sandstone and rare paving flags. | | | | |

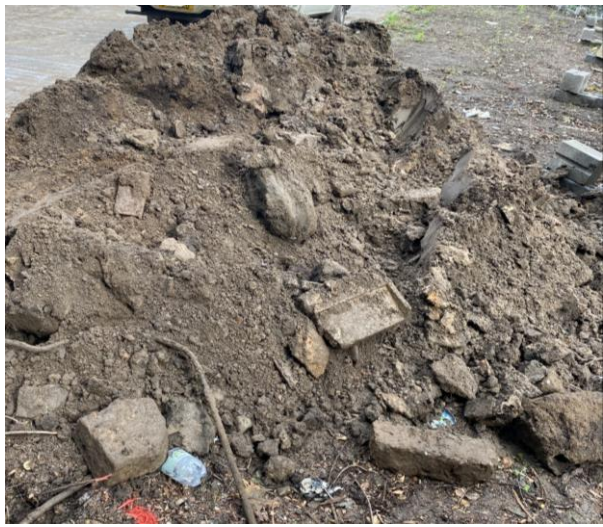
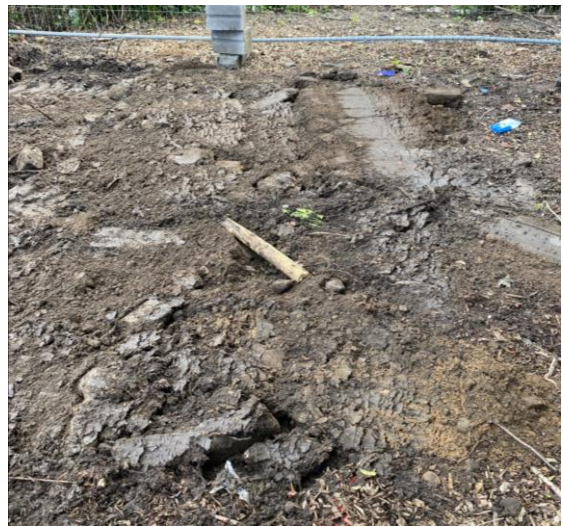
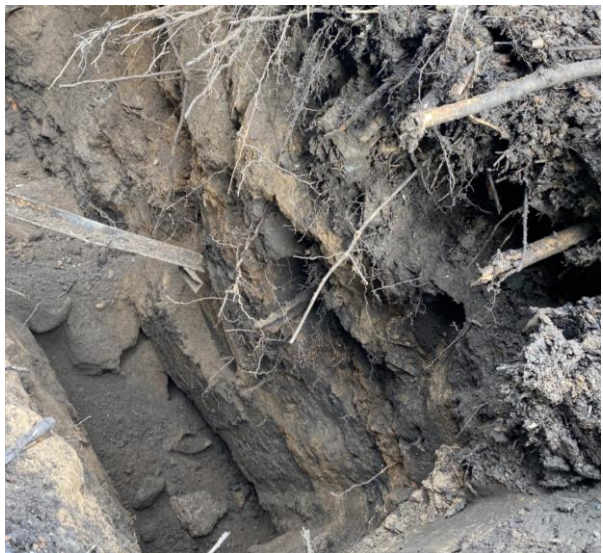
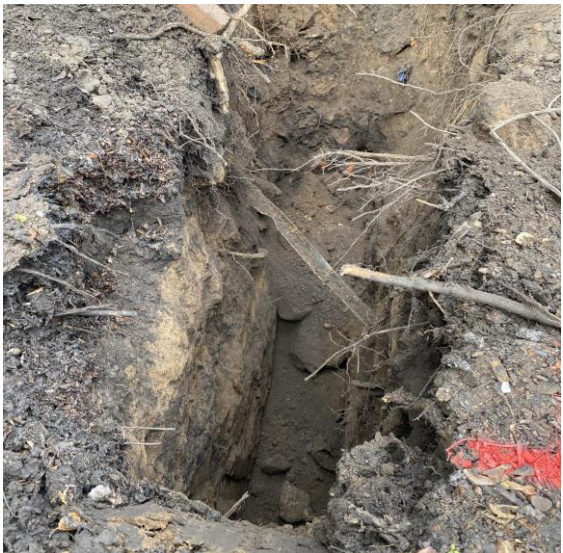
| Contamination | Elevated levels of Lead, PAHs and TPHs identified in the made ground. Asbestos insulation in BH M4 and chrysotile bundles in TP5 identified. |

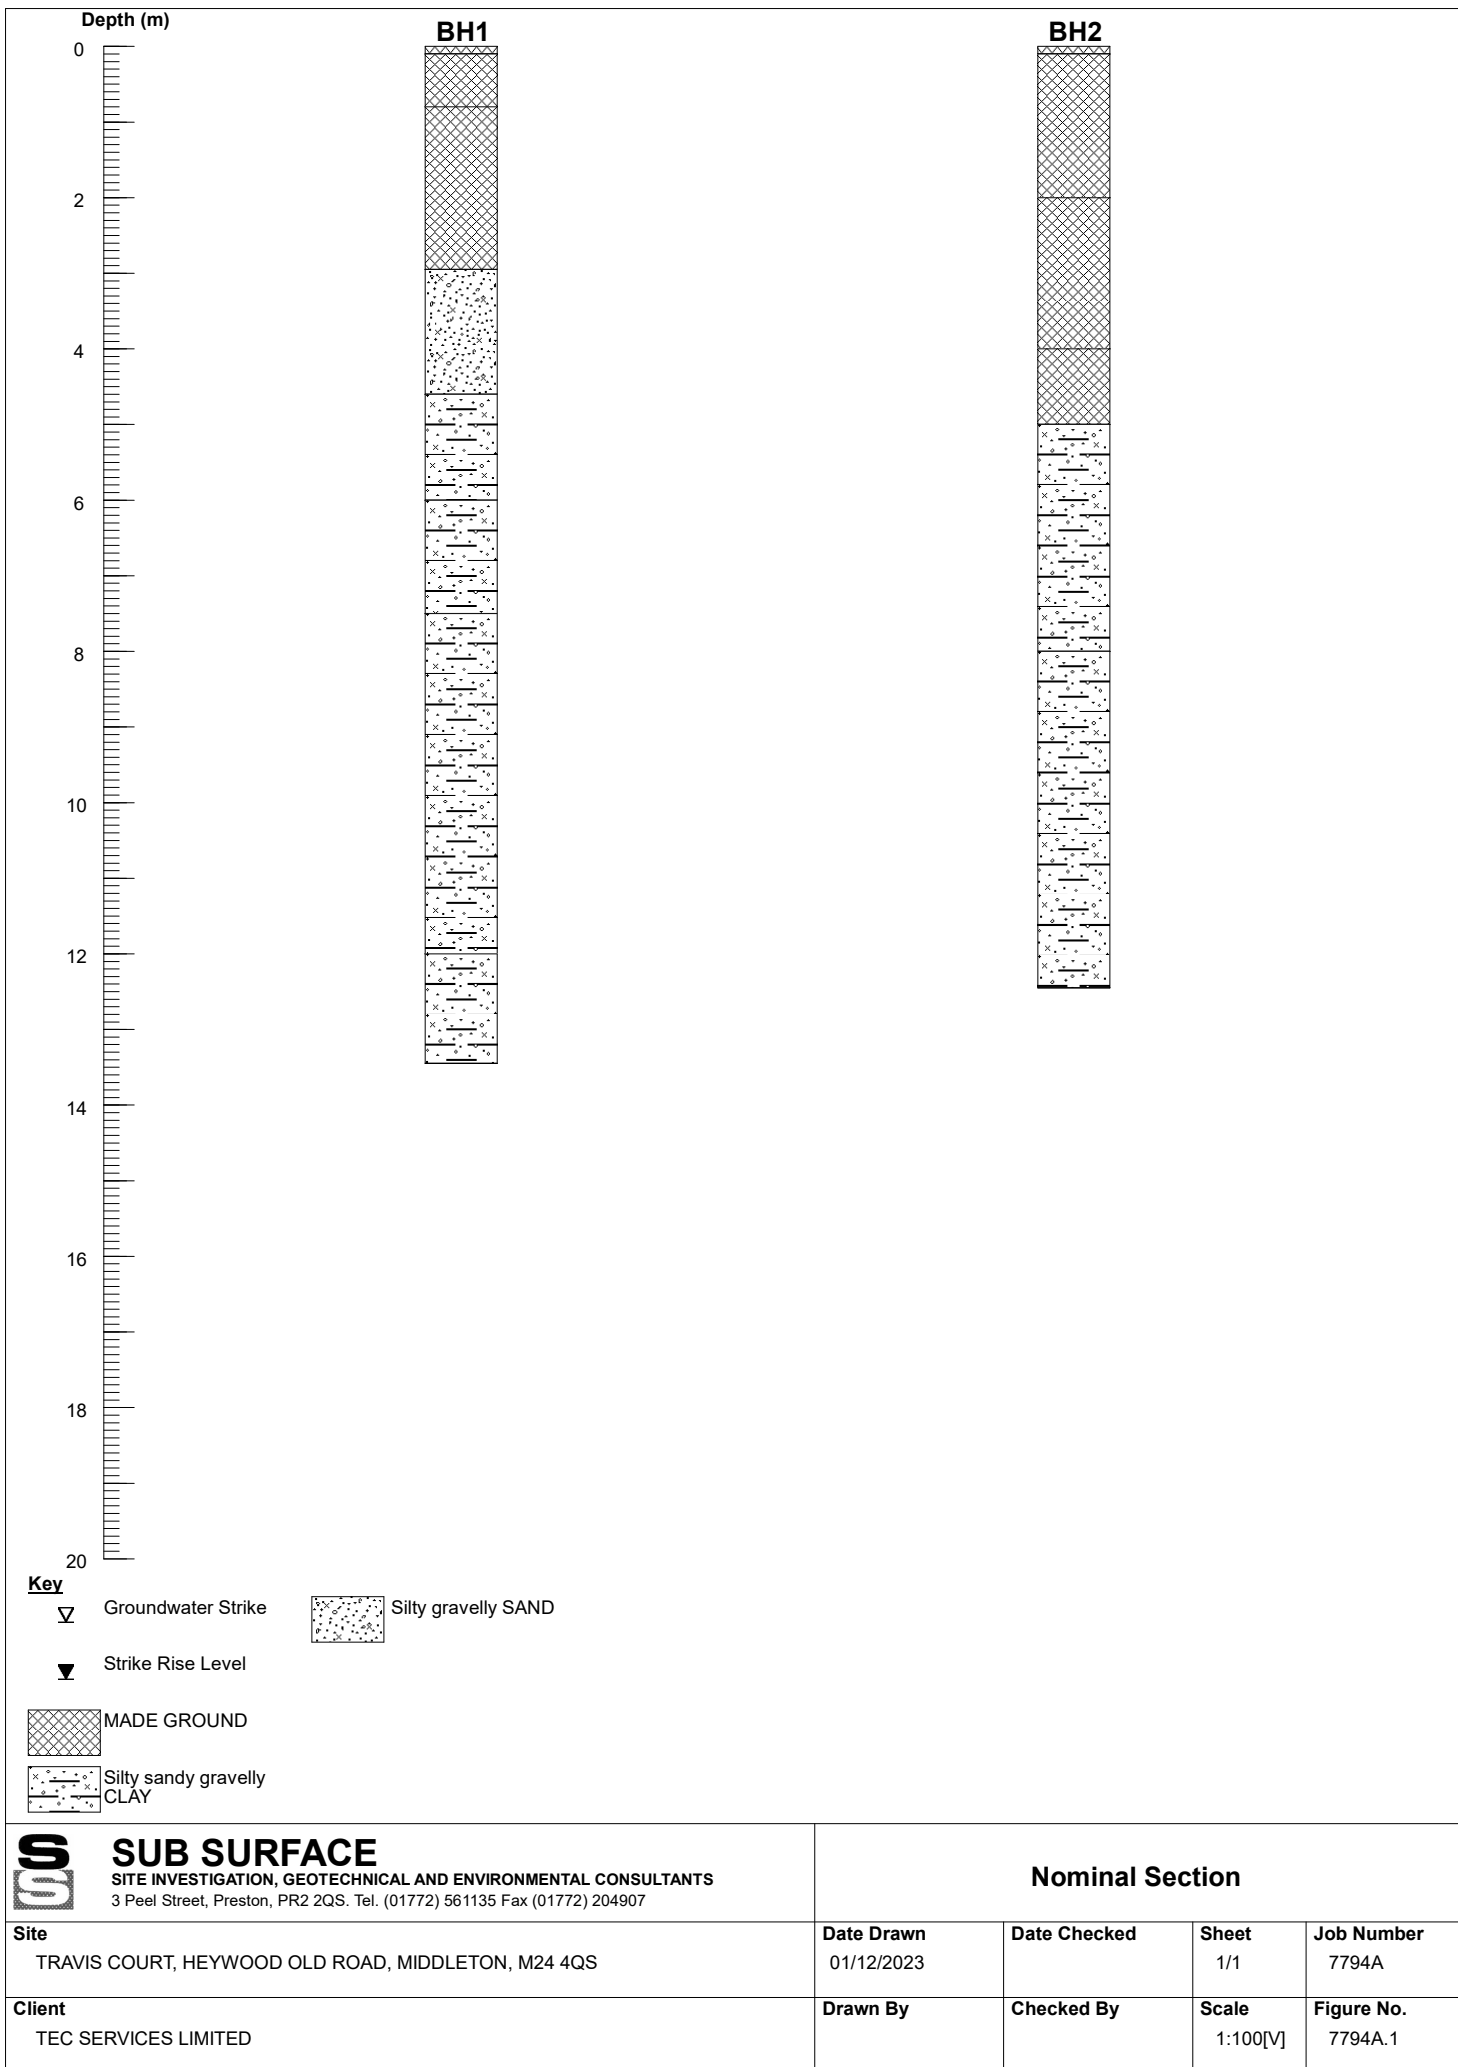
| 3.00-3.45<br>3.00-3.45 | SPT(C) N=9<br>B | | | 2,2/2,3,2,2 | | 2.95 | Loose brown speckled black and grey slightly gravelly silty fine to coarse SAND. Gravel sized fragments are subrounded to rounded fine to coarse of sandstone and siltstone. | | | |
