# **+** Intelligent Ground Remediation **+**

## **Remediation Strategy**

Plot U2, Kingsway  
Sir Isaac Newton Way,  
Rochdale  
OL16 4XB

03 February 2023  
Report ref. 23/1354.1.1

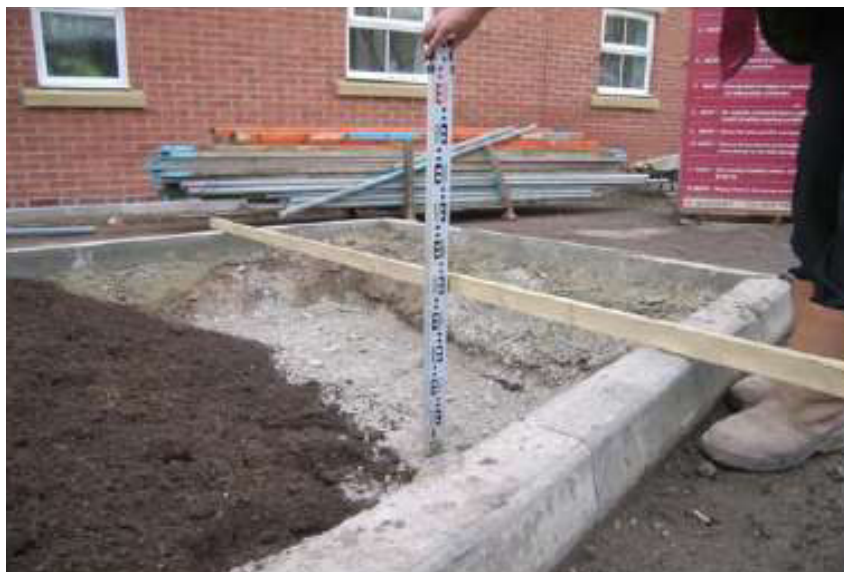
Photograph 1:  
Depth check of inert  
cover within area of  
public open space.  
Physical break layer  
and topsoil visible.

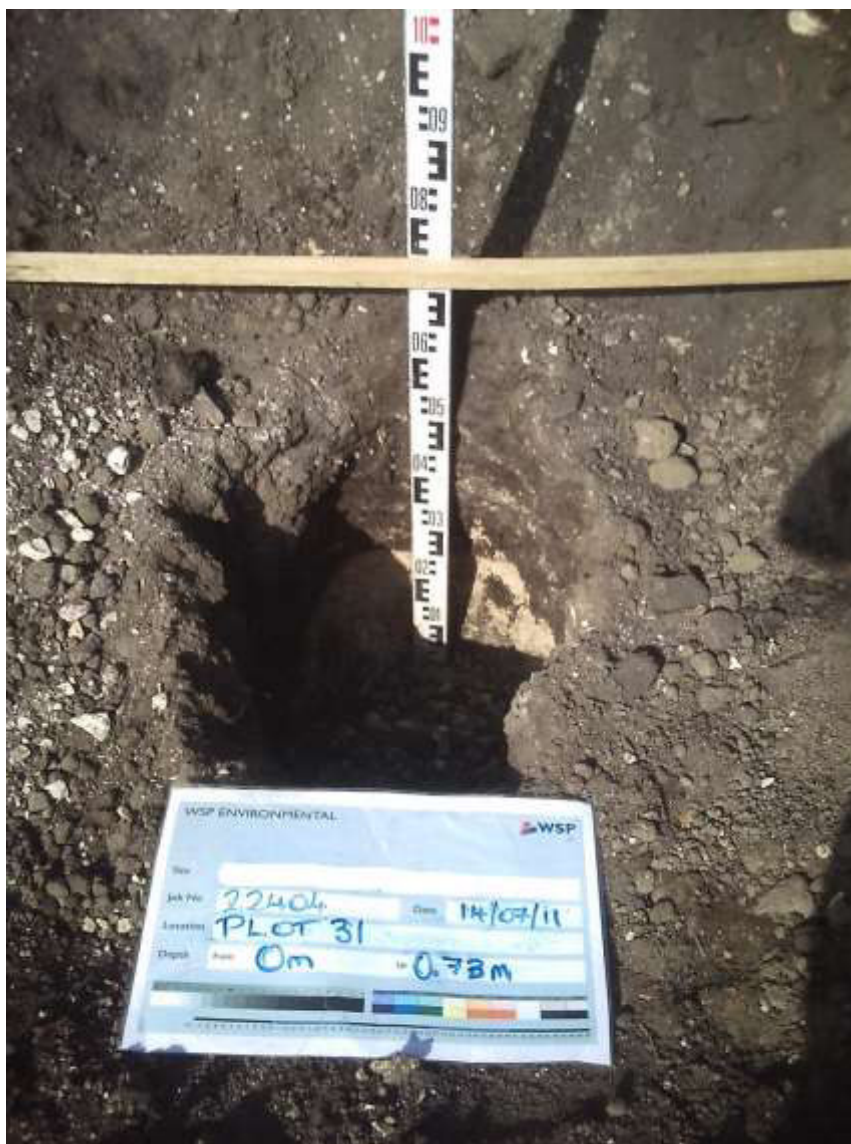
Photograph 2:  
Depth check of inert  
cover with Site &  
Location Information  
Board.

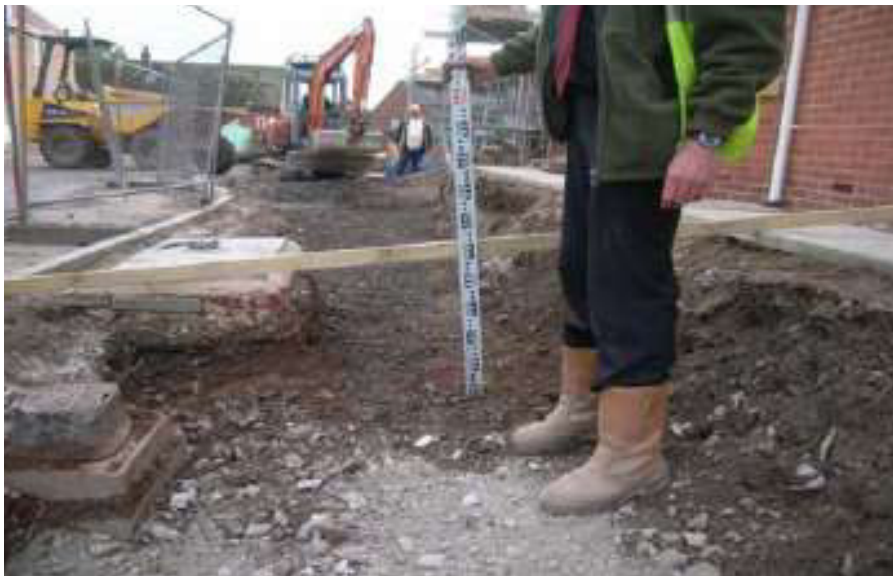
Photograph 3:  
Depth check of inert cover within areas of front gardens.

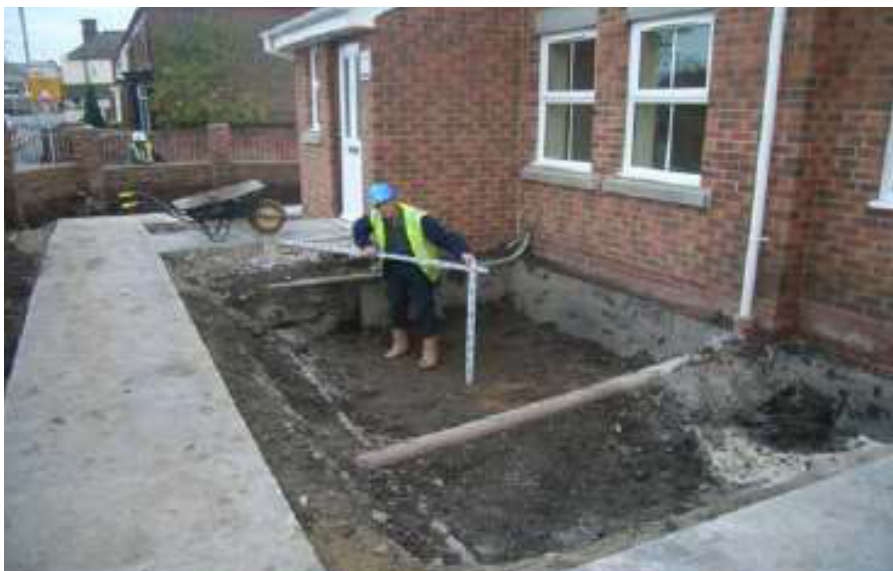
Photograph 4:  
Depth check of inert cover within areas of front gardens.

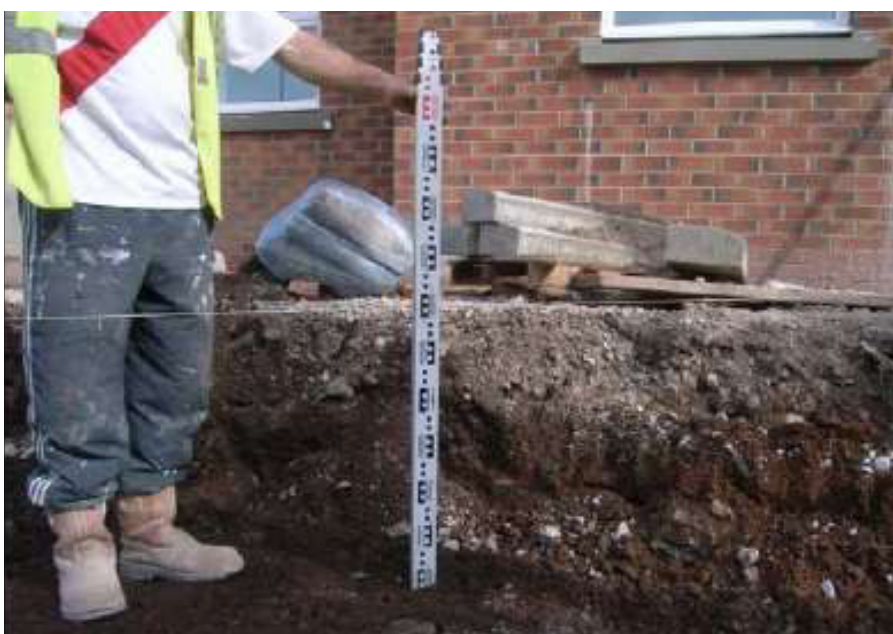
Photograph 5:  
Depth check of inert cover within rear gardens. Taut string line spans across excavation.

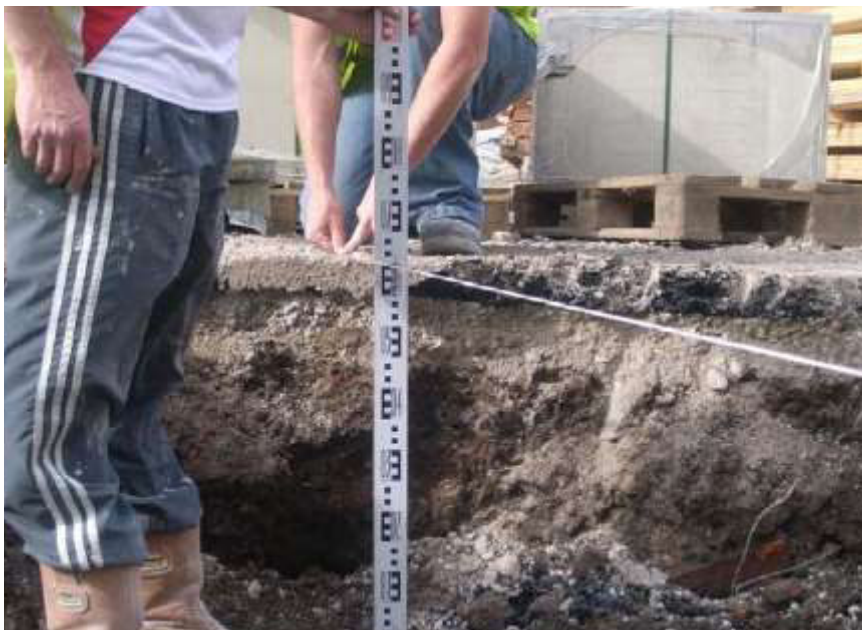
Photograph 6:  
Depth check of inert  
cover within rear  
gardens. Taut string  
line spans across  
excavation.

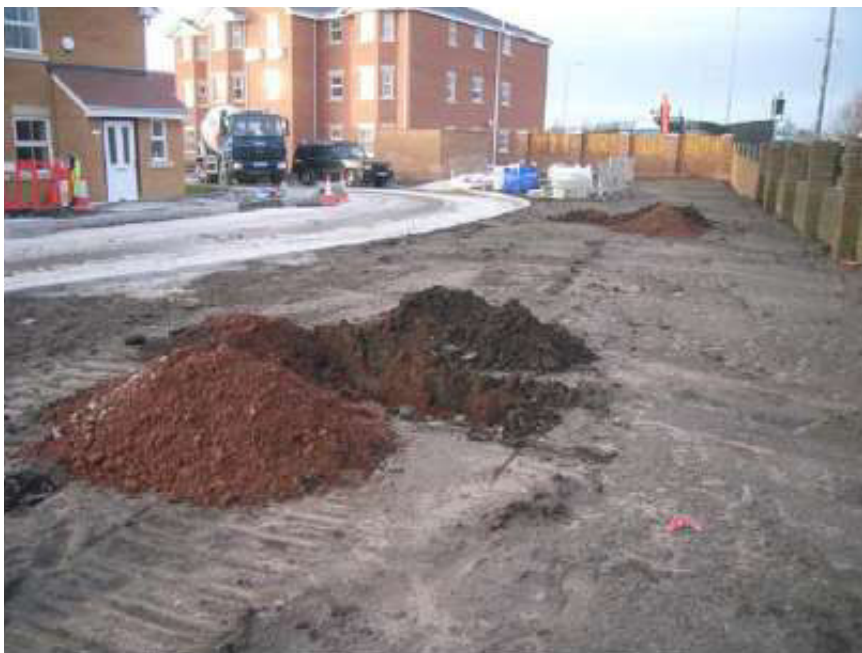
Photograph 7:  
Shows the spatial  
location of the  
verification pit.

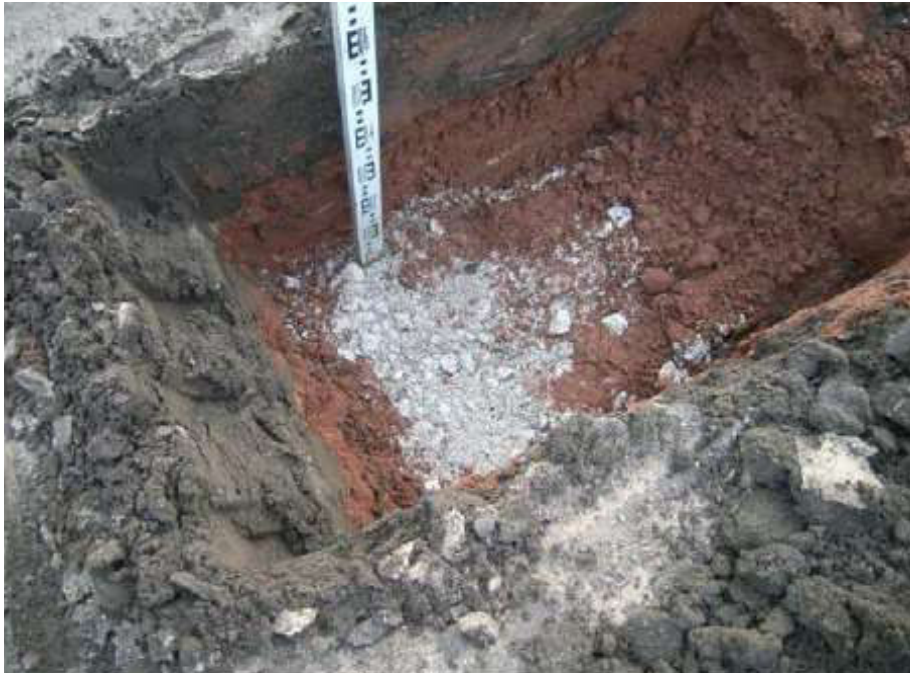
Photograph 8:  
Excavation within public open space and verification pit showing the presence of a remediation break layer at the base, a crushed sandstone inert fill overlain by topsoil.

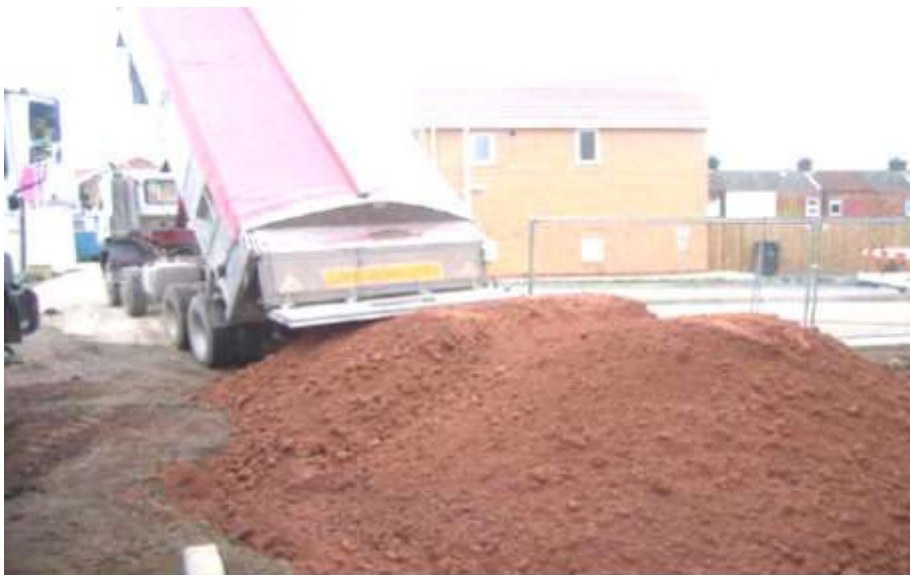
Photograph 9:  
Inert crushed sandstone being delivered. The spatial area of the remediation can be observed from these photographs (old terrace housing).

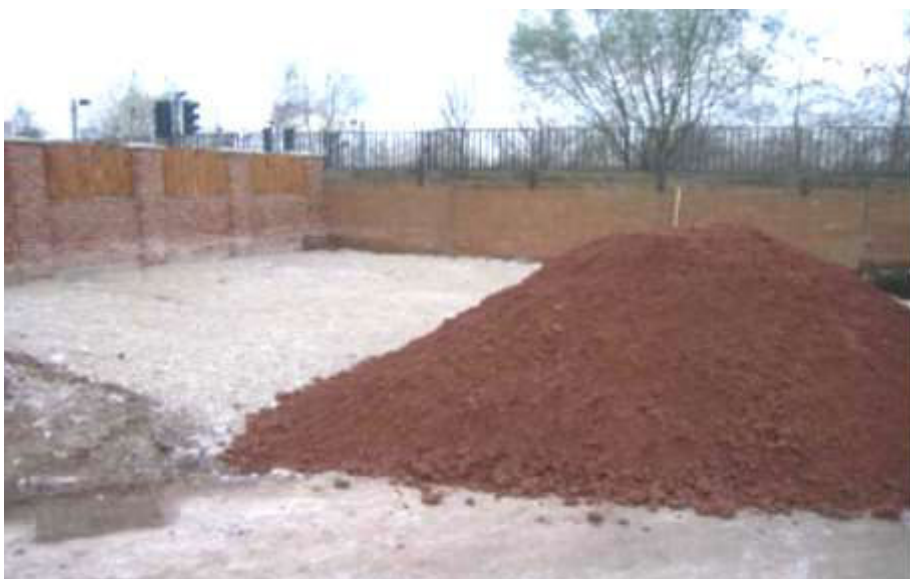
Photograph 10: Inert crushed sandstone being delivered with visible remediation break layer. The spatial area of the remediation can be observed from these photographs (traffic lights).

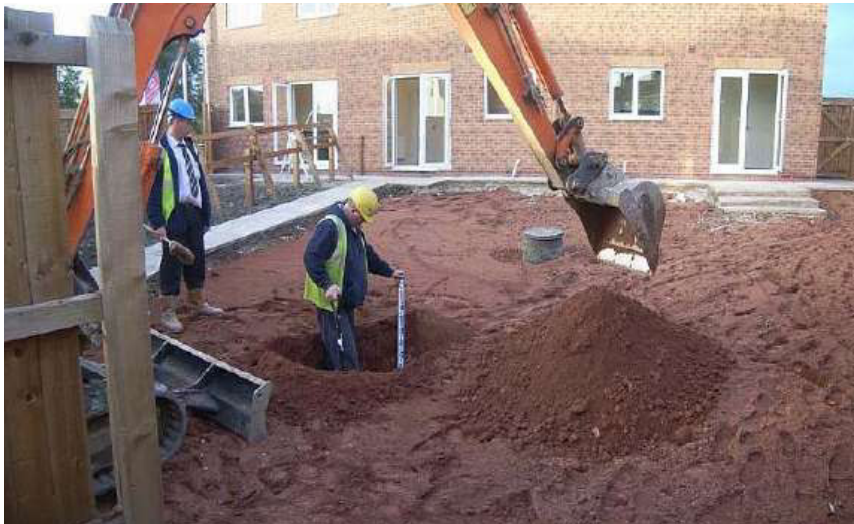
Photograph 11:  
Shows the  
remediation of the  
rear garden, with a  
significant depth  
(1.0m) of inert cover.  
This photograph has  
been stitched to form  
a panoramic  
photograph and  
hence there is slight  
distortion

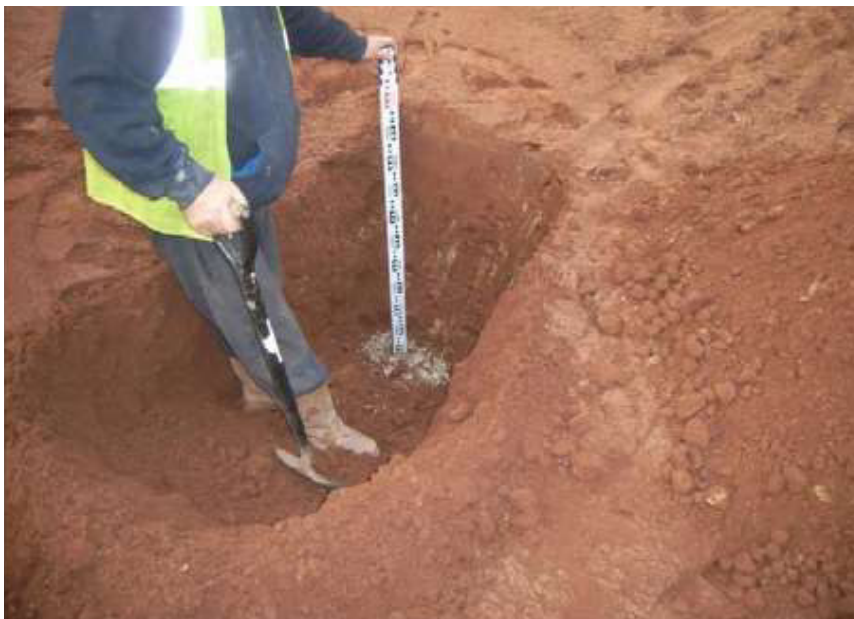
Photograph 12:  
Shows the  
remediation of the  
rear garden, with a  
significant depth  
(1.0m) of inert cover.  
Remediation break  
layer visible at the  
base of the  
excavation.
