## Heritage Statement

### Town Head House, Yorkshire Street, Rochdale

Our Ref: 15-035

July 2015

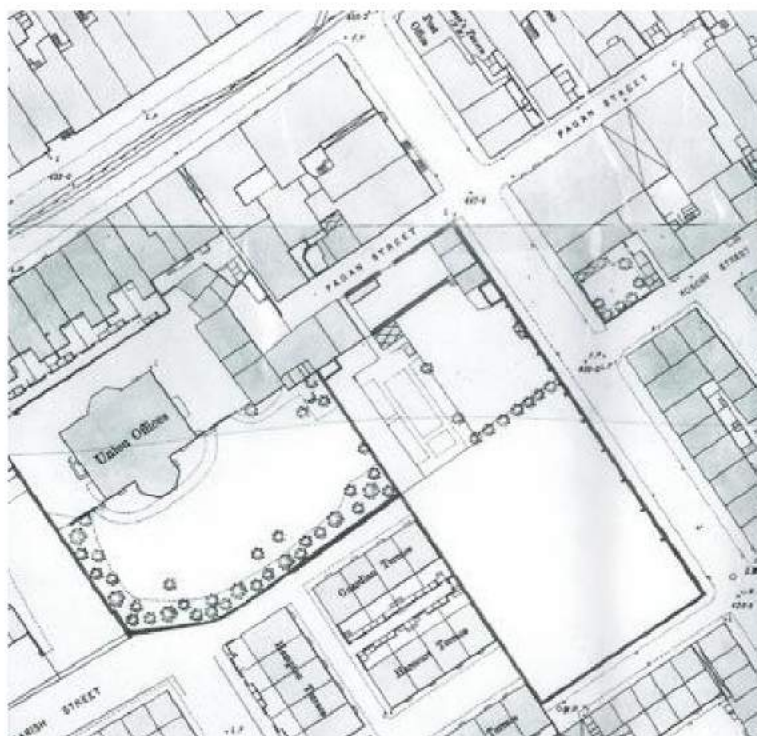
*Fig. 3. Ordnance Survey map of 1892. The bay to the south of the house has been rebuilt. Stabling is to the east with a service access off Pagan Street. In addition to the main garden to the south, there is a further kitchen garden, with glasshouse extending down John Street which remains from the domestic use of the house. The property is labelled 'Union Offices'*

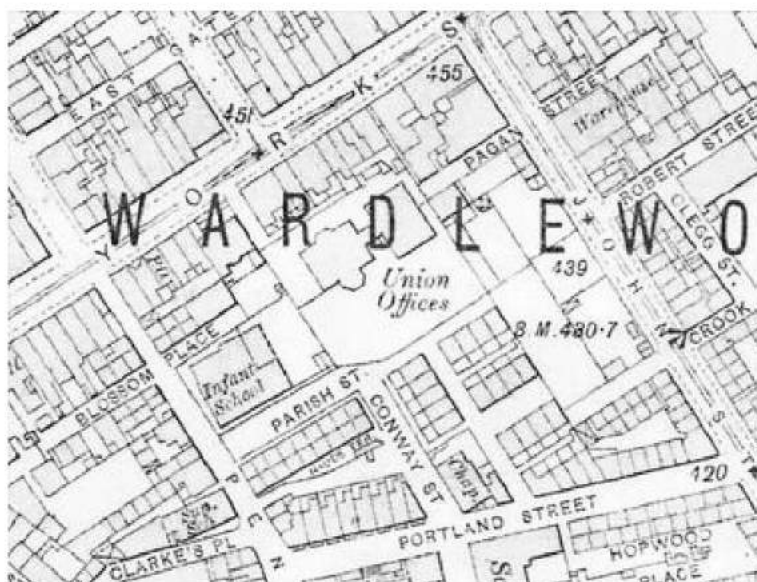
*Fig. 4. Ordnance Survey map of 1910. The Board office extension has been added.*

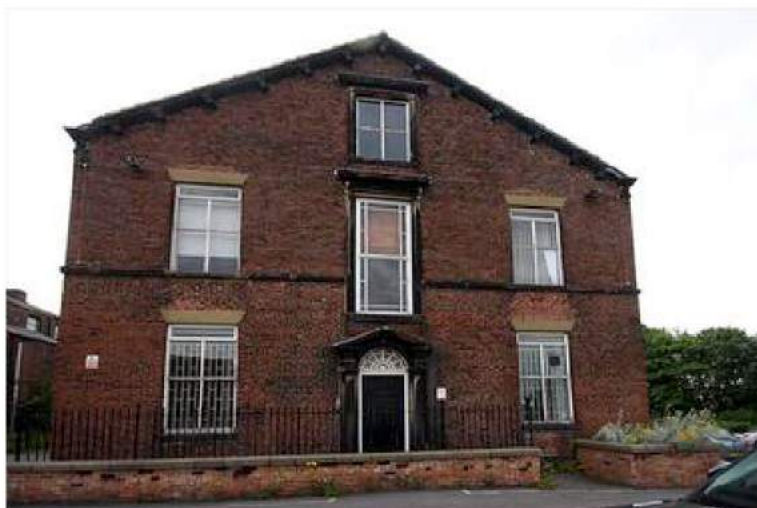
The house is constructed in brick with stone dressings. Windows have stone cills and lintels which may be replacements for flat brick arches and stone keystones which are still to be found on the side elevations. Stone ground and first floor cill banding and an eaves banding course run around the entire building.

The main entrance door to the west has attached Doric columns, with a cast iron fanlight and open pediment. The central first floor window has stone architrave, consoles cornice and marginal glazing bars. The windows throughout the building were originally sash, but many have now had fixed lights or top hung casements often inserted into the sash boxes.

*Fig. 5. Front Elevation of Town Head House.*

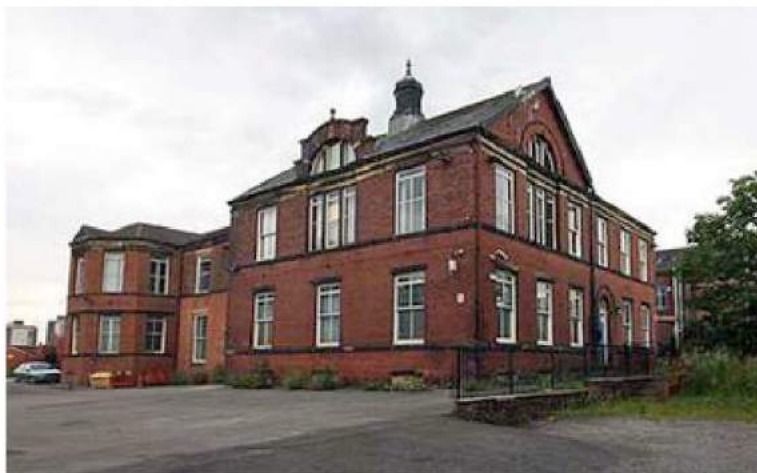
The extension is constructed to match the house, two storeys, plus basement, in brick with stone dressings, but is visually of a later classical freestyle. Windows have stone cills and lintels. A ground and first floor banding courses run round the entire building. As to the house, the windows were originally sash, but many have now had fixed lights or top hung casements inserted into the sash boxes. The board room is emphasised by a semi-circular extension of the central windows above the head band into the gables and by a Dutch gable to the south elevation. The northern section of the building has a hipped roof, whilst the board room has a dual pitched roof with gables east and west, together with the Dutch gable to the south. The extension is roofed in Welsh grey slates. The link is similarly detailed.

*Fig. 6. The Poor Law Union Office Extension*

In the mid C20 a single storey brick infill has been added to the rear of the link. An external metal escape stair has also been added to the north elevation of the extension, with a door formed in a first floor window opening.

| Element | Significance |
|---|---|
| The metal fire escape is visually detrimental and could be removed. | |
| The single storey office to the north of the link is of no conservation merit and could be remodeled. | |

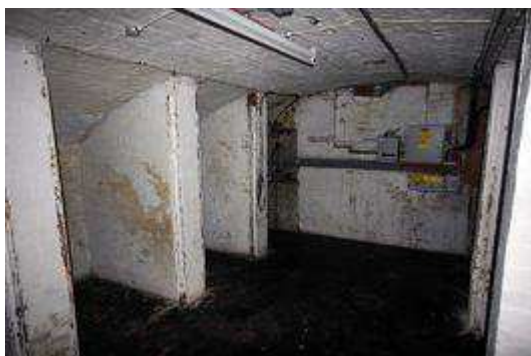
| Room | Location | Use | Original Use | Significance |
|---|---|---|---|---|
| B6 | House | Vacant Store | Beer Cellar | Medium |

The stillages should be retained, or recorded if removed.

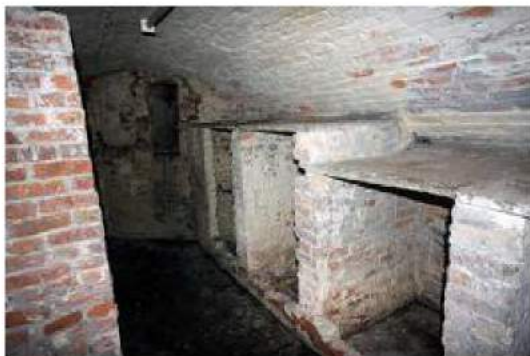
| Room | Location | Use | Original Use | Significance |
|---|---|---|---|---|
| B9 | House | Vacant Store | Cool (meat and dairy) Pantry | Medium |

The table should be retained, or recorded if removed.

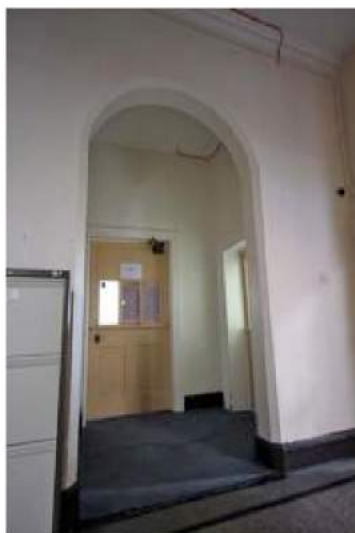
| Room | Location | Use | Original Use | Significance |
|---|---|---|---|---|
| G11 | House | Office | Living Accommodation, possibly Drawing Room. | Medium |

Retain coving. Retain joinery where practicable. Repair door by replacing panel.

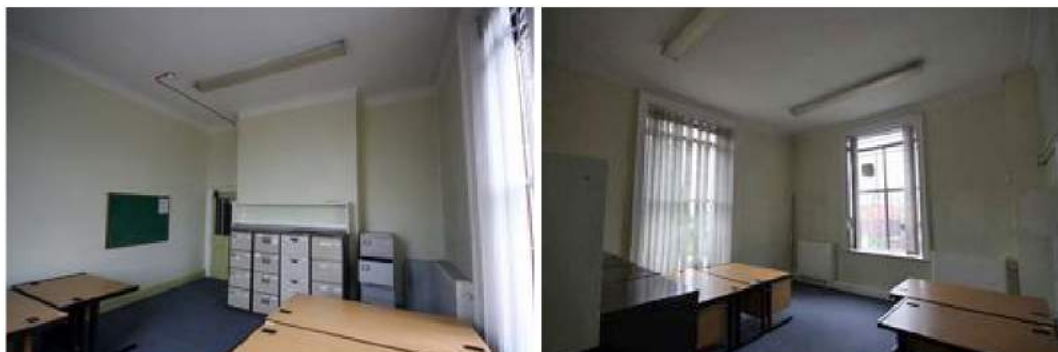
| Rooms | Location | Use | Original Use | Significance |
|---|---|---|---|---|
| G12 and G13 | House | Entrance Hall and vestibule | Hall and vestibule | High |

Coved flat plaster ceiling to G13, with C19 Adam revival style mouldings. Plastered walls. C19 skirtings. Scagliola floor. Modern partition and door inserted between hall and vestibule. Glazed screen and door from G13 to G4 divides the family's daytime living space in the house from the stairs and the ground floor service rooms. The Vestibule G12 has a modern stair inserted, with ceiling replaced. Modern Finishes.

Consideration should be given to rationalising the partition crudely inserted between G12 and G13.

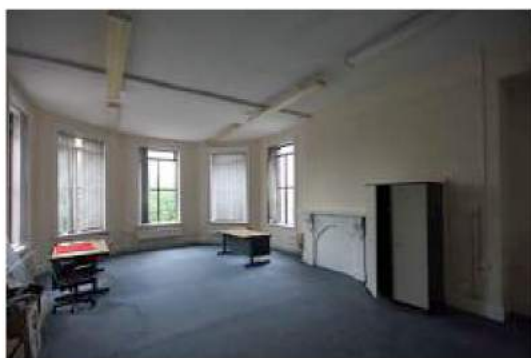
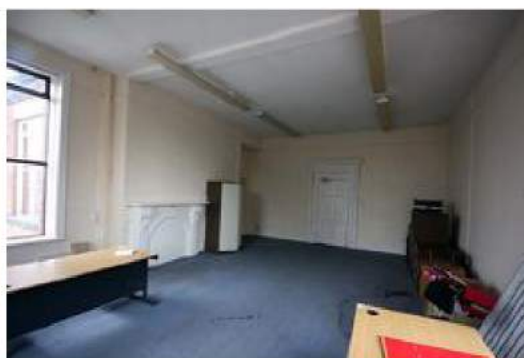
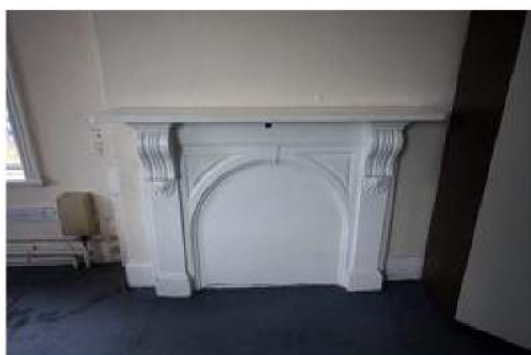
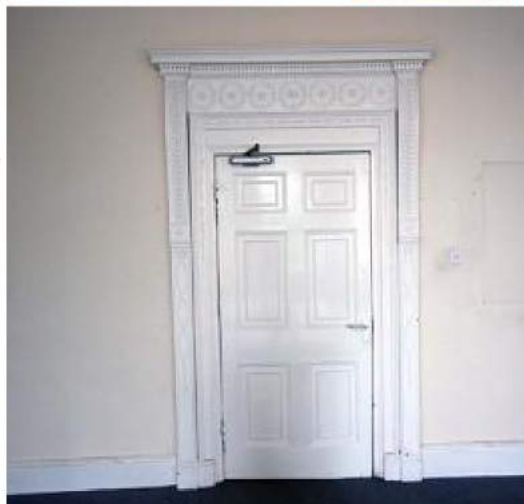
| Room | Location | Use | Original Use | Significance |
|---|---|---|---|---|
| F9 | House | Office | Bedroom | Medium |

**Notes:**

**Recommendations:** *Unless stated otherwise finishes and fittings should be retained.*

Retain door, and window surround.

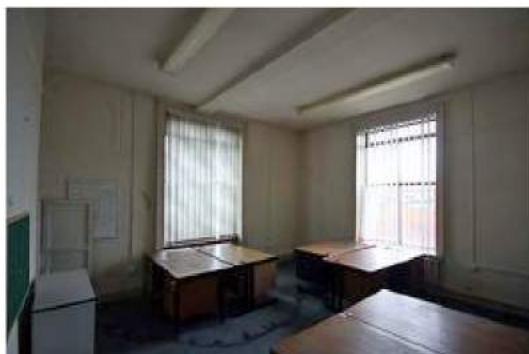
| Rooms | Location | Use | Original Use | Significance |
|---|---|---|---|---|
| F10 and F11 | House | Landing and Stair | Landing | High |

Consideration should be given to rationalising the partition between the spaces to avoid the stagger at the doorway.

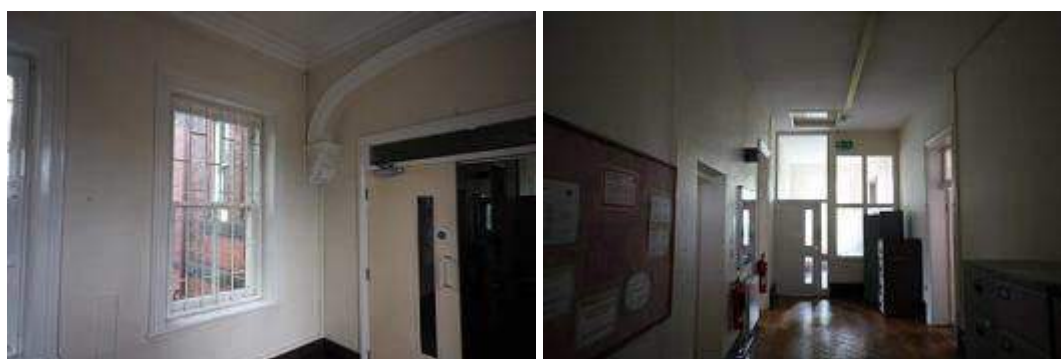
| Room | Location | Use | Original Use | Significance |
|---|---|---|---|---|
| F14 and F15 | Extension | Toilets | Office, possibly toilets or service rooms | Low |

Sub-divisions and modern fit out is of poor quality and would benefit from removal. Sash windows should be retained. The etched glass marked 'RU' should be recorded and protected. It should be retained within a window in the extension, but could be protected by encapsulation within a glazed unit. If relocation is required, but the glass is difficult to safely remove from the frame the lower sash could be replaced, allowing the glass to be removed for reuse together with its frame.

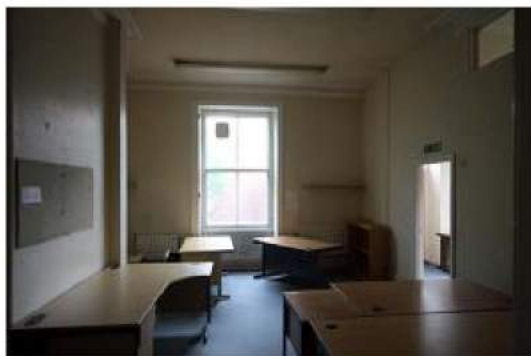
The room was built as the board room for the Governors of the Poor Law Union. It is a high status room with a decorated barrel vaulted ceiling and Venetian windows to each end. Some plaster damage to ceiling, with loss of features. Original joinery, including doors and window surrounds remain, but some windows have been replaced. New partitions or walls have been inserted to sub-divide the space.

Removal of later sub-divisions would enhance understanding of the space. Sub-division in another form may reduce understanding from the present state and needs to be carefully detailed to maintain appreciation of the ceiling and the large volumes of the spaces. The window surrounds and panels below should be retained.

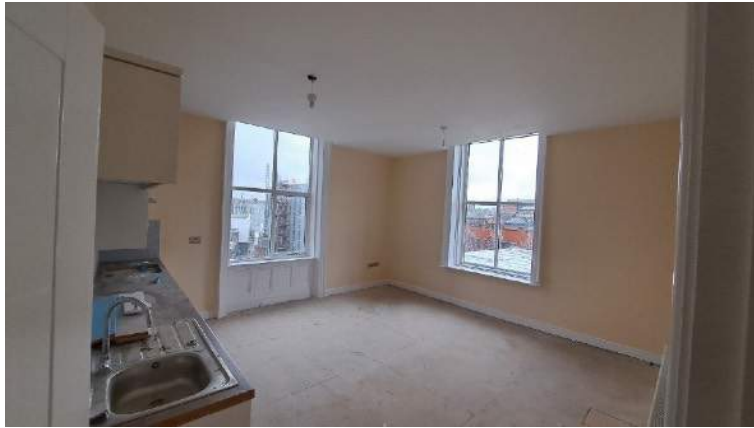
A09.2 House Office Bedroom Medium

Notes: **F9** former bedroom now forms Room2 of Apartment 10. Modern windows in original surrounds have bulkheads
