# COAL MINING RISK ASSESSMENT

Chestnut Way

Littleborough

Author: Daniel Slattery  
Client: Clive Rainford Homes  
Reference: rep-tjba-CRH-chestnut way-CMRA-160523.docx

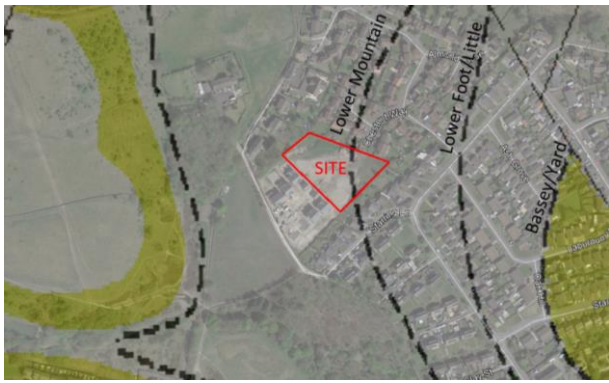
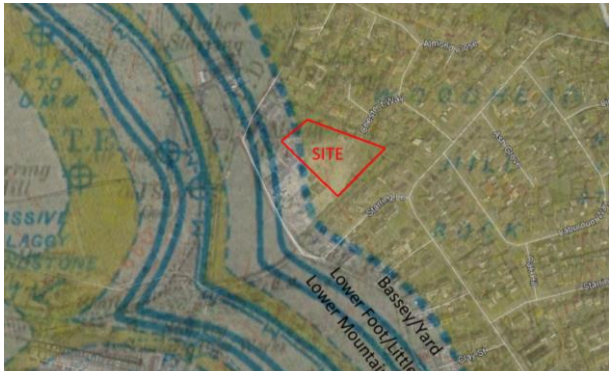
| Coal Seams/Faults. | <p>There are a number of coal seams in the local area but there is ambiguity as to whether these underly the Site or not.</p> <p>The 1:50000 scale map (top) identifies the Lower Mountain seam subcropping beneath the east corner of the Site. The dip direction is to the southwest so the Lower Foot and the Bassey/Yard would both underly the Development Site.</p> <p>The 1:10000 scale map (bottom) identifies local stratigraphy dipping SW. However, subcropping seam positions as identified on the map place the lowest seam in the stratigraphy (the Yard/Bassey), to the west corner which would suggest no seams actually exist below the majority of the Site.</p> <div style="display: flex; align-items: center;"> </div> |

| Probable/Potential Workings: | Shallow | <p>There is significant ambiguity on the different BGS maps, and in the Coal Authority data.</p> <p>The 1:10000 detailed map makes the most sense given the seam positions annotated on the maps in accordance with the topographic data for the area. In addition the coal shafts annotated on the same maps identify seams at depth where they would be expected.</p> <p>The Coal Authority and BGS 1:50000 maps do not appear to be correct.</p> <p>However, due to the different sources of data, confidence in the dataset cannot be guaranteed and as there is the chance of shallow seams beneath the Site, it would be prudent to undertake site investigations to assess the potential for shallow seams, workings, and characterisation independently.</p> <p>There are three seams locally that could have an impact on Site: Lower Mountain seam, Lower Foot (Little) seam, and the Bassey (Yard) seam.</p> |

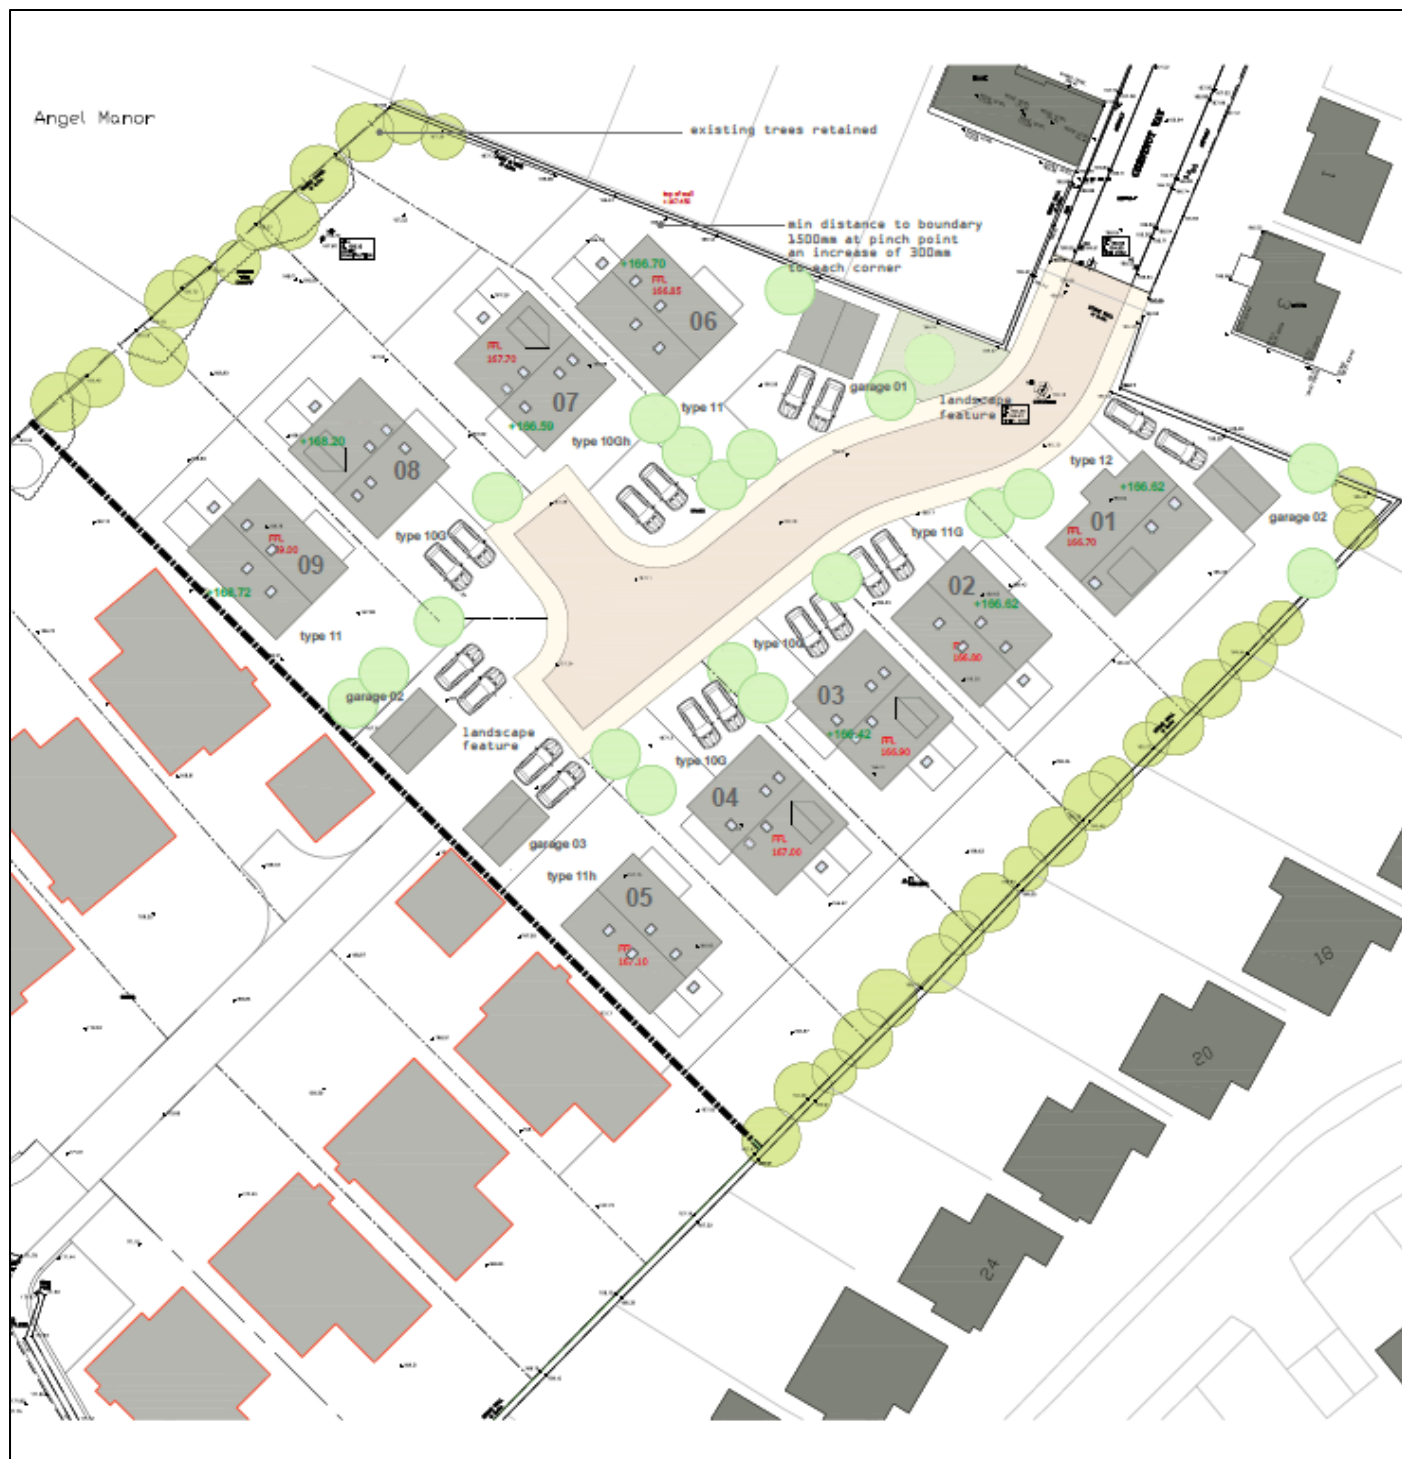
### 12.3. Proposed Site Plan.

The Application Site is for a residential housing development comprising 9No. executive detached 2-storey dwellings, with associated shared access road, private driveways & gardens.

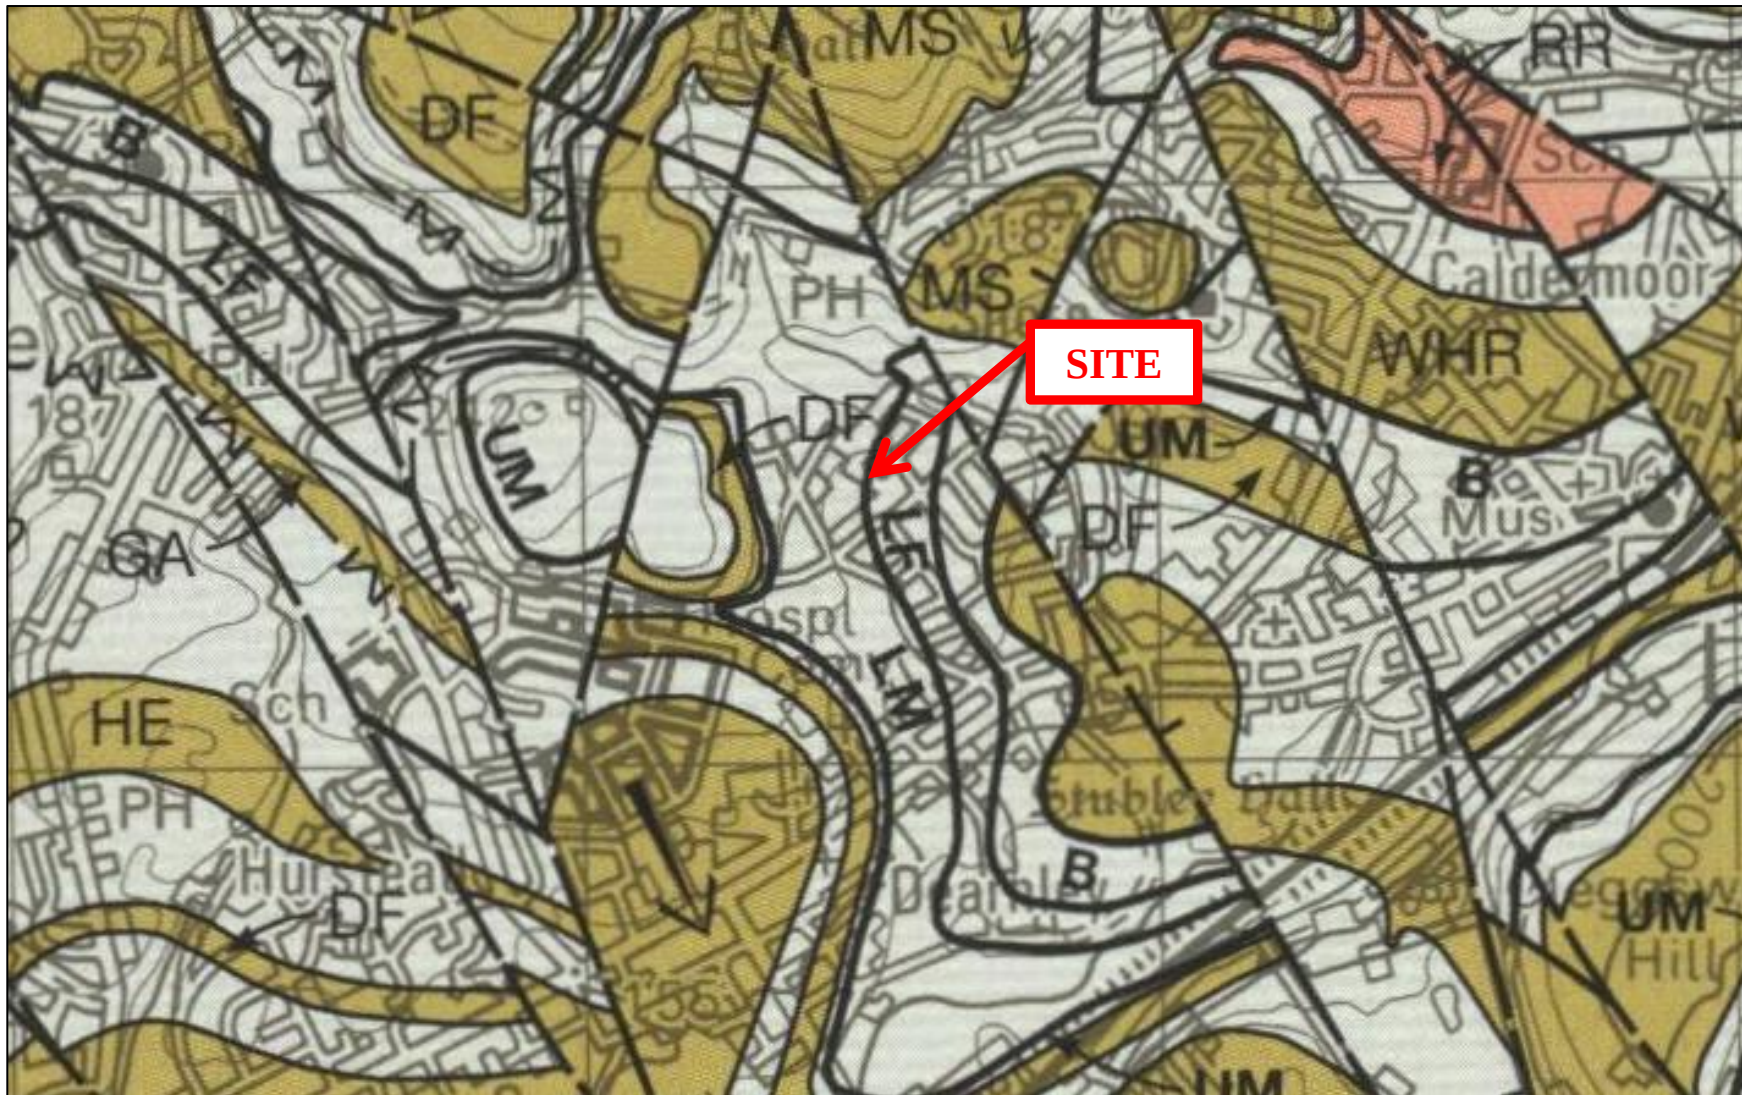
## 12.7. BGS Geological Maps

| Bedrock Geology: | <p>The site is underlain by undifferentiated Carboniferous Westphalian Coal Measures, generally comprising interbedded sandstone and mudstone.</p> <p>The 1:50000 scale map suggests a south to south-east dipping stratigraphy, however, older more detailed 1:10000 scale maps show identified seams dipping nominally 10degrees south-southwest, and coal shafts to the west of these specific seams are annotated to show the shafts intercepted the seam at depth – which would suggest the older map is more accurate.</p> <p>See below Coal Seam Section for relevant maps.</p> |

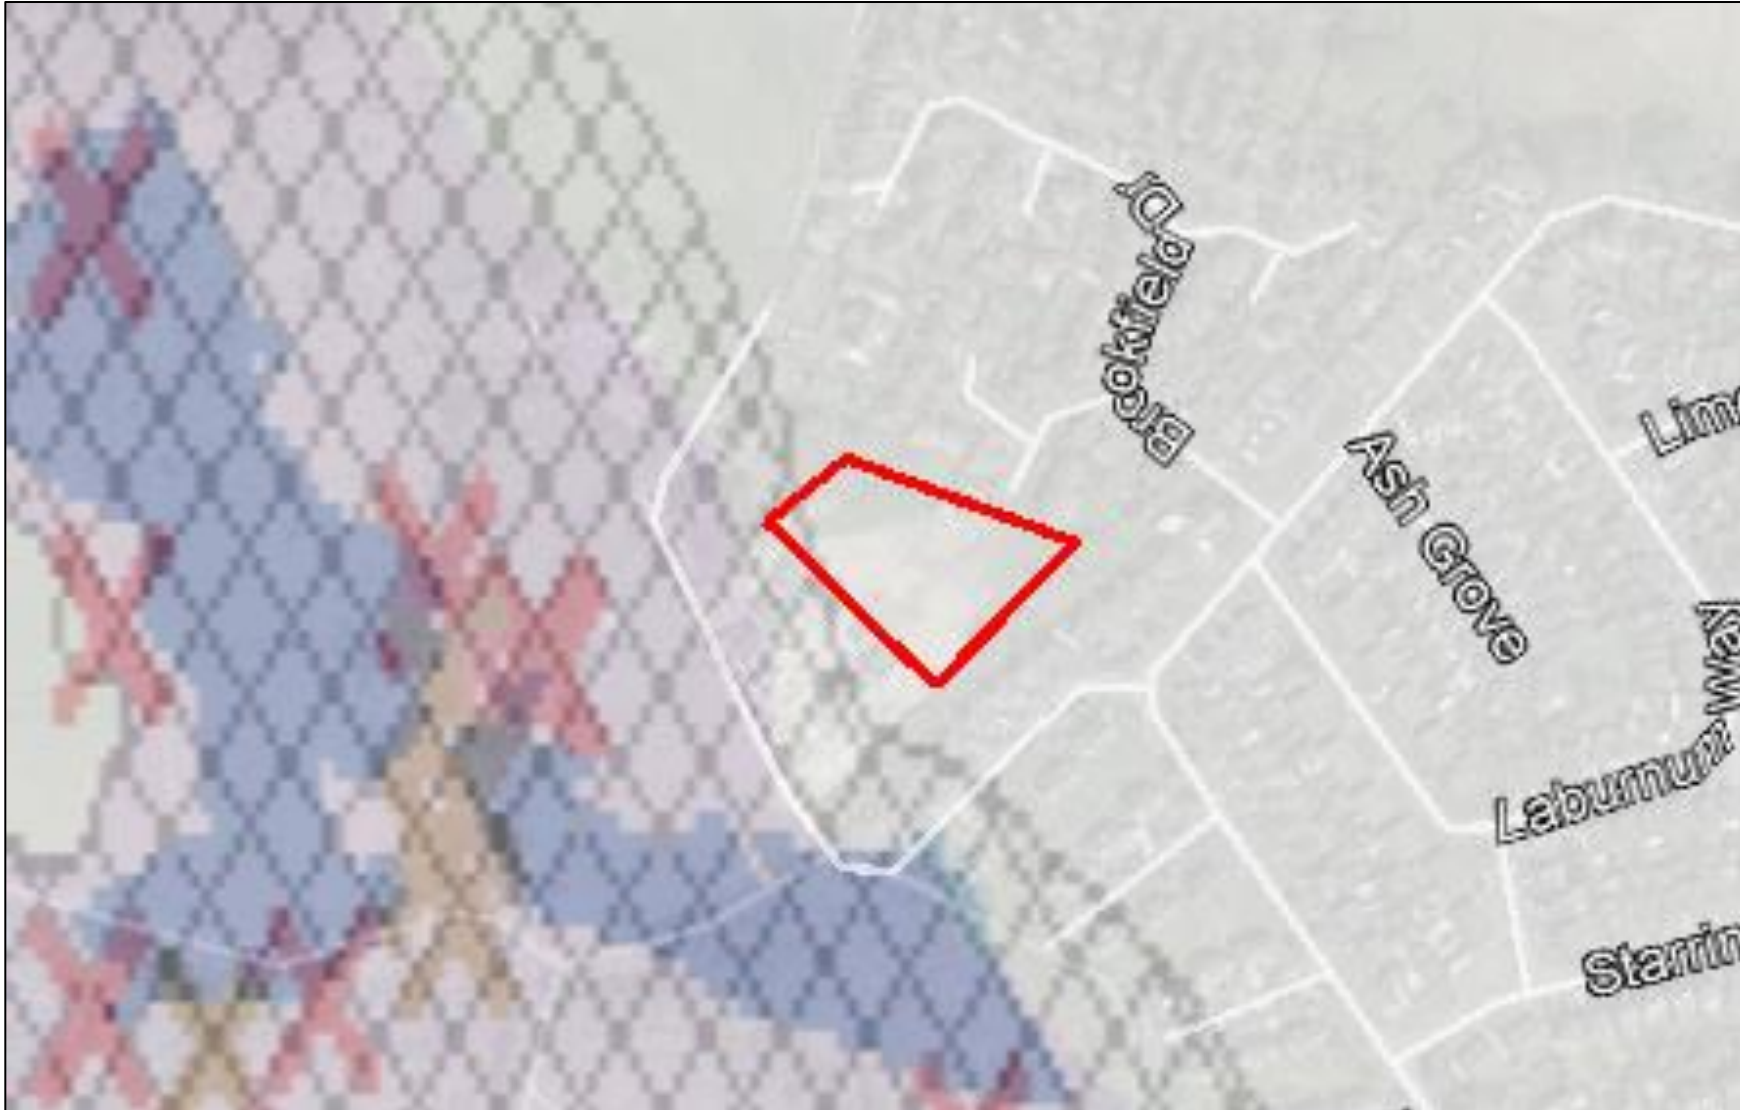
## 12.9. Coal Authority/Google Earth Overlay

| Past Recorded Underground Mining. | No workings noted beneath the Site. There are workings in the local area to the east and south east nominally 100m from the Site boundaries. |

| Development High Risk Area: | | The majority of the Site is not within a Development High Risk Area, although it does encroach on to the very west corner where outside of where the dwellings will be located. |
