**GROUNDTECH**  
CONSULTING

**Job title:** Albert's Norden, Edenfield

**Report type:** Preliminary Risk Assessment

| Document Control Form | |
|---|---|
| REPORT NAME | PRELIMINARY RISK ASSESSMENT |

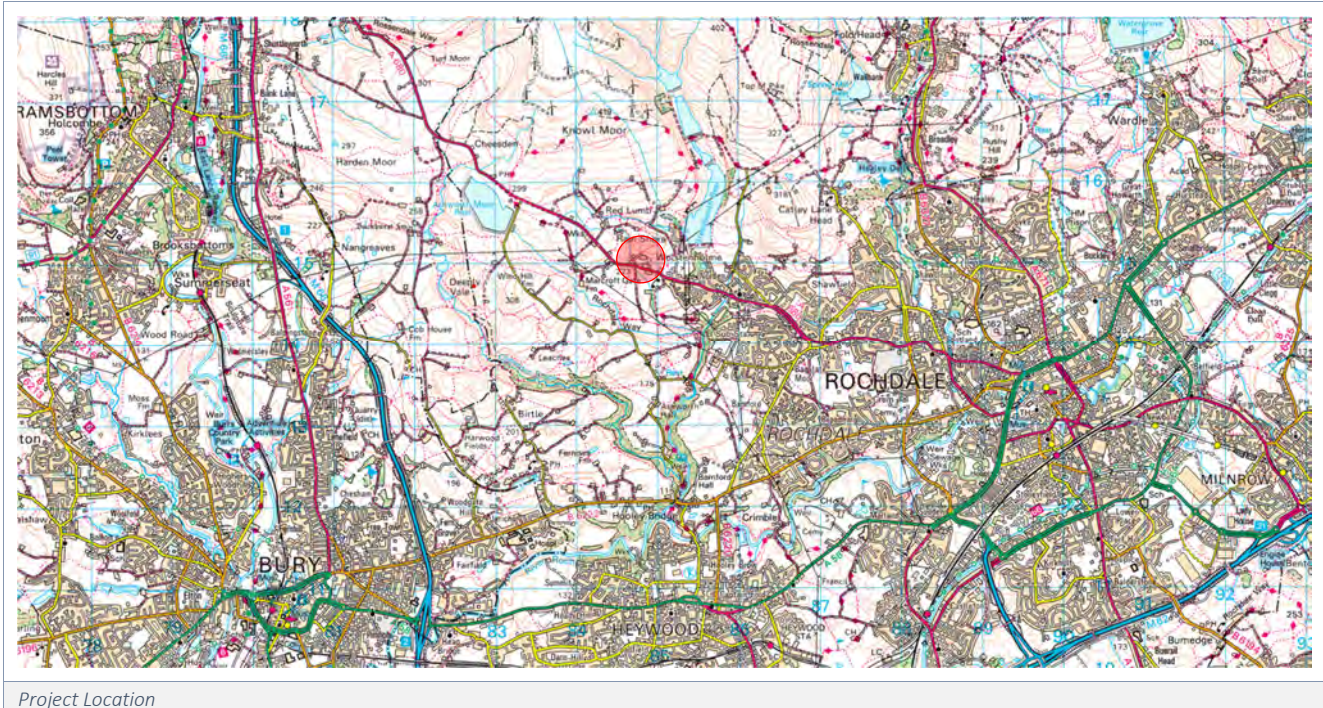
The site is located circa 3.5 miles north west of Rochdale Town Centre, as shown on the Project Location Plan GRO-22065-P01. The site is approximately centred on National Grid Reference 384845, 415043.

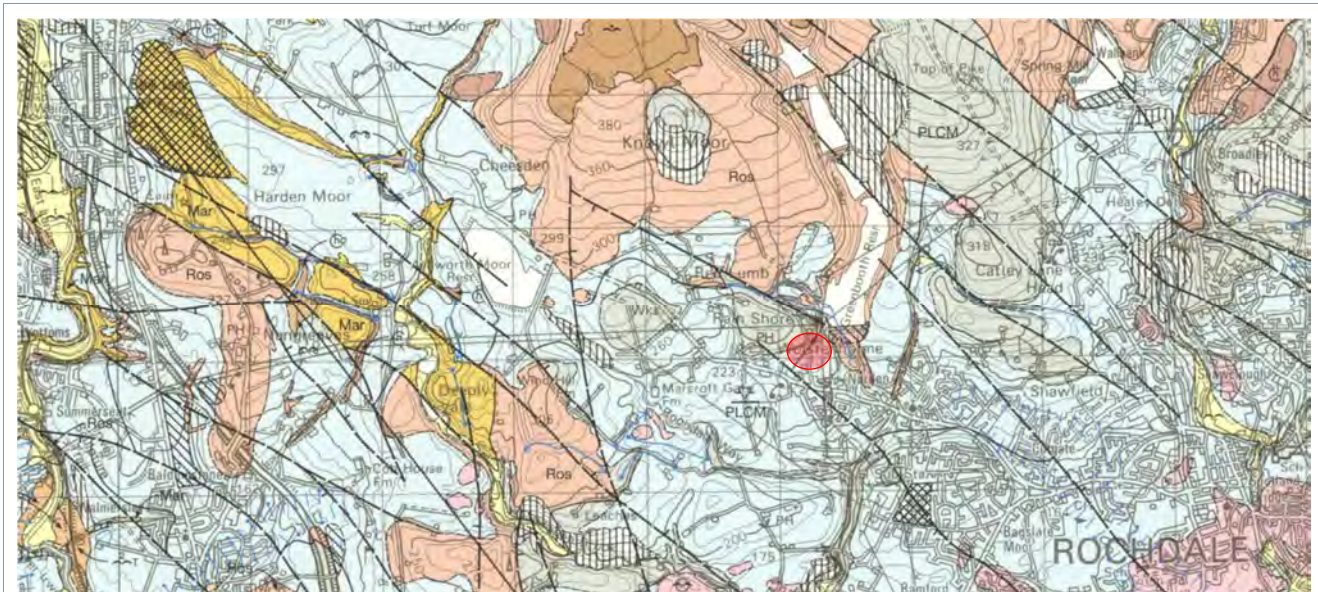
Geological Map – Superficial Deposits

The site is indicated to be underlain by Glacial Till and Diamicton, this strata characteristically comprises of clay, sand and gravel, no superficial deposits are indicated to be present adjacent to the eastern site boundary.

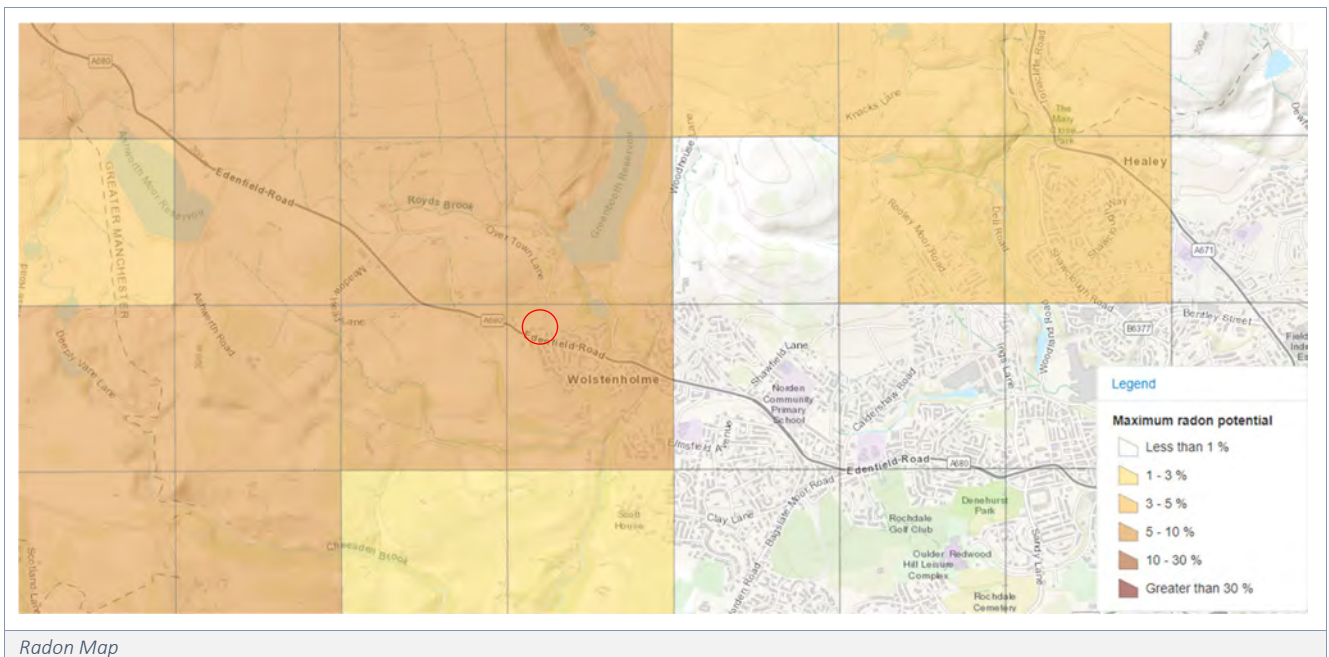
Map 13 Northern Welsh Marches and Liverpool from BRE 211 and HPA were examined which defines areas which require radon protective measures. The probability is 5-10% and Edenfield Road is an area requiring basic radon precautions in foundations in accordance with BRE Report 211 'Radon – Guidance on protective measures for new dwellings' 2015 Edition.

The radon data in the Groundsure report is supplied by the BGS/Public Health England and is the definitive map of Radon Affected Areas in Great Britain and Northern Ireland, and confirms the recommendations of radon maps. The dataset was created using long-term radon measurements in over 479,000 homes across Great Britain and 23,000 homes across Northern Ireland, combined with geological data. The dataset is considered accurate to 50m to allow for the margin of error in geological lines, and the findings of this report supersede any answer given in the less accurate Indicative Atlas of Radon in Great Britain, which simplifies the data to give the highest risk within any given 1km grid square.

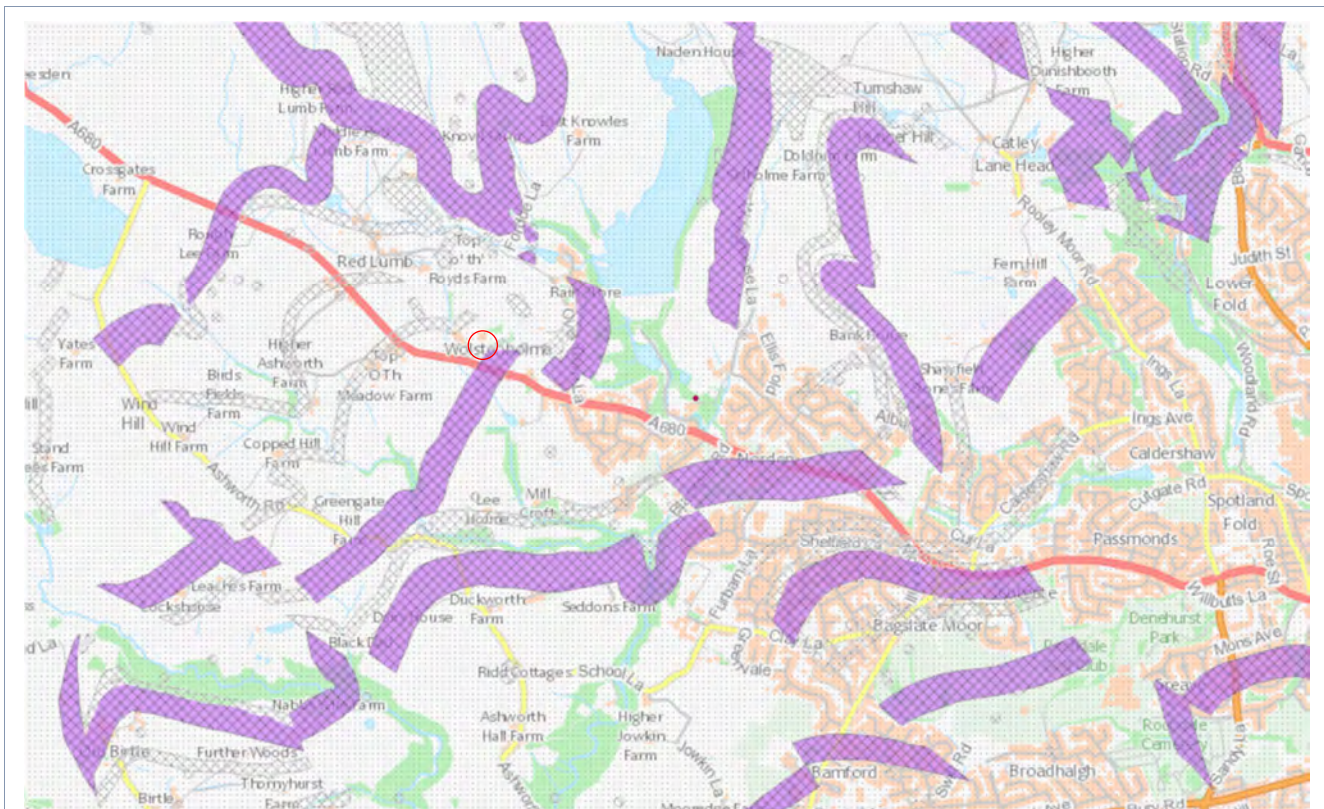
From the Coal Authority Interactive Map it can be observed that the south eastern corner of the site is within a Development High Risk Area due to Probable Workings.

An intrusive mining investigation is recommended to quantify the risk from unrecorded workings and determine if there is a requirement for stabilisation works.

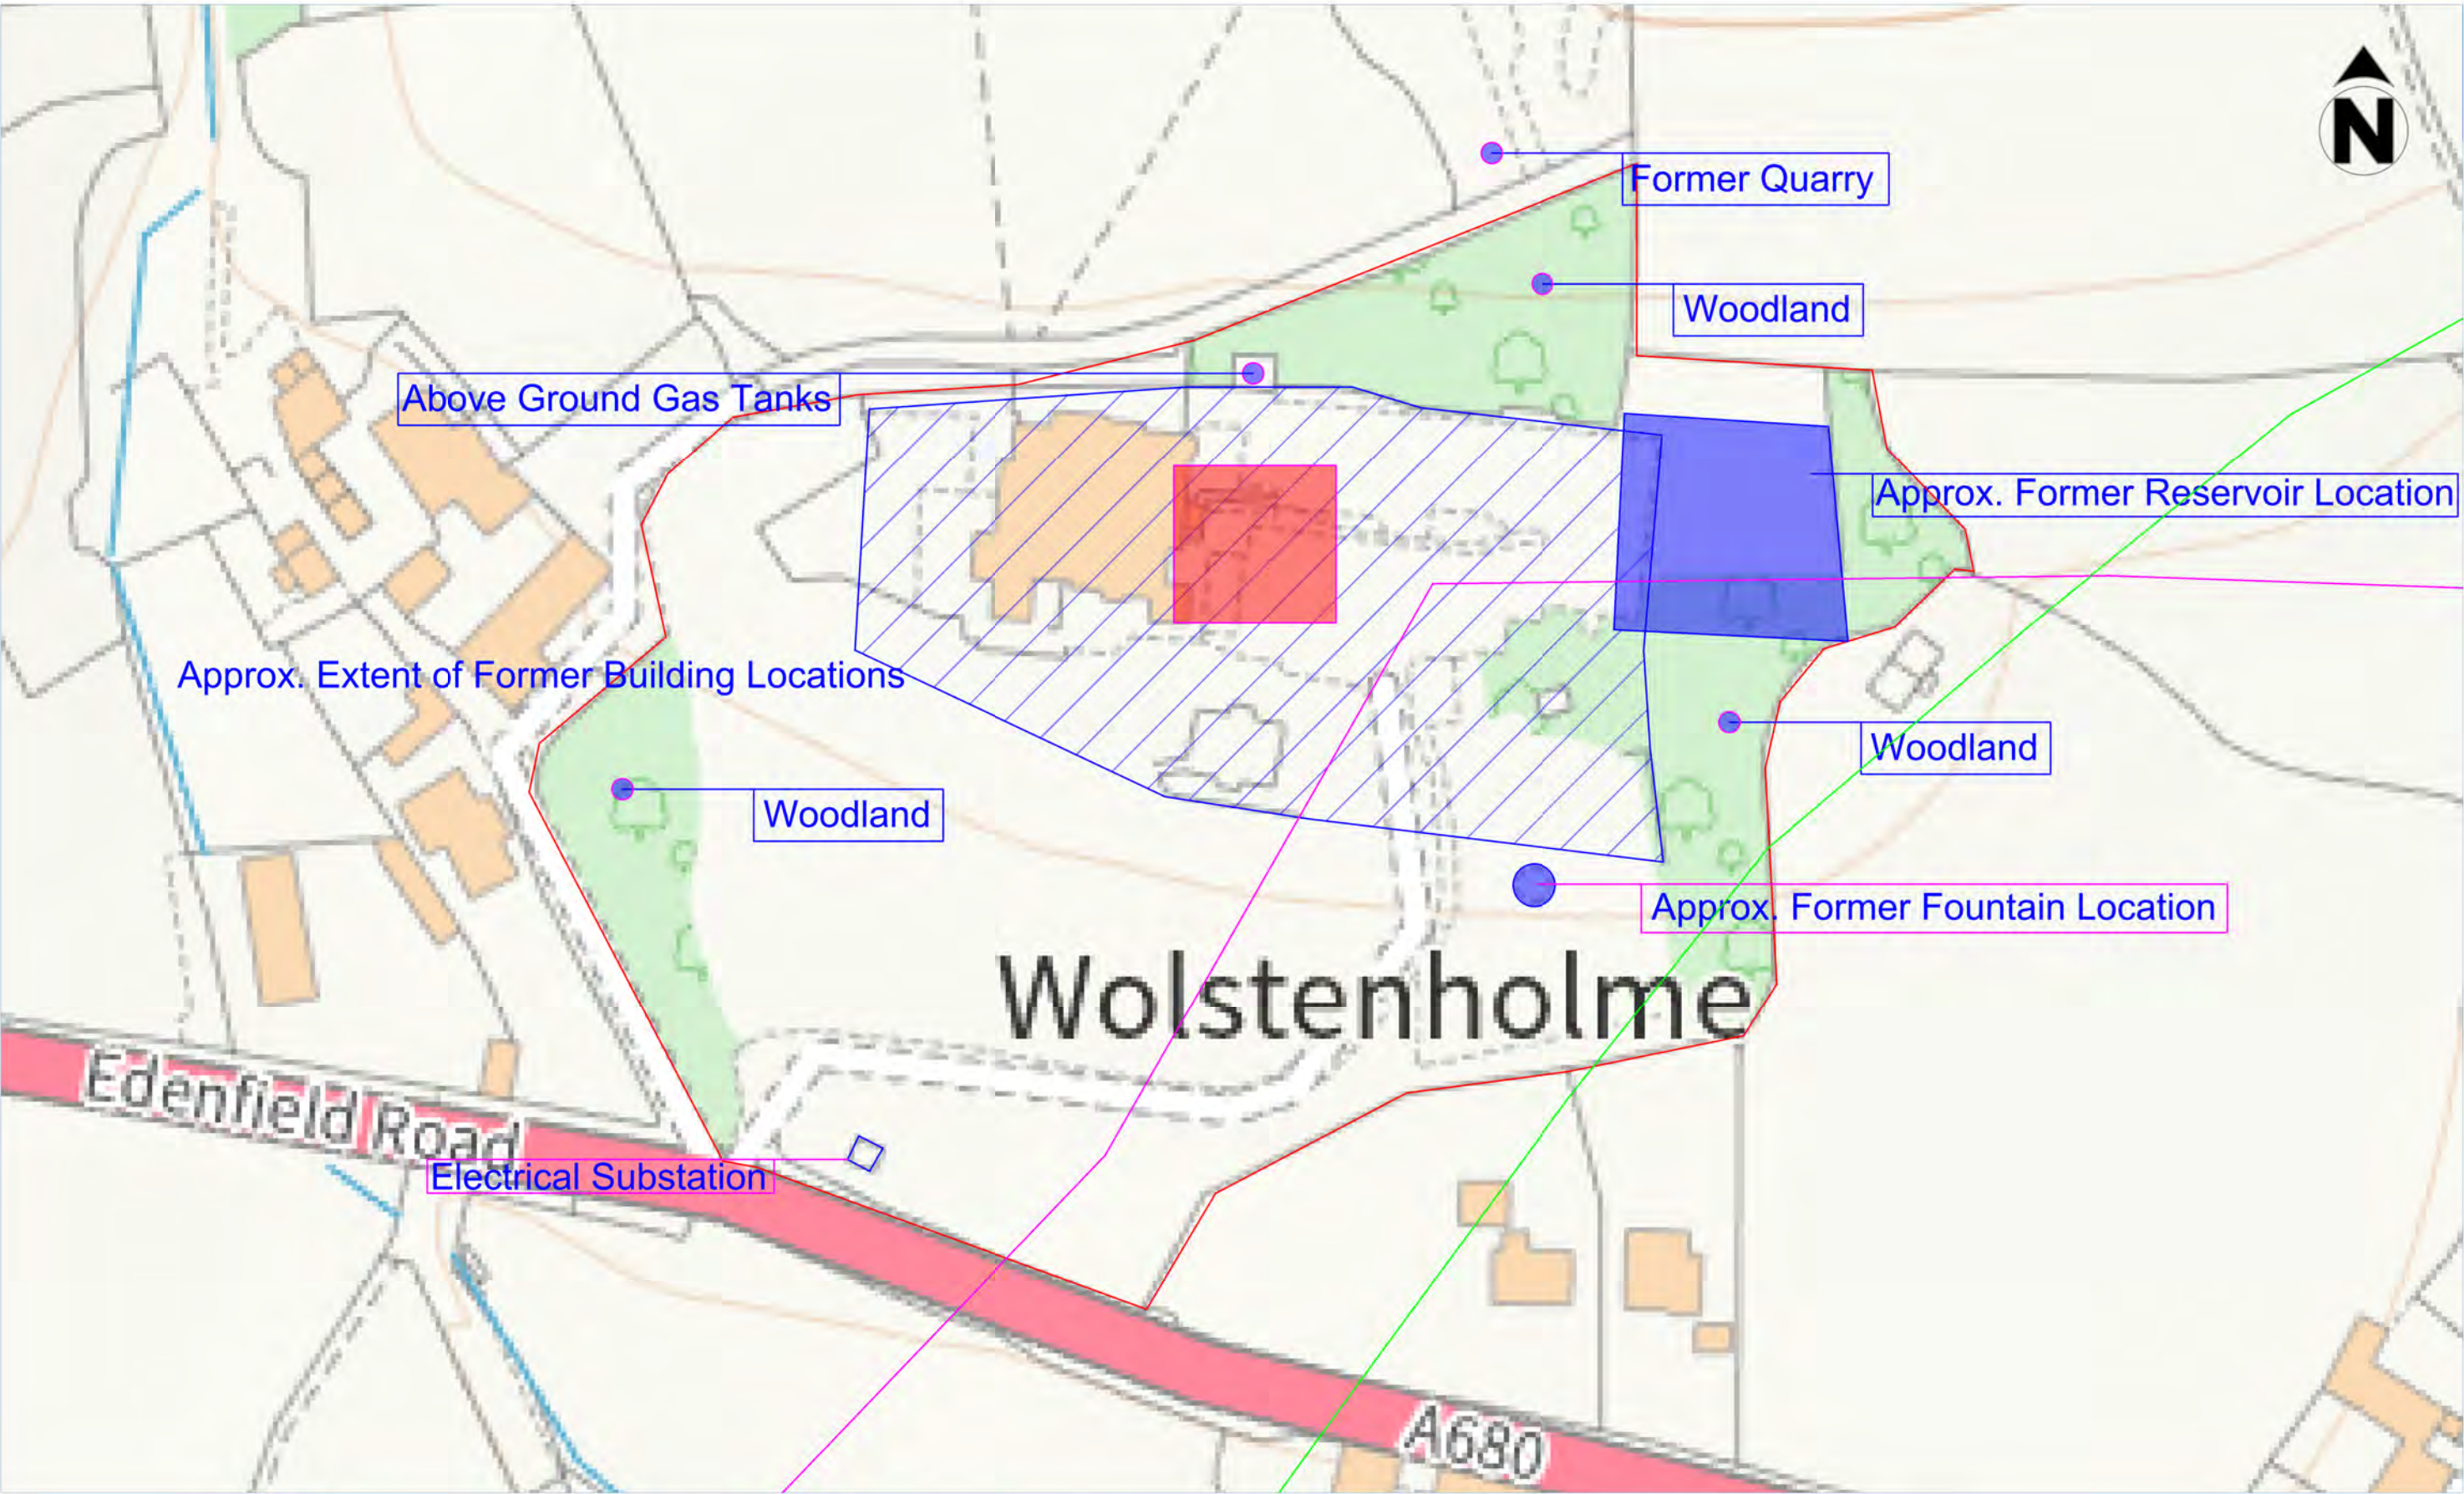
Photographs are presented in *Appendix 2* and relevant features are recorded on the Preliminary Development Constraints Plan *GRO-22065-P02*.

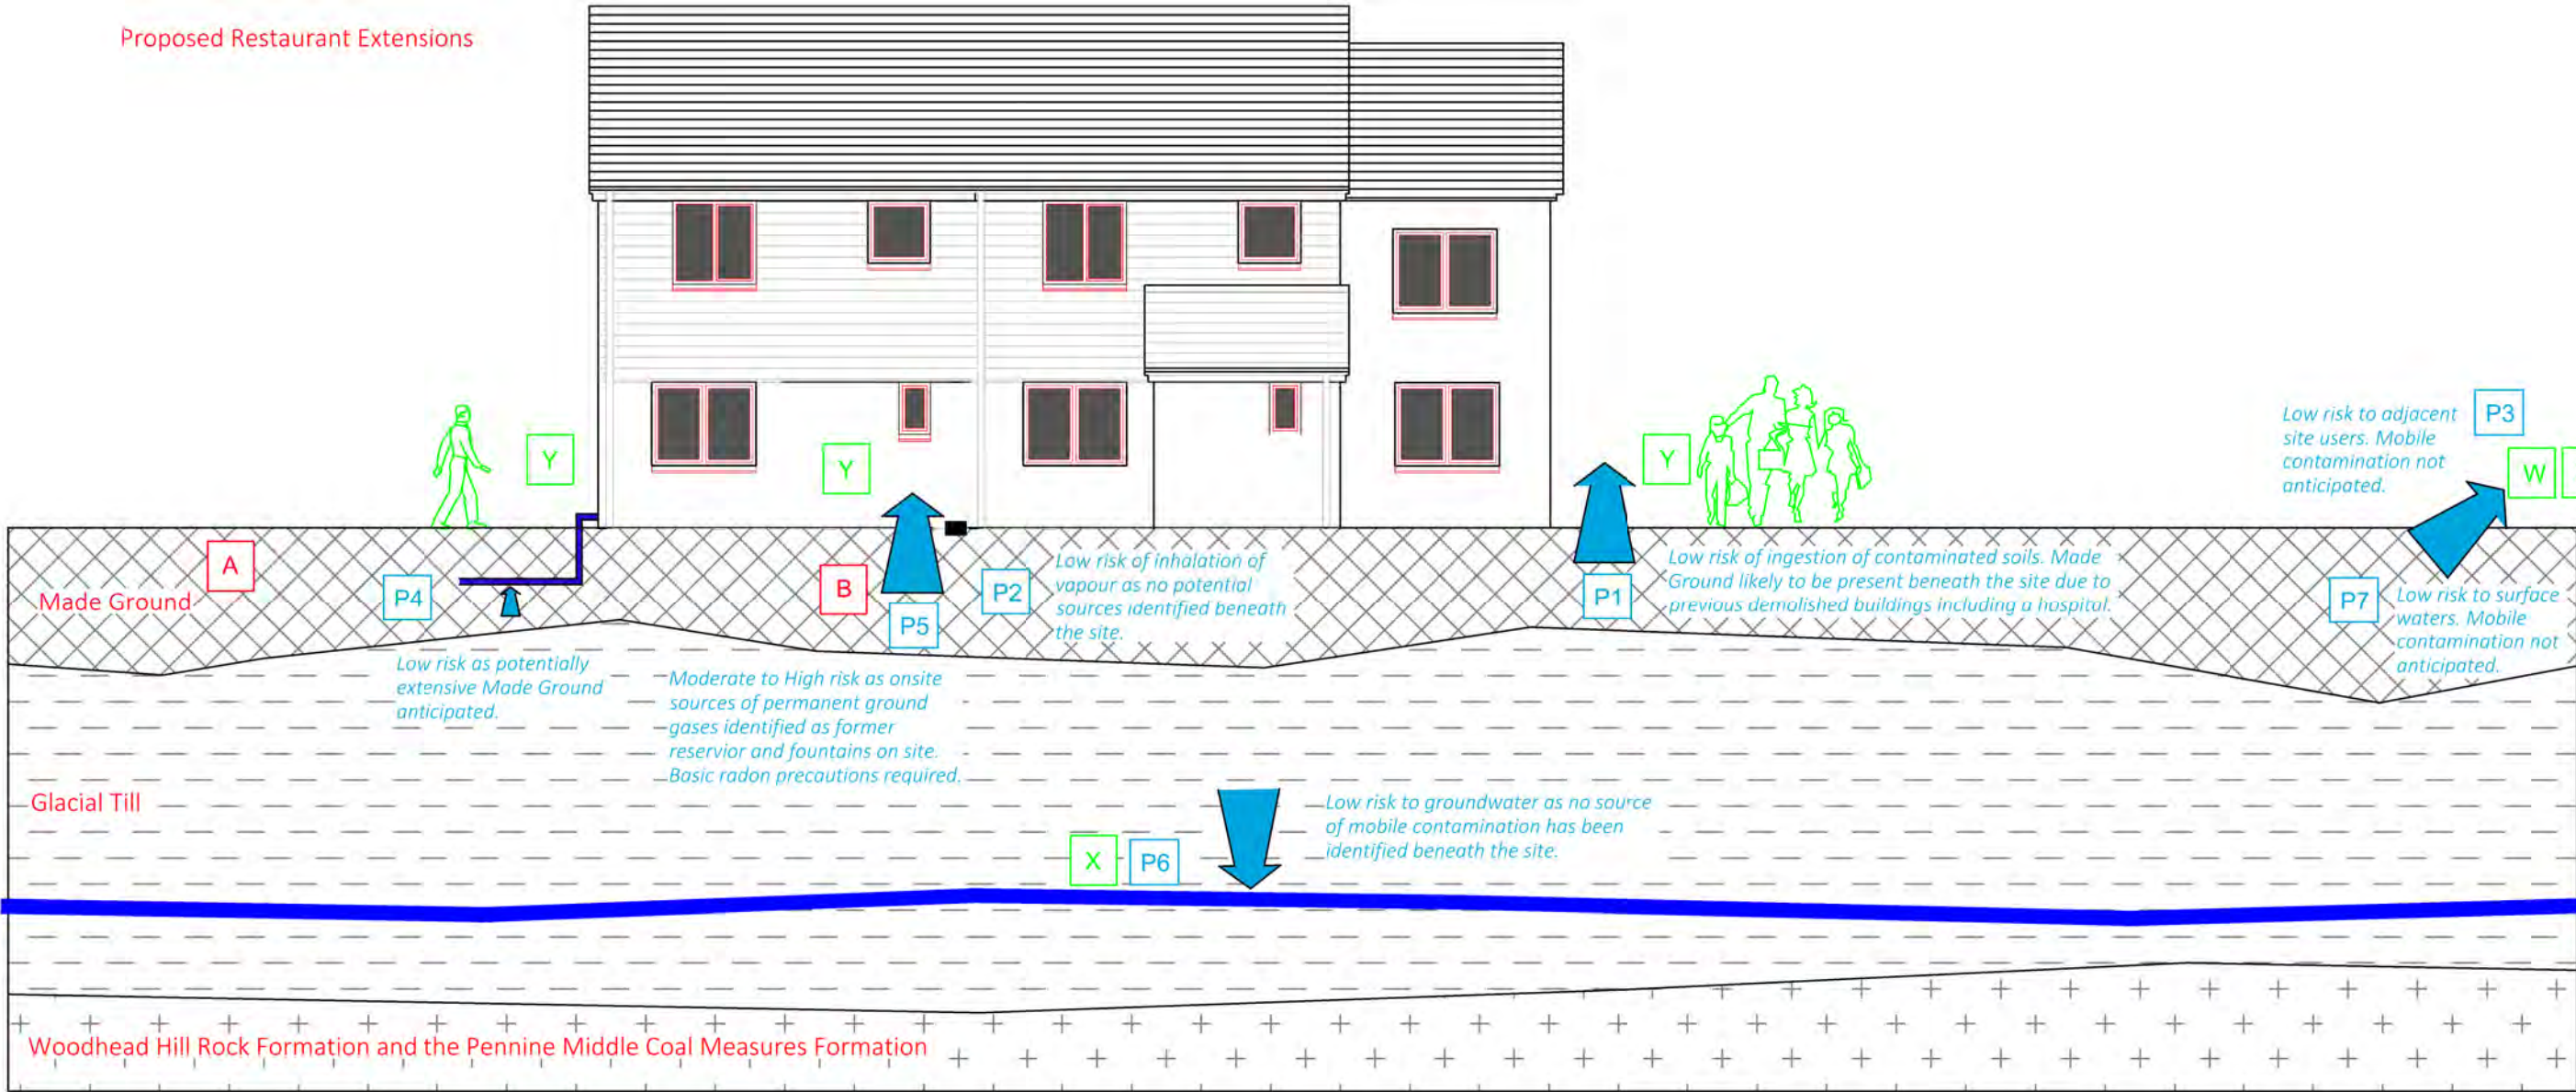
| <p><b>SOURCES</b></p> <p>A. Contaminated soils / Made Ground.<br/>B. Ground gas.</p> | <p><b>POLLUTION LINKAGES</b></p> <p>P1. Ingestion of soil and dust.<br/>P2. Inhalation of vapour.<br/>P3. Inhalation of soil dust by adjacent site users.<br/>P4. Attacking of potable water supply pipe.<br/>P5. Migration and accumulation of ground gas in internal places.<br/>P6. Impaction of groundwater from soil contamination.<br/>P7. Migration of soil and groundwater contamination impacting surface waters.</p> | <p><b>RECEPTORS</b></p> <p>W. Unnamed watercourse 41m south west.<br/>X. Groundwater within the underlying Secondary Undifferentiated superficial and Secondary A Bedrock Aquifers.<br/>Y. Site end users.<br/>Z. Adjacent site users.</p> |

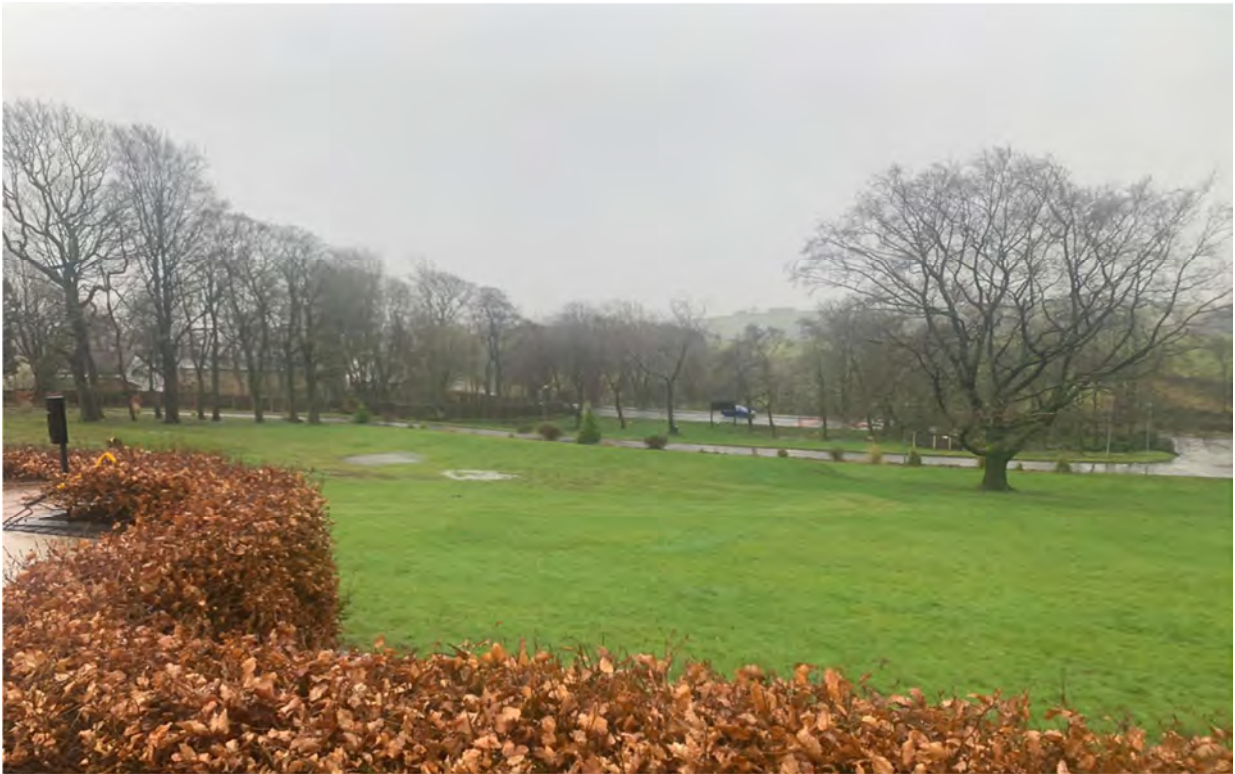
Photograph 1 - Central Field

Two fields are present at the site, the first is located within the central western area and comprises a grass surfaced field. The topography of this field follows a north to south gradient, however there is a large levelled area present which is suspected to be a former tennis court. The second field is located within the central eastern area, this field is generally flat with a circular concrete pad present in the centre, this field slopes downwards from north to south. Vegetation is present on both fields as well as mature to semi-mature trees.

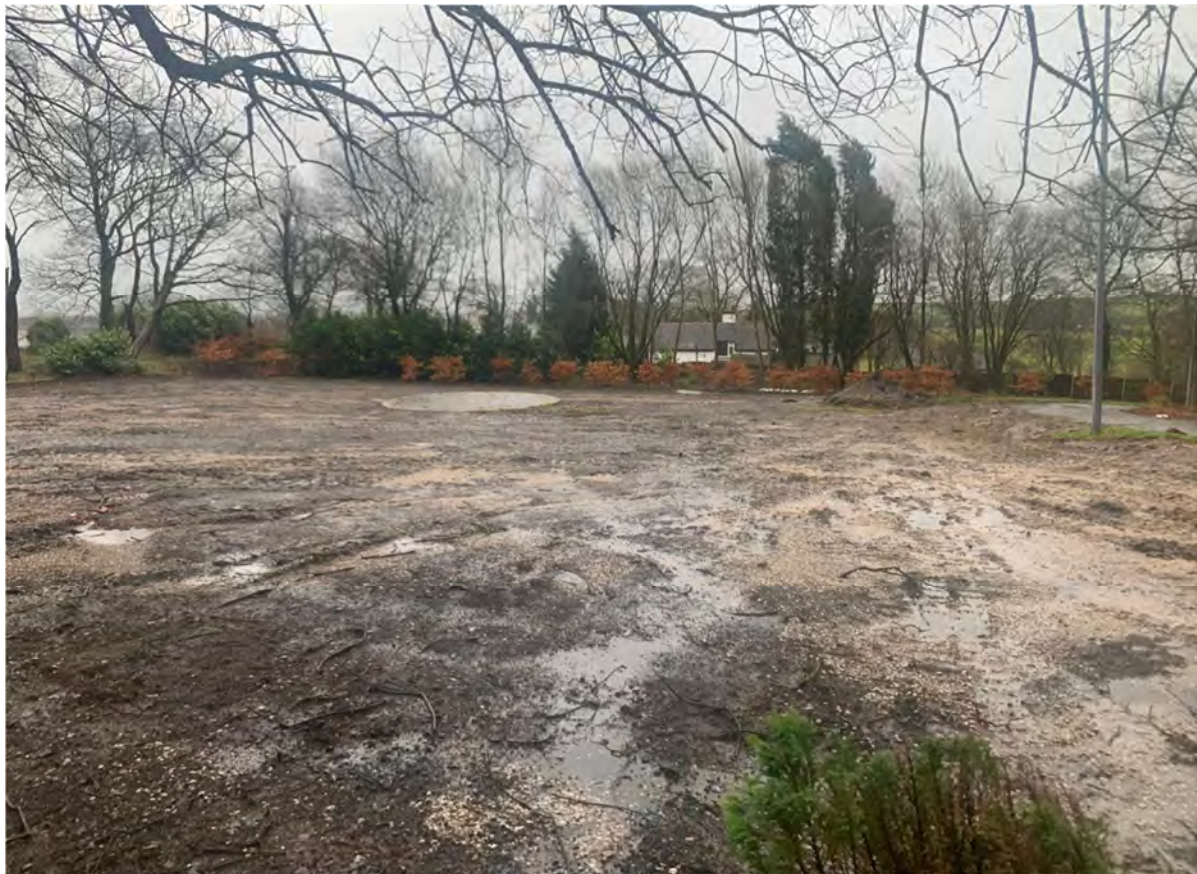
Photograph 2 - Western Field (Suspected Former Fountain).

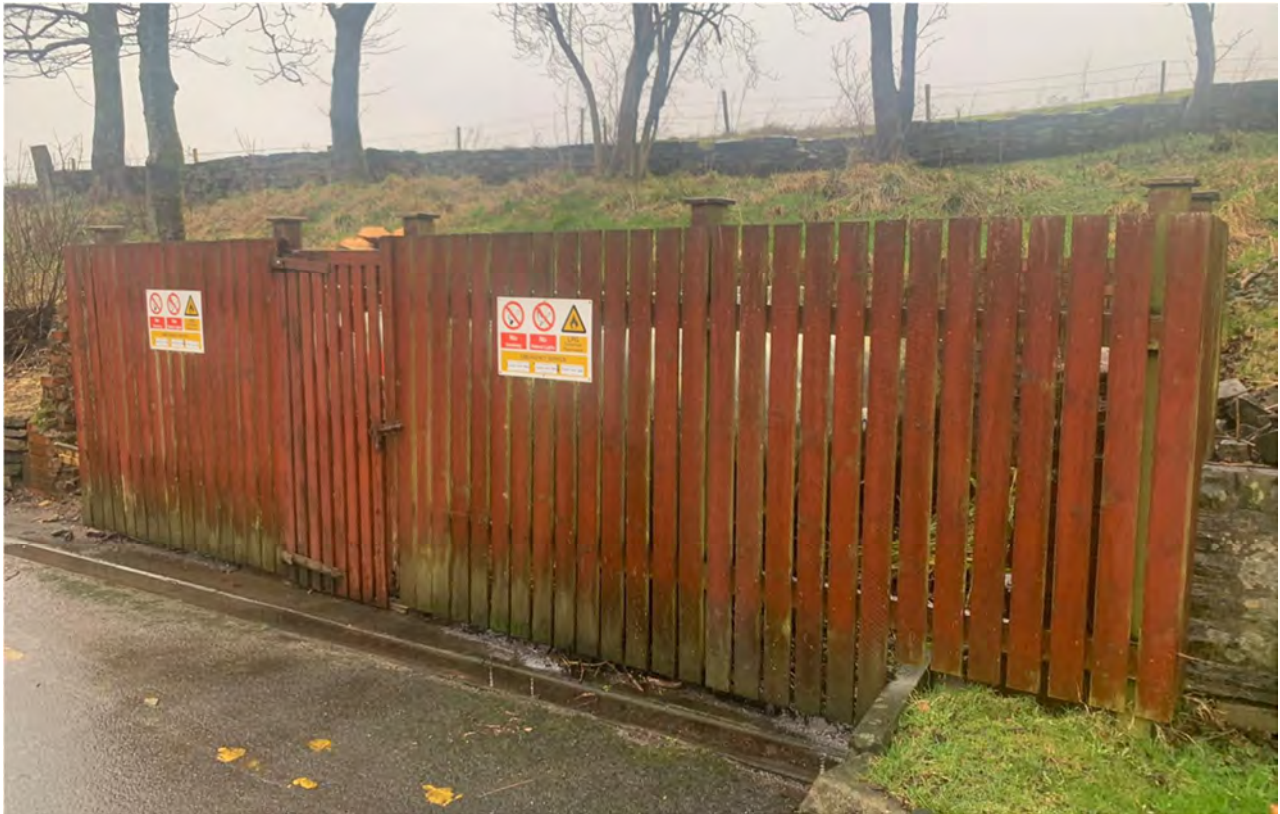
An above ground gas tank is located to the rear of the buildings on site and an electrical substation is present in the south western area.

Photograph 3 – Gas Tank located to the west of the building on site.

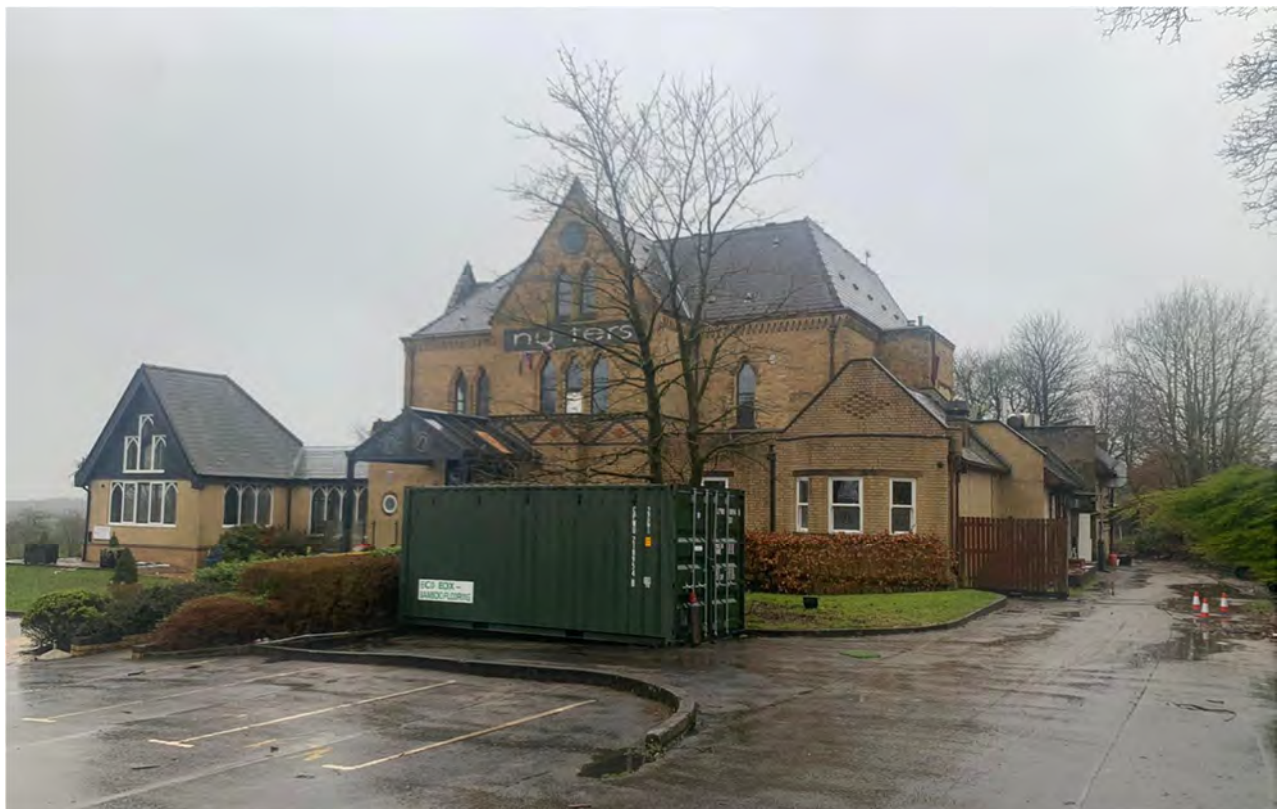
The central manor house/restaurant located within the central north western portion of the site is of early 1800s construction and has had multiple redevelopments, these are visible around the property as the building materials used are not of the original buildings design. The building is of varying construction comprising of brick, stone and breeze blocks. The main central building is of three storey construction, however some of the additional developments comprise of one and two storey designs. The building itself is an irregular shape due to the multiple developments and extensions on all faces of the building constructed off the generally square shaped original structure.

Photograph 4 - Building located on site.

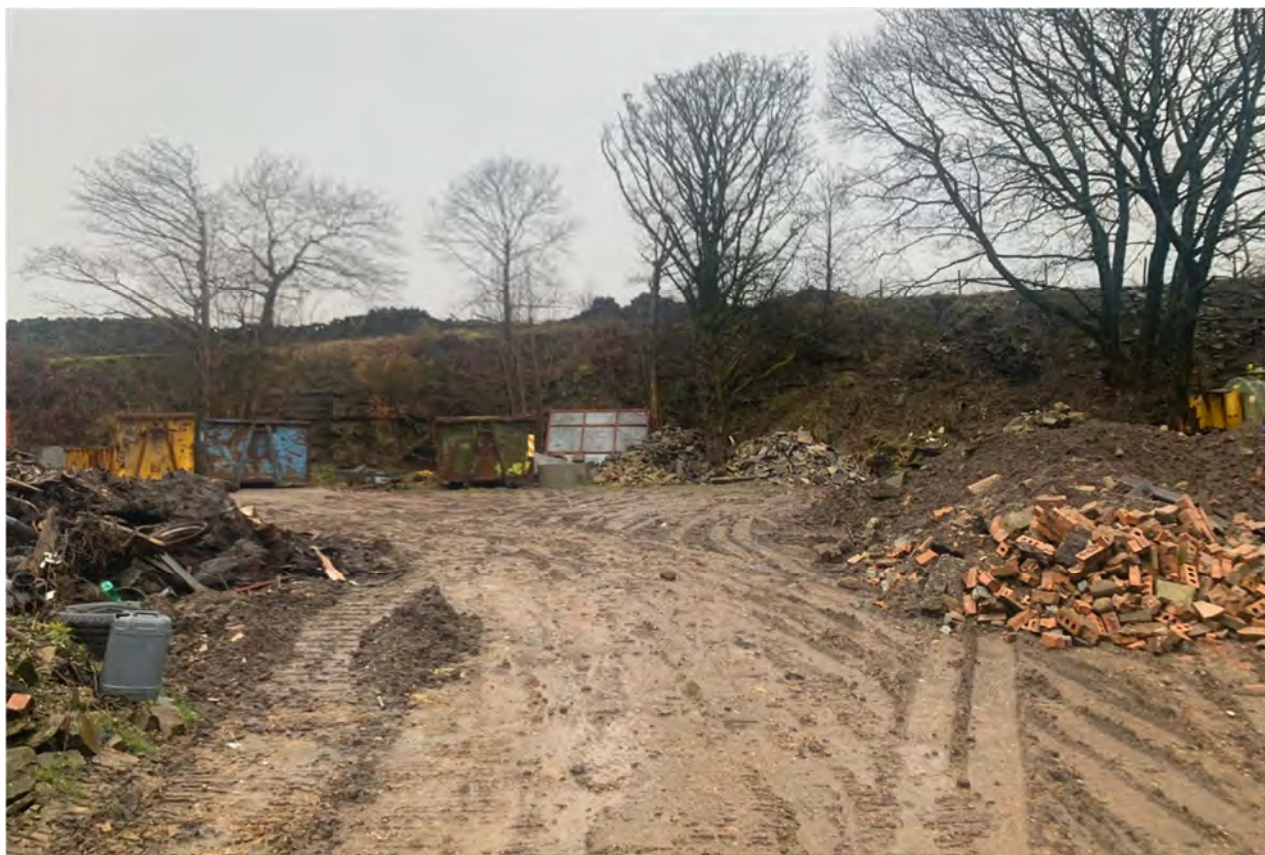
Photograph 5 - Northern former quarry (offsite).

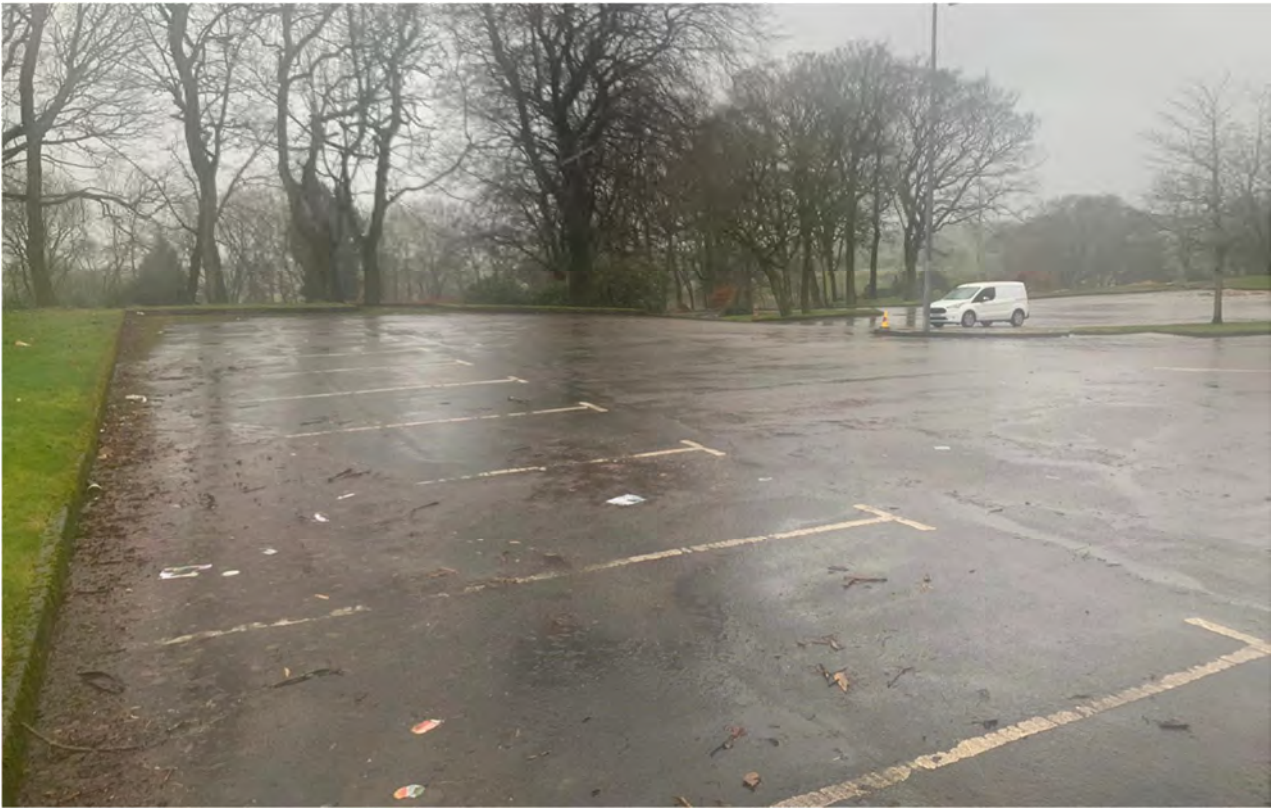
An area of hardstanding carparking is located to the east of the manor/restaurant building on site which has capacity for approx. 50 vehicles, this is connected to the roadway at the site which leads from the site entrance to the carpark via a meandering tarmac surfaced road.

Photograph 6 - Carparking Area.

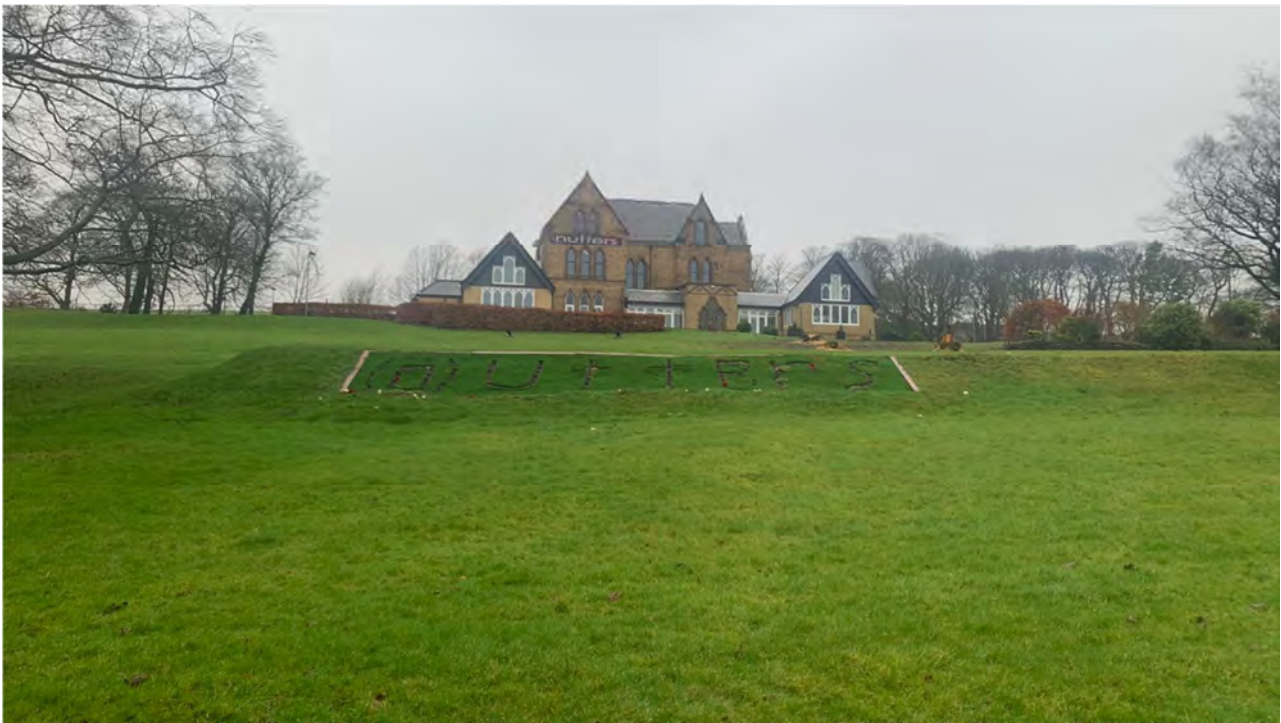
Photograph 7 - Suspected former tennis court.

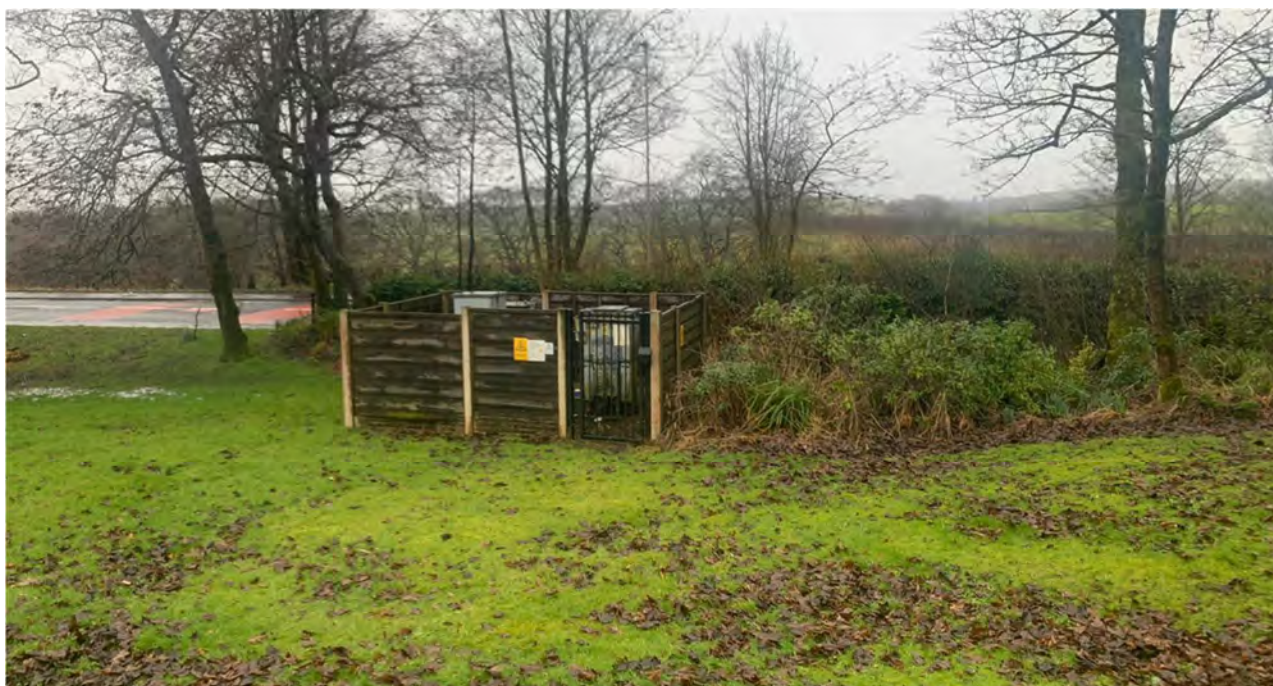
There is an electricity substation located in the southern extent of the site. Associated contaminants of concern include Polychlorinated Biphenyls (PCBs). Historically, they were used in power generation and transmission equipment, commonly found in coolants and the insulating fluids of electrical components.

*Photograph 8 - Electrical Substation.*
