## Controlled Waters Risk Assessment

Sladen Mill, Littleborough

| Project Number | 20403 |
| Report Number | 001 |

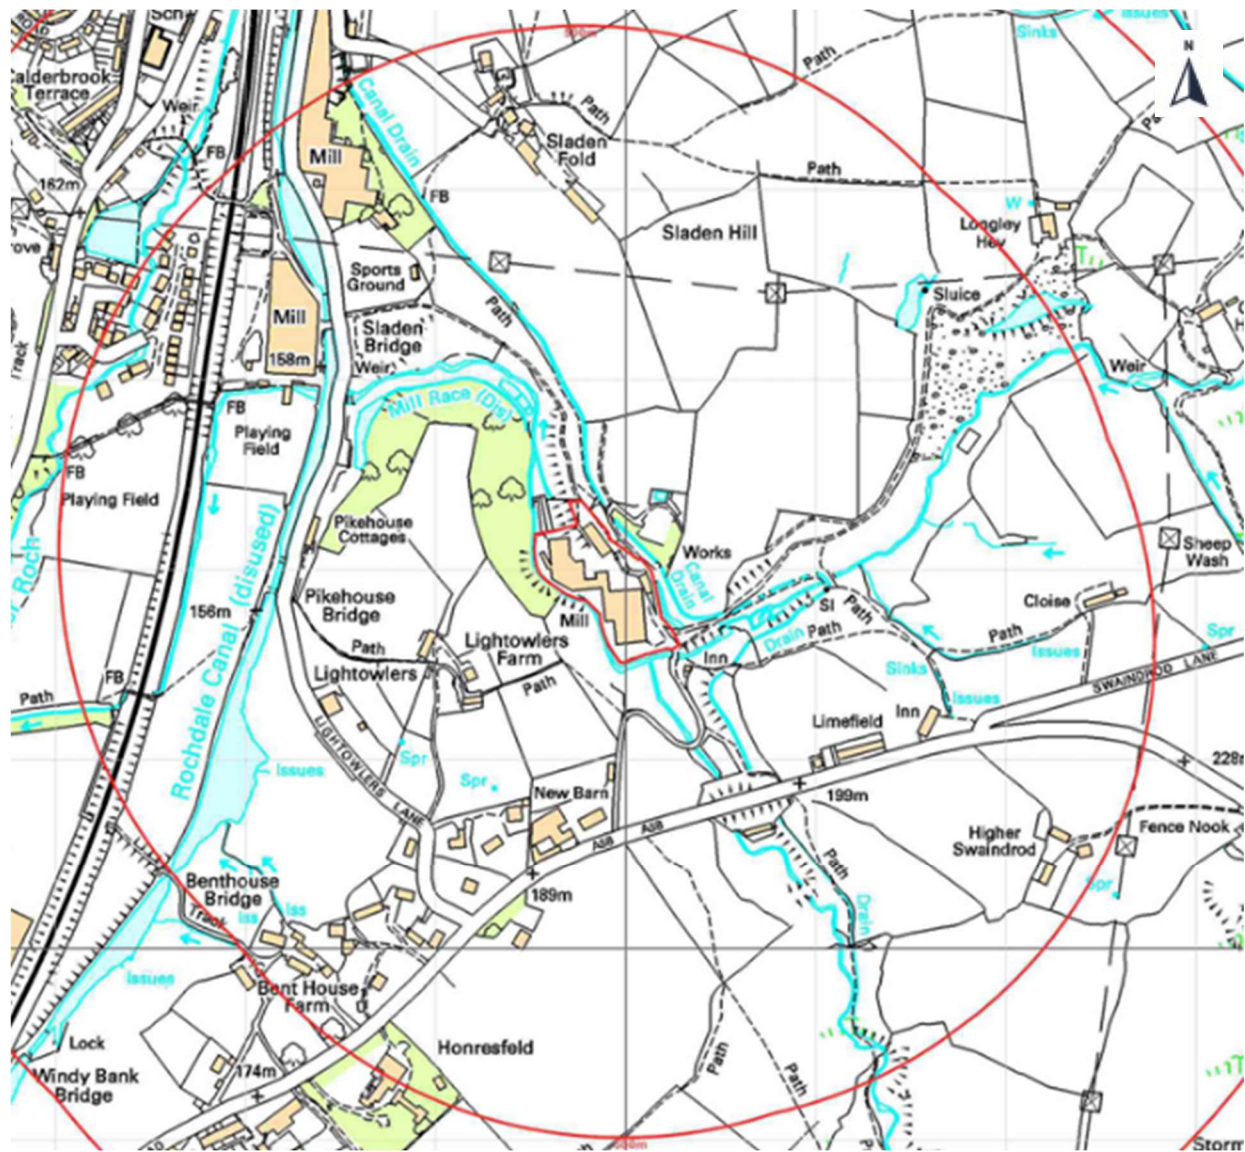
Figure 1: Location Plan

- > Site approximately centred on 394983 417383
- > Central red line = outline planning application boundary; outer red line = 500 m buffer

**Location and size:** The Site (the planning boundary) comprises a parcel of land approximately 1.30 ha in area located 175 m north of Halifax Road, Littleborough, Lancashire (Figure 1).

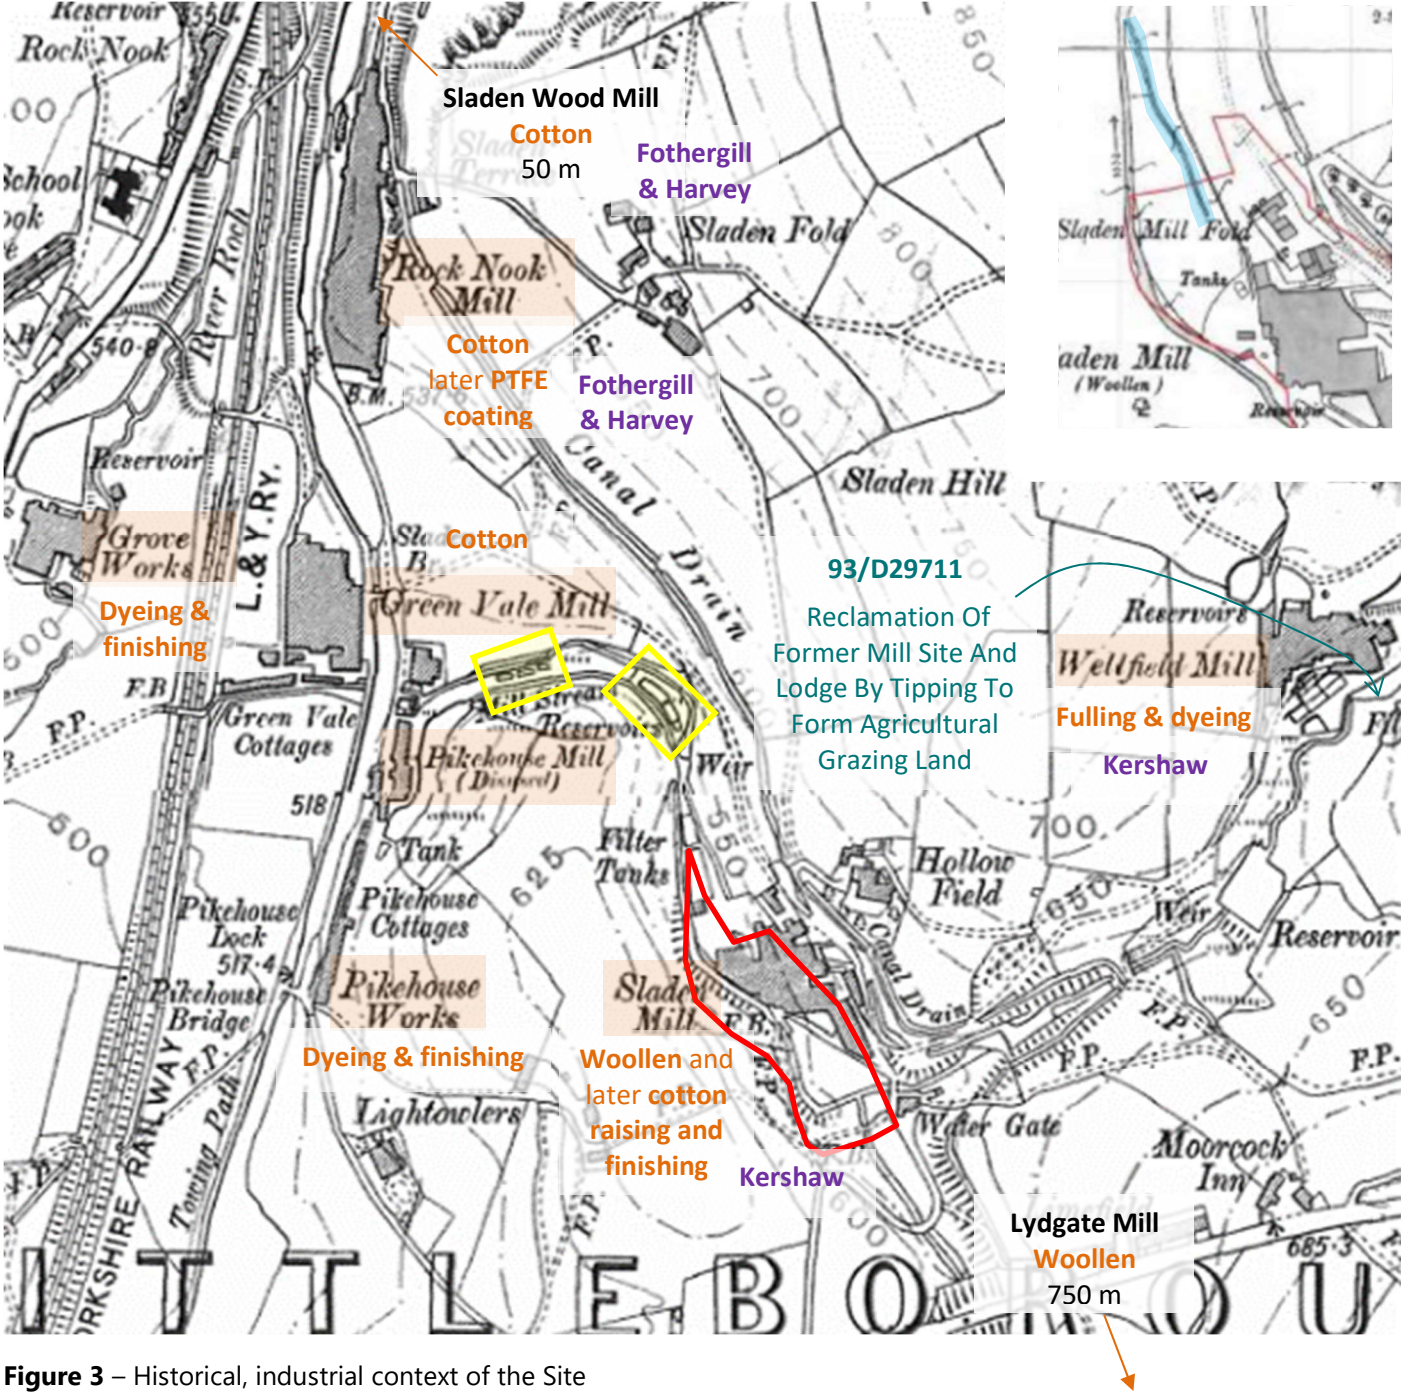
**Figure 3 – Historical, industrial context of the Site**  
> Extract from appended mapping (1910 to 1911)  
> Red line = approximate Site boundary  
> Brown shaded boxes and text = most mills within the vicinity (1000 m) of the Site and their uses  
> Purple text = Site ownership (where known; as presented with the appended Heritage Note)  
> Yellow boxes = evidence of the watercourse having been modified to include additional downstream treatment of water remote from the upstream mills  
> INSERT TOP: Extract from the 1891 Ordnance Survey mapping with the former mill race highlighted blue

**Key line of evidence:** Despite sharing a similar name Sladen Wood Mill is located c. 700 m north-north-west of the Site (Figure 3) however, the presence of a canal drain between these two mills (and others within the region) does suggest a degree of connectivity. It is however noted that numerous other mills are present closer to Sladen Wood Mill that were known to have been used for the manufacture and application of plastic materials and finishes, e.g. Rock Nook Mill, that is known to have been owned and operated by a PTFE manufacturer (a PFAS compound)<sup>1</sup>.

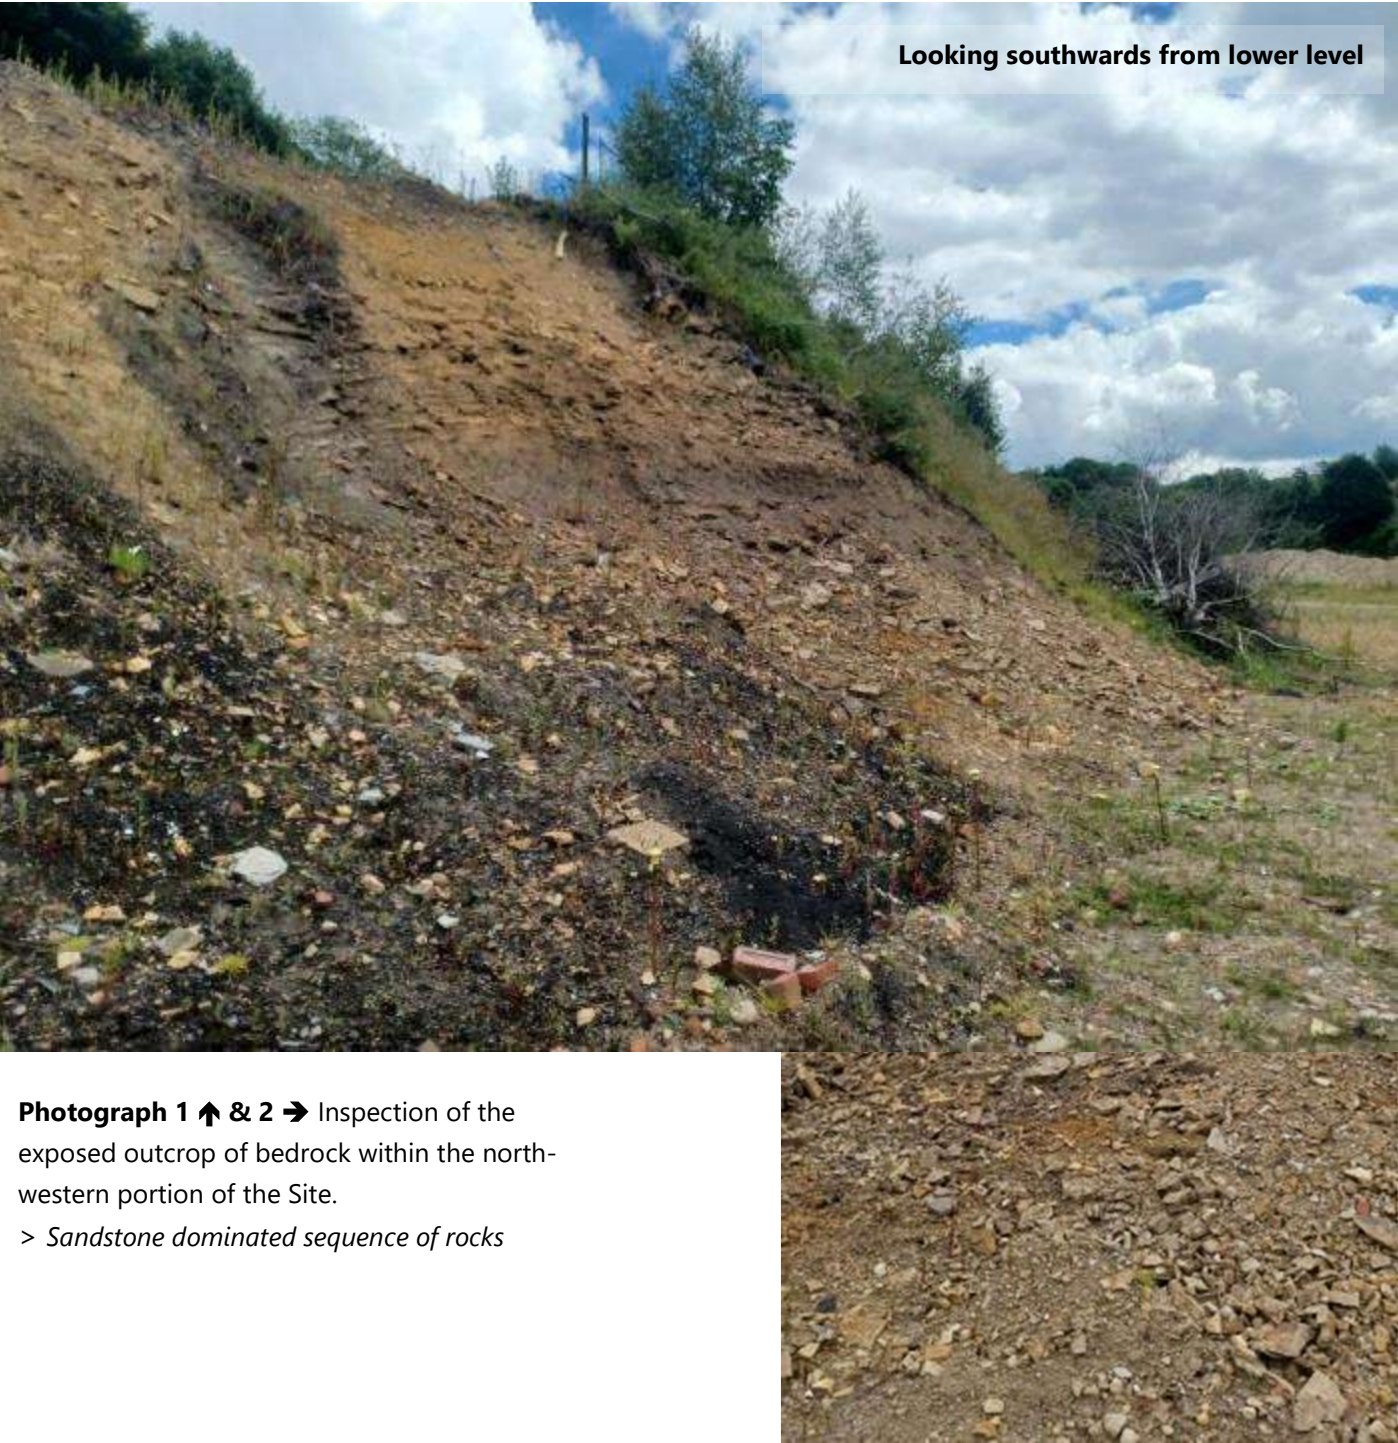
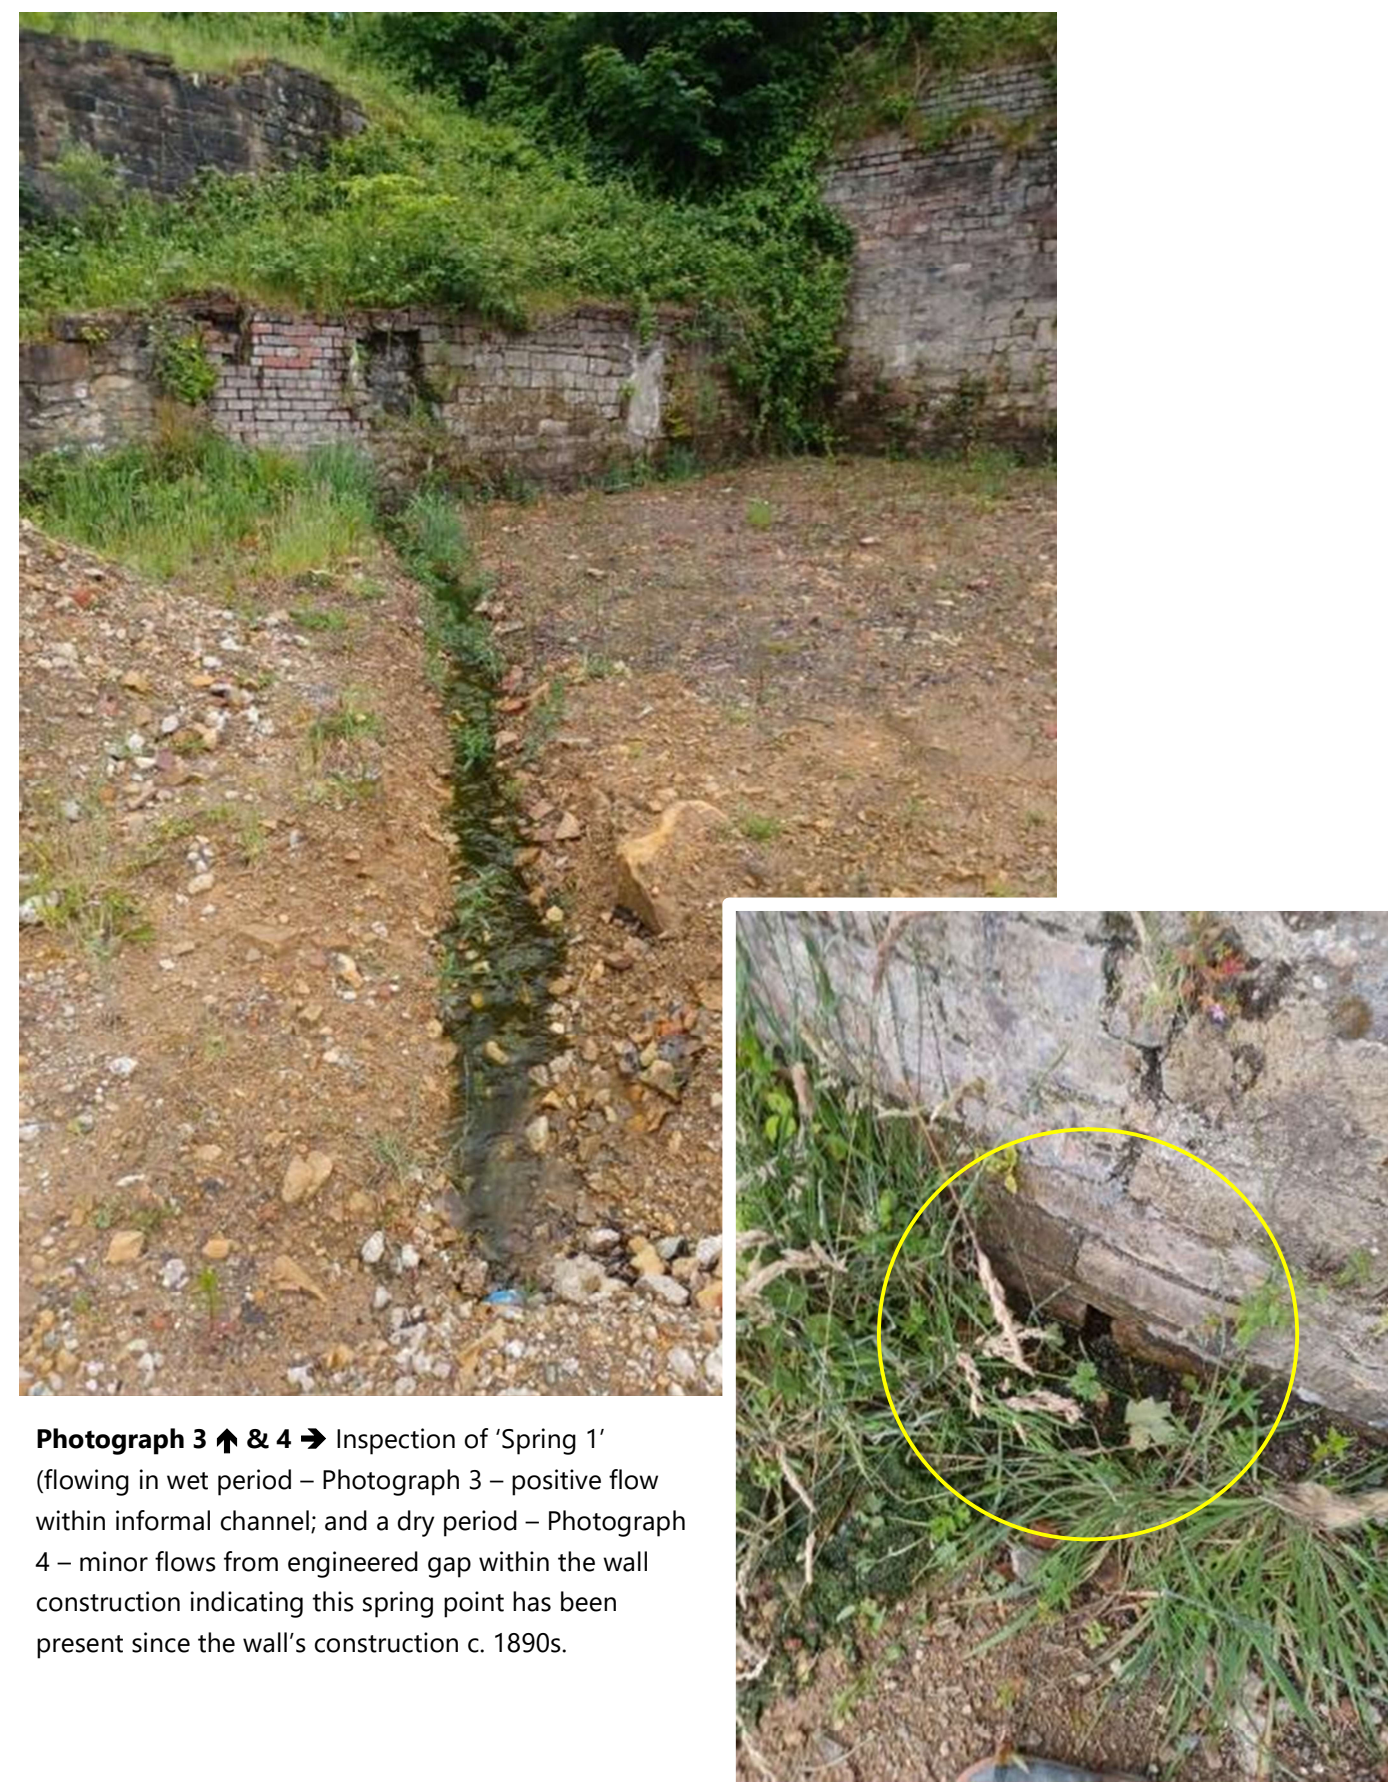
**Photograph 3 ↑ & 4 →** Inspection of 'Spring 1' (flowing in wet period – Photograph 3 – positive flow within informal channel; and a dry period – Photograph 4 – minor flows from engineered gap within the wall construction indicating this spring point has been present since the wall's construction c. 1890s.

Inspection of the springs occurred on two occasions following both wet (05 June 2024), dry (08 July 2024) and wet (10 October 2024) spells in the local weather (48 hrs prior to visit) noting that water flow rates drop off markedly following periods of dry weather with continued flow only evident from one of the spring points (Photograph 3).

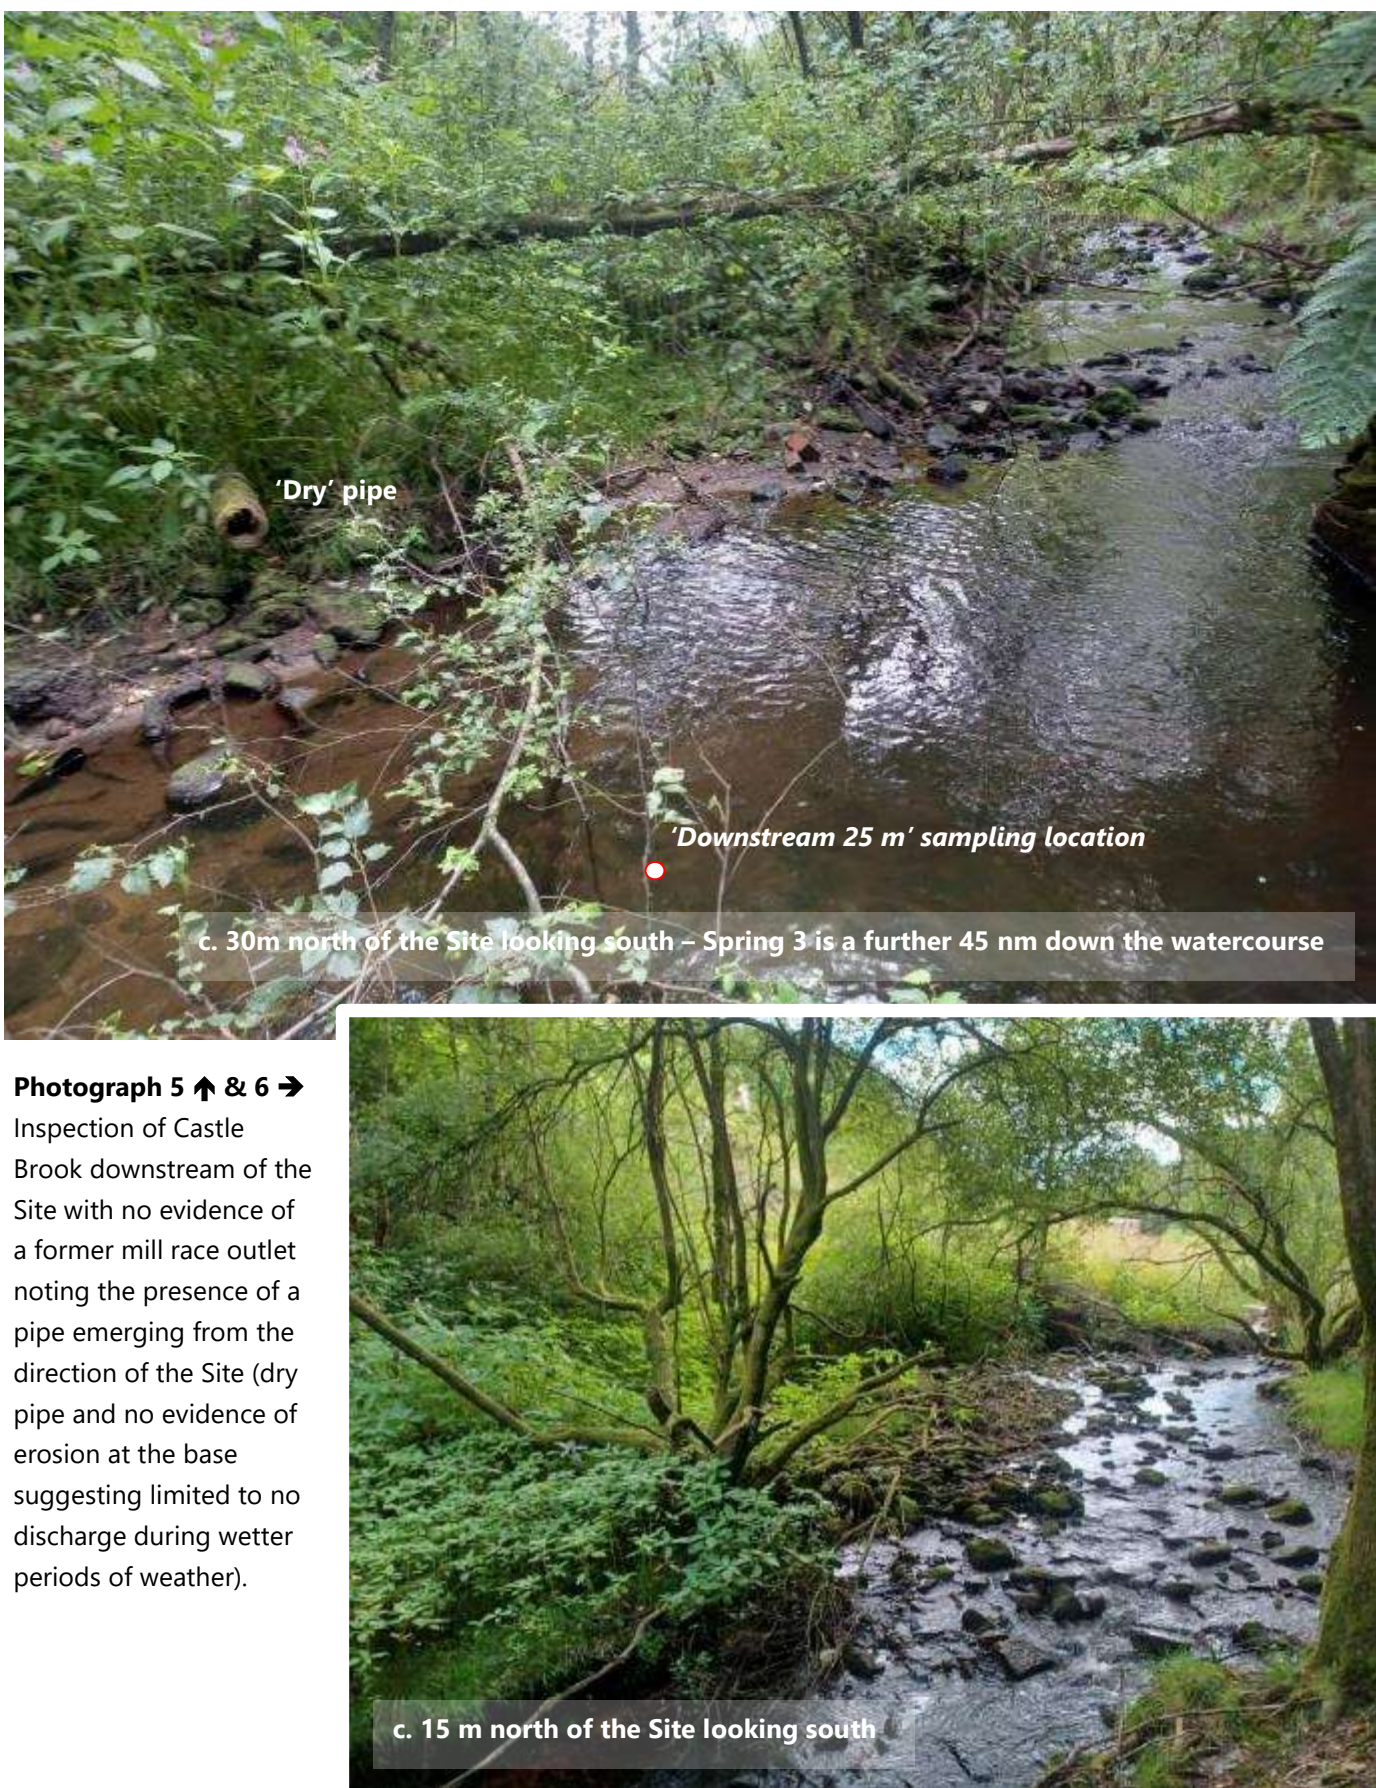
**Photograph 5 ↑ & 6 →** Inspection of Castle Brook downstream of the Site with no evidence of a former mill race outlet noting the presence of a pipe emerging from the direction of the Site (dry pipe and no evidence of erosion at the base suggesting limited to no discharge during wetter periods of weather).

- > **Springs outside of the Site boundary - 10 October 2024:** An extended walkover, 100 m downstream and 100 m upstream of the Site along Castle Brook was conducted to better understand the groundwater regime within the local catchment and obtain both spring water (downstream) and surface water (upstream) samples remote from the Site.

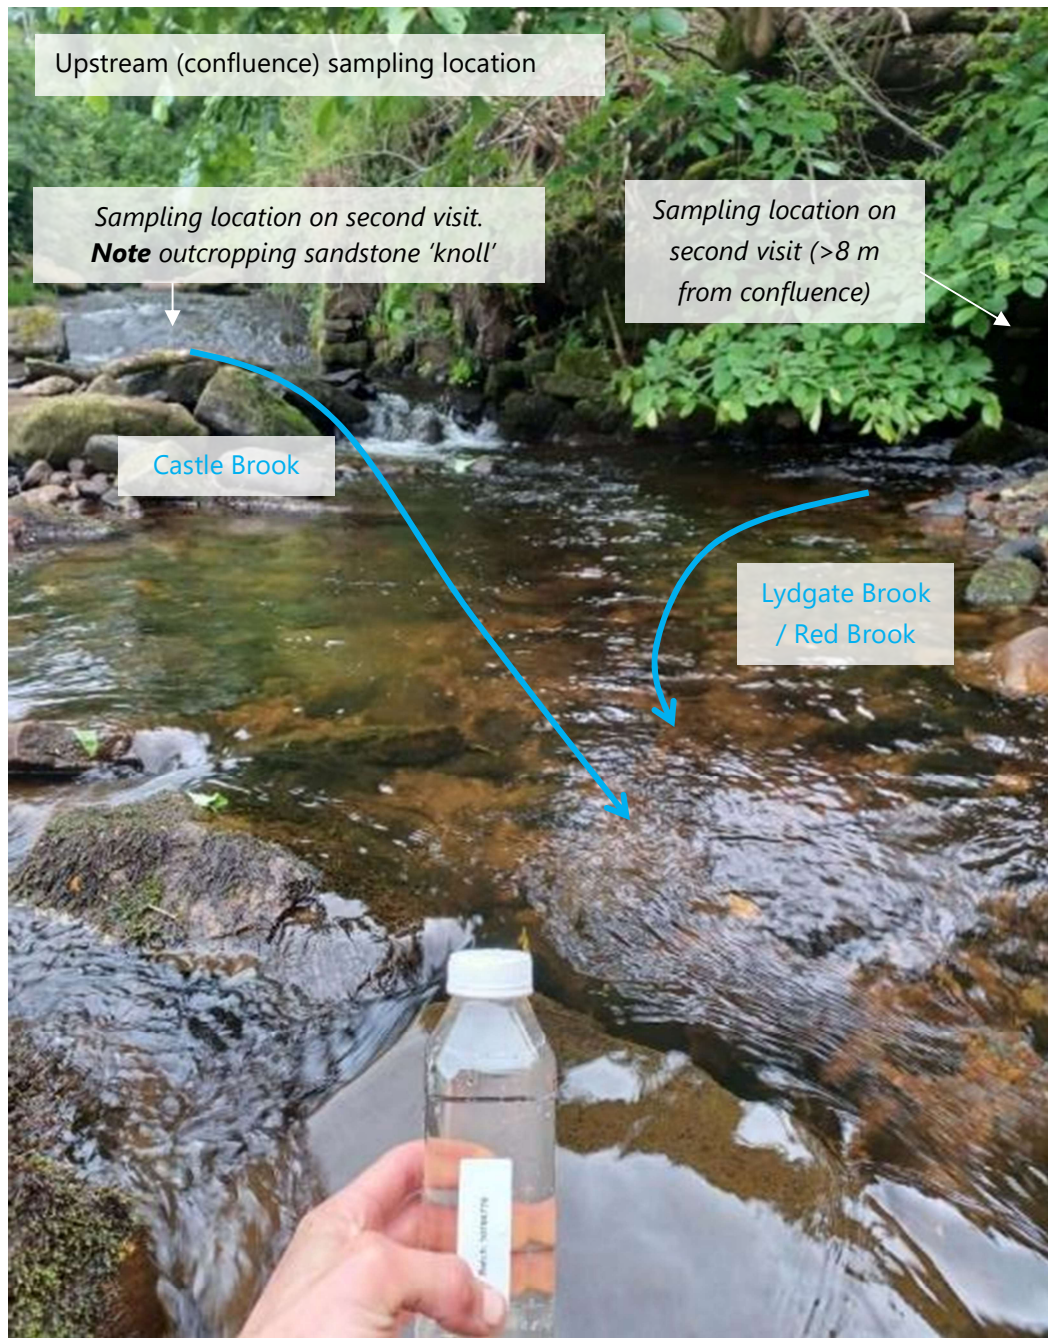
**Photograph 7** ← Confluence sampling location with discrete sampling locations within each watercourse indicated.

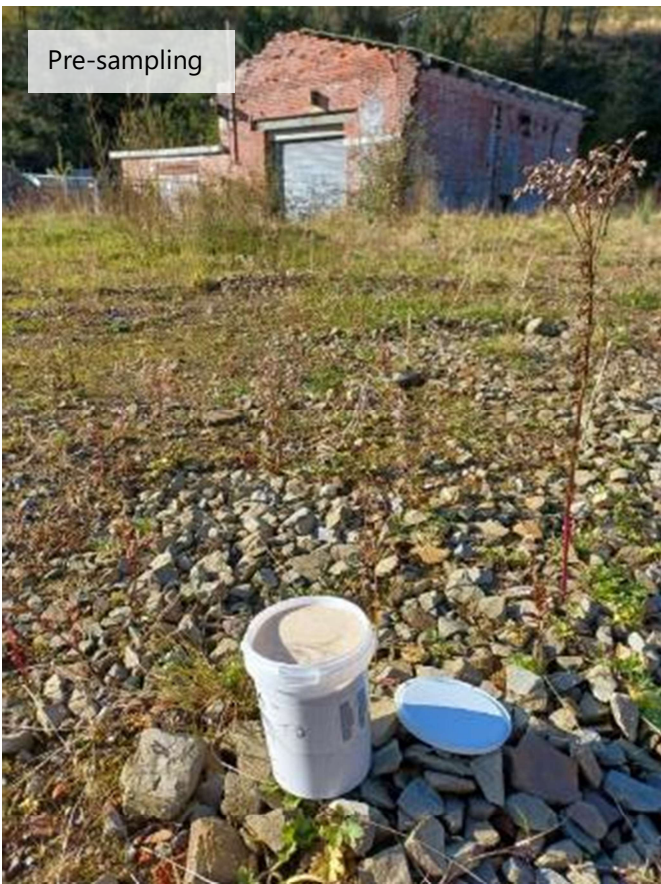
**Photograph 8** ↑ Field blanks for TOP Assay samples – hail drops evident on the post-sampling pot.

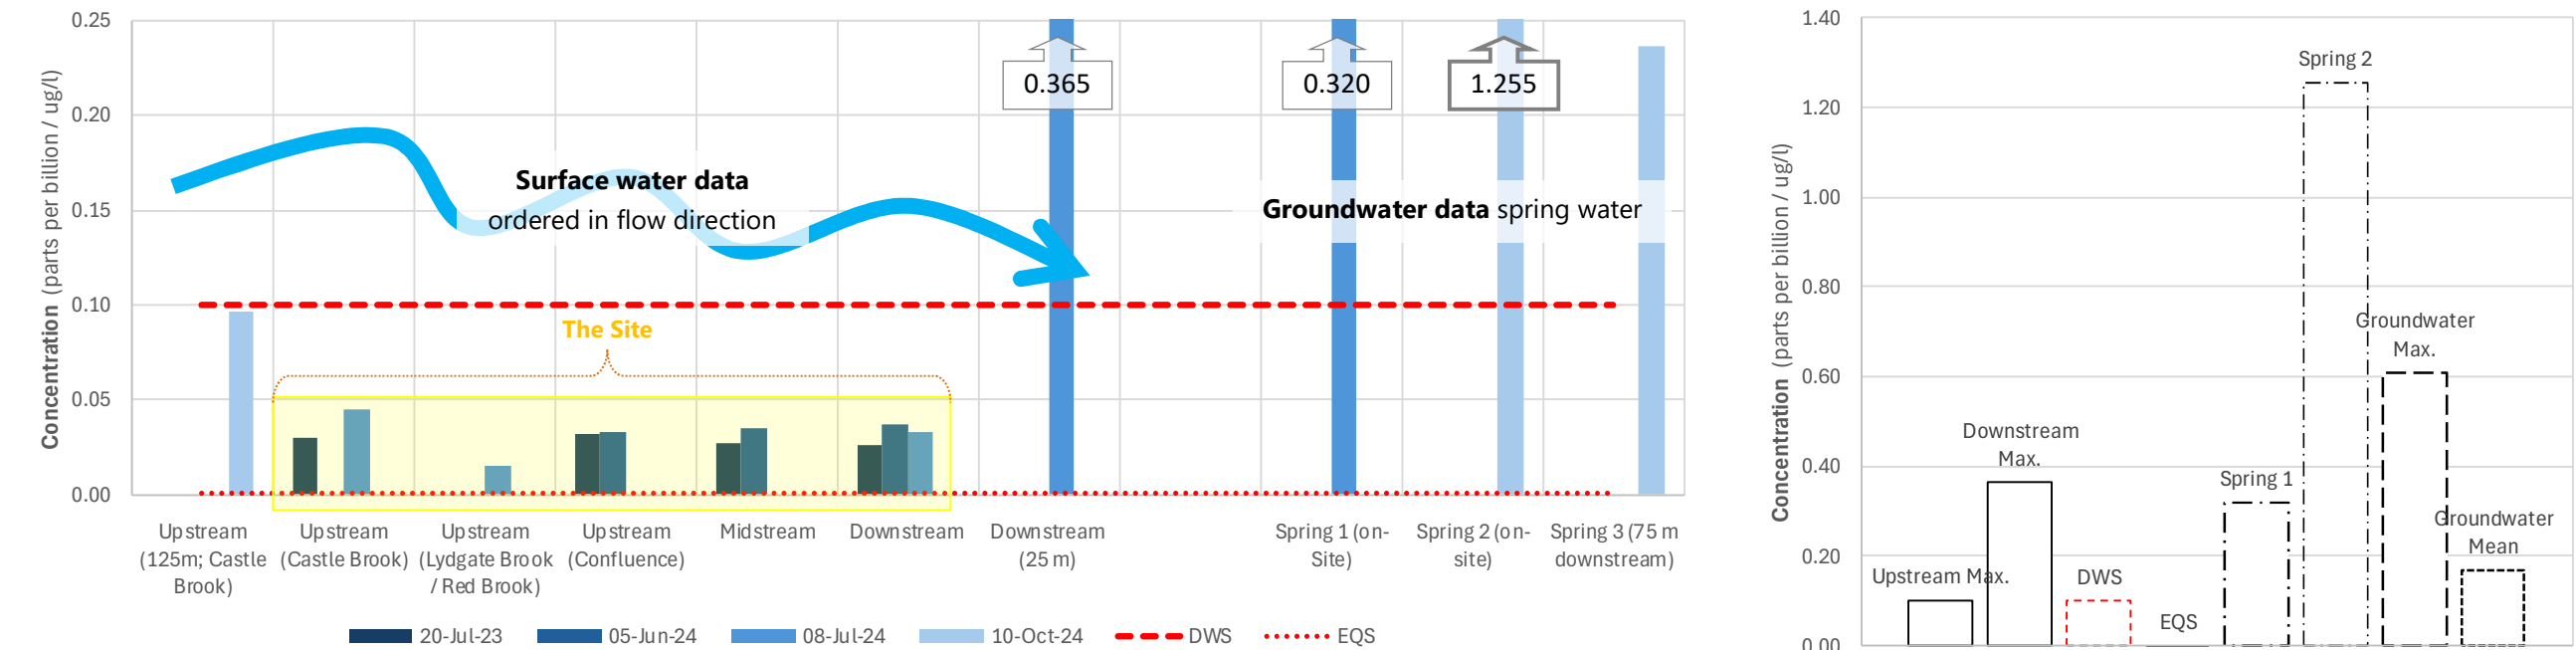
**Figure 6** – Tabulated and graphical presentations of PFAS surface water monitoring data (and maximum and mean groundwater concentrations for comparison)  
> Table: key 'maximum' concentrations highlighted light yellow  
> Left hand graph illustrating spatial and temporal trends in surface water quality data compared against different 'standards'; right hand graph comparing maximum concentrations at key locations including in groundwater (GW)

Based on the overall trend in groundwater flow patterns in this catchment, this finding is suggestive of the soils present across the Site acting as a ‘buffer’ to otherwise higher concentrations of direct discharge of PFOA into Castle Brook. The groundwater emerging from the spring-line on the eastern embankment is draining into, being diluted by infiltrating rainwater and, to a lesser extent given the high flow rates, being stored/adsorbed within the soils across the Site.

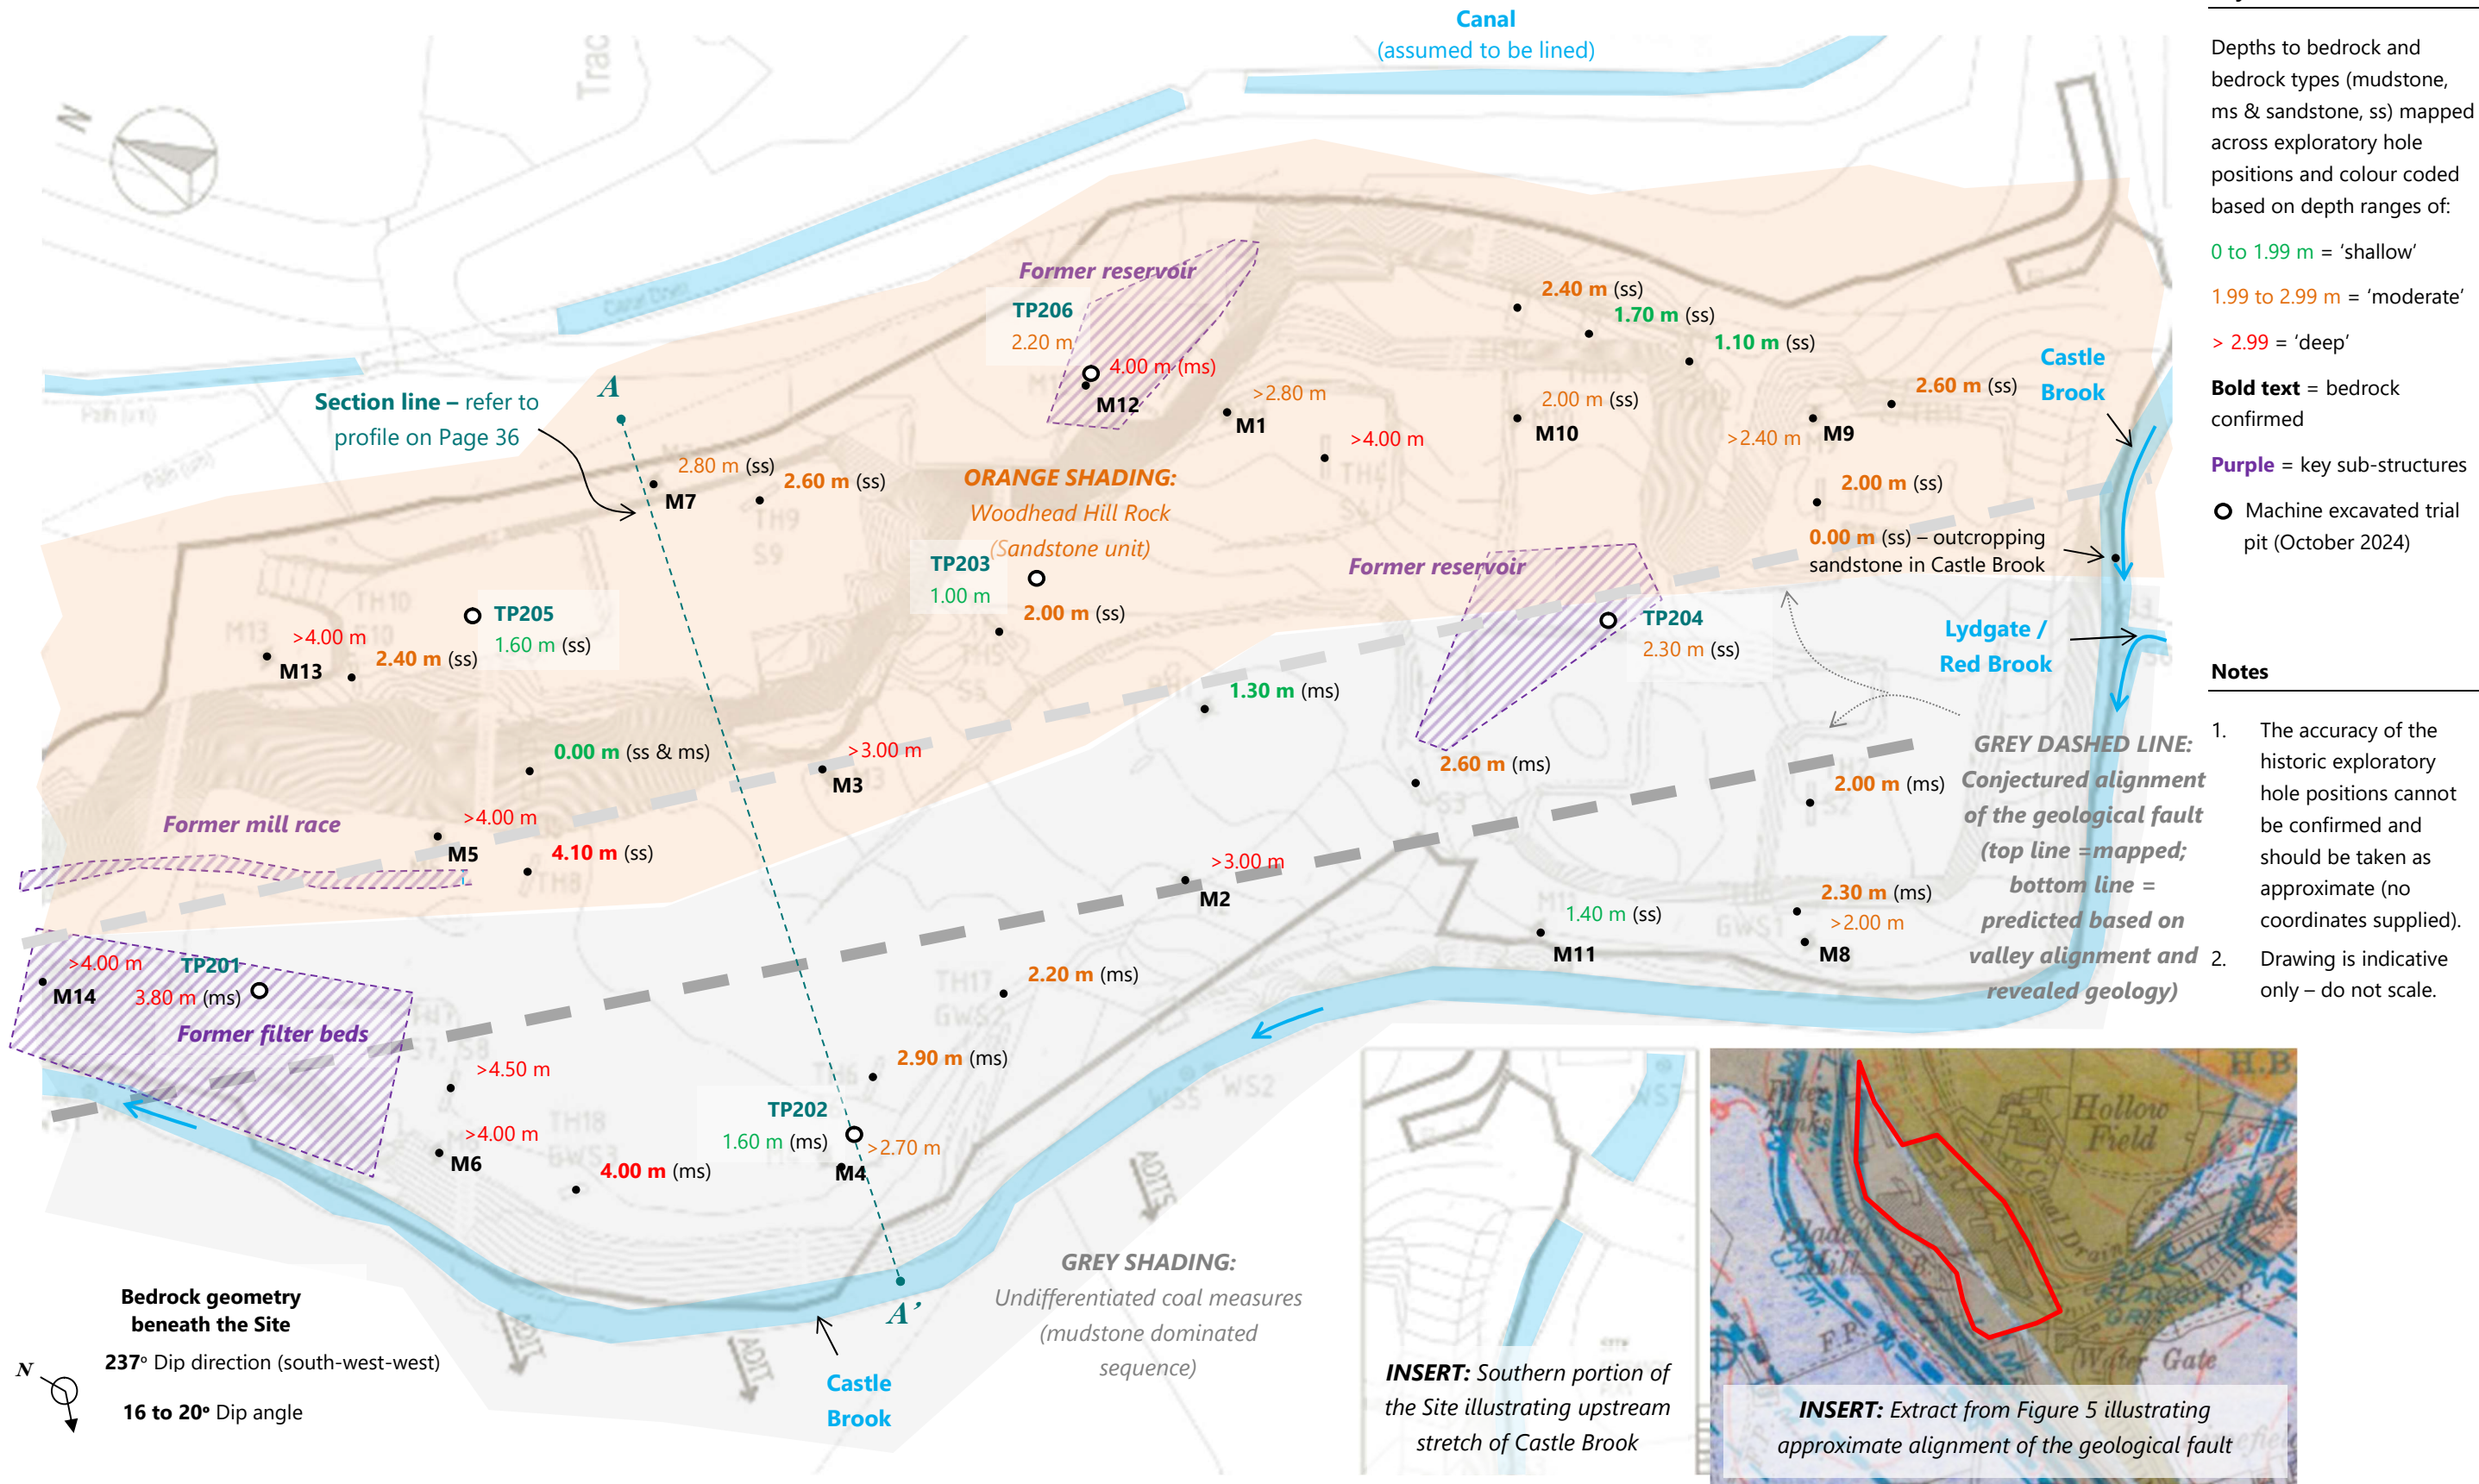
5.0 Ground Model – Baseline (Current Condition) – Plan – Geological Setting (depth to bedrock deposits)

Whilst the monitoring standpipes didn’t prove bedrock deposits categorically the base / refusal depths are typically consistent with the depths of fill within nearby machine excavated trial pits. It is however noted that fill depths of over 4.00 m were recorded in various areas of the Site (refer to Ground Model in Section 5.0).

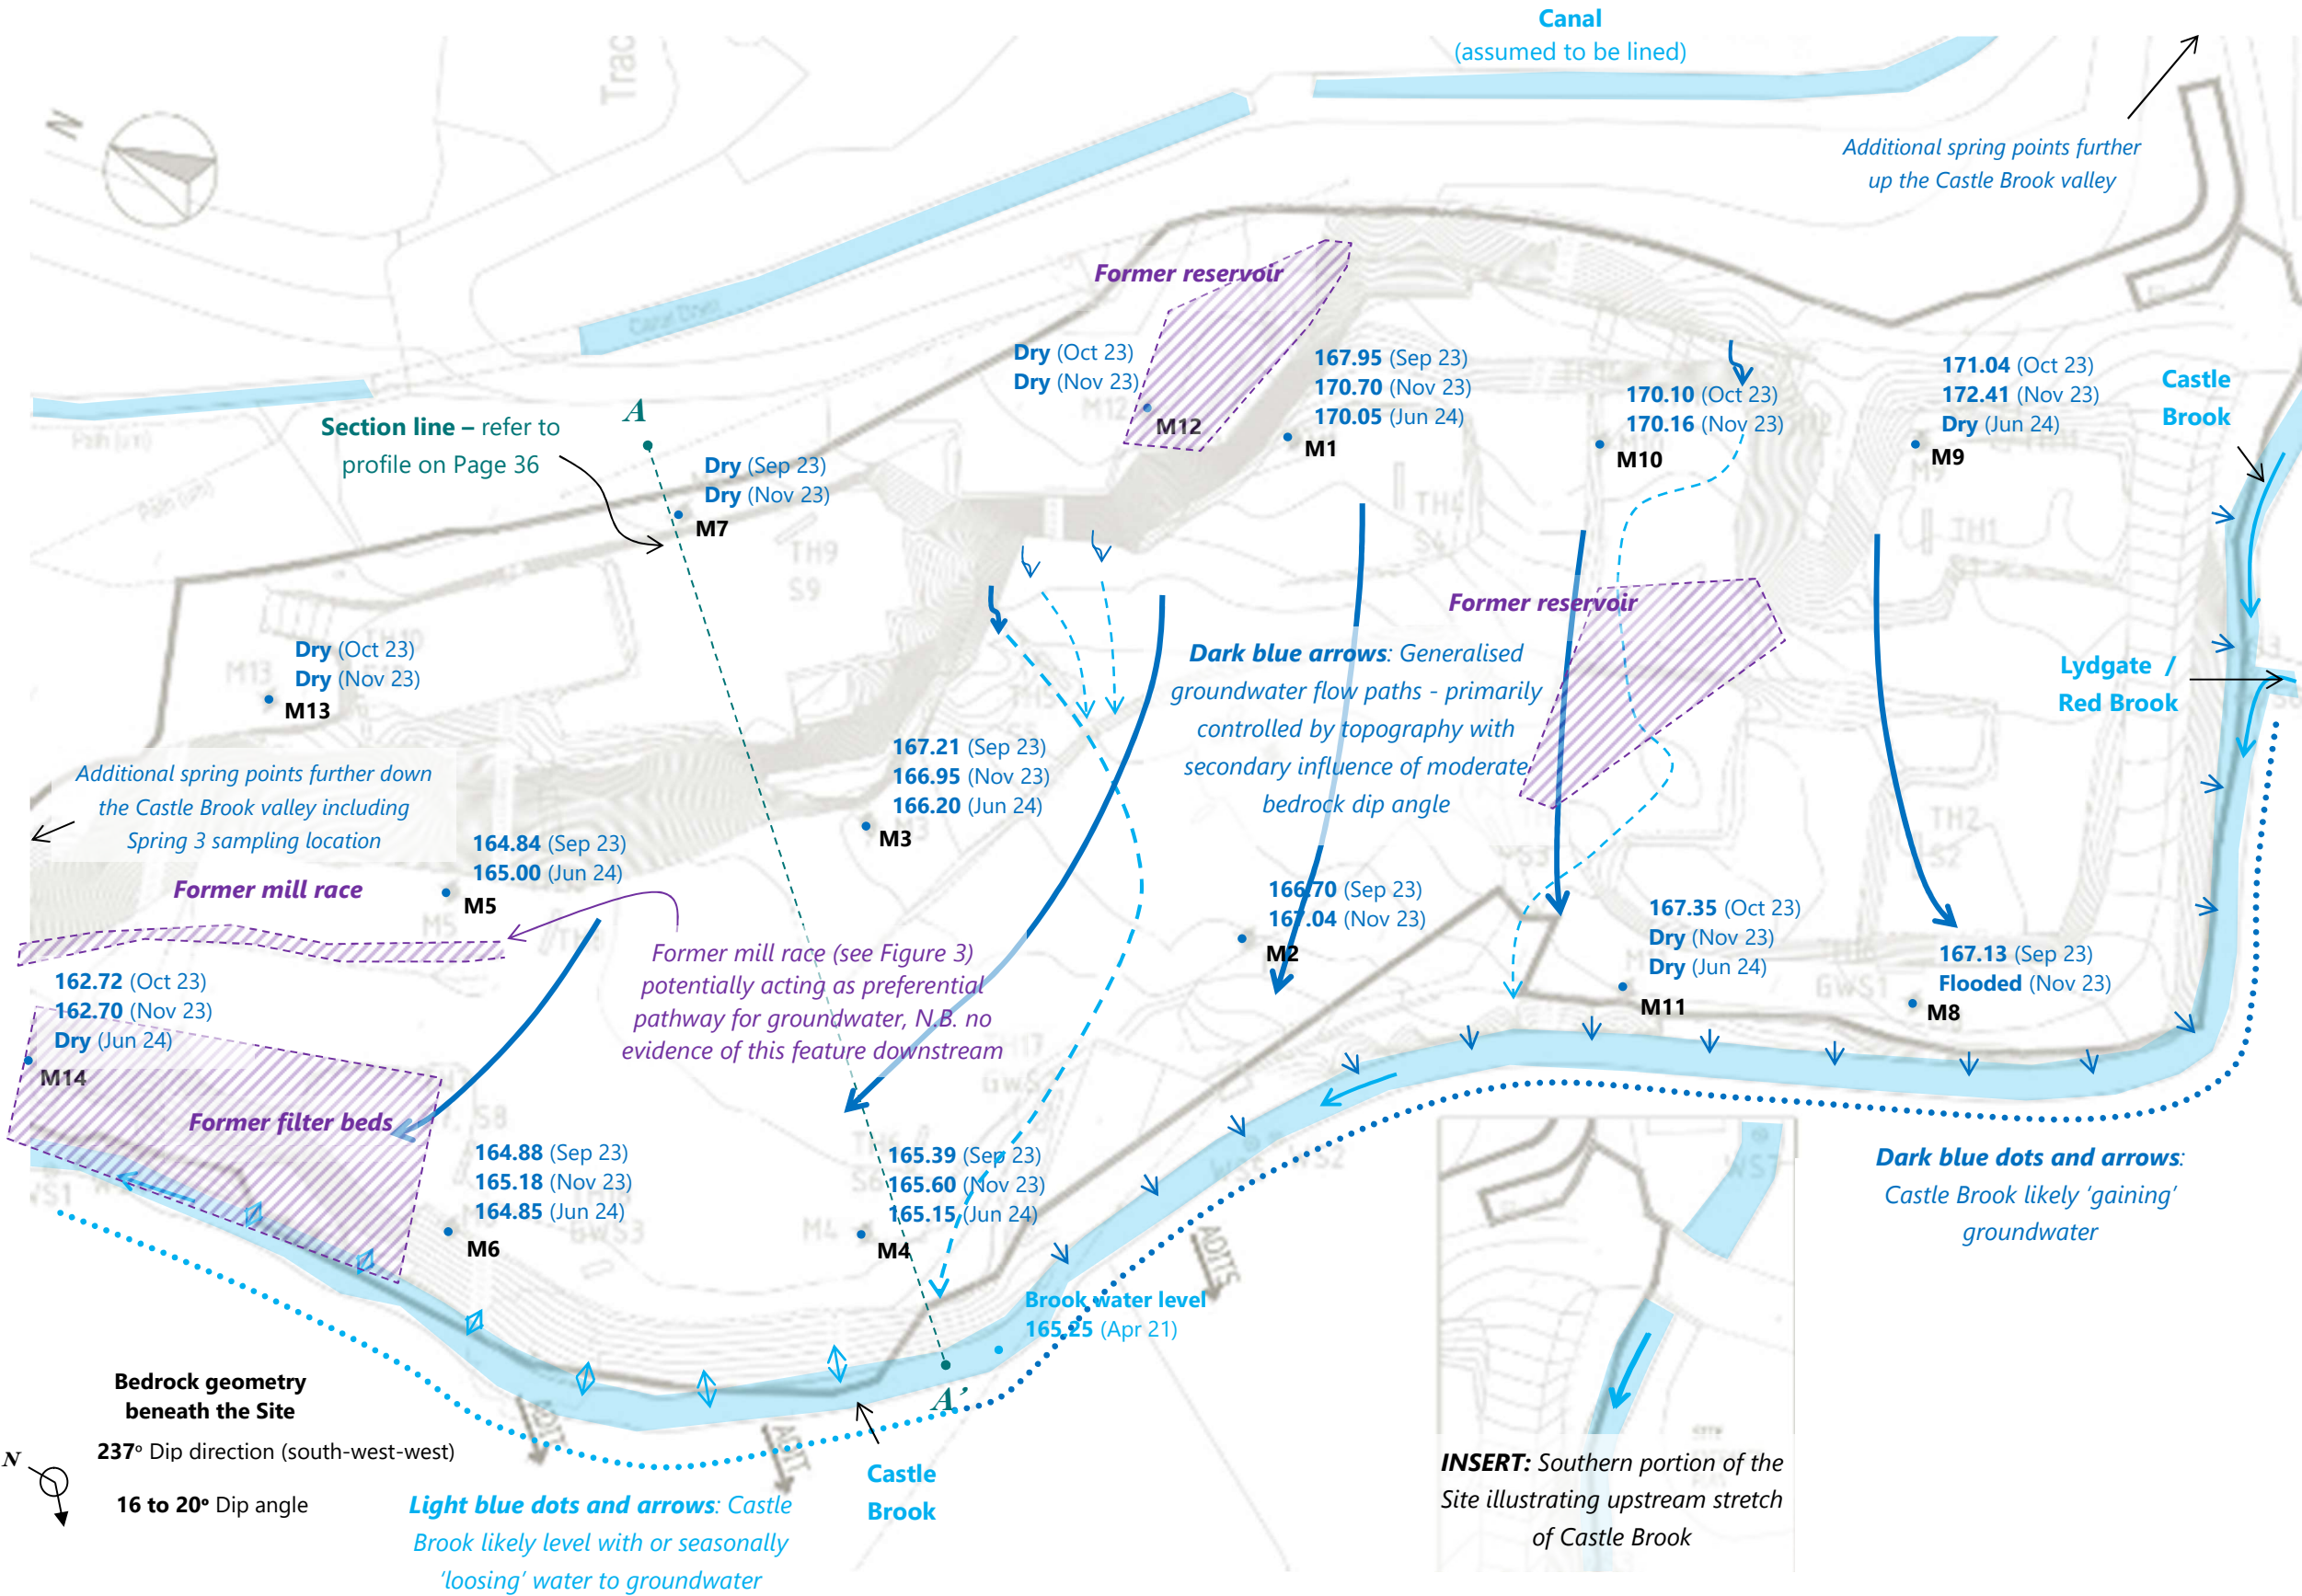
5.0 Ground Model – Baseline (Current Condition) – Plan – Hydrogeological and Hydrological Setting

Groundwater related features illustrated in dark blue.
