## Controlled Waters Risk Assessment

Sladen Mill, Littleborough

| Project Number | 20403 |
| Report Number | 001 |

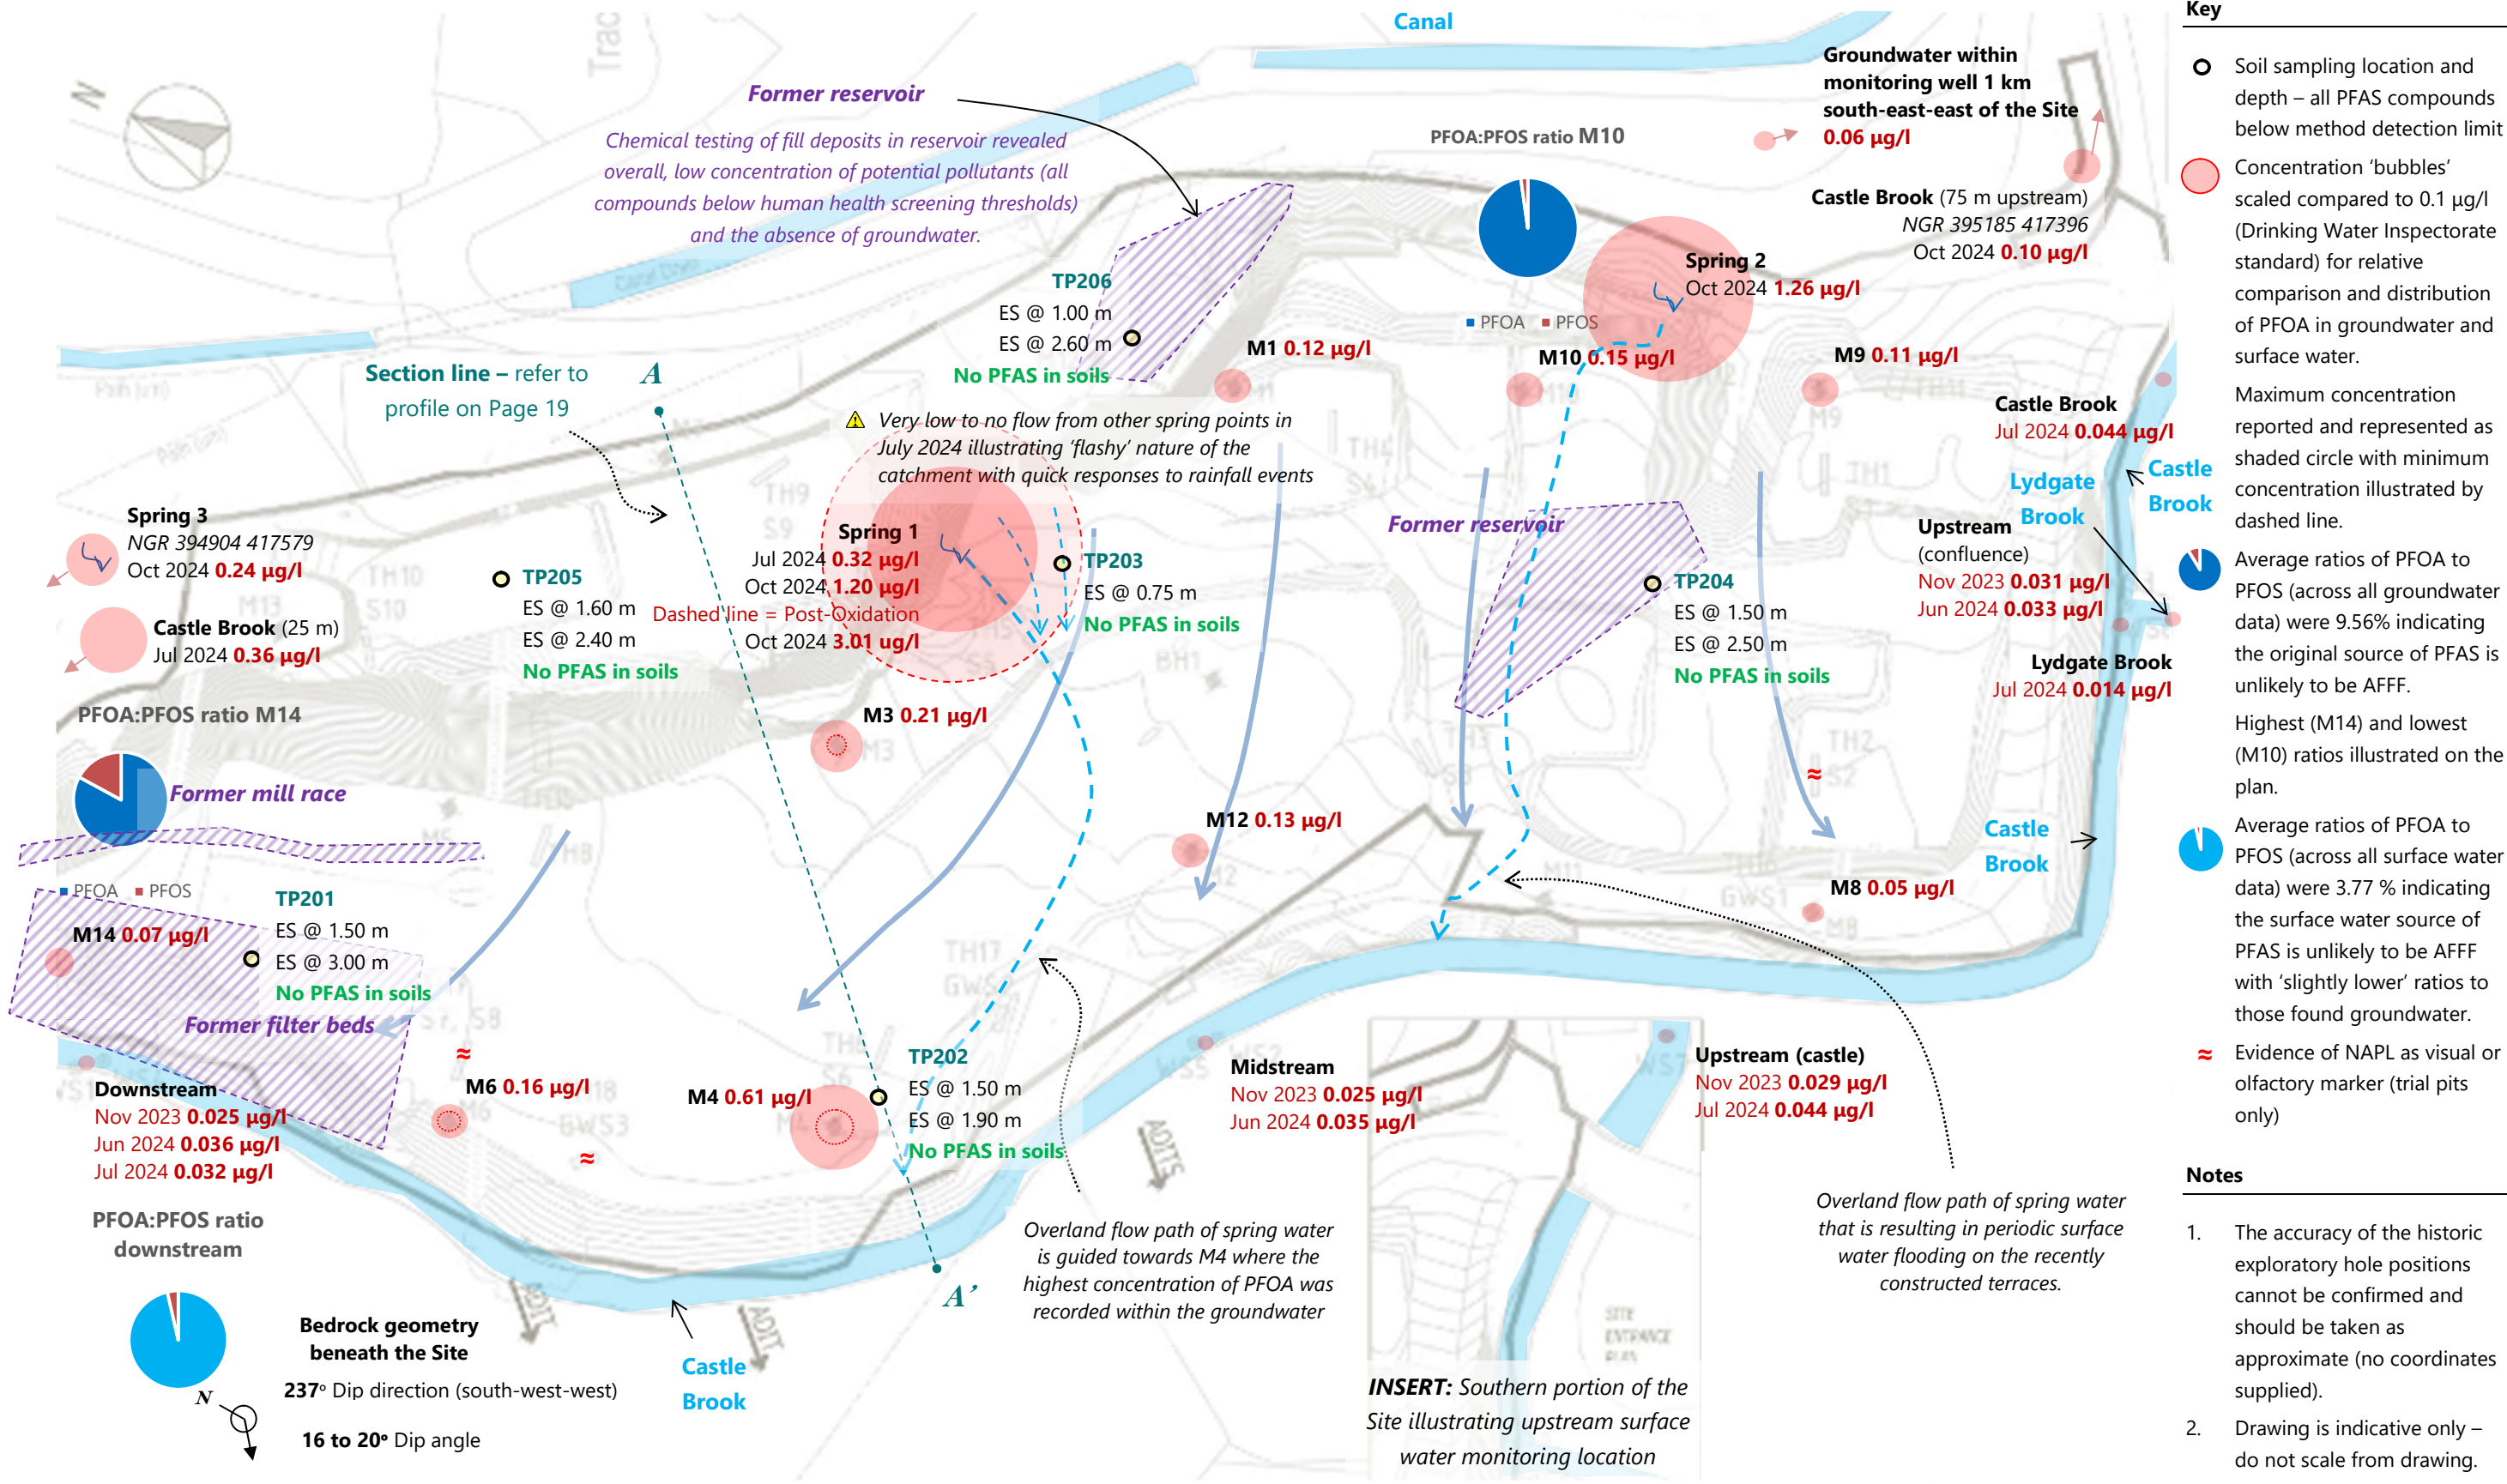
5.0 Ground Model – Baseline (Current Condition) – Plan – Spatial Distribution of PFOA Concentrations in Soil, Groundwater and Surface Water on Site and locally to the Site

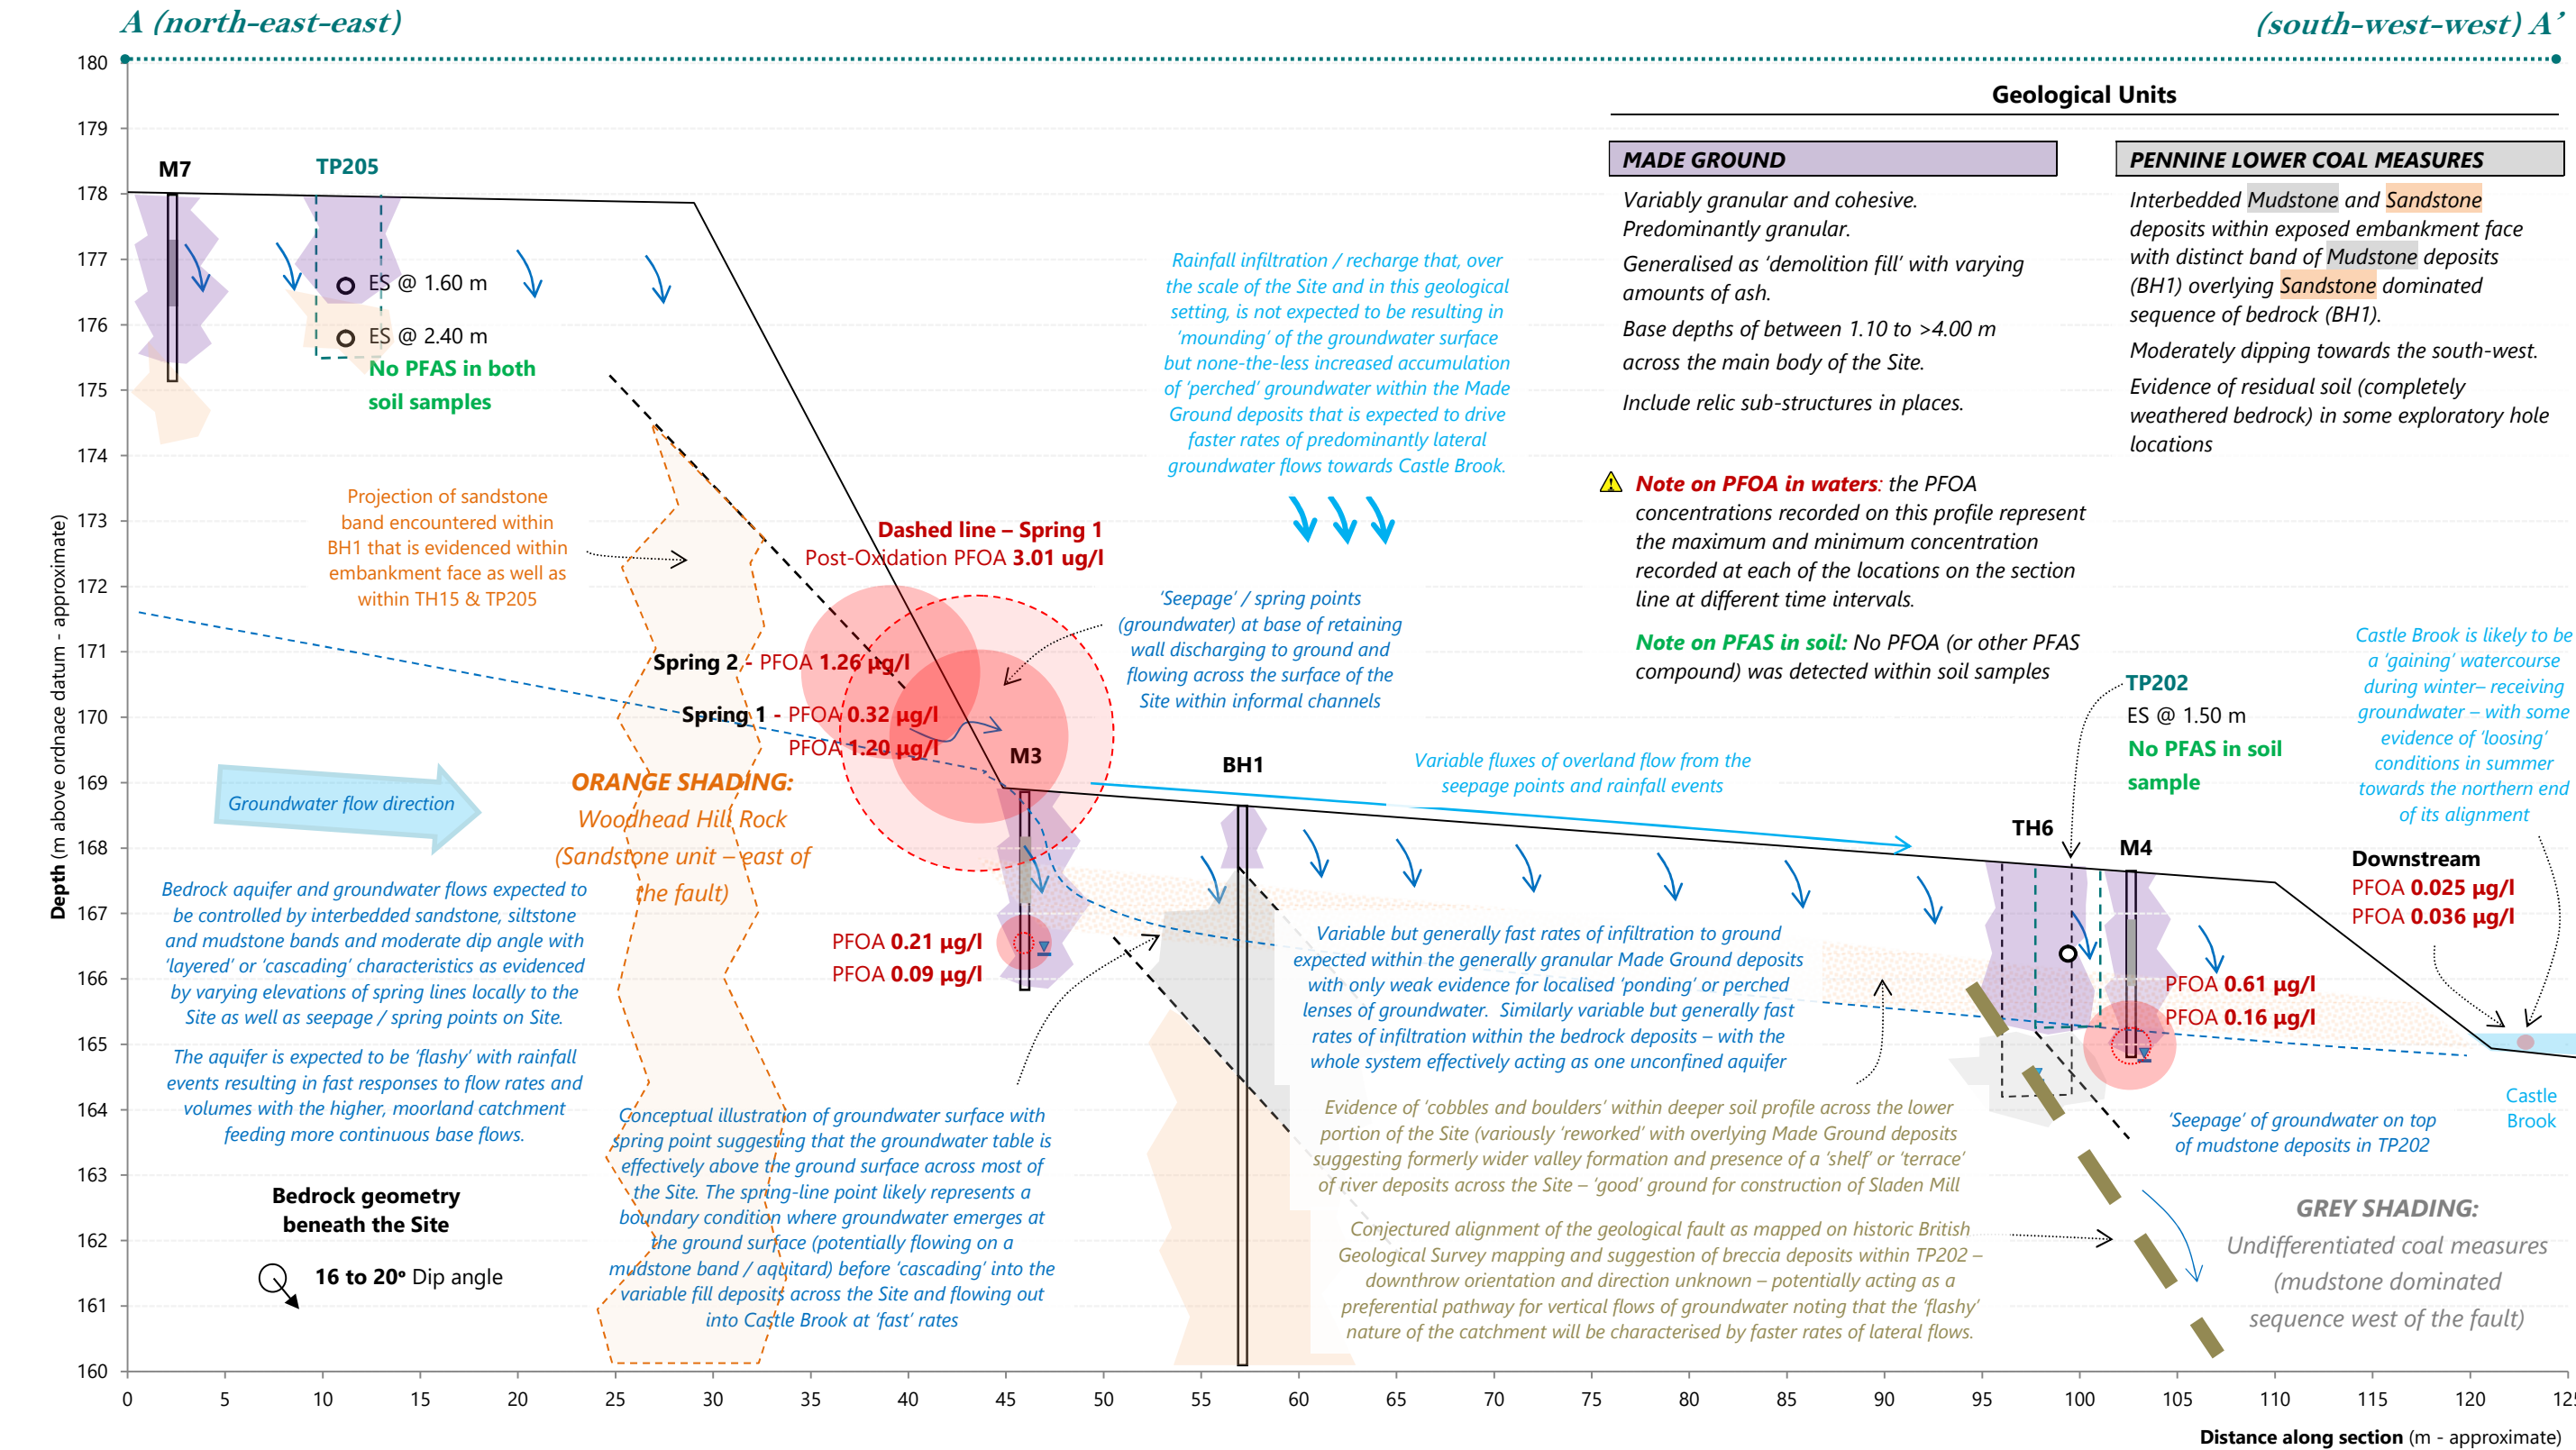
5.0 Ground Model – Baseline (Current Condition) – Profile (aligned with dip direction of bedrock)

Illustrative / conceptual only – do not scale from drawing – note compressed horizontal axis that exaggerates dip angle

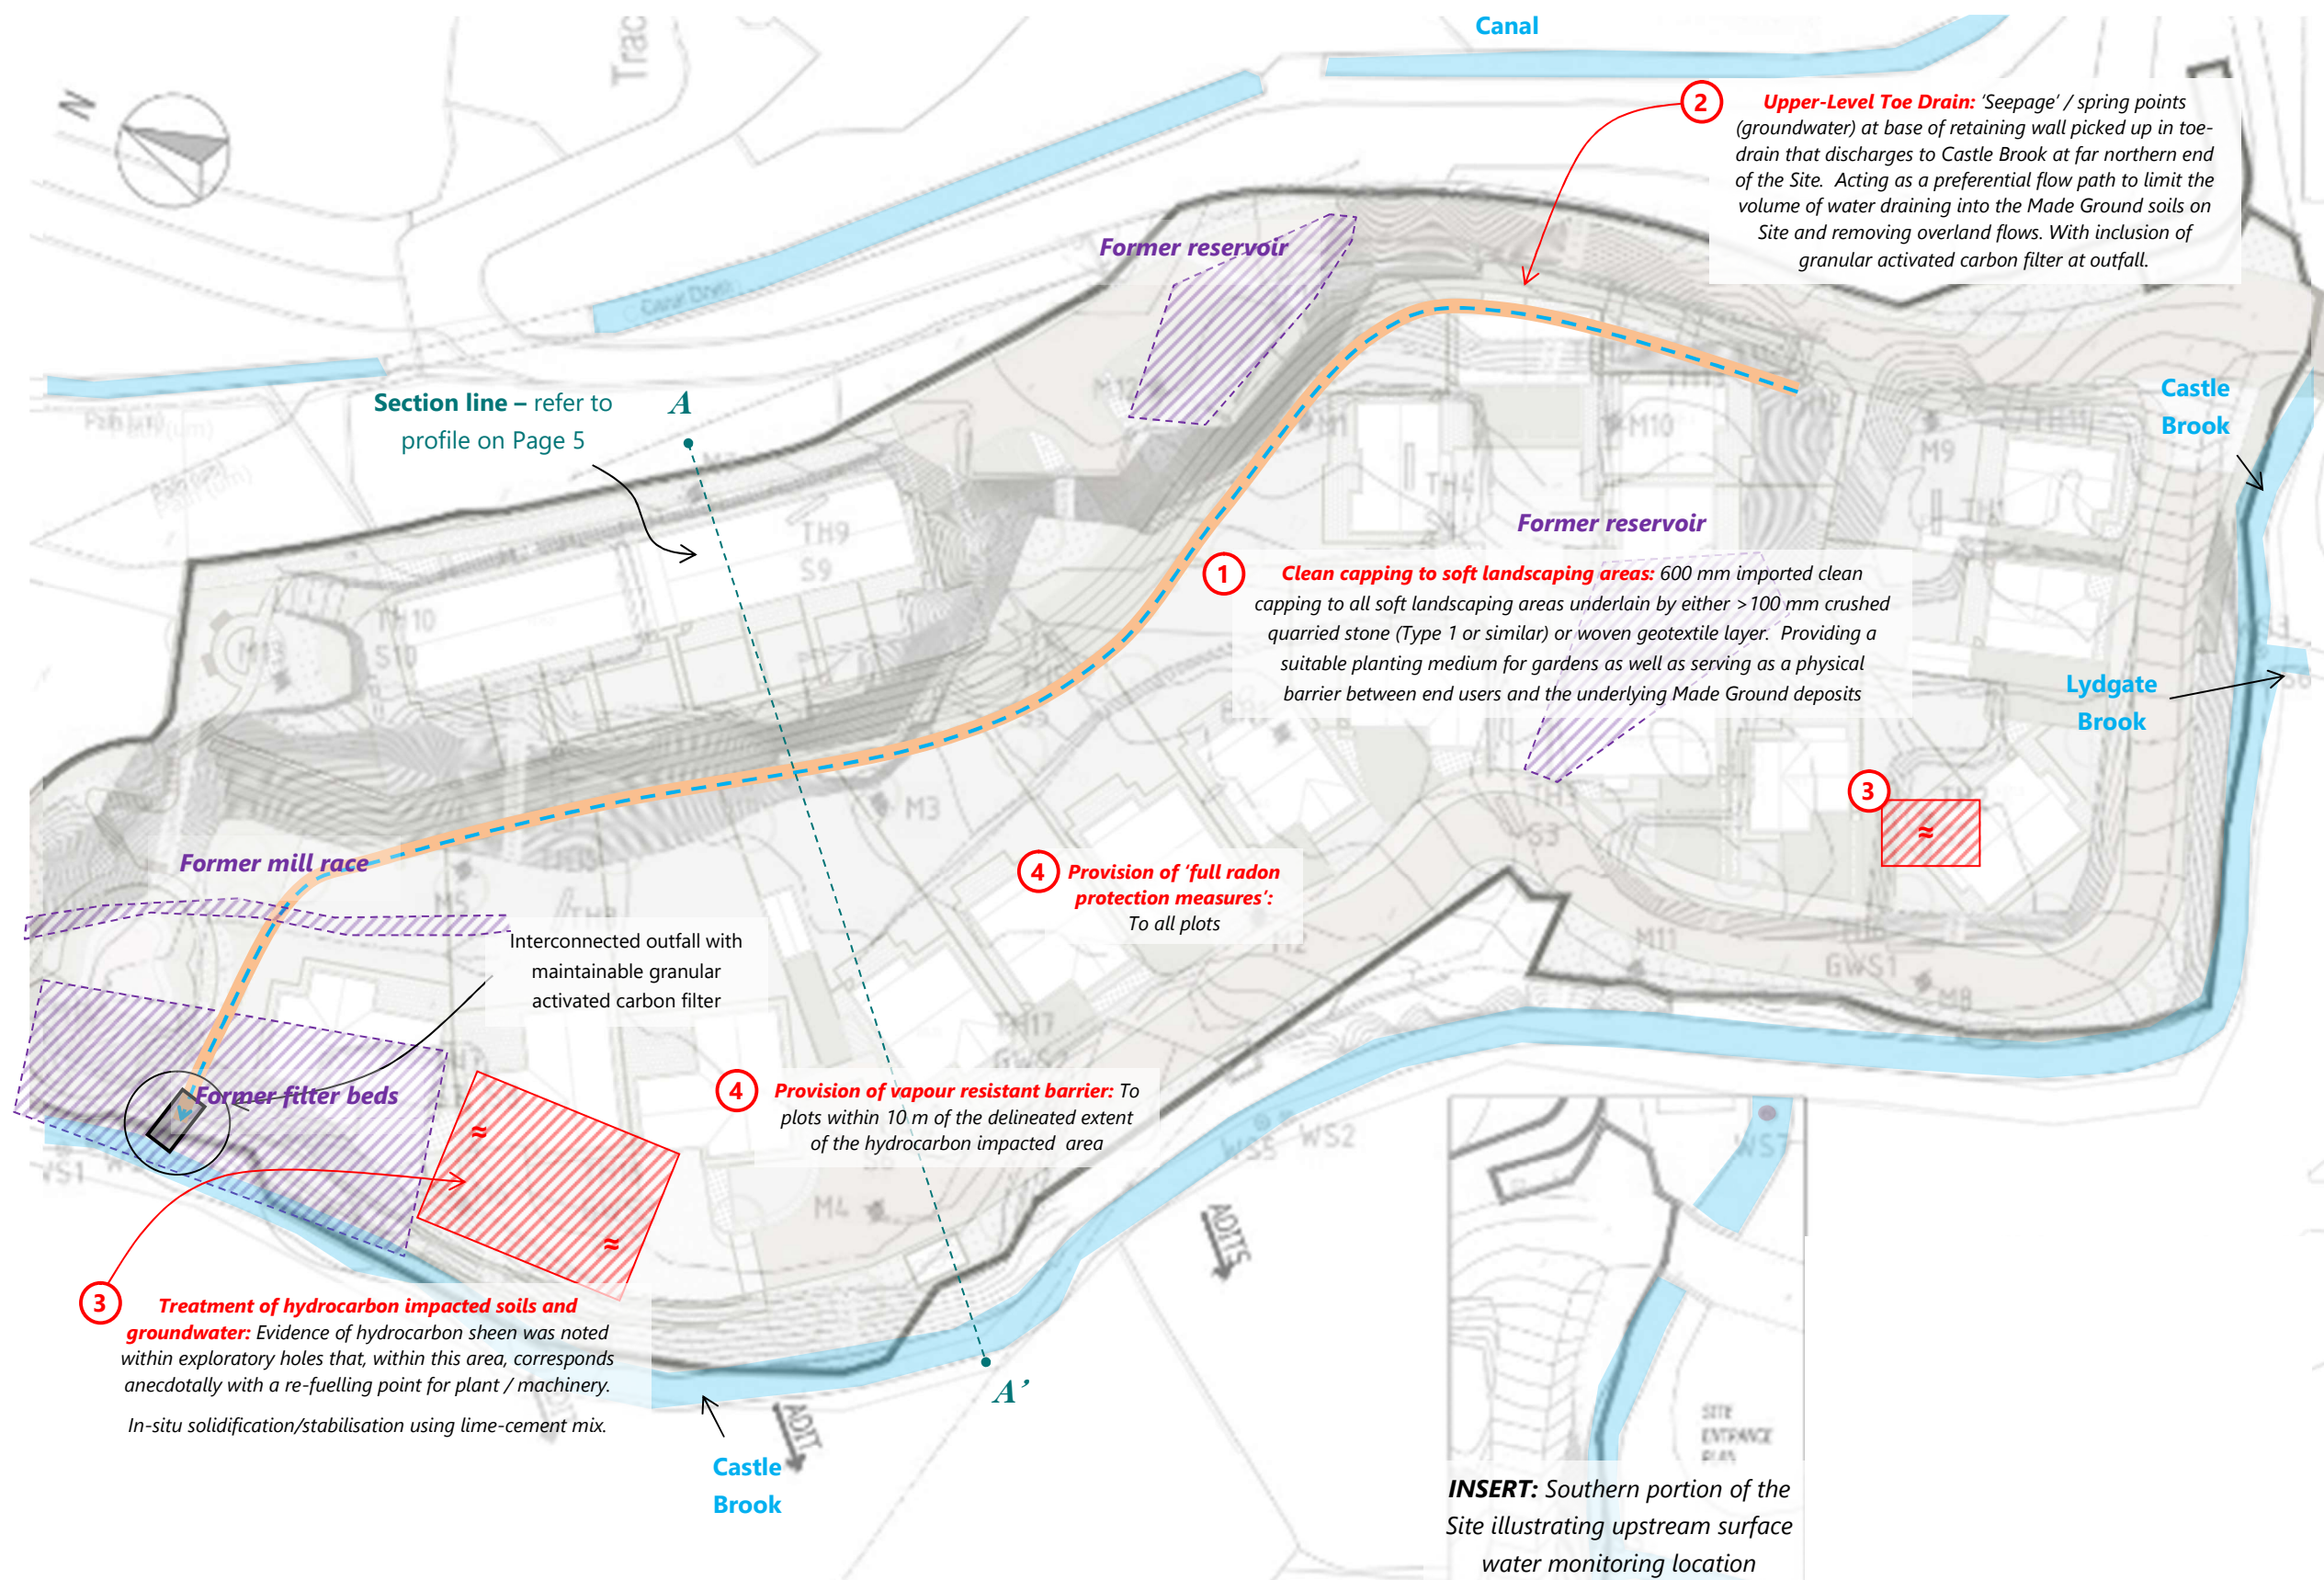
### 7.0 Ground Model – Endline (Post-Development Condition) – Plan (presenting an overview of the Remedial Actions)

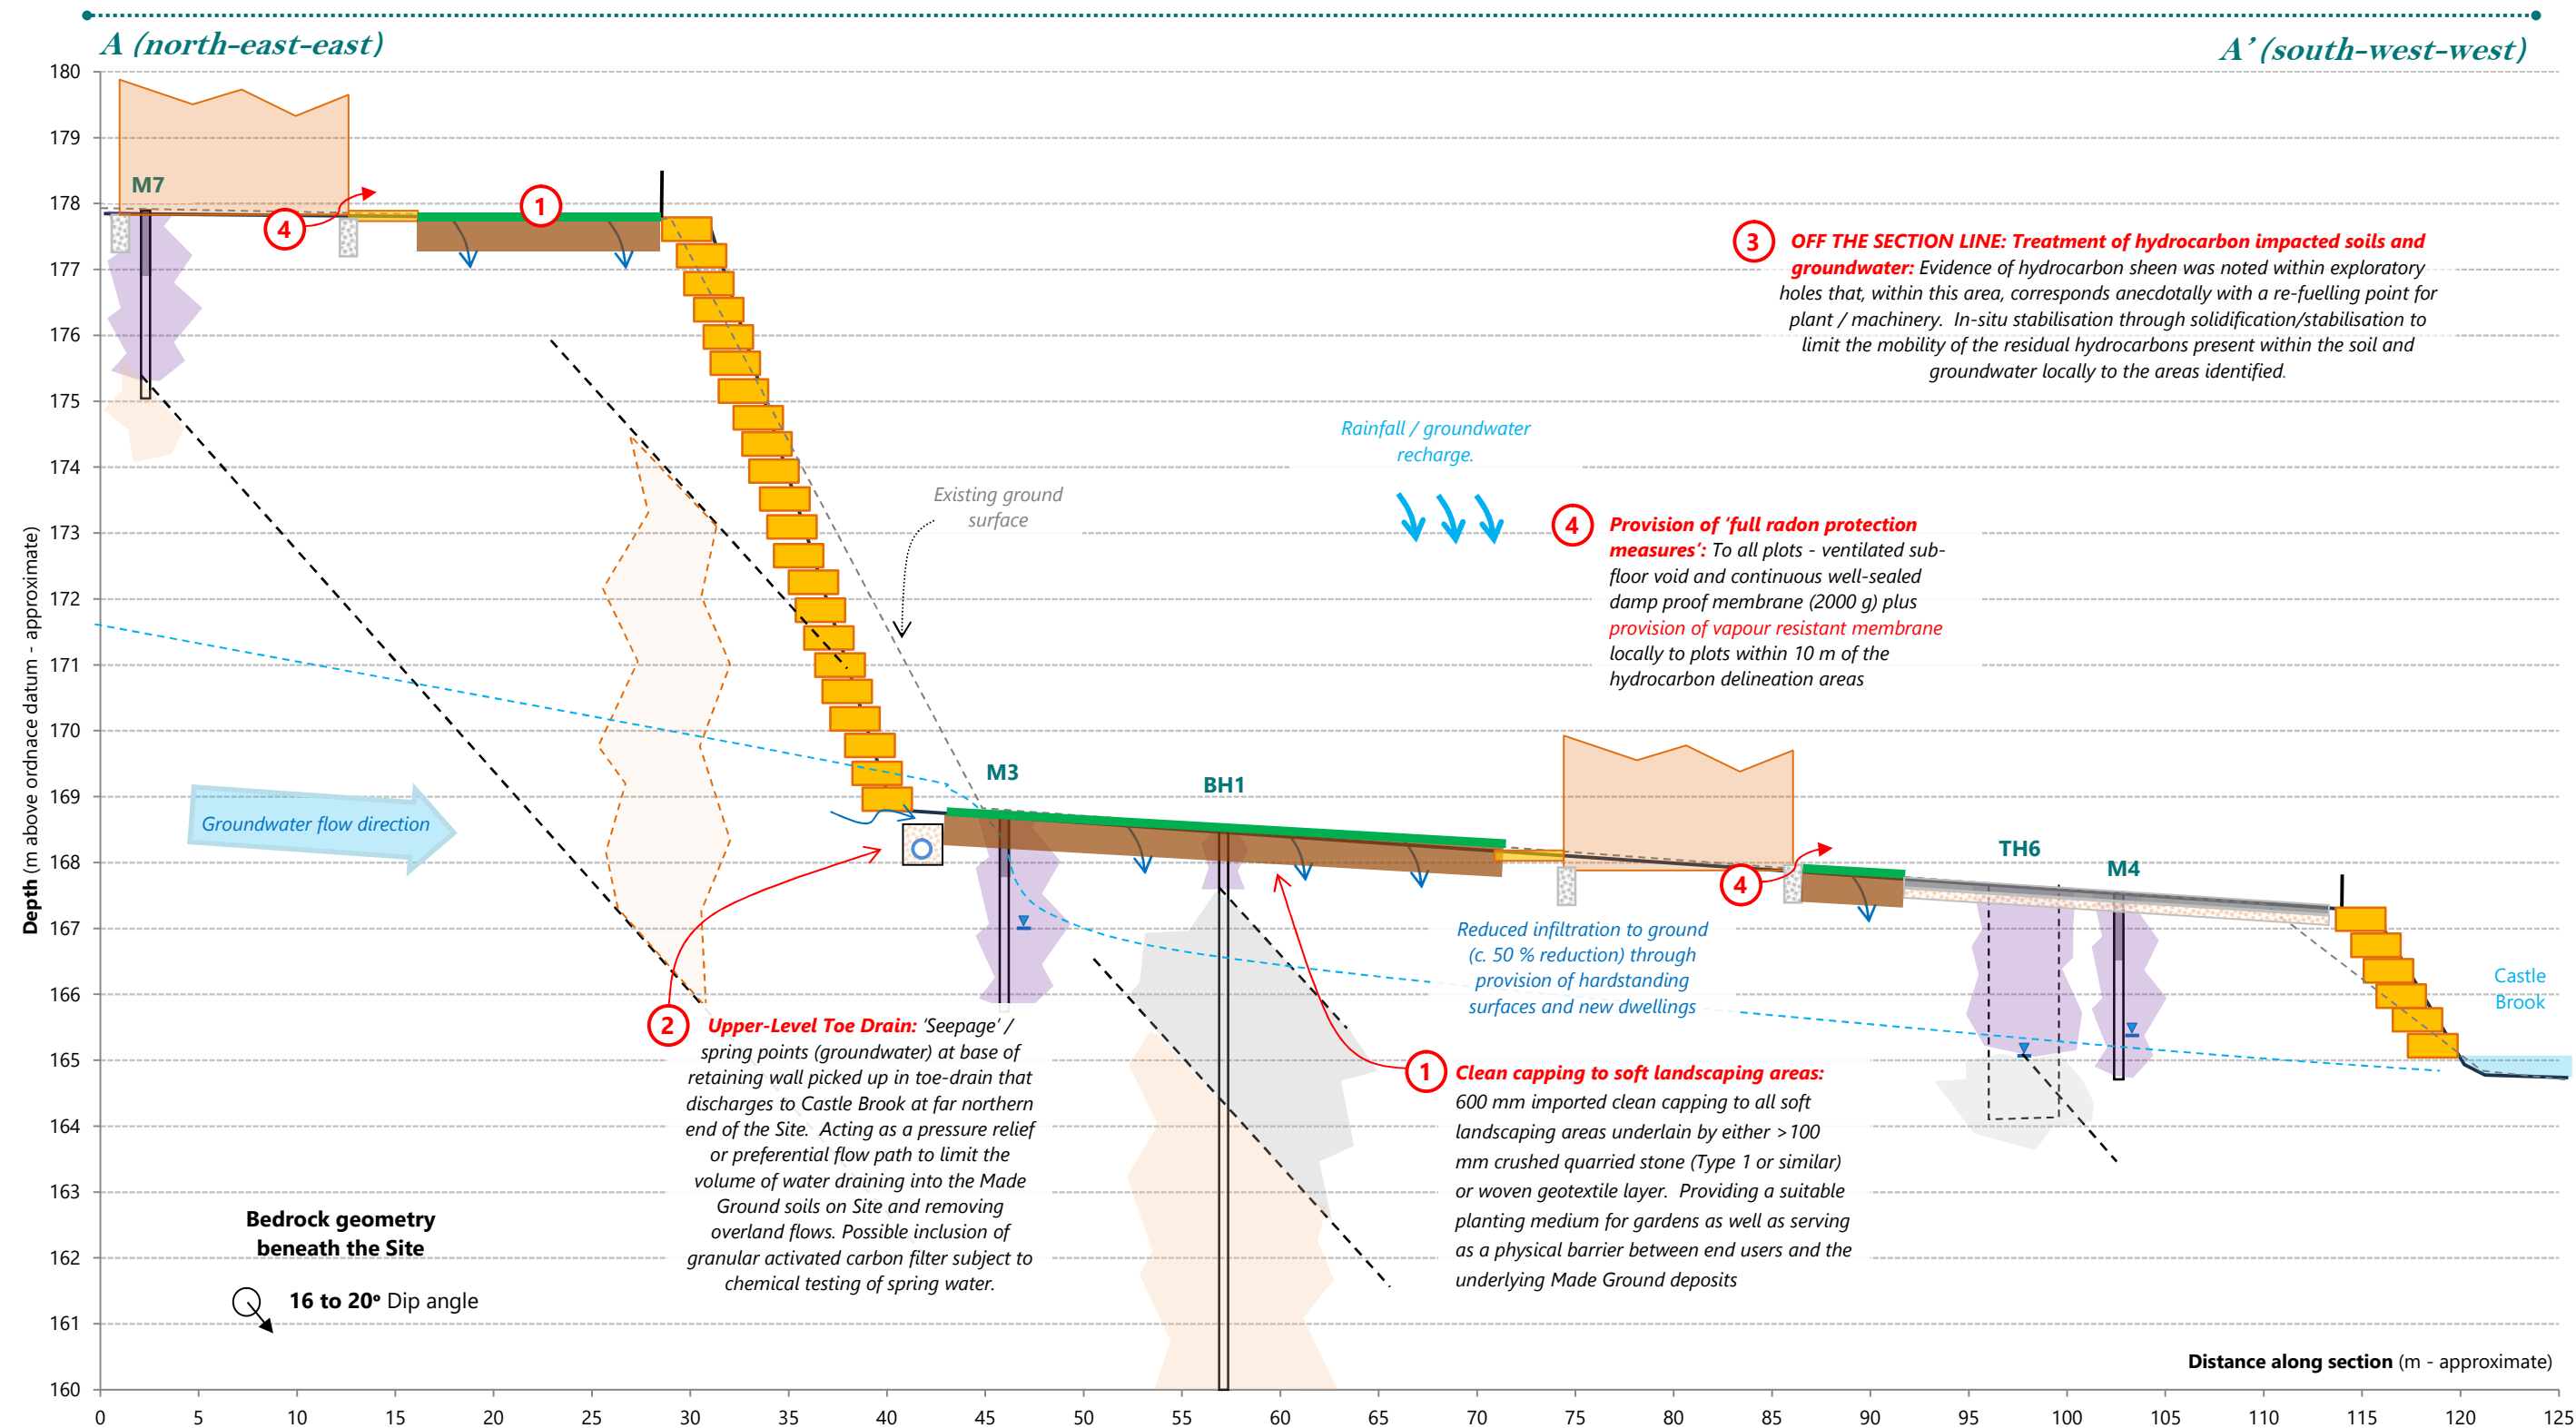
7.0 Ground Model – Endline (Post-Development Condition) – Profile (aligned with dip direction of bedrock; presenting an overview of the Remedial Actions)

Illustrative / conceptual only – do not scale from drawing – note compressed horizontal axis

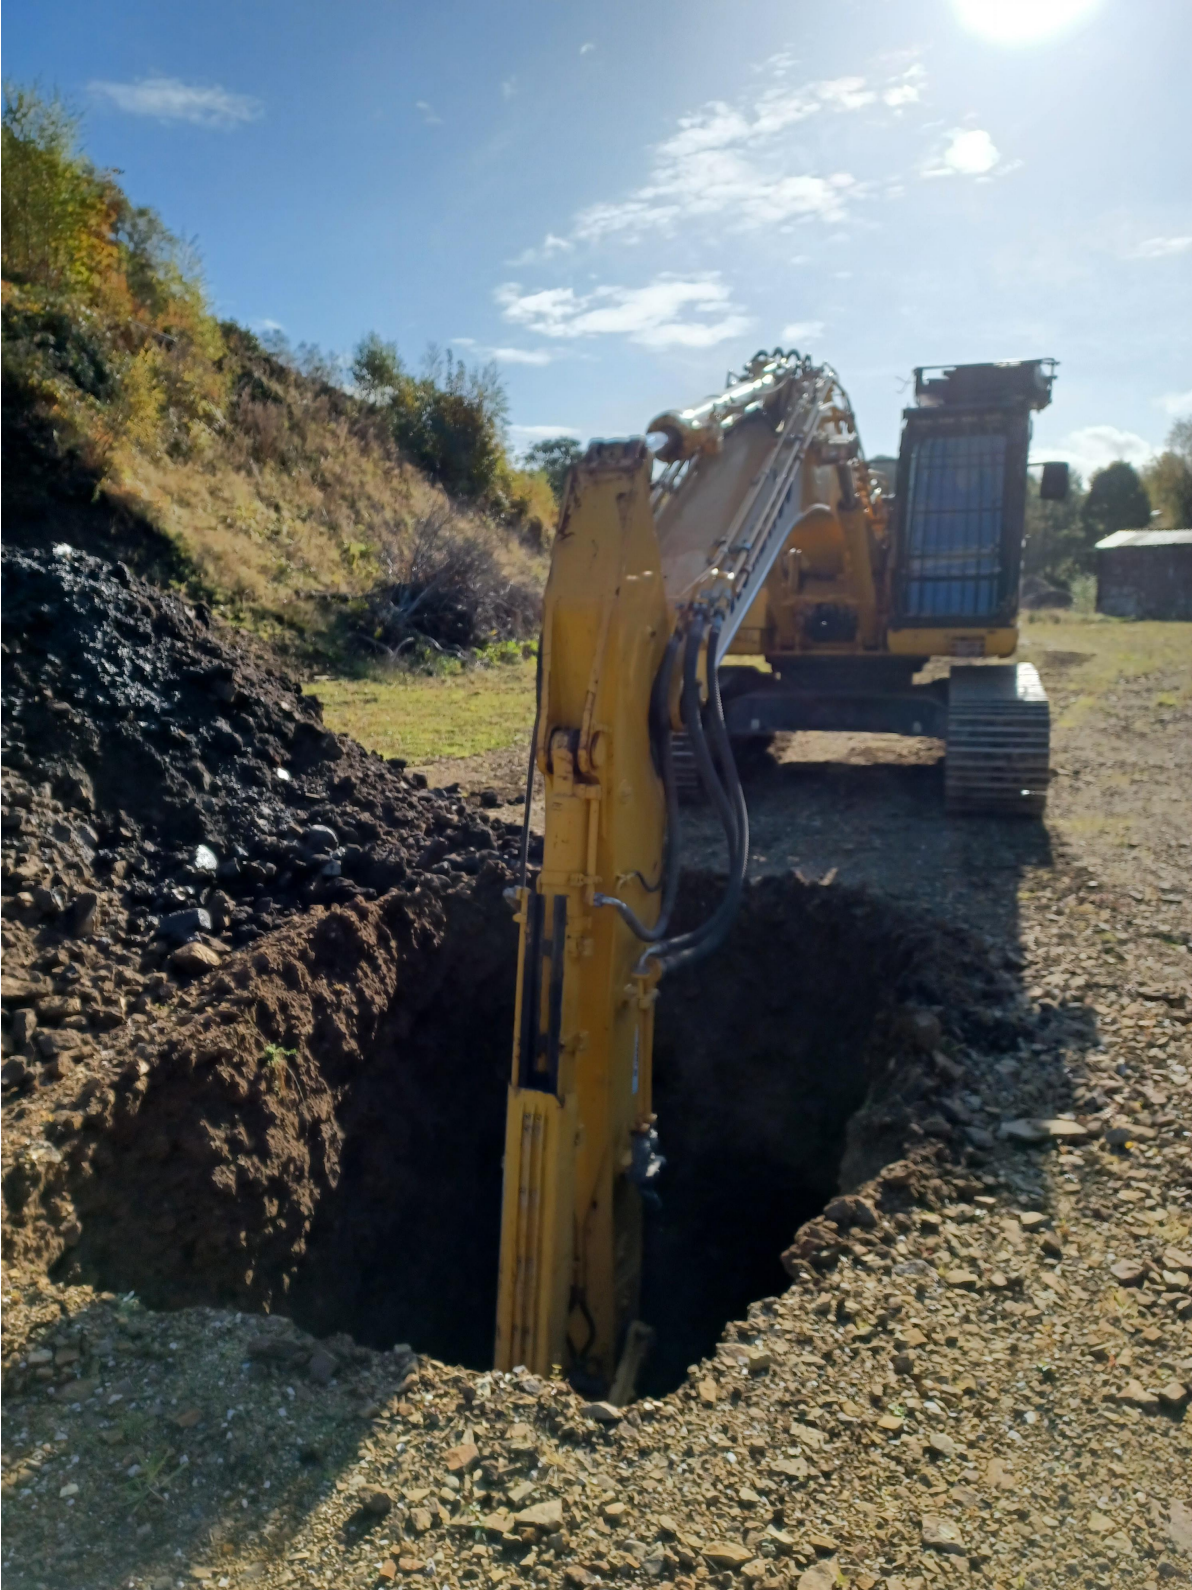
| <b>Remarks</b><br>PURPOSE: Targeting the northern portion of the Site and former reservoir. TERMINATION: Practical refusal of 36 tonne excavator with toothed bucket on intact bedrock. GROUNDWATER: East to west basal flows. STABILITY: Spalling throughout depth. OTHER: Ash present within deeper fill but otherwise no evidence of potentially polluting or harmful material. LOCATION: Referenced using free-ware on Site. GL: Estimated off May 2021 topographical survey. | | | | <b>Method, Plant, Stability, Dimensions</b><br>0.00 - 4.00m TP - Trial Pit 36 tonne tracked<br>Unstable<br>L = 2.80m<br>W = 1.20m | |

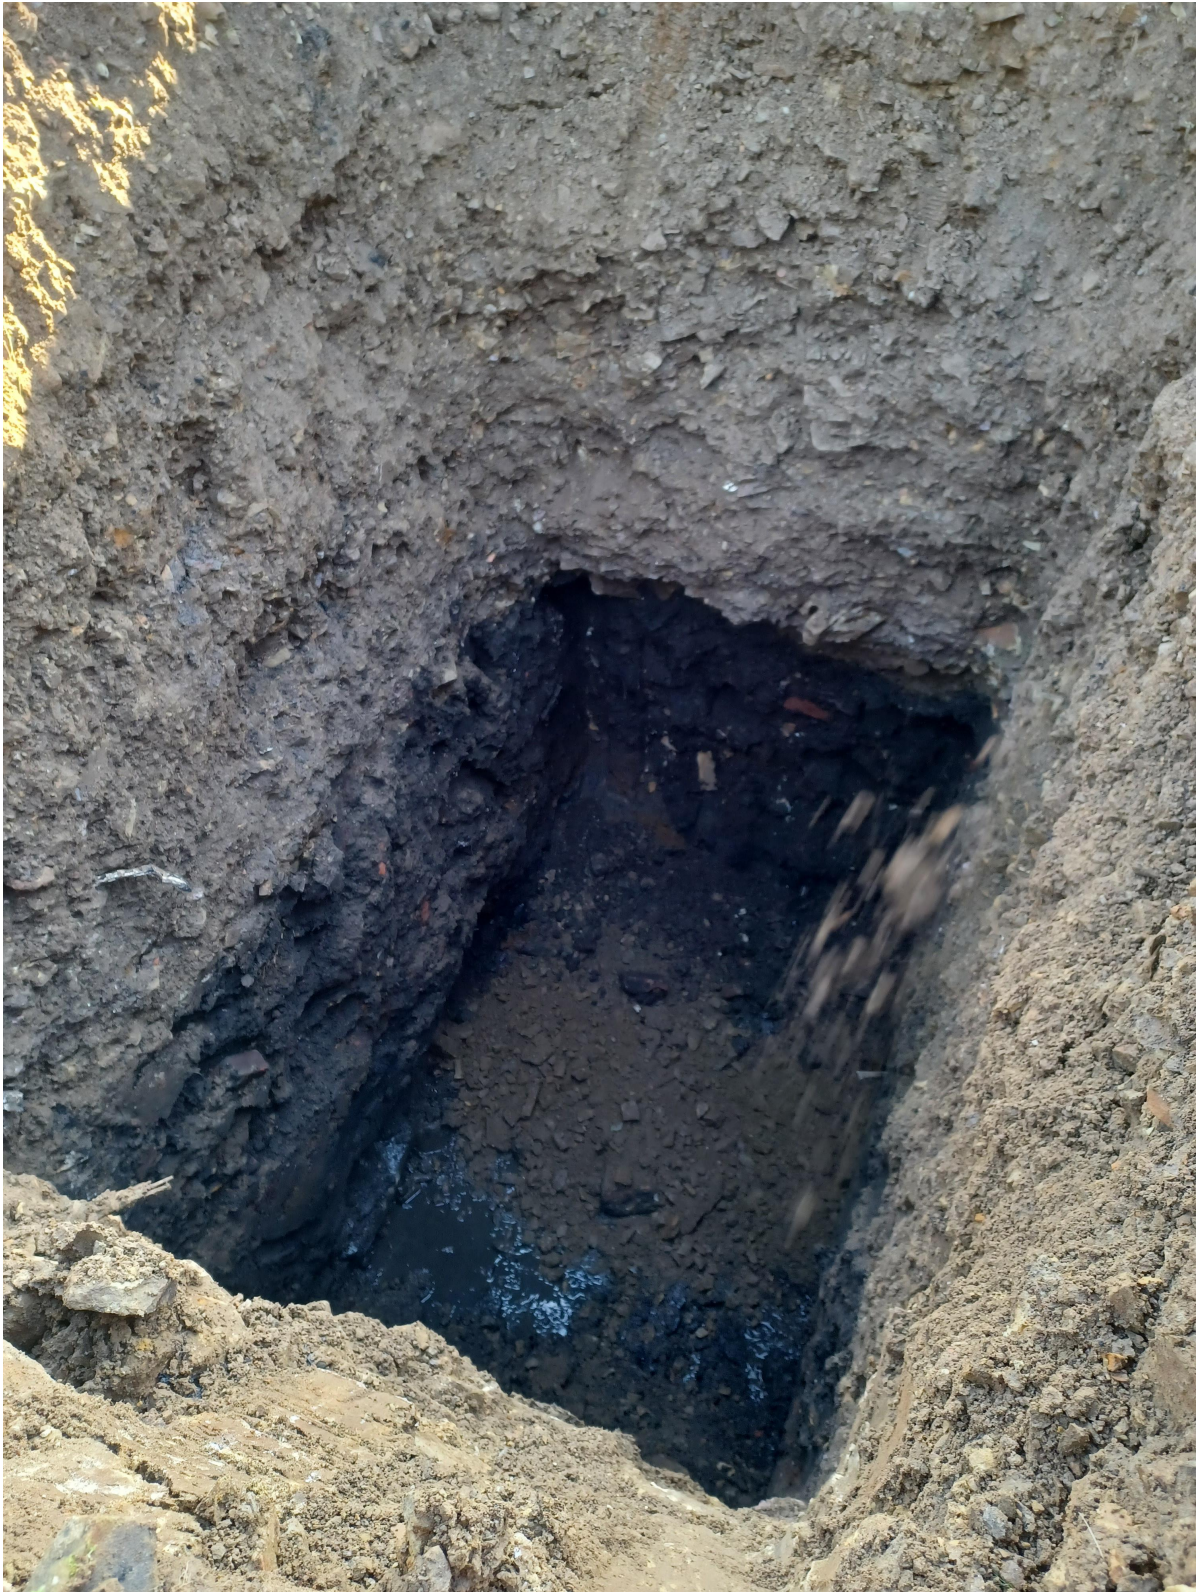
| <b>Remarks</b><br>PURPOSE: Targeting the northern portion of the Site and former reservoir. TERMINATION: Practical refusal of 36 tonne excavator with toothed bucket on intact bedrock. GROUNDWATER: East to west basal flows. STABILITY: Spalling throughout depth. OTHER: Ash present within deeper fill but otherwise no evidence of potentially polluting or harmful material. LOCATION: Referenced using free-ware on Site. GL: Estimated off May 2021 topographical survey. | | | <b>Method, Plant, Stability, Dimensions</b><br>0.00 - 4.00m TP - Trial Pit 36 tonne tracked<br>Unstable<br>L = 2.80m<br><div><div></div>W = 1.20m</div> | | |

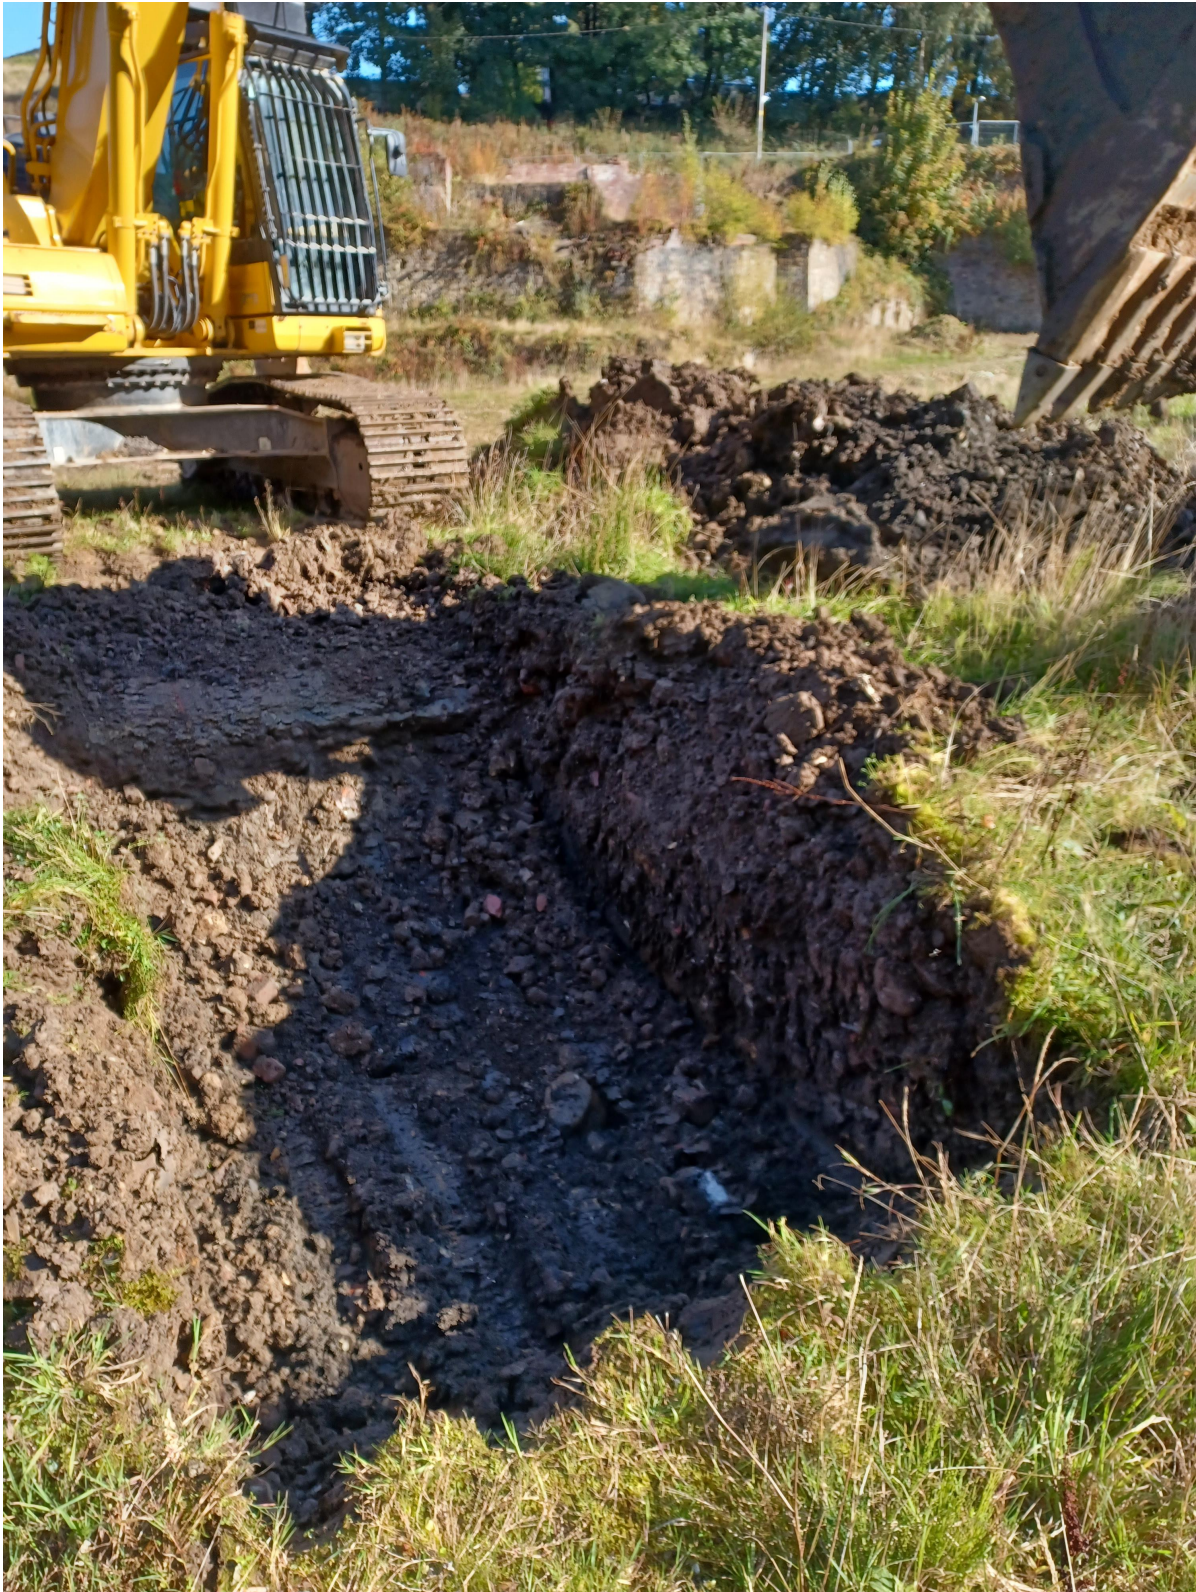
| <b>Remarks</b><br>PURPOSE: Targeting the western portion of the Site and the location of the highest recorded concentration of PFOA (borehole M4). TERMINATION: Practical refusal of 36 tonne excavator with toothed bucket on intact bedrock. GROUNDWATER: East to west basal flows. STABILITY: Sidewall collapse throughout depth. OTHER: Ash present within fill but otherwise no evidence of potentially polluting or harmful material. OTHER: Suspected breccia / fault zone - continuous collapse of side-walls limited further excavation/inspection. LOCATION: Referenced using free-ware on Site. GL: Estimated off May 2021 topographical survey. | | | <b>Method, Plant, Stability, Dimensions</b><br>0.00 - 2.30m TP - Trial Pit 36 tonne tracked<br>Unstable<br>L = 2.80m<br>W = 1.20m | | |
