## Controlled Waters Risk Assessment

Sladen Mill, Littleborough

| Project Number | 20403 |
| Report Number | 001 |

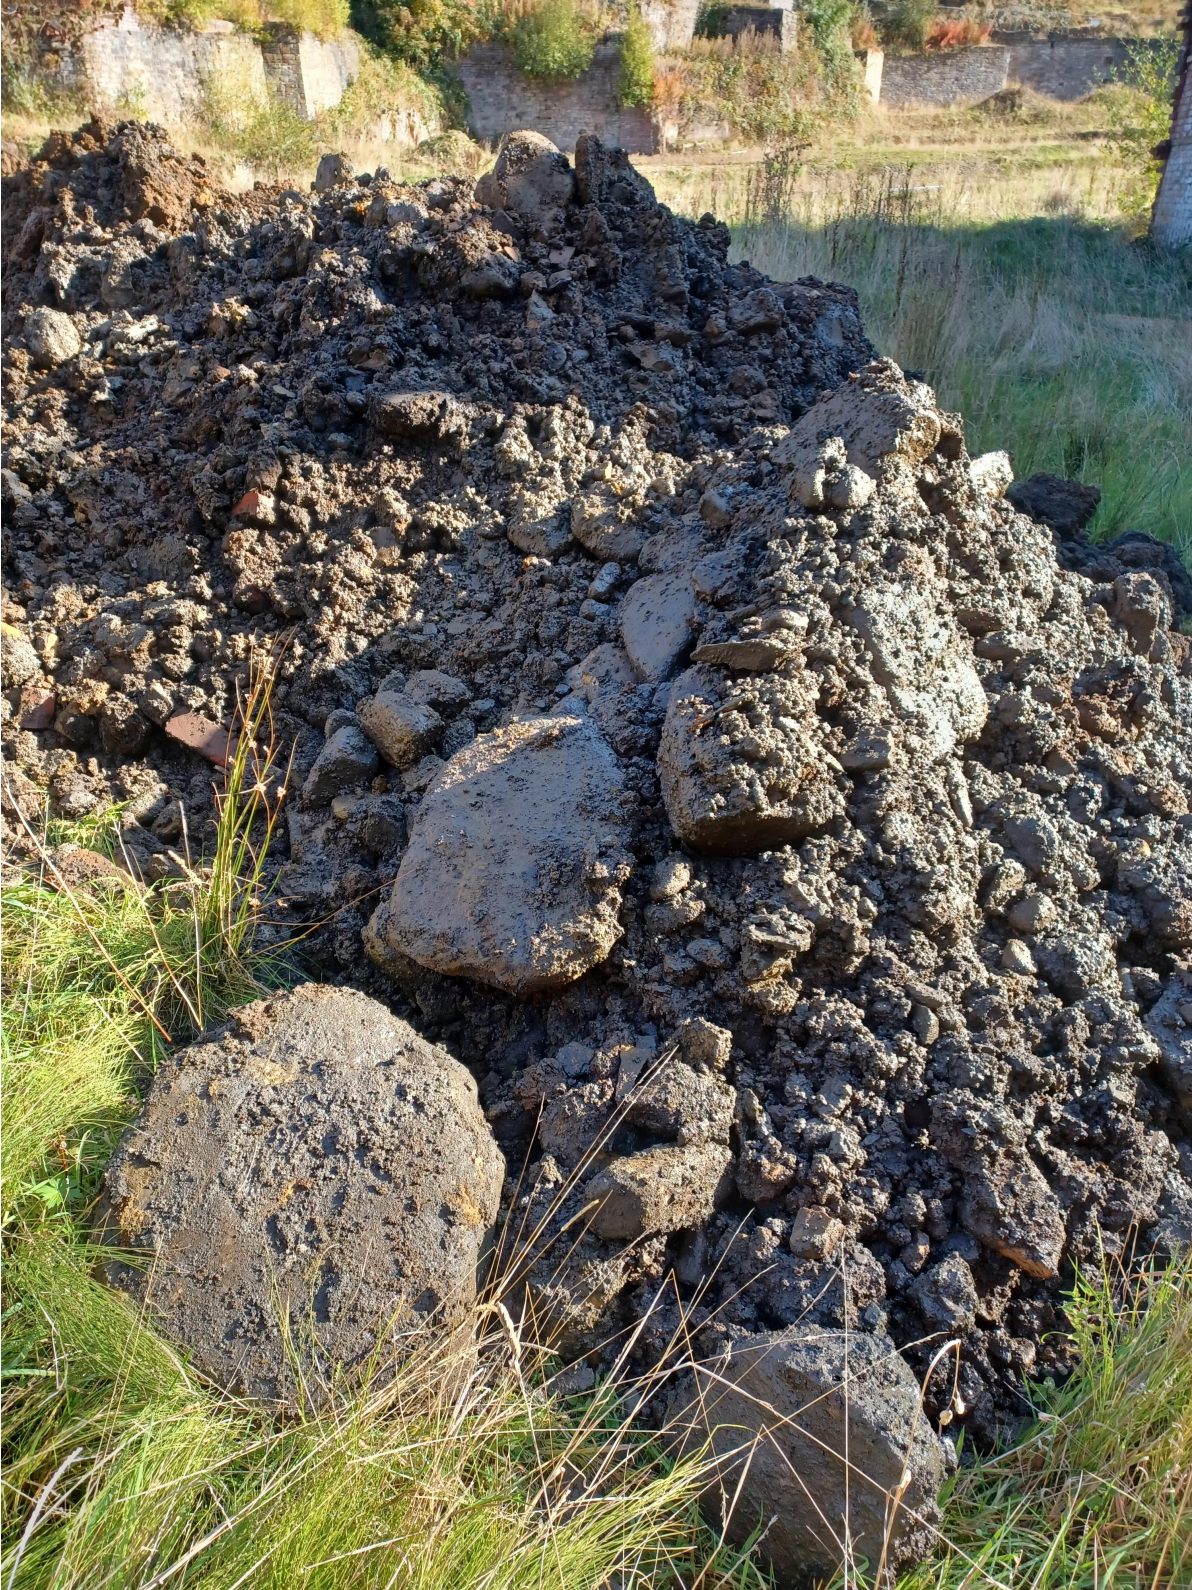
| <b>Remarks</b><br>PURPOSE: Targeting the western portion of the Site and the location of the highest recorded concentration of PFOA (borehole M4). TERMINATION: Practical refusal of 36 tonne excavator with toothed bucket on intact bedrock. GROUNDWATER: East to west basal flows. STABILITY: Sidewall collapse throughout depth. OTHER: Ash present within fill but otherwise no evidence of potentially polluting or harmful material. OTHER: Suspected breccia / fault zone - continuous collapse of side-walls limited further excavation/inspection. LOCATION: Referenced using free-ware on Site. GL: Estimated off May 2021 topographical survey. | | | <b>Method, Plant, Stability, Dimensions</b><br>0.00 - 2.30m TP - Trial Pit 36 tonne tracked<br>Unstable<br>L = 2.80m<br>W = 1.20m | | |

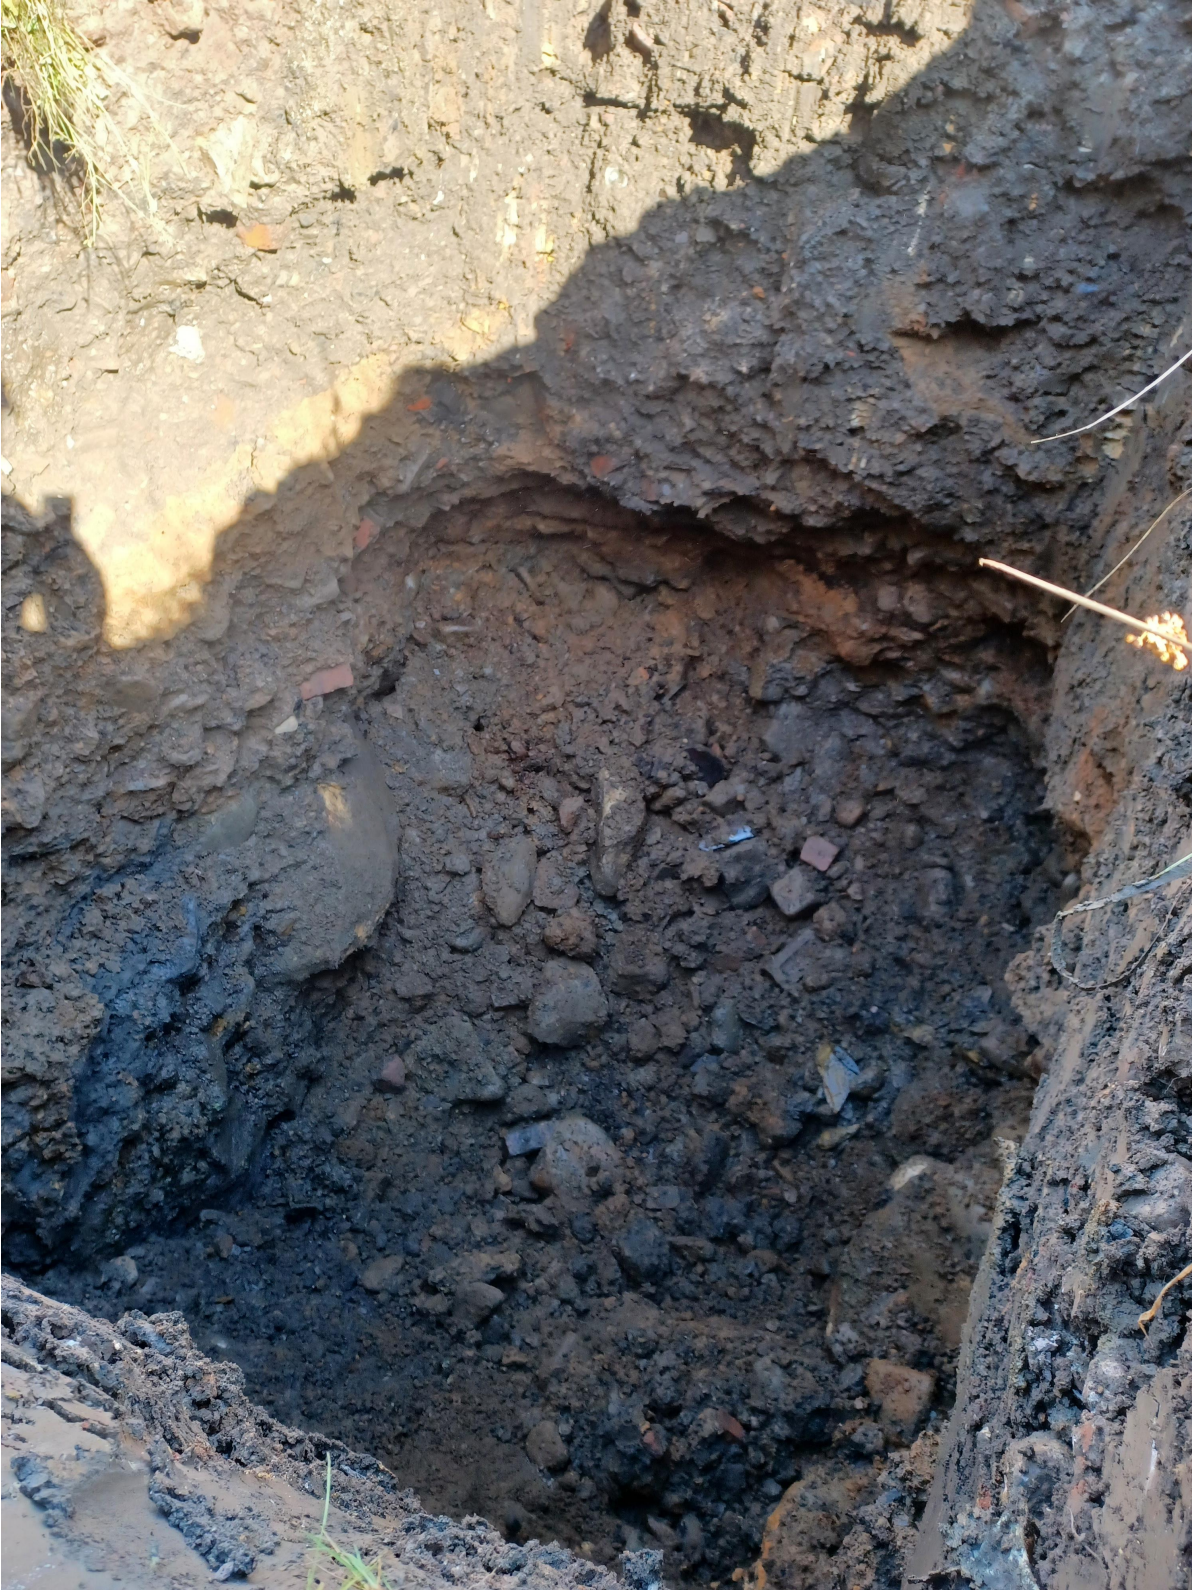
| <b>Remarks</b><br>PURPOSE: Targeting the western portion of the Site and the location of the highest recorded concentration of PFOA (borehole M4). TERMINATION: Practical refusal of 36 tonne excavator with toothed bucket on intact bedrock. GROUNDWATER: East to west basal flows. STABILITY: Sidewall collapse throughout depth. OTHER: Ash present within fill but otherwise no evidence of potentially polluting or harmful material. OTHER: Suspected breccia / fault zone - continuous collapse of side-walls limited further excavation/inspection. LOCATION: Referenced using free-ware on Site. GL: Estimated off May 2021 topographical survey. | | | <b>Method, Plant, Stability, Dimensions</b><br>0.00 - 2.30m TP - Trial Pit 36 tonne tracked<br>Unstable<br>L = 2.80m<br>W = 1.20m | | |

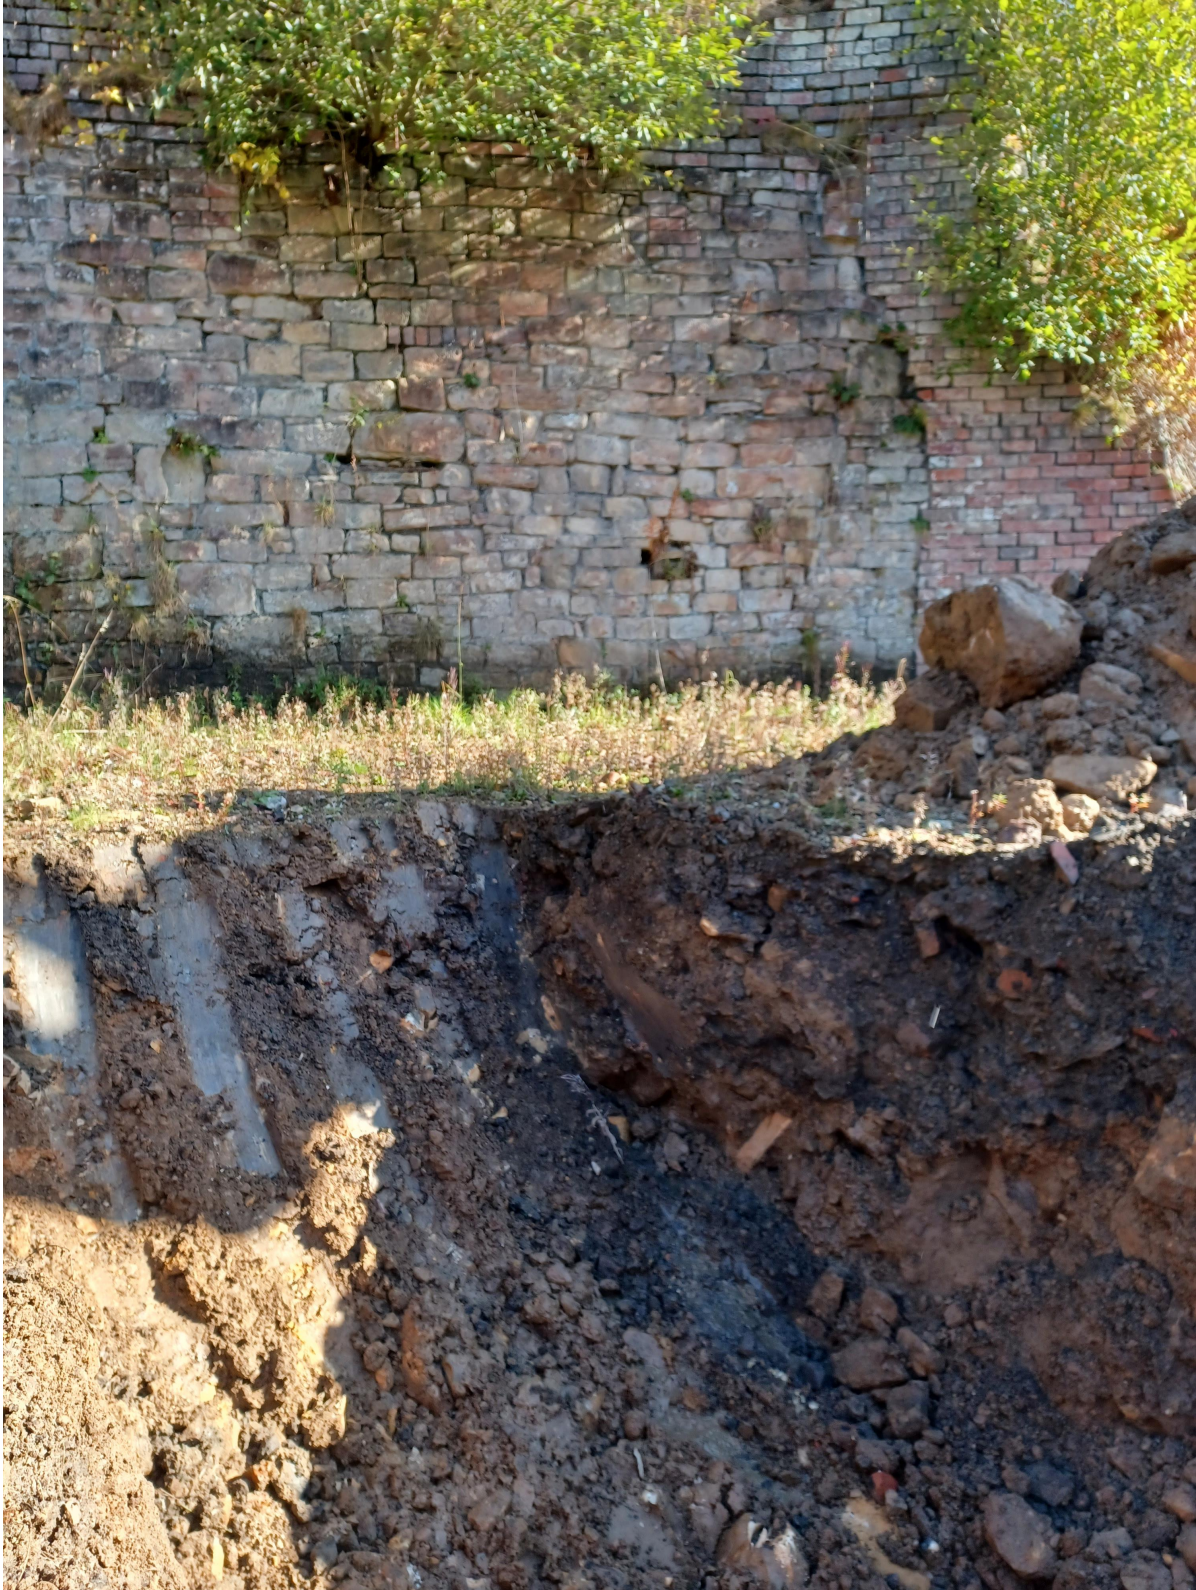
| <b>Remarks</b><br>PURPOSE: Targeting the eastern portion of the Site and the ground locally to Spring 1. TERMINATION: Practical refusal of 36 tonne excavator with toothed bucket on intact bedrock. GROUNDWATER: East to west basal flows. STABILITY: Spalling throughout depth. OTHER: No evidence of potentially polluting or harmful material. LOCATION: Referenced using free-ware on Site. GL: Estimated off May 2021 topographical survey. | | | | <b>Method, Plant, Stability, Dimensions</b><br>0.00 - 1.25m TP - Trial Pit 36 tonne tracked<br>Unstable<br>L = 2.20m<br>W = 1.20m | |

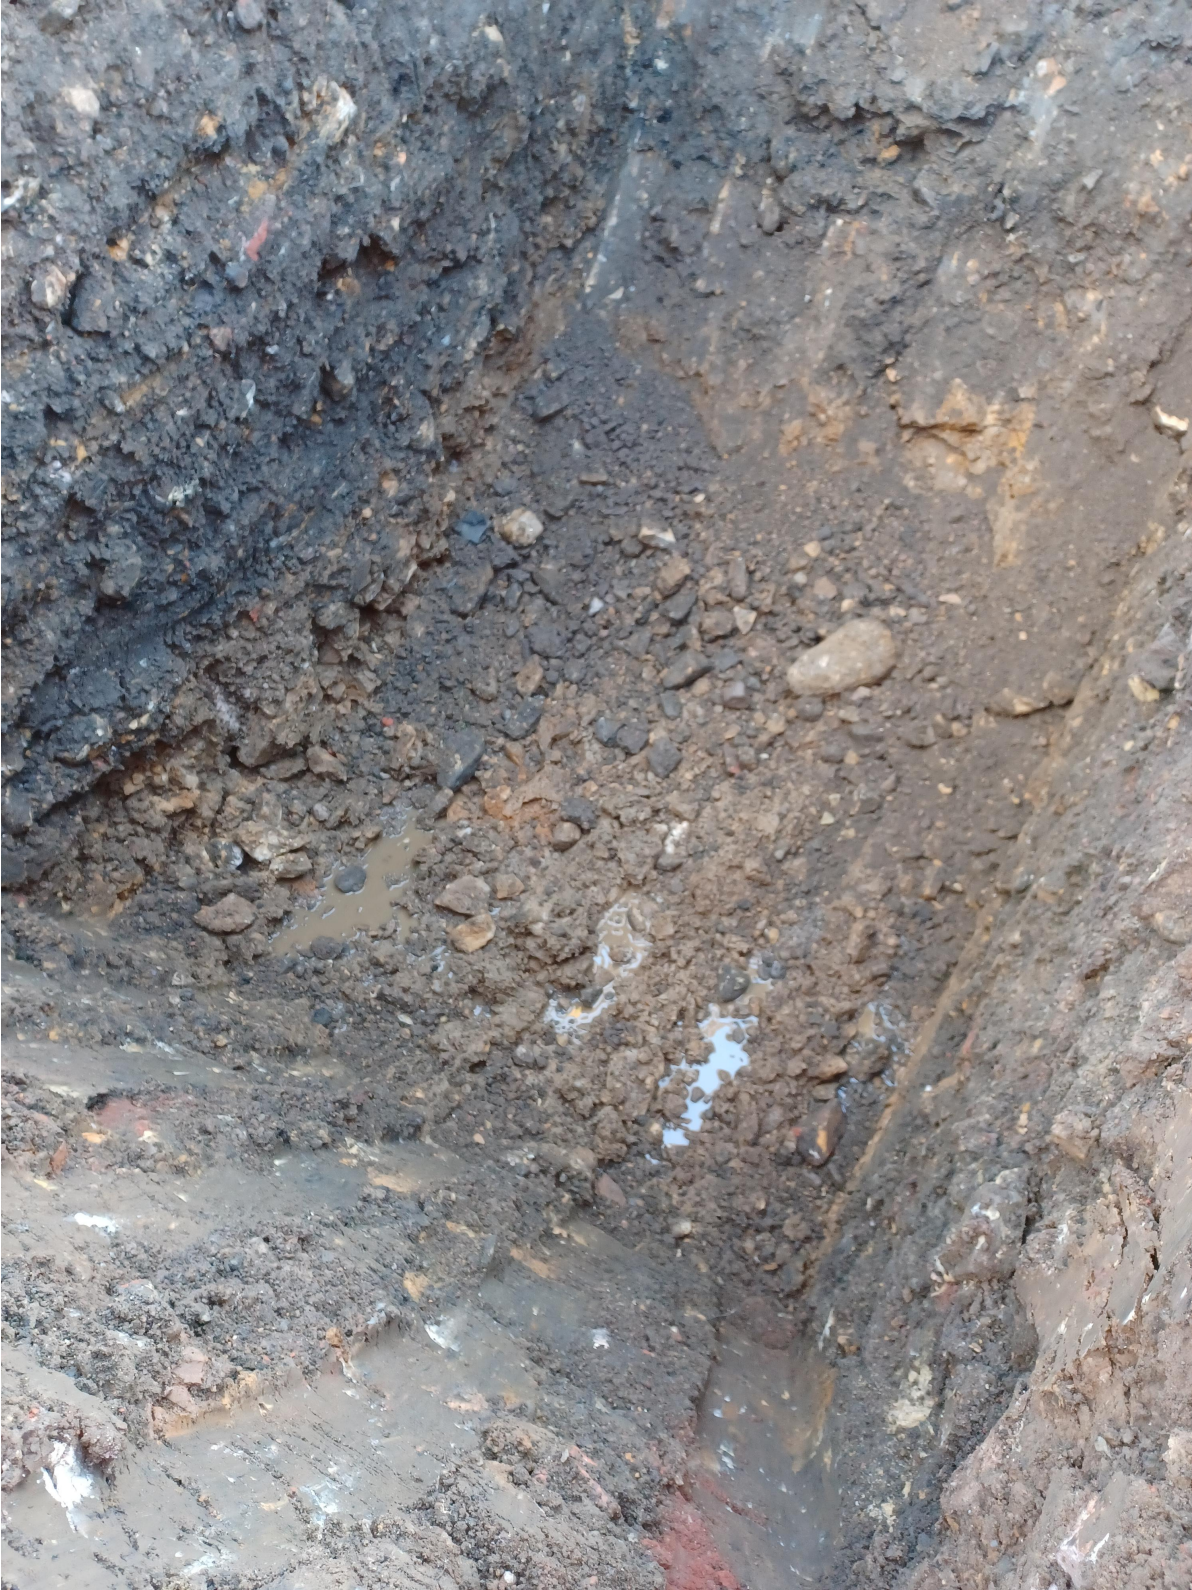
| <b>Remarks</b><br>PURPOSE: Targeting the southern portion of the Site and former reservoir. TERMINATION: Practical refusal of 36 tonne excavator with toothed bucket on intact bedrock. GROUNDWATER: East to west basal flows. STABILITY: Spalling throughout depth. OTHER: No evidence of potentially polluting or harmful material. LOCATION: Referenced using free-ware on Site. GL: Estimated off May 2021 topographical survey - TREAT WITH CAUTION - level changes across this portion of the Site. | | | | <b>Method, Plant, Stability, Dimensions</b><br>0.00 - 2.60m TP - Trial Pit 36 tonne tracked<br>Unstable<br>L = 2.60m<br>W = 1.20m | |

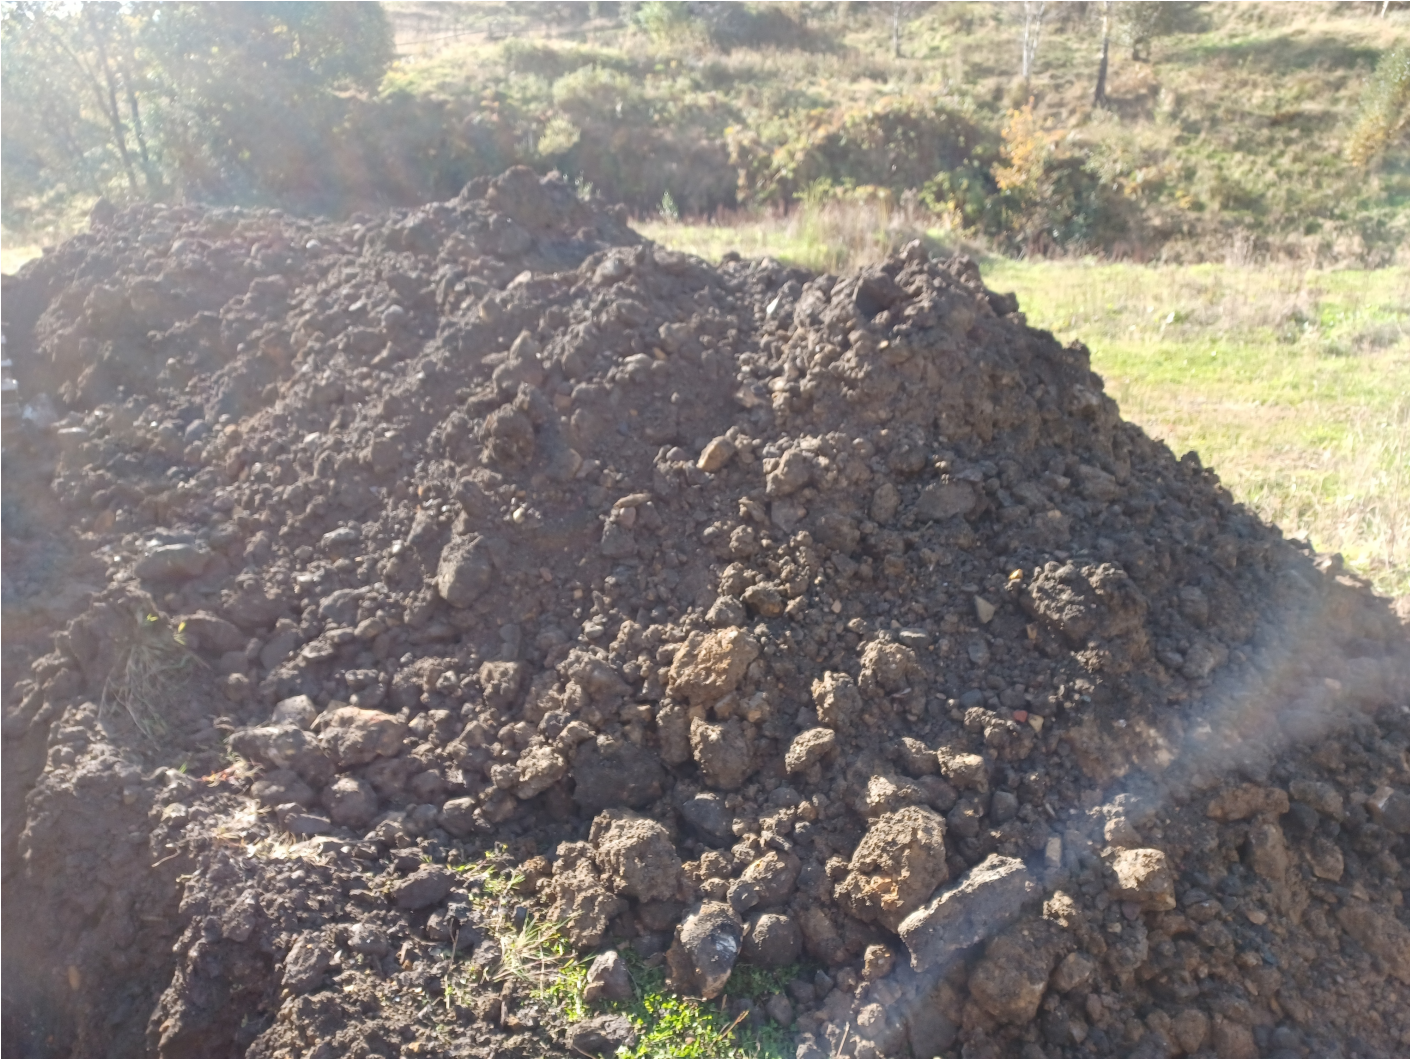
| <b>Remarks</b><br>PURPOSE: Targeting the southern portion of the Site and former reservoir. TERMINATION: Practical refusal of 36 tonne excavator with toothed bucket on intact bedrock. GROUNDWATER: East to west basal flows. STABILITY: Spalling throughout depth. OTHER: No evidence of potentially polluting or harmful material. LOCATION: Referenced using free-ware on Site. GL: Estimated off May 2021 topographical survey - TREAT WITH CAUTION - level changes across this portion of the Site. | | | | <b>Method, Plant, Stability, Dimensions</b><br>0.00 - 2.60m<br>Unstable<br>L = 2.60m<br>W = 1.20m | |

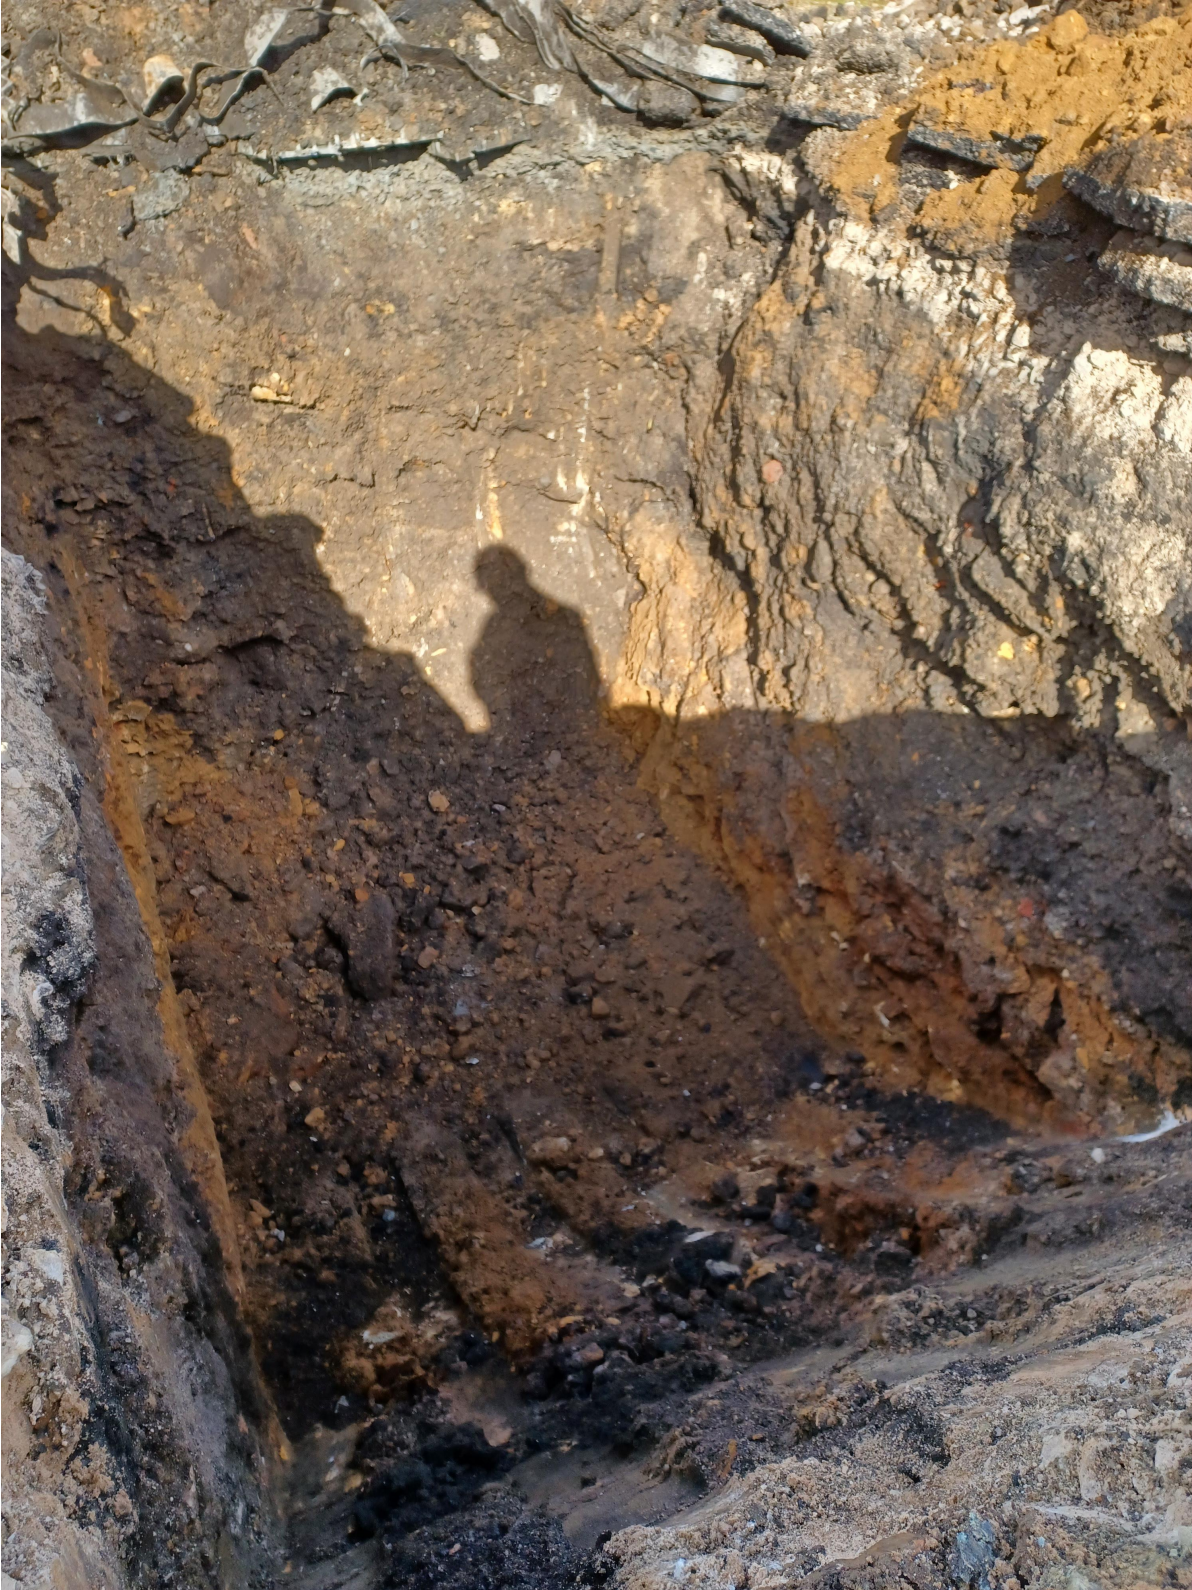
| <b>Remarks</b><br>PURPOSE: Targeting the upper portion of the Site. TERMINATION: Practical refusal of 36 tonne excavator with toothed bucket on intact bedrock. GROUNDWATER: None encountered. STABILITY: Localised spalling in the Made Ground. OTHER: Ash present within fill but otherwise no evidence of potentially polluting or harmful material. LOCATION: Referenced using free-ware on Site. GL: Estimated off May 2021 topographical survey. | | | | <b>Method, Plant, Stability, Dimensions</b><br>0.00 - 2.40m TP - Trial Pit 36 tonne tracked<br>Unstable<br>L = 2.60m<br>W = 1.20m | |

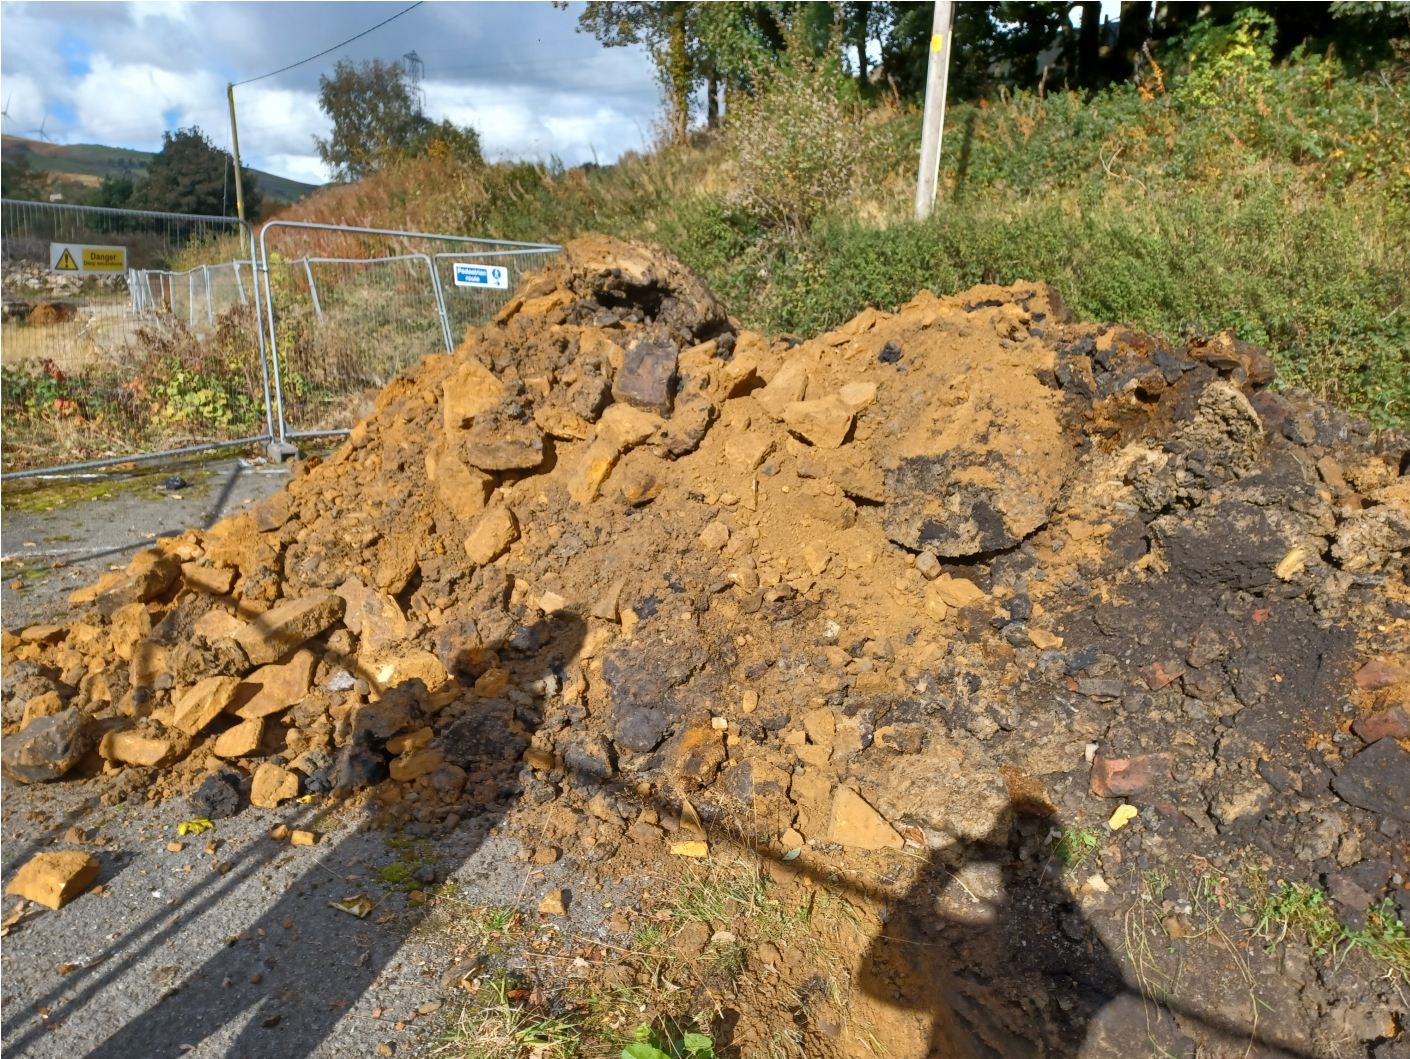
| <b>Remarks</b><br>PURPOSE: Targeting the upper portion of the Site, the former reservoir and ground up-gradient of Spring 1. TERMINATION: Practical refusal of 36 tonne excavator with toothed bucket on intact bedrock. GROUNDWATER: None encountered. STABILITY: Localised spalling in the Made Ground. OTHER: Ash present within fill but otherwise no evidence of potentially polluting or harmful material. LOCATION: Referenced using free-ware on Site. GL: Estimated off May 2021 topographical survey. | | | | <b>Method, Plant, Stability, Dimensions</b><br>0.00 - 2.90m TP - Trial Pit 36 tonne tracked<br>Unstable<br>L = 2.80m<br>W = 1.20m | |

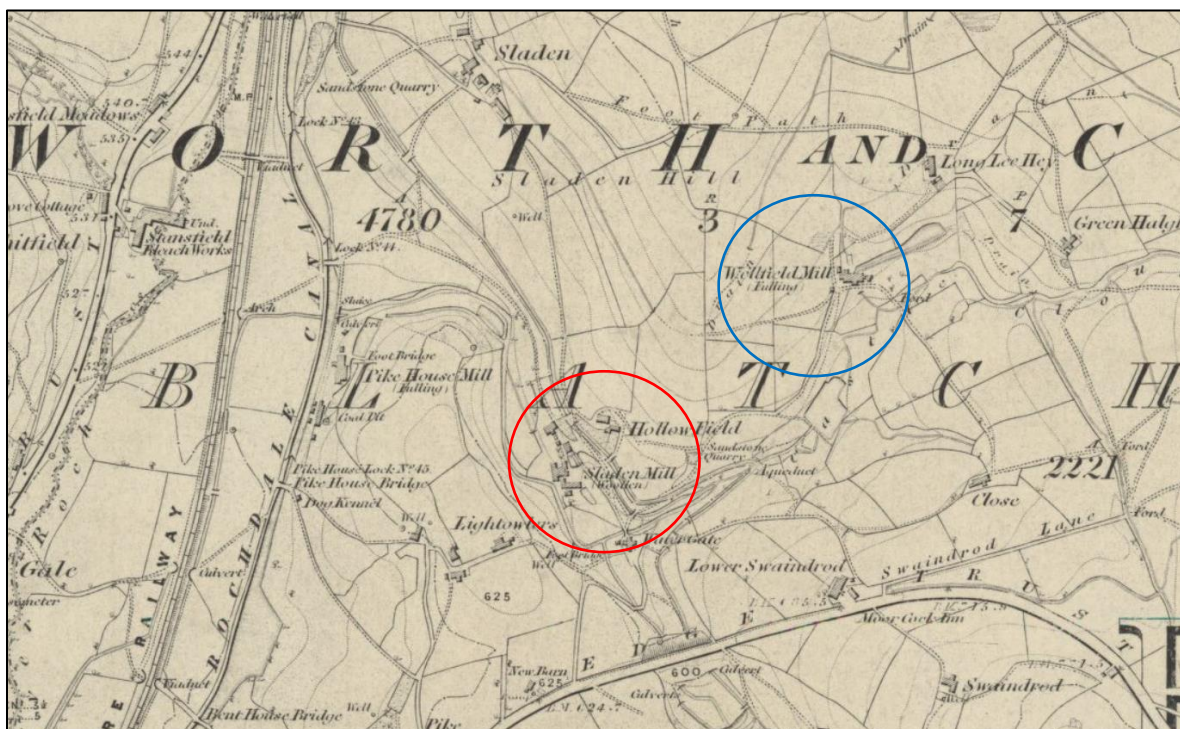
**Plate 1:** Sladen Mill on the Lancashire Map of 1851, indicated in red. Wellfield Mill indicated in blue. Reproduced with the permission of the National Library of Scotland (2024)

Situated 450m northeast of the Site is the location of the former Wellfield Mill. The earliest evidence of Wellfield Mill is shown on the Lancashire Map of 1851, where the site is labelled as a ‘fulling’ mill (Plate 1). As previously noted, Charles Kershaw operated the site under his own company name from c.1867 onwards (Seyd & Co. 1885-6). Twenty years after this event, the mill is referenced in Leuchs’ Directory as a ‘Fulling Mill’ under the ownership of Charles

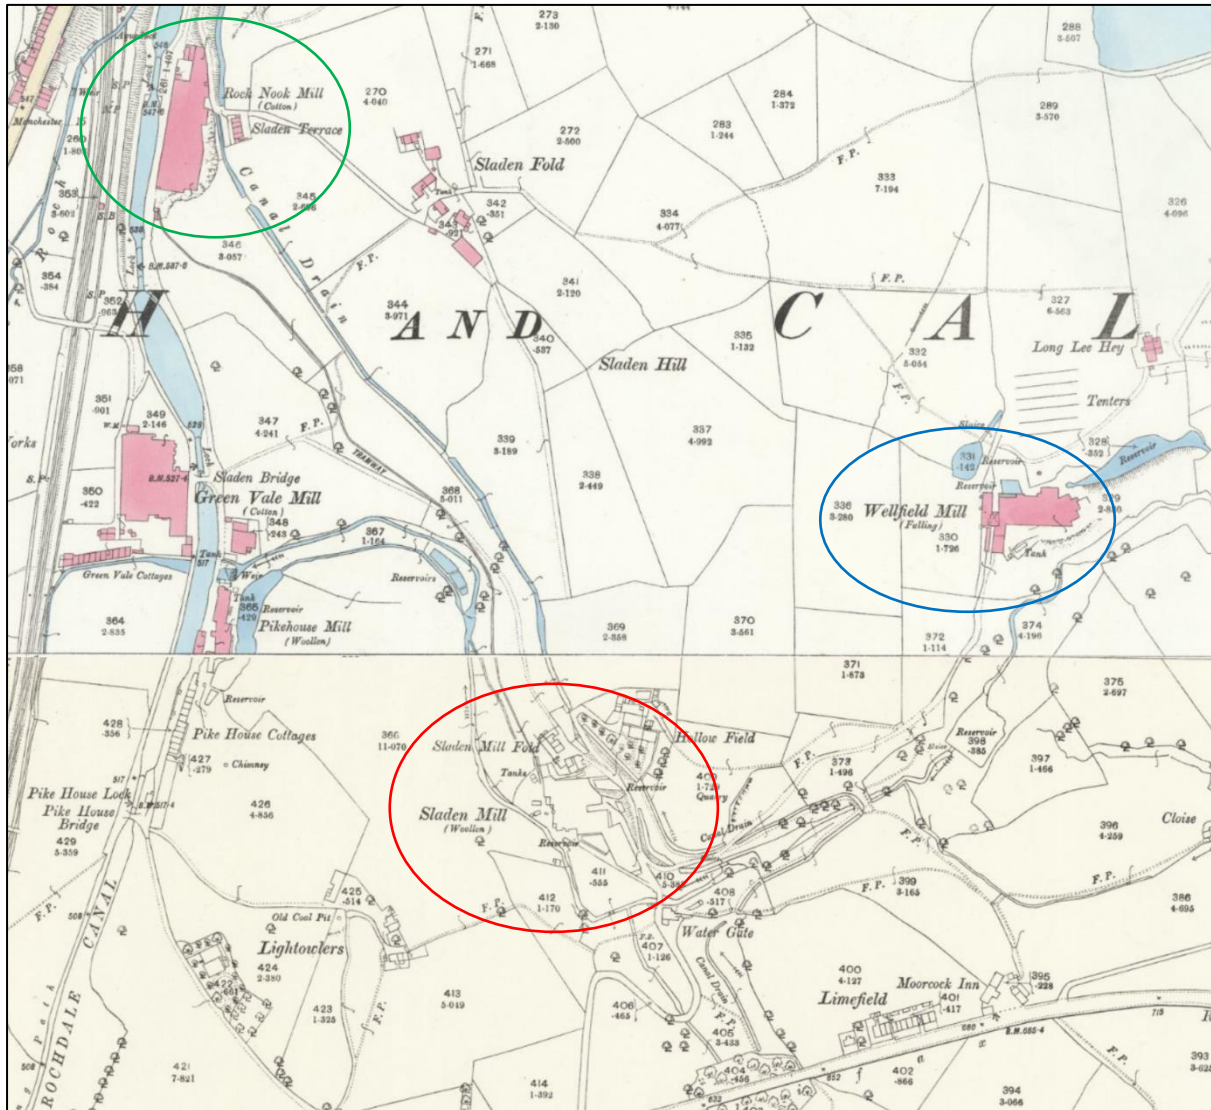
**Plate 2:** Sladen Mill on the First Edition OS Map of 1893, indicated in red. Wellfield Mill indicated in blue, and Rock Nook Mill in green. Reproduced with the permission of the National Library of Scotland (2024)

Cartographic sources can be used to show the development of the Site over time from the mid-19<sup>th</sup> century to the mid-20<sup>th</sup> century. In Lancashire map of 1851, the mill is depicted as a series of buildings in an irregular form, adjacent to a watercourse to the south (identifiable as Lydgate Brook / Lydgate Clough / Red Brook) and a canal drain to the north (Plate 1). Lydgate Brook is marked on the first edition OS map of 1893 with arrows pointing to indicate the direction of flow, marked as flowing downstream from south to north. This watercourse meanders from south towards the Site, around the Site heading north, then travelling west to pass underneath the Rochdale Canal via a weir. This course is largely unchanged and is still visible as an earthwork today (Google Earth 2024). The canal drain to the north of the Site appears to be shown extending from Wellfield Mill and heading south towards the Site, then

meandering northwest towards Rock Nook Mill (Plate 2). It is noted that the drain was constructed to transport water from surrounding reservoirs such as Hollingbrook Lake, located 2.5km south of the Site, to infill the Rochdale Canal (MBA Ltd 2020). The OS map of 1911 depicts the direction of water flow of the canal drain indicated by an arrow pointing northwest, adjacent to Rock Nook Mill (Plate 3).

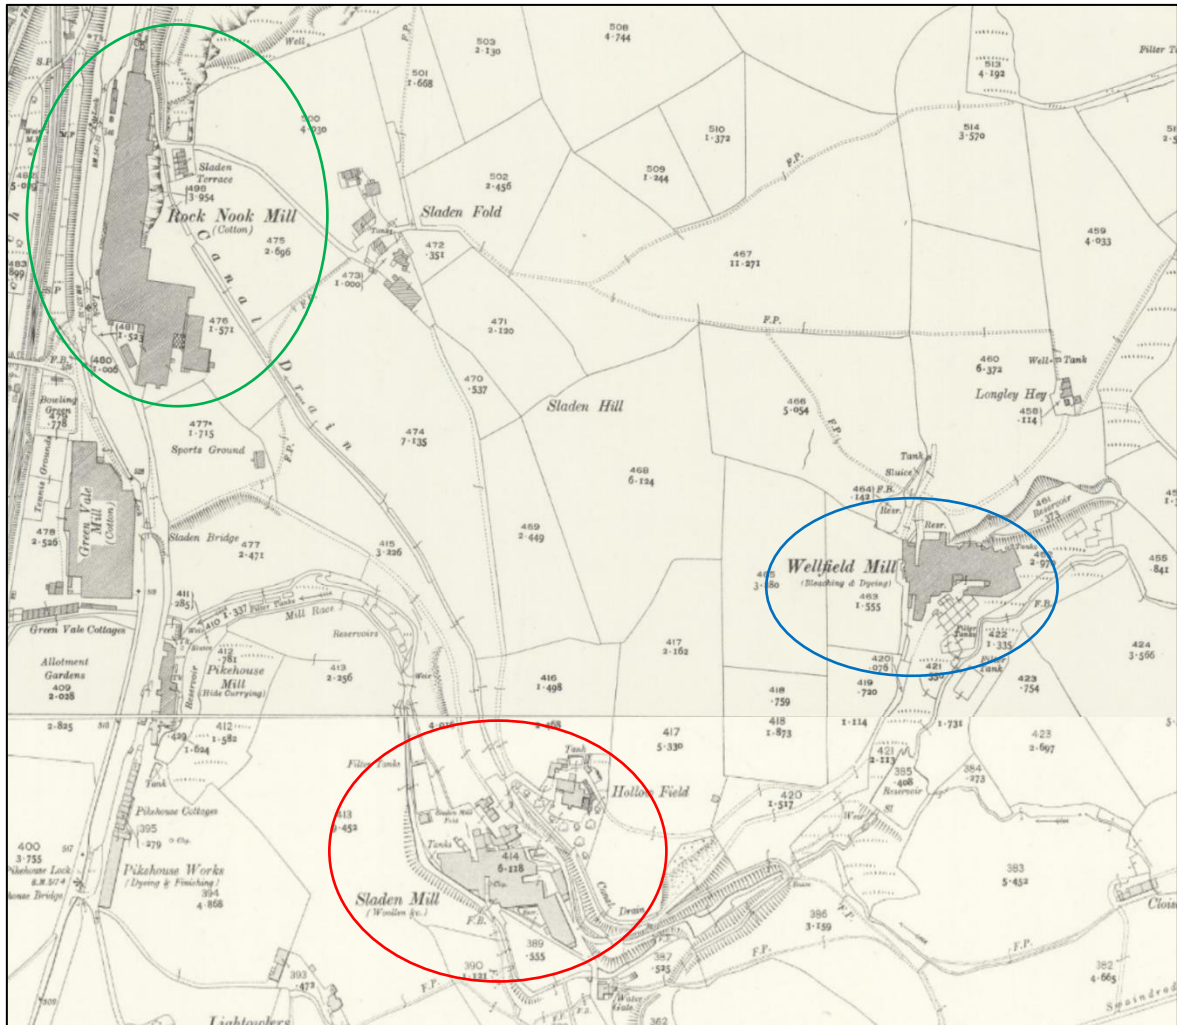
**Plate 4:** Sladen Mill depicted on the OS Map of 1930, indicated in red. Wellfield Mill indicated in blue, and Rock Nook Mill in green. Reproduced with the permission of the National Library of Scotland (2024)

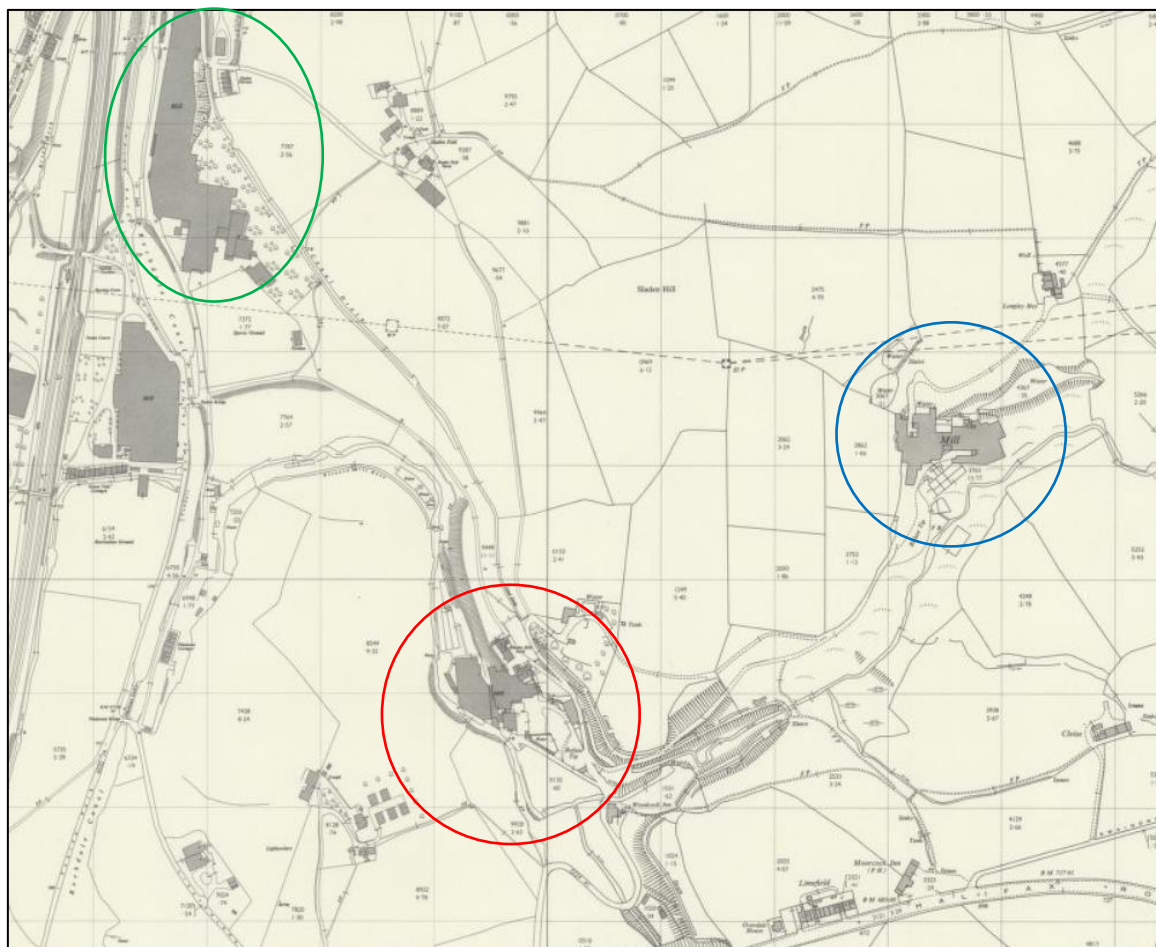
**Plate 5:** Sladen Mill on the OS Plan of 1963, indicated in red. Wellfield Mill indicated in blue, and Rock Nook Mill in green. Reproduced with the permission of the National Library of Scotland (2024)
