# GEO-ENVIRONMENTAL AUDIT

PHASE 1 Preliminary Risk Assessment

PHASE 2 Site Investigation

PHASE 3 Remediation Statement

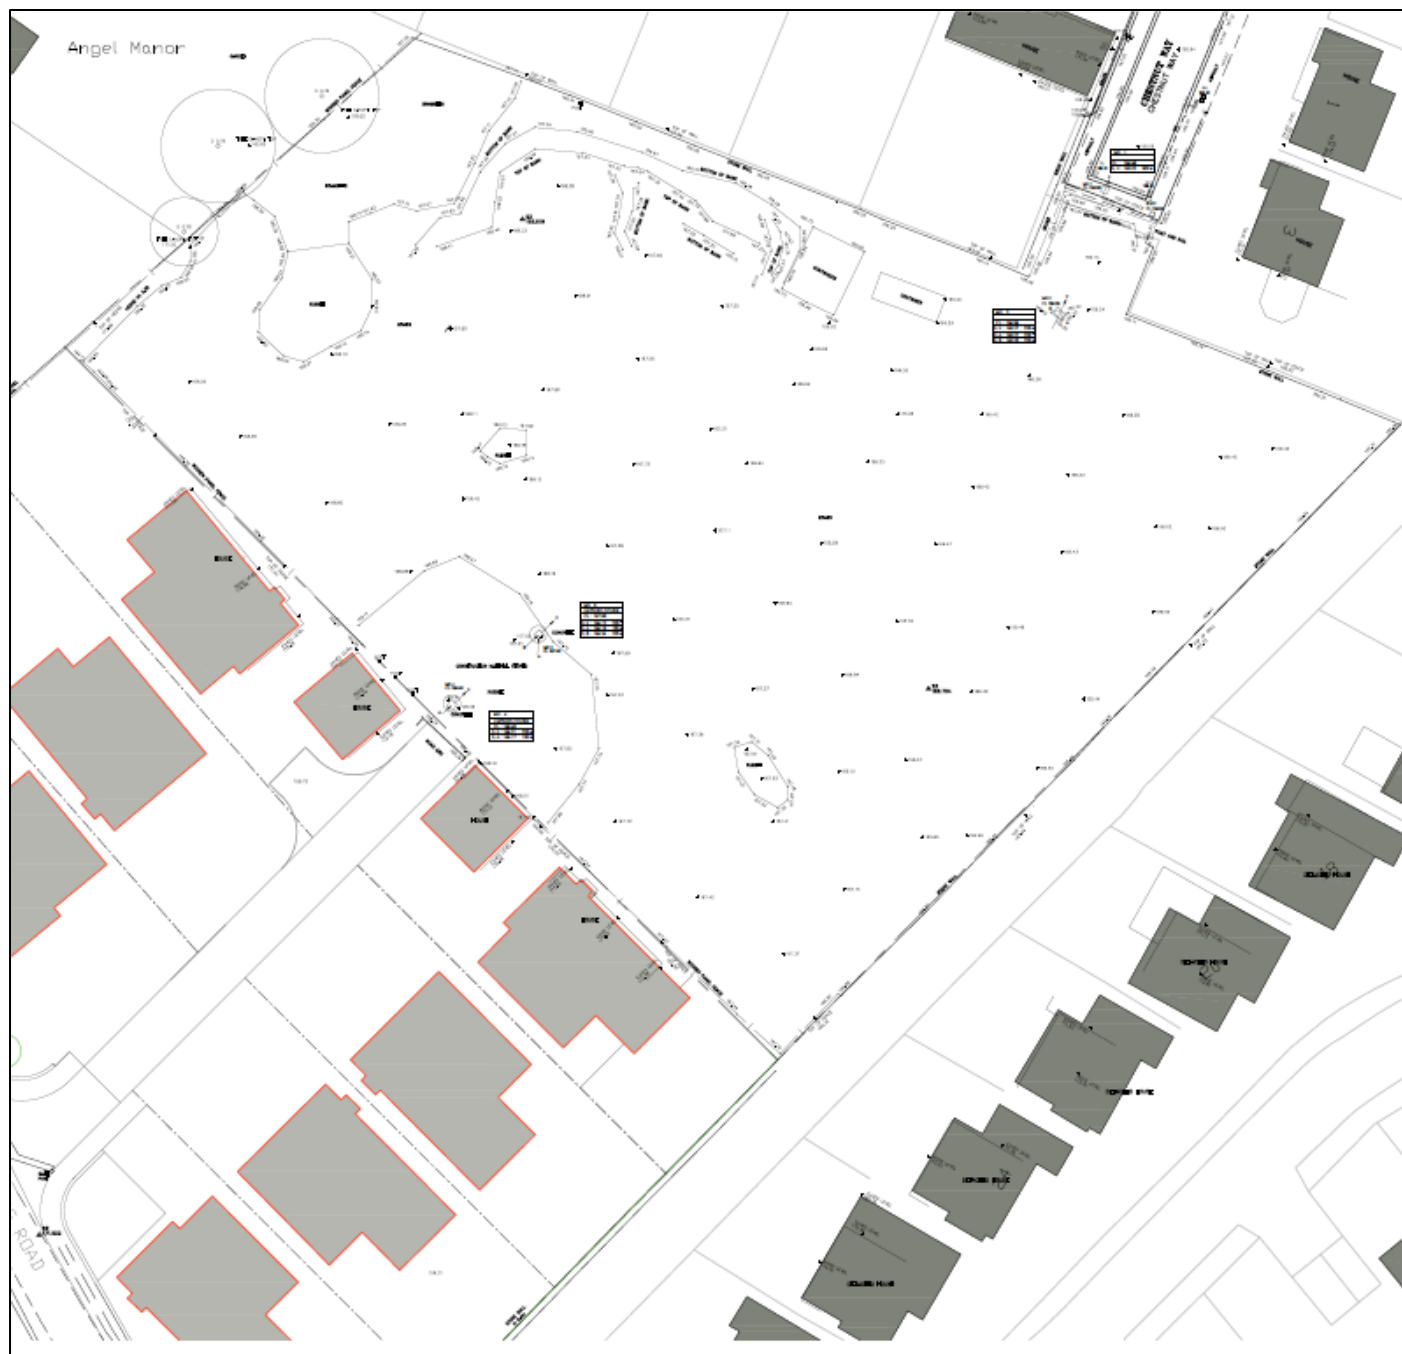
## 5.2. Existing Site Plan.

| Site Boundaries, Outlines of Structures and Buildings: | <p>The Application Site is currently vacant but was previously used to store soil stockpiles, as well as the building compounds to the Starring Road Development Site. It formerly comprised a grass field.</p> <p>The Application Site is bound by development to the NW, NE &amp; SE sides, with Starring Road to the SW. The mostly completed Starring Road Development Site now exists to the south west.</p> <p>The boundary of the Site is delineated by dry stone walls and timber fencing.</p> |
| Below Ground Obstructions: | There are 5No. manholes within the Site collecting foul and surface water from the Starring Road Development Site and flowing into Chestnut Way via a combined private sewer, and also from a private sewer to the north of the Site. |

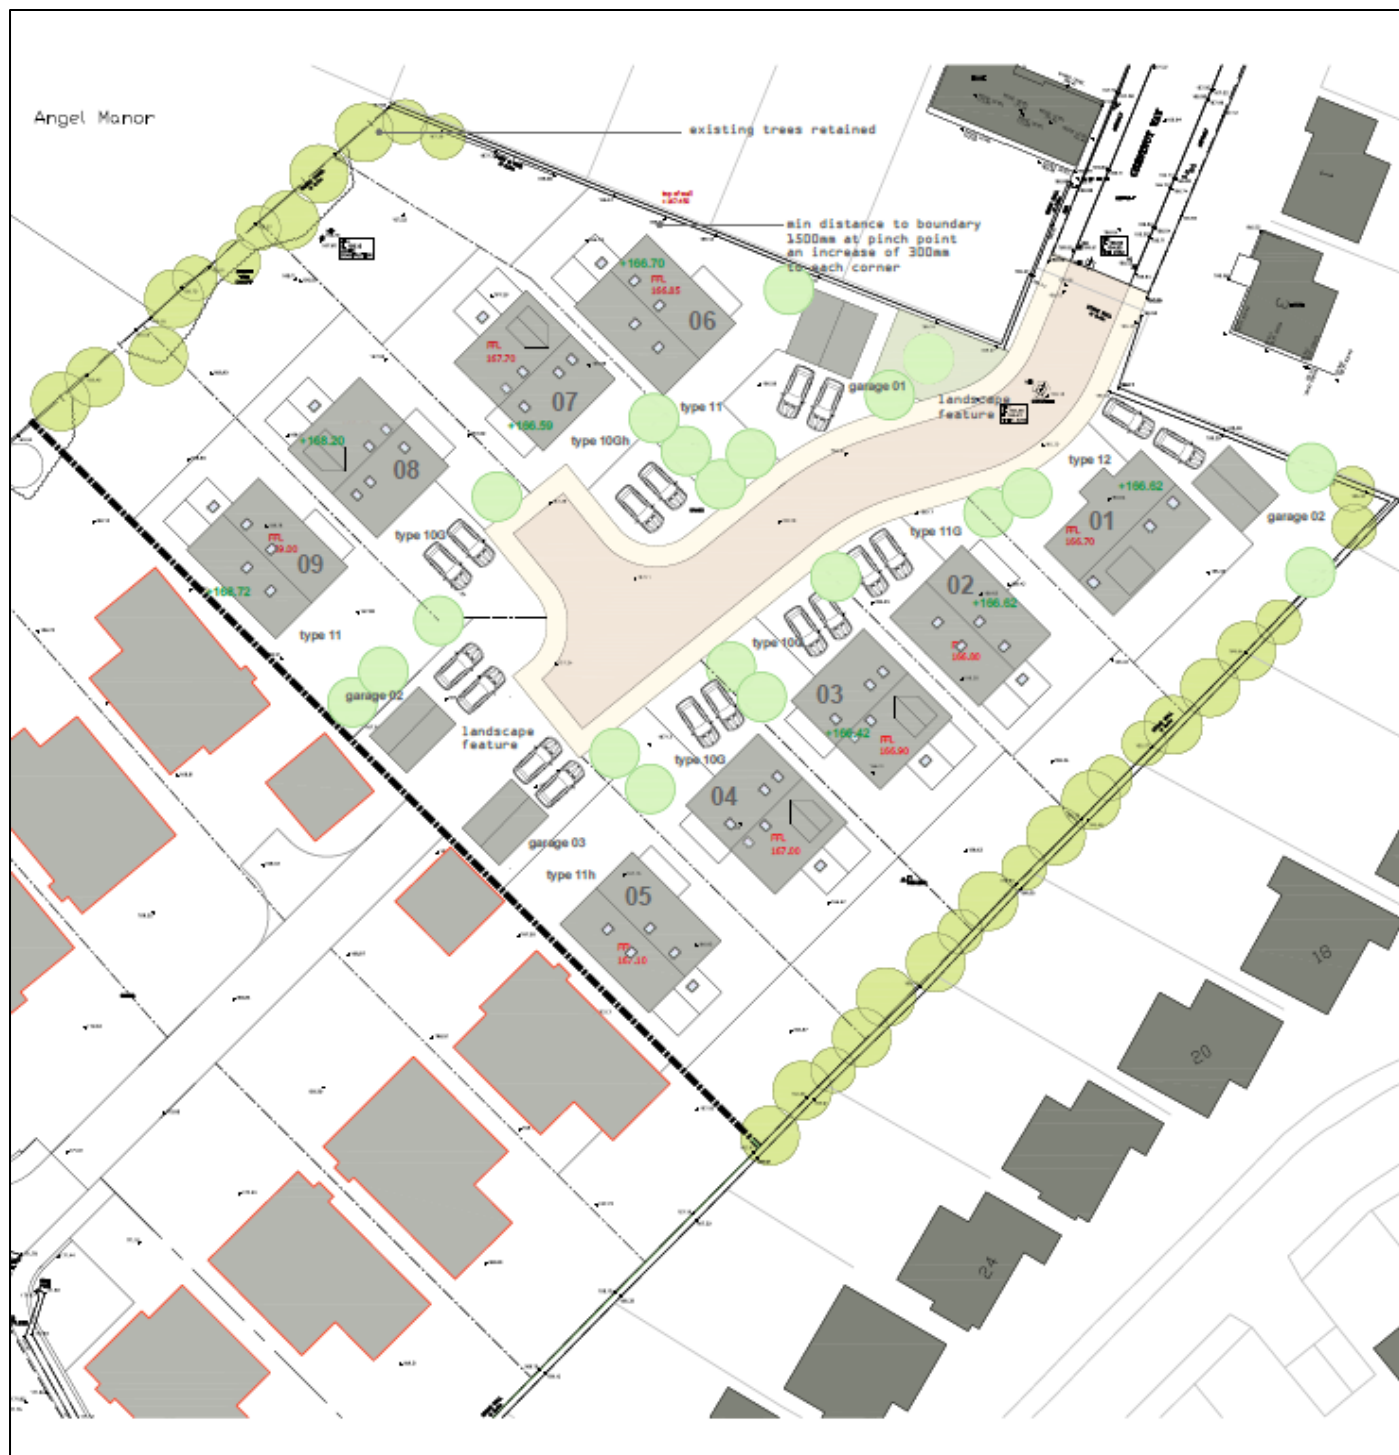
### 5.3. Proposed Site Plan.

The proposed development is for the erection of 9No. two-storey, detached residential dwellings.

The dwellings shall comprise individual plots with associated driveways, and front/rear soft landscaping/garden areas.

A new access road will run through the centre of the Site from Chestnut Way.

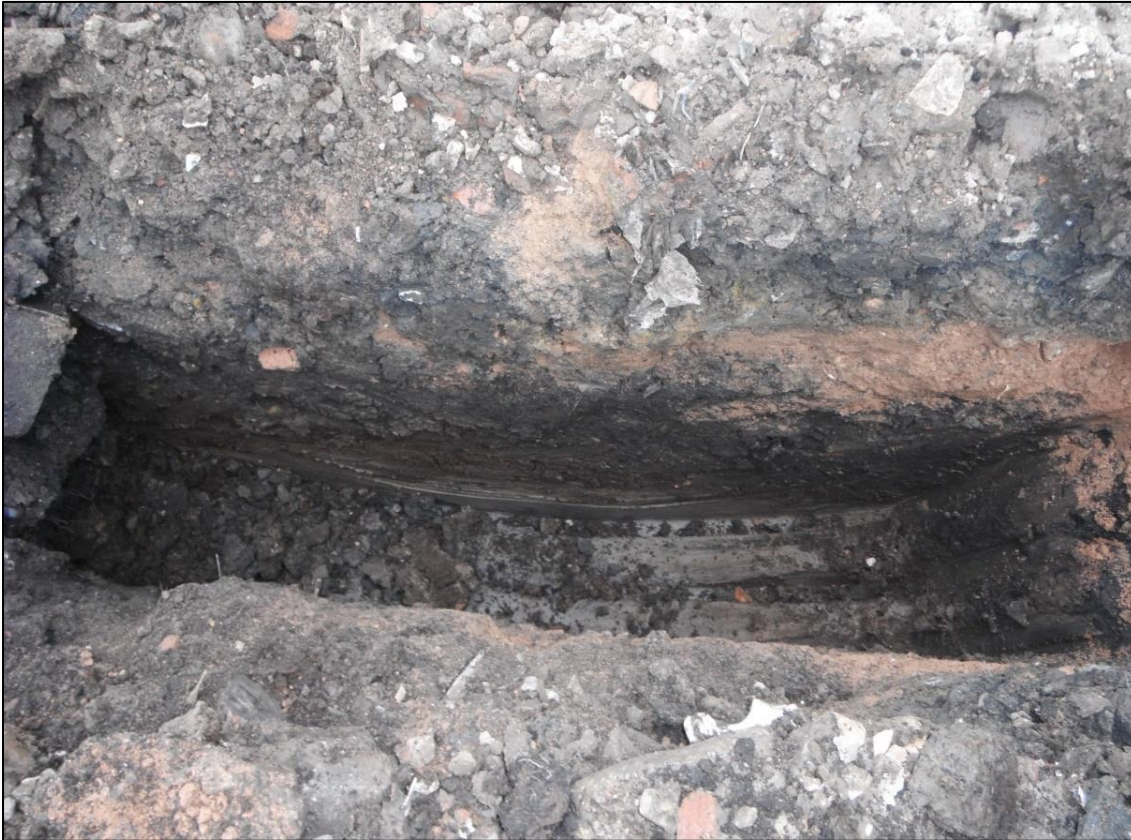
**Figure 5 – TH1**

##### **TH1 (GL 168.63m aOD)**

| 700-950 | Brown fibrous slightly spongy peaty soft CLAY. |

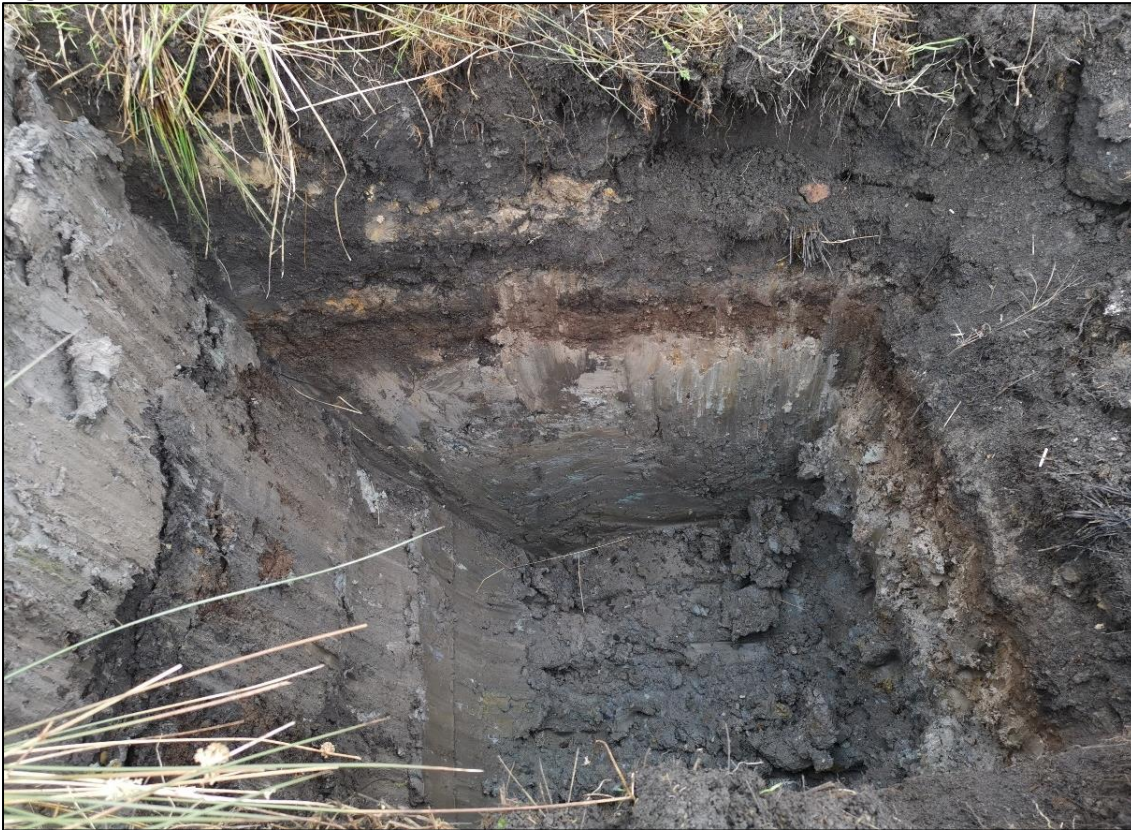
**Figure 6 – TH2**

##### **TH2 (GL 166.70m aOD)**

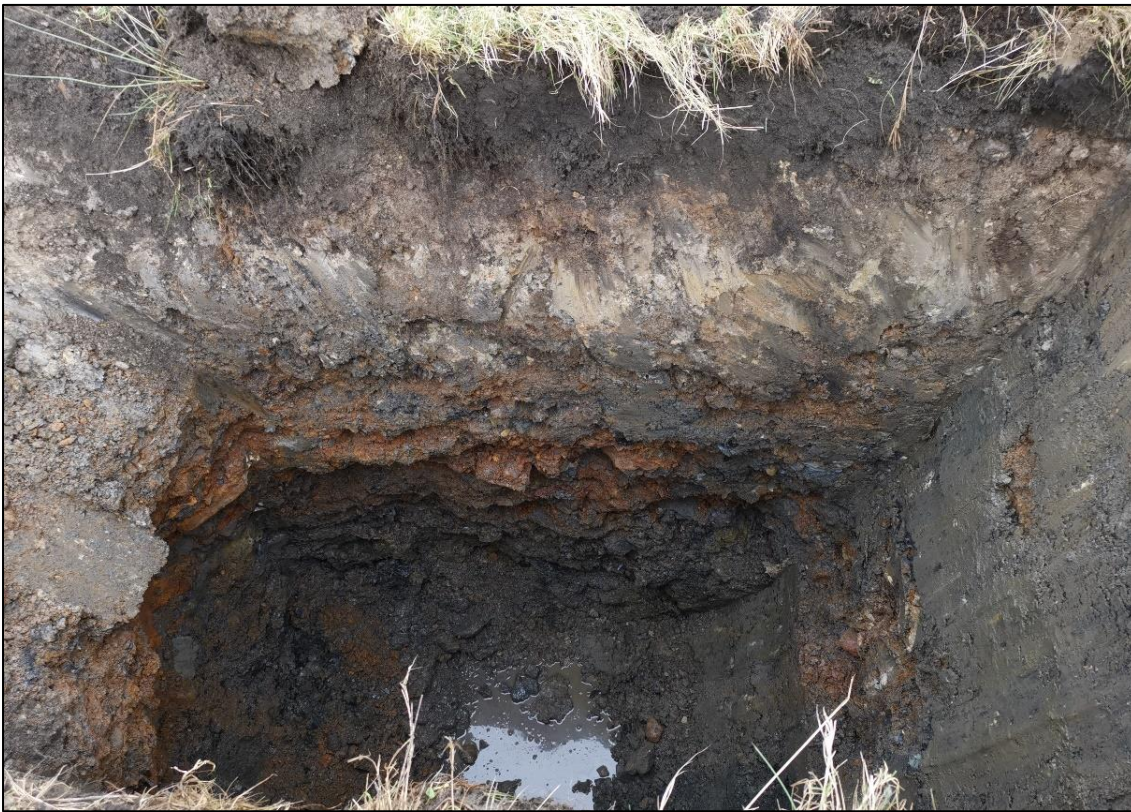
In THs 6 & 7, the area local to these trial holes only had been filled to with an angular gravel (shale) MADE GROUND, which was noted to a max depth of 3.1m (TH6).

**Figure 11 – TH6**

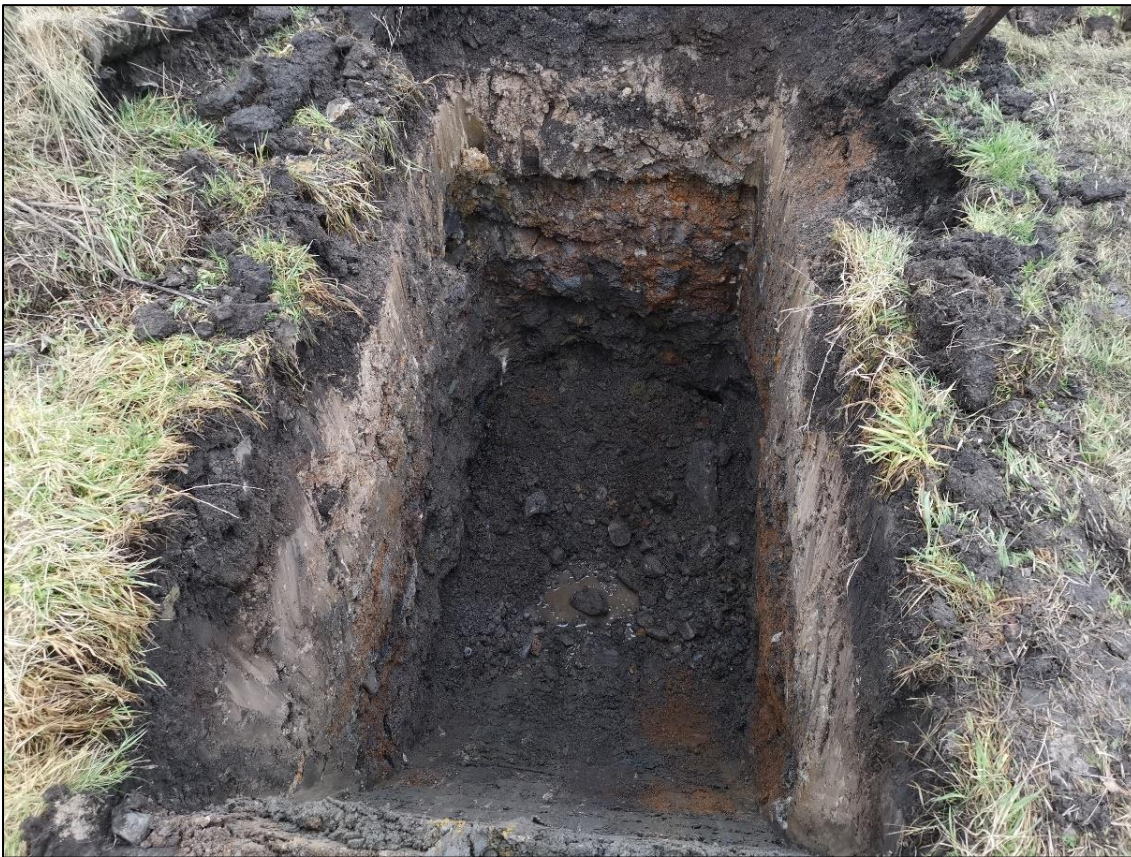
**Figure 12 – TH7**
