## **Appendix C: Public Rights of Way: Walk Over Survey**

Plan 5 - Public Right of Way Plan  
Proposal: Development within Northern Gateway JPA1.1  
Location: Bury, Manchester  
TT Job No.: 784-B048805

## Northern Gateway - JPA1.1 - PRow Walkover Survey Photographs

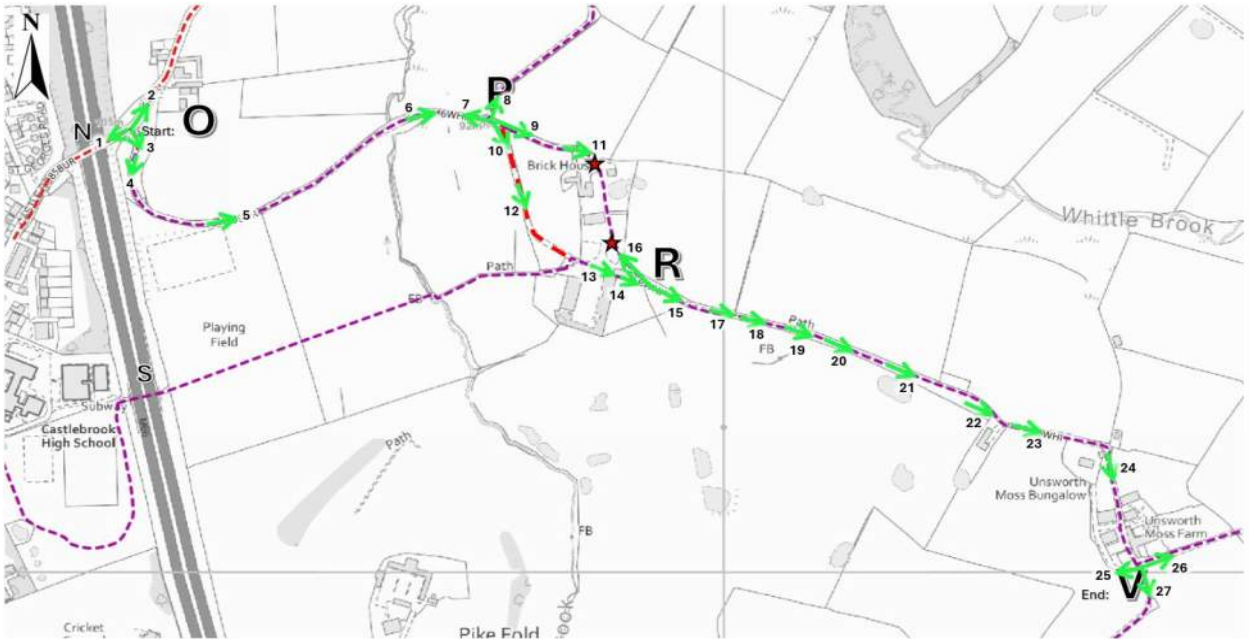
| | Section | RoW Status | Start Time | End Time | Walking Time (hh:mm) | Route Length (m) | Pedestrian Count on Walkover | Photo References | Footpath Intentionally Blocked | Hard Surfaced | Shared with Vehicles | Footpath Overgrown | Route Indistinct | Stiles/Gates in Disrepair | Signed as Private | Lit | Signposts / route arrows present |
|---|---|---|---|---|---|---|---|---|---|---|---|---|---|---|---|---|---|
| Subsection | Key Observations | Lane width average estimated at 3.5m. Only one car drove past during walkover of this section. | | | | | | 1 to 6 | N | Y | Y | N | N | n/a | Y | N | N |
| Subsection | Key Observations | Route diverted via red dashed line due to route being blocked at starred locations on the map (Brick house). The gate to the property was open on this occasion however on a previous occasion it was closed. There is no throughway at the property. | | | | | | 7 to 15 | Y | Y | Y | Y | Y | N | Y | N | Y |
| Subsection | Key Observations | Route is extremely overgrown and indistinct where it follows the boundary of golf course. It should be noted that path is overgrown with nettles & brambles making the footpath even less accessible. | | | | | | 16 to 27 | N | N | N | Y | Y | N | N | N | Y |

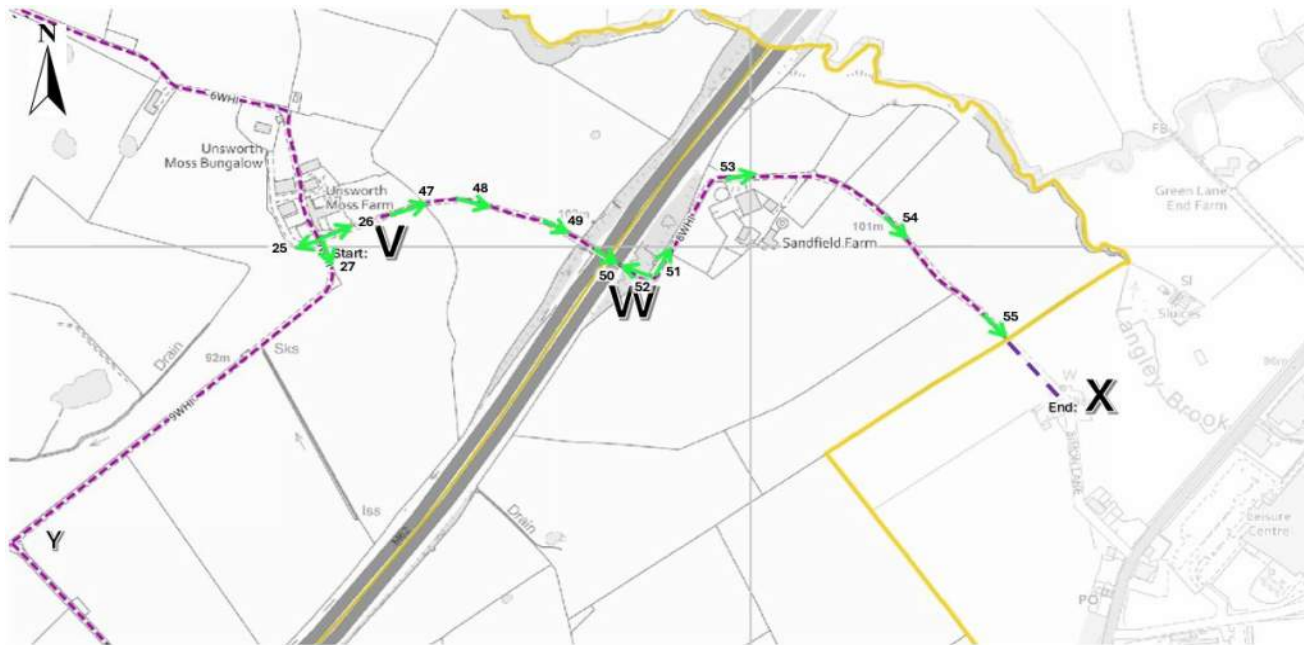
| | Section | RoW Status | Start Time | End Time | Walking Time (hh:mm) | Route Length (m) | Pedestrian Count on Walkover | Photo References | Footpath Intentionally Blocked | Hard Surfaced | Shared with Vehicles | Footpath Overgrown | Route Indistinct | Stiles/Gates in Disrepair | Signed as Private | Lit | Signposts / route arrows present |
|---|---|---|---|---|---|---|---|---|---|---|---|---|---|---|---|---|---|
| Subsection | Key Observations | Approximately 3m wide shared use surfaced track | | | | | | 25 to 50 | N | Y | Y | N | N | n/a | N | N | N |
| | Key Observations | Approximately 3m wide shared use surfaced track, conditions remain constant throughout entirety of the route | | | | | | 51 to 55 | N | Y | Y | N | N | n/a | N | N | N |
