## **Enabling Phase Validation Report**

**Wildhouse Lane, Milnrow**  
**For**  
**Lancet Homes Limited**

| <b>Report number</b> | 423.07.22.VAL |

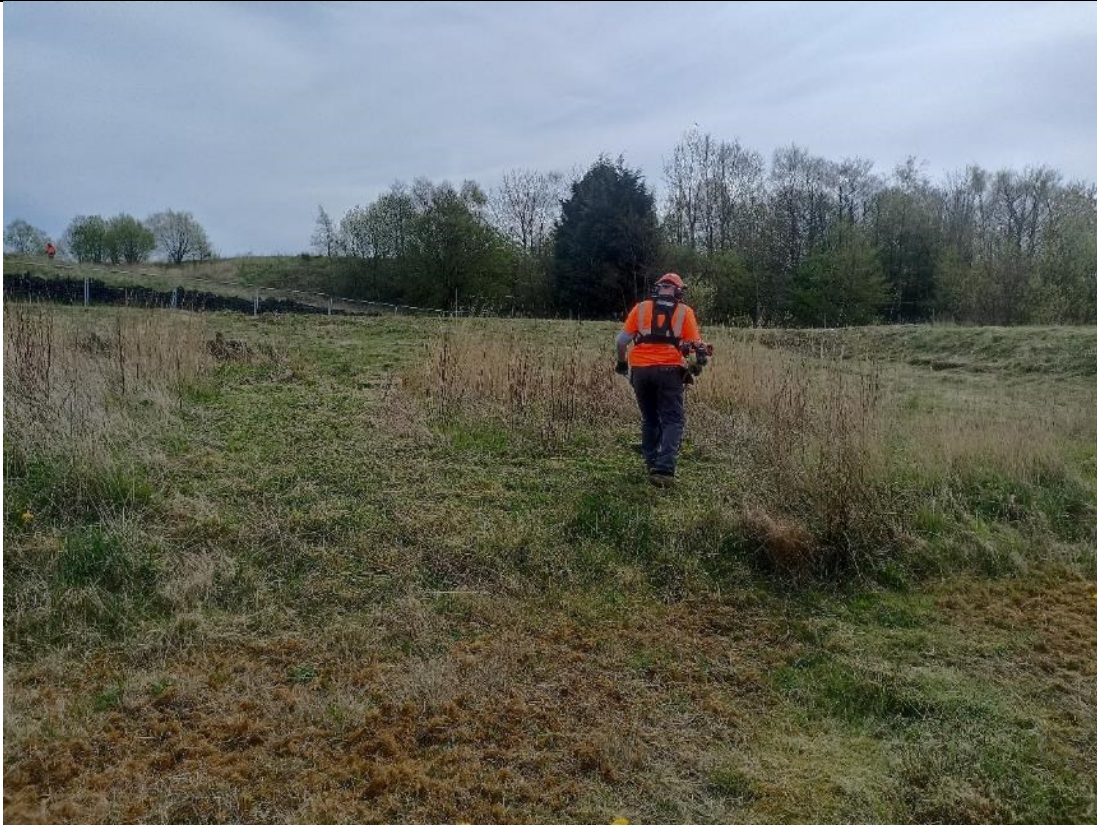
Plate No: 1.

First cut – potential newt habitat

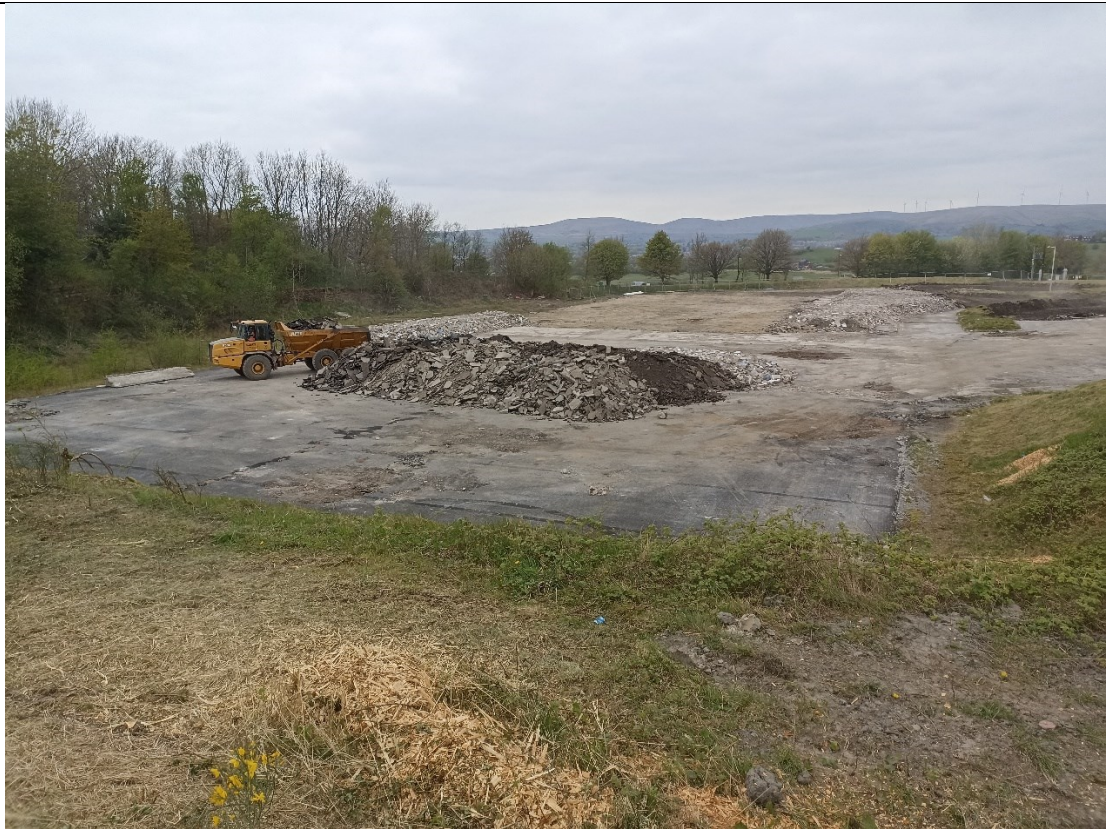
Plate No: 3.

Uplift of hardstanding and preparation of crush feedstock - Wildhouse Lane

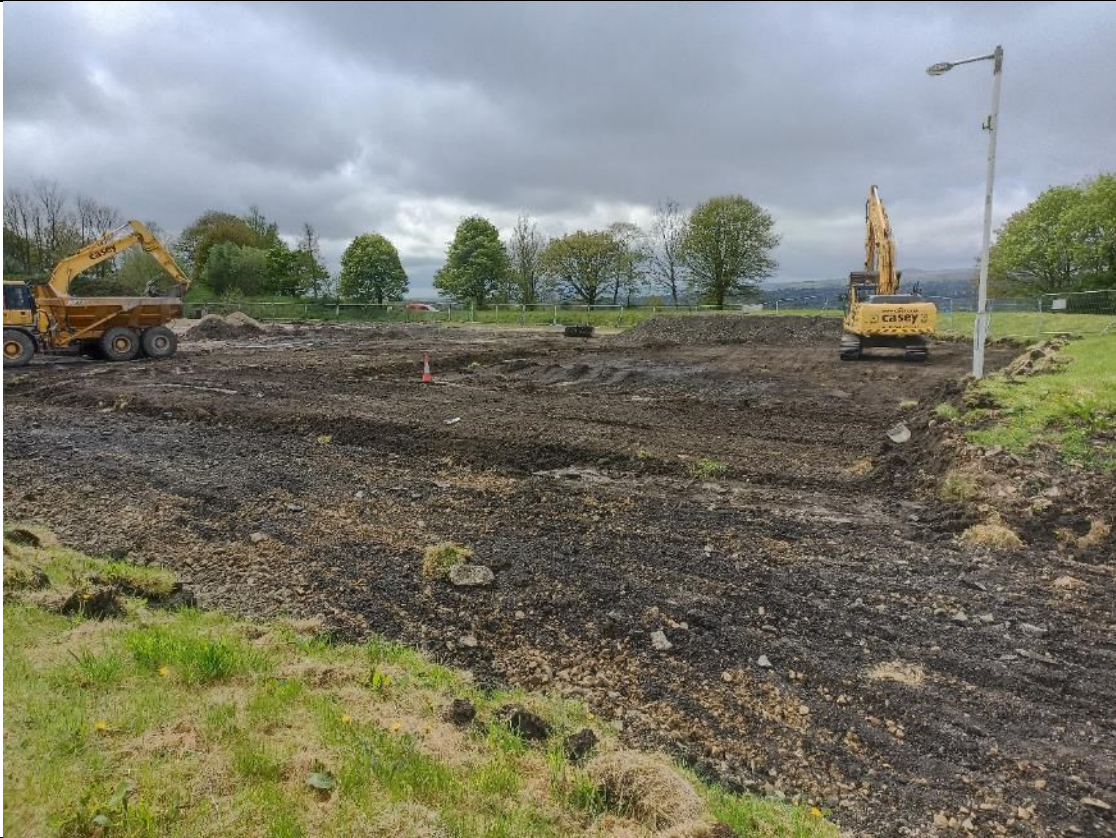
Plate No: 5.

Recovering tarmac and hardcore for reuse

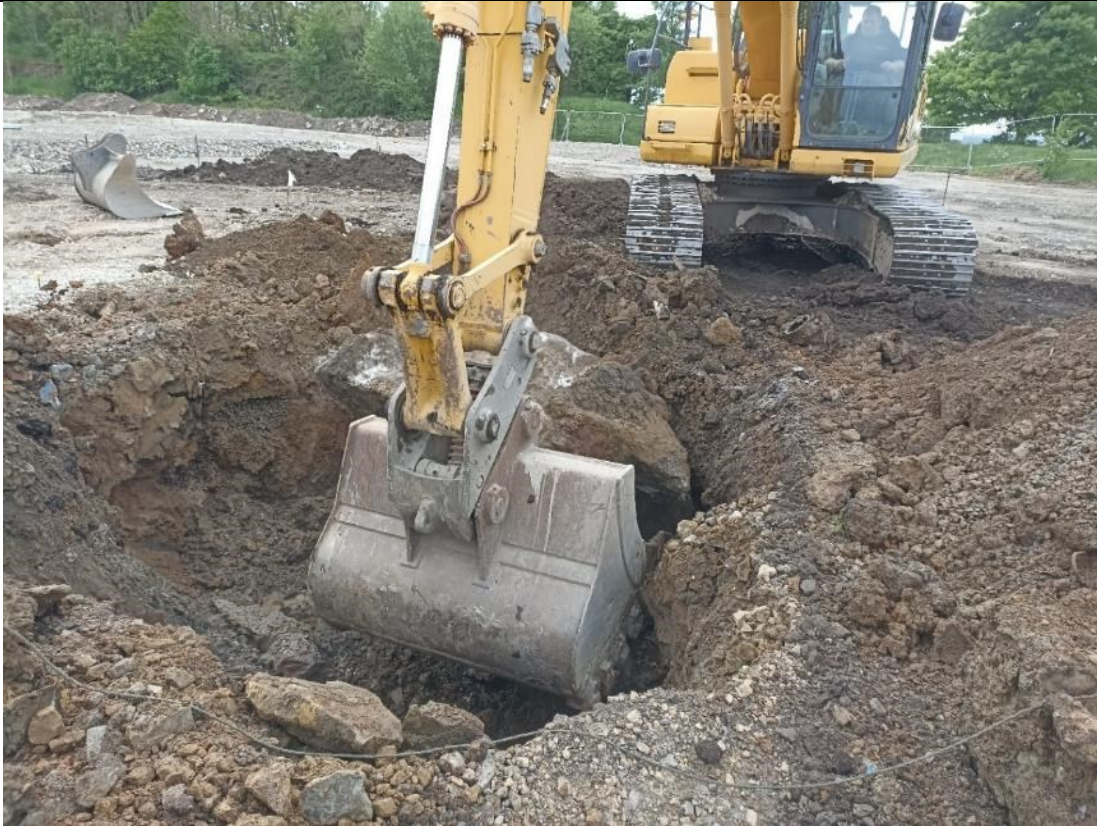
Plate No: 11.

Removing Historical Foundations

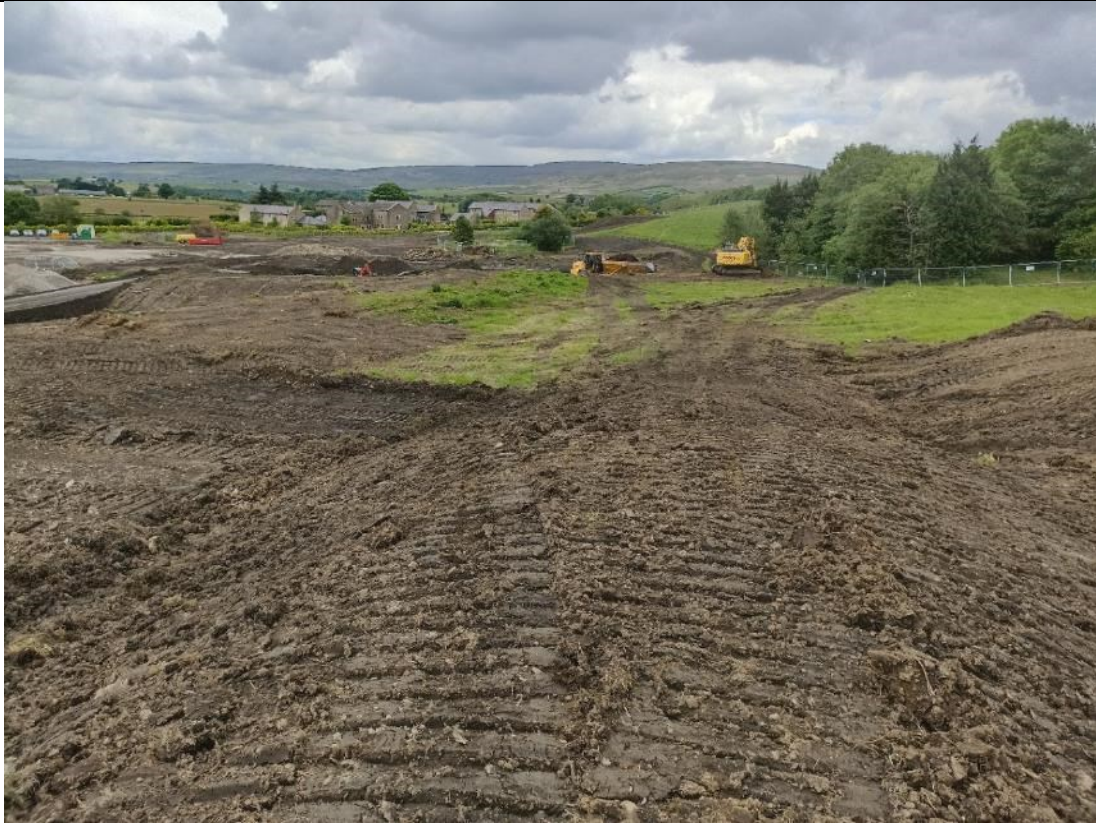
Plate No: 15.

Vegetation Strip

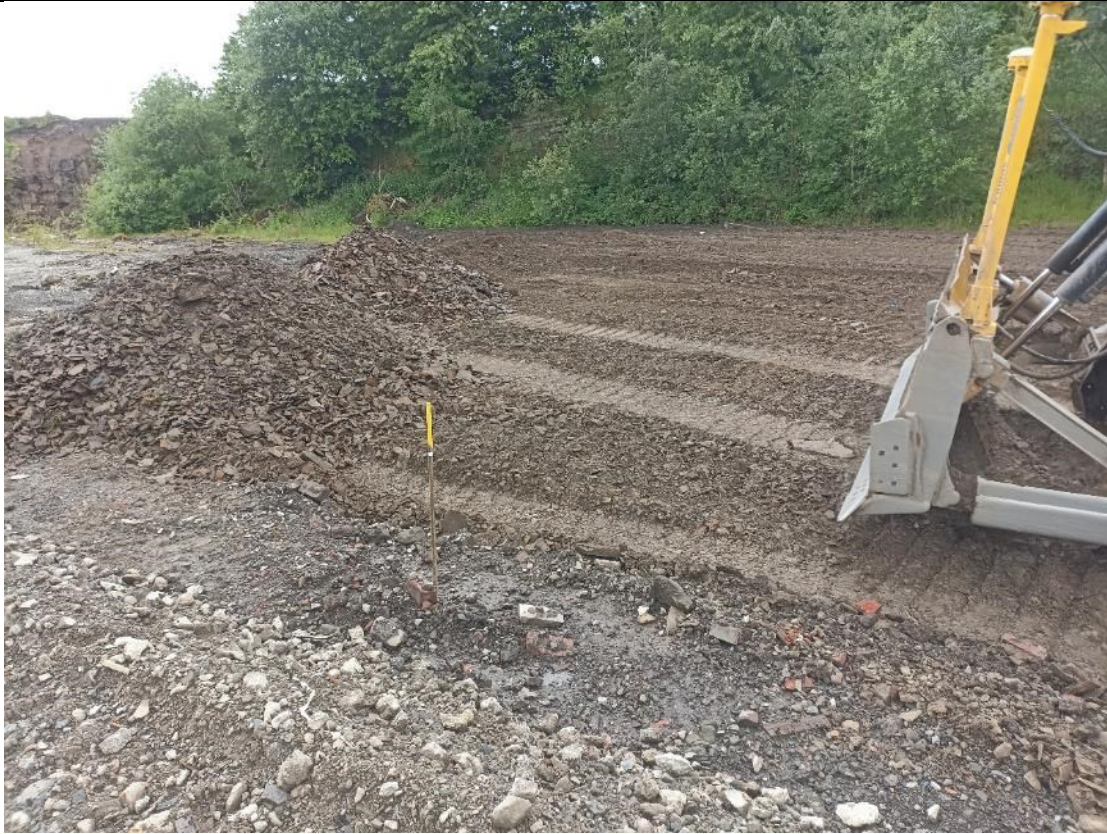
Plate No: 17.

Placing Fill Materials

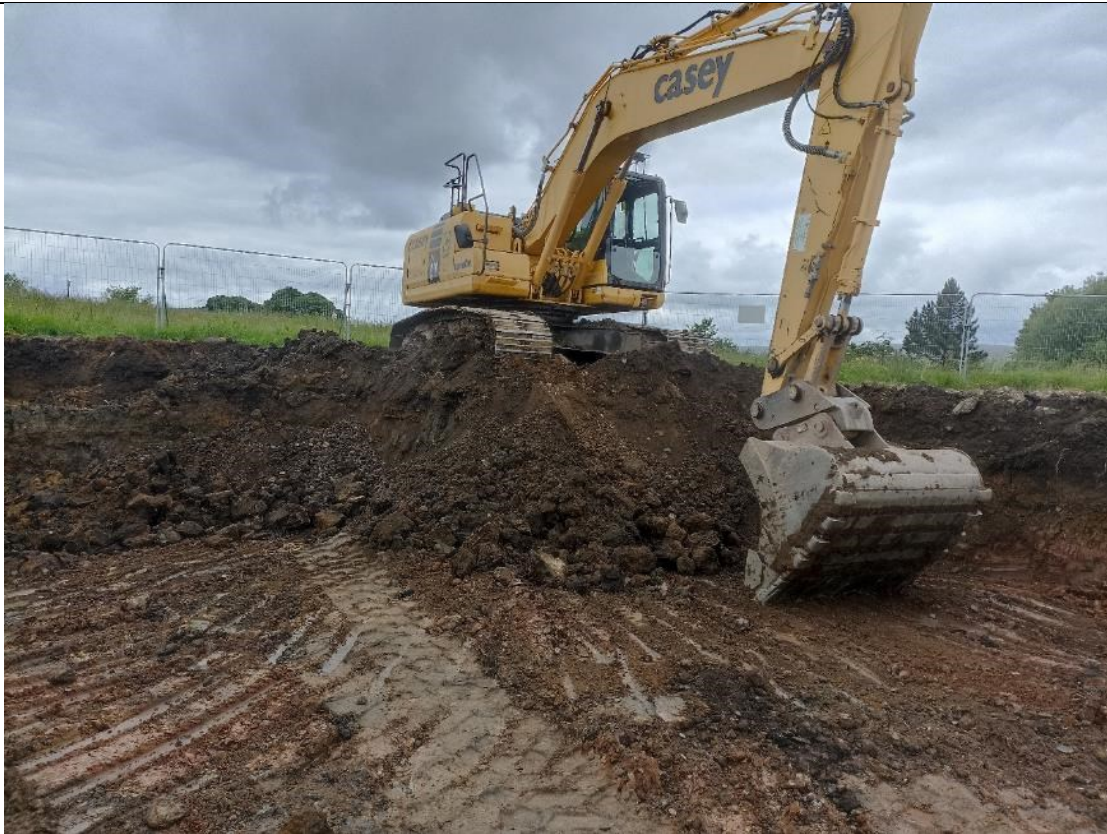
Plate No: 19.

Materials cut for stockpiling as Subsoil

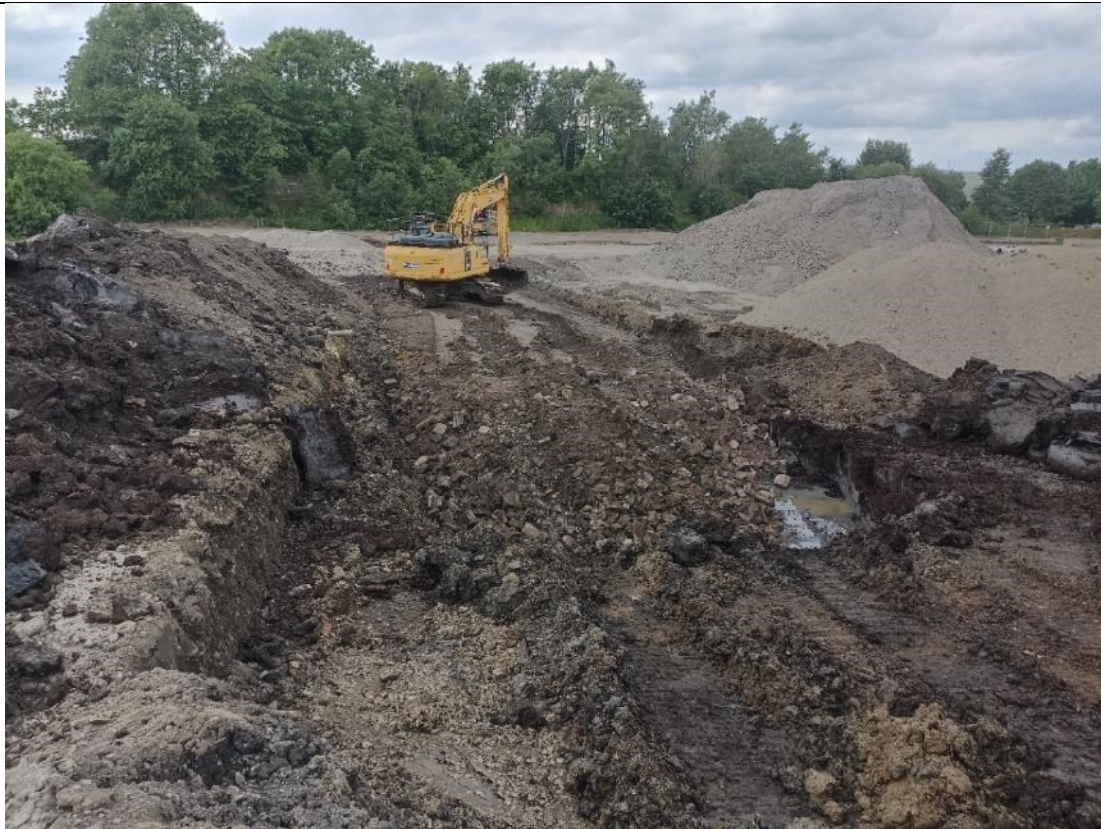
Plate No: 21.

Placing Cut Made Ground as Fill Under Roads

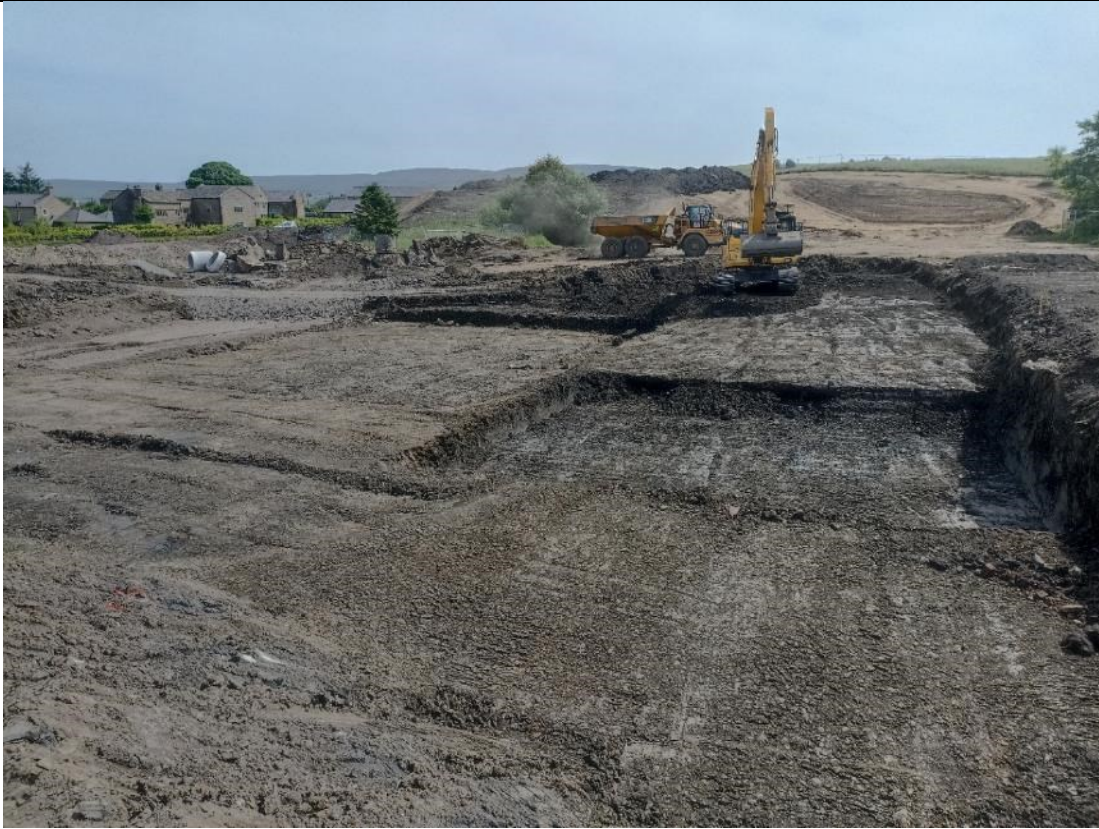
Plate No: 23.

Cut and Fill Reprofilng

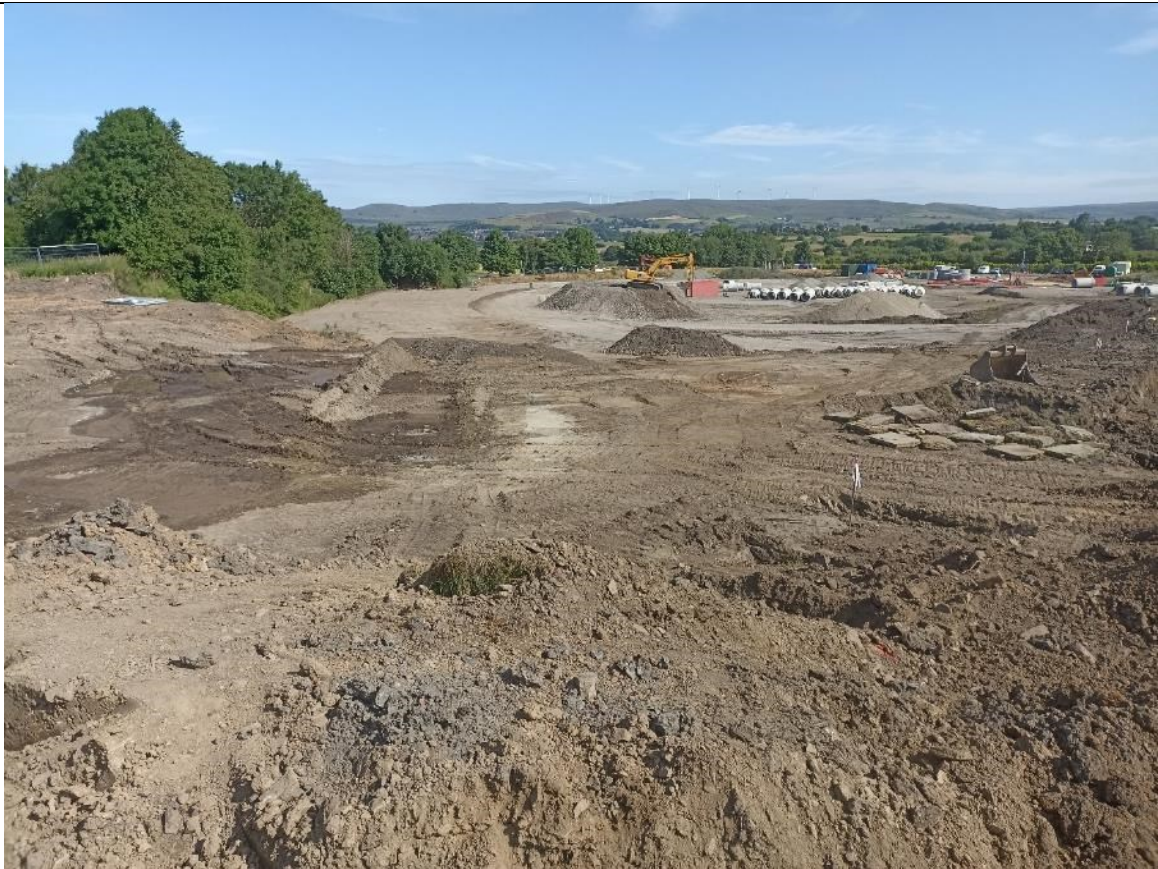
Plate No: 25.

Cut and Fill Reprofiling

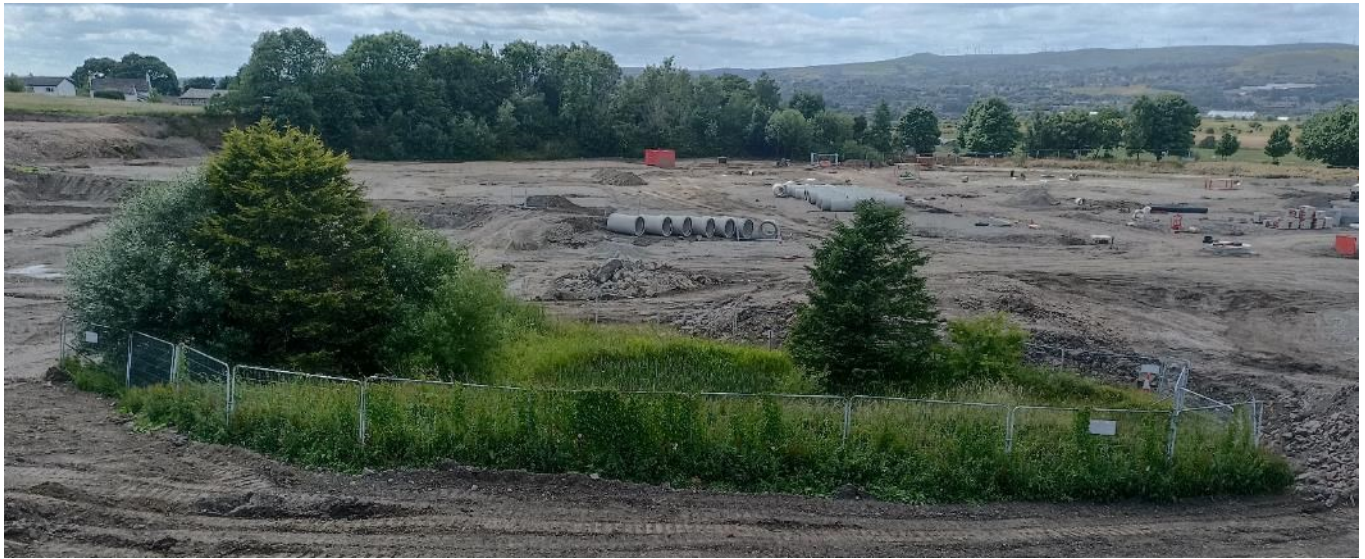
Plate No: 29.

Tree Protection Fencing – Retained Habitat, Pond

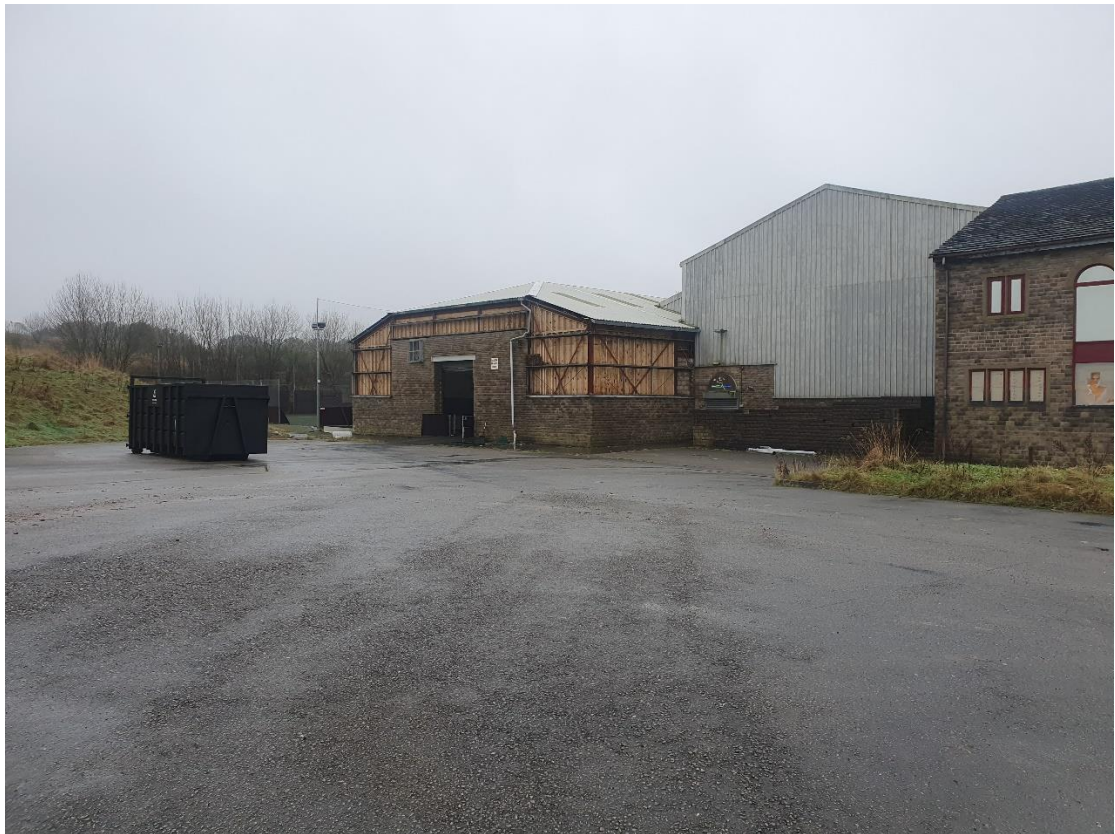
Plate No: 5.

Asbestos sheeting removed

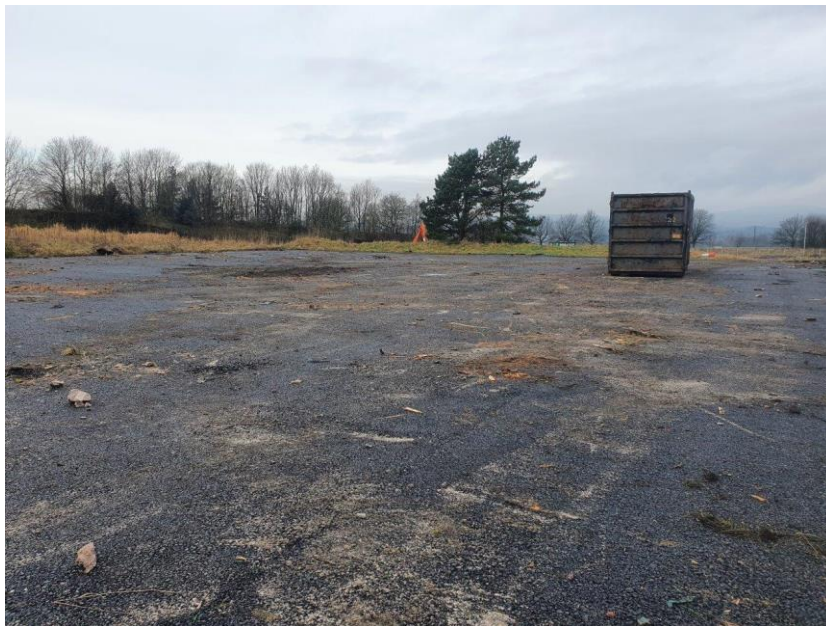
Plate No: 18.

Final site condition

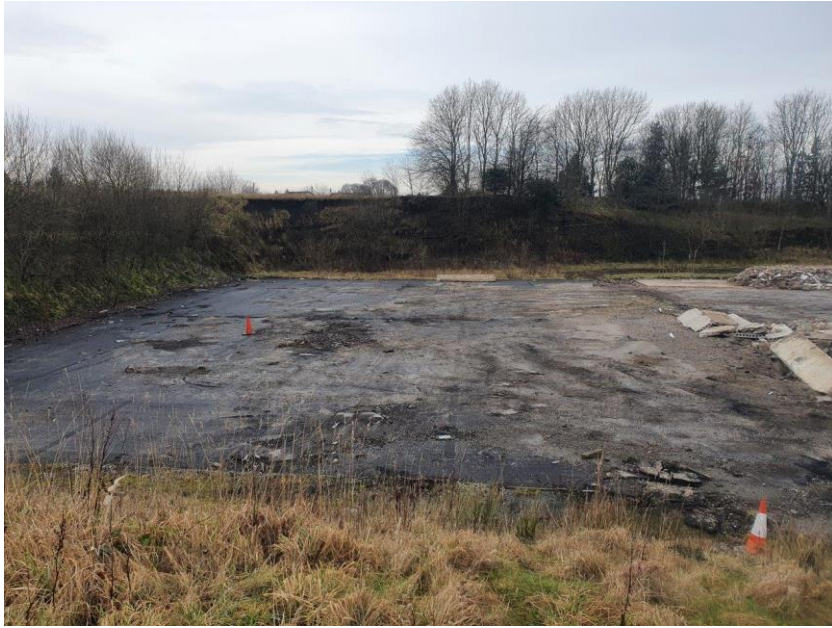
Plate No: 19.

Final site condition of outdoor courts area

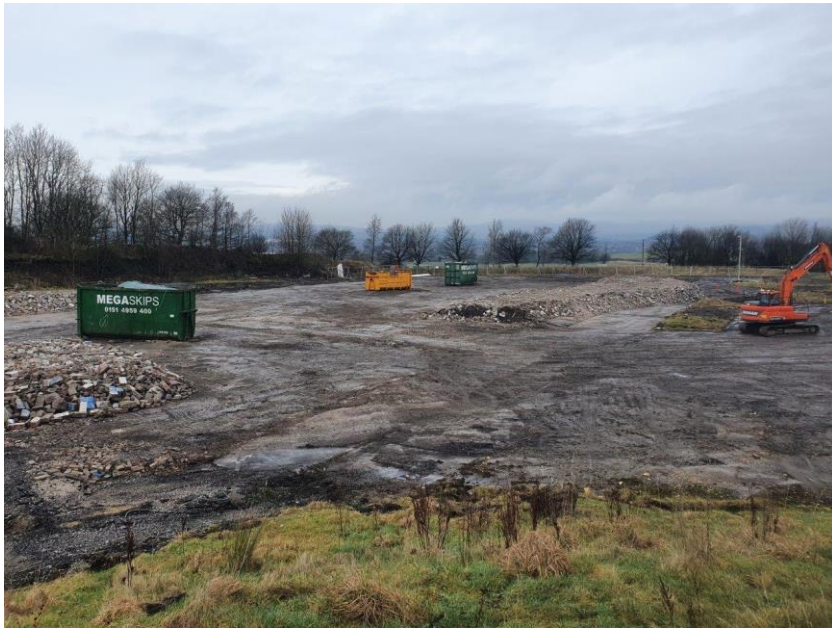
Plate No: 20.

Final site condition of stockpiled material
