# GEO-ENVIRONMENTAL AUDIT

## PHASE 1 PRELIMINARY RISK ASSESSMENT

**SALT SEPARATION SERVICES**  
**UNIT 6&6**  
**FLETCHER STREET**  
**ROCHDALE**  
**OL11 1AE**

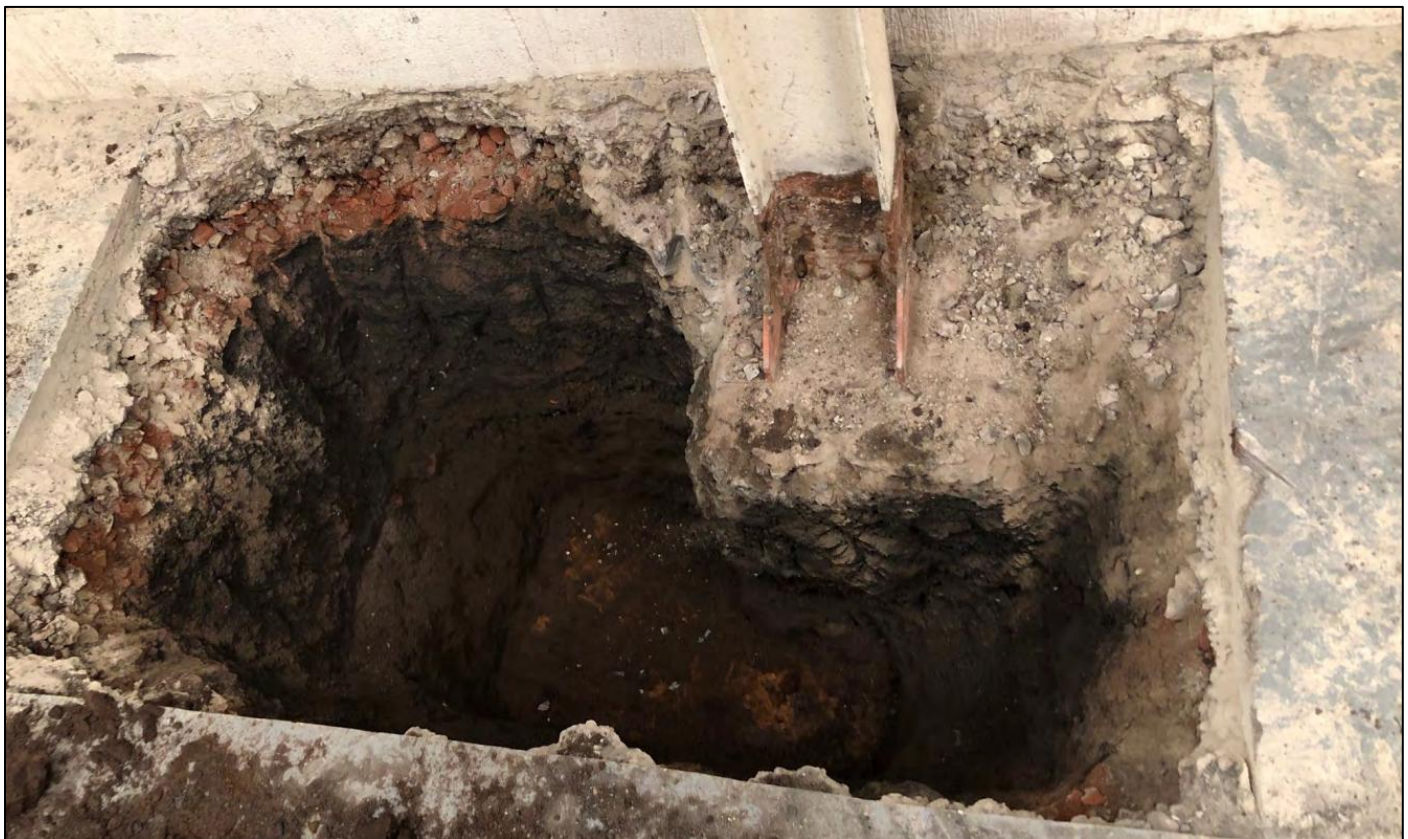
## 2.4. Photographs.

| | | | | | | | | | | | |
|---|---|---|---|---|---|---|---|---|---|---|---|
| Details of Existing Structures: | <p>The site has been visited on numerous occasions.</p> <p>The building comprises a red brick masonry structure with cladded roof &amp; concrete floor slabs. It has an external concrete hardstanding strip of land between the building and the Fletcher Street, with two vehicular openings to the south elevation.</p> <p>The building had been recently used as an automobile repair &amp; MOT garage, prior to being developed into a fabrication work shop.</p> <p>The garage had a small sump/pit nominally 150mm deep to the west side, and internal manholes assumed to be part of an interceptor system.</p> <p>There were also internal office rooms.</p> <p>Past investigations at the site suggest the following floor make-up inside the building, (refer to photo in Appendix):</p>

<table><tr> <td>0-100mm</td><td>MADE GROUND: Conc floor slab;</td></tr><tr> <td>100-300mm</td><td>MADE GROUND: Hardcore blinding;</td></tr><tr> <td>300-900mm</td><td>MADE GROUND: Sand &amp; gravel (Ash);</td></tr><tr> <td>900-1200mm</td><td>Suspect MADE GROUND: CLAY</td></tr><tr> <td>1200-1500mm</td><td>Glaciofluvial SAND.</td></tr></table>
