# LEOPOLD COURT, ROCHDALE

## Bat Survey Report

*November 2025*

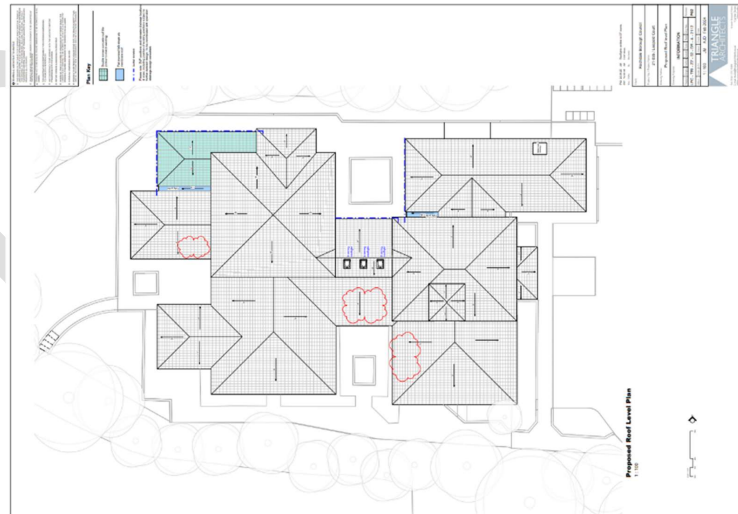
Figure 2.2. Proposed roof level plan produced by Triangle Architect Ltd.

- 2.2.2. The endoscope survey targeted external areas of the building that are likely to be affected by the proposed extension works. Based on the architectural plans provided by Triangle Architects Ltd. (ref. Figure 2.2), the proposed extensions, highlighted in blue, consist of two primary areas, comprising a rectangular addition to the existing single storey lean-to projection, and a smaller extension linking the central northeast projection to the main structure. The northwestern extension incorporates a gable roof finished with double roman tiles, which ties into the adjacent roof projection via a short section of flat roof. The northeastern connecting extension is designed with a flat roof profile.

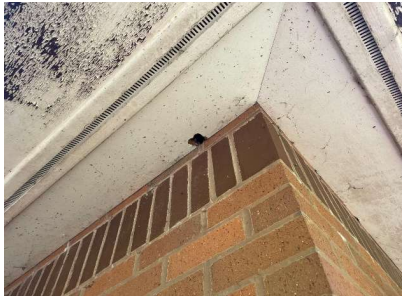
| Feature | Description | Photographs |
|---|---|---|
| Hole in soffit | <p>A small hole was identified in the soffit of the neighbouring projection. Endoscopic inspection of the feature found that it provides ingress into the internal loft space.</p> <p>Endoscopic and visual inspections of the interior found no evidence of bat use, and no staining or wear was observed around the entrance.</p> <p>The feature is assessed as having low suitability for roosting due to the influence of external lighting on the lower elevations.</p> | |

- 3.2.4. Other features, including partially lifted tiles, small gaps around lead flashing, and the hole in the soffit, are considered to be of low suitability for bats due to their limited size and shelter. If occupied, these features are likely to support only individual bats or small numbers of crevice-dwelling species. External lighting is likely to further reduce the suitability of features at lower elevations.

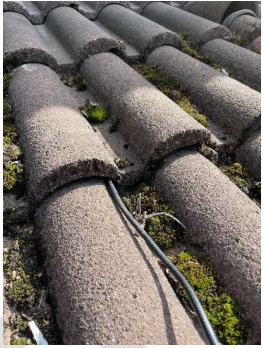
| Lifted tiles | <p>Three partially lifted roof tiles were identified on the west-facing roof slope. The features create small gaps of sufficient size to permit access for crevice-dwelling bat species. These openings lead only into shallow voids beneath the roof tiles, which are considered too exposed to provide suitable or stable roosting conditions. However, concealed features under the roof tiles may be present. No evidence of bat use was recorded during inspection.</p> | |

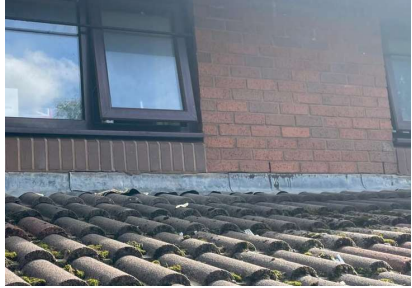
| Gaps along lead flashing | <p>Approximately ten small gaps were identified along sections of lead flashing which may provide potential crevice roosting opportunities for bats. No evidence of bat use was recorded during inspection and several contained spider webs, indicating no recent usage.</p> | |

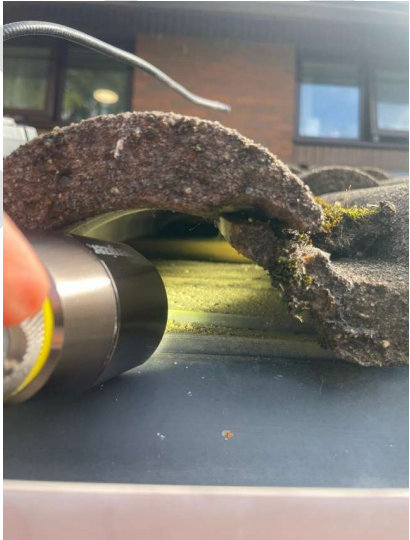
| Under roof tiles | <p>A shallow void beneath roof tiles provides some shelter but is relatively exposed. Horizontal timber joints within the roof structure may create crevices that could offer roosting opportunities for crevice-dwelling bats, particularly deeper within the structure where visibility was restricted. No evidence of roosting bats was found during inspection.</p> | |

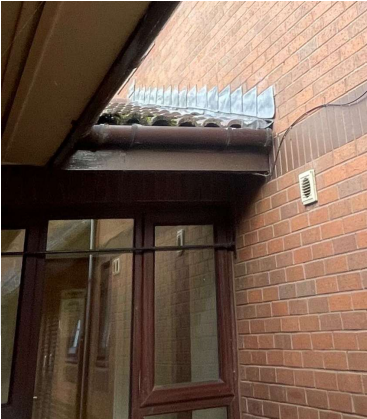
| Feature | Description | Photographs |
|---|---|---|
| Gap under lead flashing | A small gap is present beneath the lead flashing at the roof edge, consistent with flashing elsewhere on the building. The feature could potentially provide roosting opportunities for crevice-dwelling bats; however, no evidence of bat activity was observed, and intact spider webs suggest the feature has not been recently used. | |

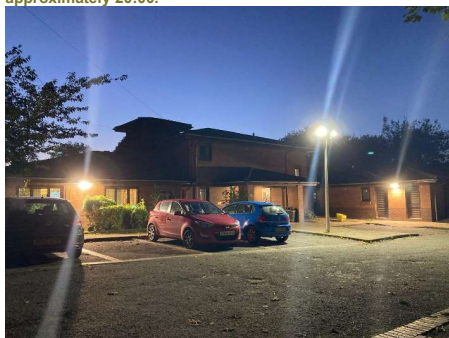
Photograph A: Eastern elevations; photo taken at approximately 20:00.

- 3.1.4. External lighting came on at approximately 19:15, comprising streetlamps in the car park to the east of the site and external wall-mounted lights on the lower elevations of the building. This lighting is likely to have caused some disturbance to bats, particularly around the illuminated areas, and may have reduced the likelihood of bats roosting on or near these locations. Photographs of external lighting taken during the survey is provided in Appendix II.

4.3.1. As bats are known to be utilising the site for foraging and commuting purposes, any additional lighting to the building should be designed and installed to comply with current legislation and to minimize the impact on any bats in the locale, with current lighting retrofitted where possible. Guidance outlined in the Institute for Lighting Engineers document "Guidance for the Reduction of Obtrusive Lighting" (2005) and BCT's "Bats and Artificial Lighting in the UK" (2018) suggests the following:
