# HISTORIC BUILDING RECORD

Client: Hopwood Hall College  
Project: Conversion of Former Chapel  
Reference: HCO-SEV-XX-XX-RP-A-09104  
Date: July | 2025

| DOCUMENT TITLE | HISTORIC BUILDING RECORD |

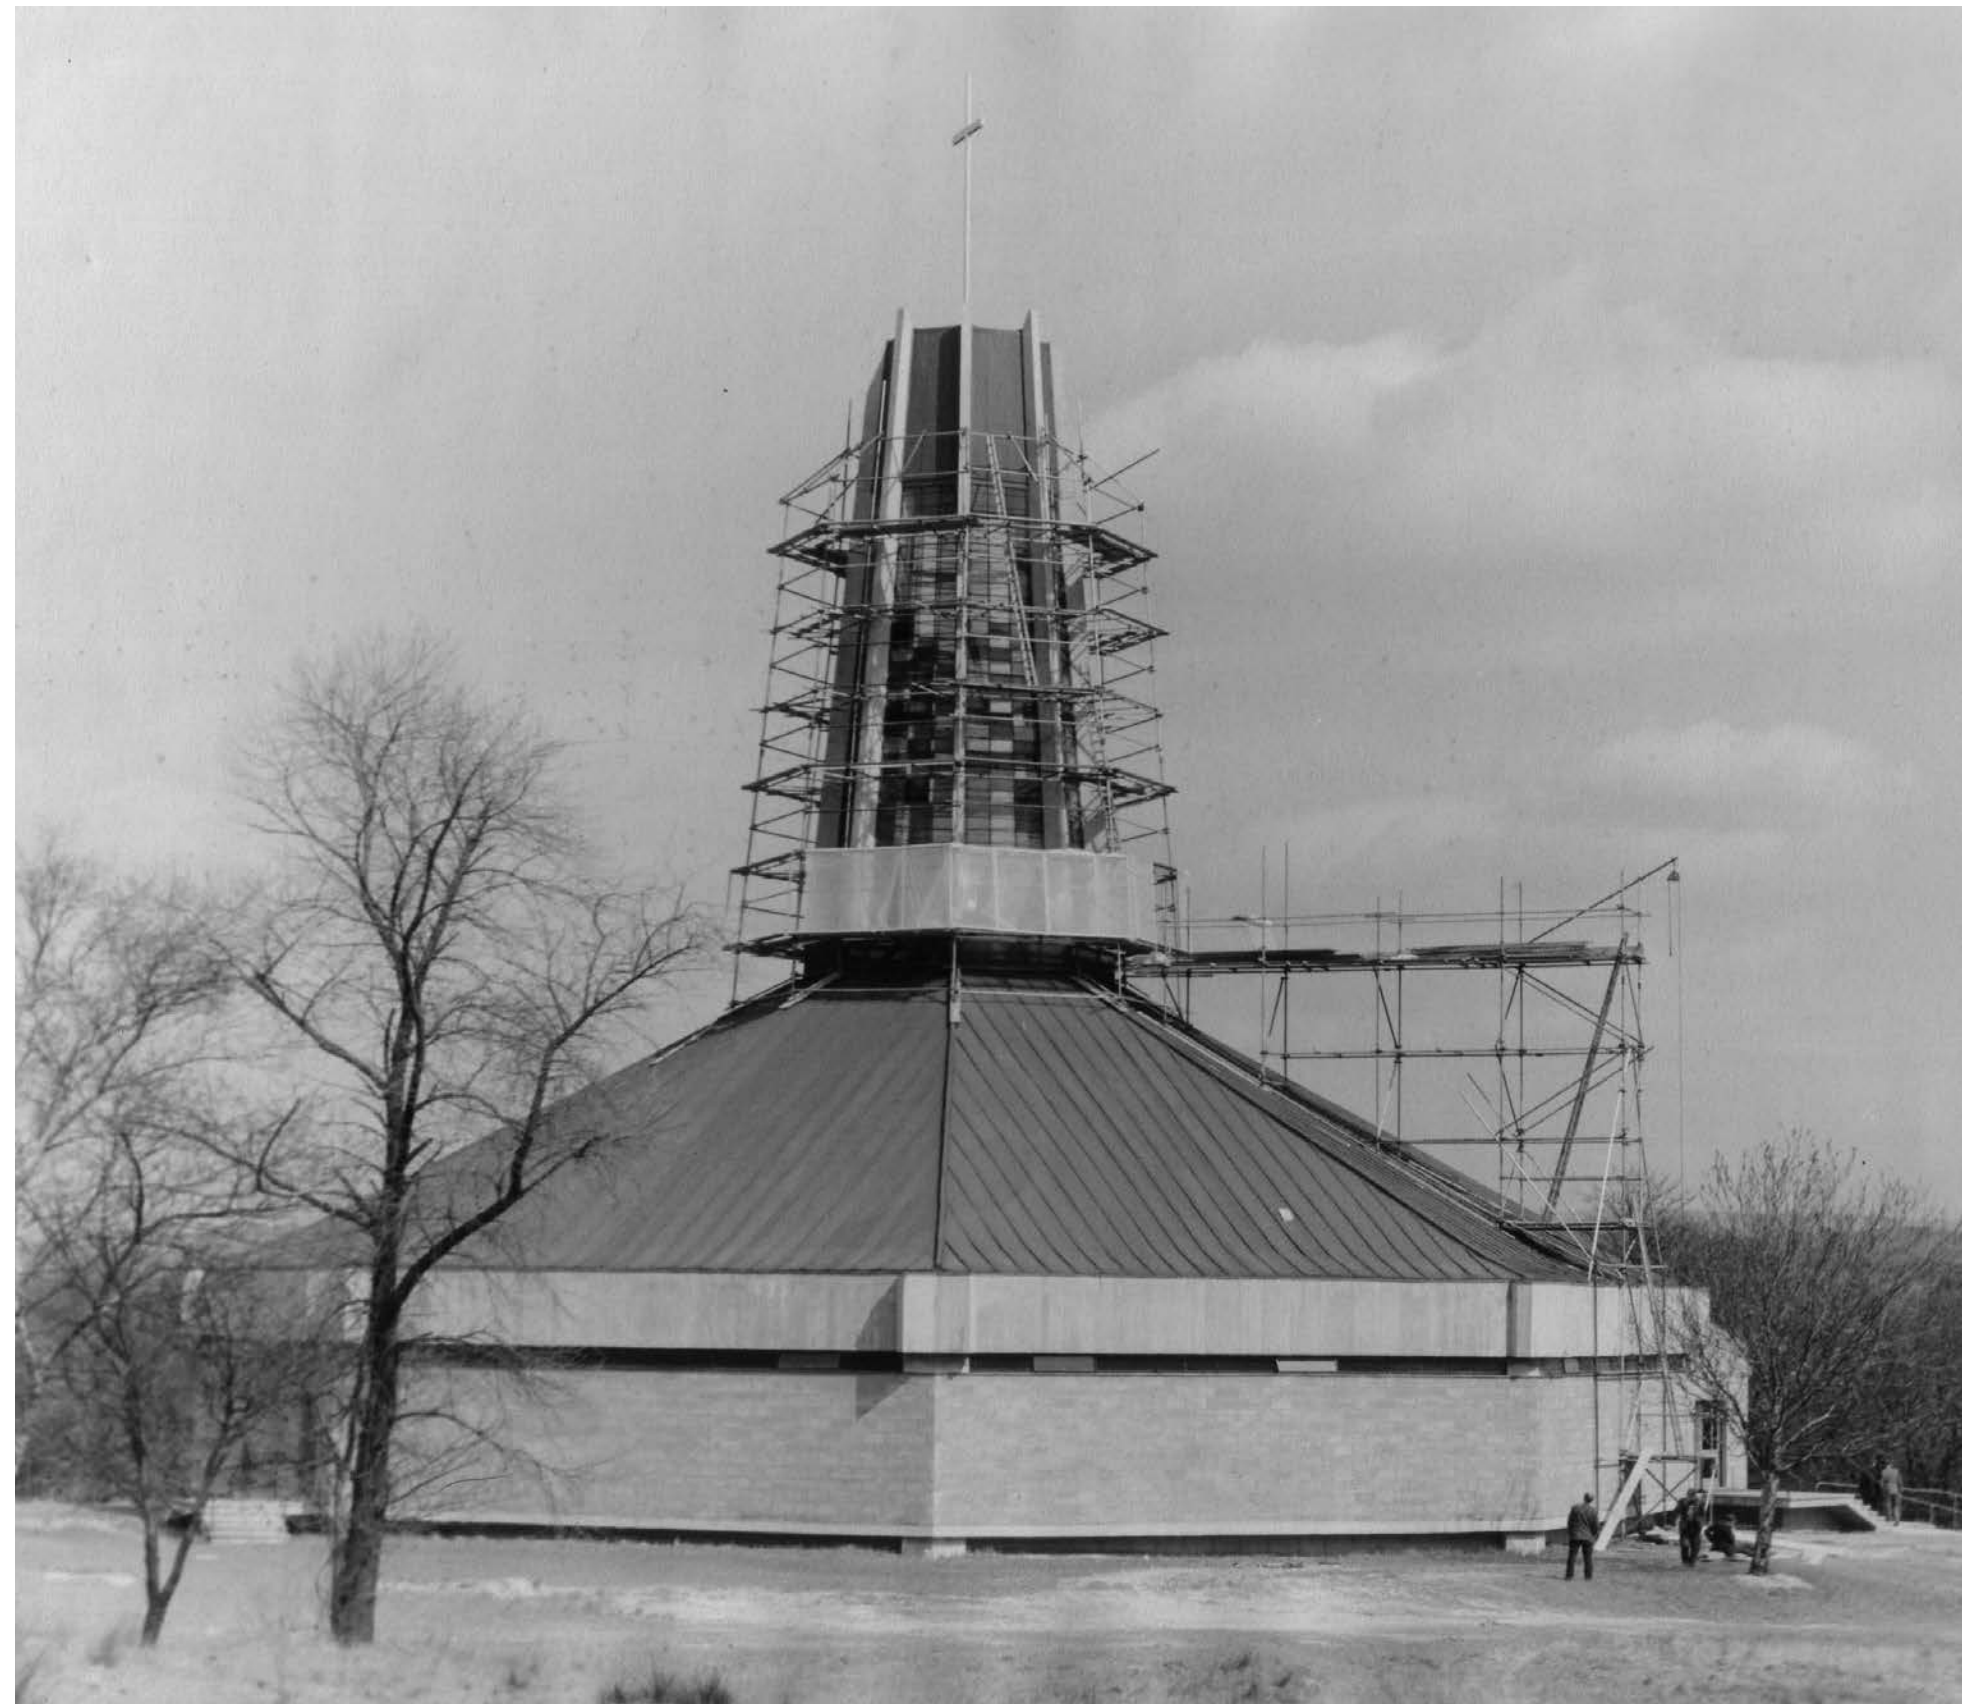
Figure 4.24  
The Chapel during construction  
(Source: Rochdale Archives)

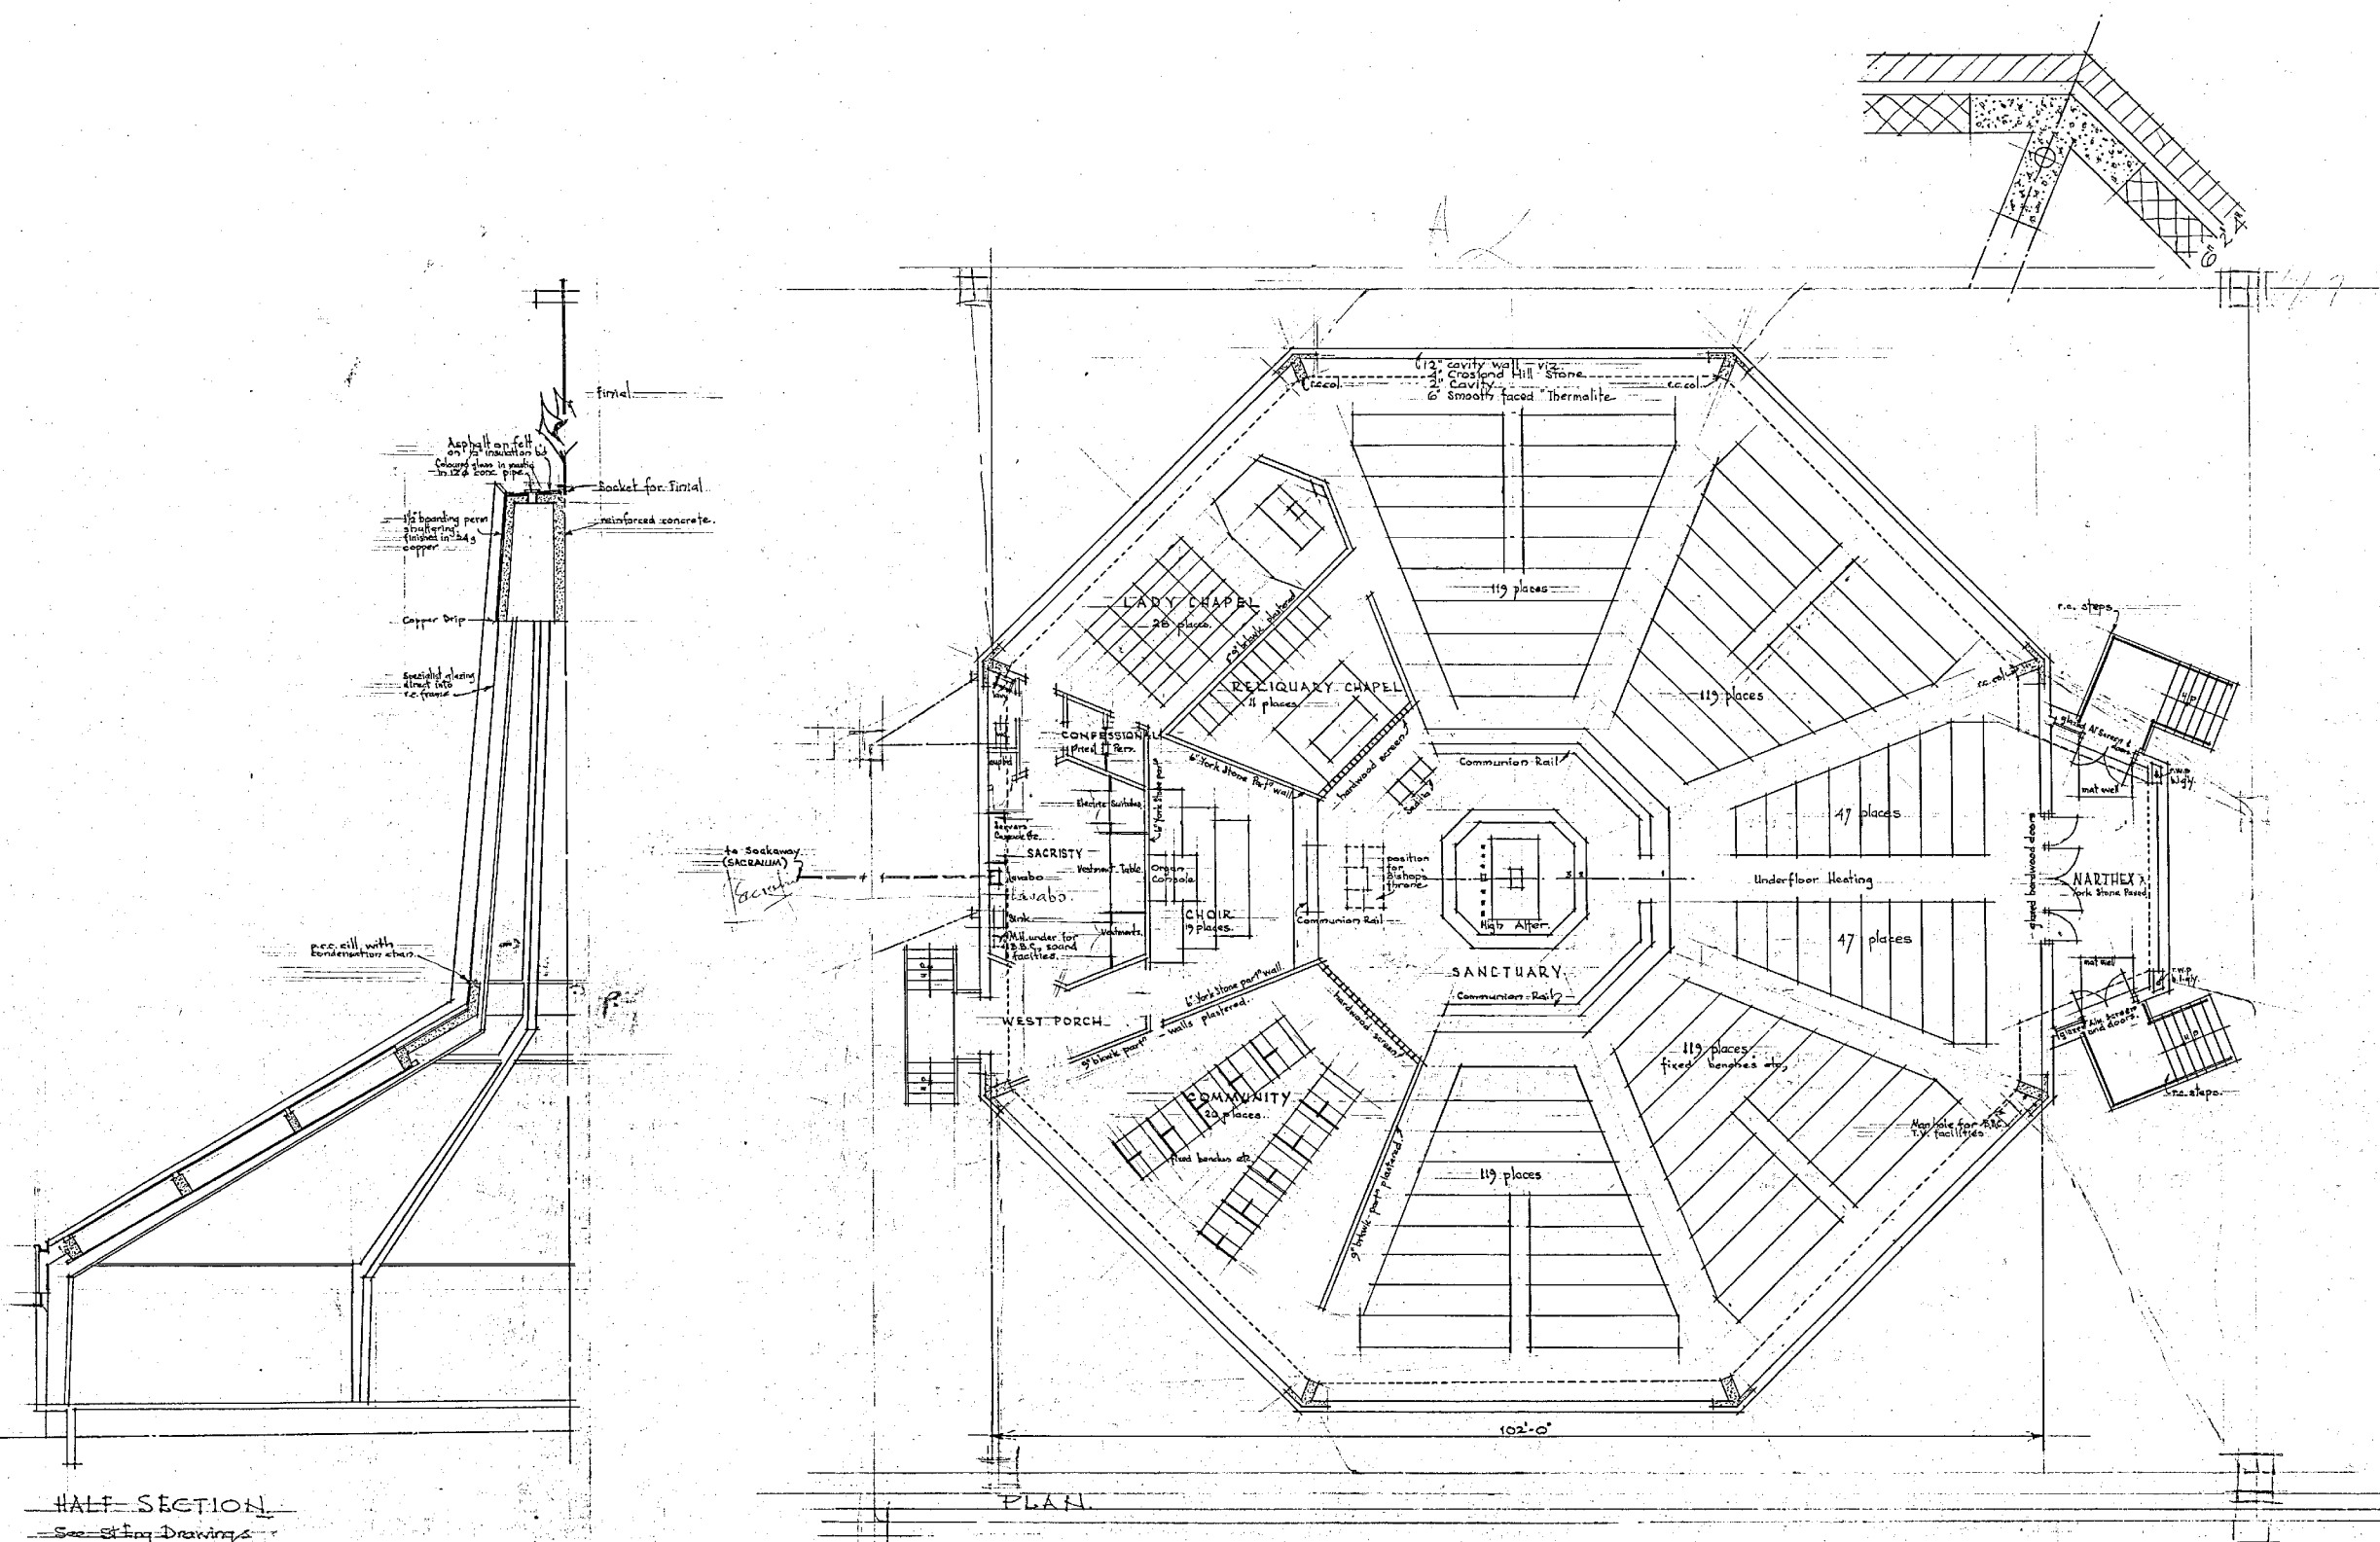
In the segment to the north of the Sacristy, the 1962 plan illustrates a semi-enclosed Lady Chapel, with an adjacent Reliquary Chapel, separated from the Sanctuary by a hardwood screen. Alterations to this design are evident in the 1964 Reynolds and Scott Lighting Plan (number 783-13, dated 12 April 1964), which reconfigures the space into a smaller Chapel (seating 12) with an altar beneath a ciborium. A detailed drawing by Reynolds and Scott (number 37, date unknown) reflects this simplified design, labelled the 'Blessed Sacrament Chapel.' The walls of this Chapel are noted as being constructed from '12" Thermalite Y-tong' smooth-faced blocks, supported by a blue brick course'. The altar is positioned on a predella of Accrington Brick, featuring a brick-on-edge detail. Historical photos from the 1960s (Figure 4.28) illustrates the originally constructed form of the Blessed Sacrament Chapel, with blockwork walls obscuring the altar from view.

Figure 4.25  
Extract from Reynolds and Scott Floor Plan (Drg No.1) dated 14.2.62  
(Source: Hopwood Hall College)

The external walls were noted on the 1962 Reynolds and Scott Plan (number 1) as '*4" crossland stone, 2" cavity, 6" smooth faced Thermalite*'. The stone external leaf was at some point substituted for fair faced concrete blockwork, presumably owing to budgetary constraints.

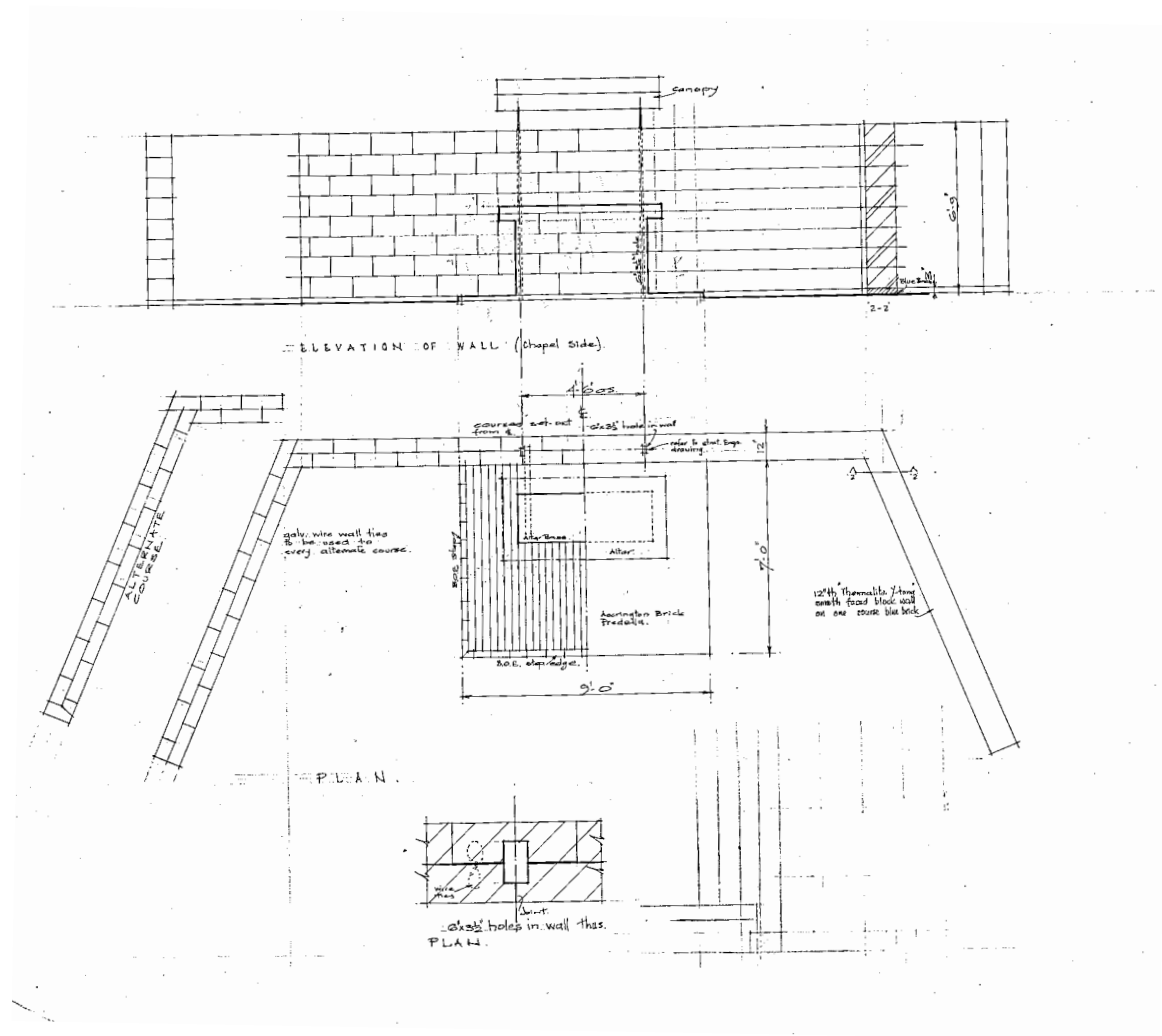
Figure 4.29  
Extract from Reynolds and Scott drawing Blessed Sacrament Chapel Blockwork (Drg No.37)  
(Source: Hopwood Hall College)

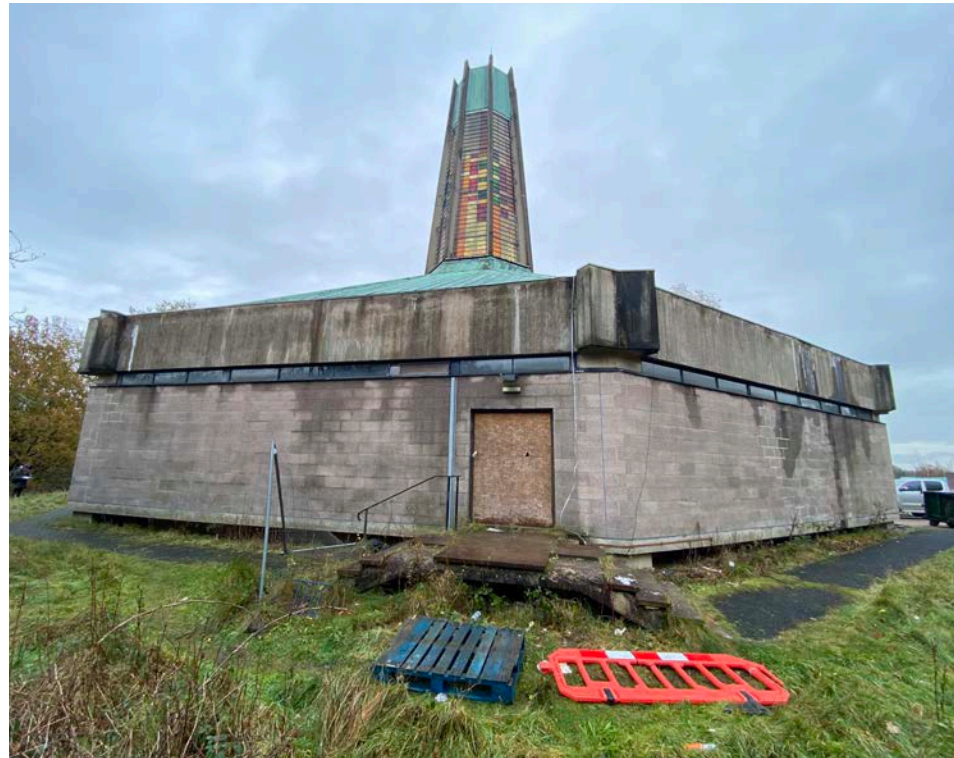
To the rear, the west porch to the building is accessed through hardwood timber framed double doors featuring narrow bands of glazing with a central horizontal timber bar. The doors appear to be original and are generally in fair condition.

External access into the west porch to the rear of the building is via a set of flying concrete steps which, although in poor condition, appear to have been little altered from the original design.

6 West Elevation Looking Towards the West Porch

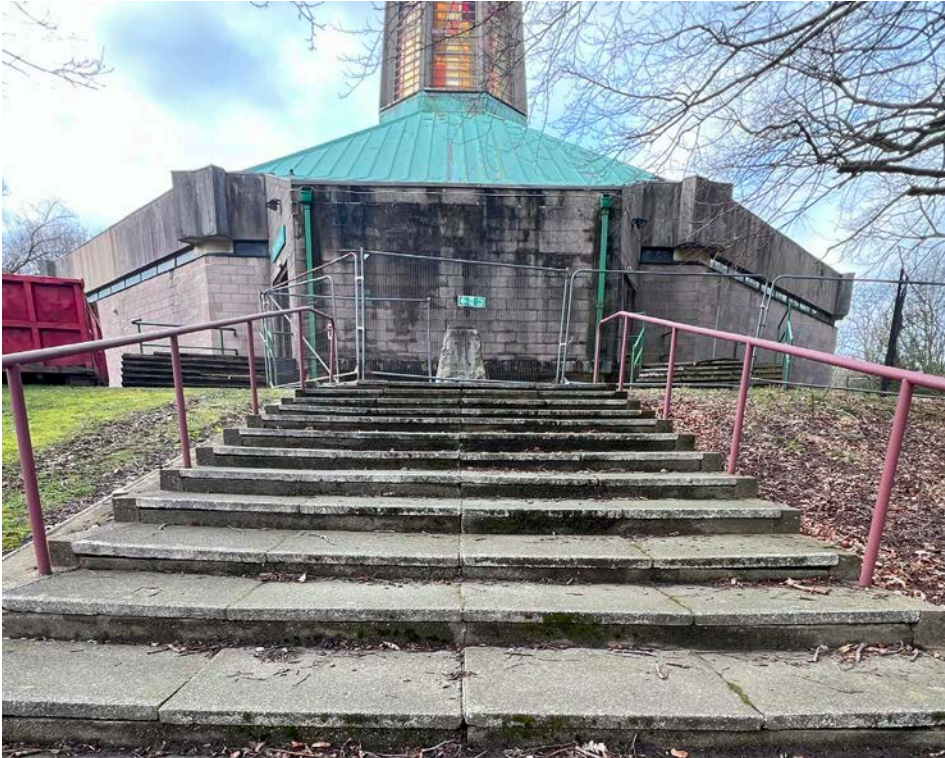
The concrete blockwork to the Narthex is heavily stained and appears to have been saturated by water for a prolonged period.

The building is primarily entered from the Narthex to east via two sets of flying concrete steps with metal handrails. The underside of the steps was unsympathetically infilled with brickwork in the 1990s and the original handrails were also replaced.

14 View of East Elevation looking Towards the Narthex

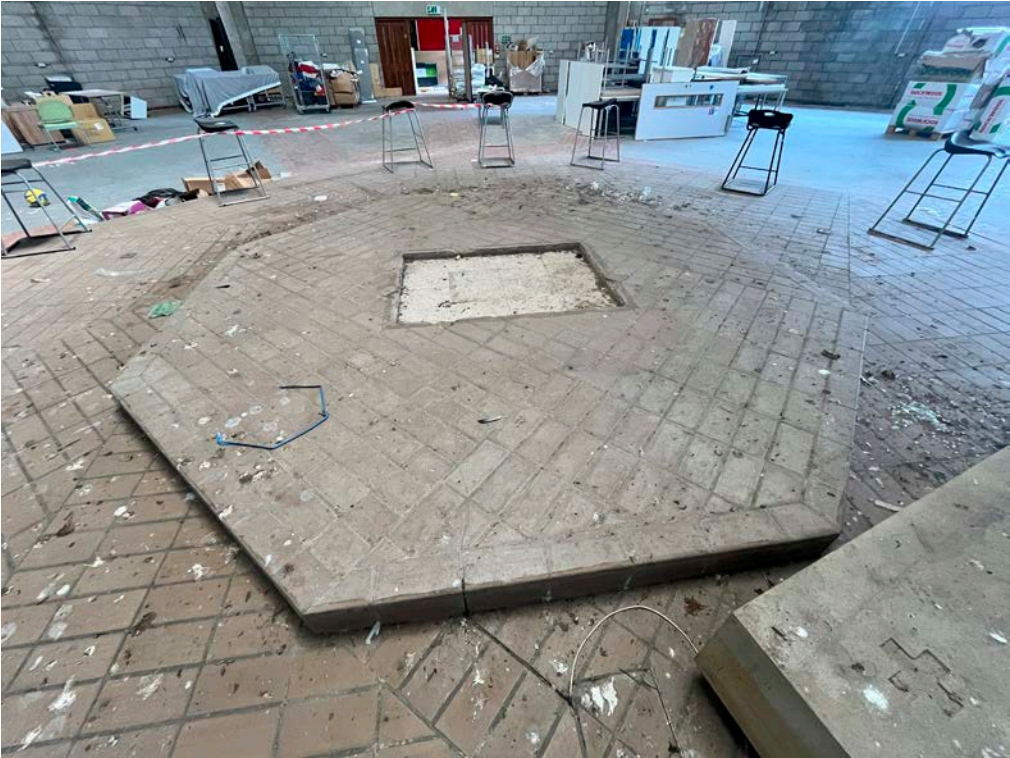
The raised dais to the Sanctuary features two outer steps with a central raised area with a recess for the base of the Altar stone which have been previously dismantled and set aside. The dais features buff coloured brick pavements set out in a decorative radial pattern, as shown on the original drawings. The paving is in fair condition with a few areas of damage and a previous services channel cut out of the floor with flush steel edging. The altar stone features four carved inset crosses, one in each corner, which are still legible.

123 View of Sanctuary raised Dias
