**Existing Male Basement Toilet  
Additional Works  
Rochdale Town Hall**

March 2025

### 1. Male Toilets – Existing

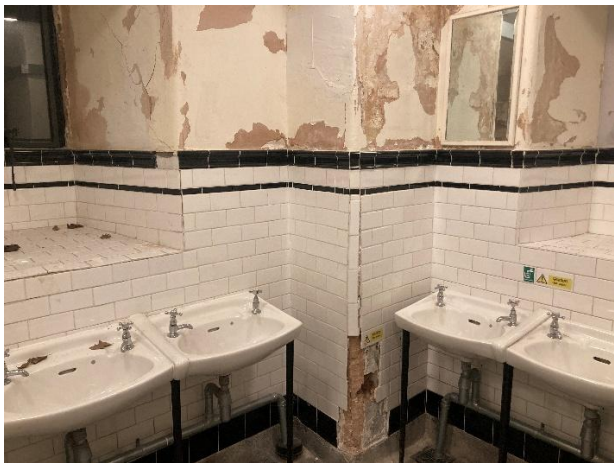
Image 1

1.9 Remove damp damaged plaster from walls to areas shown on drawing 2000 and replaster with lime plaster. See **images 1, 2 and 4** for examples of damp plasterwork.

1.14 Remove areas of failing tiling, re-adhere and regrout. Allow for 20% new tiles to match existing where existing tiles cannot be salvaged. Circa. 8m<sup>2</sup>. See **images 1, 2 and 4** for examples of failing existing tiling.

1.2 Ensure all existing sanitaryware being retained is overhauled to full working order (see **image 1** for example)

1.17 Replace 8no. modern tap heads with new to match remaining – See adjacent women's toilets. Sample to be provided for approval. Note if exact match cannot be found taps to be re-ordered so that all replacement taps are located within one sink run. See **image 17** for example of tap to be matched and **image 1** for example of modern tap head to be replaced.

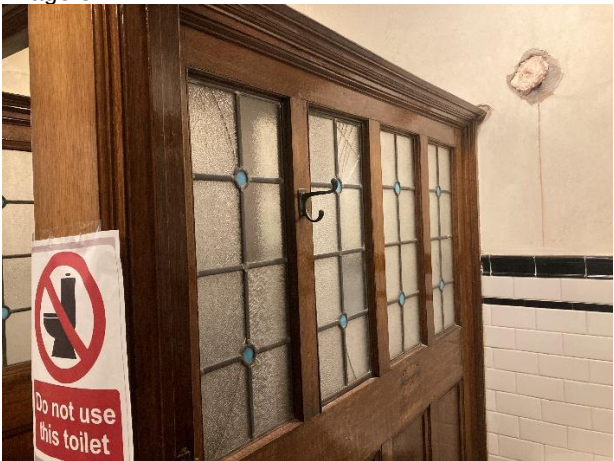
Image 5

1.12 Replace 3no. cracked panes to cubicles with new to match existing. Sample pane of glass to be provided for approval prior to undertaking repairs. See **image 5** for example pane.

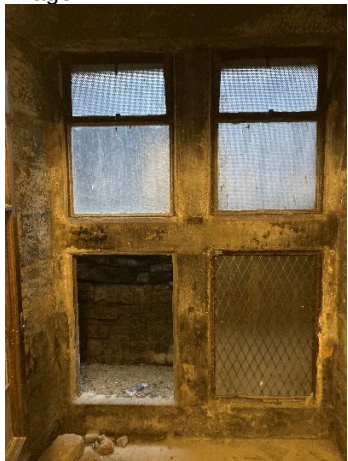
Image 6

1.10 Replace existing window to light wells with new refer to drawing 2000. See **image 6** for existing window to be replaced.

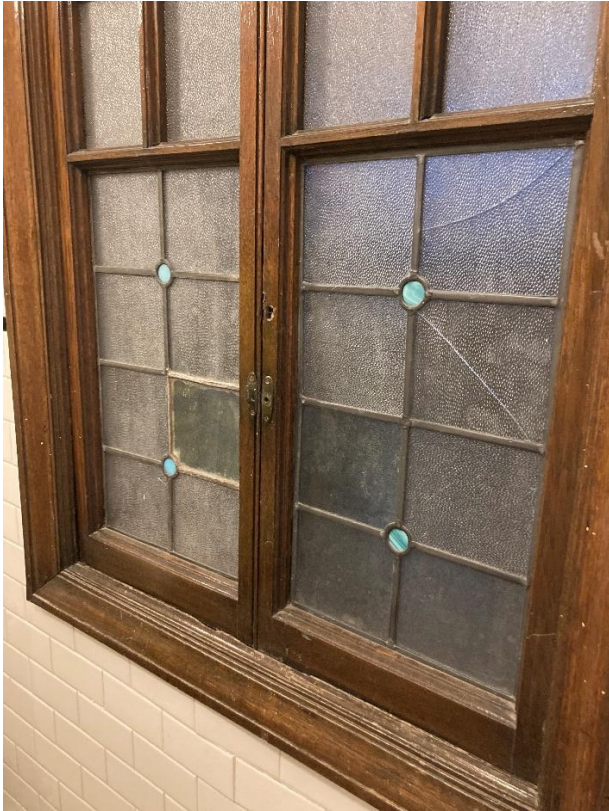
Image 7

1.11 Replace 2no. cracked panes of glass to leaded light with new to match existing (to basement lightwell window). Provide new window clasp to match existing to ensure window remains fixed shut. See **image 7** for existing clasp to be replaced. Sample pane of glass to be provided for approval prior to undertaking repairs.

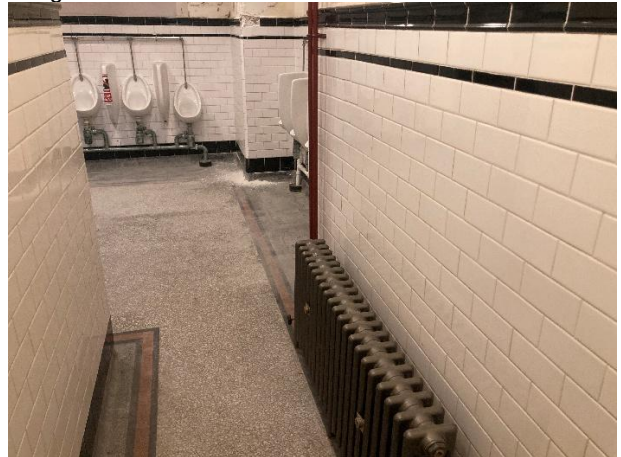
Image 15

Deep clean to be carried out to an agreed standard. Carry out 1m2 sample area for architect's approval prior to continuing with remaining. See **image 15** for general example of male WC area to be cleaned.

1.1 Provide a full deep clean of the following elements:

- Terrazzo floor
- All sanitaryware being retained.
- All walls
- All tiled surface
- All joinery and glazing to cubicles
- Timber window to lightwell
- All ceilings .
- Steps and handrails

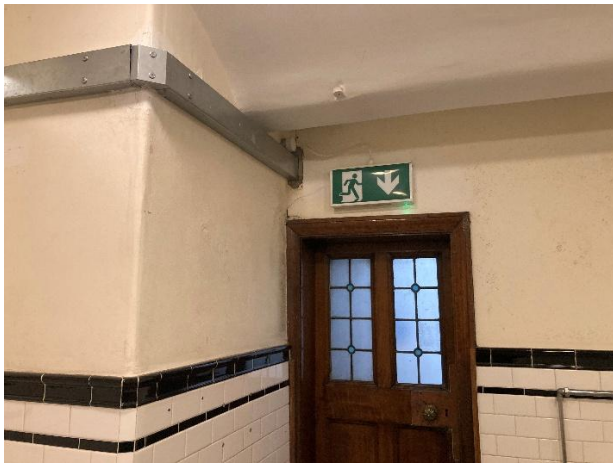
Image 16

1.15 Pull all previous fixings to tiling and fill any residual holes associated with removal of FF&E with grout to match tile colour. Clean down any associated marking to tiling. See **image 16** for example of previous fixing holes / marks.

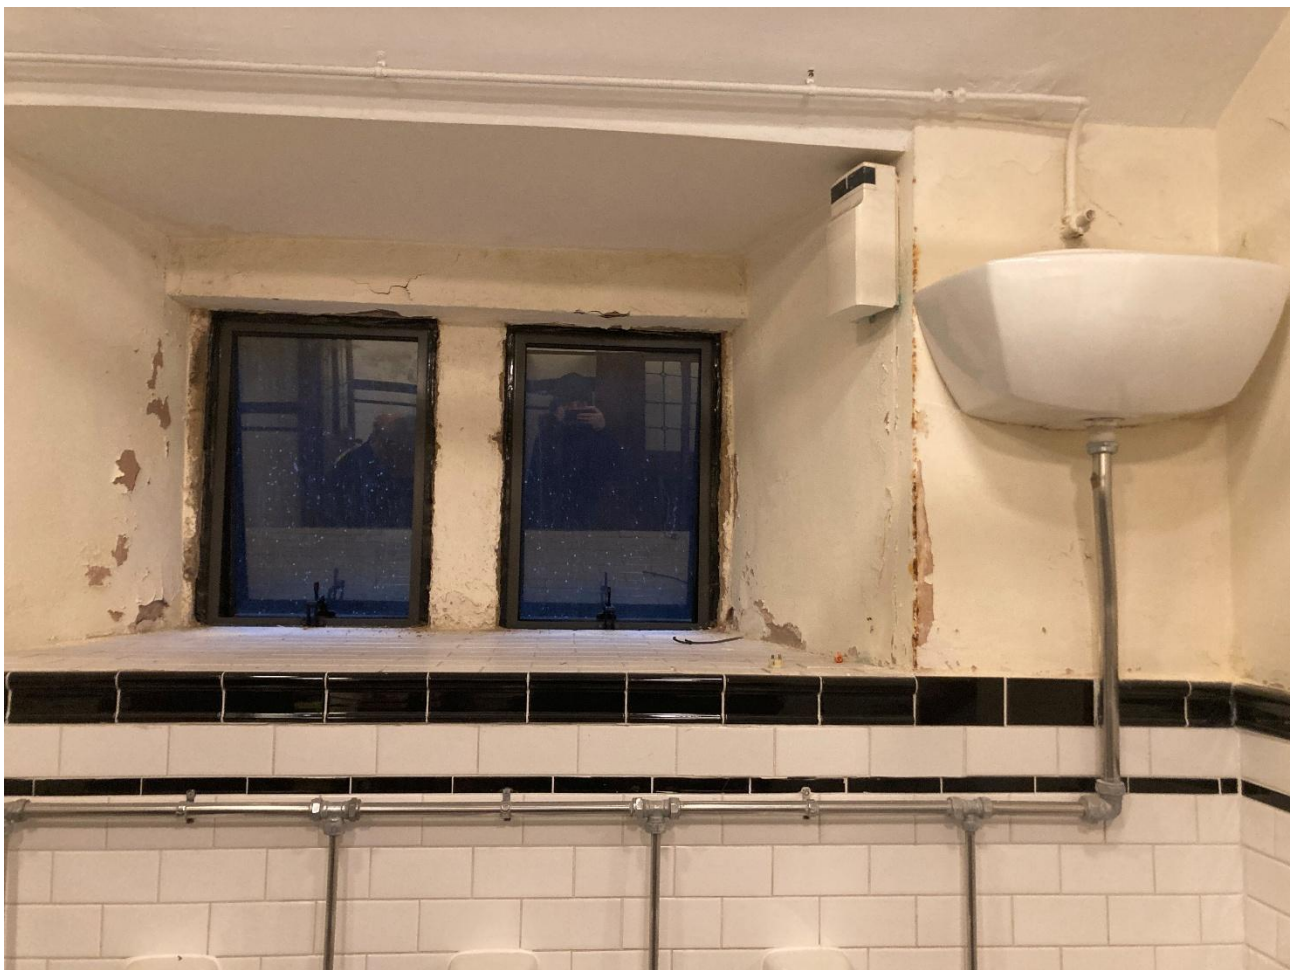
Image 18

1.16 Remove unit from window reveal. See **image 18**
