**Phase II Contaminated Land Risk Assessment**

**Church Avenue, Middleton**

**Sept 2025**

**Site Ref: 6192/VCA-CLRA v1.00**

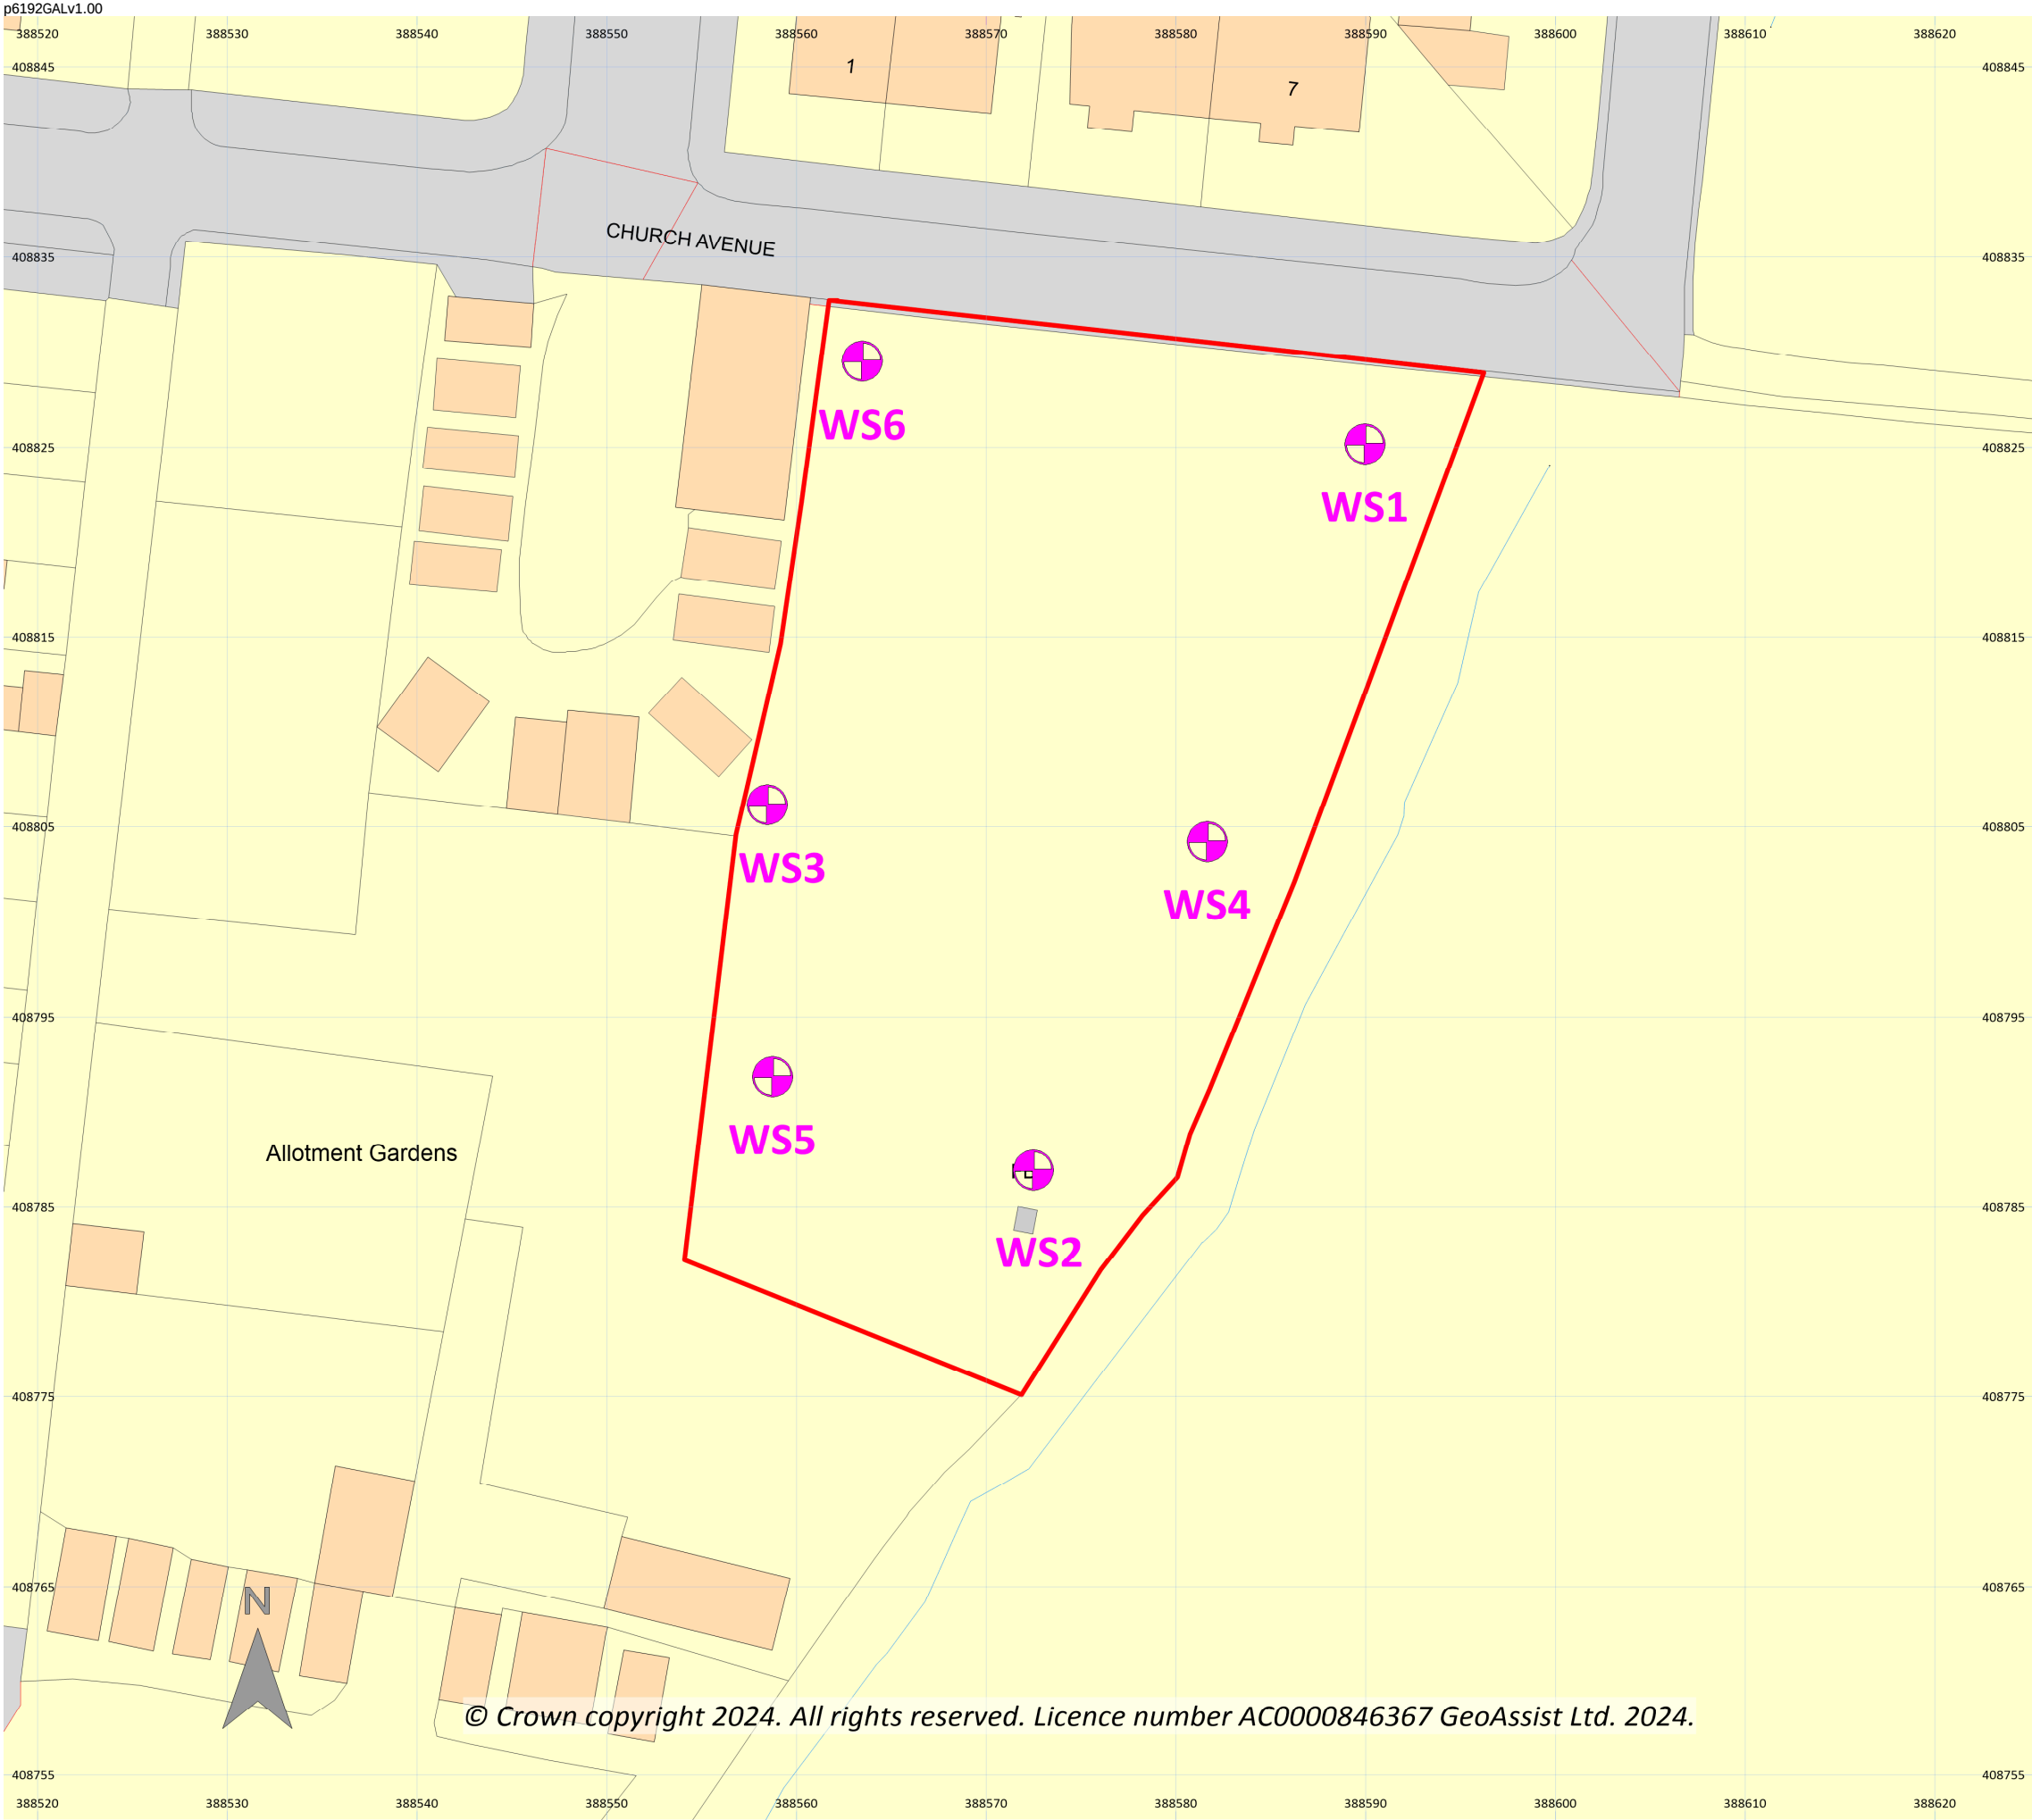
# A1 Site Plan

considered during the positioning of the exploratory holes. A plan showing the locations of the exploratory holes established as part of the investigation forms Appendix A1 to this report.

The fieldwork for all exploratory holes was completed on 07<sup>th</sup> July 2025 in dry weather conditions. The location of the exploratory holes are shown on the site plan in Appendix A1.
