## **Hopwood Hall College, Rochdale Building investigation Test Report**

**Site Address: Hopwood Hall College, St Mary's Gate,  
Rochdale, OL12 6RY**

**Report Ref: STR2829      Issue Number: 01      Issue Date: 28.01.25**

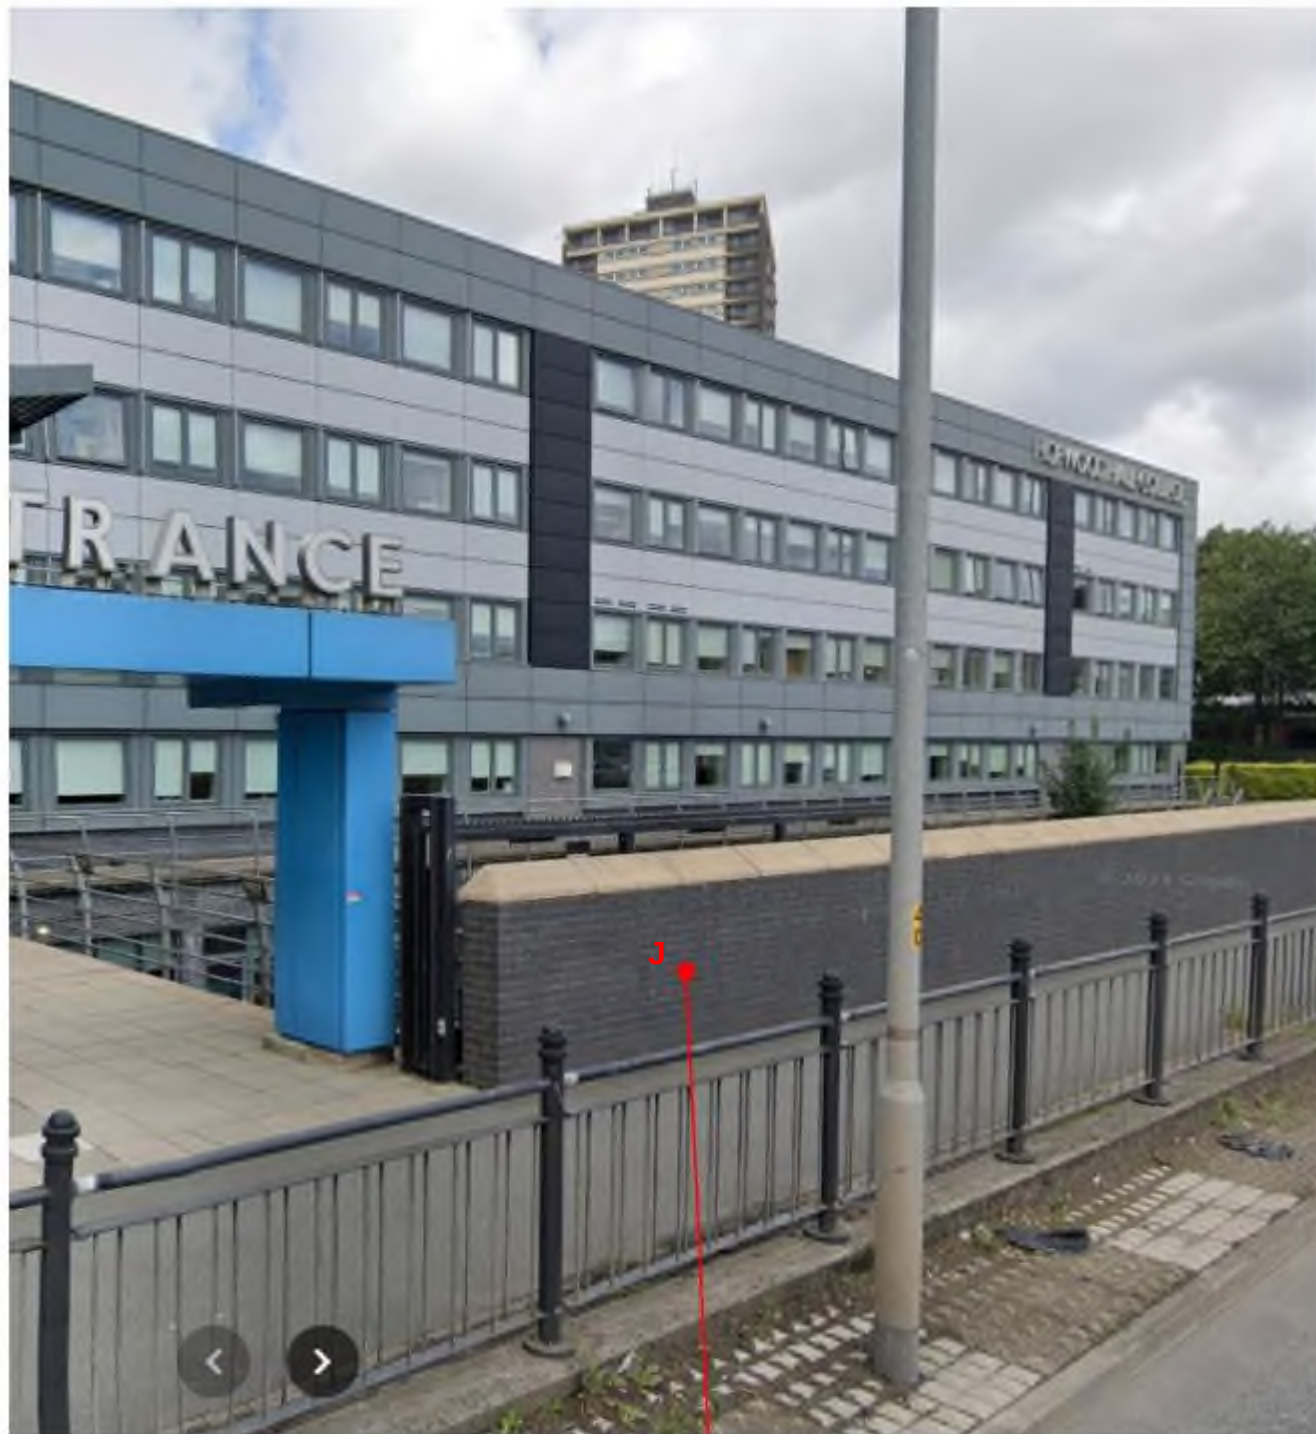
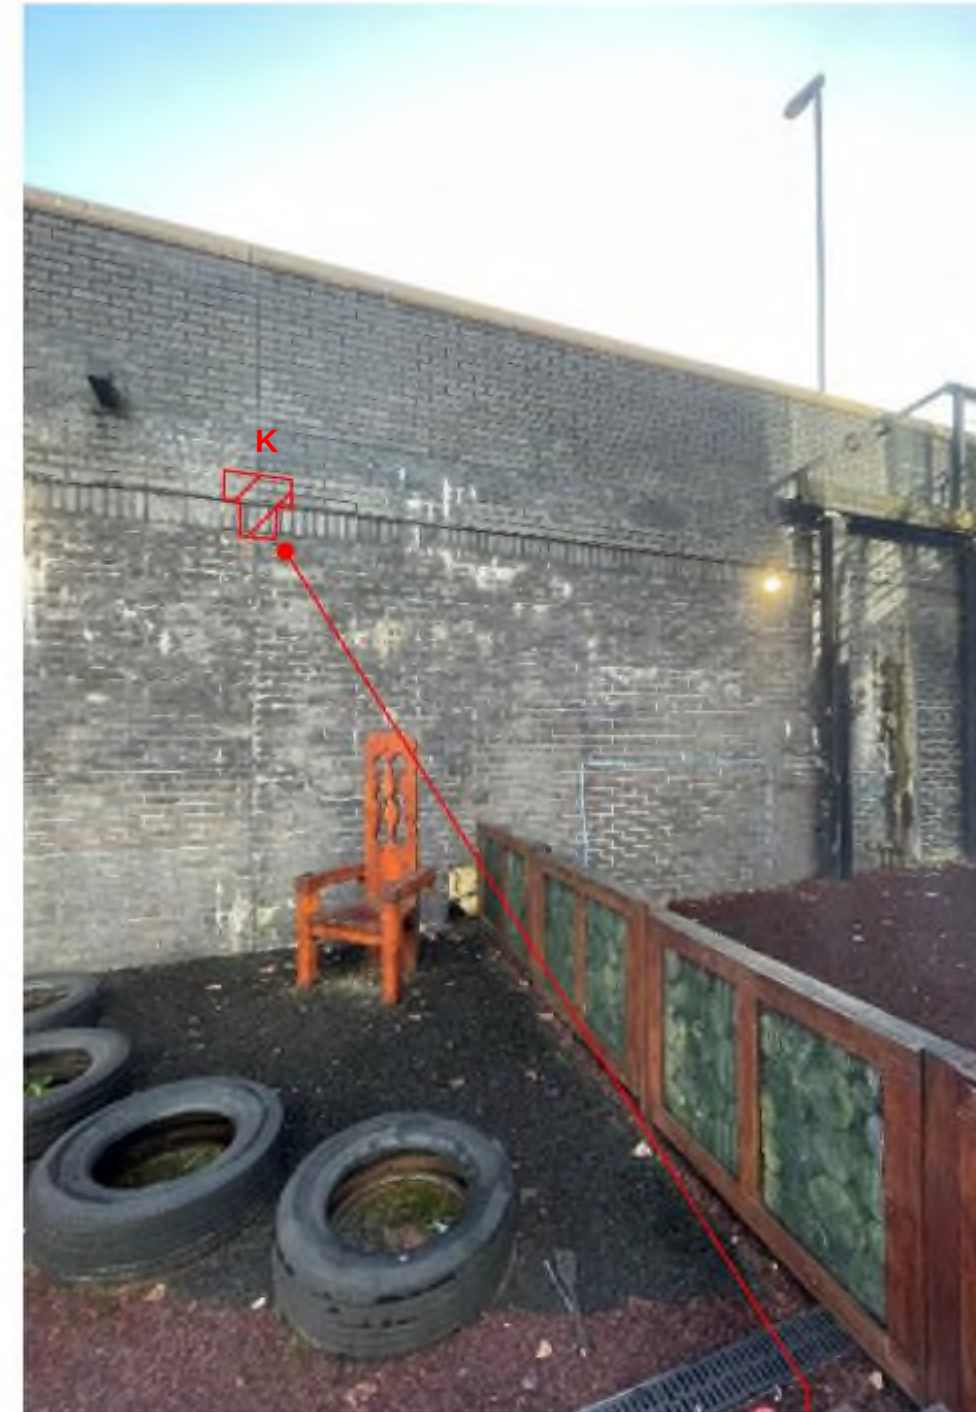
### Indicative inspection locations – St Mary's Gate Wall

Core required through wall to determine build up, thickness and presence of rebar (if concrete)

Area of brickwork to be locally removed to expose detail at soldier course / movement joint. Is there a cavity or does concrete wall extend up?

Solider course is believed to be the head of the original wall before it was extended.

Suitable repair / reinstatement detail required

Brickwork reinstatement required.

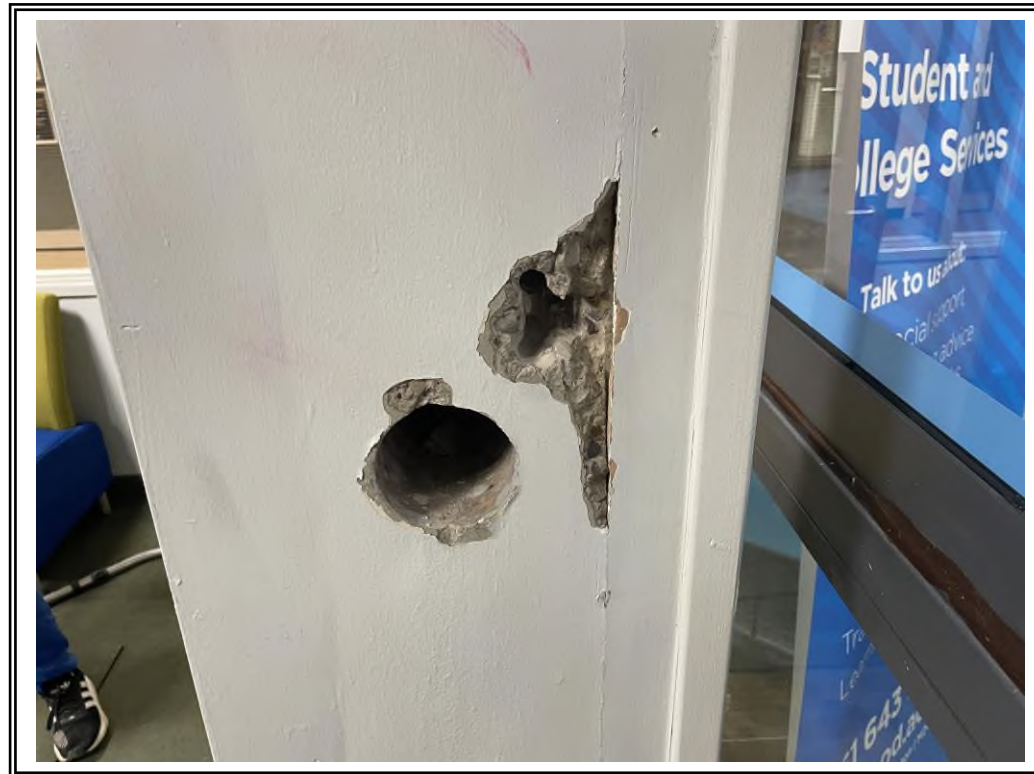
### Core location information

Core 1 – Location D – Column, west face  
Offset 170mm from north edge; 1280mm from ground level

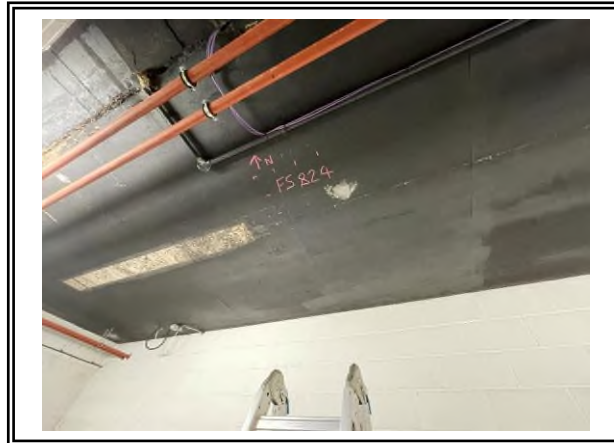
**Location A – Slab joint survey – Scan 824 – Slab, soffit**  
**Top left of scan offset 4200mm from east wall; 930mm from north wall**  
(viewed from below)

Note: Section of mastic removed to expose joint between slabs, no connection between slabs at this location. Scan shows reinforcement on both sides of the joints. Scan 820 (location F) shows reinforcement from top side of slab.

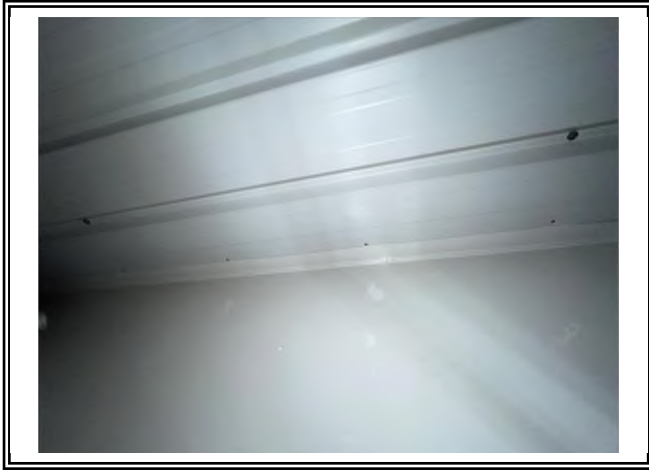
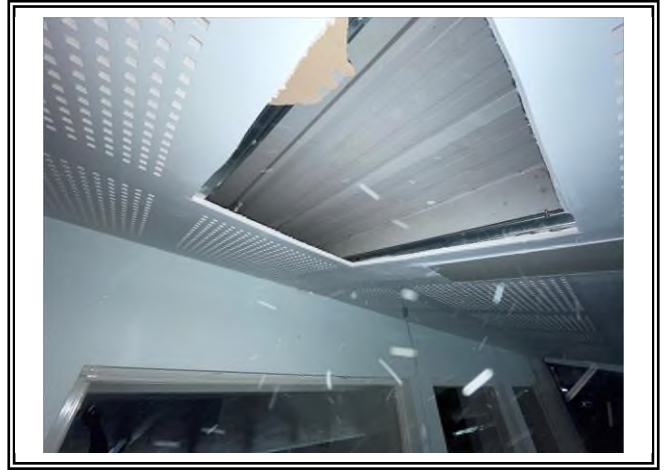
### **Location C – Roof fixing to beam – Photographs**

Corrugated steel roofing is riveted to top of tapered beam at intervals of 470mm.

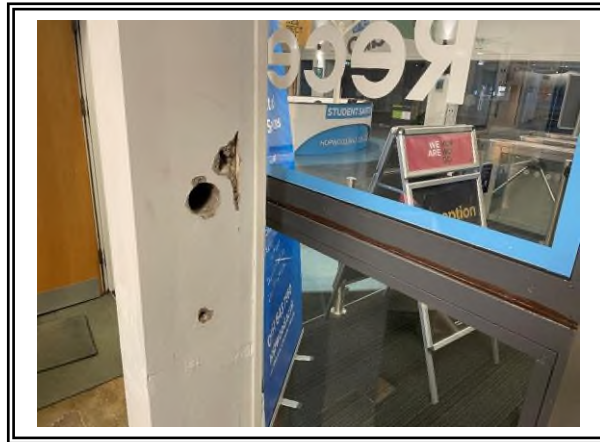
**Location D – Concrete column survey – Breakout 1 – Column, west face**  
**Offset 215mm from north edge; 1340mm from ground level**

Bar 2

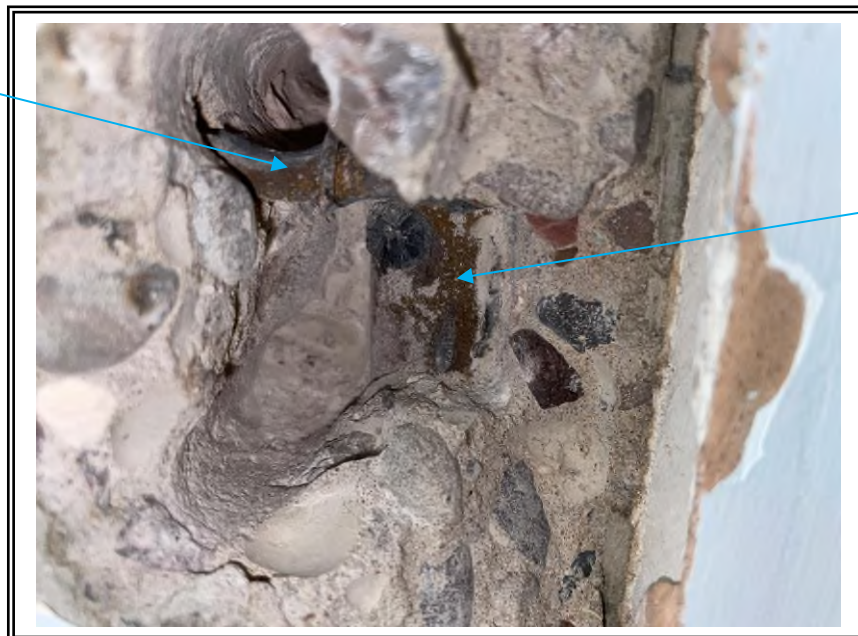
Bar 1

| Bar reference | Bar 1 | Bar 2 |
|---|---|---|
| Type of bar | Square twisted | Smooth round |
| Diameter (mm) | 18 | 6 |
| Cover (mm) | 31 | 25 |
| Condition of reinforcement | Partial surface rust | Partial surface rust |
| Bar spacing (mm) | 220 to next bar | 200 to next bar |

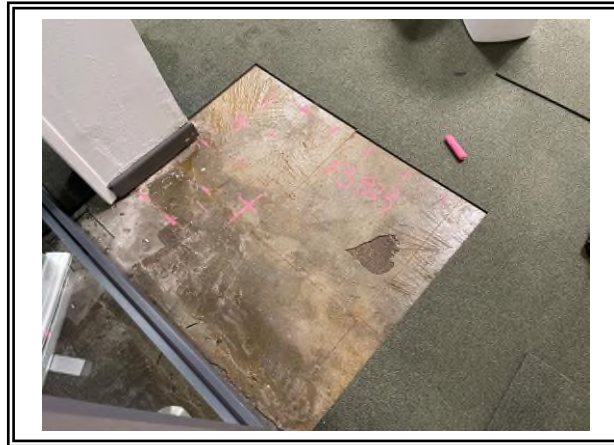
**Location E – Concrete beam survey – Scan 823 – Slab, top face**  
**Top left of scan offset 1770mm from west corridor wall; 820mm from south glass partition**  
(plan view)

Scanned area is 600mm x 600mm

No discernible bars found

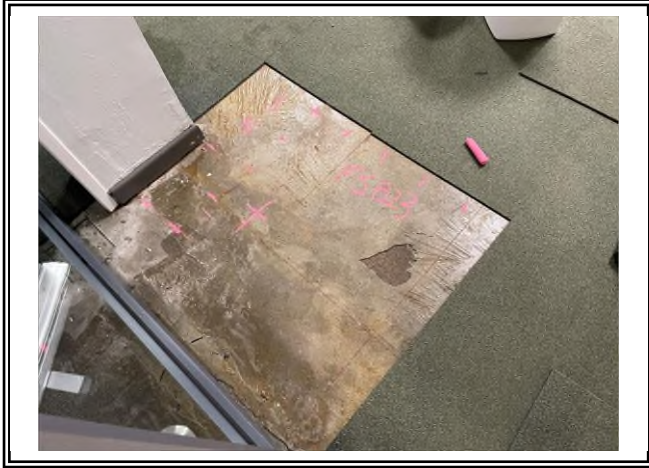
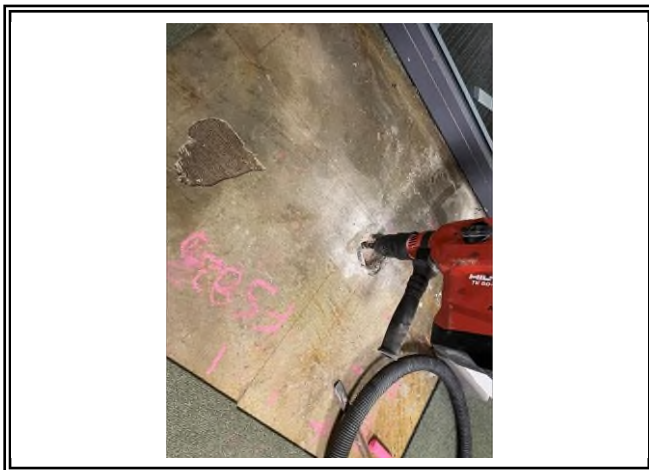
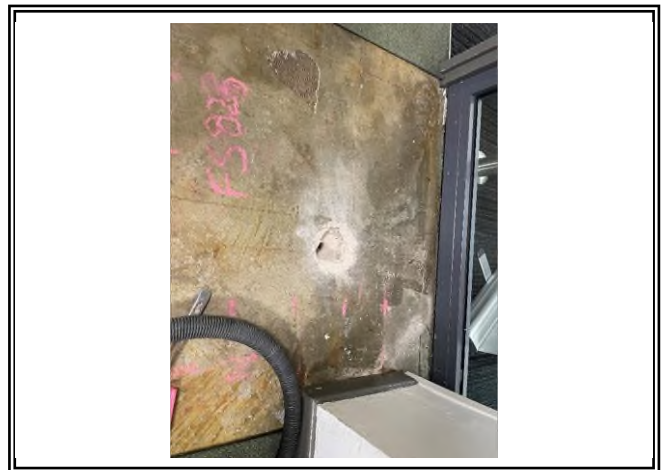
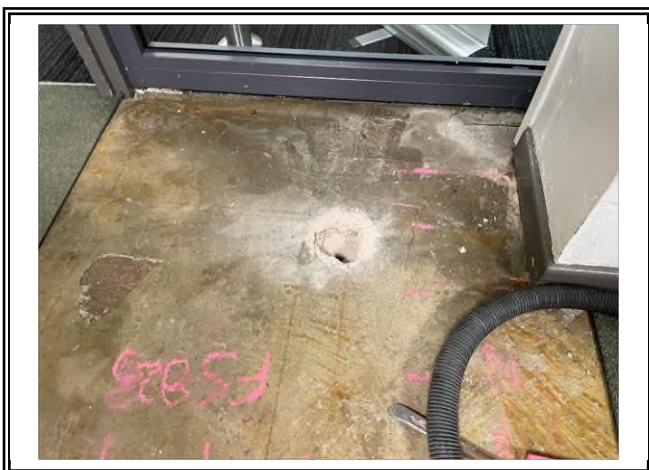
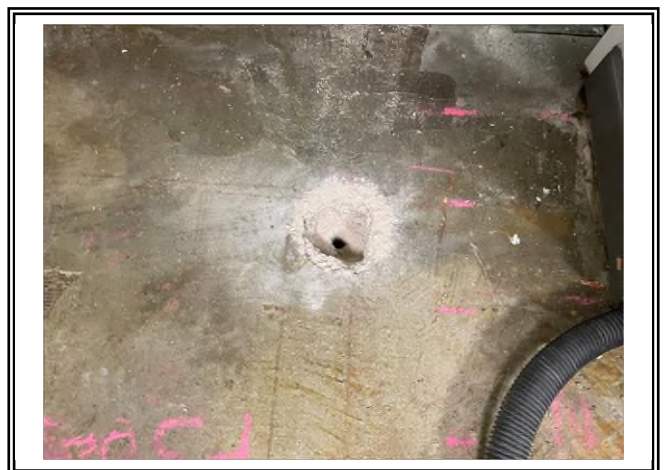
### Location E – Concrete beam survey – Photographs

Unable to determine presence of reinforcement due to unclear scan image. Pilot hole drilled 500mm through slab on beam line then a further 300mm into load bearing masonry wall below slab.

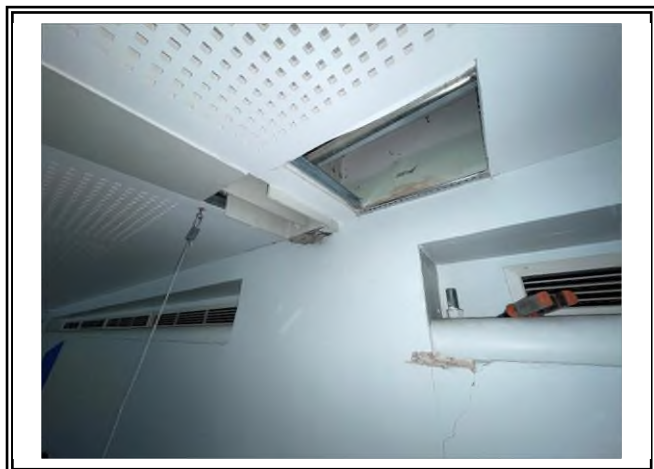
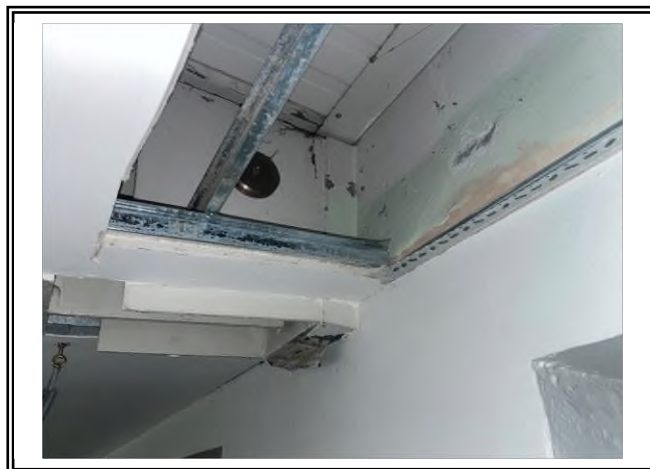
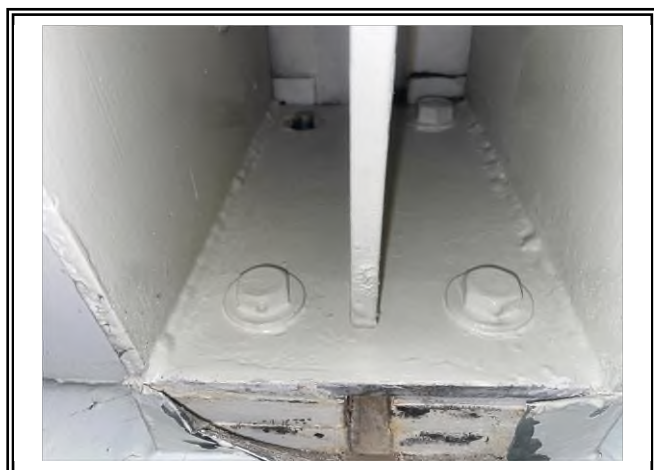
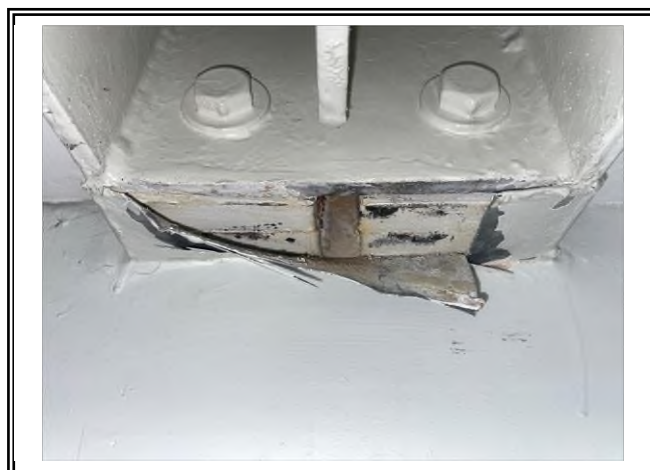
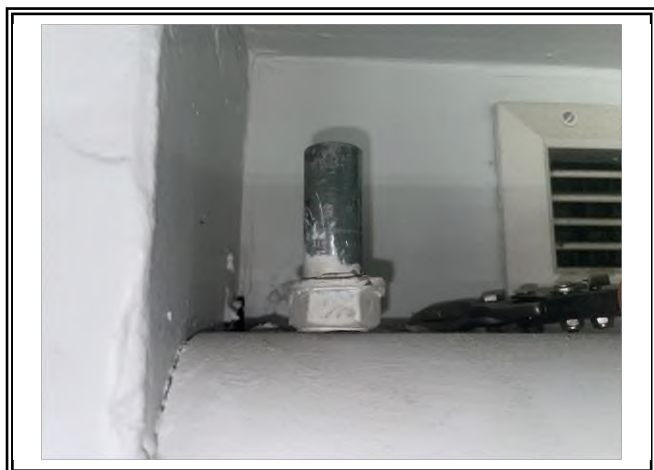
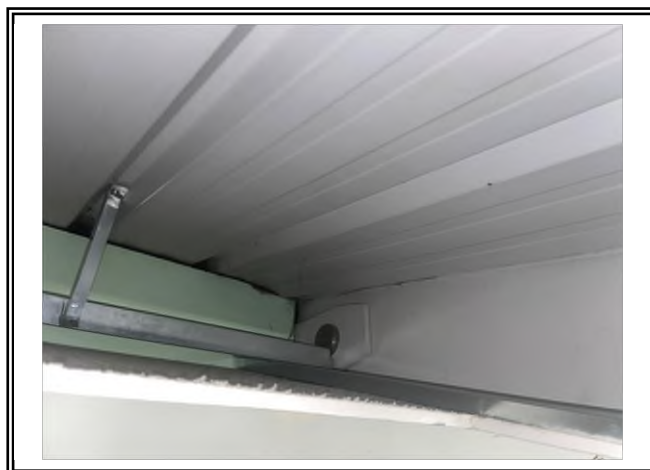
### Location G – Plate build up – Photographs

Location G2 is visually of similar construction to location G1, but unable to measure due to scaffolding.

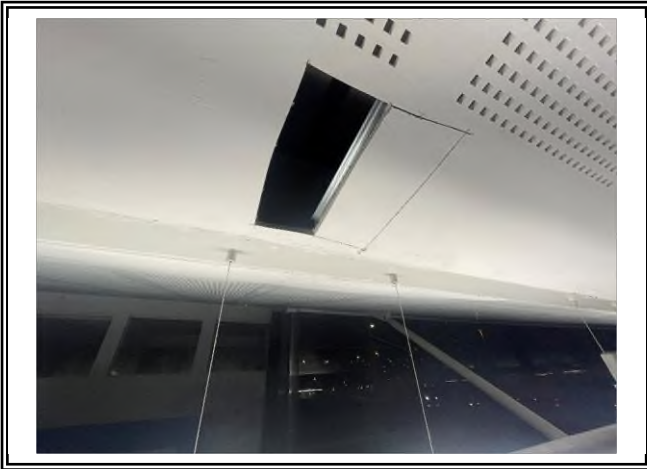
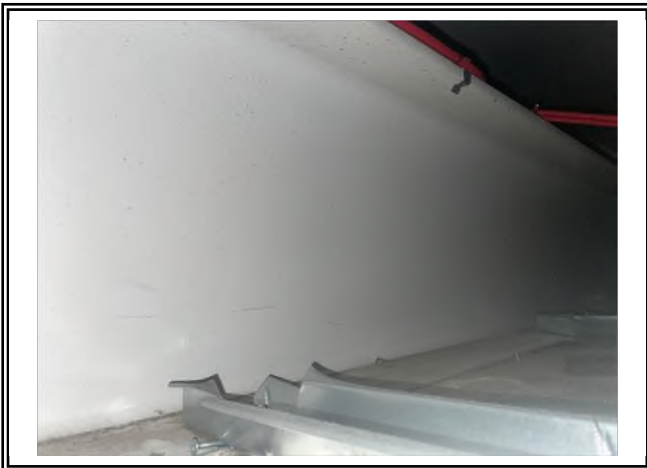
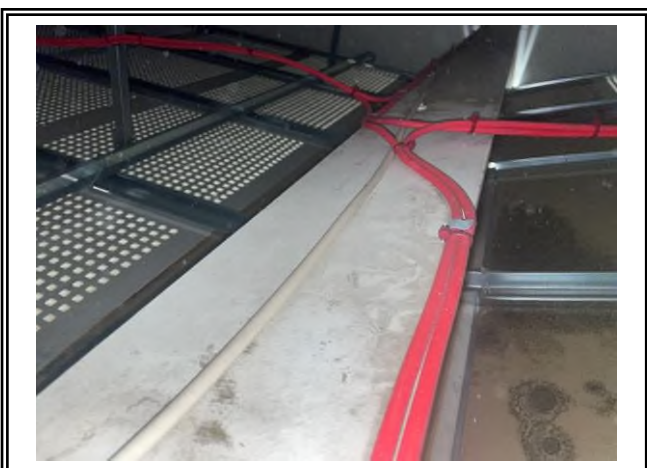
## Location H – Central steel ridge beam – Photographs

Height measurement taken directly above bracing point.
