| CLIENT | Rochdale Borough Council |
| PROJECT | SMP - St Mary's CE Primary School |
| TITLE | Roof - Fabric Repair Plan |
| NUMBER | SMP-SEV-XX-R1-DR-A-02012 |

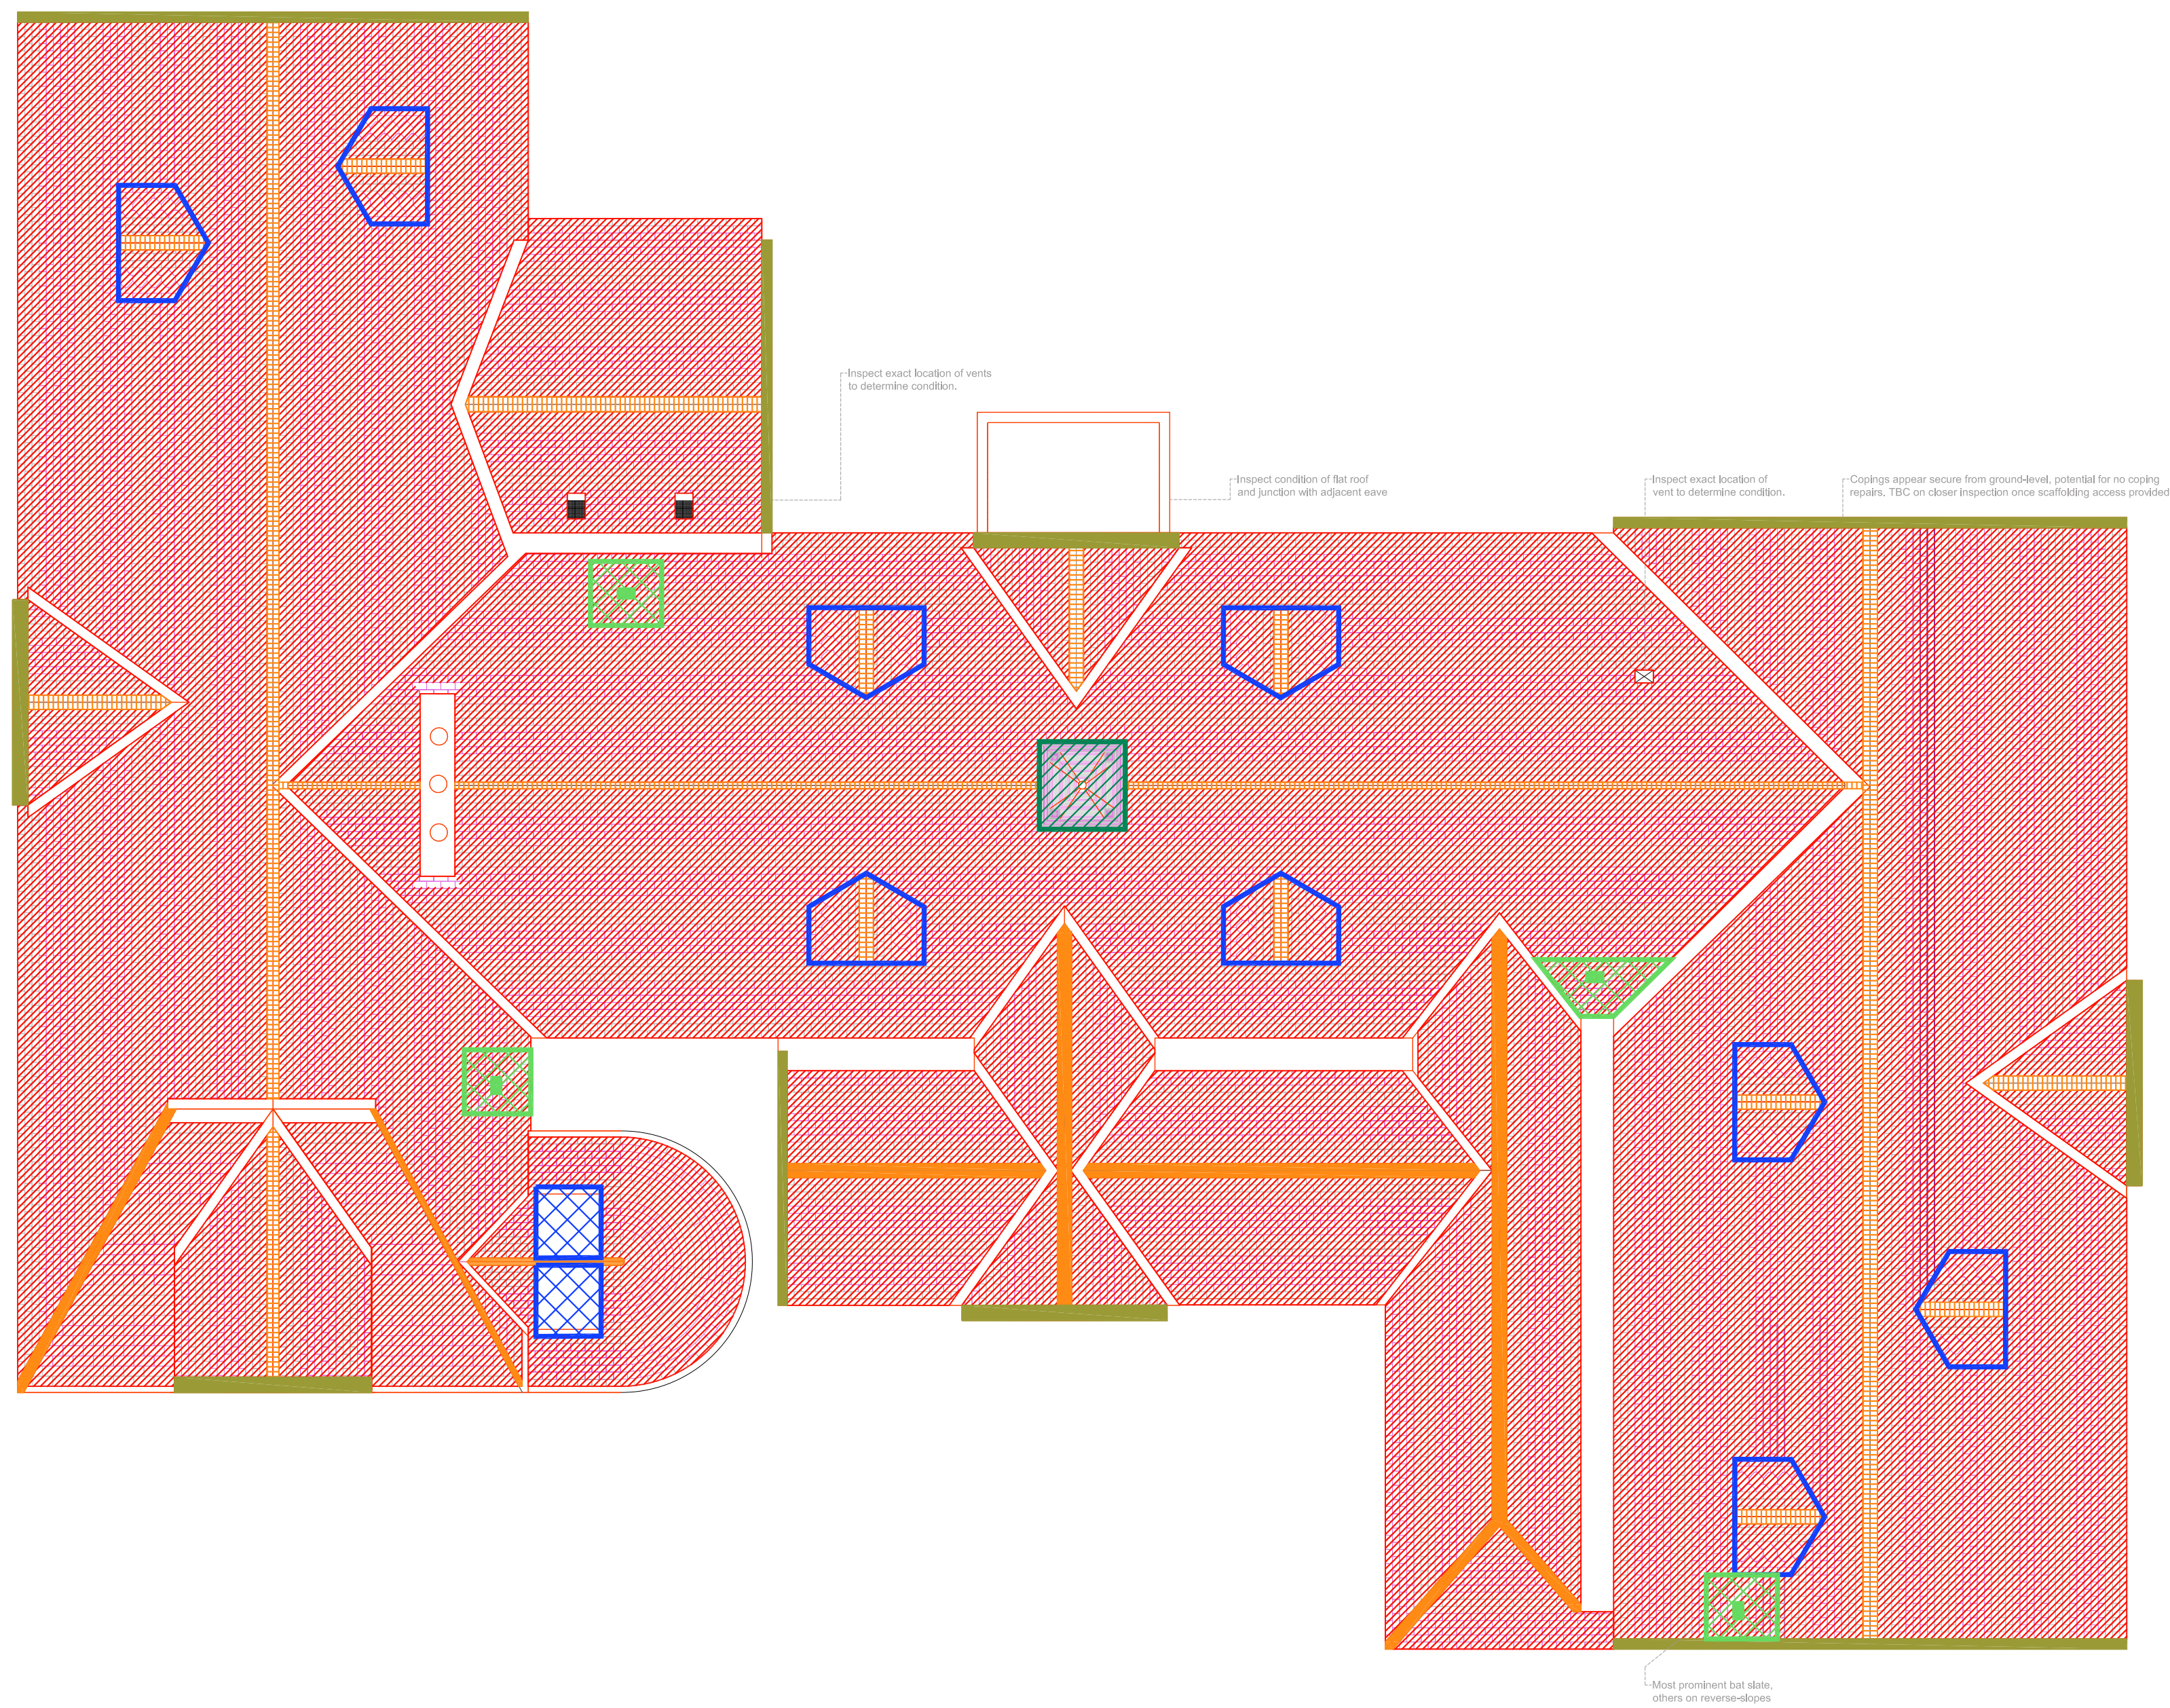
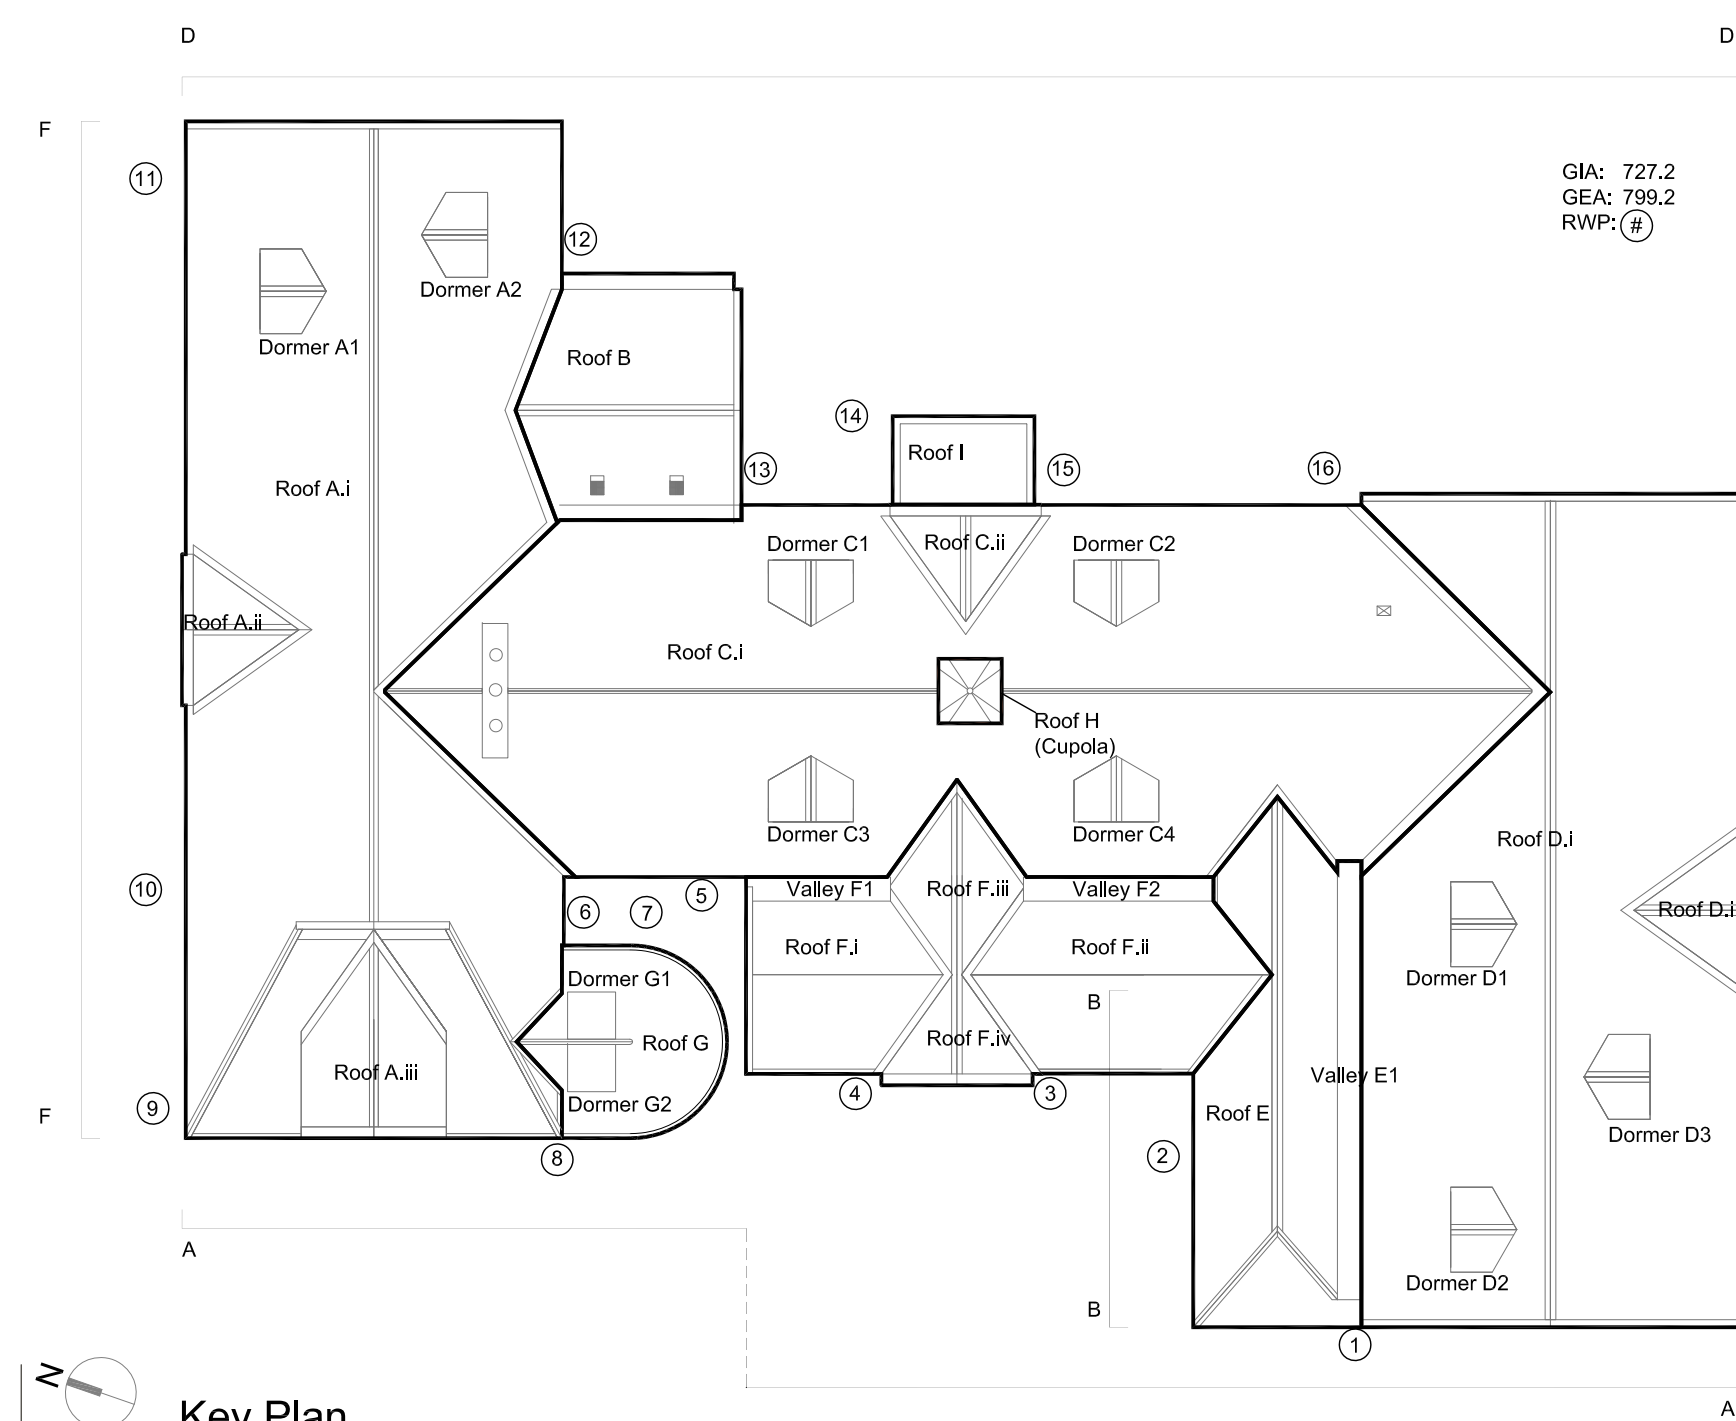
**Roof Slate Restoration:** 762sqm / 8220sqft  
Strip existing slate roof coverings and set aside salvaged slates for re-use. Strip existing battens, felt, lead-lined gutters and gutter structure then safely dispose of any defective material. Re-felt & batten existing roof slope. As per detail A-A in drawing SMP-SEV-XX-XX-DR-A-03100 (Typical Roof Built-Up)

**Dormer Window:** 09 no.  
Splice in new timbers where appropriate. Access to be provided for detailed inspection and methodology agreed. Carefully sand down and repaint in appropriate materials as per the specification. Roofing section per detail F-F in drawing SMP-SEV-XX-XX-DR-A-03105 (Typical Dormer Window)

**Cupola:** 01 no.  
Splice in new timbers where appropriate. Access to be provided for detailed inspection and methodology agreed. Carefully sand down and repaint in appropriate materials as per the specification. Cupola roofing is as per the building's other slate roof eaves, but is at a steeper gradient (assume larger area than in plan).

**Decorative Ridge Tiles:** 105 Lm  
Ridge tiles to be removed and set aside with salvaged tiles for re-use.  
Replace damaged tiles as per the existing style. Ridge ventilation provided with new linear vent.  
Ridge venting per detail F-F in drawing SMP-SEV-XX-XX-DR-A-03105 (Typical Dormer Window)

**Flat Ridge Tiles:** 50 Lm  
Ridge tiles to be removed and set aside with salvaged tiles for re-use.  
Replace damaged tiles like-for-like.

**Stone Capping:**  
Take up and re-bed any loose or damaged existing stone capping places and re-point. Ensure appropriate stiff mortar (NHL 3.5 Lime Mortar) applied to capping sections. Ensure that new capping pieces be required; sample cappings to be provided to ensure secure structure.

**Non-Gabled Dormer Windows:**  
‘Shed Dormer’ windows with flat felt topping. Splice in new timbers where appropriate. Access to be provided for detailed inspection and methodology agreed. Carefully sand down and repaint in appropriate materials as per the specification. Remove felt and re-top with terne-coated stainless steel (TCSS) with a round-batten seam to match Historic England (HE) Guidelines.

**Slate Tiles:**  
Grey and Grey-Purple slate tiles.  
To be relocated in the same location/pattern as existing, with photographic records used to ensure consistency. Methodology to be agreed with Conservation Officer regarding relocation of any slates.

**Bat Slate:** [Dashed Hatch Approx. Location. Solid Hatch Exact Location]  
Integrated Bat access state: metal vent to allow access for bats into roof void, with sufficient gap cut into roof structure underneath. Fitted within a hole cut to slate which is placed over the vent to reduce visual impact. 1no. Bat Slate located in area of observed bat emergence (west wing of the building, facing north, adjacent to Dormer D2) and then 3no. supplementary ‘enhancement slates’ along remaining gables (north, east, south).
