## PRELIMINARY RISK ASSESSMENT REPORT FOR HOPWOOD HALL COLLEGE, ROCHDALE

**TE1880-TE-00-XX-RP-GE-001-V03**

**12 MARCH 2025**

Wilmott Dixon Construction Ltd

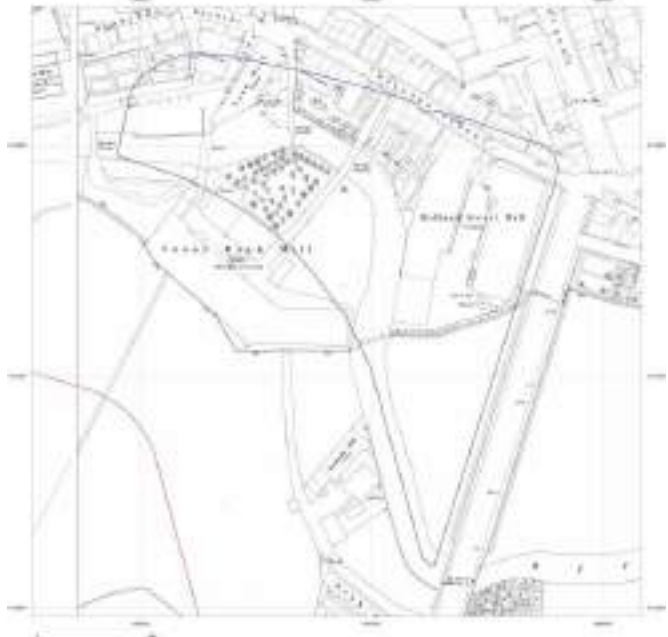
| Time Period | On-site features | Off-site features |
|---|---|---|
| Pre-1900 | <p>1851</p> <ul style="list-style-type: none"> <li>Holland Street Mill (cotton) is present in the northeast of the site, inclusive of a pump, and extending into the southeast of the site during the 1890s. Town Mill (fulling) and dye works are present in the northwest, with tank shown in the southwest of the site by 1890. A second dye works is shown immediately adjacent to the northwestern boundary (which whilst not within the planning boundary, is understood to form a wider part of the site ownership).</li> <li>Holland Street and the (presumed) residential properties lining it to the north encroaches into the northeastern corner of the site, trending approx. NW to E, and into the northwest of the site trending approx. north to southwest</li> </ul> | <ul style="list-style-type: none"> <li>A mixture of presumed residential and industrial properties are present within the immediate vicinity of the site, including a boiler house, tanks, weighing machines and cess pool to the north, dye works extending off to the northwest, Sunny Bank Mill (woollen and cotton) and Bankside Mill (cotton) to the south. Rochdale Cricket ground is labelled to the south of these.</li> <li>Numerous mills (predominantly cotton) are present within the close surrounding vicinity of the site, with a cattle market present approx. 20m east of the site.</li> <li>Manchester New Road is present immediately beyond the eastern boundary, with (presumed) residential properties and parks present further east.</li> </ul> |

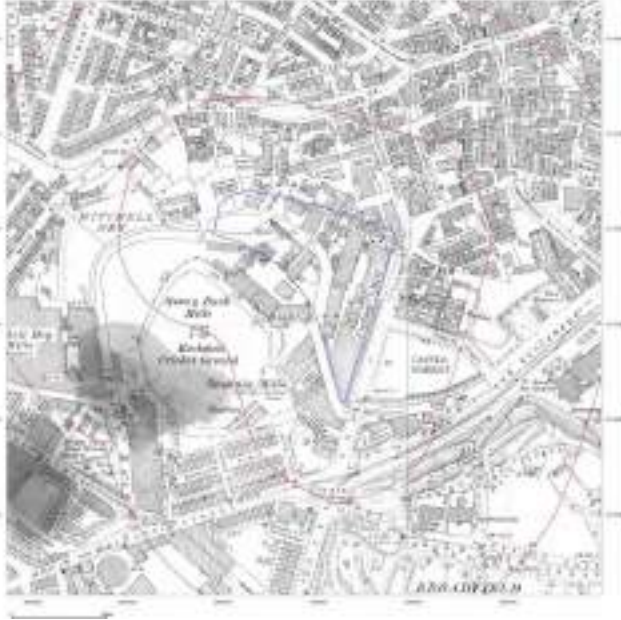
| Time Period | On-site features | Off-site features |
|---|---|---|
| 1900 to 1939 (Pre-war period) | <p>1930</p> | |
| | <ul style="list-style-type: none"> <li>No significant change</li> </ul> | <ul style="list-style-type: none"> <li>No significant change</li> </ul> |

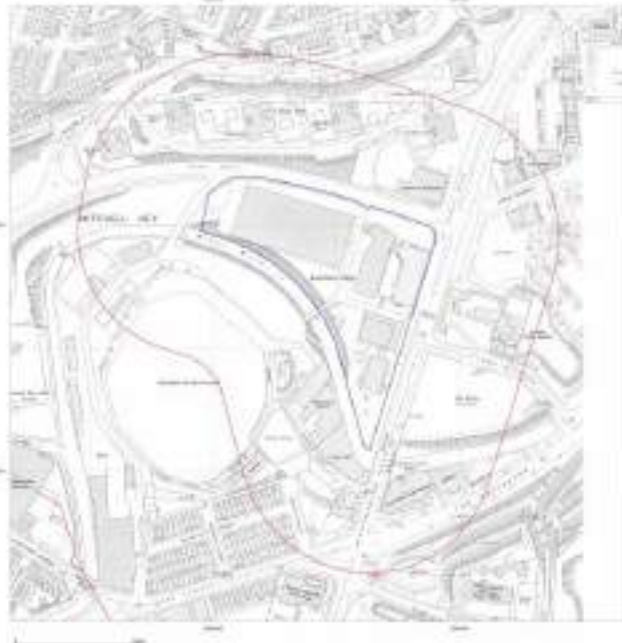
| Time Period | On-site features | Off-site features |
|---|---|---|
| 1960-1980 (Mid to late 20th Century period) | | |
| | <p>1967-1972</p> <ul style="list-style-type: none"><li>The River Roch has been infilled through the site, and has been rerouted to flow offsite parallel to the southwestern boundary. Embankments are shown along its banks, suggesting a raising of levels may have occurred on site</li><li>The former buildings and allotments in the north west of the site have been demolished and replaced with a large rectangular building, labelled along with other buildings on site as Rochdale College.</li></ul> | <ul style="list-style-type: none"><li>Holland Street immediately beyond the northern boundary (and on site) has been rerouted to become a straight road roughly orientated east to west, and renamed Bury Road.</li><li>High rise residential buildings and a telephone exchange replace the former mills present from approx. 50m north of the site. This area may have also been built up significantly as an embankment is shown, approx. 10m north of the site.</li><li>The ironworks 250m southwest of the site is no longer shown</li></ul> |

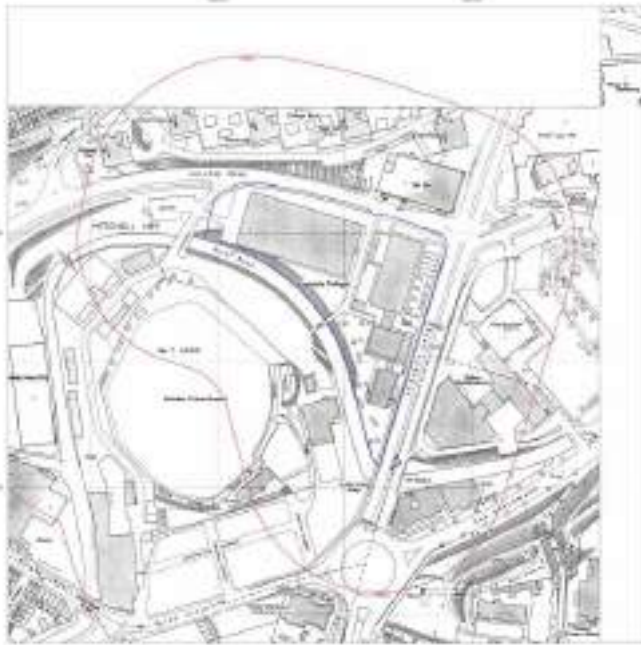
| Time Period | On-site features | Off-site features |
|---|---|---|
| 1980 – 2000 (Late 20th century period) | <div> <p>1979-1981</p> </div> | |
| | <ul style="list-style-type: none"> <li>The northeastern and southeastern college buildings appear to have been linked together</li> </ul> | <ul style="list-style-type: none"> <li>The gas works and adjacent works approx. 250m to the southwest of the site appear to be undergoing partial demolition by 1987</li> </ul> |

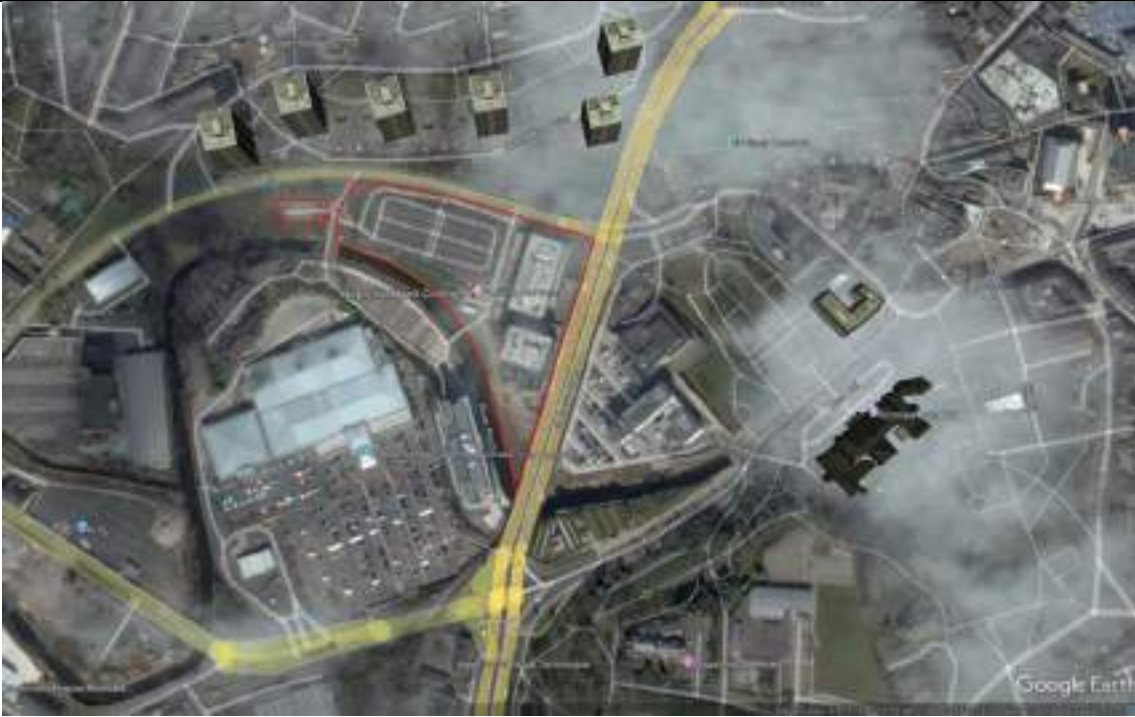
| Time Period | On-site features | Off-site features |
|---|---|---|
| 2000 to 2025 (Modern day period) | <p>Google Earth Aerial Imagery dated 2013</p> | |
| | <ul style="list-style-type: none"> <li>• Google Streetview last shows the large building in the northwest on imagery dated 2008, with the car park surfacing to be in completion in May 2012. The car park is shown in use by 2013 as shown on Google Earth Aerial Imagery. The smaller building in the south of the site is also shown to be undergoing demolition in this image.</li> </ul> | <ul style="list-style-type: none"> <li>• The former cricket ground and mill/works buildings have been redeveloped into a supermarket and commercial properties</li> </ul> |
