## Remediation Strategy

Land off Oldham Road, Rochdale

Report Status

| Report Number | 002 |

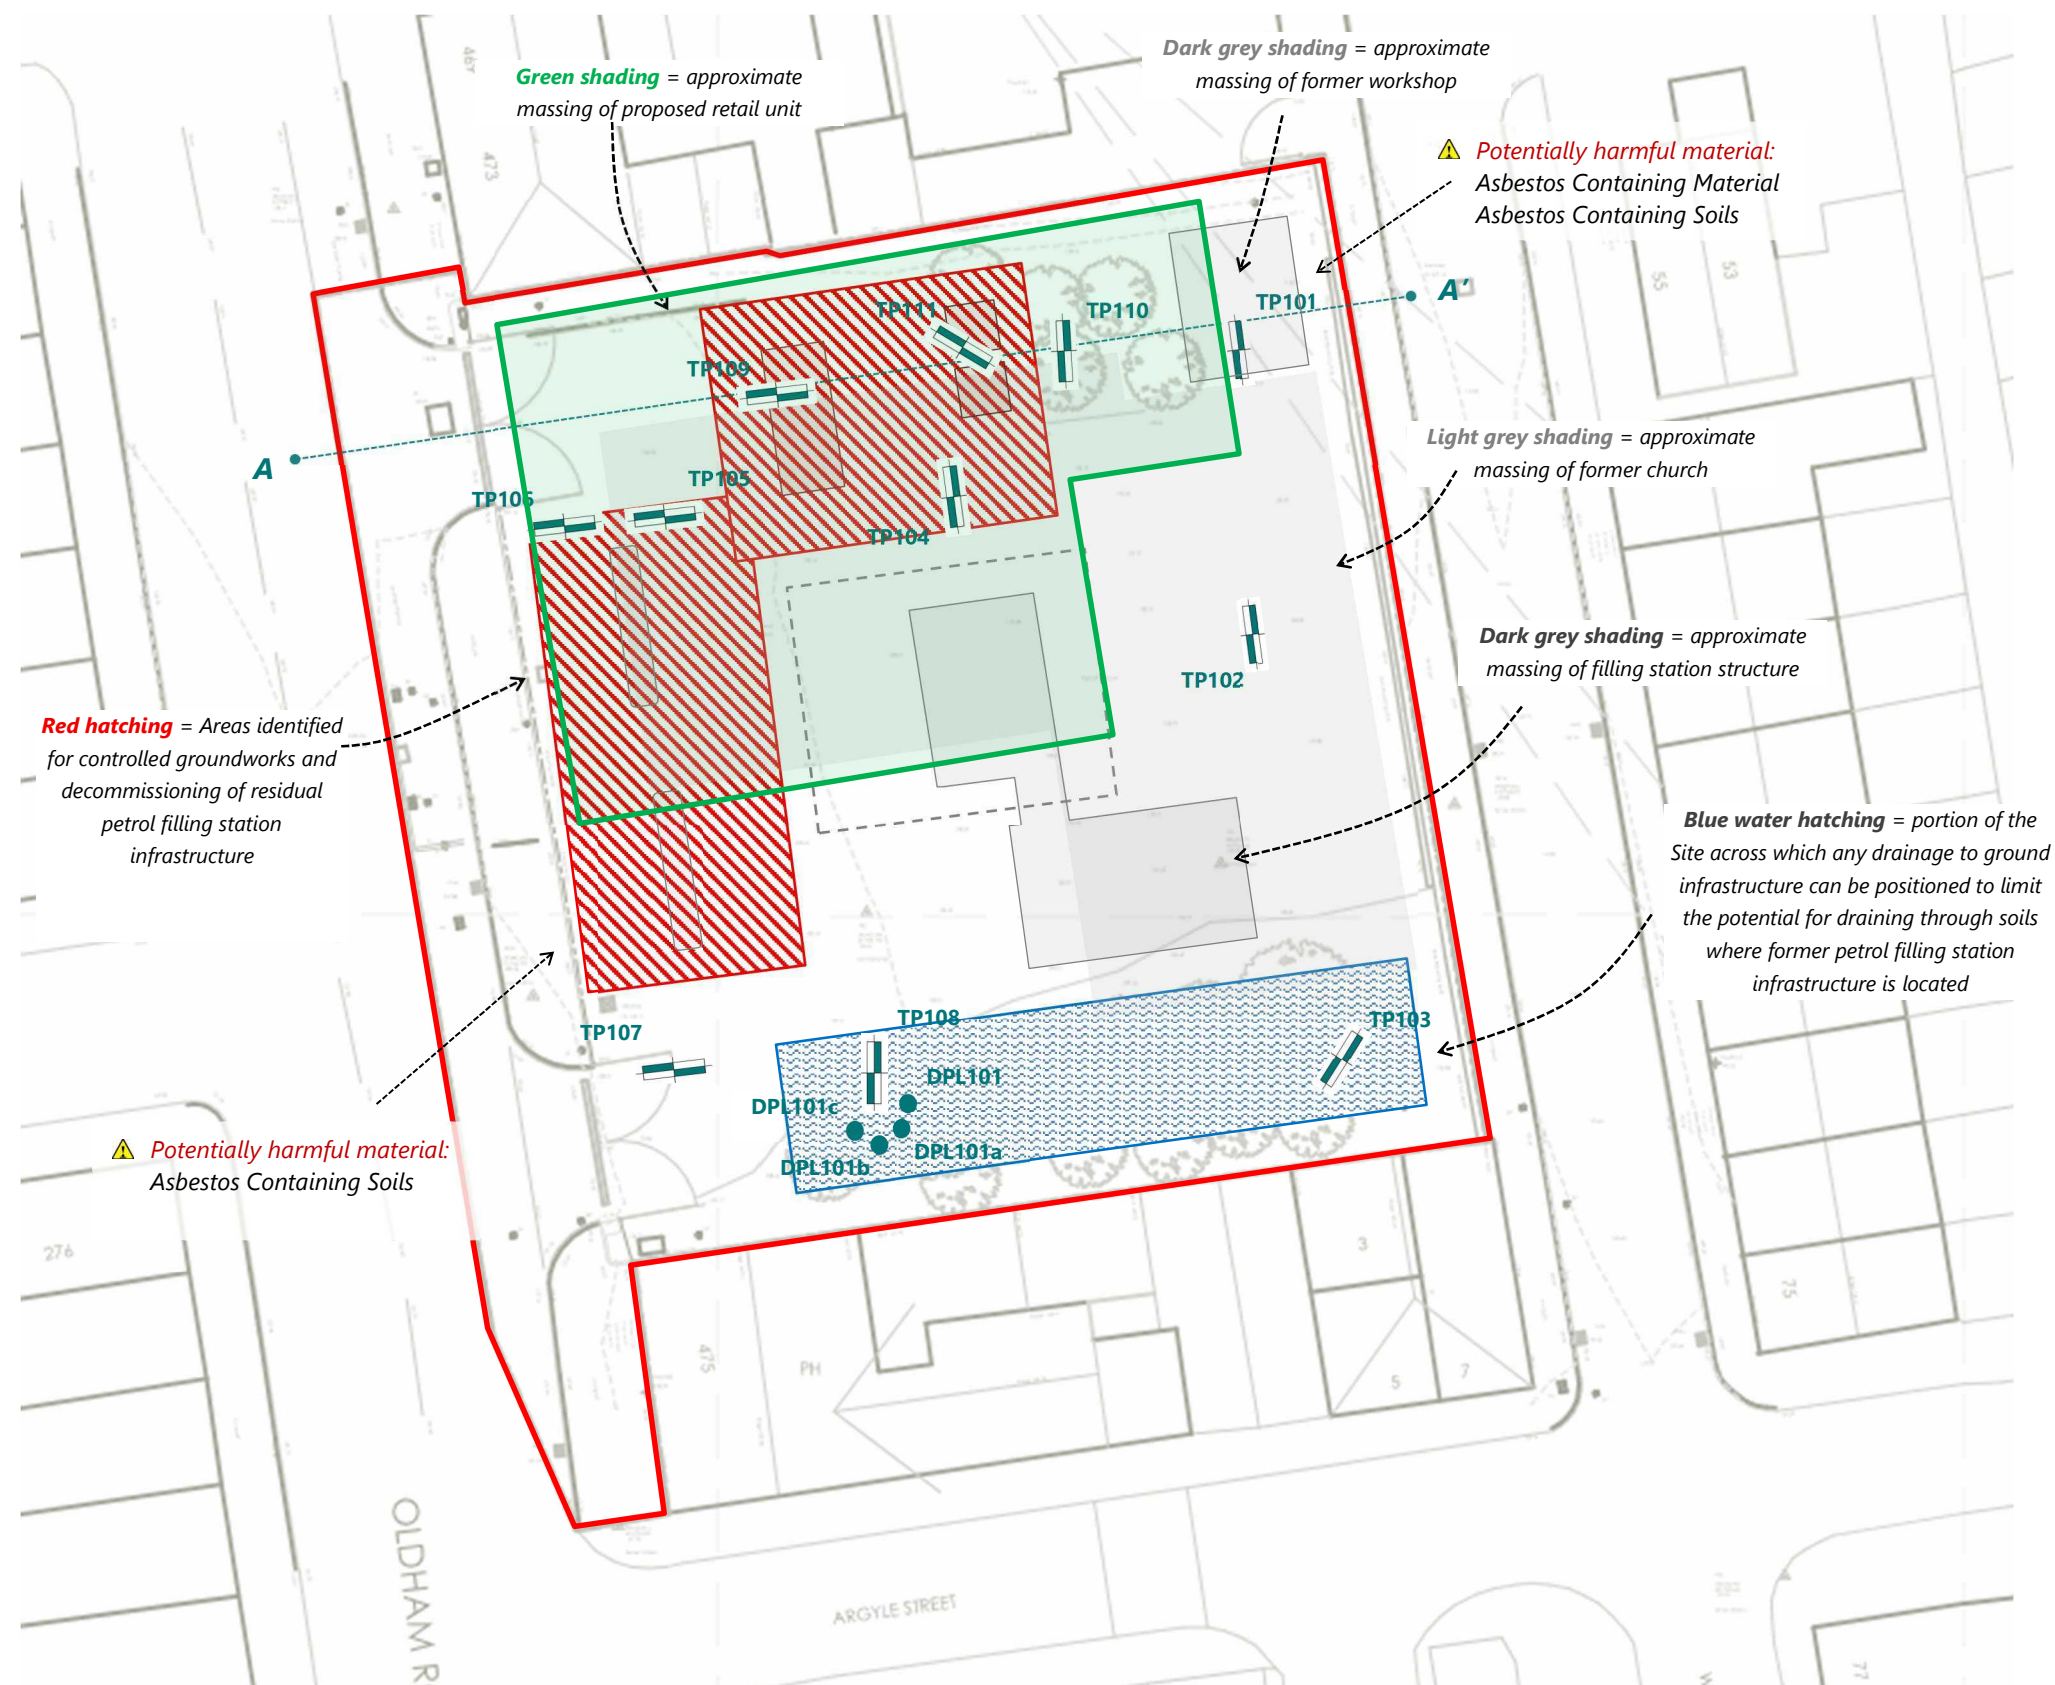
**Conceptualisation of Post-Development Condition of the Site** (adapted from Ground Model - Plan in Section 5.0 of the Ground Investigation Report)

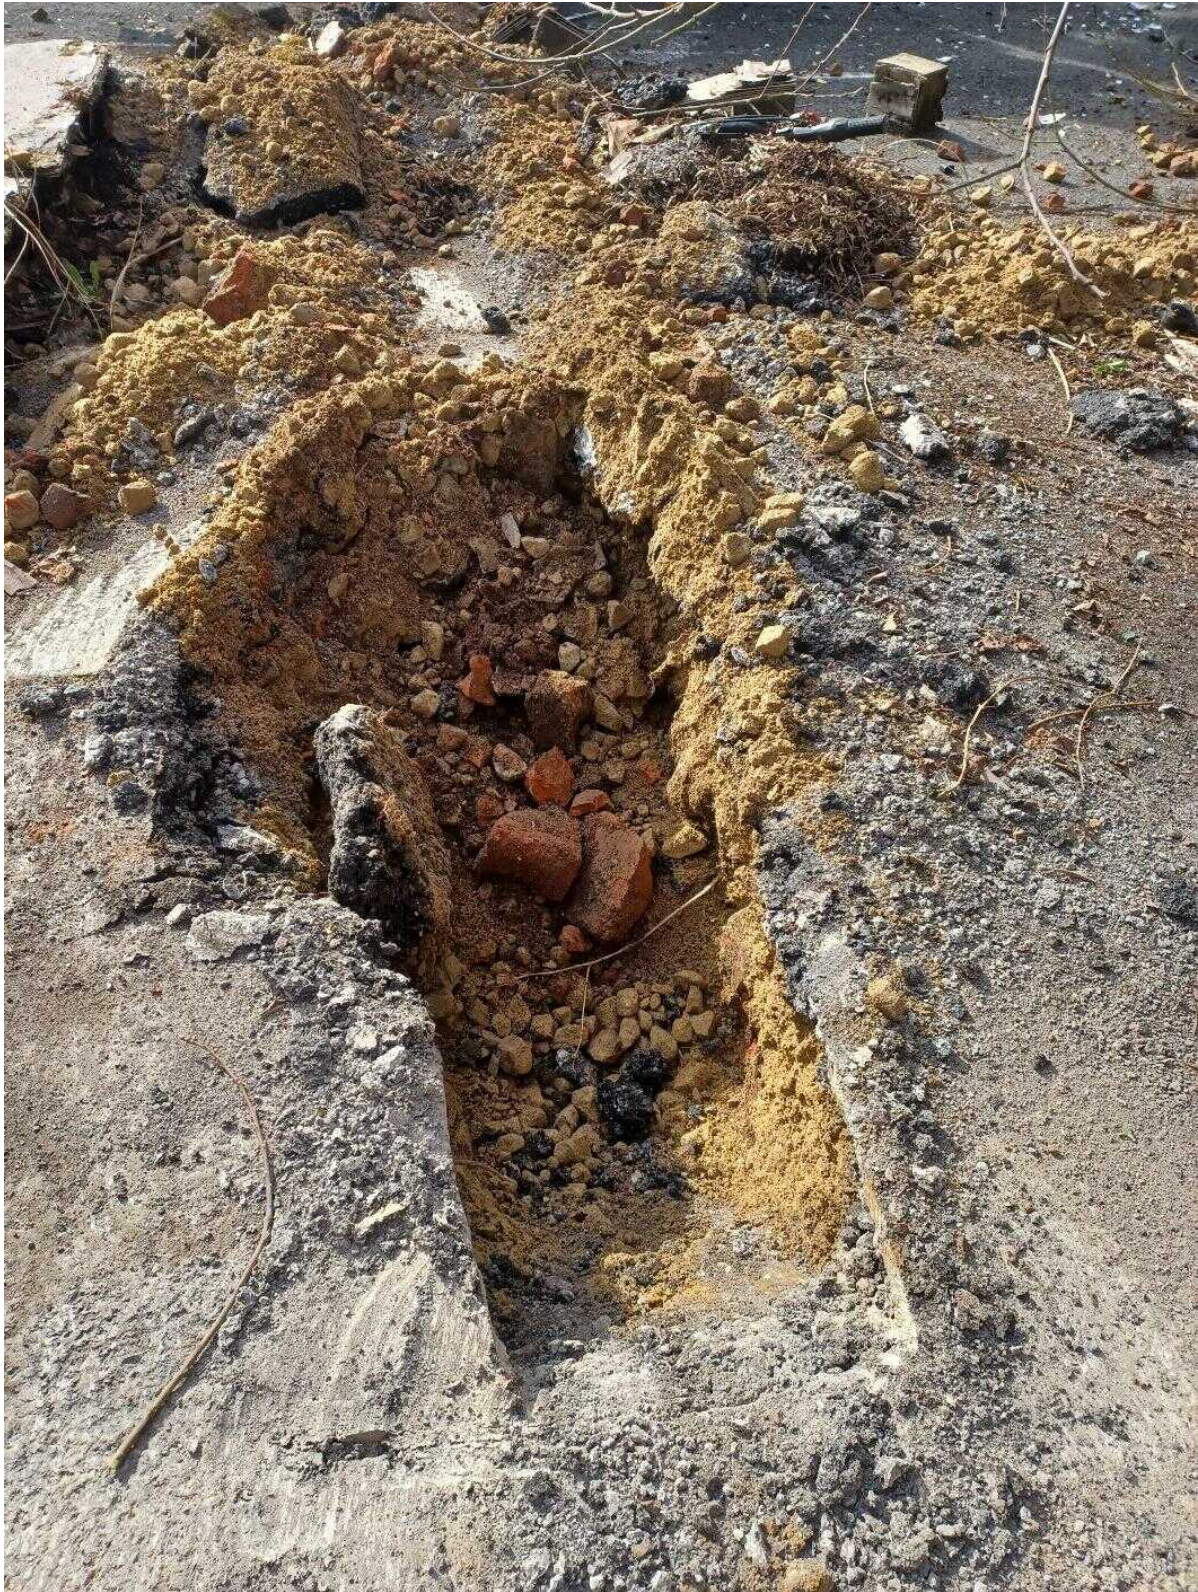
| Remarks<br>PURPOSE: General coverage of the Site. TERMINATION: Frequent, suspected asbestos containing material (ACM) encountered. LOCATION: Surveyed using freeware on Site. GL: Estimated off topographical survey. STABILITY: Stable. GROUNDWATER: None encountered. OTHER: No evidence of potentially harmful or polluting material other than ACM. | Method, Plant, Stability, Dimensions<br>0.00 - 0.60m TP - Trial Pit tonne tracked<br>Stable<br>L = 1.20m<br>W = 0.60m | Logger<br>RB |

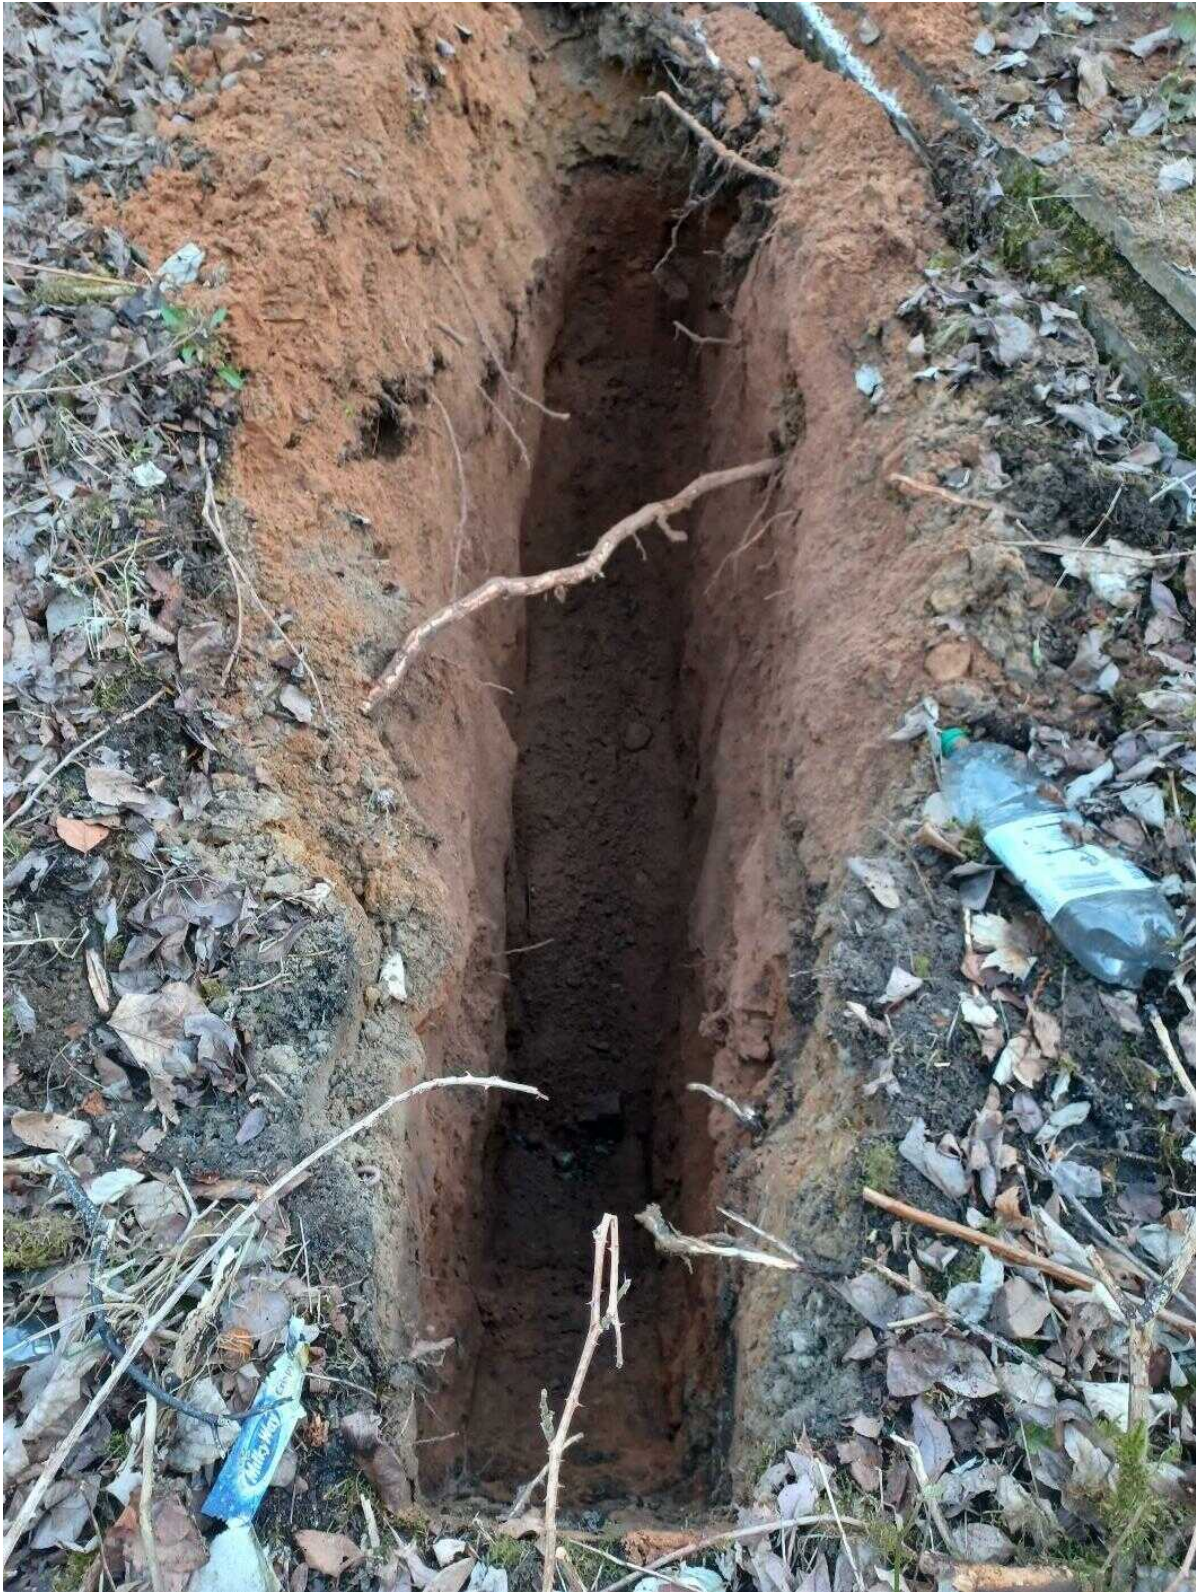
| Remarks<br>PURPOSE: General coverage of the Site. TERMINATION: Engineer decision, target depth achieved. LOCATION: Surveyed using freeware on Site. GL: Estimated off topographical survey. STABILITY: Side wall collapse adjacent to relic wall to depth of 1 m below ground level. GROUNDWATER: None encountered. OTHER: No evidence of potentially harmful or polluting material. | | | Method, Plant, Stability, Dimensions<br>0.00 - 1.90m TP - Trial Pit tonne tracked<br>Unstable<br>L = 2.00m<br>W = 0.60m | | |

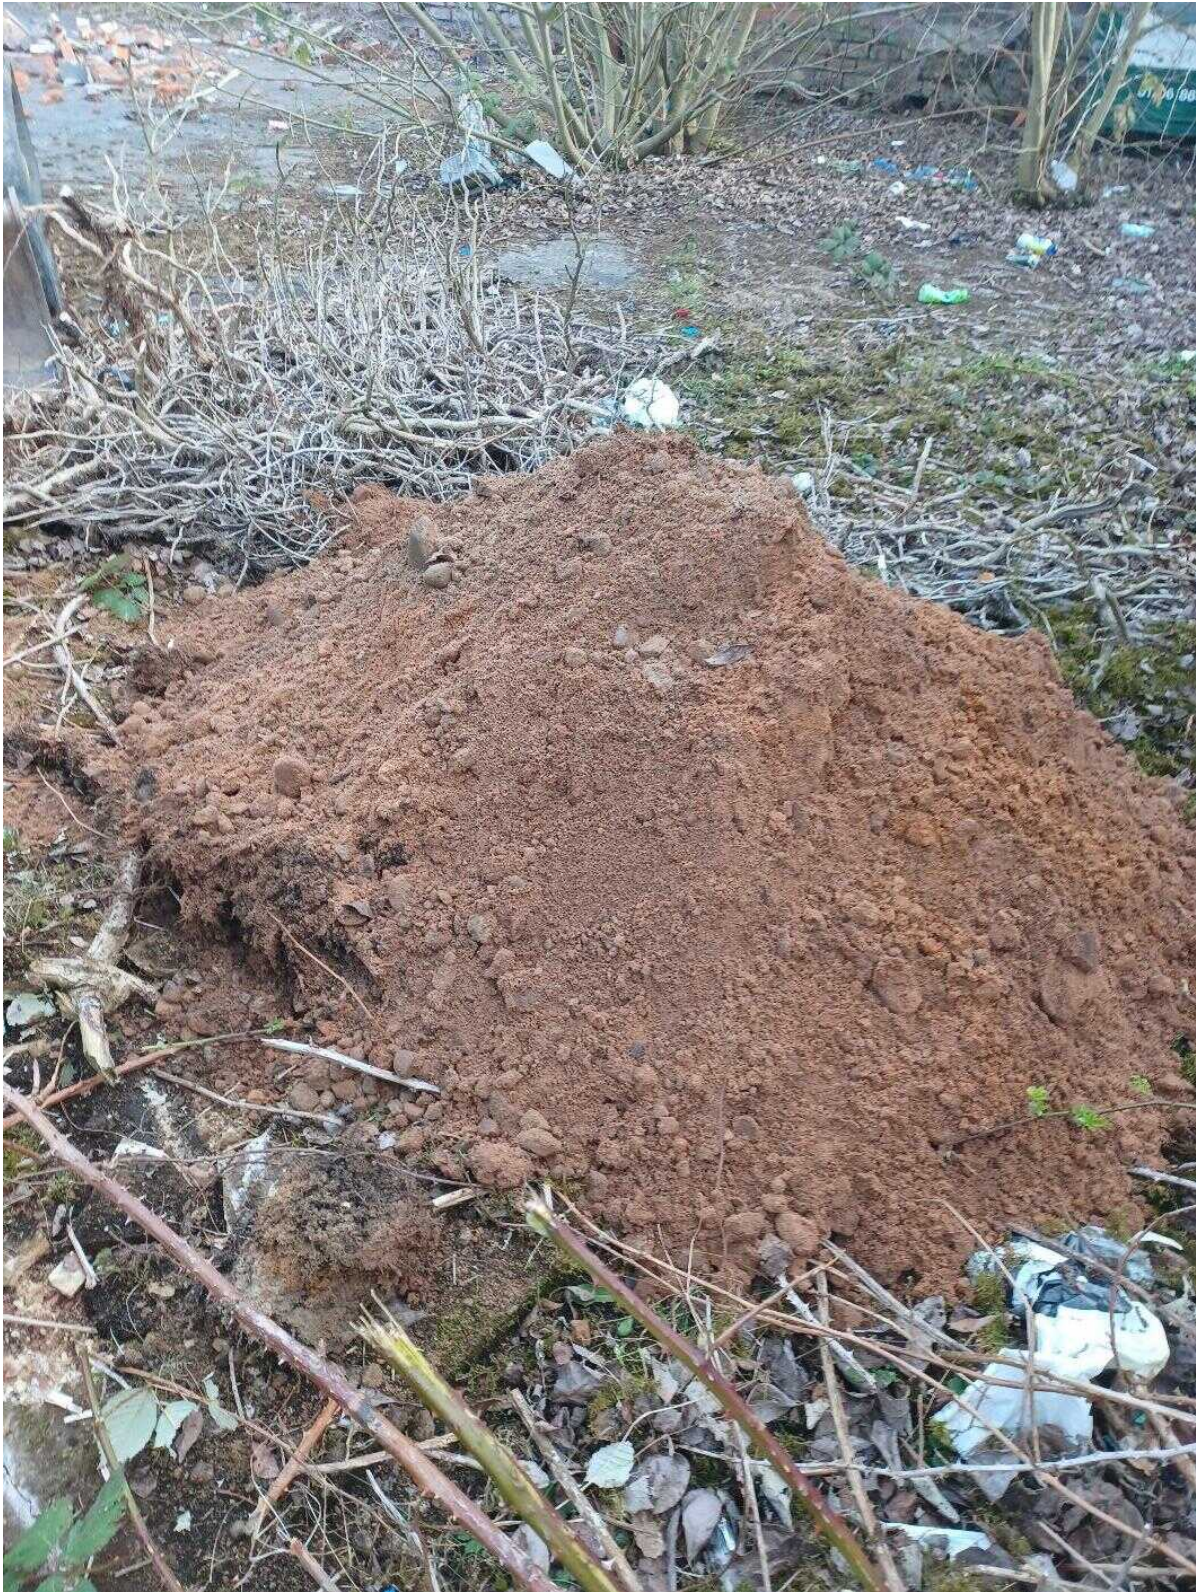
| <b>Remarks</b><br>PURPOSE: General coverage of the Site. TERMINATION: Engineer decision, target depth achieved. LOCATION: Surveyed using freeware on Site. GL: Estimated off topographical survey. STABILITY: Side wall collapse adjacent to relic wall to depth of 1 m below ground level. GROUNDWATER: None encountered. OTHER: No evidence of potentially harmful or polluting material. | | | | <b>Method, Plant, Stability, Dimensions</b><br>0.00 - 1.90m TP - Trial Pit tonne tracked<br>Unstable<br>L = 2.00m<br><div></div> W = 0.60m | |

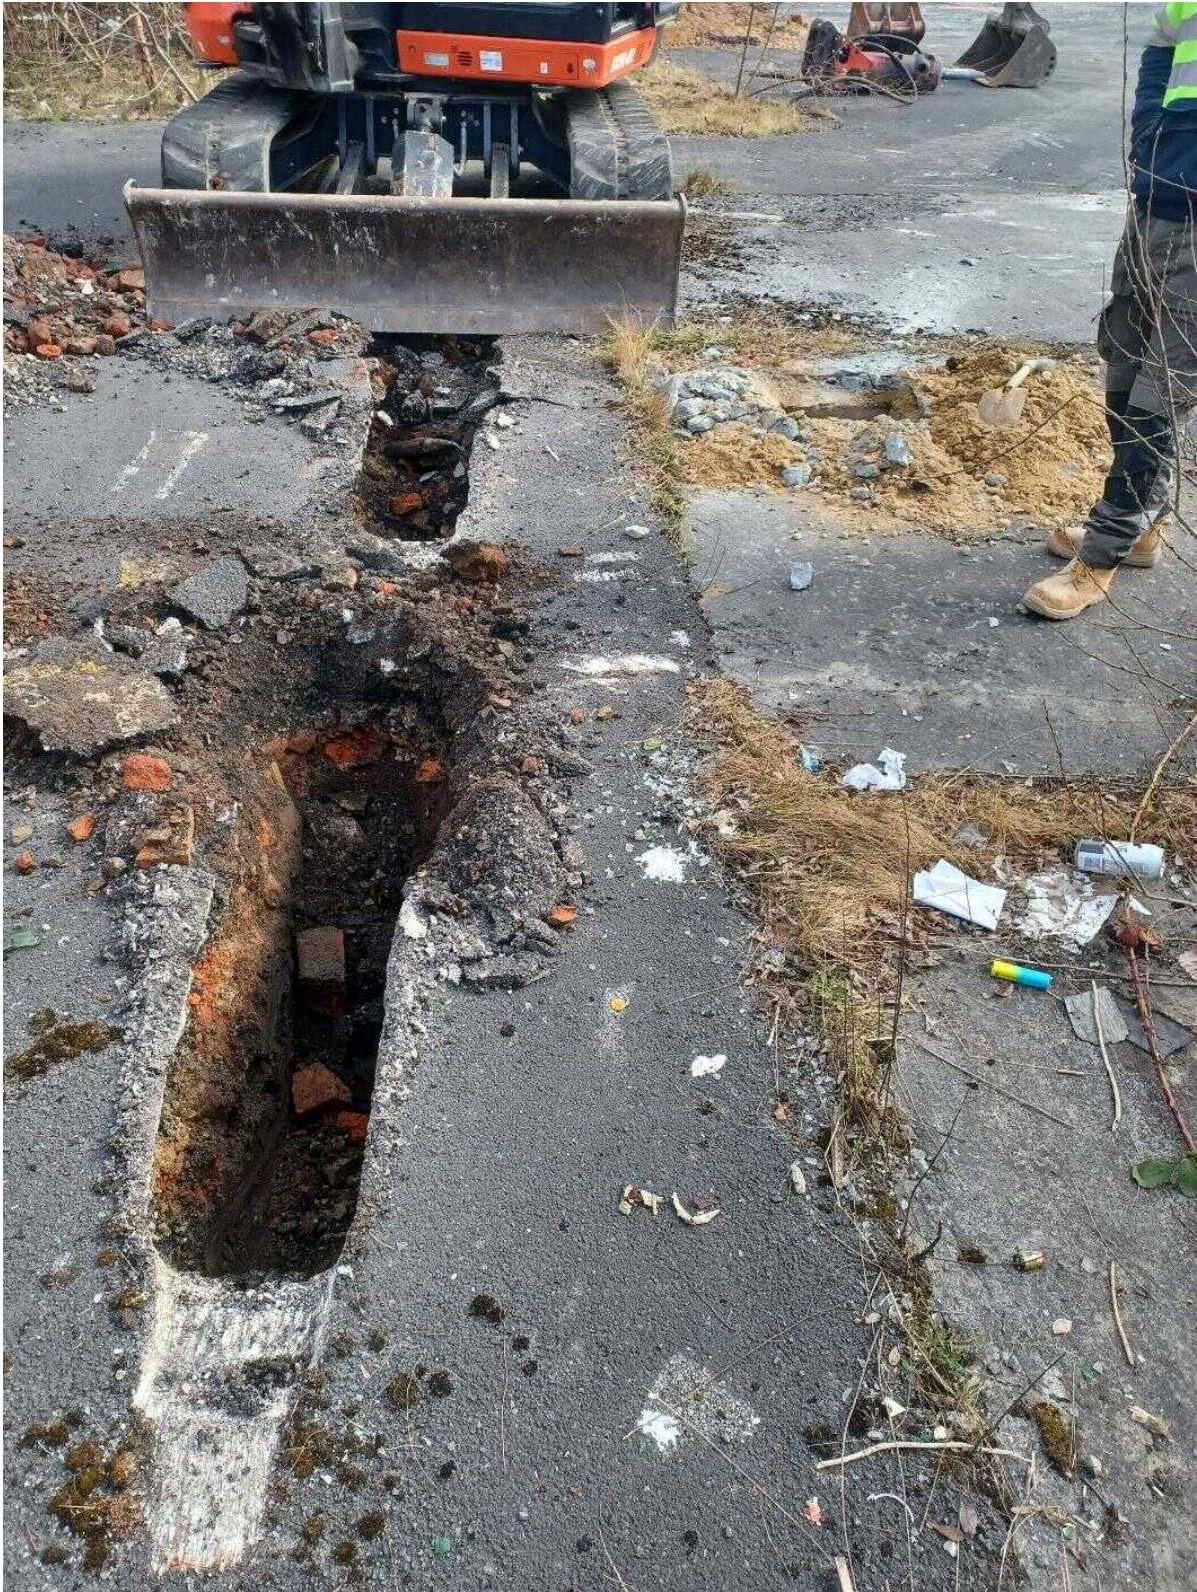
| Remarks<br>PURPOSE: Targeting are immediately north of former forecourt. TERMINATION: Engineer decision, target depth achieved. LOCATION: Surveyed using freeware on Site. GL: Estimated off topographical survey. STABILITY: Stable. GROUNDWATER: None encountered. OTHER: No evidence of potentially harmful or polluting material. | Method, Plant, Stability, Dimensions<br>0.00 - 1.60m TP - Trial Pit tonne tracked<br>Stable<br>L = 2.20m<br>W = 0.60m | Logger<br>RB |

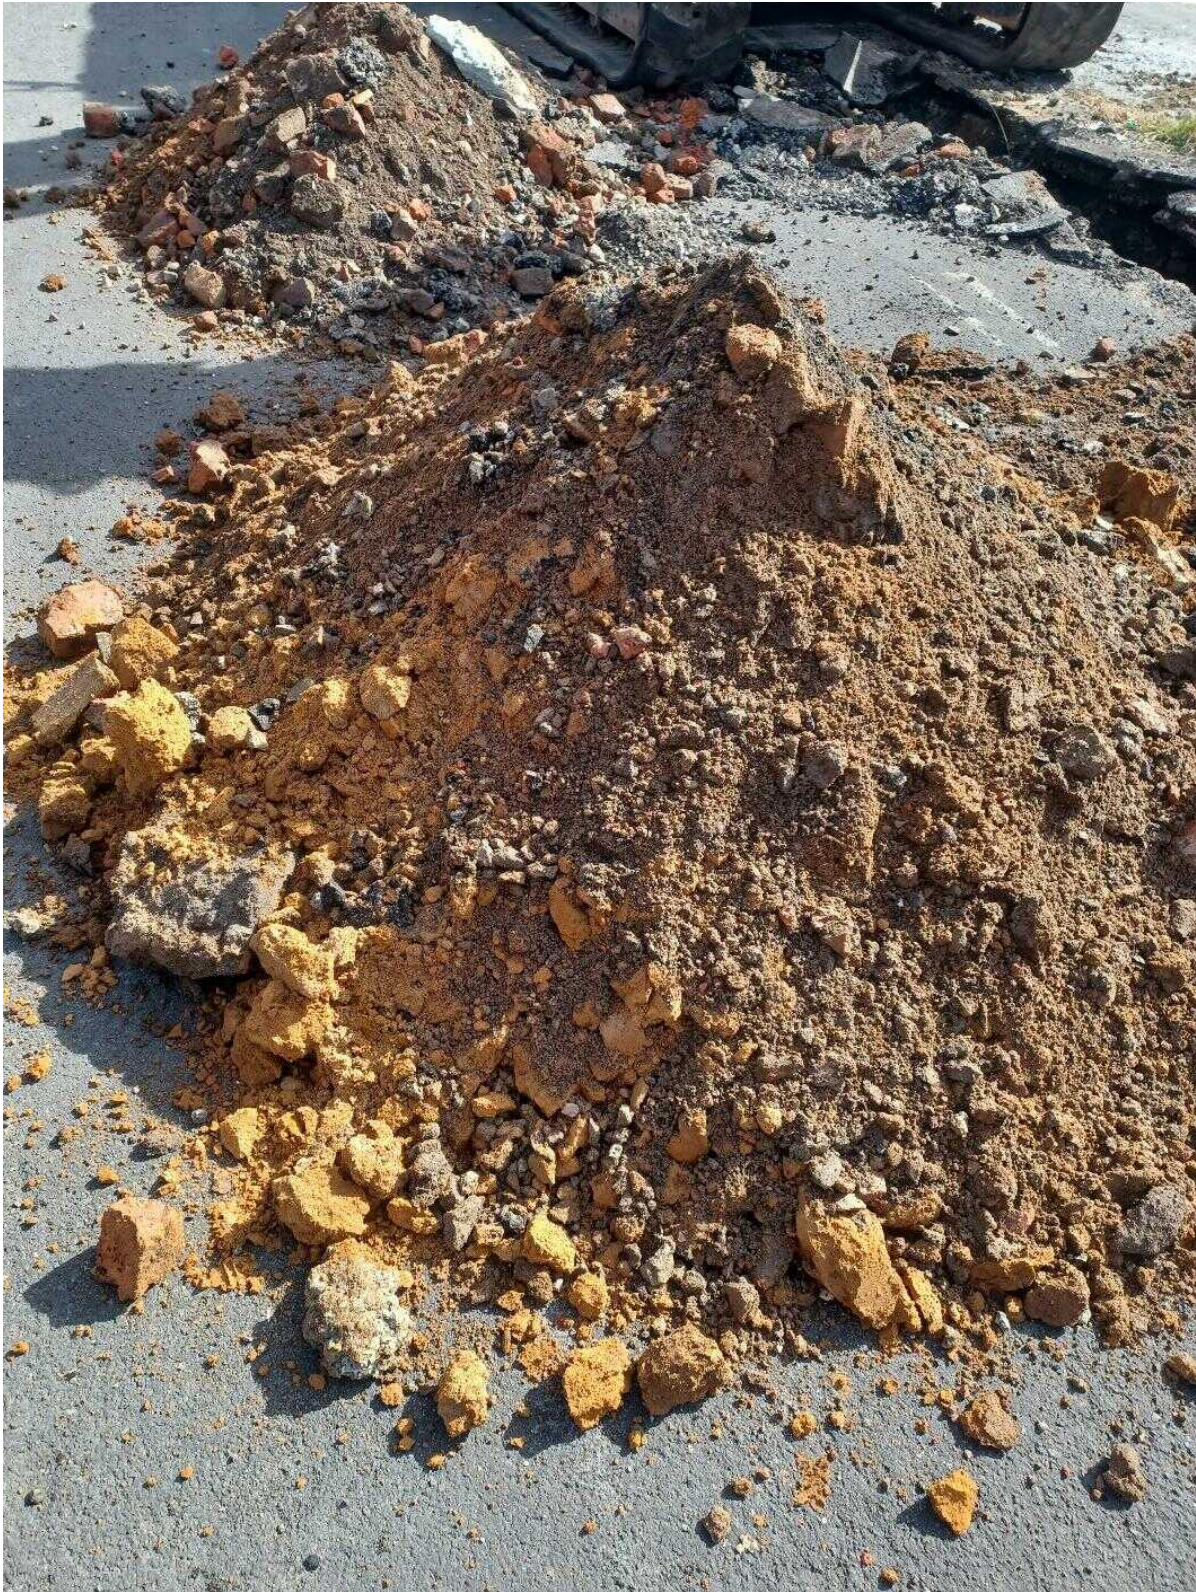
| Remarks<br>PURPOSE: Targeting are immediately north of former forecourt. TERMINATION: Engineer decision, target depth achieved. LOCATION: Surveyed using freeware on Site. GL: Estimated off topographical survey. STABILITY: Stable. GROUNDWATER: None encountered. OTHER: No evidence of potentially harmful or polluting material. | Method, Plant, Stability, Dimensions<br>0.00 - 1.60m TP - Trial Pit tonne tracked<br>Stable<br>L = 2.20m<br>W = 0.60m | Logger<br>RB |

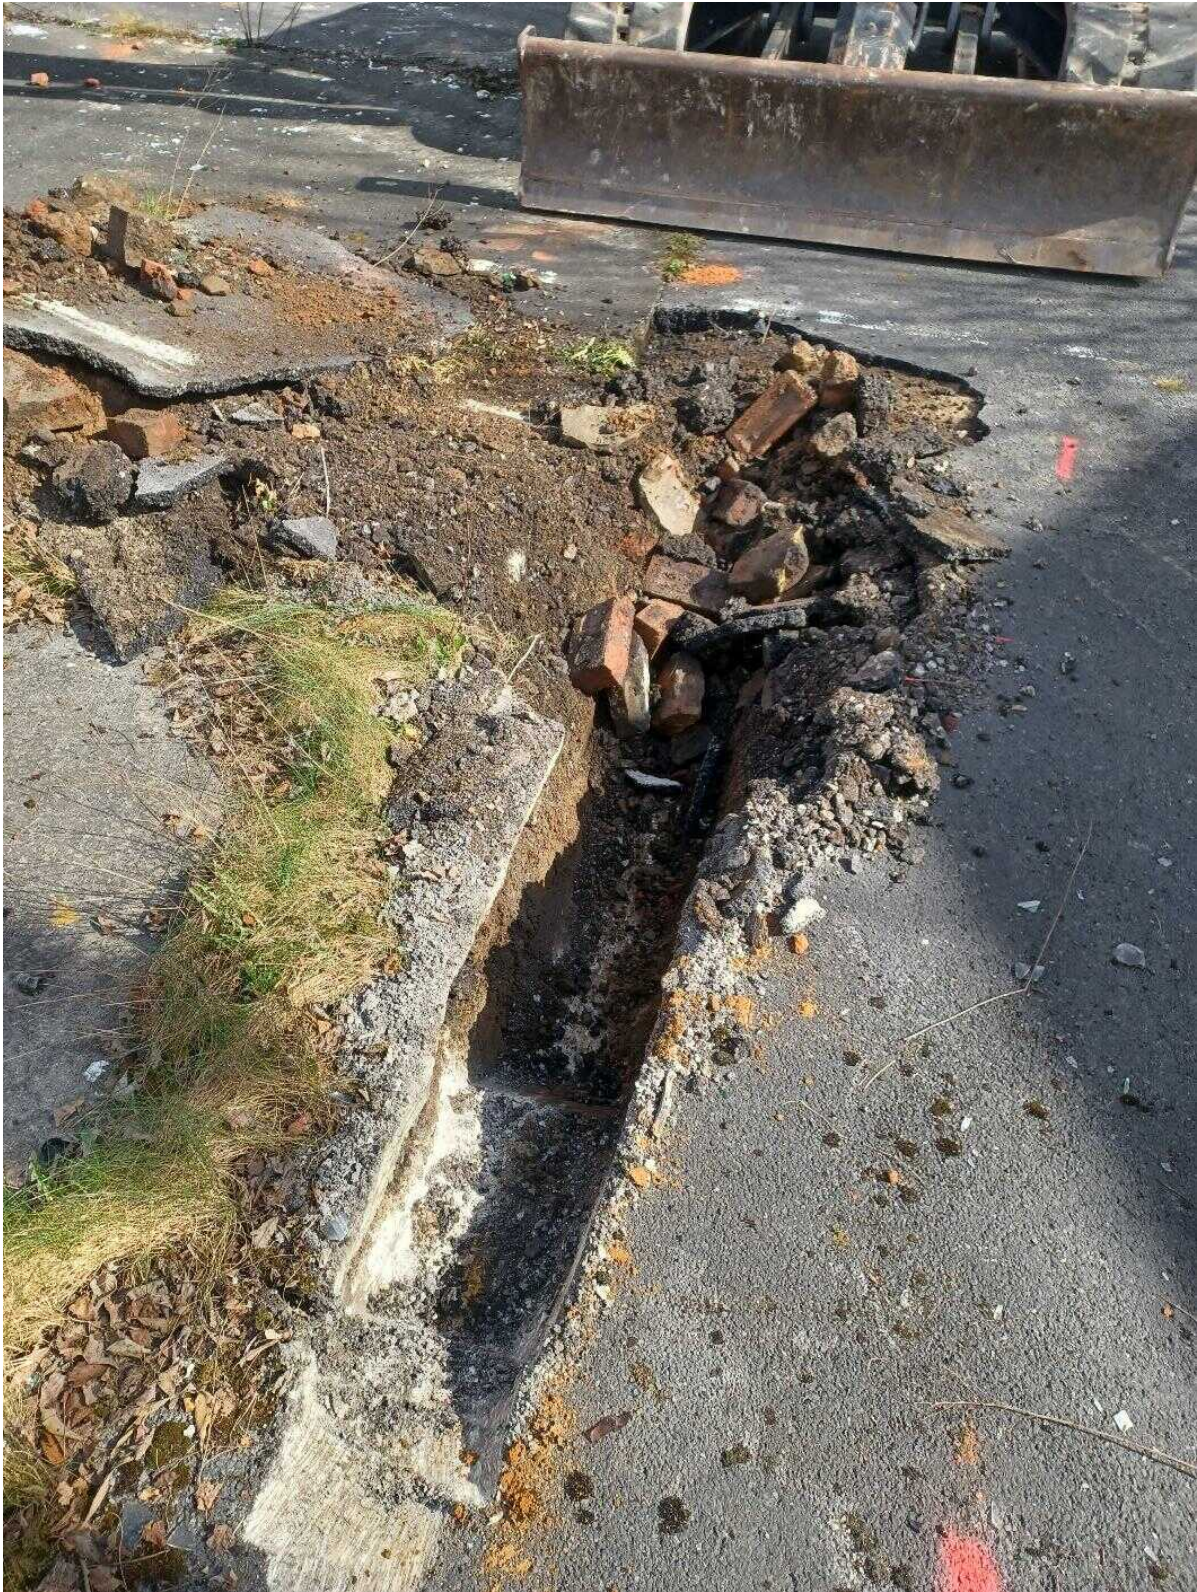
| PURPOSE: Targeting are immediately south of former forecourt. TERMINATION: Refusal on concrete slab. | 0.00 - 0.40m TP - Trial Pit tonne tracked | RB |

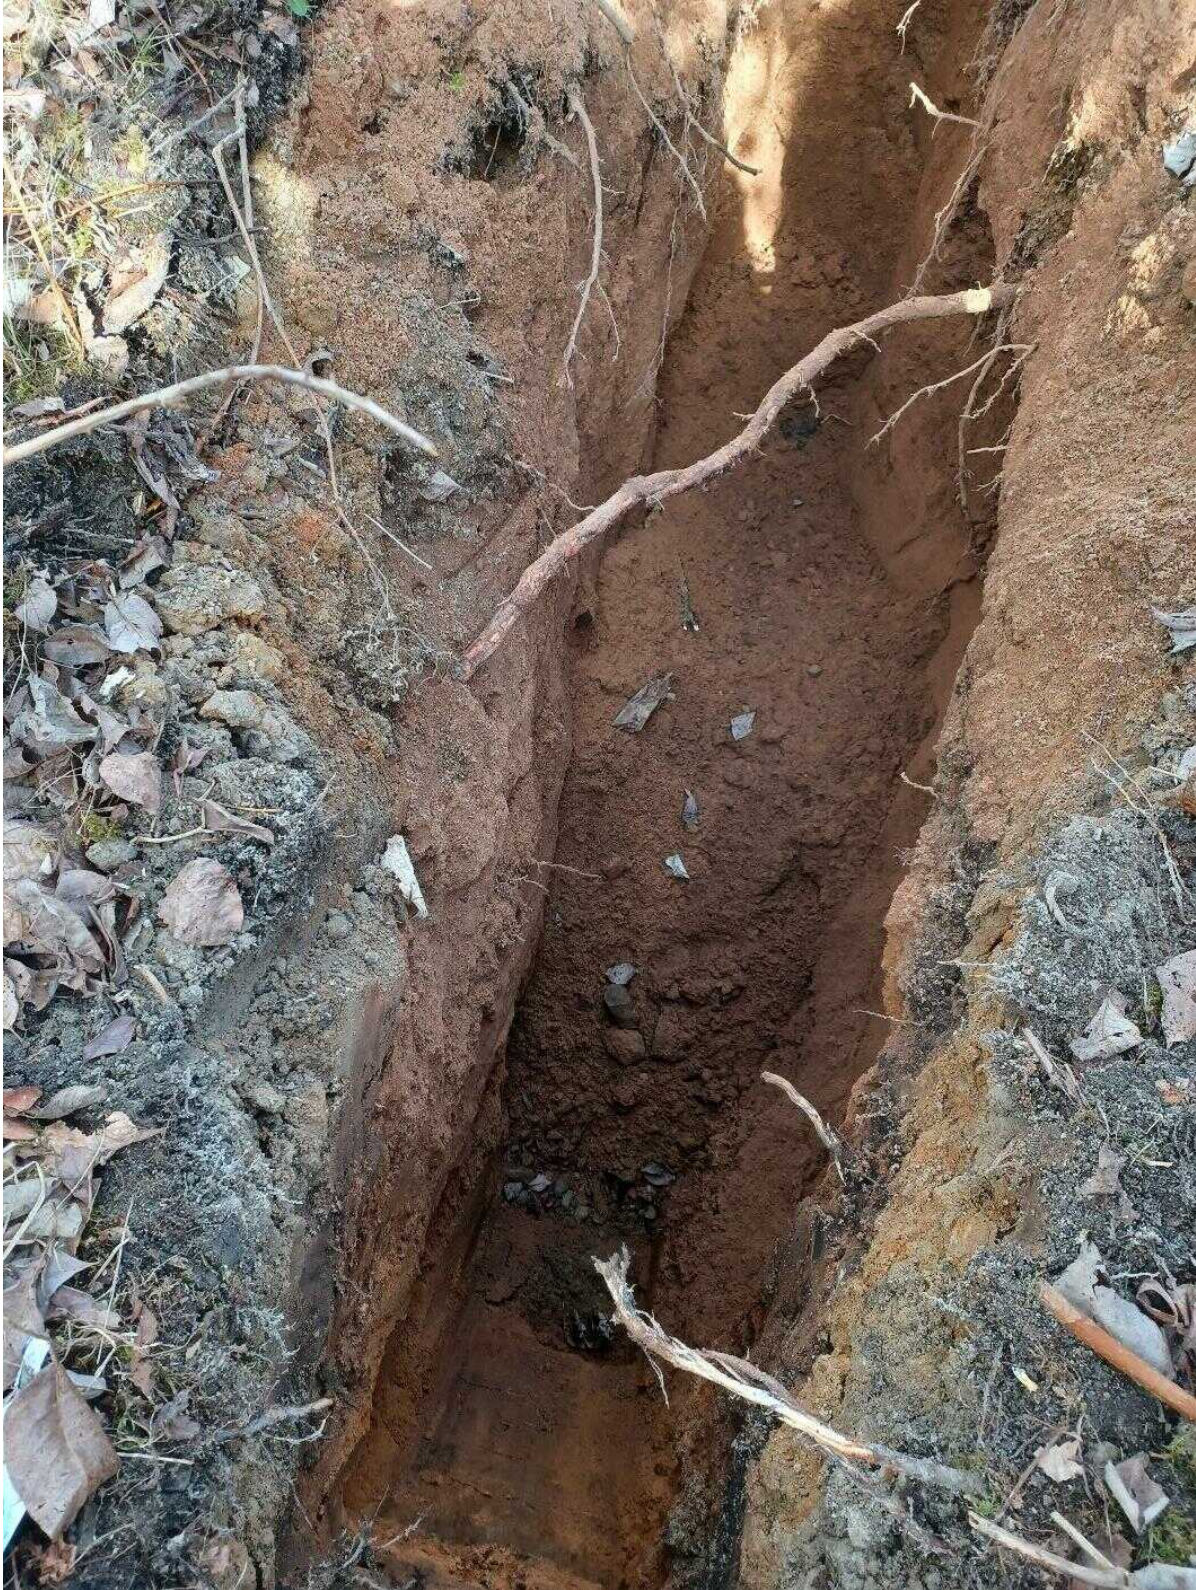
| <b>Remarks</b><br>PURPOSE: General coverage of the Site and to permit in-situ testing. TERMINATION: Engineer decision, target depth achieved to permit infiltration testing. LOCATION: Surveyed using freeware on Site. GL: Estimated off topographical survey. STABILITY: Continual collapse within Made Ground deposits. GROUNDWATER: None encountered. OTHER: No evidence of potentially harmful or polluting material. | | | | <b>Method, Plant, Stability, Dimensions</b><br>0.00 - 1.40m TP - Trial Pit tonne tracked<br>Stable | |

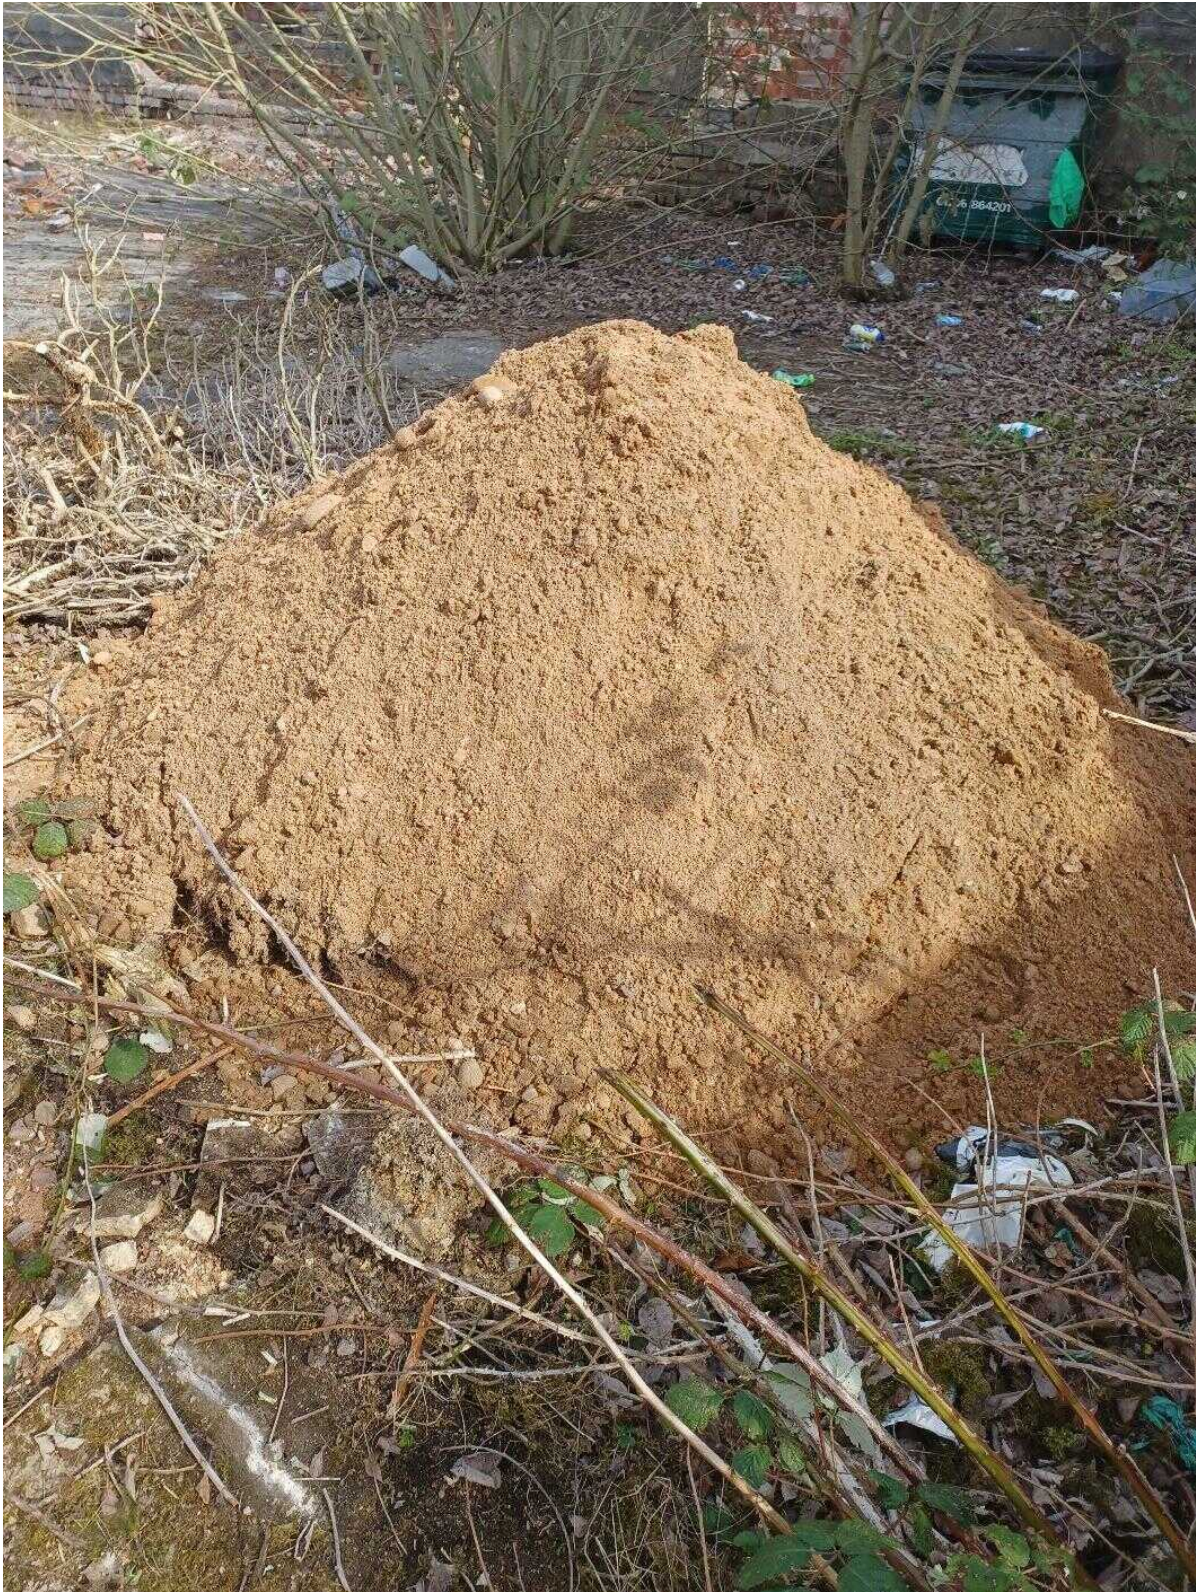
| <b>Remarks</b><br>PURPOSE: General coverage of the Site and to permit in-situ testing. TERMINATION: Engineer decision, target depth achieved to permit infiltration testing. LOCATION: Surveyed using freeware on Site. GL: Estimated off topographical survey. STABILITY: Continual collapse within Made Ground deposits. GROUNDWATER: None encountered. OTHER: No evidence of potentially harmful or polluting material. | | | <b>Method, Plant, Stability, Dimensions</b><br>0.00 - 1.40m TP - Trial Pit tonne tracked<br>Stable | | |

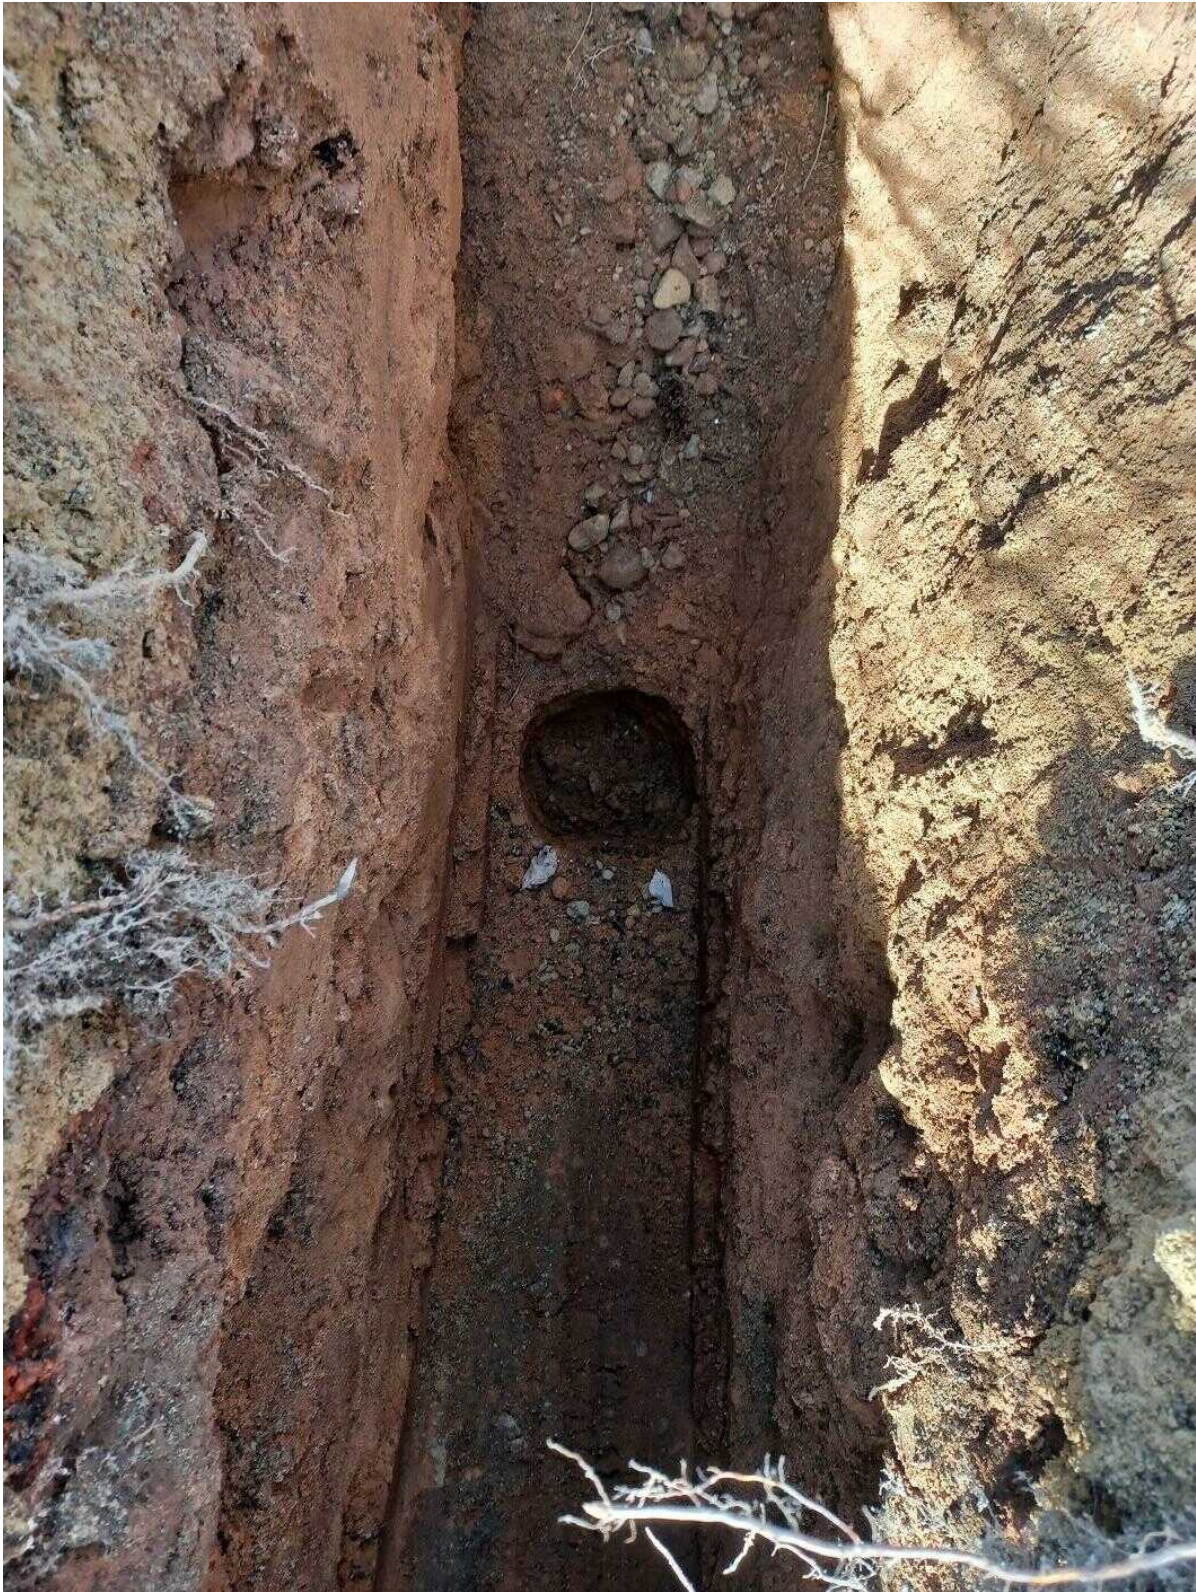
| <b>Remarks</b><br>PURPOSE: GEneral coverage of the Site and to permit in-situ testing. TERMINATION: Engineer decision, target depth achieved to permit infiltration testing. LOCATION: Surveyed using freeware on Site. GL: Estimated off topographical survey. STABILITY: Continual collapse within Made Ground deposits. GROUNDWATER: None encountered. OTHER: No evidence of potentially harmful or polluting material. | | | <b>Method, Plant, Stability, Dimensions</b><br>0.00 - 1.40m TP - Trial Pit 7 tonne tracked<br>Stable | | <b>Logger</b><br>RB |
