## Remediation Strategy

Land off Oldham Road, Rochdale

Report Status

| Report Number | 002 |

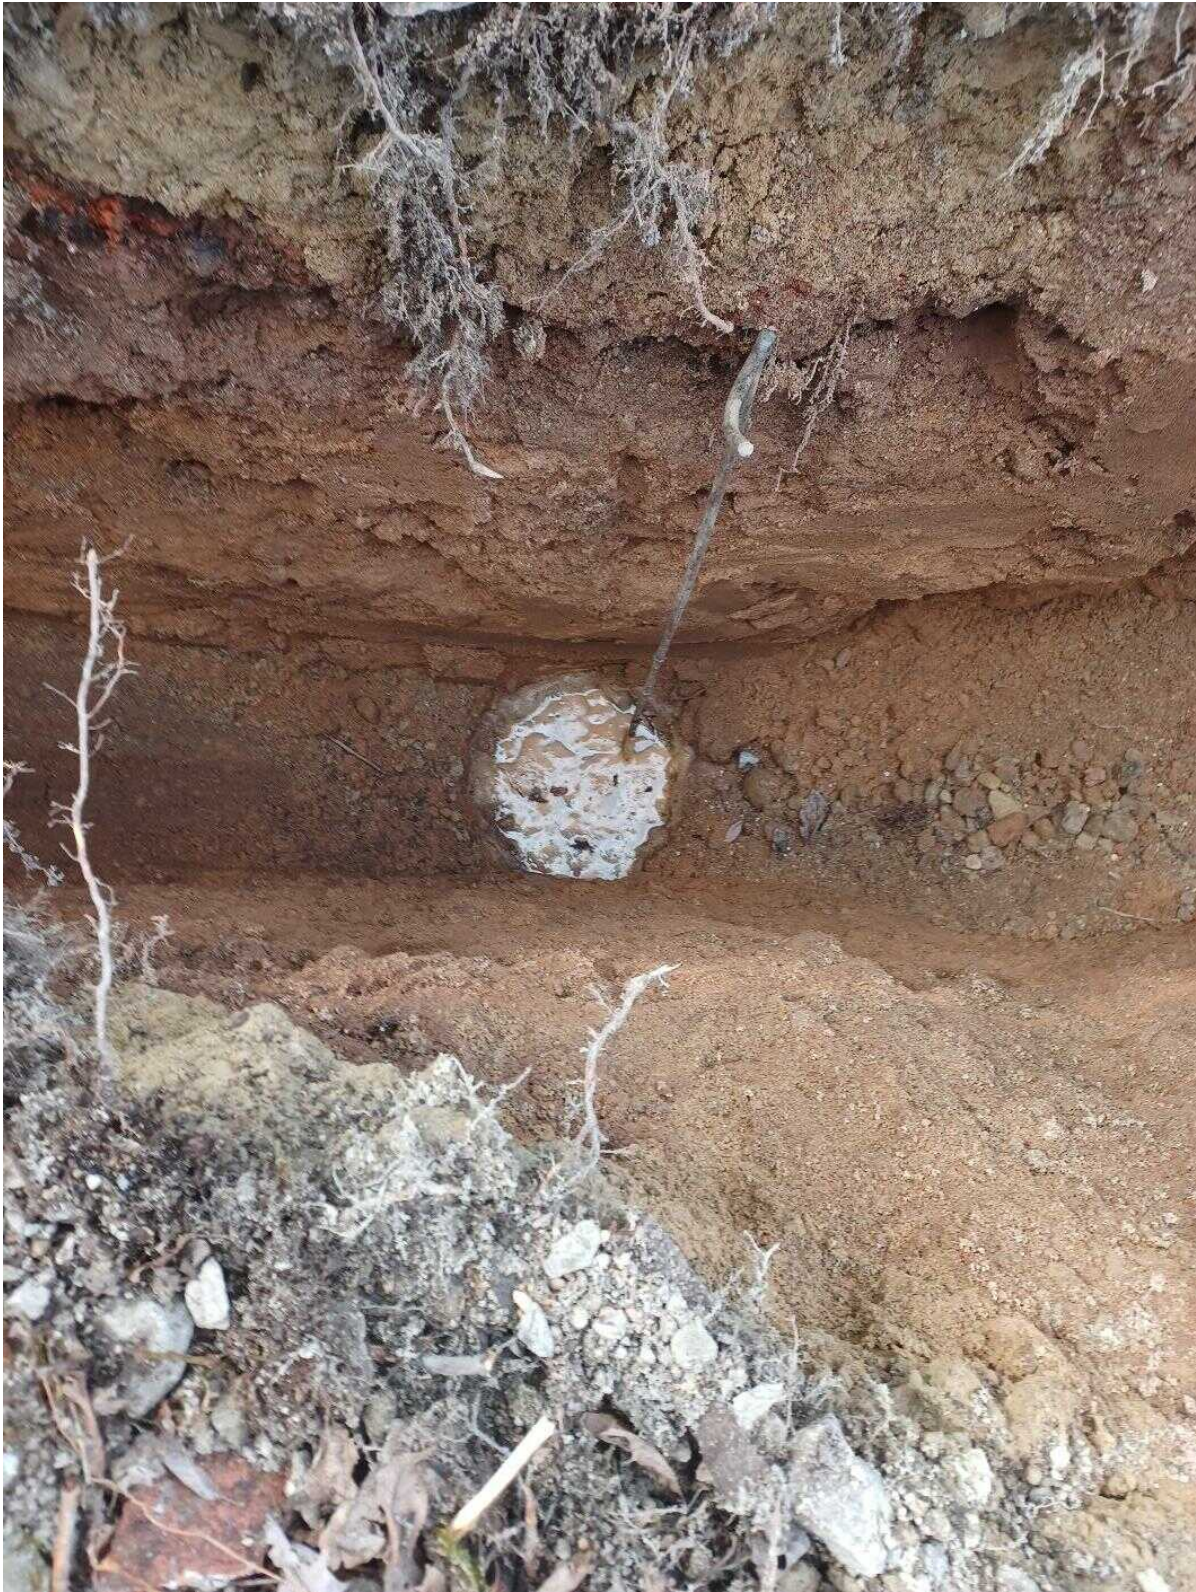
| Remarks<br>PURPOSE: GEneral coverage of the Site and to permit in-situ testing. TERMINATION: Engineer decision, target depth achieved to permit infiltration testing. LOCATION: Surveyed using freeware on Site. GL: Estimated off topographical survey. STABILITY: Continual collapse within Made Ground deposits. GROUNDWATER: None encountered. OTHER: No evidence of potentially harmful or polluting material. | Method, Plant, Stability, Dimensions<br>0.00 - 1.40m TP - Trial Pit 1 tonne tracked<br>Stable | Logger<br>RB |

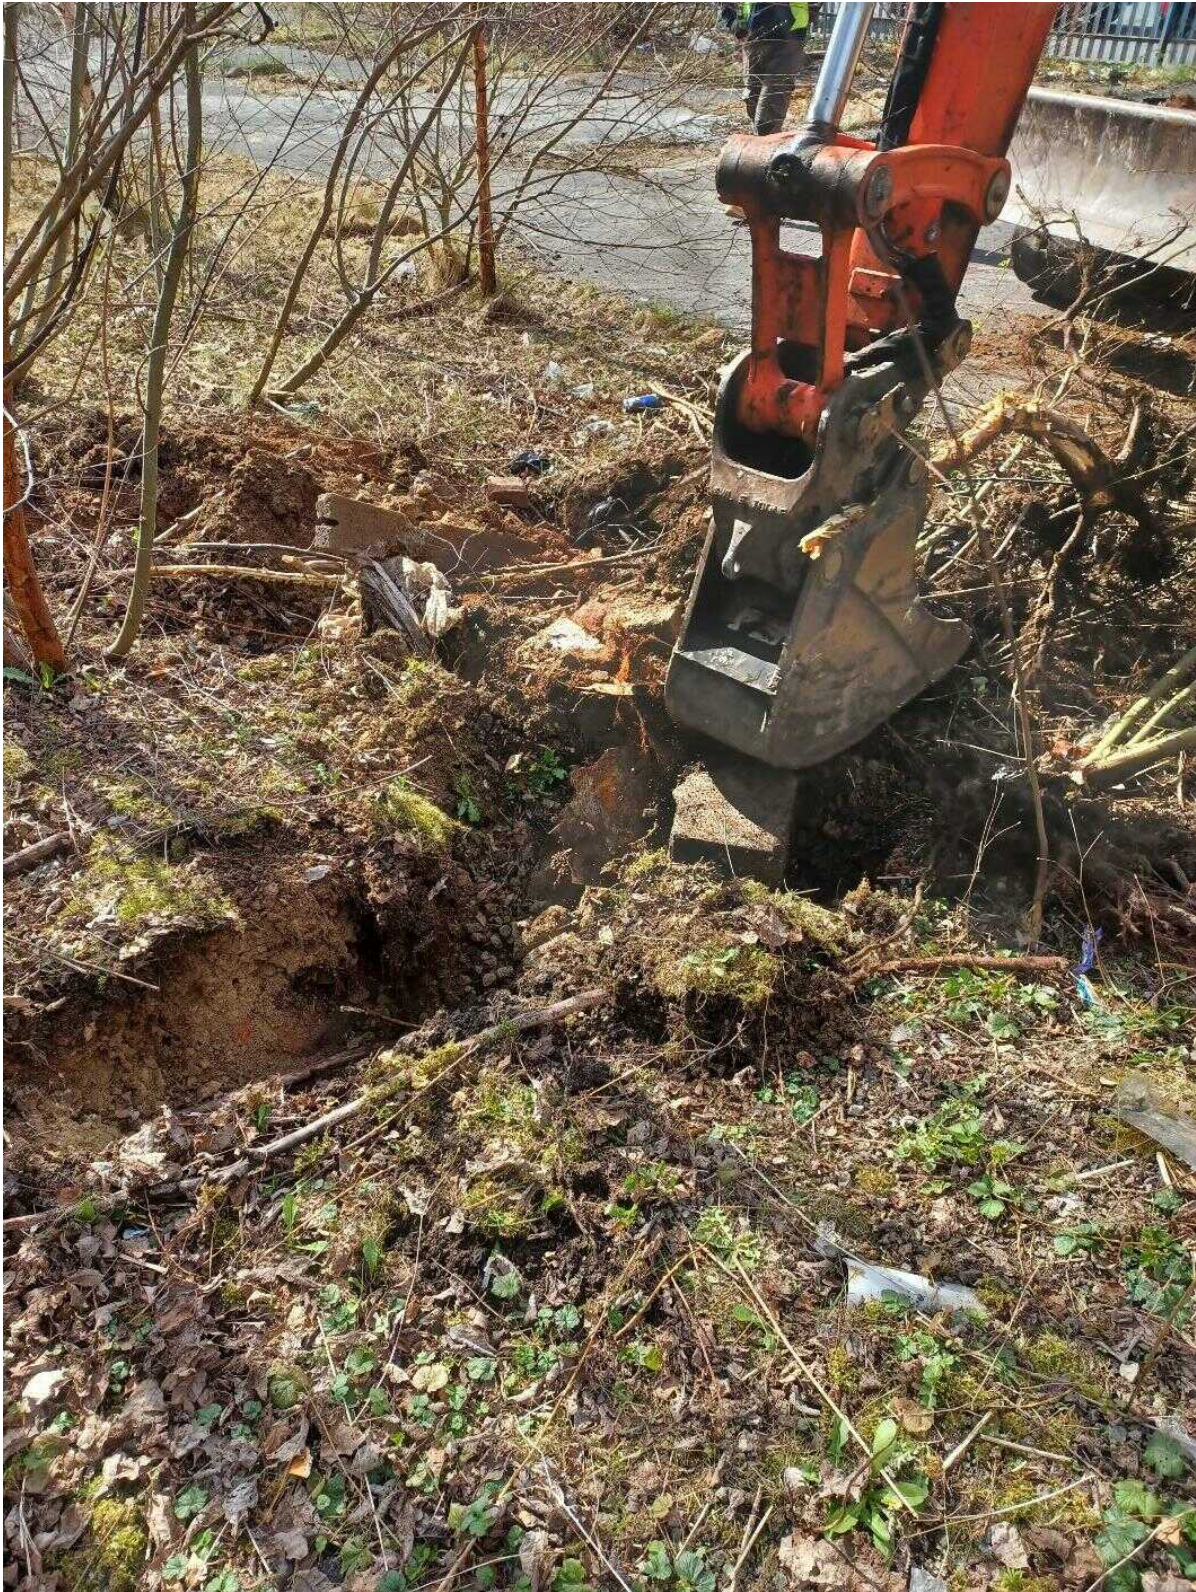
| <b>Remarks</b><br>PURPOSE: Targeting former location of underground storage tank (UST) as indicated by neighbour. TERMINATION: Engineer decision, target depth achieved - relic concrete footing (base of former UST) encountered and dug through. LOCATION: Surveyed using freeware on Site. GL: Estimated off topographical survey. STABILITY: Continual collapse within Made Ground deposits. GROUNDWATER: None encountered. OTHER: No evidence of potentially harmful or polluting material. | <b>Method, Plant, Stability, Dimensions</b> | | <b>Logger</b><br>RB |

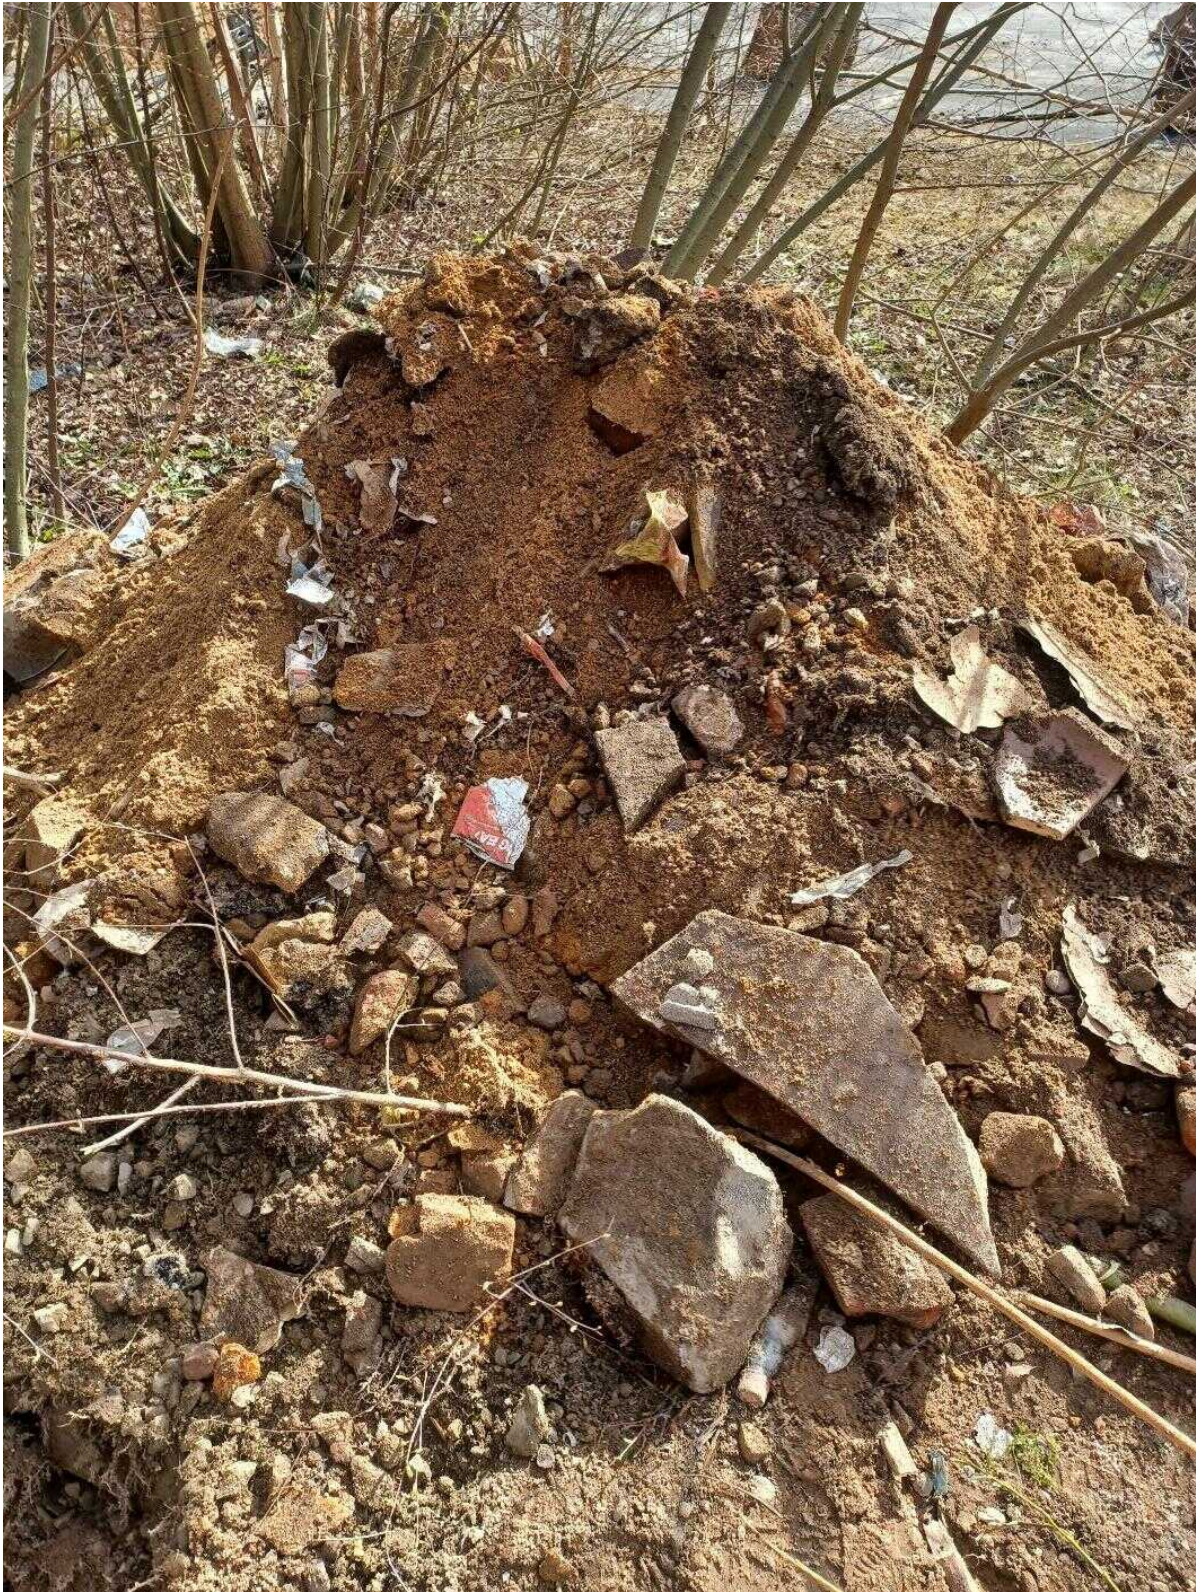
| PURPOSE: Targeting former location of underground storage tank (UST) as indicated by neighbour. TERMINATION: Engineer decision, target depth achieved - relic concrete footing (base of former UST) encountered and dug through. LOCATION: Surveyed using freeware on Site. GL: Estimated off topographical survey. STABILITY: Continual collapse within Made Ground deposits. GROUNDWATER: None encountered. OTHER: No evidence of potentially harmful or polluting material. | 0.00 - 2.00m TP - Trial Pit tonne tracked<br>Unstable | RB |

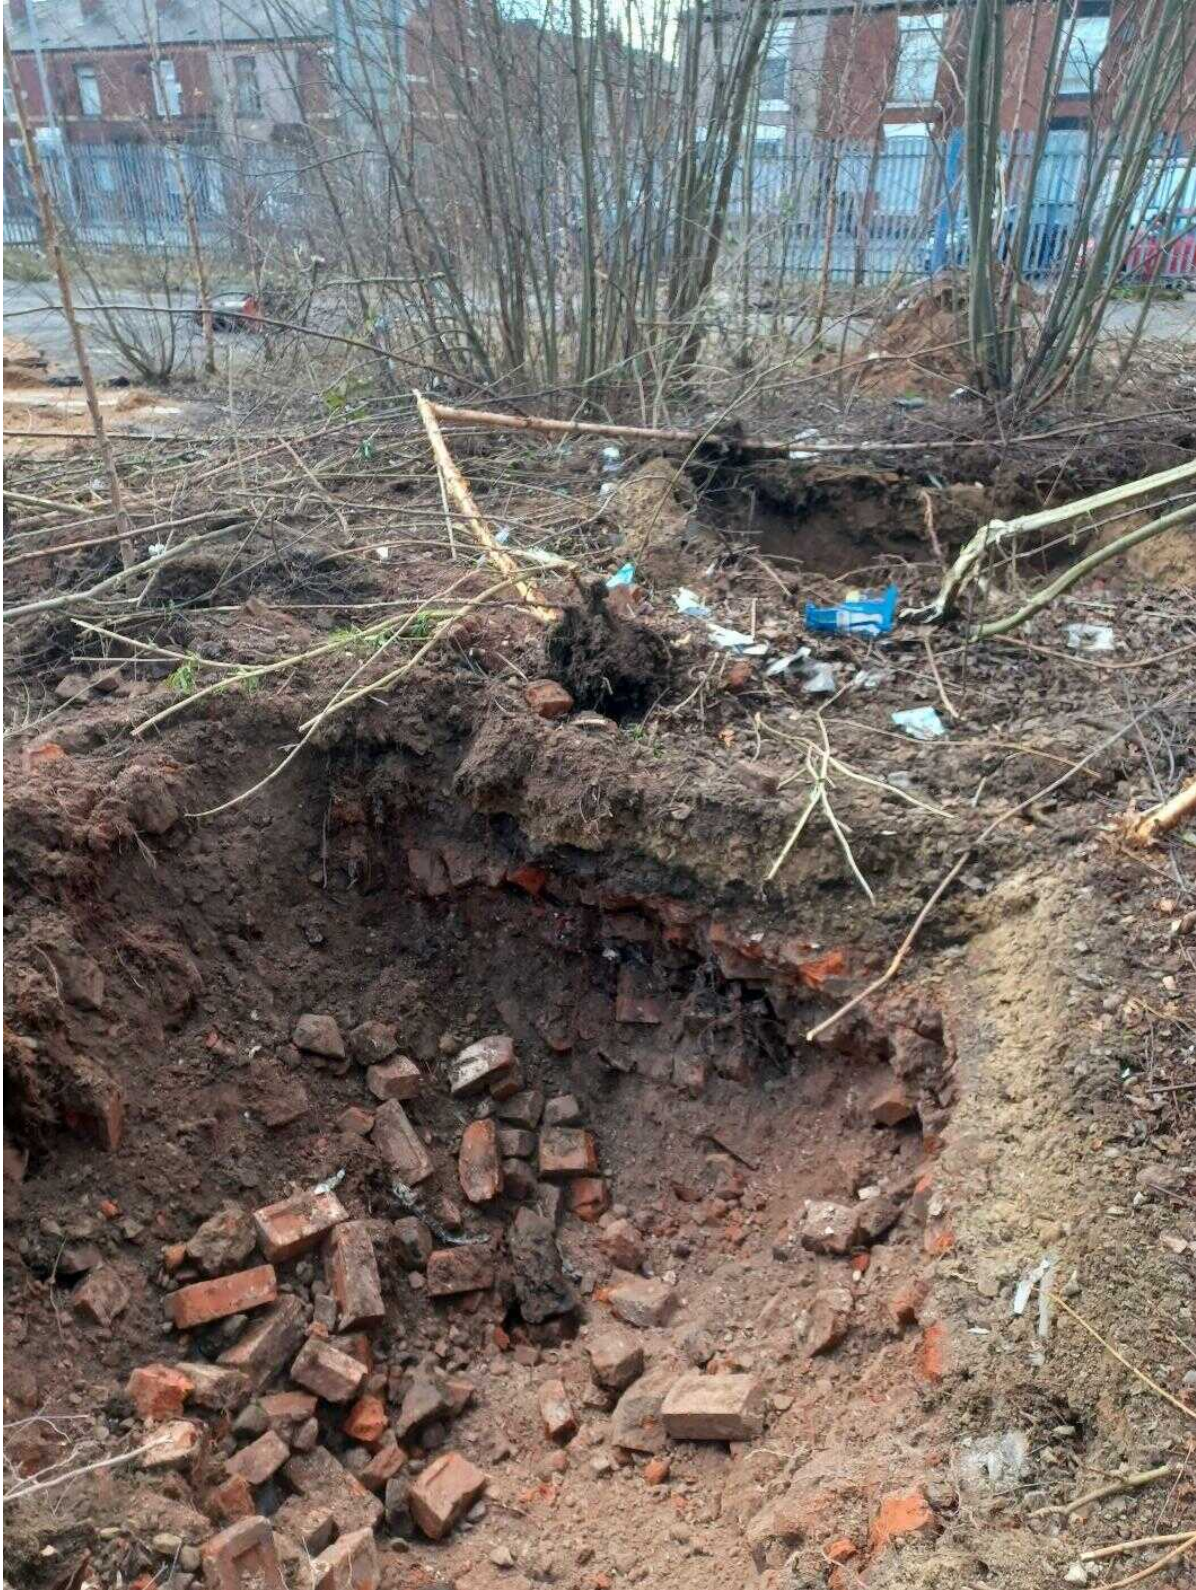
| Remarks<br>PURPOSE: Targeting location of remaining underground storage tank (UST) as indicated by neighbour.<br>TERMINATION: Engineer decision, target depth achieved - no evidence of relic USTs. LOCATION: Surveyed using freeware on Site. GL: Estimated off satellite imagery. STABILITY: Localised collapse within Made Ground deposits. GROUNDWATER: None encountered. OTHER: No evidence of potentially harmful or polluting material. | | | Method, Plant, Stability, Dimensions<br>0.00 - 1.40m TP - Trial Pit tonne tracked<br>Unstable | | Logger<br>RB |

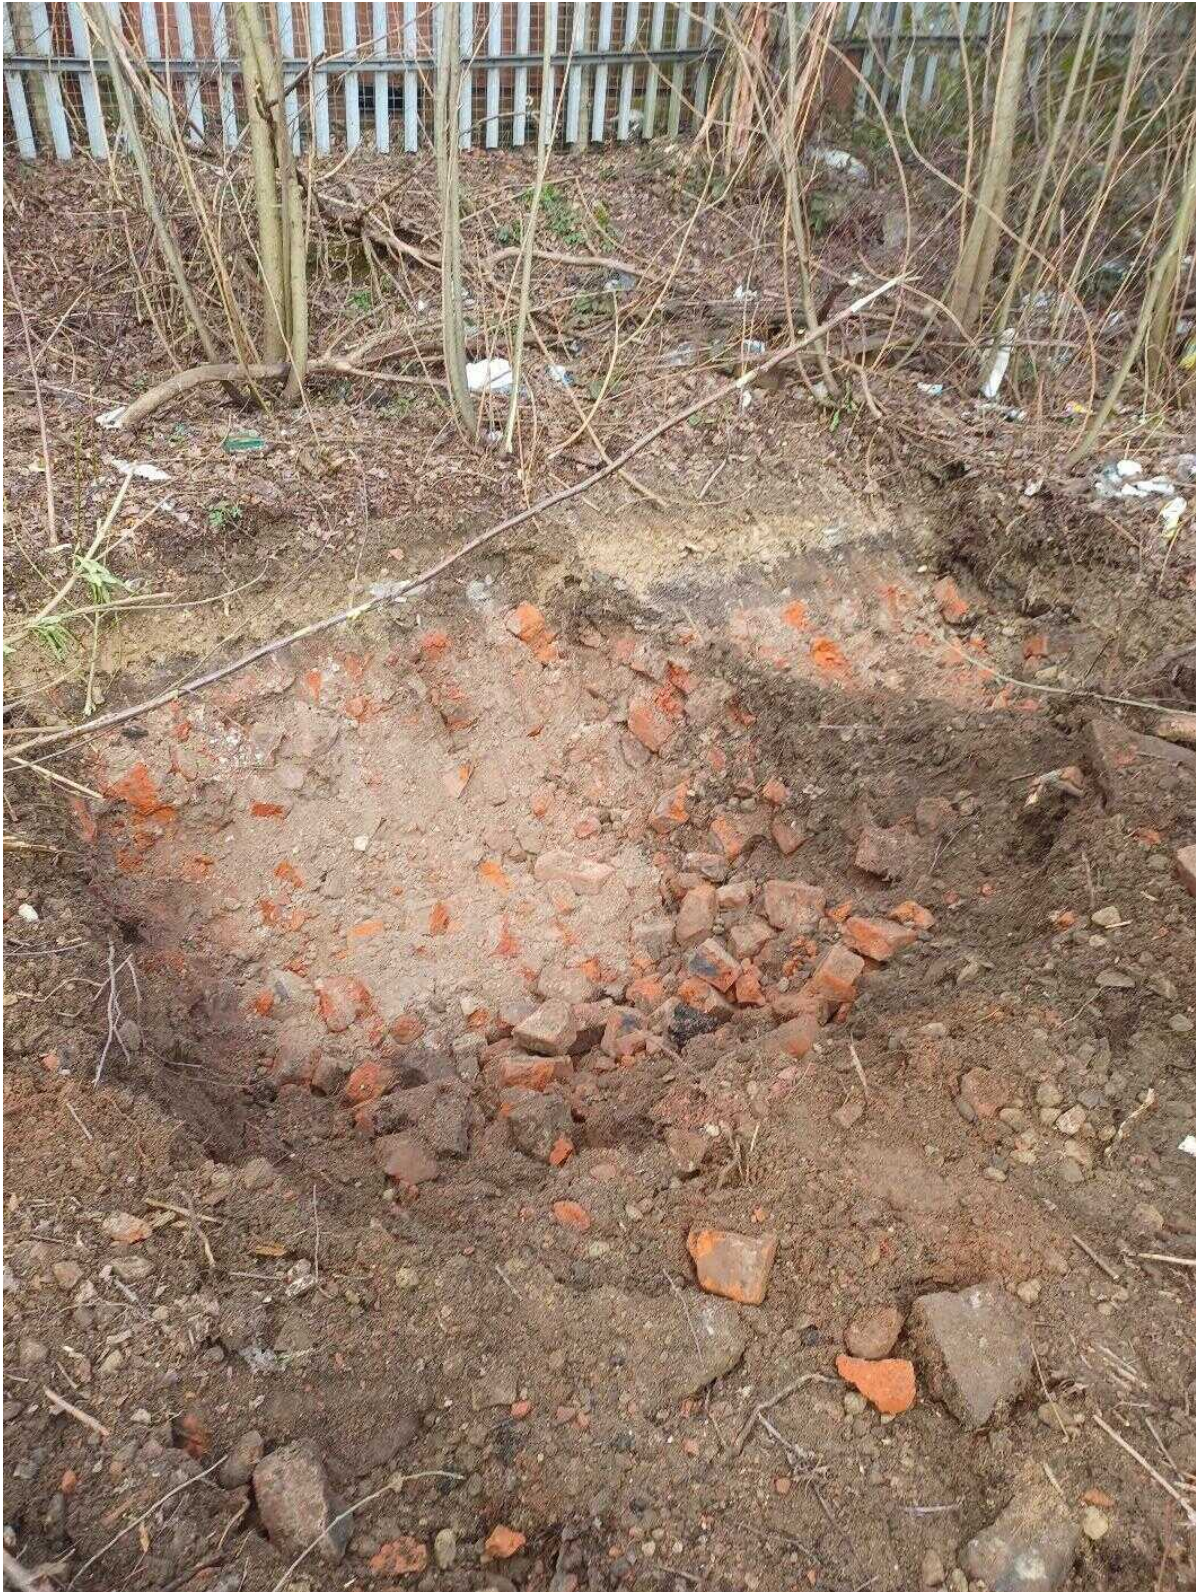
| <b>Remarks</b><br>PURPOSE: Targeting location of remaining underground storage tank (UST) as indicated by neighbour.<br>TERMINATION: Engineer decision, target depth achieved - no evidence of relic USTs. LOCATION: Surveyed using freeware on Site. GL: Estimated off satellite imagery. STABILITY: Localised collapse within Made Ground deposits. GROUNDWATER: None encountered. OTHER: No evidence of potentially harmful or polluting material. | | | | <b>Method, Plant, Stability, Dimensions</b><br>0.00 - 1.40m TP - Trial Pit tonne tracked<br>Unstable | |

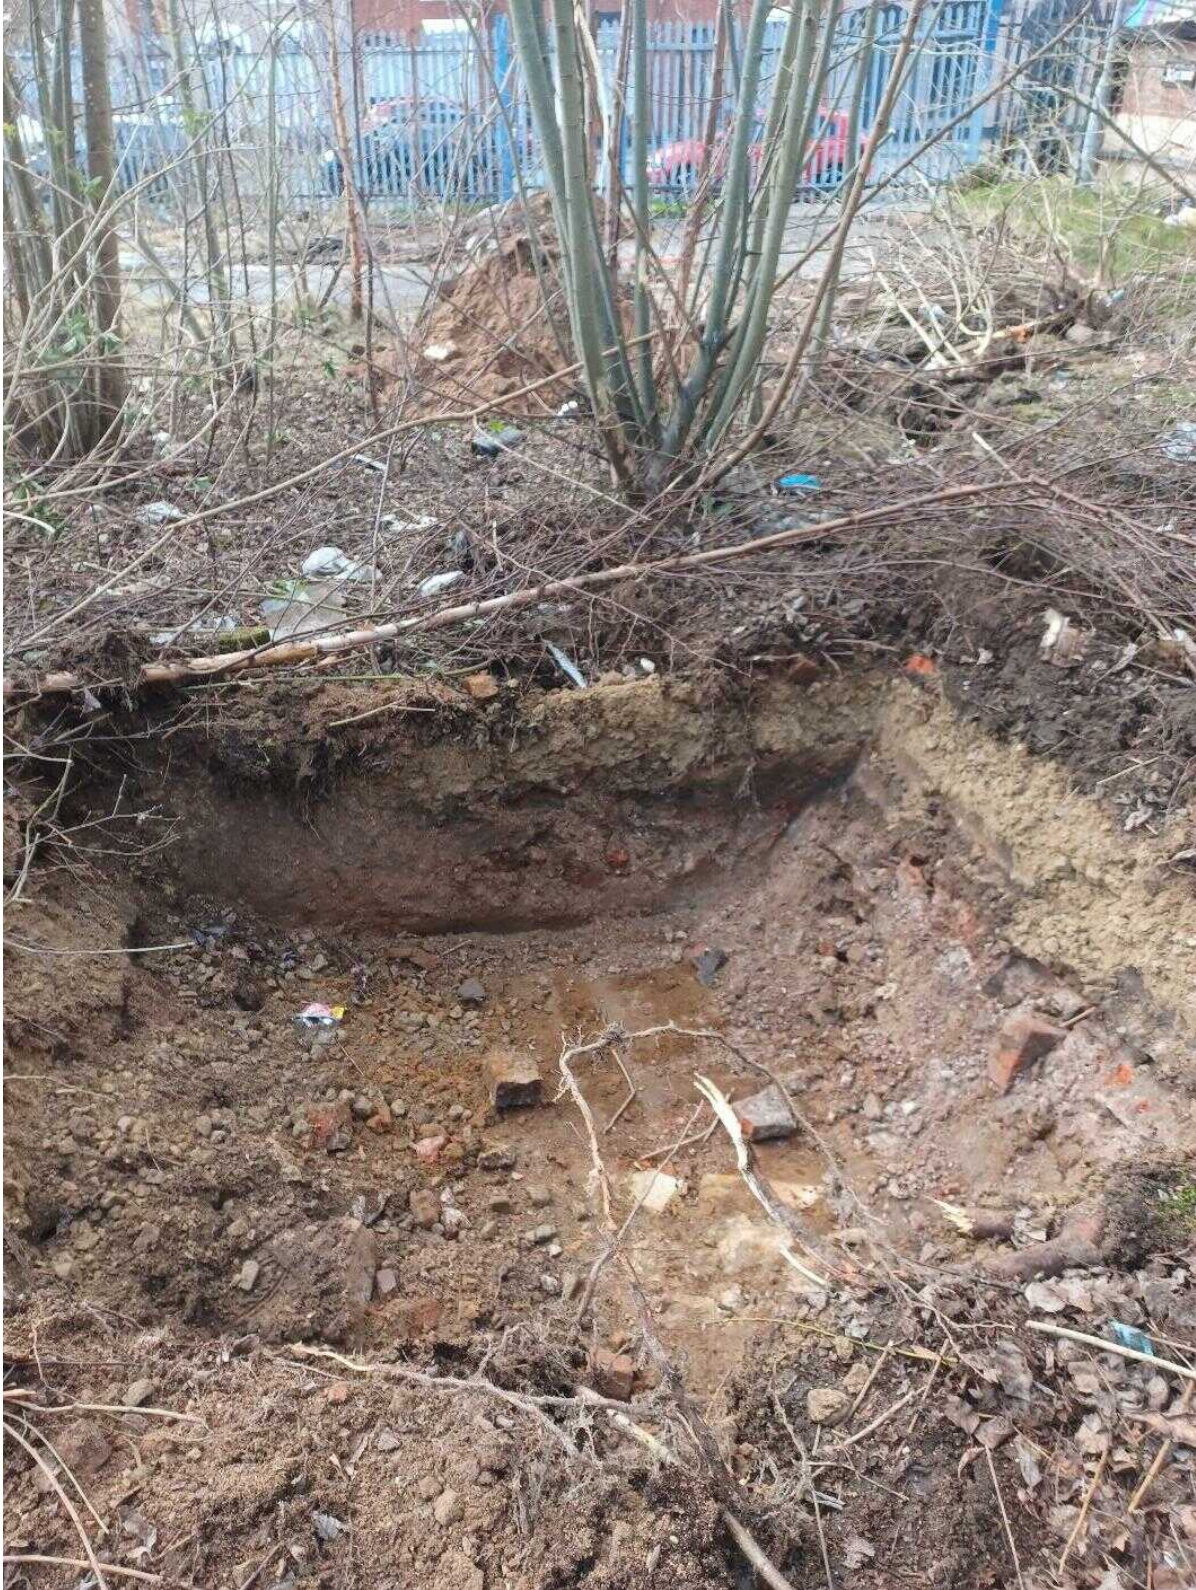
| Remarks<br>PURPOSE: Targeting location of remaining underground storage tank (UST) as indicated by neighbour.<br>TERMINATION: Engineer decision, target depth achieved - no evidence of disturbed ground or evidence of relic USTs. LOCATION: Surveyed using freeware on Site. GL: Estimated off topographical survey. STABILITY: Stable.<br>GROUNDWATER: None encountered. OTHER: No evidence of potentially harmful or polluting material. | | | Method, Plant, Stability, Dimensions<br>0.00 - 0.90m TP - Trial Pit tonne tracked<br>Stable | | |
