Phase I & II Geoenvironmental Site Assessment  
North Manchester Golf Club

Reference: 14-807-R1-2  
Date: January 2022

North Manchester Golf Club,  
Manchester Old Road,  
Middleton,  
Manchester M24 4PE

Prepared for:  
**Duchy Homes**

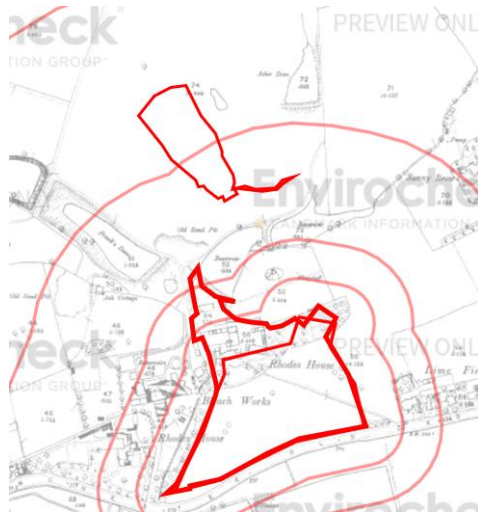
| MAP EDITION | HISTORICAL LAND USE | HISTORICAL MAP EXCERPT |
|---|---|---|
| <p>1893<br/>1:2,500</p> | <p>A building is present in the north of the southern sector of the site. No significant changes to the site.</p> | |

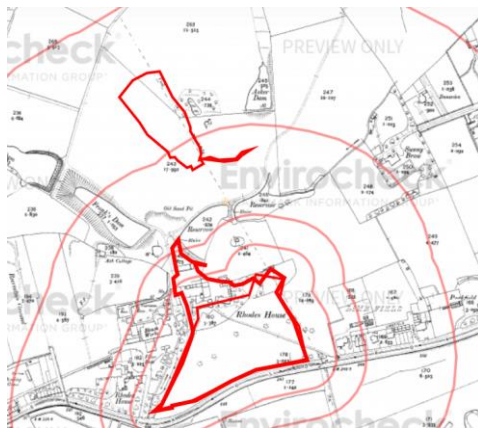
| MAP EDITION | HISTORICAL LAND USE | HISTORICAL MAP EXCERPT |
|---|---|---|
| <p>1909<br/>1:2,500</p> | <p>The gardens in the northeast of the site have undergone alteration.<br/><br/>No other significant changes to the site.</p> | |

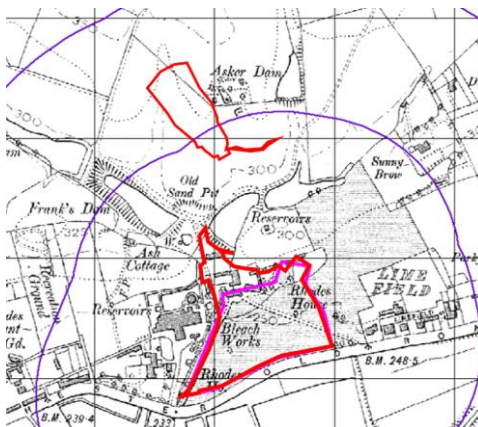
| MAP EDITION | HISTORICAL LAND USE | HISTORICAL MAP EXCERPT |
|---|---|---|
| <p>1910<br/>1:10,560</p> | <p>Contour lines are noted across the central area of the southern sector of the site and in the centre of the northern sector of the site.</p> | |

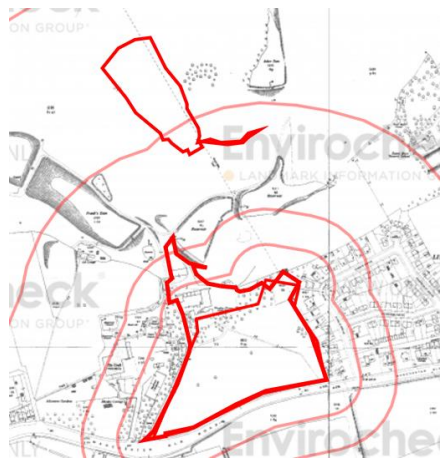
| MAP EDITION | HISTORICAL LAND USE | HISTORICAL MAP EXCERPT |
|---|---|---|
| <p><b>1955</b><br/><b>1:2,500</b></p> | <p>Within the southern sector, the track is now noted as a footpath with a new entrance to the site now present on the western boundary of the site and in the north-western corner of this sector.</p> <p>A number of trees are now present in the northern area of the sector, with the pond feature no longer present.</p> <p>The site now appears to be used as a golf course. A building associated with Rhodes House is no longer present.</p> <p>The remainder of the site appears to be unchanged.</p> | |

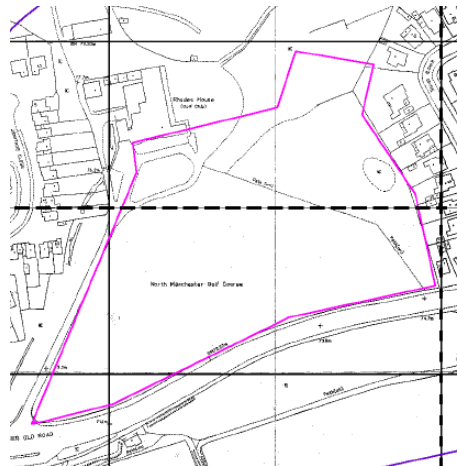
| MAP EDITION | HISTORICAL LAND USE | HISTORICAL MAP EXCERPT |
|---|---|---|
| <p><b>1992</b><br/><b>1:1,250</b></p> | <p>A possible sand pit is now present in the eastern sector of the site, however, this feature is likely to be associated with the golf course.</p> <p>Within the northern sector of the site, no significant changes have been noted.</p> | |

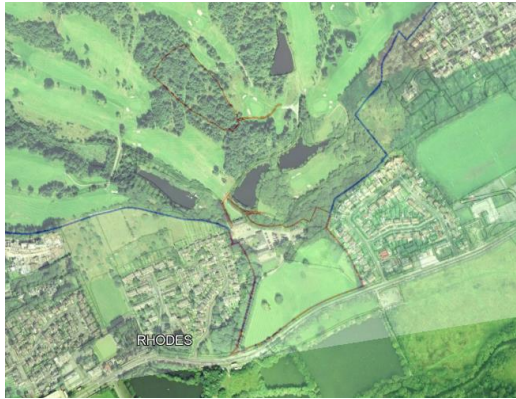
| MAP EDITION | HISTORICAL LAND USE | HISTORICAL MAP EXCERPT |
|---|---|---|
| <p><b>2000</b><br/><b>Google Earth</b></p> | <p>Sand Pit is no longer present. No significant changes to the site.</p> | |

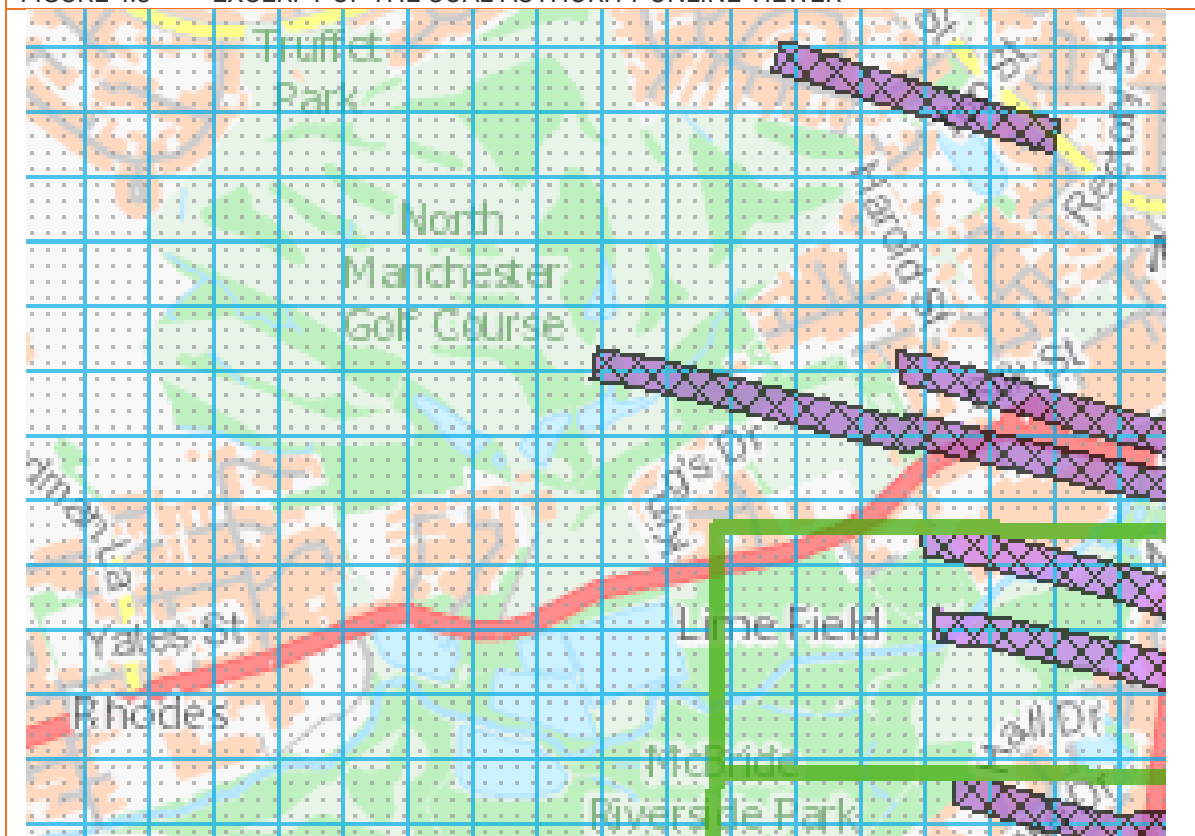
FIGURE 4.3 EXCERPT OF THE COAL AUTHORITY ONLINE VIEWER

As the site is within an area affected by Coal Mining E3P have consulted with the Coal Authority who have provided a Consultant Coal Mining Report for the site (Ref:51002462756001).

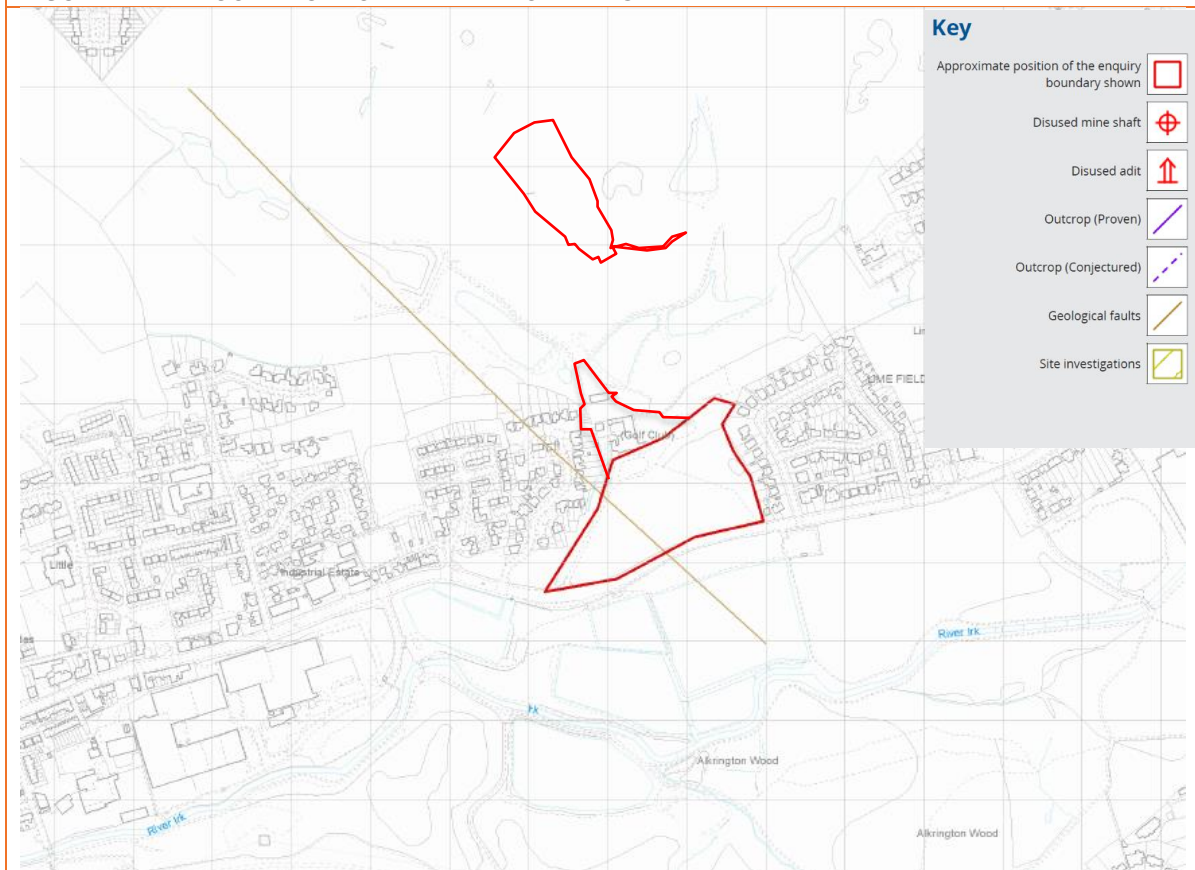
FIGURE 4.4 COAL AUTHORITY PLAN FOR THE SITE

**Note:** The boundary has been extended by E3P to that in which has been provided by the Coal Authority.

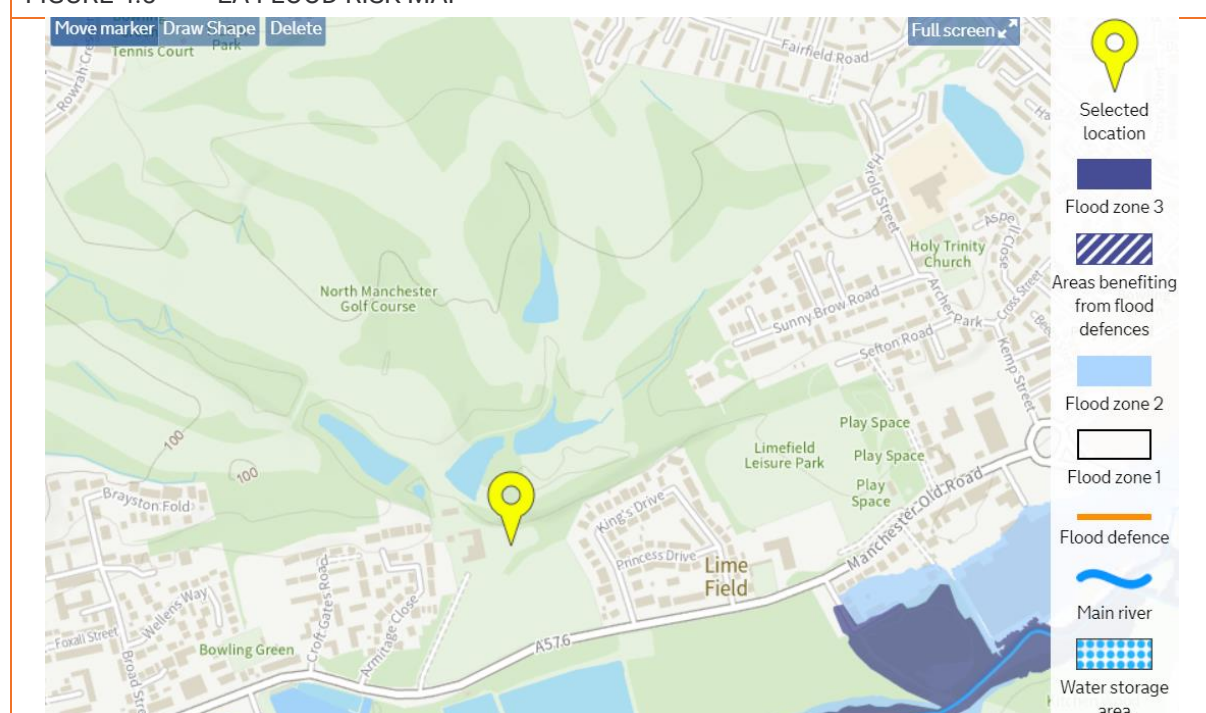
FIGURE 4.5 EA FLOOD RISK MAP

The site is located within a currently defined "Flood Risk Zone 1"; defined as land assessed as having less than 1 in 1,000 annual probability of river or sea flooding (< 0.1%), and as such is considered to be unaffected by river flooding. In addition, the Envirocheck report states there is a potential for groundwater flooding to occur at the surface. The Environment Agency (EA) Flood Risk Map for the site is presented as Figure 4.5.

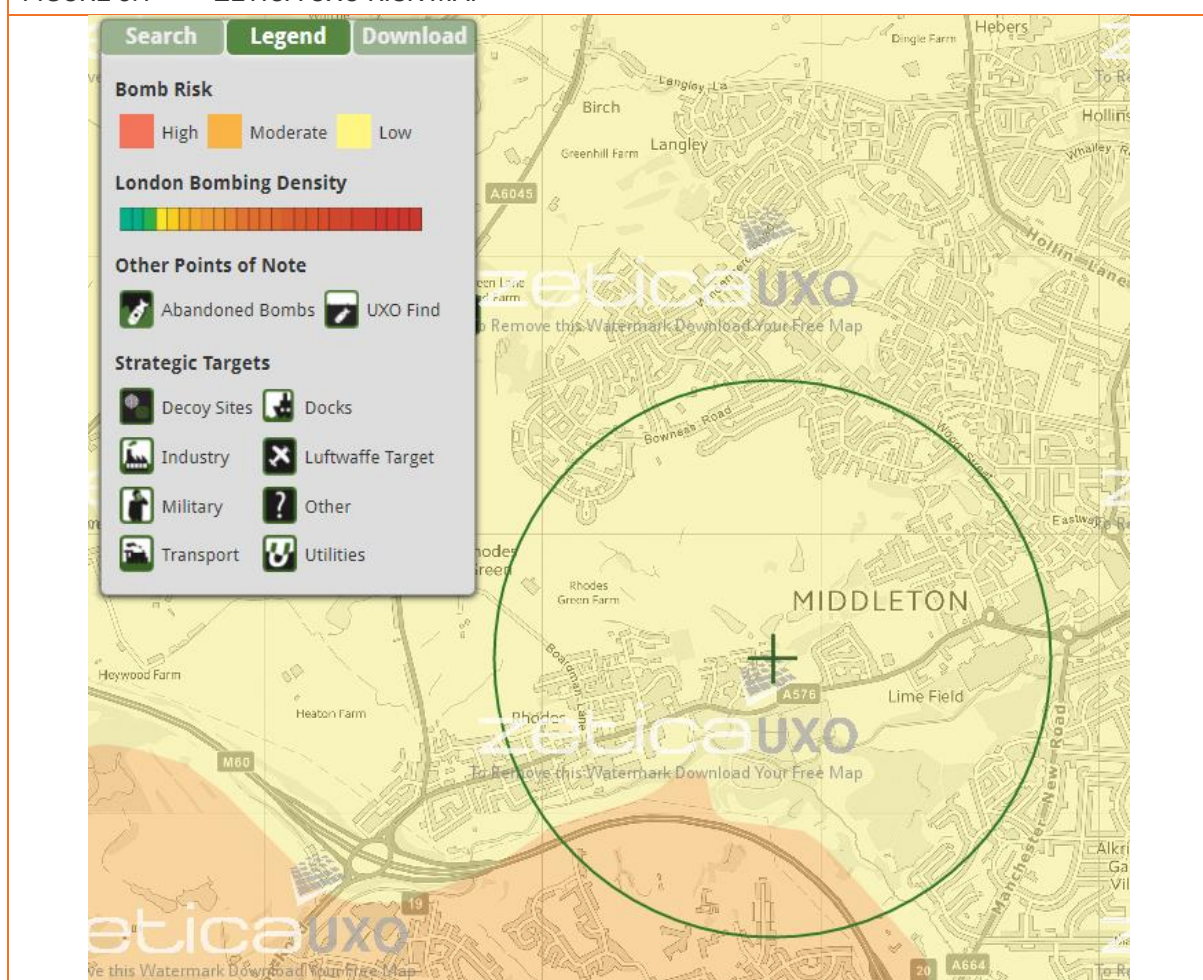
FIGURE 5.1 ZETICA UXO RISK MAP

The regional unexploded bomb risk map from Zetica (2014) indicates that the site is in an area at low risk from possible unexploded ordnance (UXO) resulting from the Second World War. The Zetica UXO Risk Map is presented as Figure 5.1.

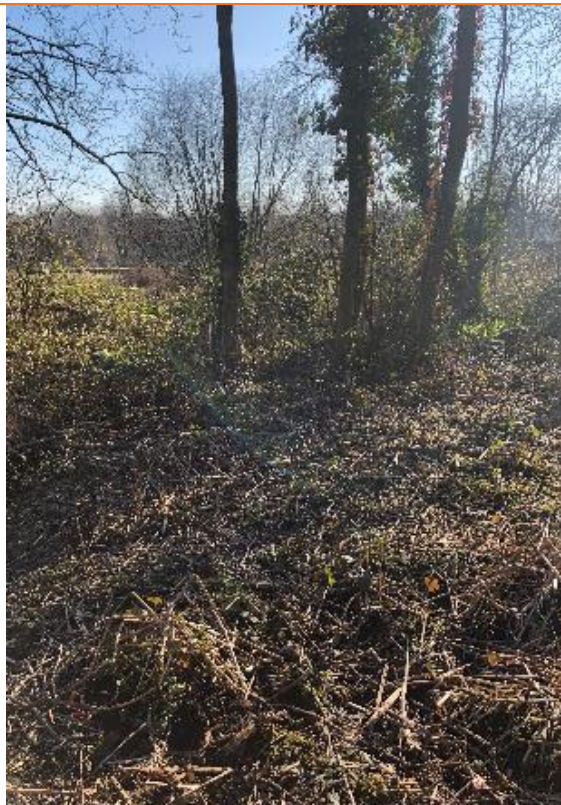
PLATE 2 HIMALAYAN BALSAM (DEAD AT TIME OF WALKOVER)

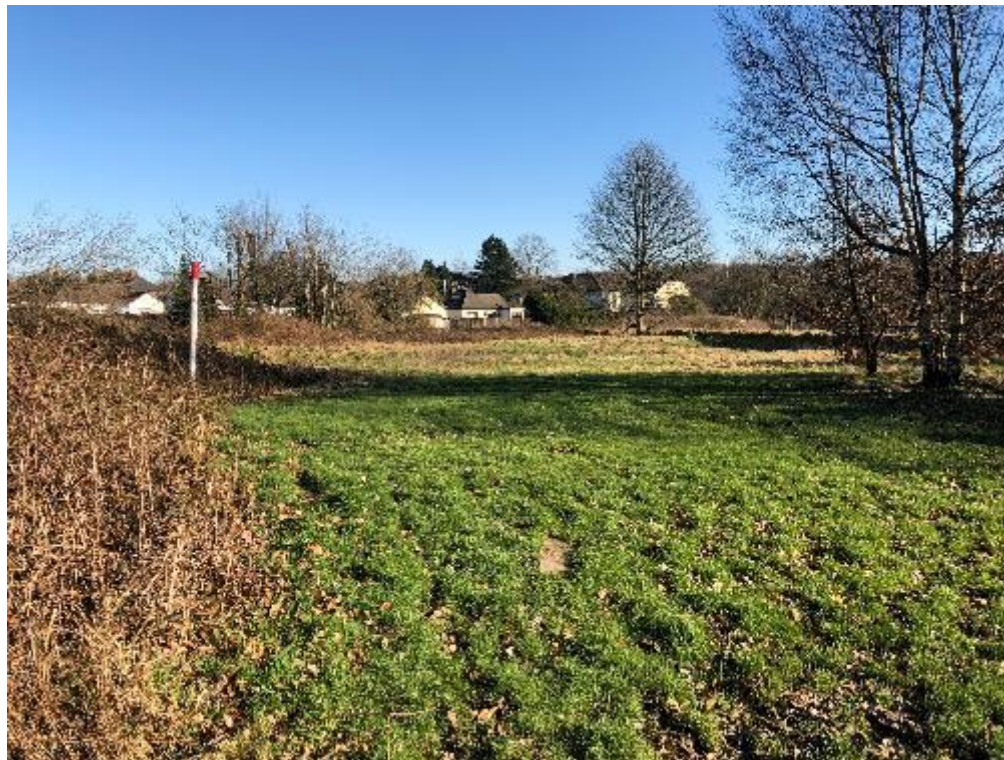
PLATE 4 VIEW OF THE EASTERN SECTOR IN PROXIMITY TO LHP GAS MAIN AND BUND

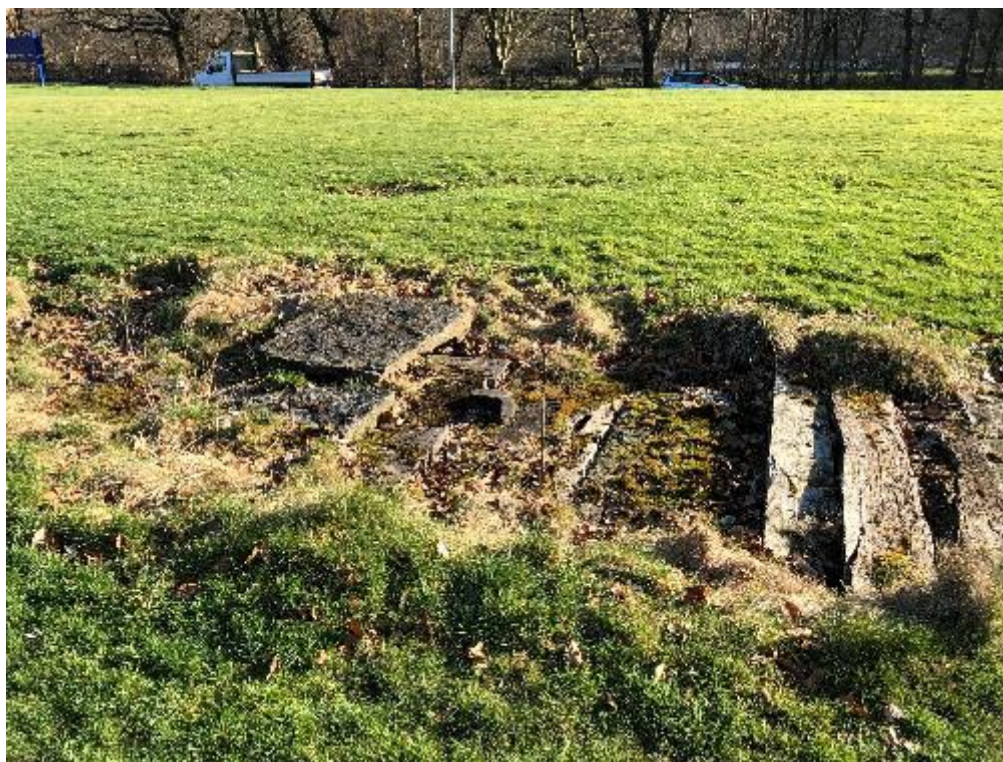
PLATE 11 CHAMBER IN SOUTH OF SITE

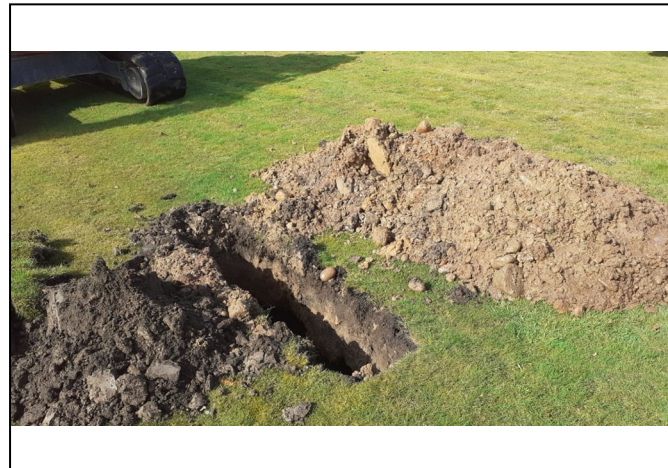
Trial Pit 105

Remarks: 1. Complete. 2. Water strike encountered at 0.80m bgl. 3. SANDS noted to be saturated from 0.80m bgl.

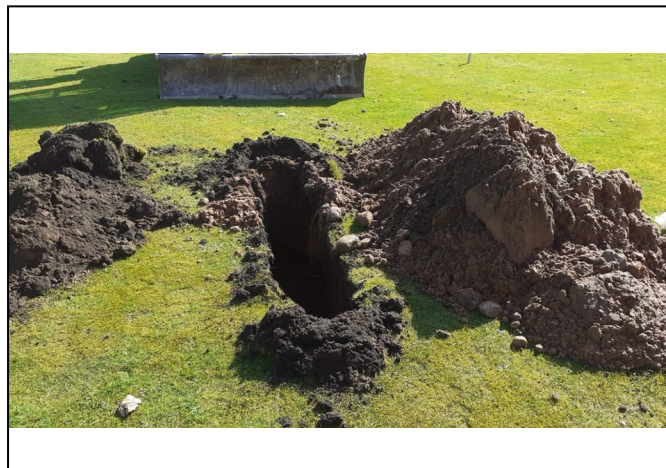
Trial Pit 106

Remarks: 1. Complete. 2. Water strike encountered at 1.00m bgl. 3. SANDS noted to be saturated from 1.00m bgl.

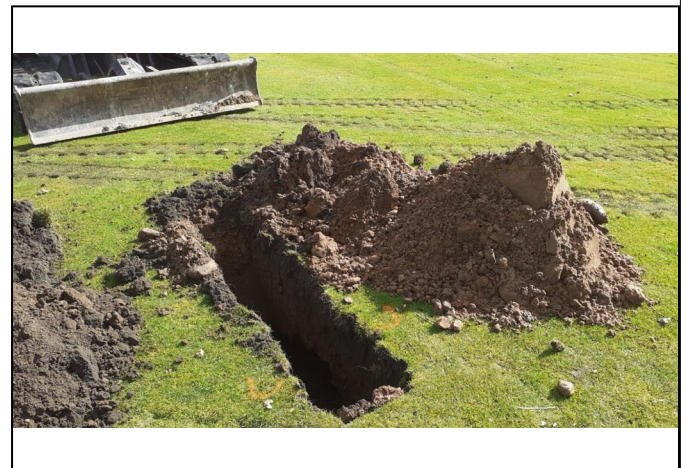
Trial Pit 107

Remarks: 1. Complete. 2. Water strike encountered at 1.60m bgl. 3. SANDS noted to be saturated from 1.60m bgl.

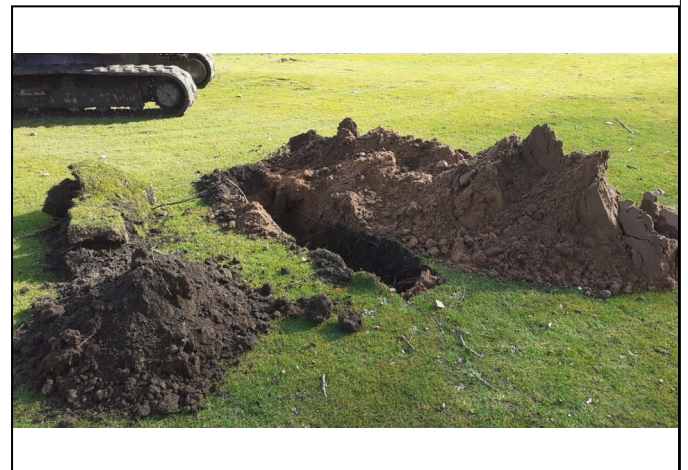
Trial Pit 108

Remarks: 1. Complete. 2. Water strike encountered at 1.80m bgl. 3. SANDS noted to be saturated.

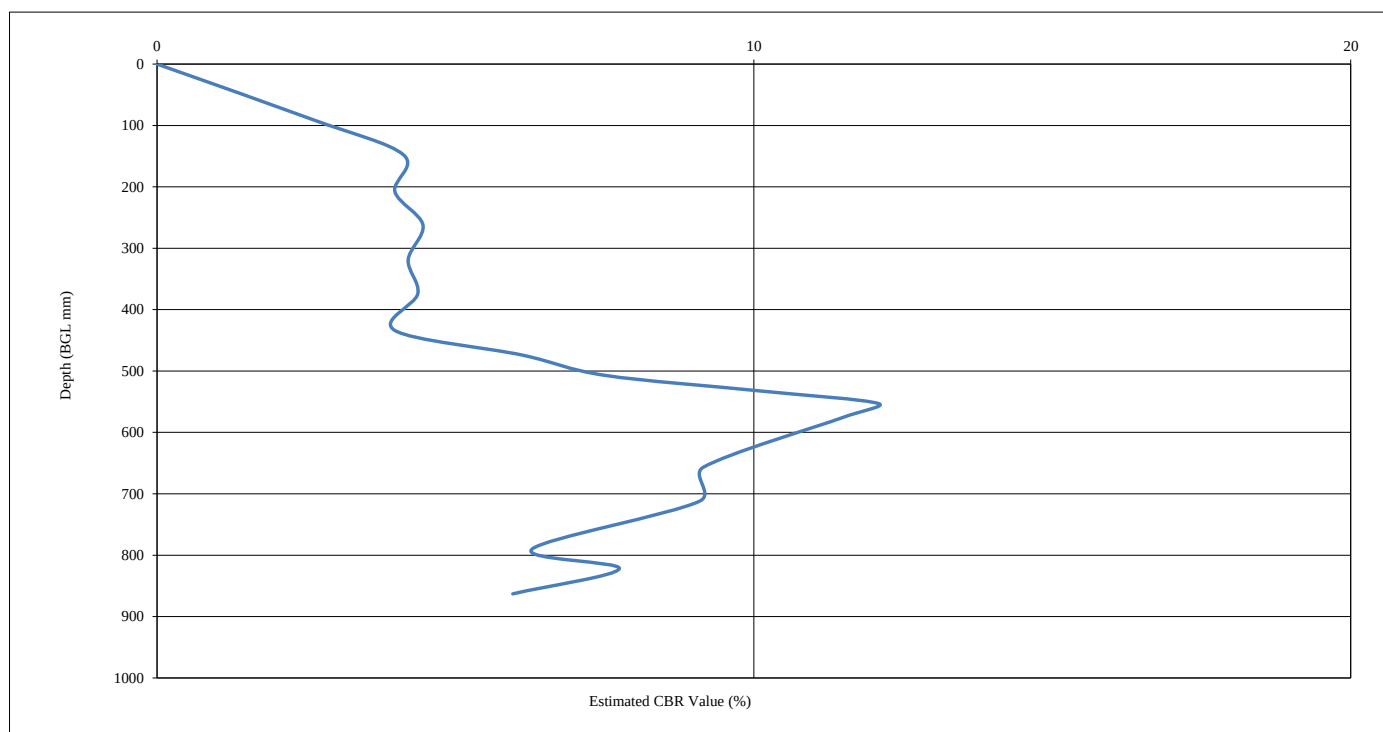
### Estimated California Bearing Ratio Graph

| Start Depth (mm) BGL | Finish Depth (mm) BGL | No. of Blows | Blows Per Layer | DCP mm/Blows | Ave Estimated Layer (CBR %) |
|---|---|---|---|---|---|
| 0 | 148 | 2 | 2 | 74.00 | 3.19 |

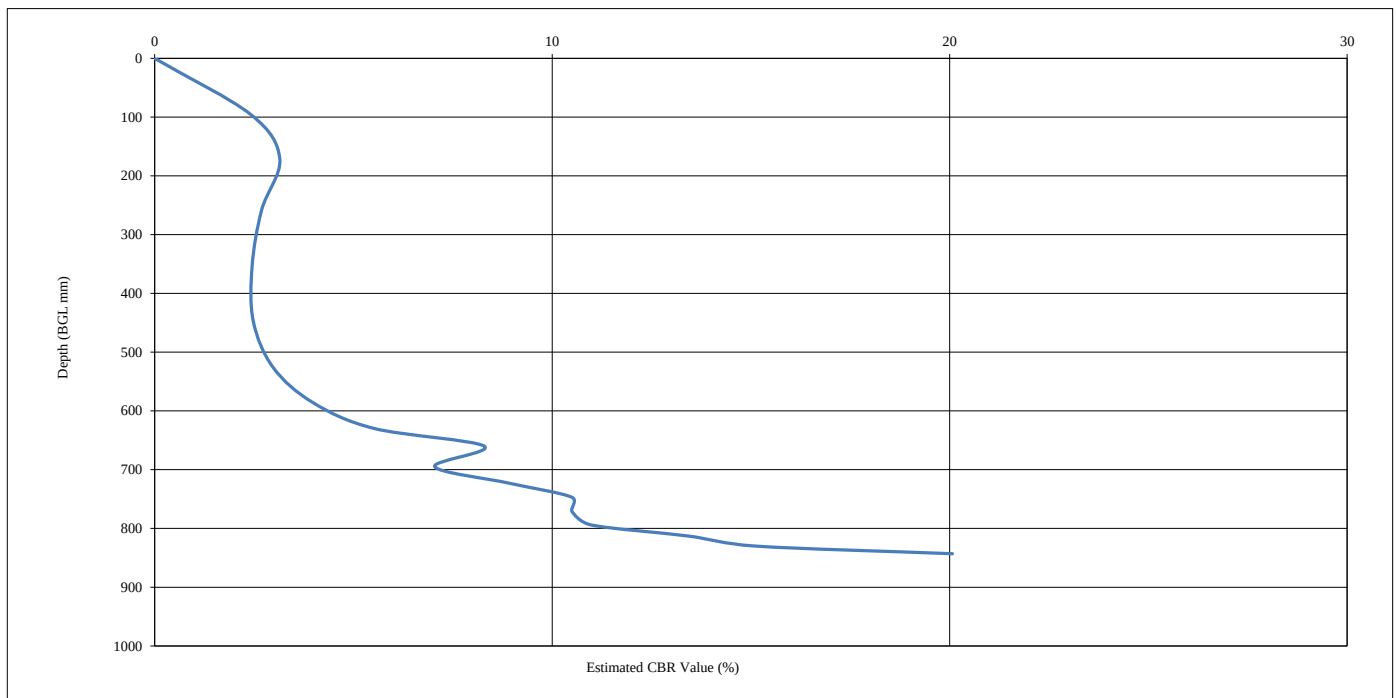
## Estimated California Bearing Ratio Graph

| Start Depth (mm) BGL | Finish Depth (mm) BGL | No. of Blows | Blows Per Layer | DCP mm/Blows | Ave Estimated Layer (CBR %) |
|---|---|---|---|---|---|
| 0 | 171 | 2 | 2 | 85.50 | 2.74 |

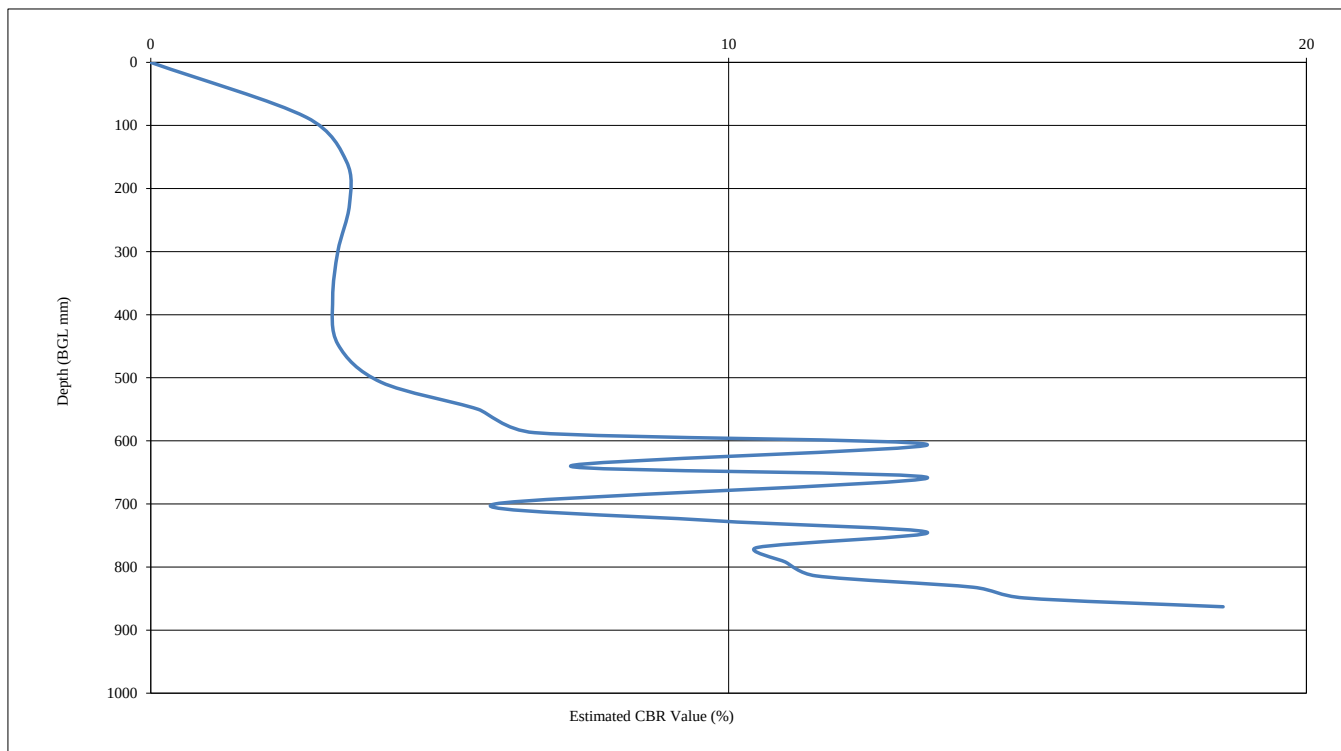
### Estimated California Bearing Ratio Graph

| Start Depth (mm) BGL | Finish Depth (mm) BGL | No. of Blows | Blows Per Layer | DCP mm/Blows | Ave Estimated Layer (CBR %) |
|---|---|---|---|---|---|
| 0 | 157 | 2 | 2 | 78.50 | 3.00 |

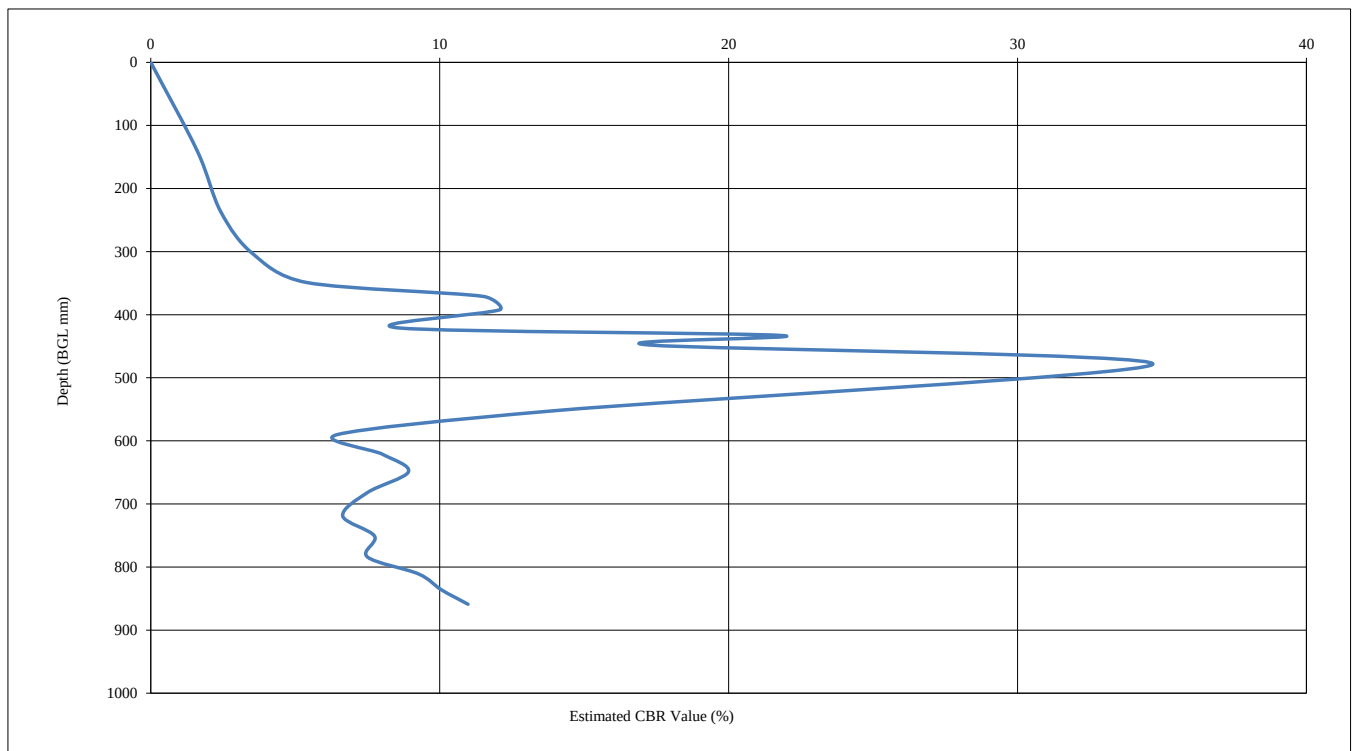
### Estimated California Bearing Ratio Graph

| Start Depth (mm) BGL | Finish Depth (mm) BGL | No. of Blows | Blows Per Layer | DCP mm/Blows | Ave Estimated Layer (CBR %) |
|---|---|---|---|---|---|
| 0 | 349 | 4 | 4 | 87.25 | 2.68 |

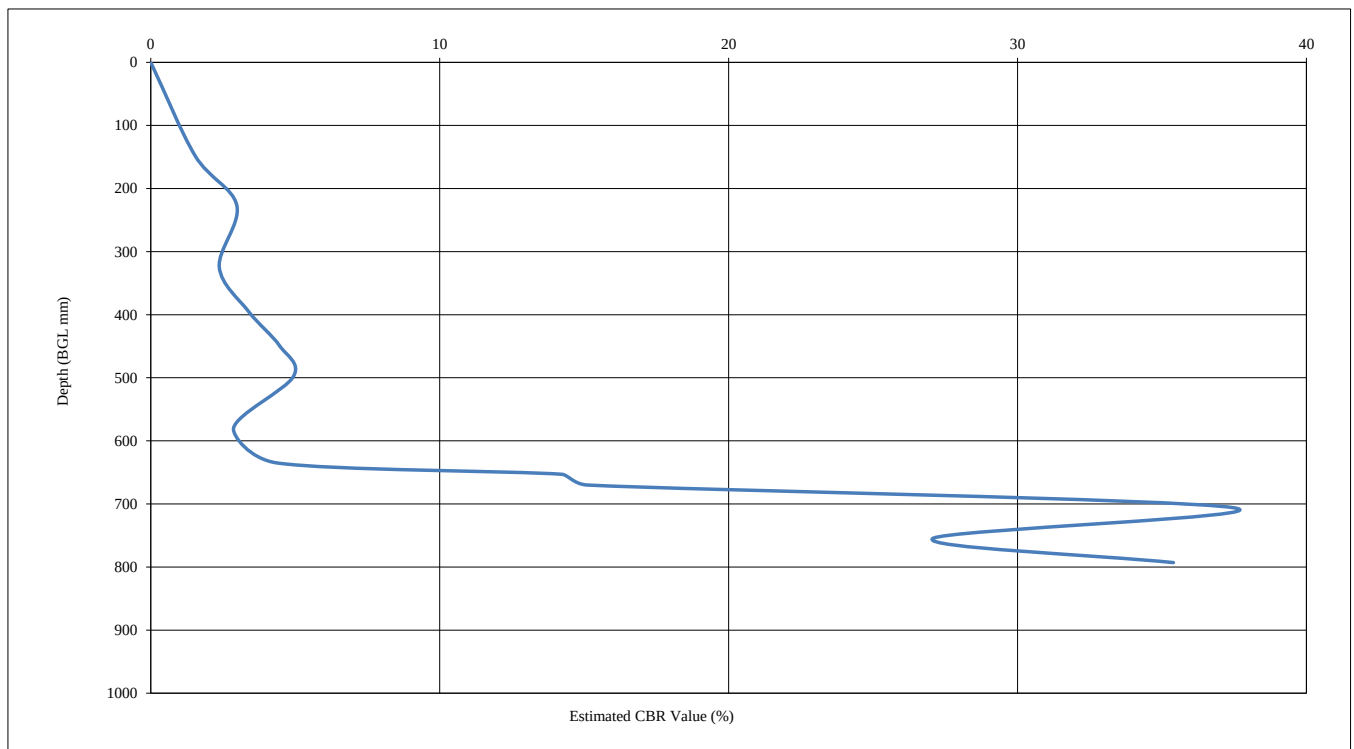
### Estimated California Bearing Ratio Graph

| Start Depth (mm) BGL | Finish Depth (mm) BGL | No. of Blows | Blows Per Layer | DCP mm/Blows | Ave Estimated Layer (CBR %) |
|---|---|---|---|---|---|
| 0 | 227 | 2 | 2 | 113.50 | 2.03 |

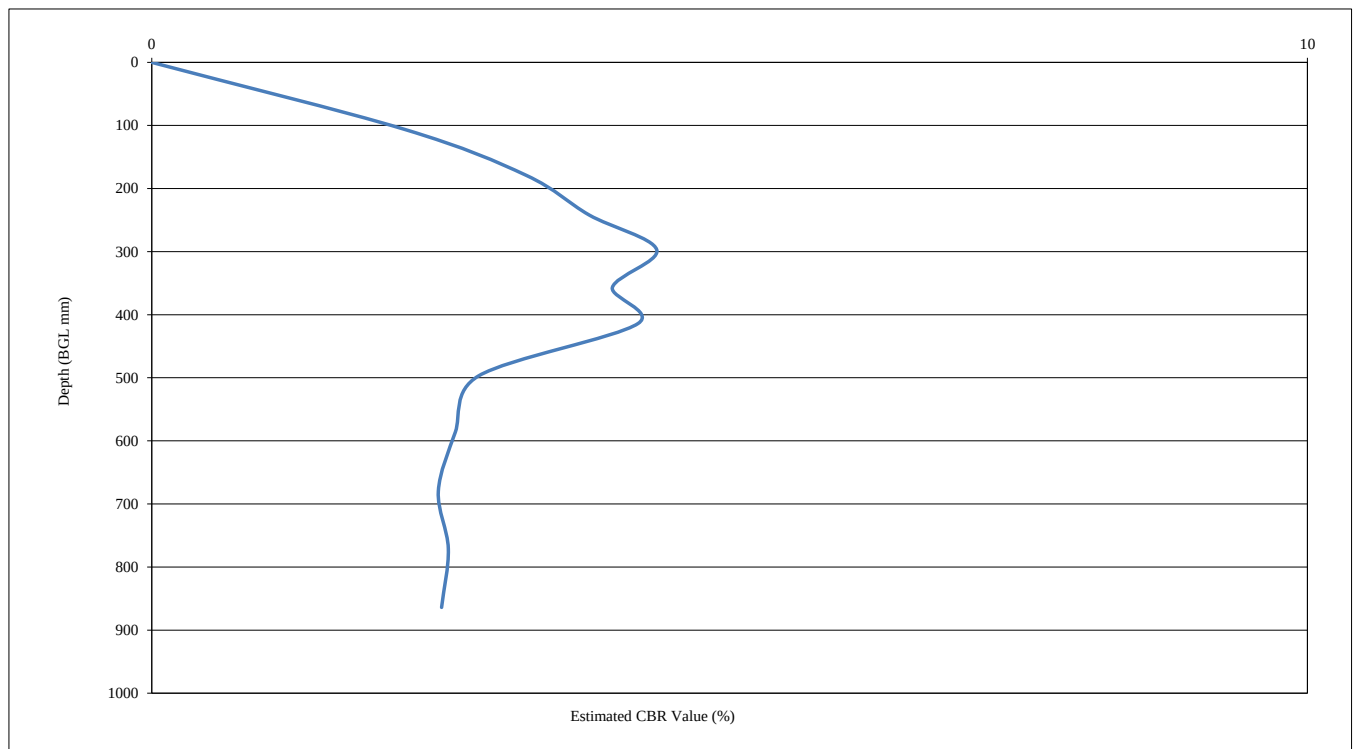
### Estimated California Bearing Ratio Graph

| Start Depth (mm) BGL | Finish Depth (mm) BGL | No. of Blows | Blows Per Layer | DCP mm/Blows | Ave Estimated Layer (CBR %) |
|---|---|---|---|---|---|
| 0 | 242 | 3 | 3 | 80.67 | 2.91 |

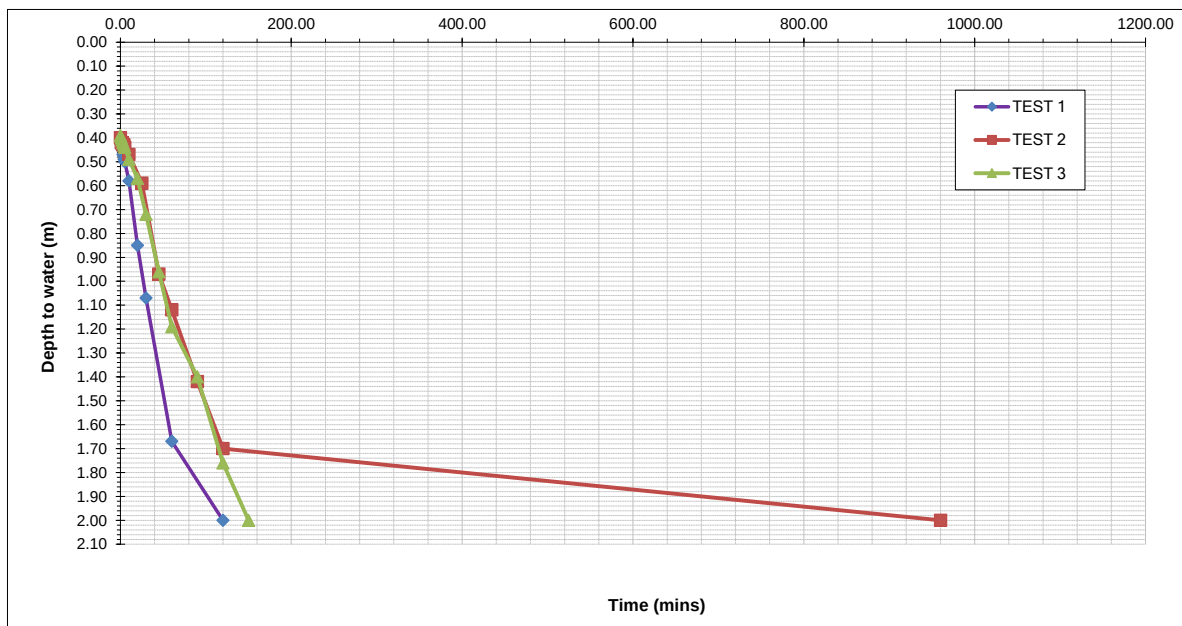
| DESIGN SOIL INFILTRATION RATE, f | 3.02E-05 |

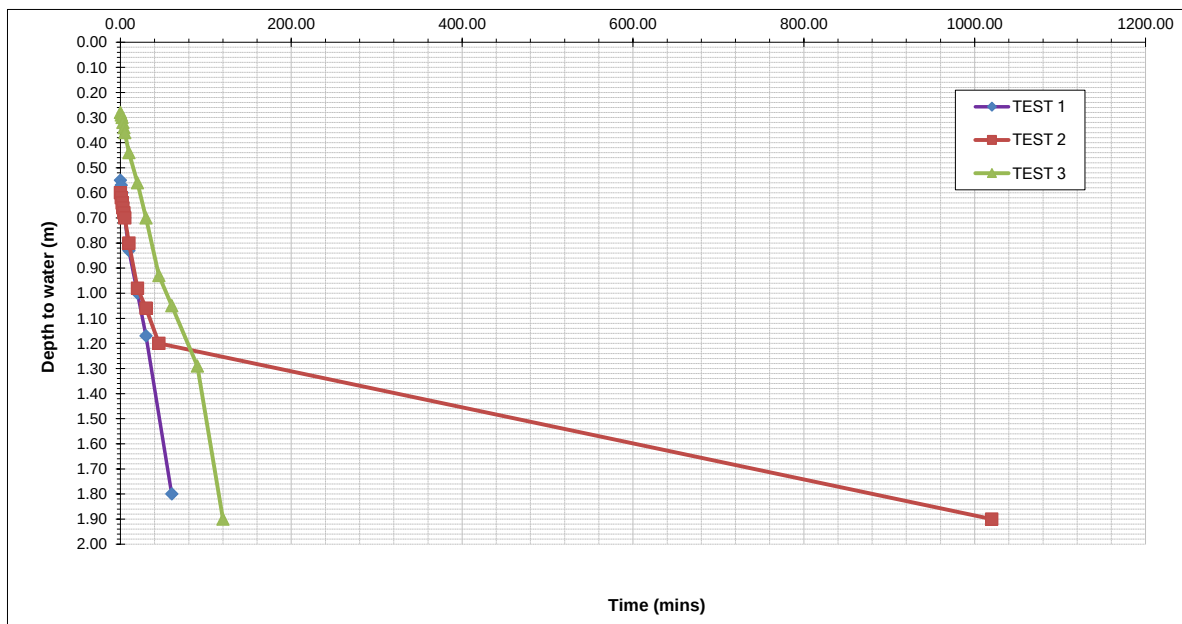
| DESIGN SOIL INFILTRATION RATE, f | 6.63E-05 |

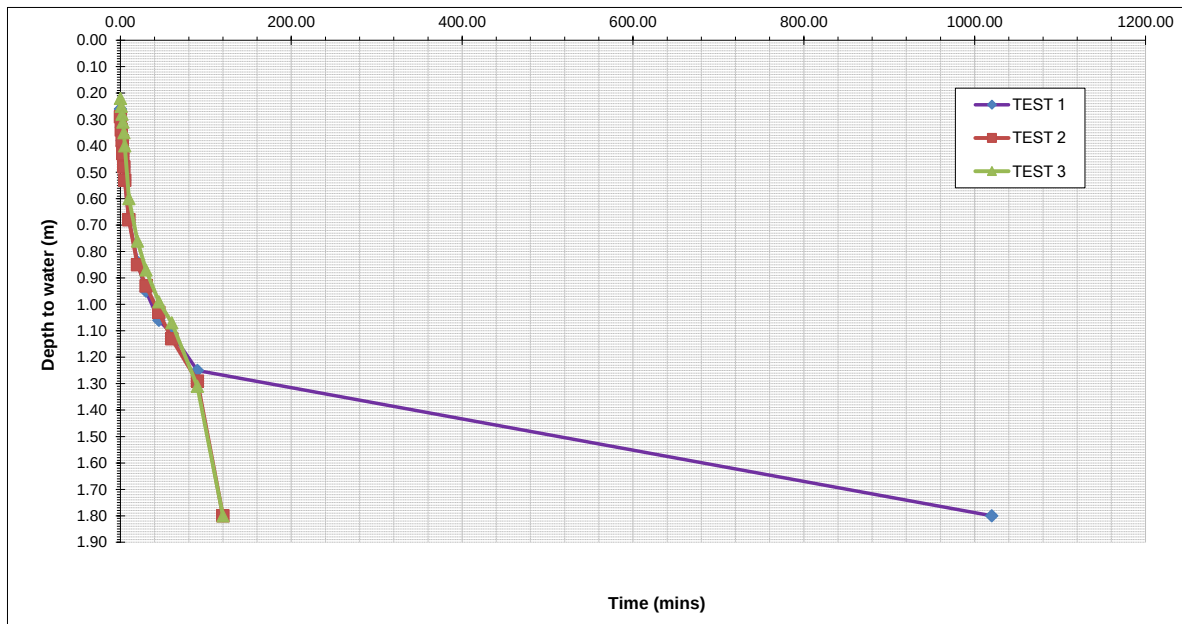
| <b>DESIGN SOIL INFILTRATION RATE, f</b> | <b>2.26E-05</b> |
