# **GEO-ENVIRONMENTAL AUDIT**

## **PHASE 1 PRELIMINARY RISK ASSESSMENT**

**Proposed Residential Development**  
**Church Avenue**  
**Middleton**  
**Manchester**

Author: Daniel Slattery  
Client: Harrison Construction Ltd  
Reference: rep-tjba-harrison-church ave-phs1\_2\_3env-270824.docx

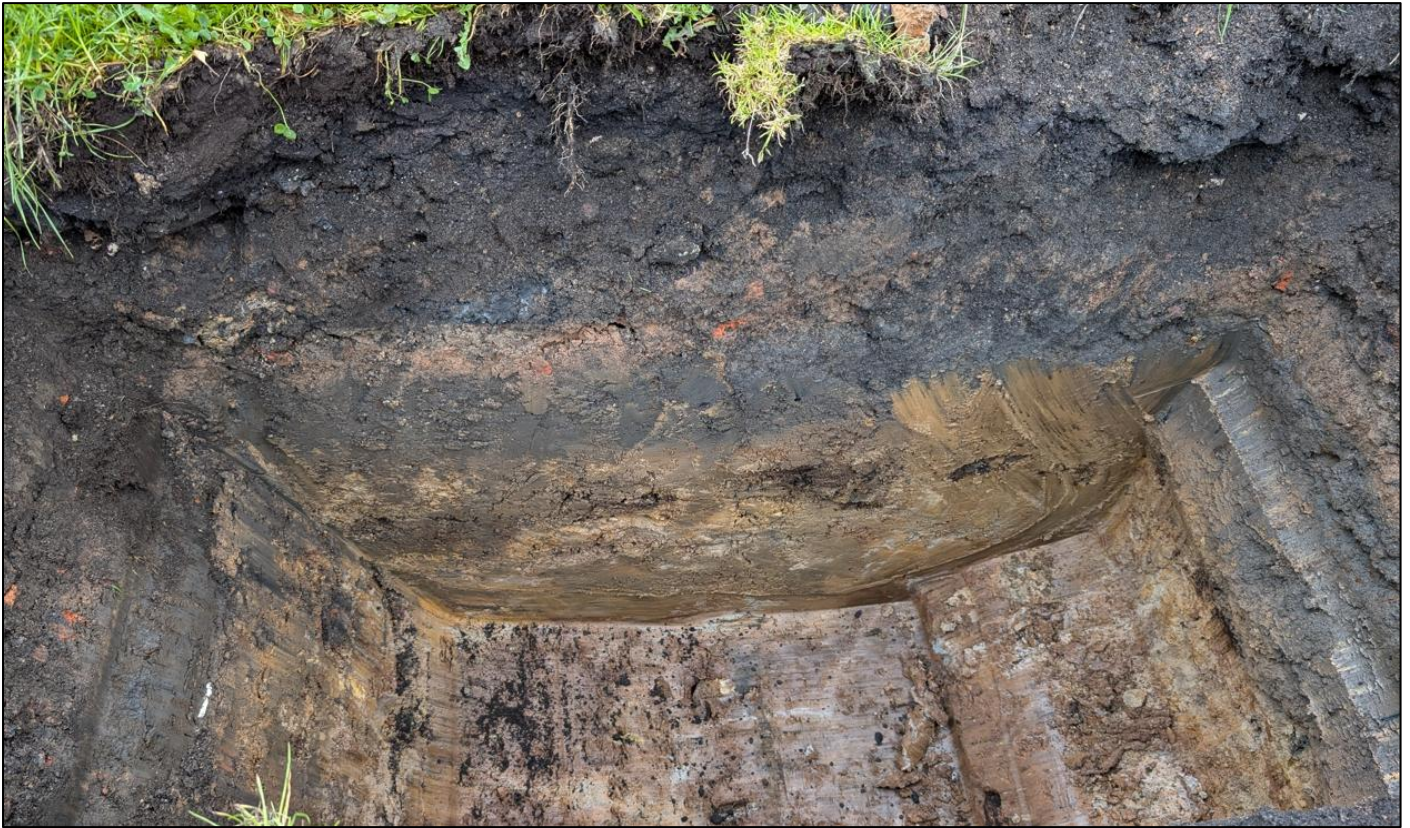
Trial Hole 1.

200-400 thick                      MADE GROUND; sand & gravel. Gravel was sandstone, brick, slate, ash, macadam.

Approx 1m thick                      Firm to stif occasionally very stiff CLAY.

| Trial Hole/Soil Sample | Made ground horizon | Mitigation/Action |
|---|---|---|
| TH1/S1 | Lead at threshold, asbestos at threshold, Benzo(a)pyrene, benzo(b)fluoranthene, dibenz(a,h)anthracene. | FURTHER ACTION |

Dependent on the final finished levels, existing made ground within proposed soft landscaping areas, should either be covered with 600mm of imported soil, or excavated to 600mm from finish levels and replaced with a clean imported cover soil to suit finishes. The 600mm cover system is adopted for the following reasons:

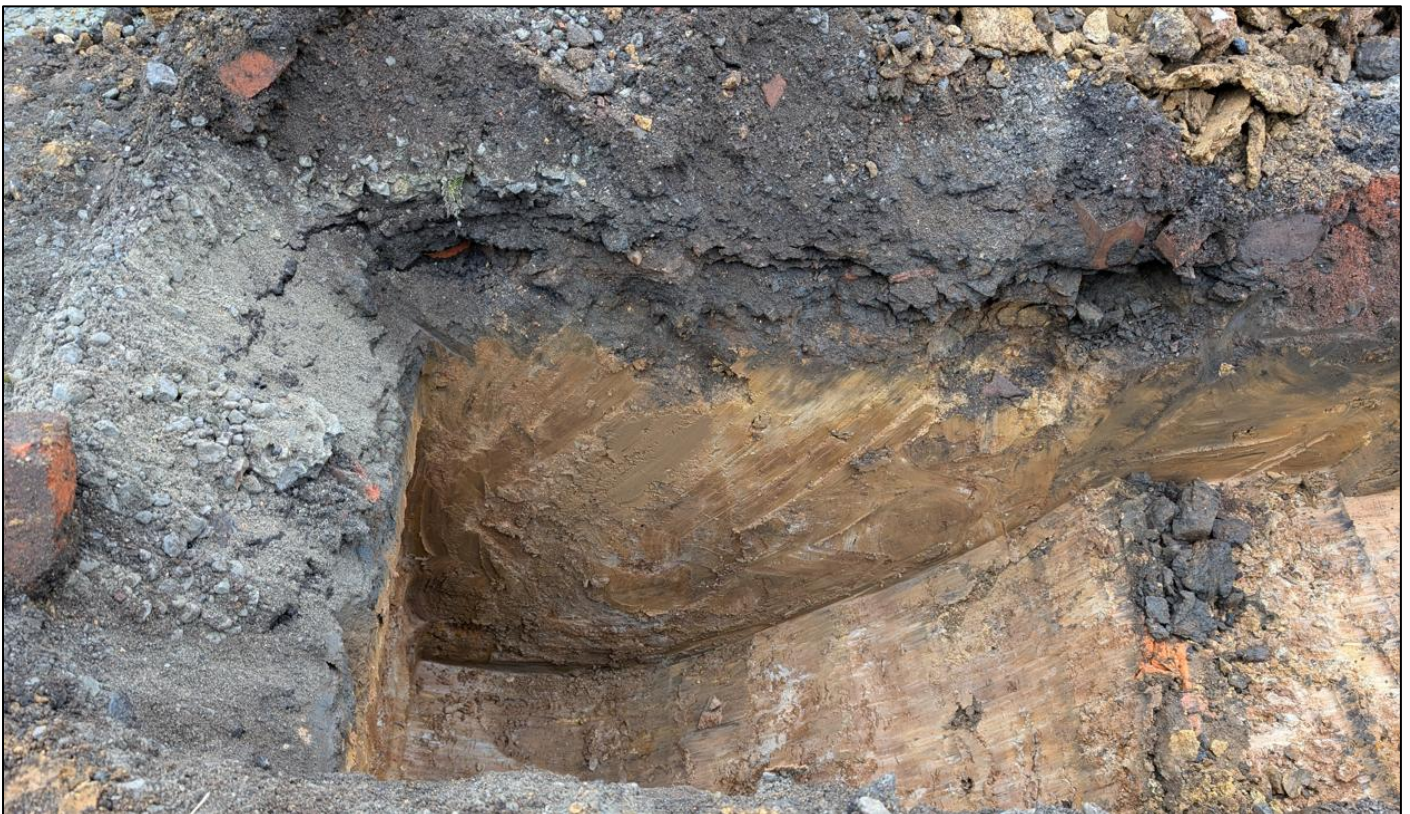
Trial Hole 2.

| TH2/S2 | No exceedances. | PASS |

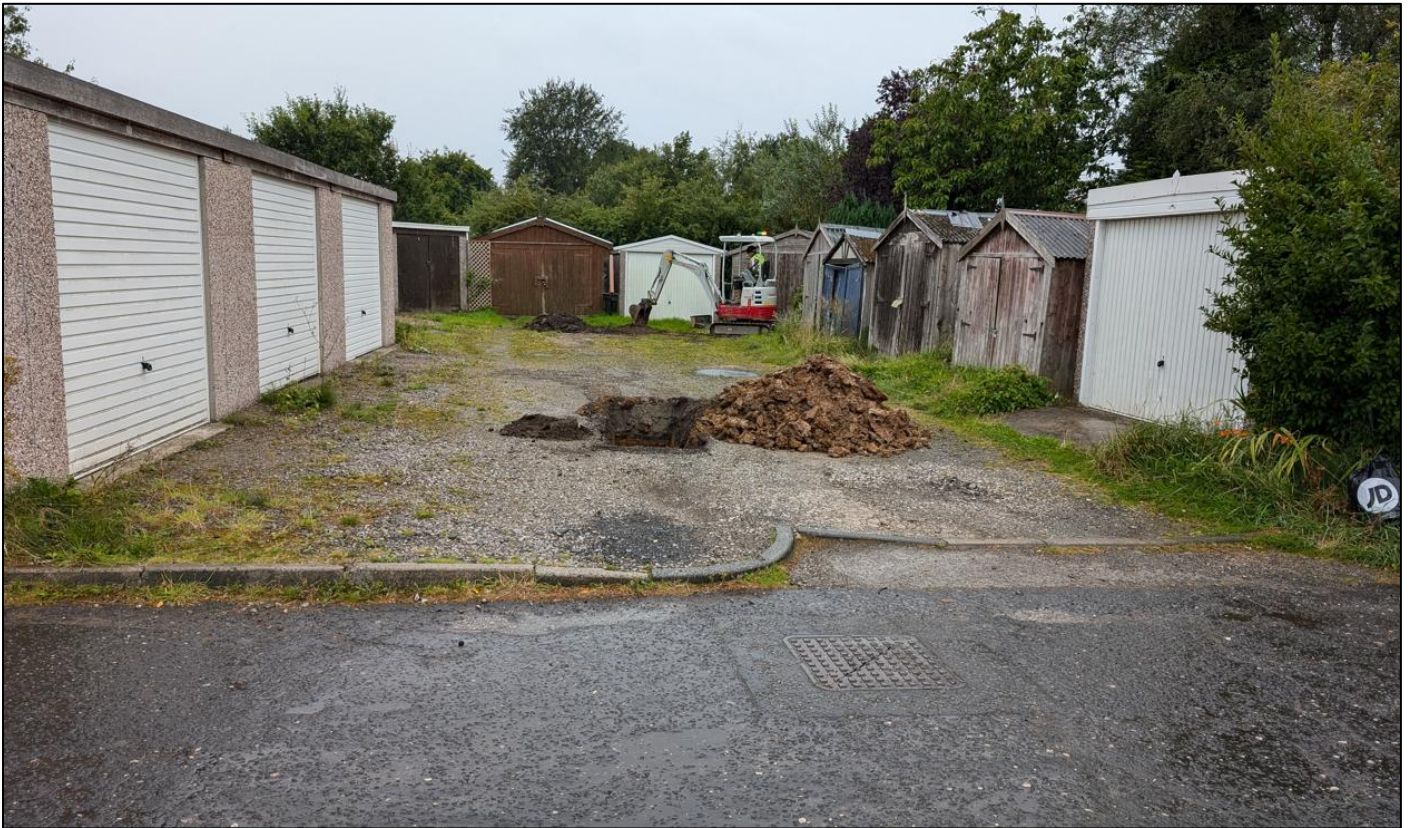
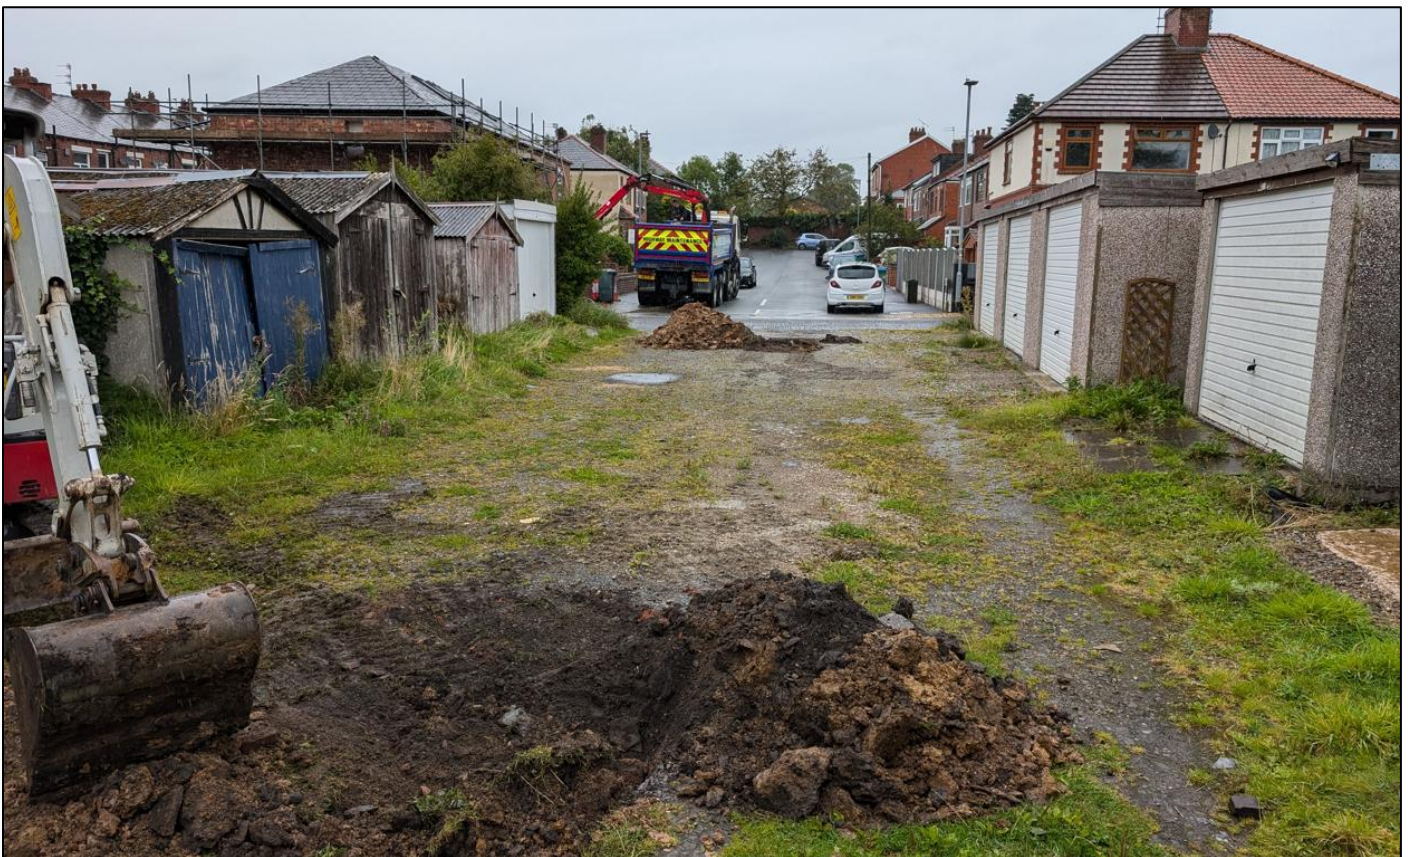
General site photographs.

| Details of existing structures: | <p>A site reconnaissance was undertaken in August 2024.</p> <p>The Site was still being used as a garage plot by local residents, and was lined with garages to the east, west, and south sides.</p> <p>Access was from Church Street at the north side of the plot, and comprised a made ground surface with little to no macadam noted.</p> <p>Some of the garages comprised asbestos sheet cladding to the roofs.</p> <p>The Site was generally fenced off from neighbouring gardens/allotments.</p> |
