## Ground Investigation Report

Proposed Residential Development

Cowm Top, Rochdale

Document no.: STV5936-R04-Rev\_A

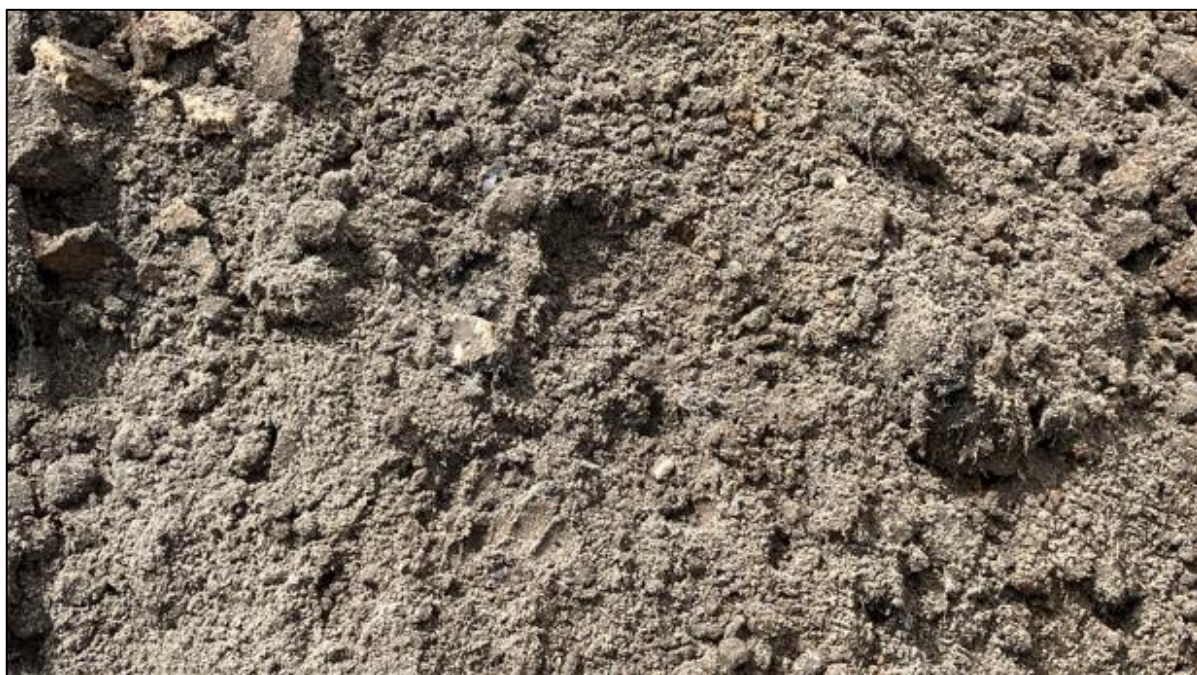
*Figure 5-A: Sandy Topsoil deposits encountered in TP21*

- 5.2.1 Topsoil was encountered in all exploratory holes typically 0.2m-0.4m thick.
- 5.2.2 The composition of the Topsoil encountered was variable across site, consisting of either organic clayey gravelly sand or organic sandy gravelly clay. Rare anthropogenic inclusions were noted including brick and ceramic.
- 5.2.3 A photograph of topsoil deposits encountered is presented below.

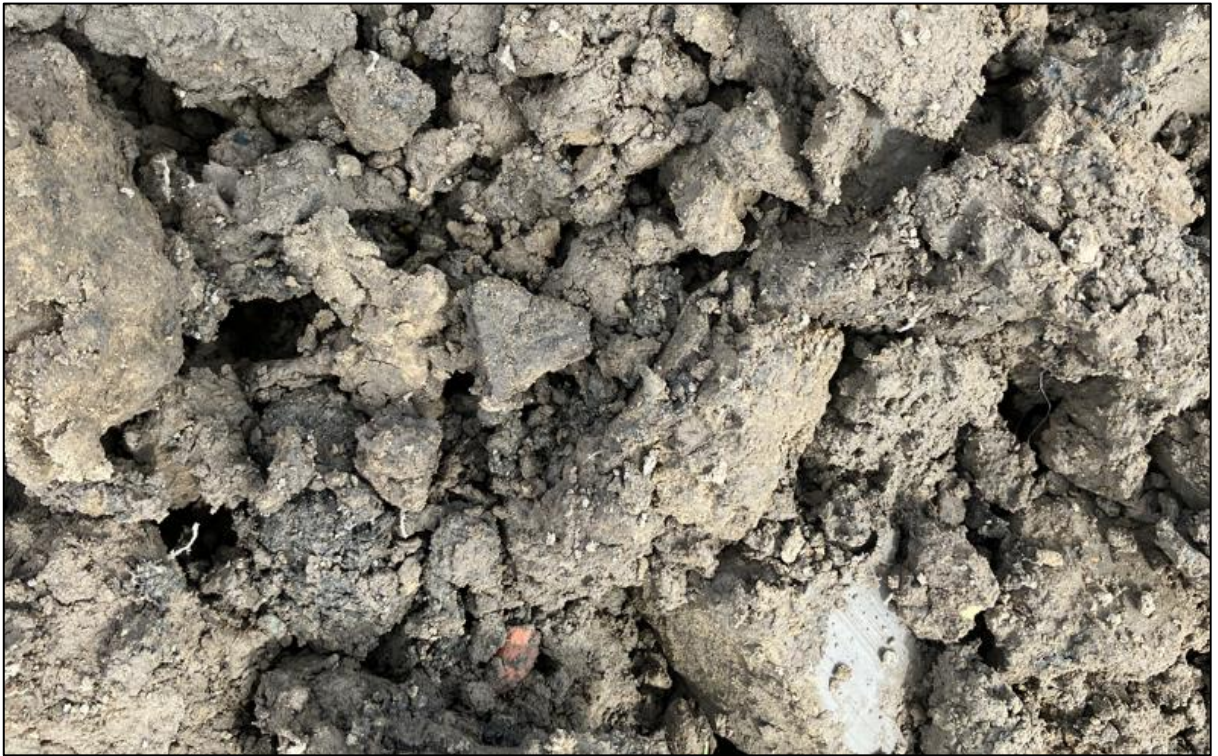
*Figure 5-C: Made Ground encountered in TP10*

- 5.3.1 Localised Made Ground was encountered within the areas southeast, northeast and west of the site, consistent with previous ground investigations. The areas are defined on Drawing 01A/B. A very localised area immediately at surface was also encountered in the area of SL02.
- 5.3.2 In the south-eastern area of the site, the base of the Made Ground was encountered between depths of 0.70m (TP14) and 2.80m BGL (TP11) and varied between 0.45m and 2.50m in thickness. The Made Ground largely comprised sandy gravelly clay with brick, concrete, coal with timber and ceramic fragments, and is anticipated to comprise reworked material sourced from the formation of the adjacent A627(M).

5.3.3 A photograph of the Made Ground encountered in the southeast of the site is presented below.

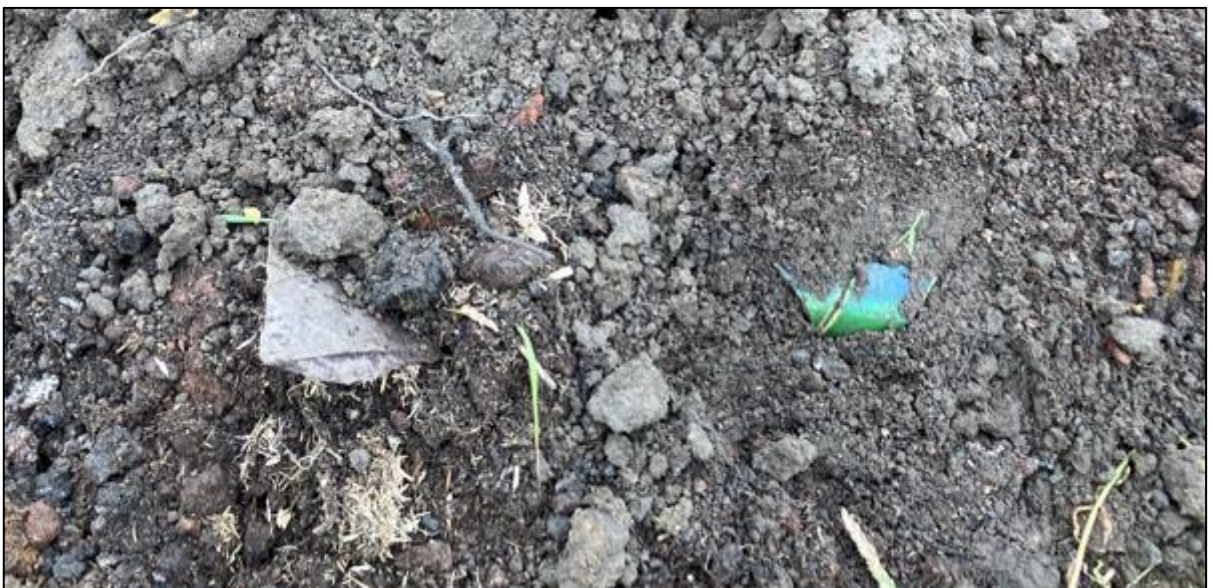
*Figure 5-D: Made Ground encountered in TP03*

5.3.4 Made Ground was also encountered in the northeast of the site within TP01 and TP03. The base of the unit was located between depths of 0.60m and 1.30m BGL and varied between 0.30m and 1.10m in thickness.

5.3.5 The Made Ground encountered consisted of silty sandy cobbly gravel of clinker, ceramic, glass, metal and brick fragments. A hydrocarbon odour was noted between depths of 1.10-1.30m BGL in TP03.

5.3.6 A photograph of the Made Ground from the north-eastern area of the site is presented below.

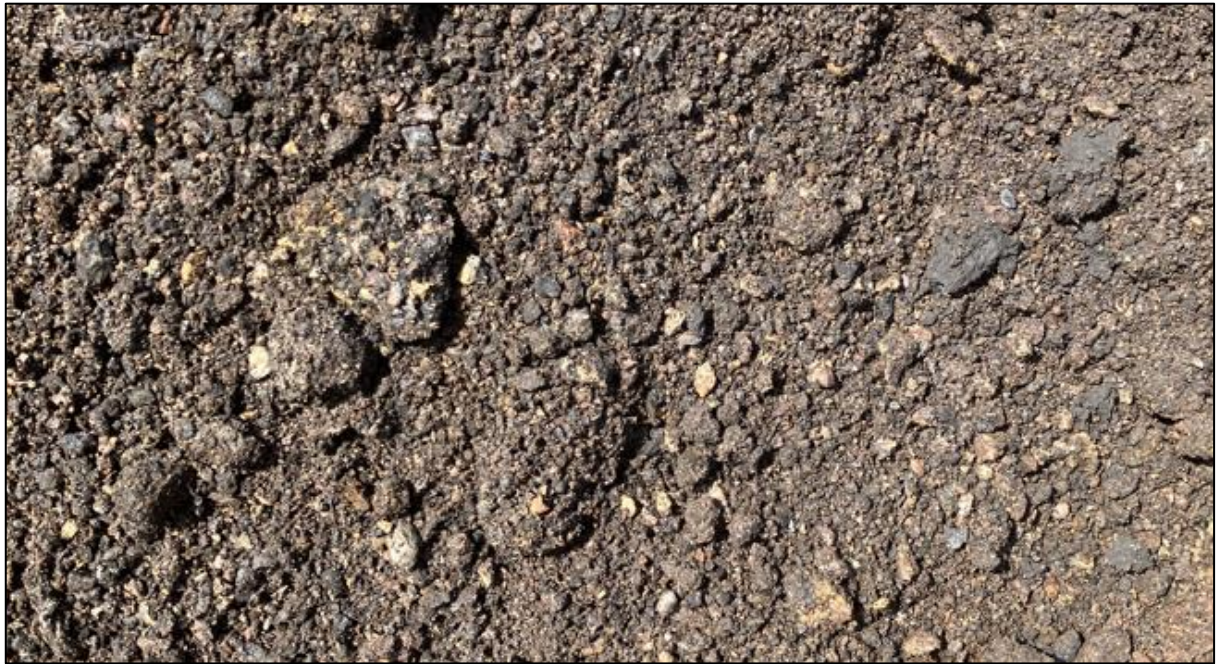
*Figure 5-E: Made Ground encountered in TP19*

- 5.3.7 Made Ground was also encountered in the south-western area of the site within TP19 & TP20. The base of the unit was located between depths of 1.05m and 1.40m BGL, with no topsoil overlying.
- 5.3.8 The Made Ground varied between the two positions, consisting of gravels of brick, clicker, glass, ceramic, timber and metal fragments within TP19, and clay with brick and plastic fragments within TP20.
- 5.3.9 A photograph of the Made Ground encountered within the south-western area of the site is presented below.

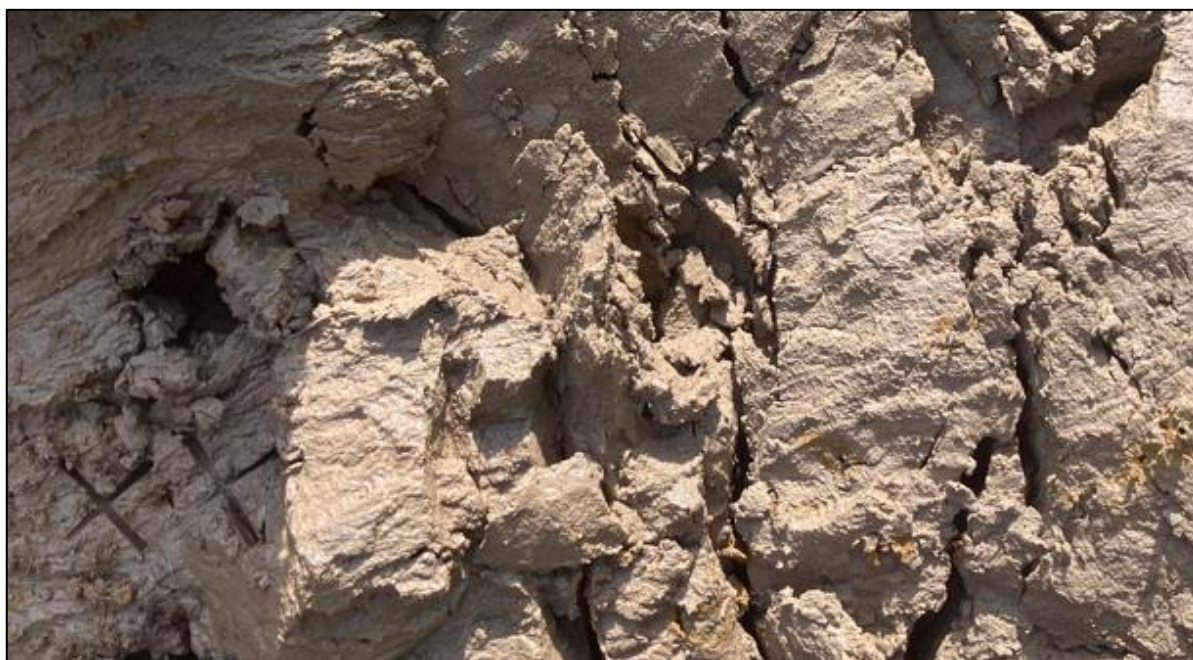
*Figure 5-F: Alluvium deposits encountered in TP20*

- 5.4.1 Alluvium was encountered within the western valley floor in TP17, TP19 and TP20. The base of the Alluvium was recorded as 0.9m and 1.6m in TP17 and TP19 respectively but was not encountered in TP20 where the maximum excavation depth was 2.30m.
- 5.4.2 The Alluvium encountered typically consisted of soft dark grey/brown sandy gravelly silt. Deposits were also encountered in the eastern valley area during previous ground investigations by Smith Grant LLP.
- 5.4.3 A photograph of the Alluvium encountered is presented below.

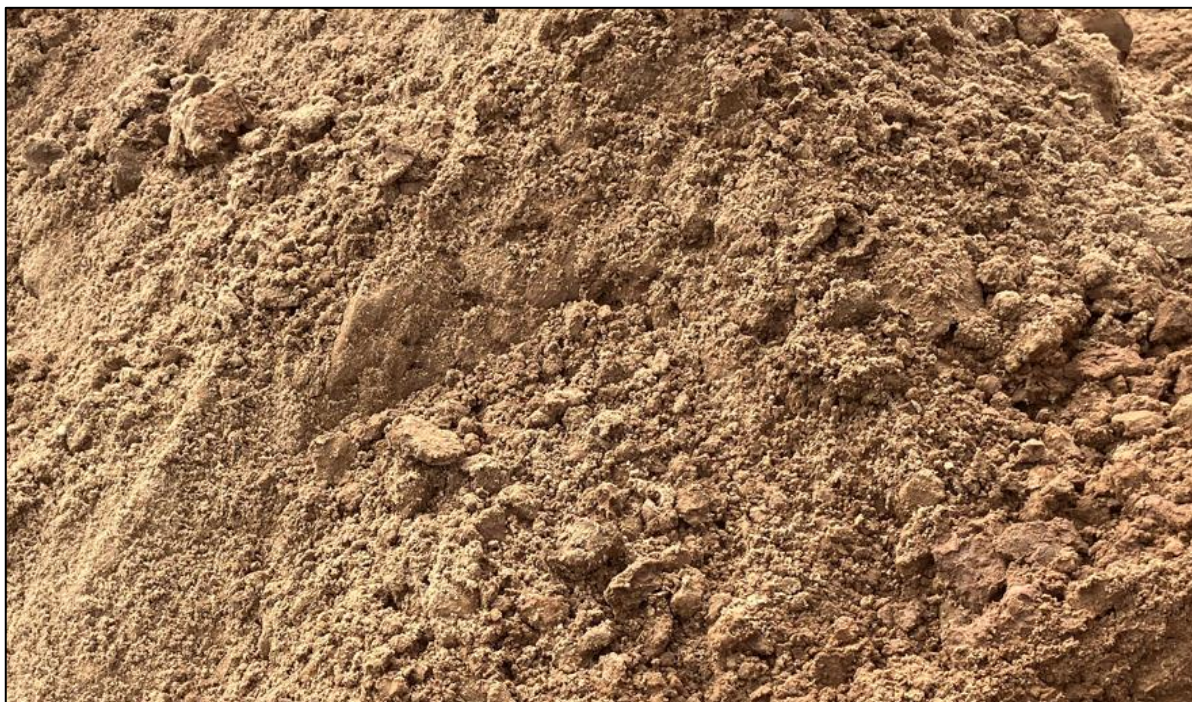
*Figure 5-G: Hummocky Glacial Deposits consisting of gravelly sands encountered in TP16*

- 5.5.1 Hummocky Glacial Deposits were encountered in every exploratory position beyond the maximum excavation depth of 15.45m BGL.
- 5.5.2 The Hummocky Glacial Deposits encountered had variable composition site-wide, consisting of interbedded layers of fine-grained clay materials and coarse-grained sand materials. Boreholes in the centre and south of the site (BH03-BH05, BH07, BH08 and BH11) generally recorded dominantly coarse-grained materials with some lenses of fine-grained clays, whereas BH01, BH02 and BH10 in the north and east, as well as BH09 in the southwest recorded generally fine-grained materials with lenses of coarse-grained sand, generally at greater depth.
- 5.5.3 A series of photographs of the Hummocky Glacial Deposits encountered are presented below.

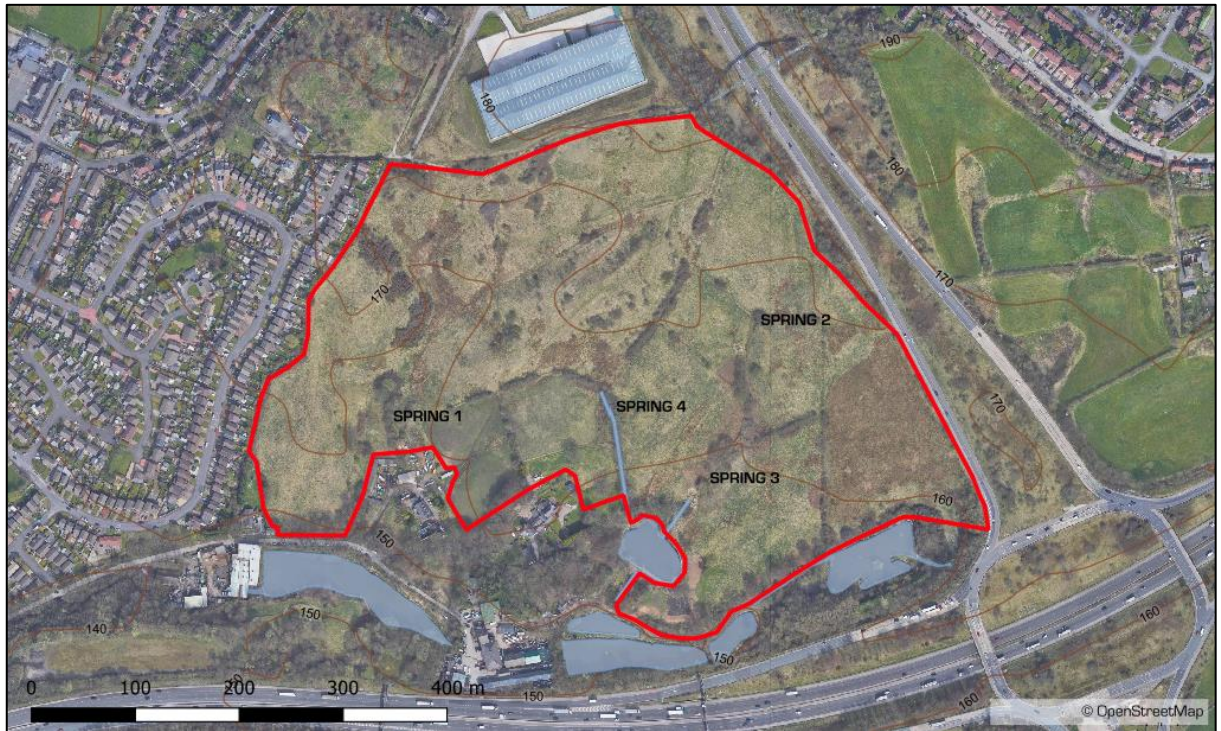
Figure 7-A: Location of spring monitoring positions

- 7.7.3 As part of the preliminary slope stability works package (ref Section 1.2.3) previously issued in March 2023, surface water was sampled at four spring locations onsite with subsequent laboratory testing to establish a baseline water quality within the site prior to any construction works. In addition, water quality measurements were taken insitu utilising a quality meter. Water quality measurements are presented in Appendix F and laboratory test data is presented in Appendix H. The locations of surface water samples are shown in the figure below.

- 7.7.4 Screening of baseline data with Environmental Quality Standards (EQS) presented in Appendix I indicates exceedances of guidelines for various metals, largely cadmium, chromium, copper and zinc, with localised marginal exceedances of nickel and lead. No elevated concentrations of PAHs were noted. Given the lack of sources of contamination onsite, such concentrations are likely to be indicative of natural background concentrations for surface waters in the area. It is also noted that guidelines for contaminants such as cadmium, copper and zinc are affected by the bioavailability parameters of the receiving water course. As such, the guideline values utilised within the current assessment are considered conservative for such contaminants.
