# GEO-ENVIRONMENTAL AUDIT

## PHASE 2 SITE INVESTIGATIONS

## PHASE 3 REMEDIATION STATEMENT

**PROPOSED RESIDENTIAL DEVELOPMENT**  
**TRUB ROAD**  
**CASTLETON**  
**ROCHDALE**  
**OL11 2WH**

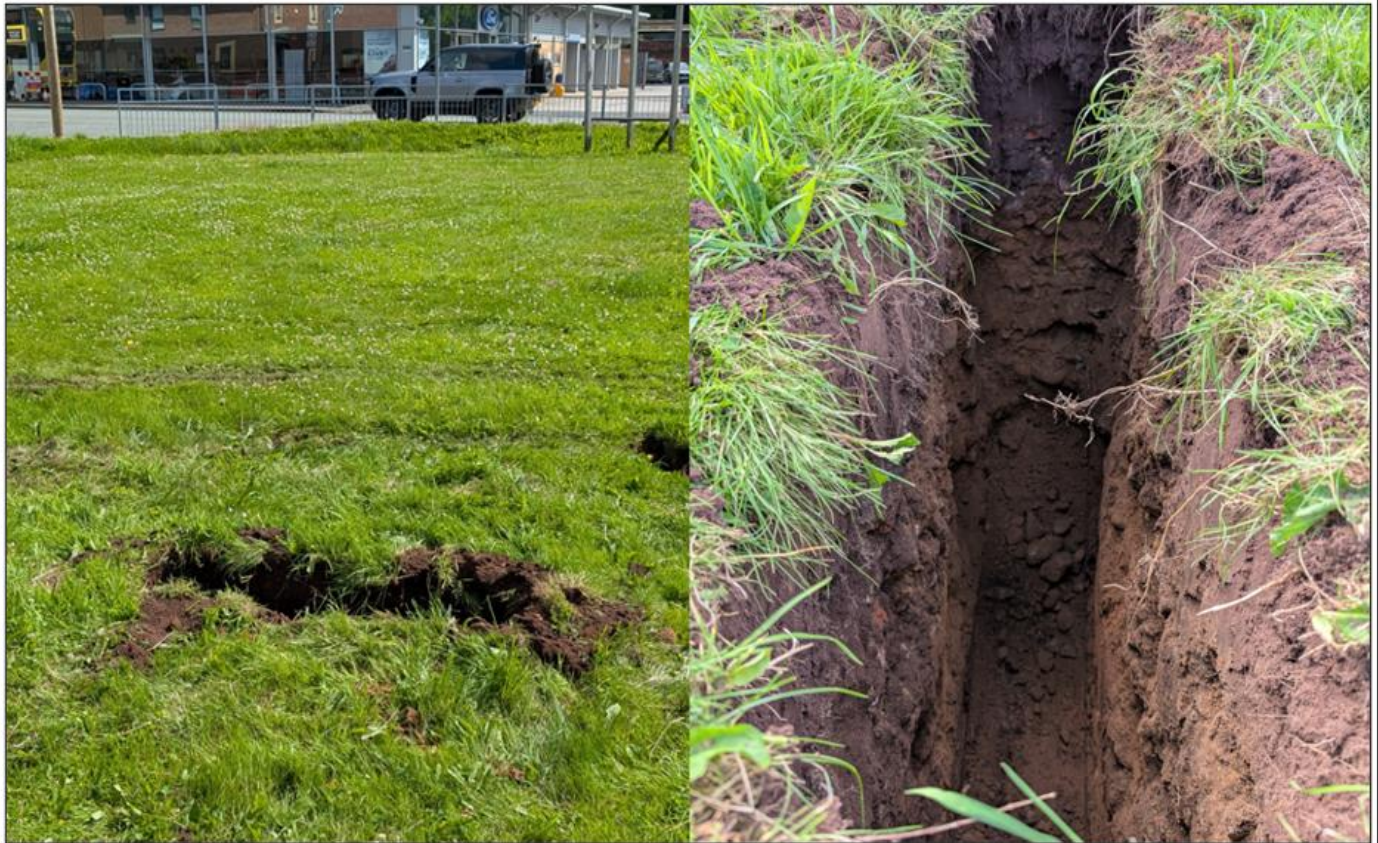
| Trial pit reference TH1 | | | | Sheet 1 of 1 |

| Trial pit reference TH1 | | | | Sheet 1 of 1 |
|---|---|---|---|---|
| | 134.60 | X X<br>X X | (0.40)<br>0.40 | Brown slightly gravelly very sandy silt MADE GROUND (topsoil). (S1) |
| | 134.05 | : o : o :<br>o : o : o<br>: o : o : | (0.55)<br>0.95 | Medium dense light brown-orange silty SAND AND GRAVEL with occasional cobbles & boulders. |
| | 133.50 | : x : x :<br>x : x : x<br>: x : x : | (0.55)<br>1.50 | Medium dense light brown-orange silty medium SAND |

Additional notes: No groundwater noted.

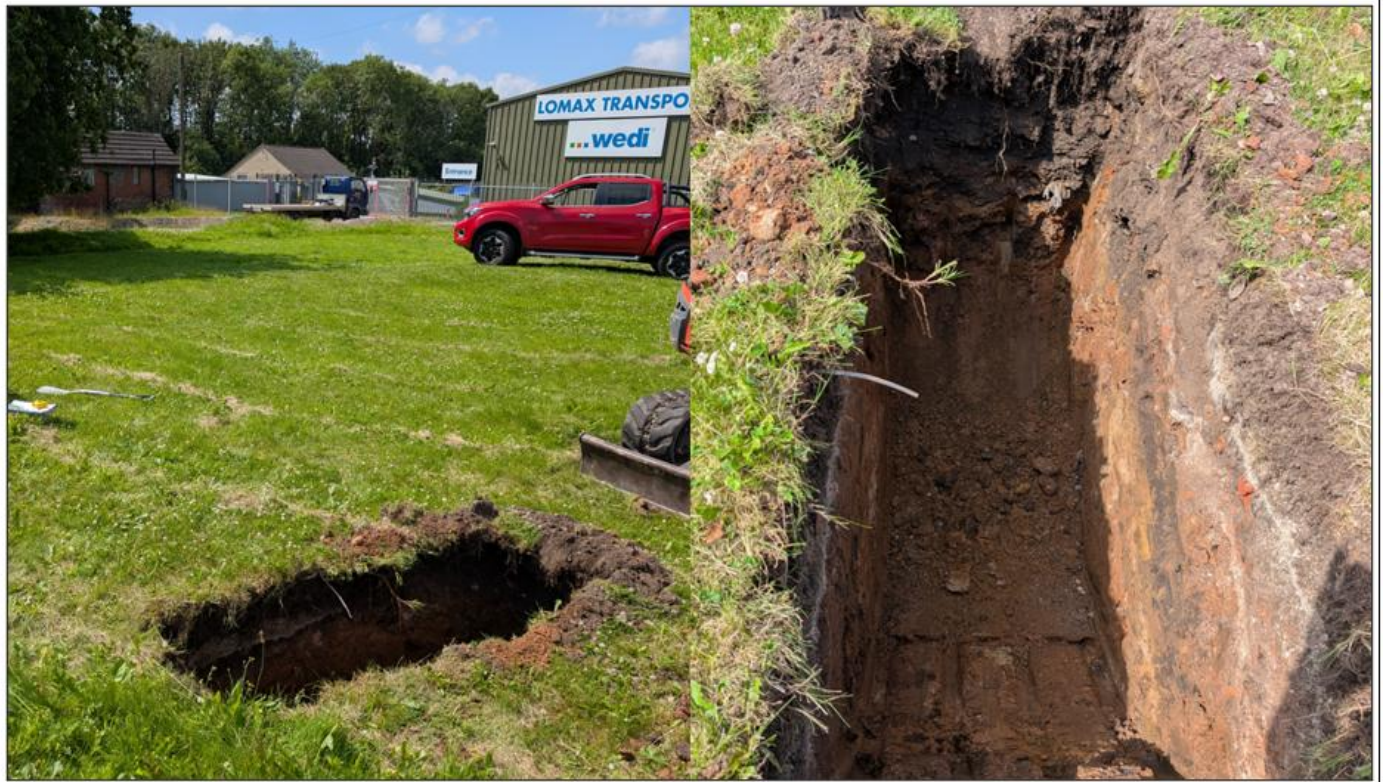
## Trial pit reference TH2

| Water | Reduced Level (m) | Legend | Depth (m) | Description |
|---|---|---|---|---|
| | 135.30 | X X<br>X X | (0.25)<br>0.25 | Brown sand & gravel MADE GROUND. Gravel is brick, stone, slate & MOT. (S2) |
| | 134.95 | X - X -<br>- X - X - | (0.35)<br>0.60 | Very stiff dark brown-black clayey MADE GROUND |
| | 134.15 | - - - - -<br>- - - - -<br>- - - - -<br>- - - - - | (0.80)<br>1.40 | Very stiff brown-grey mottled sandy CLAY |

Additional notes: No groundwater noted.

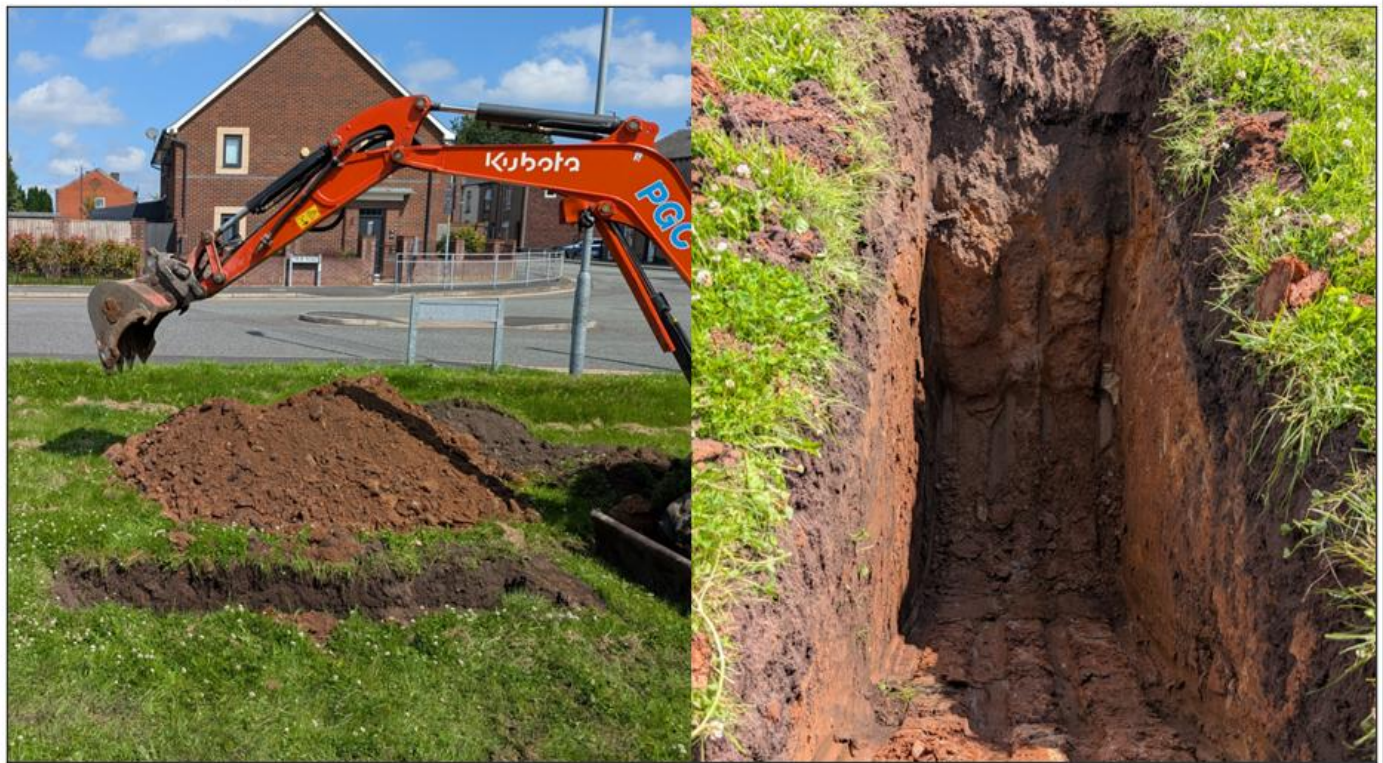
## Trial pit reference TH3

| Water | Reduced Level (m) | Legend | Depth (m) | Description |
|---|---|---|---|---|
| | 135.05 | X X<br>X X | (0.40)<br>0.40 | Brown slightly gravelly very sandy silt MADE GROUND (topsoil). (S3) |
| | | - - - - -<br>- - - - -<br>- - - - -<br>- - - - -<br>- - - - -<br>- - - - - | (1.05) | Very stiff brown-grey mottled sandy CLAY |

Additional notes: No groundwater noted.

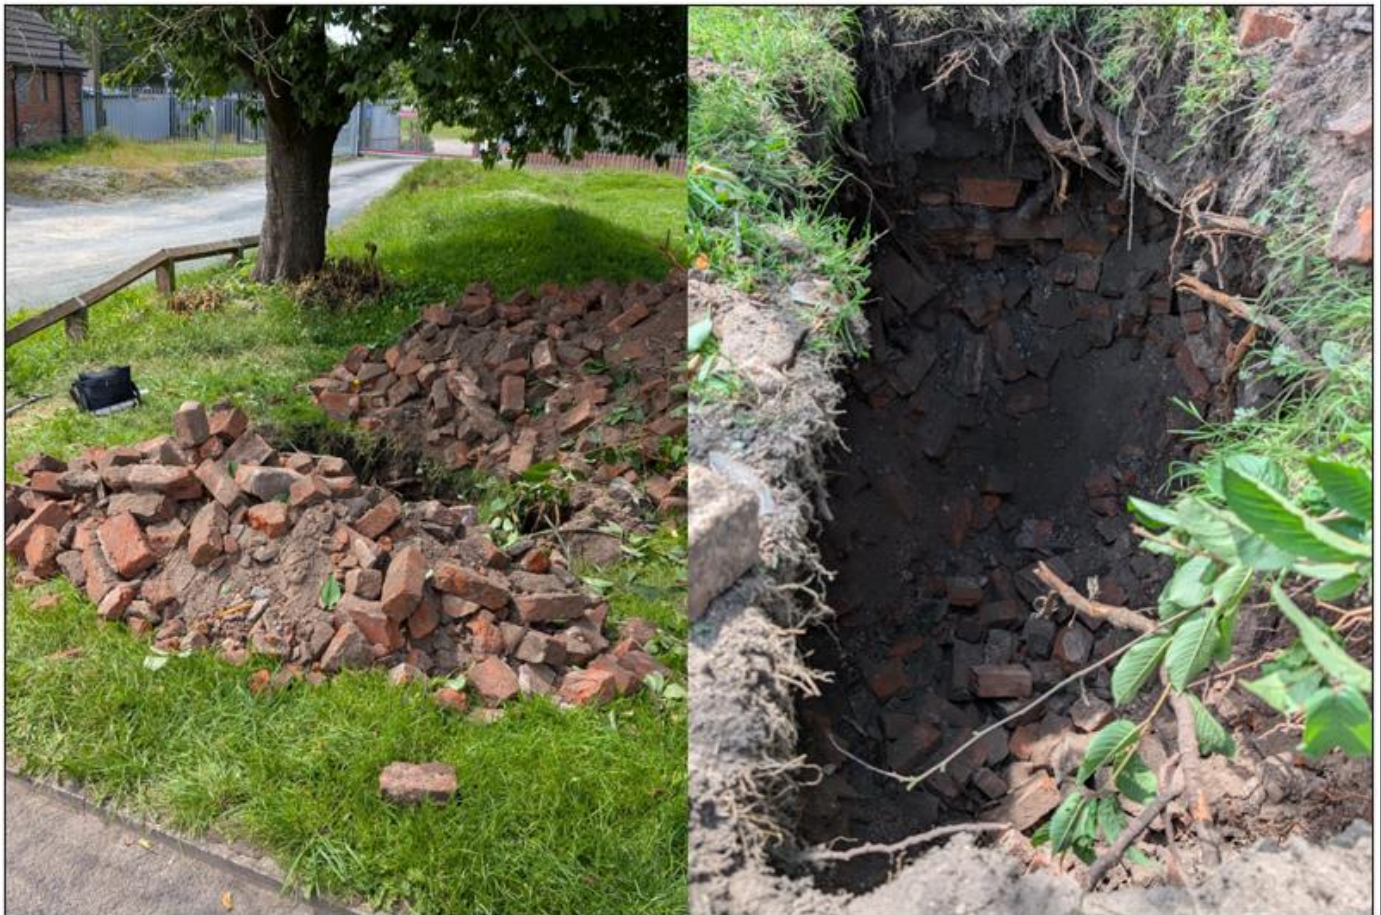
## Trial pit reference TH4

| Water | Reduced Level (m) | Legend | Depth (m) | Description |
|---|---|---|---|---|
| | 134.70 | X X<br>X X | (0.30)<br>0.30 | Brown sand & gravel MADE GROUND (topsoil). Occasional brick, stone, slate etc. |
| | | X X<br>X X<br>X X<br>X X<br>X X<br>X X<br>X X<br>X X | (1.90) | Very loose brown-red sand & gravel MADE GROUND with abundant cobble sized brick (brick infill). Sand & gravel is brick, plaster, mortar, slate, etc. (S4) |

Additional notes: No groundwater noted.

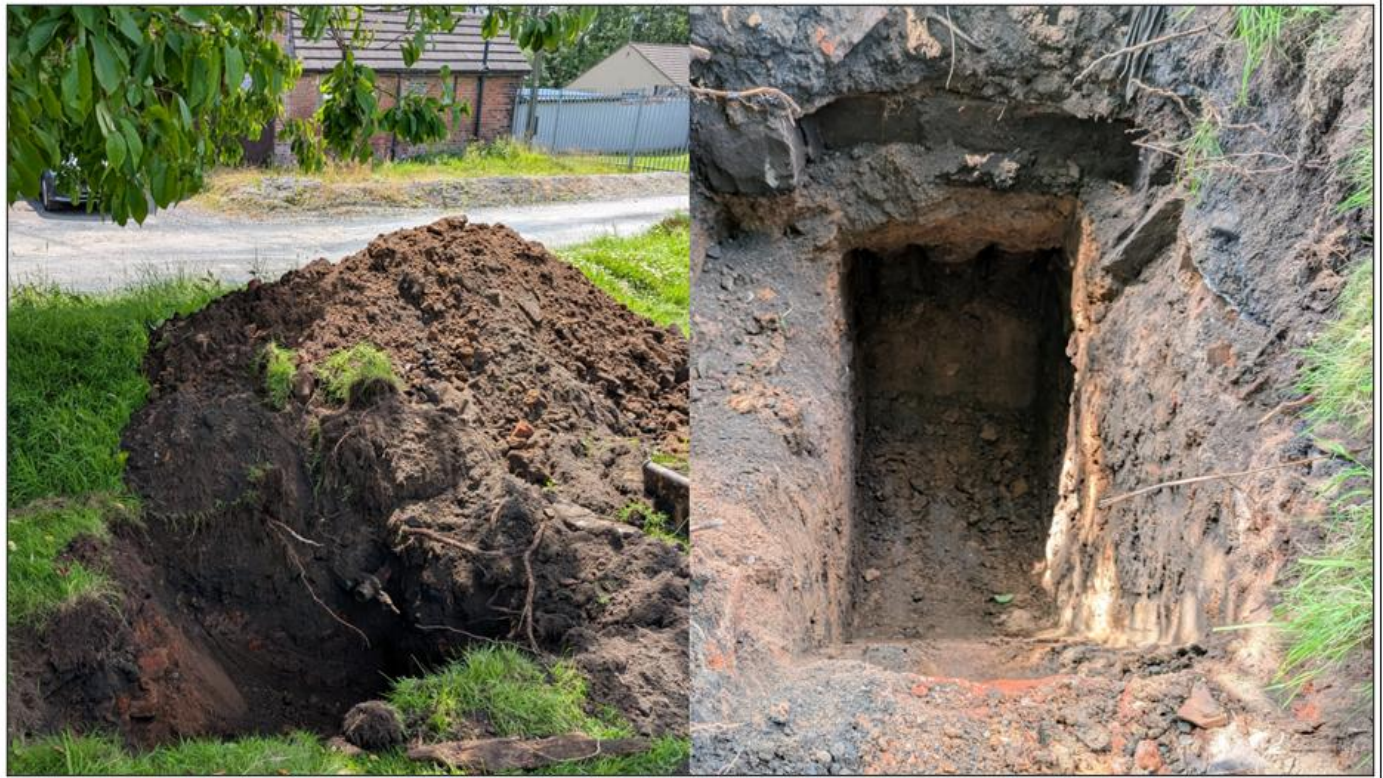
## Trial pit reference TH5

| Water | Reduced Level (m) | Legend | Depth (m) | Description |
|---|---|---|---|---|
| | 134.21 | X X<br>X X<br>X X<br>X X | (0.80)<br>0.80 | Dark brown-black sand & gravel MADE GROUND (S5). Relict foundation noted to east side of TH. Former cobbles noted to approx 800mm depth on west side (old alleyway?). |
| | 133.61 | X X<br>X X<br>X X | (0.60)<br>1.40 | Stiff brown gravelly clay MADE GROUND. Gravel is brick, stone, slate, mortar, coal & ash. |
| | 133.21 | - - -<br>- - - | (0.40)<br>1.80 | Firm brown slightly sandy slightly gravelly CLAY becoming clayey SAND at bottom. |

Additional notes: No groundwater noted.

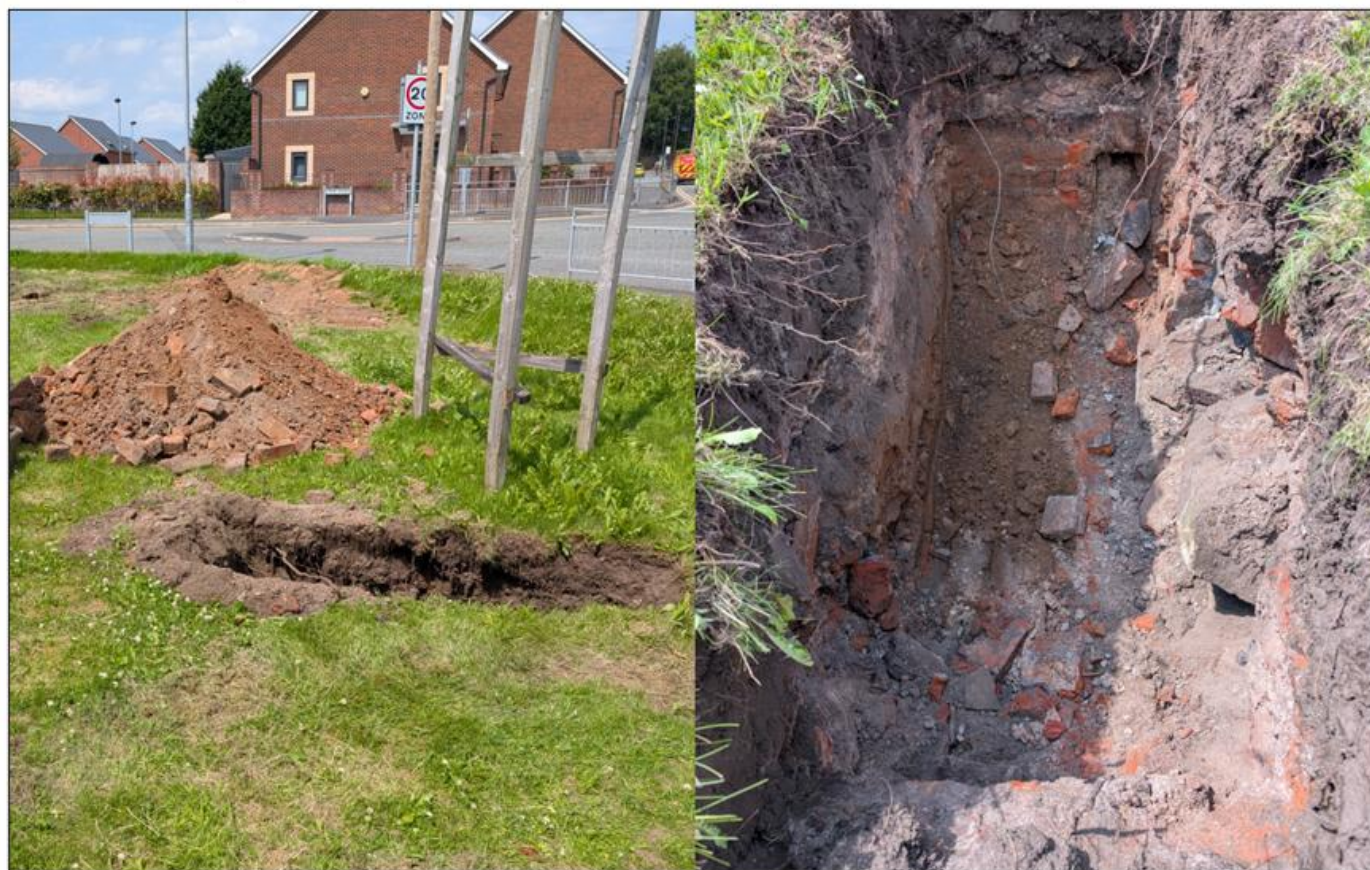
## Trial pit reference TH6

| Water | Reduced Level (m) | Legend | Depth (m) | Description |
|---|---|---|---|---|
| | 135.00 | X X<br>X X | (0.30)<br>0.30 | Brown sand & gravel MADE GROUND (topsoil). |
| | 134.00 | X X<br>X X<br>X X<br>X X | (1.00)<br>1.30 | Loose to medium dense red-brown sand & gravel MADE GROUND. Relict foundations noted through the centre of TH in east-west & north-south alignment. |
| | 133.90 | - - - - - | 1.40 | Firm brown sandy CLAY |

Additional notes: No groundwater noted.
