# **GEO-ENVIRONMENTAL AUDIT**

## **PHASE 1 PRELIMINARY RISK ASSESSMENT**

**Proposed Residential Development**  
**Hillbank Street**  
**Middleton**  
**Manchester**

Author: Daniel Slattery  
Client: Harrison Construction Ltd  
Reference: rep-tjba-harrison-hillbank st-phs1\_2\_3env-270824.docx

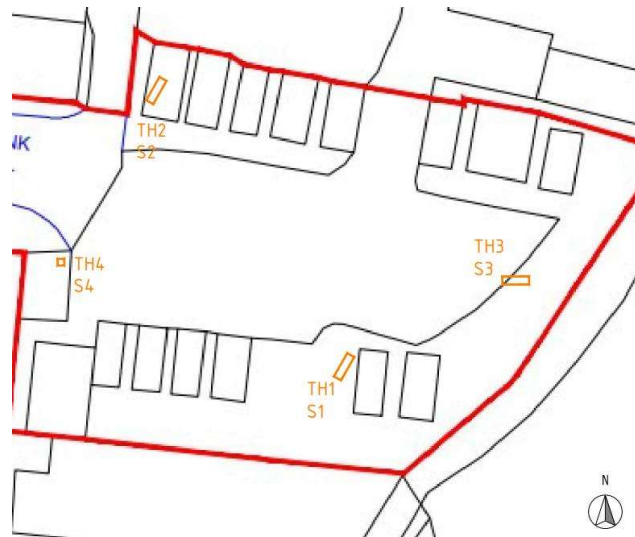
To date, a single investigation has been undertaken by T J Booth Associates comprising trial holes and soil sampling, refer to Site Investigation Plan excerpt below:

Site Investigations were undertaken by T J Booth Associates and comprised 4No. trial holes (THs 1-4), undertaken with a 3.5t back acting excavator.

4No. soil samples (S1-4) were also taken representative of the upper soil horizon to assess for potential contamination.

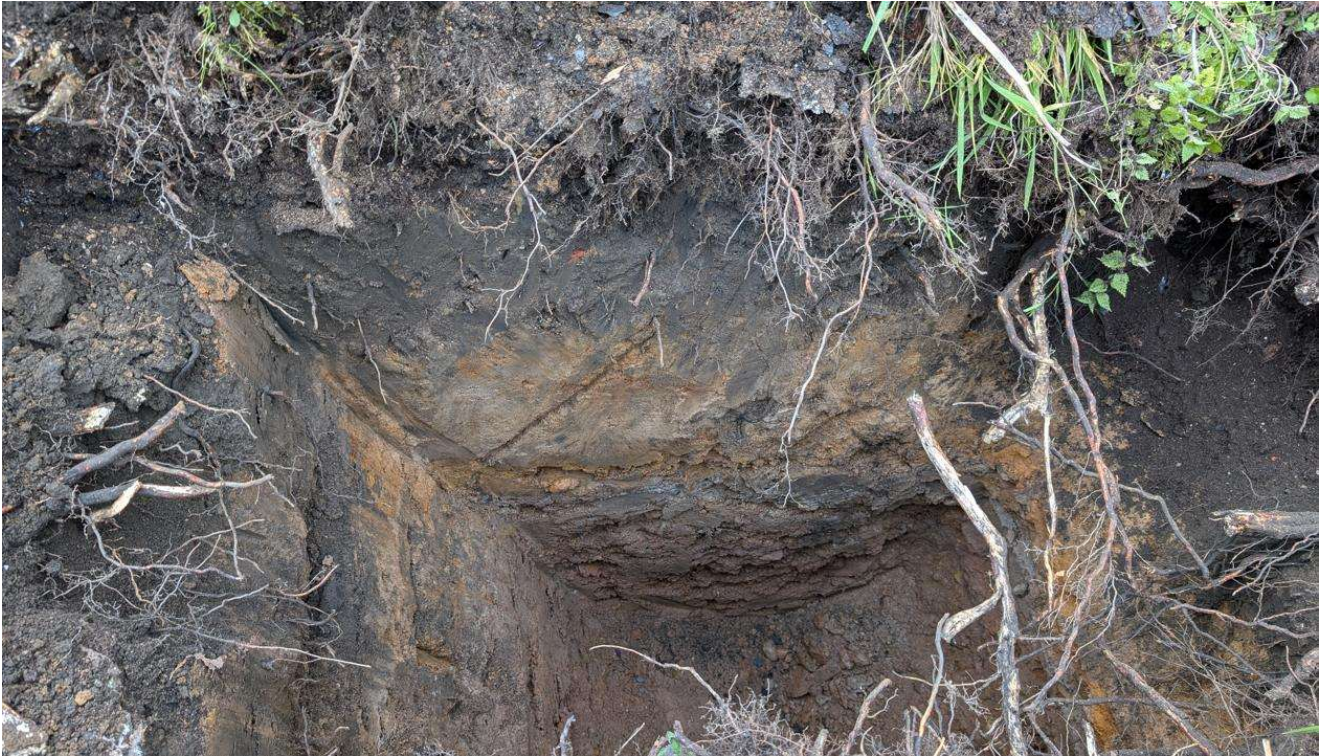
Trial Hole 1.

| Trial Hole/Soil Sample | Made ground horizon | Mitigation/Action |
|---|---|---|
| TH1/S1 | Lead. | FURTHER ACTION |

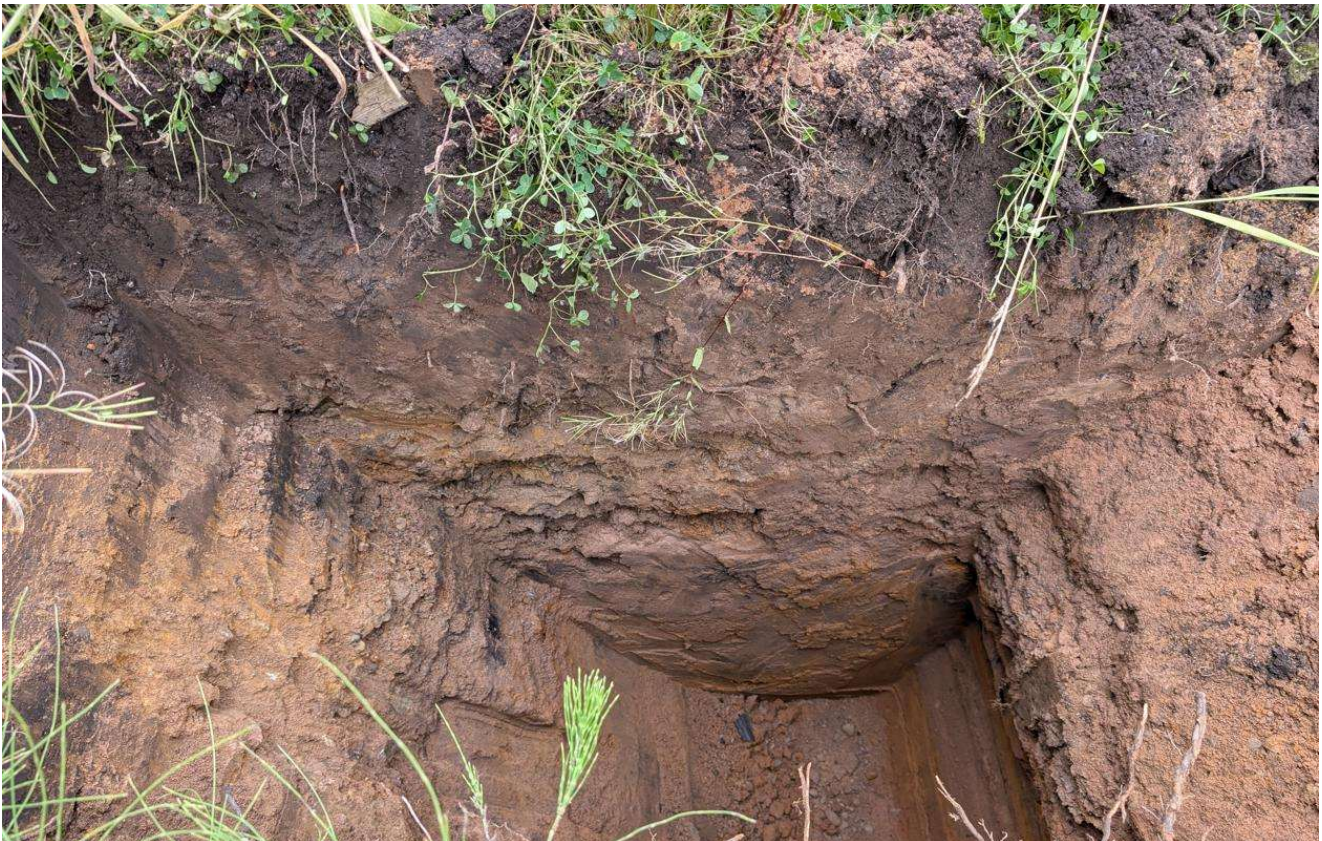
Trial Hole 2.

| TH2/S2 | Benzo(a)pyrene, benzo(b)fluoranthene, dibenz(a,h)anthracene. | FURTHER ACTION |

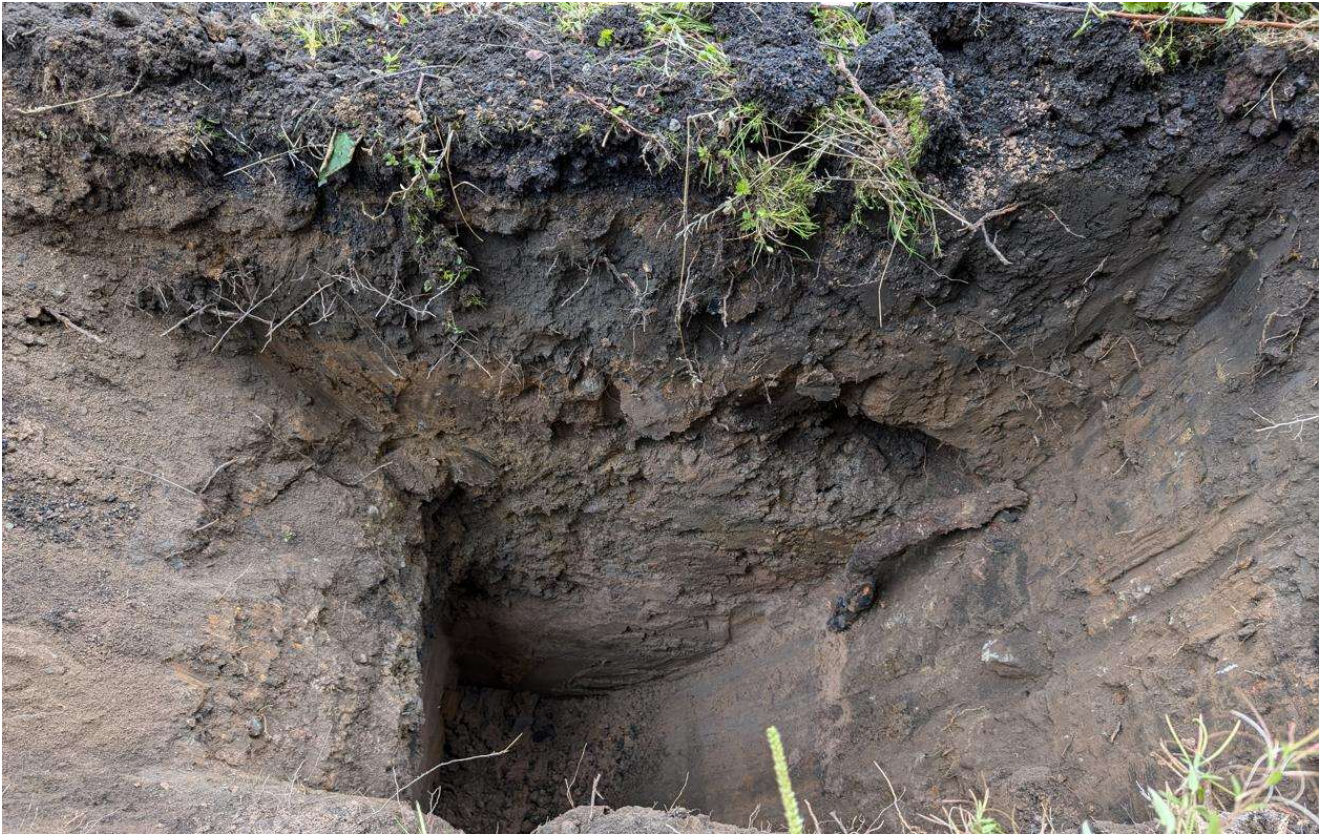
Trial Hole 3.

| TH3/S3 | No exceedences. | PASS |
