**Study Area** has been defined as encompassing the site and wider environs including local surroundings and localities which may extend or exist beyond the application site but may relate either directly or indirectly to this assessment.

Natural Power understands Scout Moor Wind Farm Expansion Limited is exploring the possibility of expanding Scout Moor Wind Farm with 16 wind turbine generators and associated infrastructure. The detailed description of the development study area is provided within the main chapters of the Environmental Statement. The following is an outline of the proposed key infrastructure elements:

### 3. Mining Setting

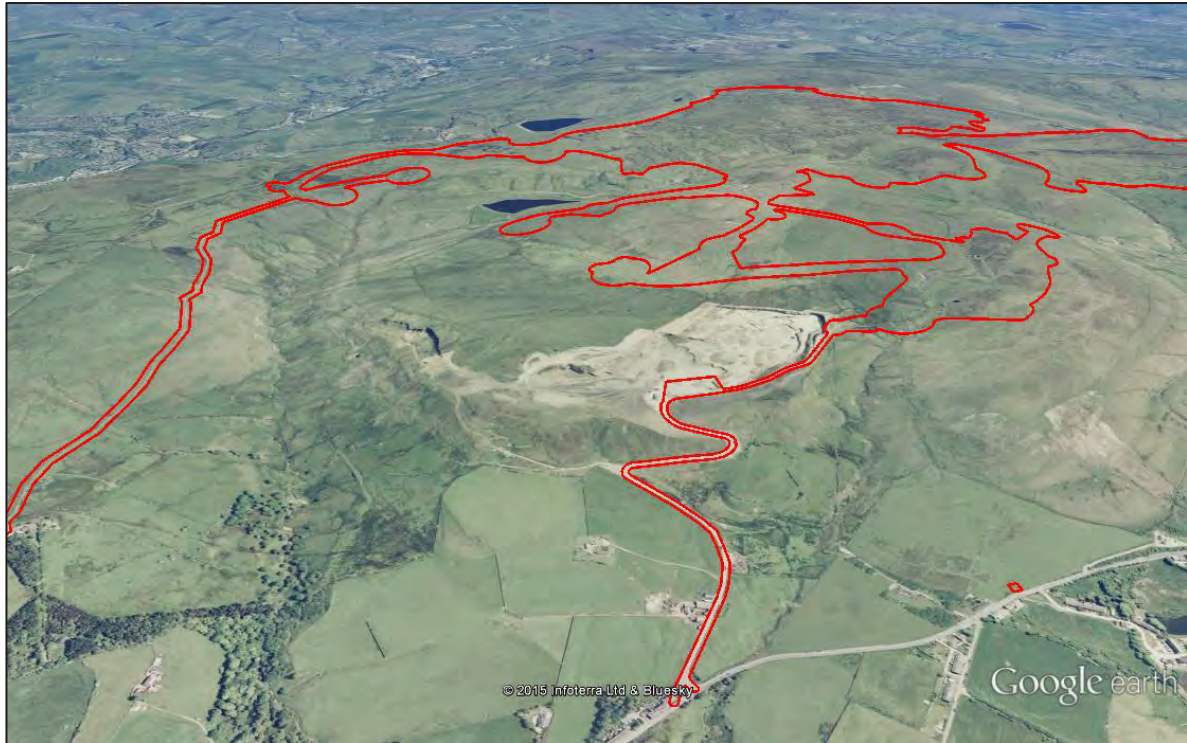
The image below depicts the western part of Application Site and combines a digital terrain model and aerial photographic imagery dating from 2005 (Google Earth Professional). The view aspect is looking towards the east. The outer red line boundary delineates the planning application boundary.

From the A680, the pre-existing access track climbs through Scout Moor Quarry towards currently existing wind turbines and the internal access track network. The Western Application Site is predominantly set across southerly and westerly aspect sloping moorland. The land surface is of modified peat land, grass and heather cover. The flat lying high plateau contains historic artificial trellised drainage networks. The steeper valley sides and escarpments are affected by a natural dendritic drainage comprising ephemeral streams minor tributaries and tertiary rivers. A dominant land form is the steep sided valley containing Dearden Brook & Scout Moor Brook which is headed by the Scout Moor High Level Reservoir. The reservoir is understood to be supplied by the upland catchment of Scout Moor. The reservoir is retained by a multi-tiered rock fill and earth embankment dam, set into a steep sided 'v-shaped' valley. Down-stream the east-west orientated valley system turns south with Dearden Brook out-flowing towards the village of Edenfield.

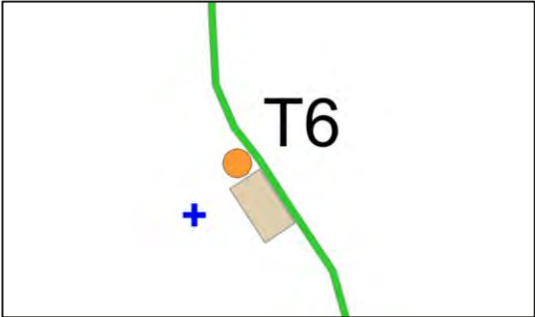
| Turbine ID | Proximity to Historical Ground Working or Mine Entry | Recorded Shallow Mine Workings | Depth of Working (mbgl) | Risk |
|---|---|---|---|---|
| T6 | Within Upper Haslingden Flags quarry recorded surface working 50m southwest. | None Indicated | - | Moderate |
| | | <p>GIS analysis of turbine position T6 showing the singular surface ground working feature approximately 50m to the southwest. This is noted as a former quarry working in the Upper Haslingden Flag Sandstone. During the site walkover there was abundant surface evidence for past quarrying activity recorded at this location.</p> | | |

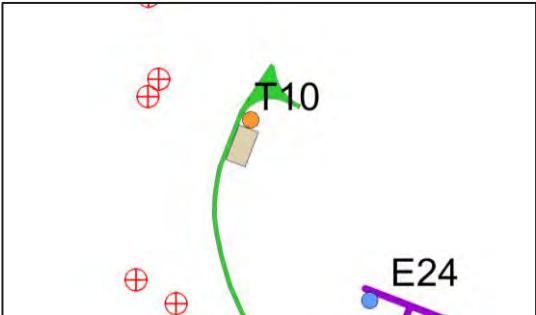
| Turbine ID | Proximity to Historical Ground Working or Mine Entry | Recorded Shallow Mine Workings | Depth of Working (mbgl) | Risk |
|---|---|---|---|---|
| T10 | None indicated | Unspecified mine entry (117296) – 125m west | <30mbgl | Moderate |
| | | <p>GIS analysis of turbine position T10, indicating relative close proximity of mine entries to the west. These are down-slope from the turbine position and therefore potential adits and shallow underground workings may extend east below the proposed position.</p> | | |

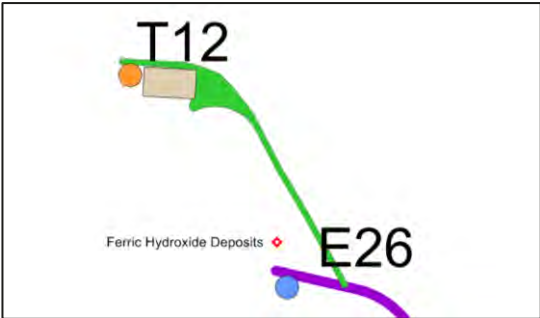
| Turbine ID | Proximity to Historical Ground Working or Mine Entry | Recorded Shallow Mine Workings | Depth of Working (mbgl) | Risk |
|---|---|---|---|---|
| T12 | None Indicated | Ferric Hydroxide deposits indicating coal mine drainage located ~190m south east from turbine centre | - | Low |
| | | <p>GIS analysis of turbine position T12. Limited archival data was available with no recorded underground or surface ground workings in close proximity to the position. During the site walkover a deposit of ferric hydroxide was noted in a spring, approximately 190m south east from the turbine centre. This may be a signal of subsurface coal mine workings draining groundwater which is affected by acidification. No ground information details of the operational turbine T26 were available at the time of reporting.</p> | | |

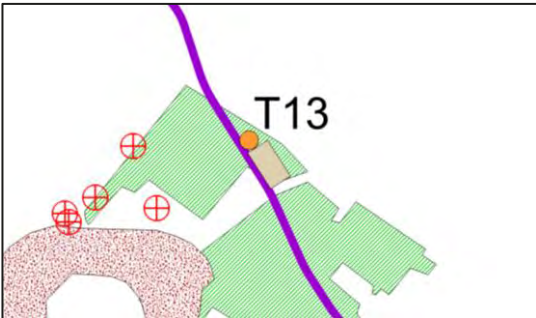
| Turbine ID | Proximity to Historical Ground Working or Mine Entry | Recorded Shallow Mine Workings | Depth of Working (mbgl) | Risk |
|---|---|---|---|---|
| T13 | Unspecified mine entry (114226) – 120m south west | Sited over recorded workings in sand rock coal seam | <20mbgl | High |
| | | <p>GIS analysis of turbine position T13 showing the high risk from shallow underground mine workings. The turbine is directly above recorded underground workings within the 'Sand rock' coal seam. Coal Authority data indicates these workings to influence ground at shallow depths of &lt;20mbgl. The area of workings extends south and west of the turbine with several mine entries recorded to the south west.</p> | | |
