# Ground Investigation Report [intrusive]

Land off Oldham Road, Rochdale

Soil and Structures Ltd were instructed by Metalcraft Group Ltd (*the Client*) in January 2025 to prepare a Ground Investigation Report (*this Report*) in support of a planned development of a parcel of land located off Oldham Road, Rochdale (the Site).

Development proposals include for the construction of a single-storey retail unit and associated hard standing (parking and goods yard).

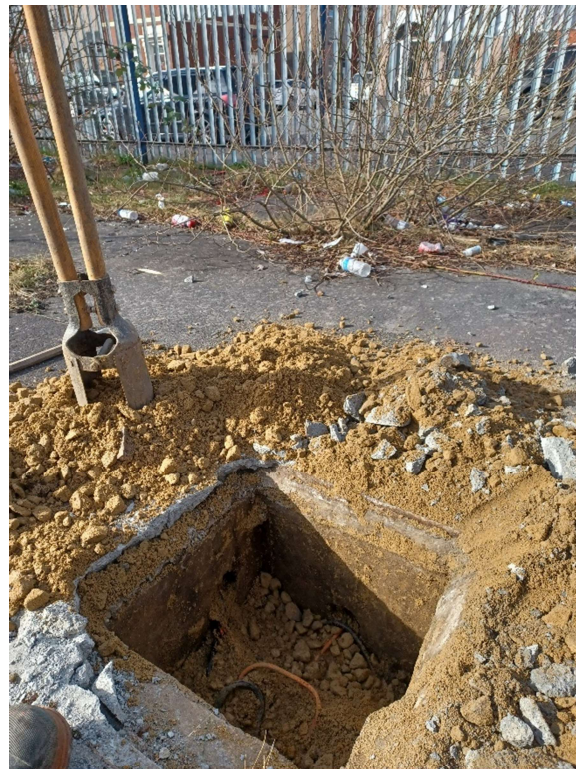
^^ Photograph 1: Utility box likely serving as power to the fuel pumps – no trace on CAT4+

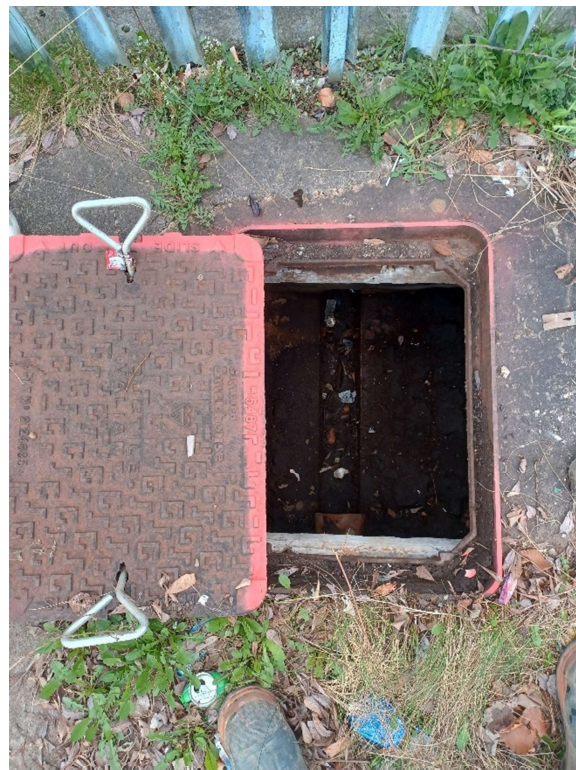
^^ Photograph 2: Drain cover with pipe flow towards Oldham Road – invert = 0.97 mbgl. No evidence of fuel odours or staining

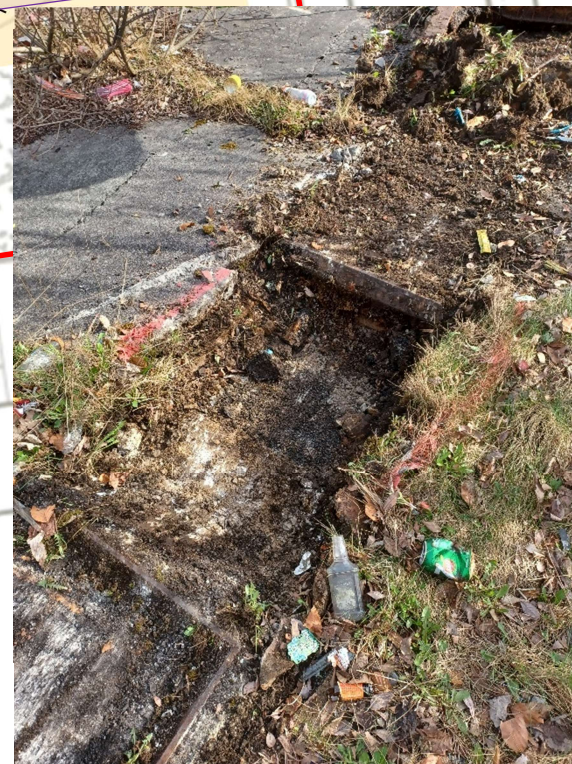
- > **Observation 1:** A fuel pipeline running from the location of the former USTs towards the former forecourt area was revealed within TP105.
- > **Observation 2:** Relic drainage infrastructure on the Site was found to be free from odour (slightly stagnant air) and generally limited suggesting that any rainwater and other liquids landing on the hardstanding surface would have historically drained to the metal-grated channels running along the western edge of the Site.

Suspected fuel pipeline, possibly pinched by excavator bucket leading to localised odour within pit – no evidence of staining within soils

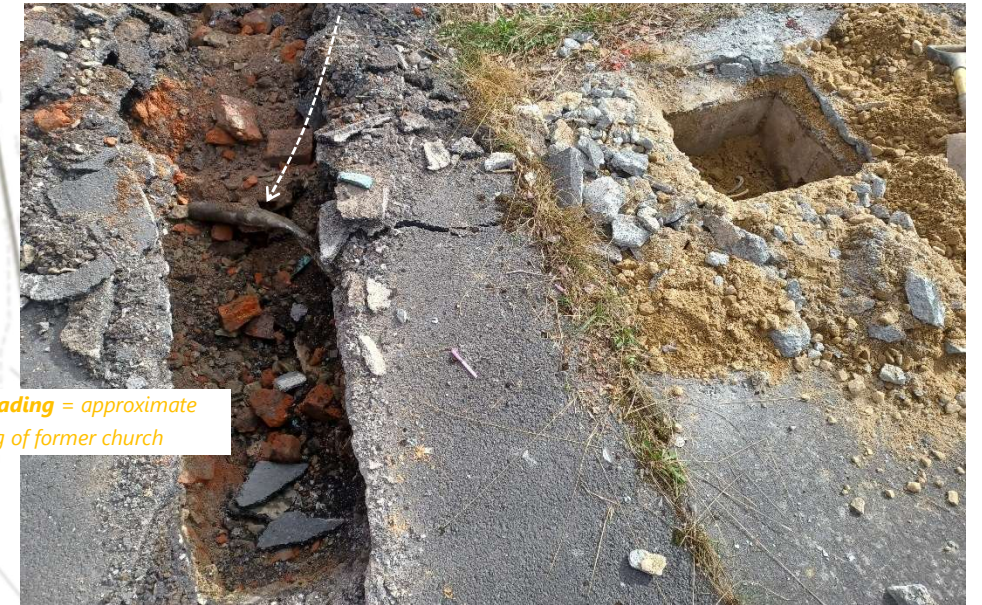
^^ Photograph 3: TP105 and utility box in Photograph 1 – facing eastwards

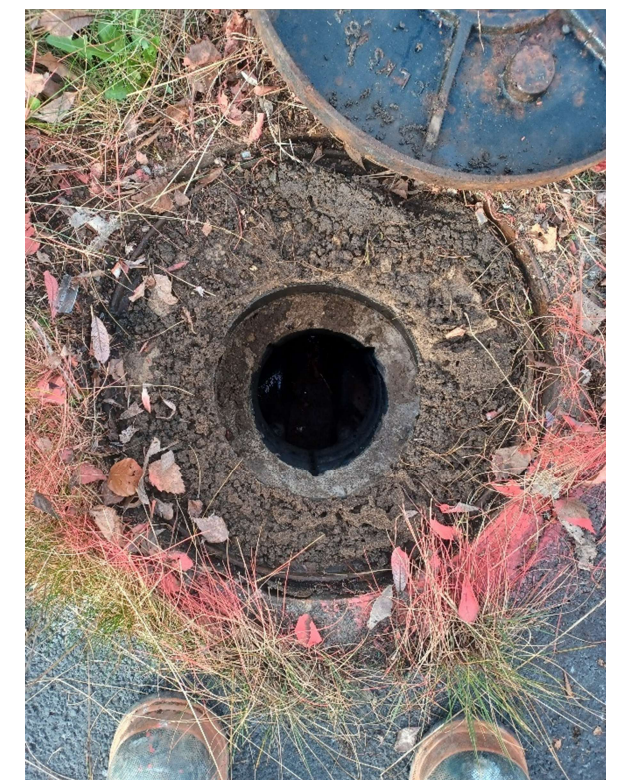
^^ Photograph 4: Drain cover with inspection chamber (?) – invert = 0.65 mbgl. No evidence of fuel odours or staining

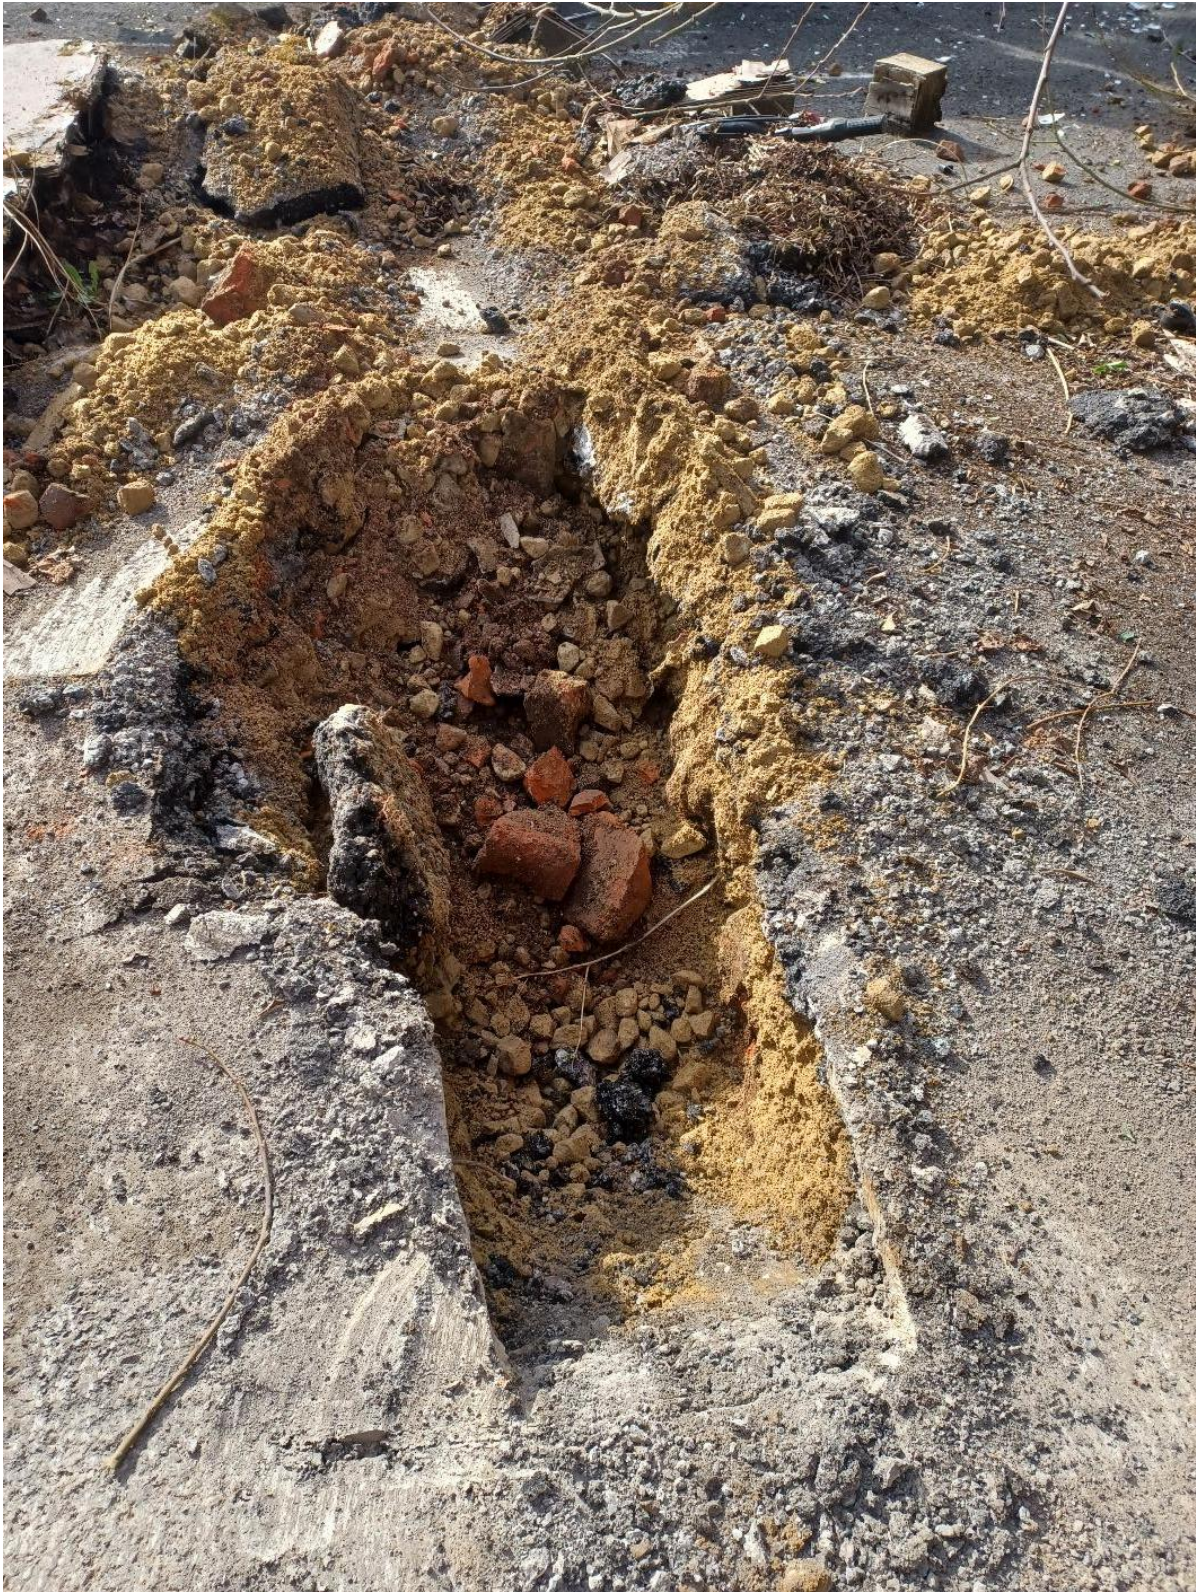
| Remarks<br>PURPOSE: General coverage of the Site. TERMINATION: Frequent, suspected asbestos containing material (ACM) encountered. LOCATION: Surveyed using freeware on Site. GL: Estimated off topographical survey. STABILITY: Stable. GROUNDWATER: None encountered. OTHER: No evidence of potentially harmful or polluting material other than ACM. | Method, Plant, Stability, Dimensions<br>0.00 - 0.60m TP - Trial Pit tonne tracked<br>Stable<br>L = 1.20m<br>W = 0.60m | Logger<br>RB |

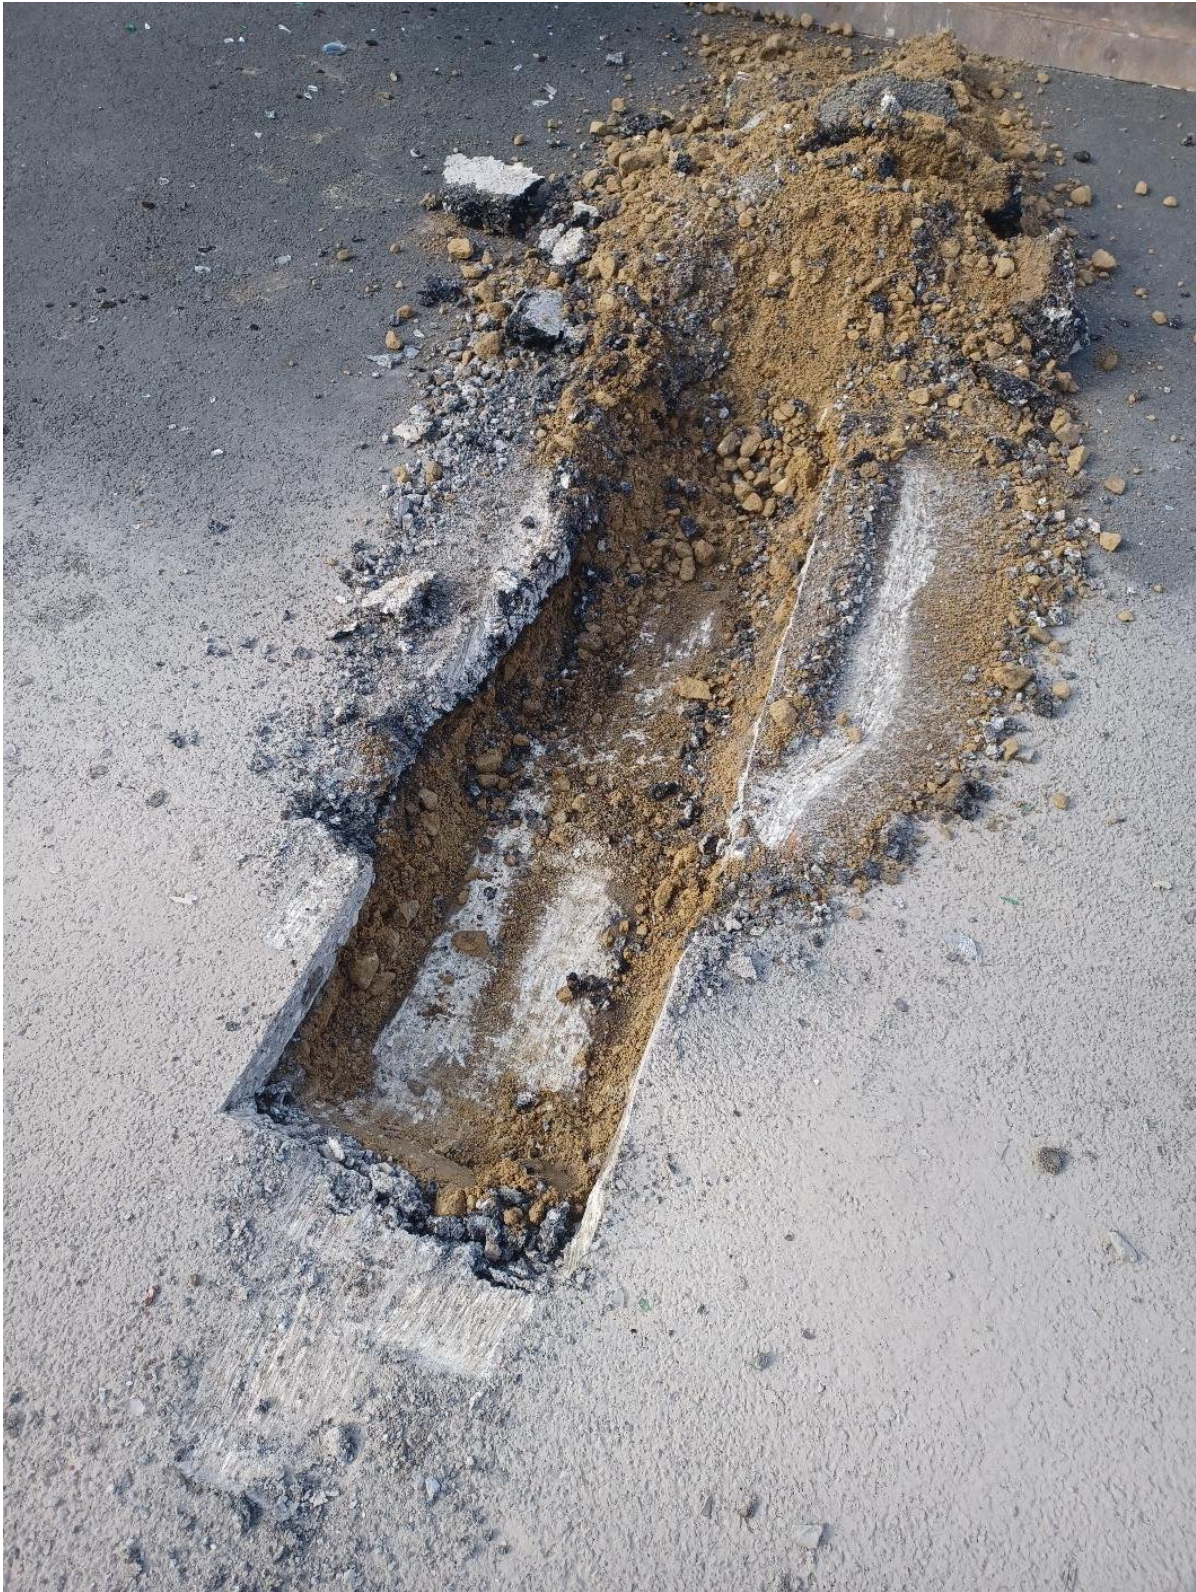
| Remarks<br>PURPOSE: General coverage of the Site. TERMINATION: Practical refusal of excavator on concrete slab.<br>LOCATION: Surveyed using freeware on Site. GL: Estimated off topographical survey. STABILITY: Stable.<br>GROUNDWATER: None encountered. OTHER: No evidence of potentially harmful or polluting material. | Method, Plant, Stability, Dimensions<br>0.00 - 0.30m TP - Trial Pit tonne tracked<br>Stable<br>L = 1.50m<br>W = 0.60m | Logger<br>RB |

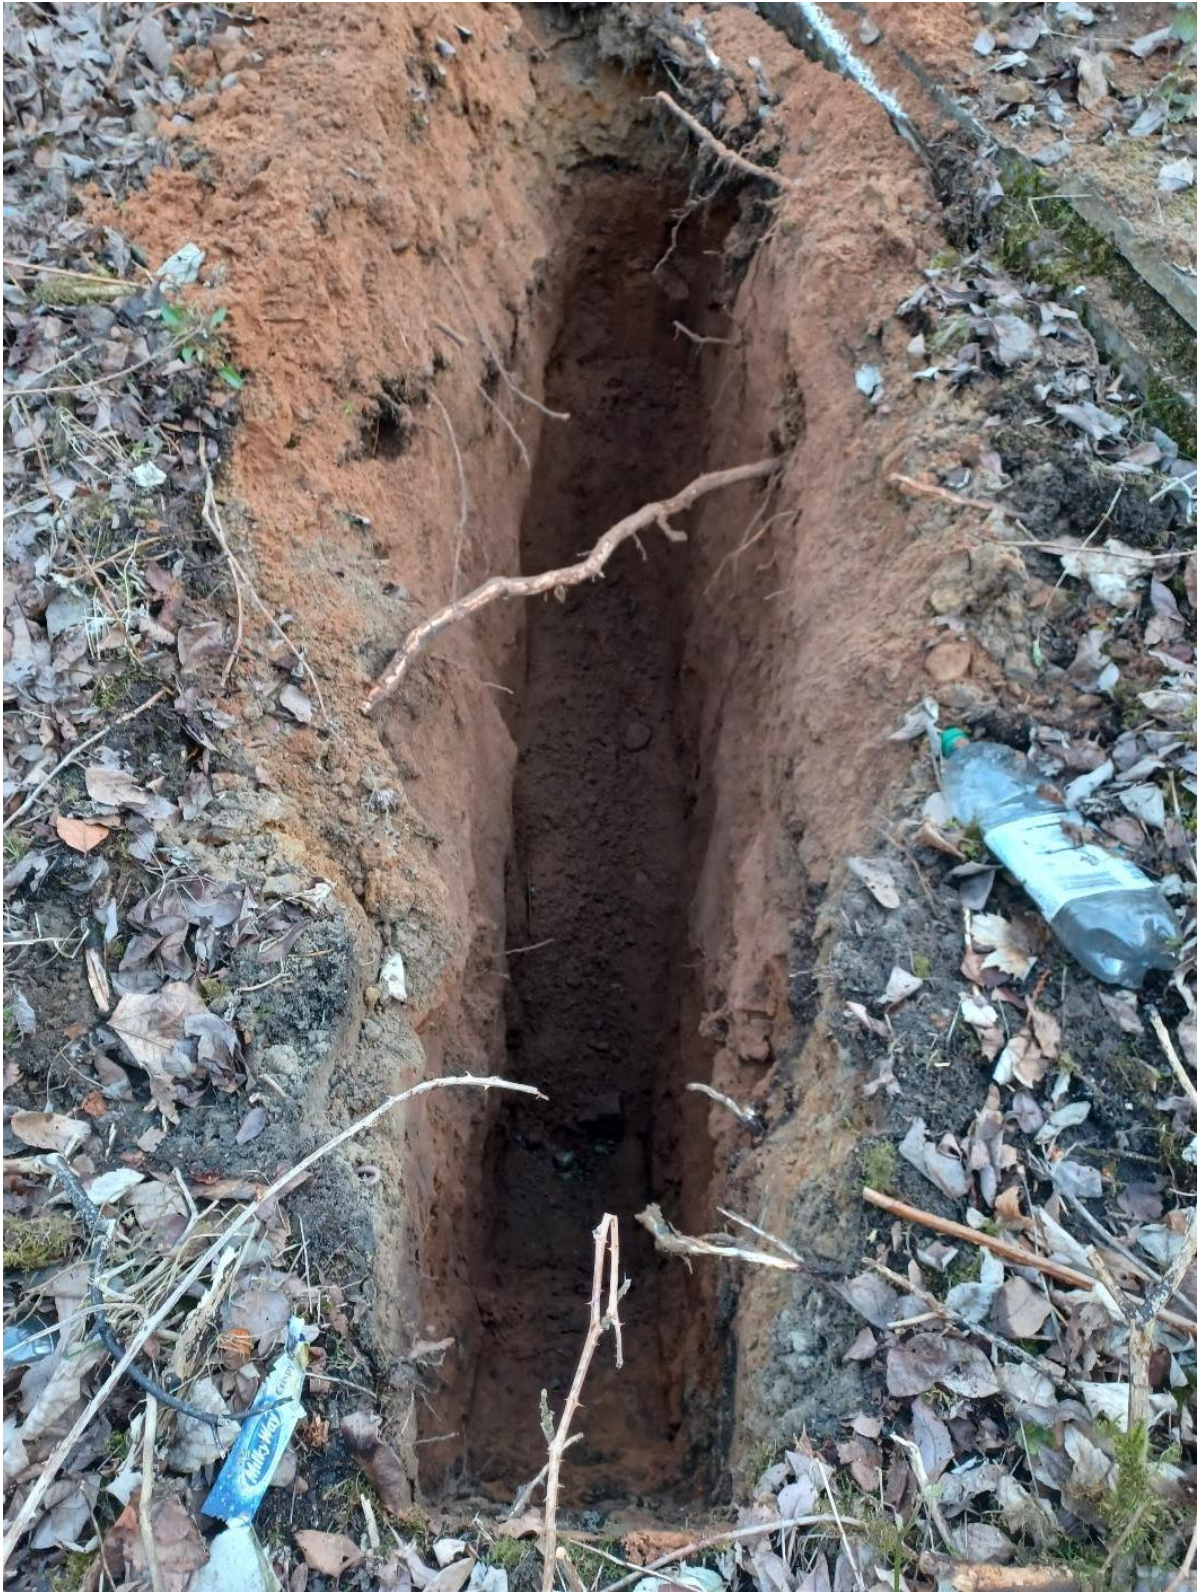
| PURPOSE: General coverage of the Site. TERMINATION: Engineer decision, target depth achieved. LOCATION: Surveyed using freeware on Site. GL: Estimated off topographical survey. STABILITY: Side wall collapse adjacent to relic wall to depth of 1 m below ground level. GROUNDWATER: None encountered. OTHER: No evidence of potentially harmful or polluting material. | 0.00 - 1.90m<br>Unstable<br>L = 2.00m<br>W = 0.60m | TP - Trial Pit<br>tonne tracked<br>RB |

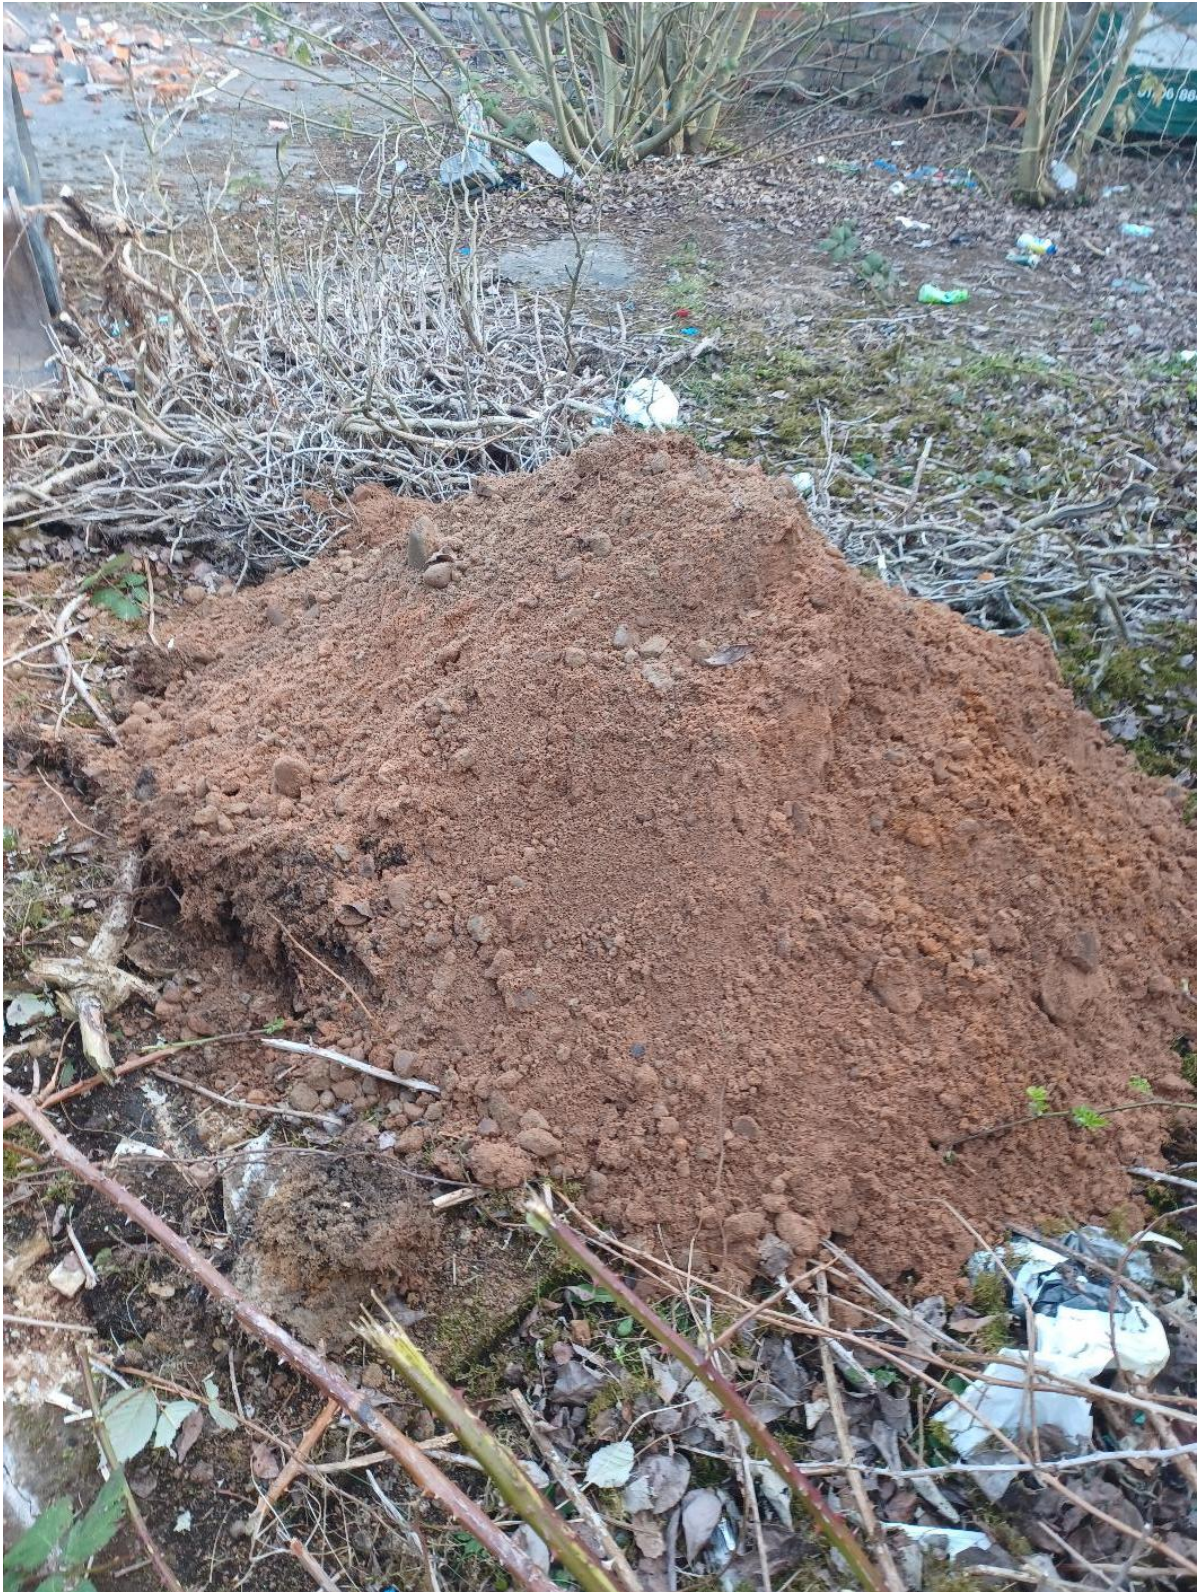
| PURPOSE: General coverage of the Site. TERMINATION: Engineer decision, target depth achieved. LOCATION: Surveyed using freeware on Site. GL: Estimated off topographical survey. STABILITY: Side wall collapse adjacent to relic wall to depth of 1 m below ground level. GROUNDWATER: None encountered. OTHER: No evidence of potentially harmful or polluting material. | 0.00 - 1.90m<br>Unstable<br>L = 2.00m<br>W = 0.60m | TP - Trial Pit tonne tracked<br>RB |

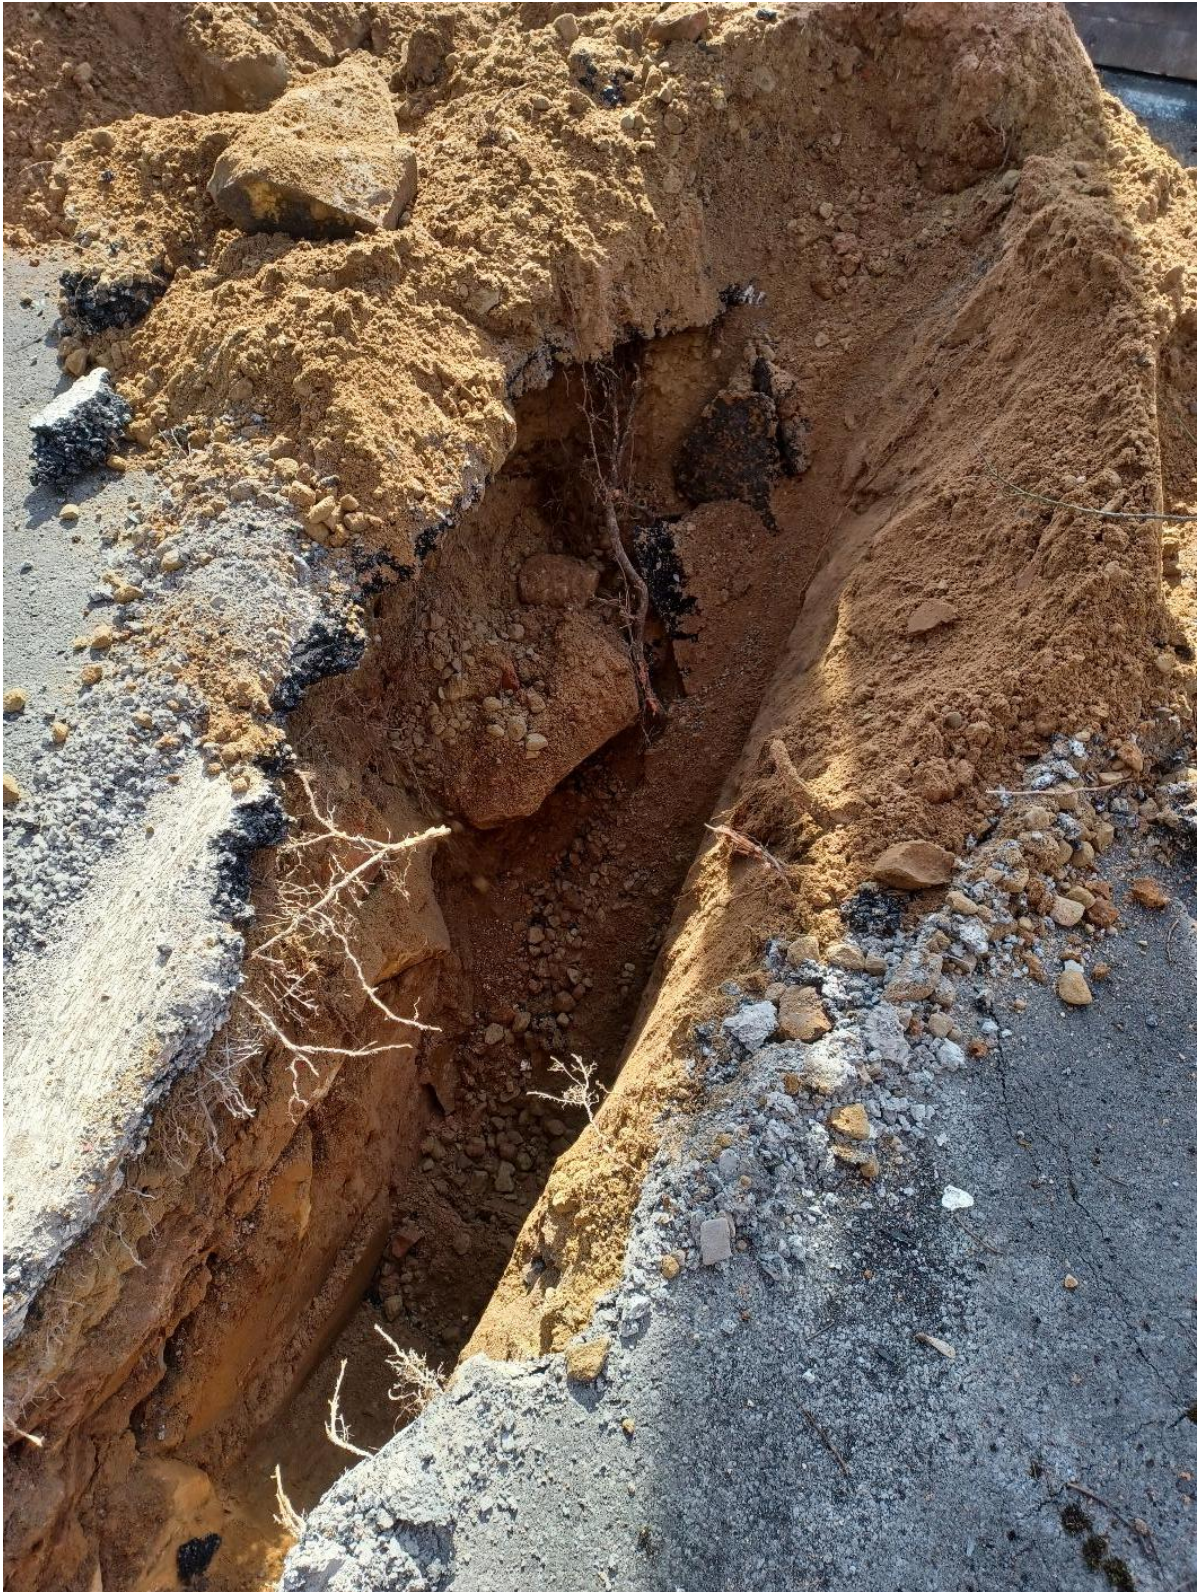
| Remarks<br>PURPOSE: General coverage of the Site. TERMINATION: Engineer decision, target depth achieved. LOCATION: Surveyed using freeware on Site. GL: Estimated off topographical survey. STABILITY: Localised collapse adjacent to relic foundations to depths of 0.75 m below ground level. GROUNDWATER: None encountered. OTHER: No evidence of potentially harmful or polluting material. | Method, Plant, Stability, Dimensions<br>0.00 - 2.70m TP - Trial Pit tonne tracked<br>Unstable<br>L = 2.20m<br>W = 0.60m | Logger<br>RB |

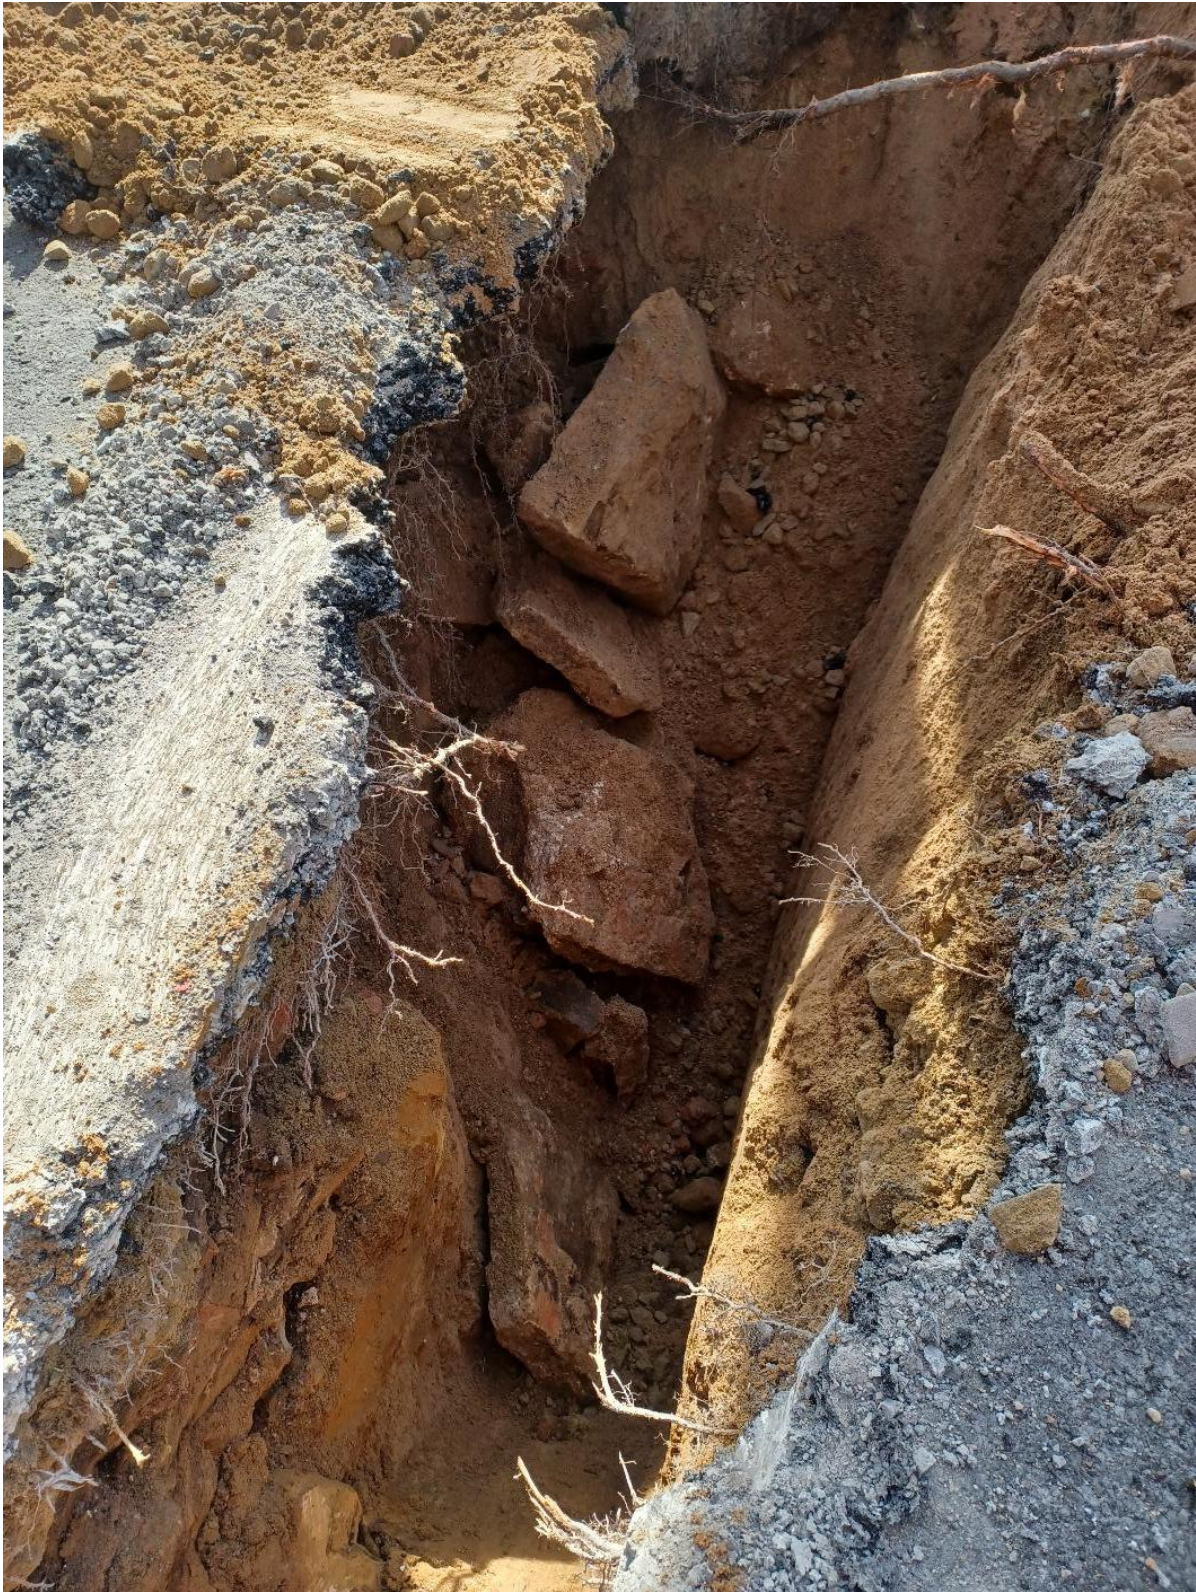
| Remarks<br>PURPOSE: General coverage of the Site. TERMINATION: Engineer decision, target depth achieved. LOCATION: Surveyed using freeware on Site. GL: Estimated off topographical survey. STABILITY: Localised collapse adjacent to relic foundations to depths of 0.75 m below ground level. GROUNDWATER: None encountered. OTHER: No evidence of potentially harmful or polluting material. | Method, Plant, Stability, Dimensions<br>0.00 - 2.70m TP - Trial Pit tonne tracked<br>Unstable<br>L = 2.20m<br>W = 0.60m | Logger<br>RB |

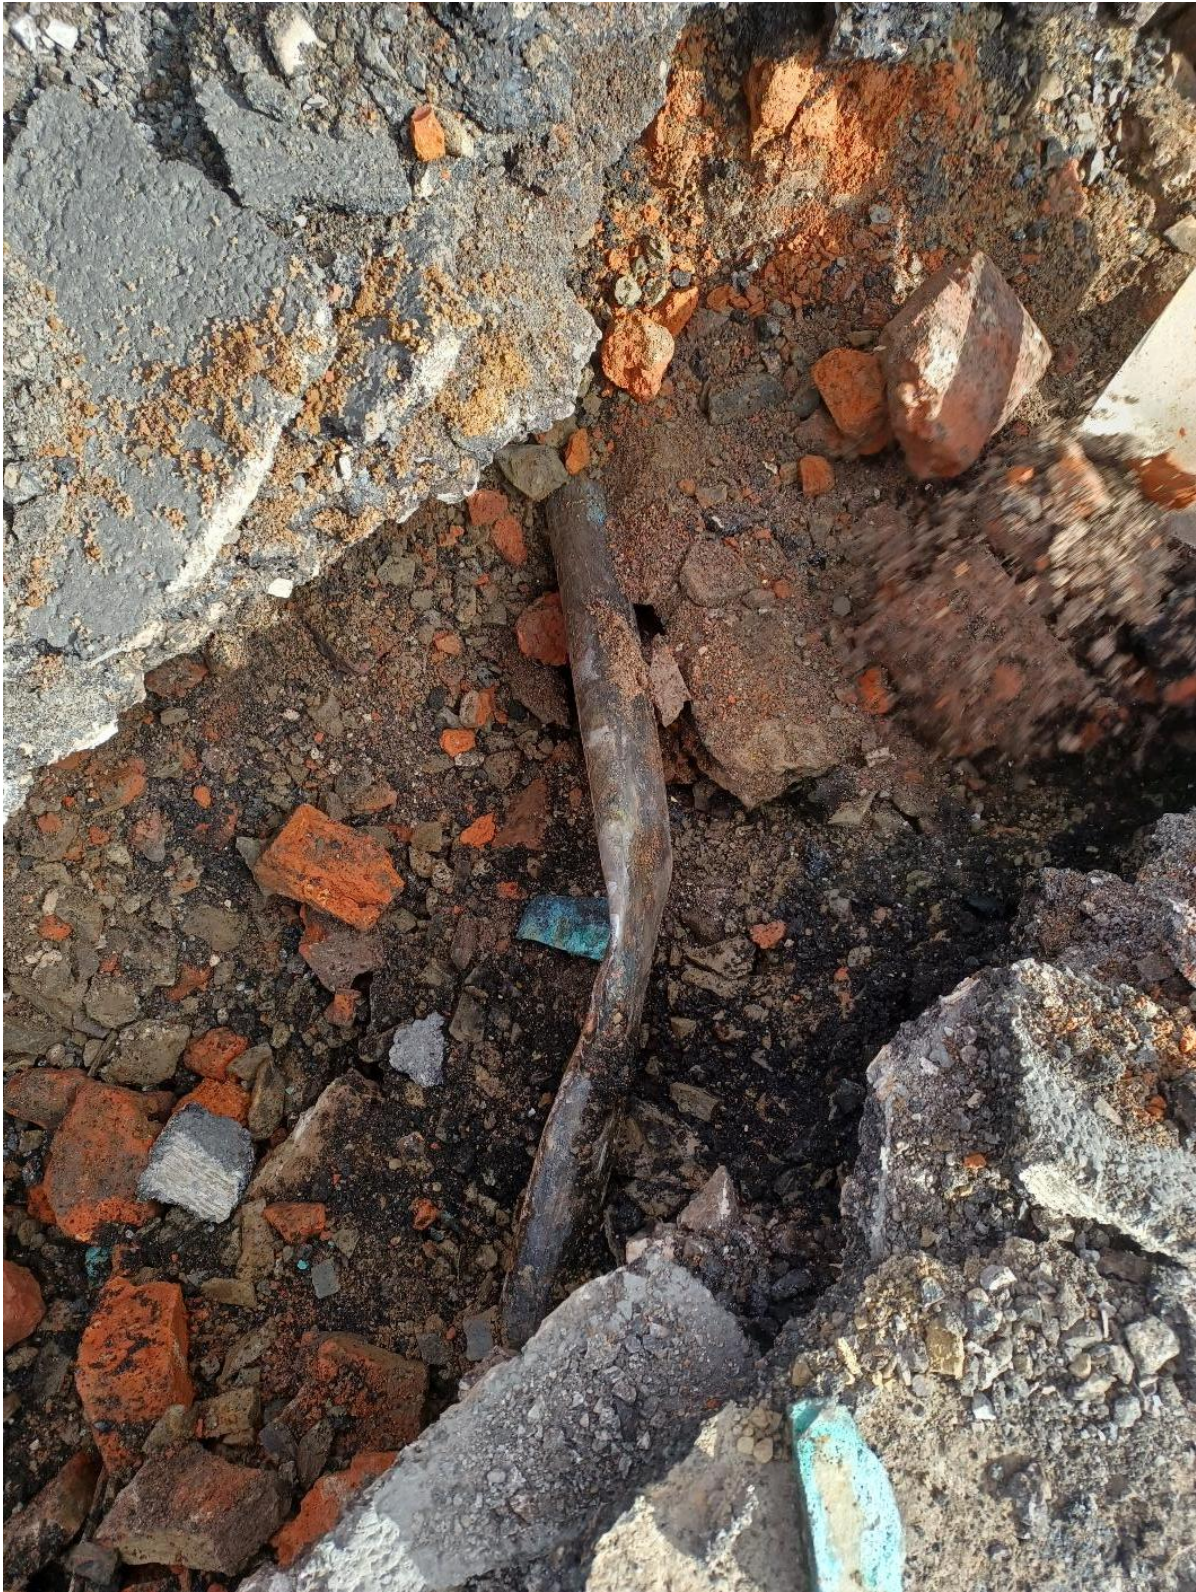
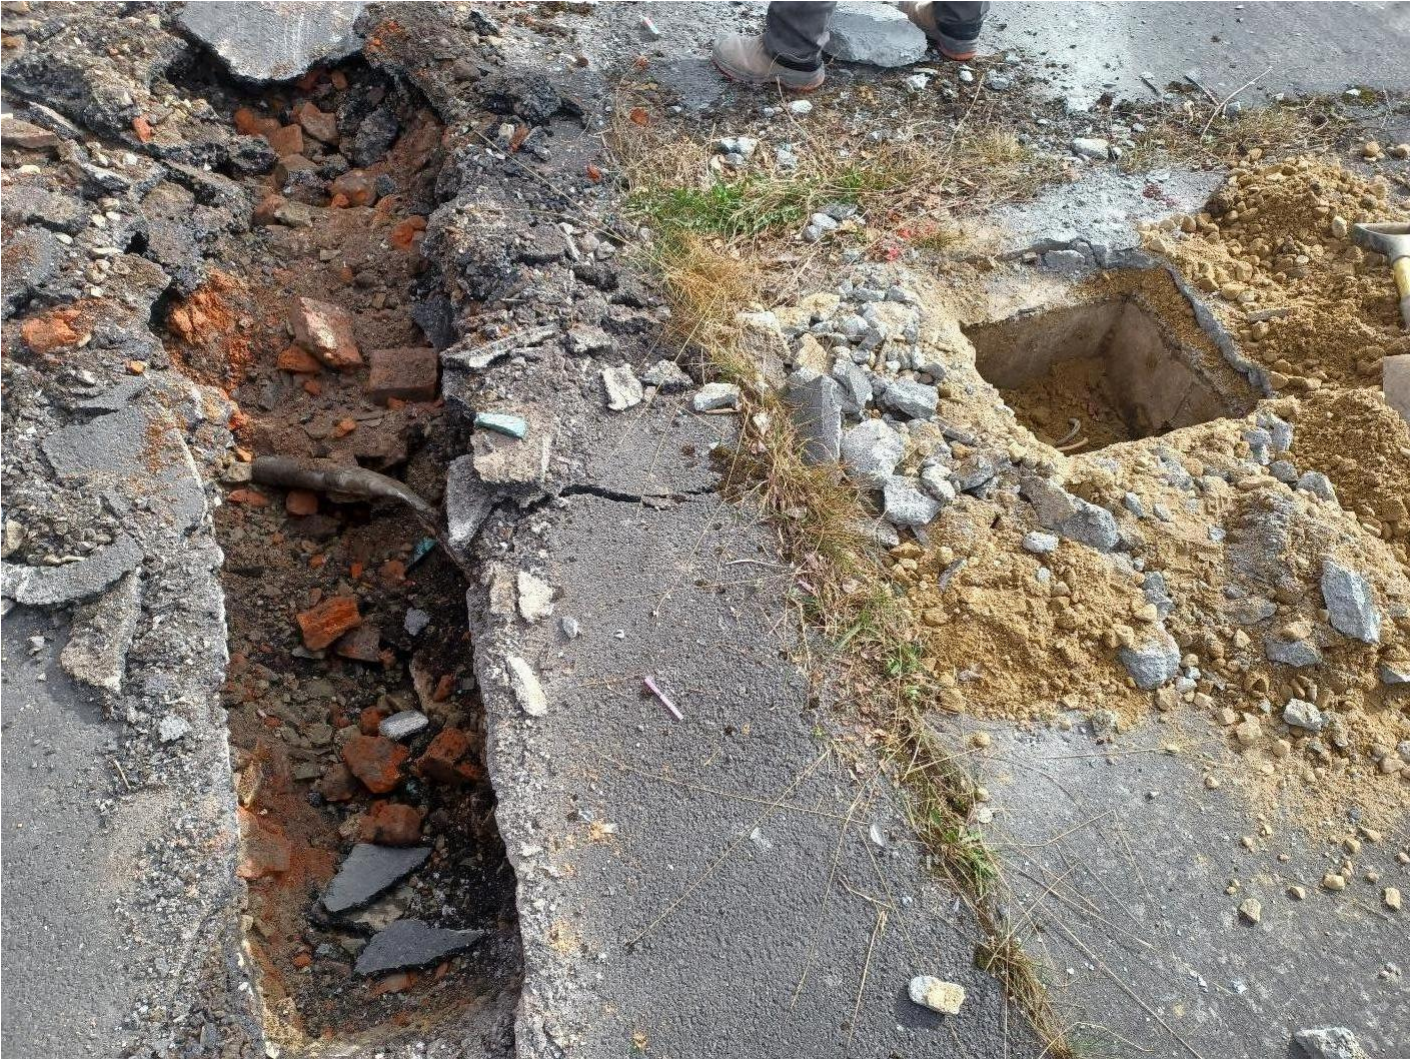
| Remarks<br>PURPOSE: Targeting are immediately north of former forecourt. TERMINATION: Evidence of concrete encased, suspected fuel pipelines encountered. LOCATION: Surveyed using freeware on Site. GL: Estimated off topographical survey. STABILITY: Stable. GROUNDWATER: None encountered. OTHER: Faint, slight odour of petrol locally to pipeline within Made Ground. | Method, Plant, Stability, Dimensions<br>0.00 - 0.50m TP - Trial Pit<br>Stable<br>L = 2.00m<br>W = 0.60m | Logger<br>RB |

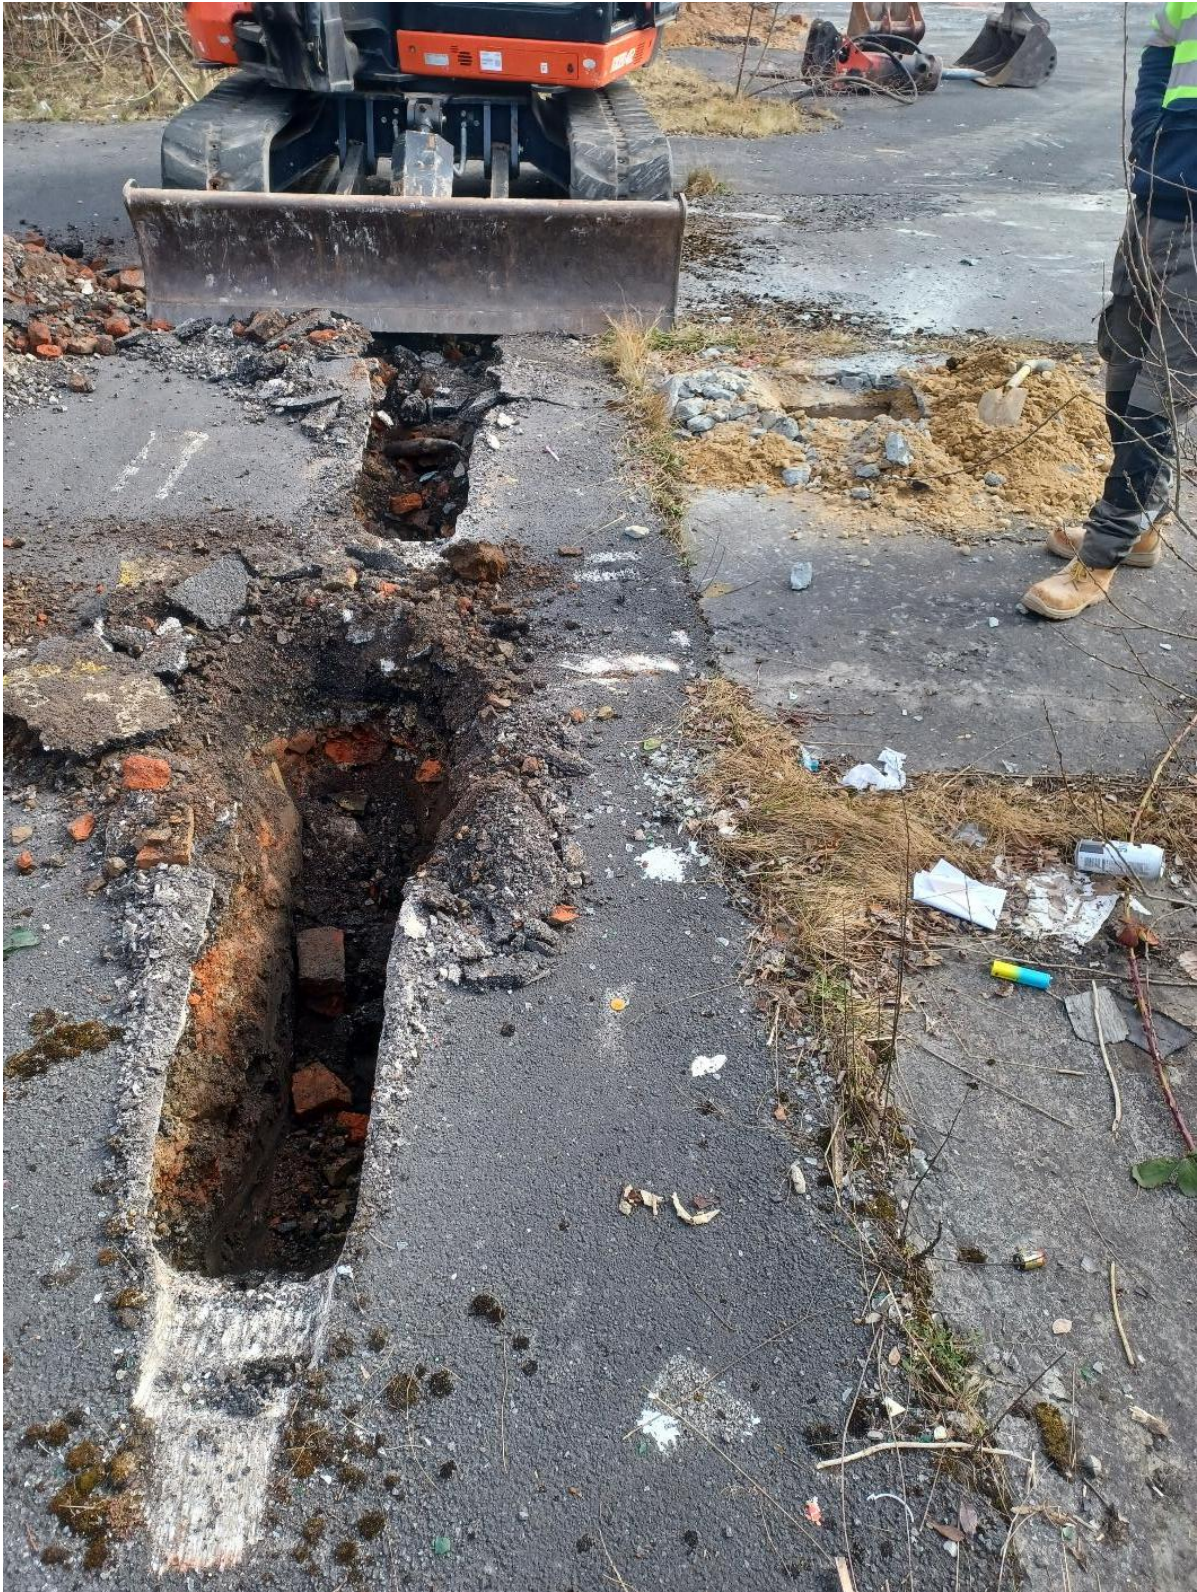
| Remarks<br>PURPOSE: Targeting are immediately north of former forecourt. TERMINATION: Engineer decision, target depth achieved. LOCATION: Surveyed using freeware on Site. GL: Estimated off topographical survey. STABILITY: Stable. GROUNDWATER: None encountered. OTHER: No evidence of potentially harmful or polluting material. | Method, Plant, Stability, Dimensions<br>0.00 - 1.60m TP - Trial Pit tonne tracked<br>Stable<br>L = 2.20m<br>W = 0.60m | Logger<br>RB |

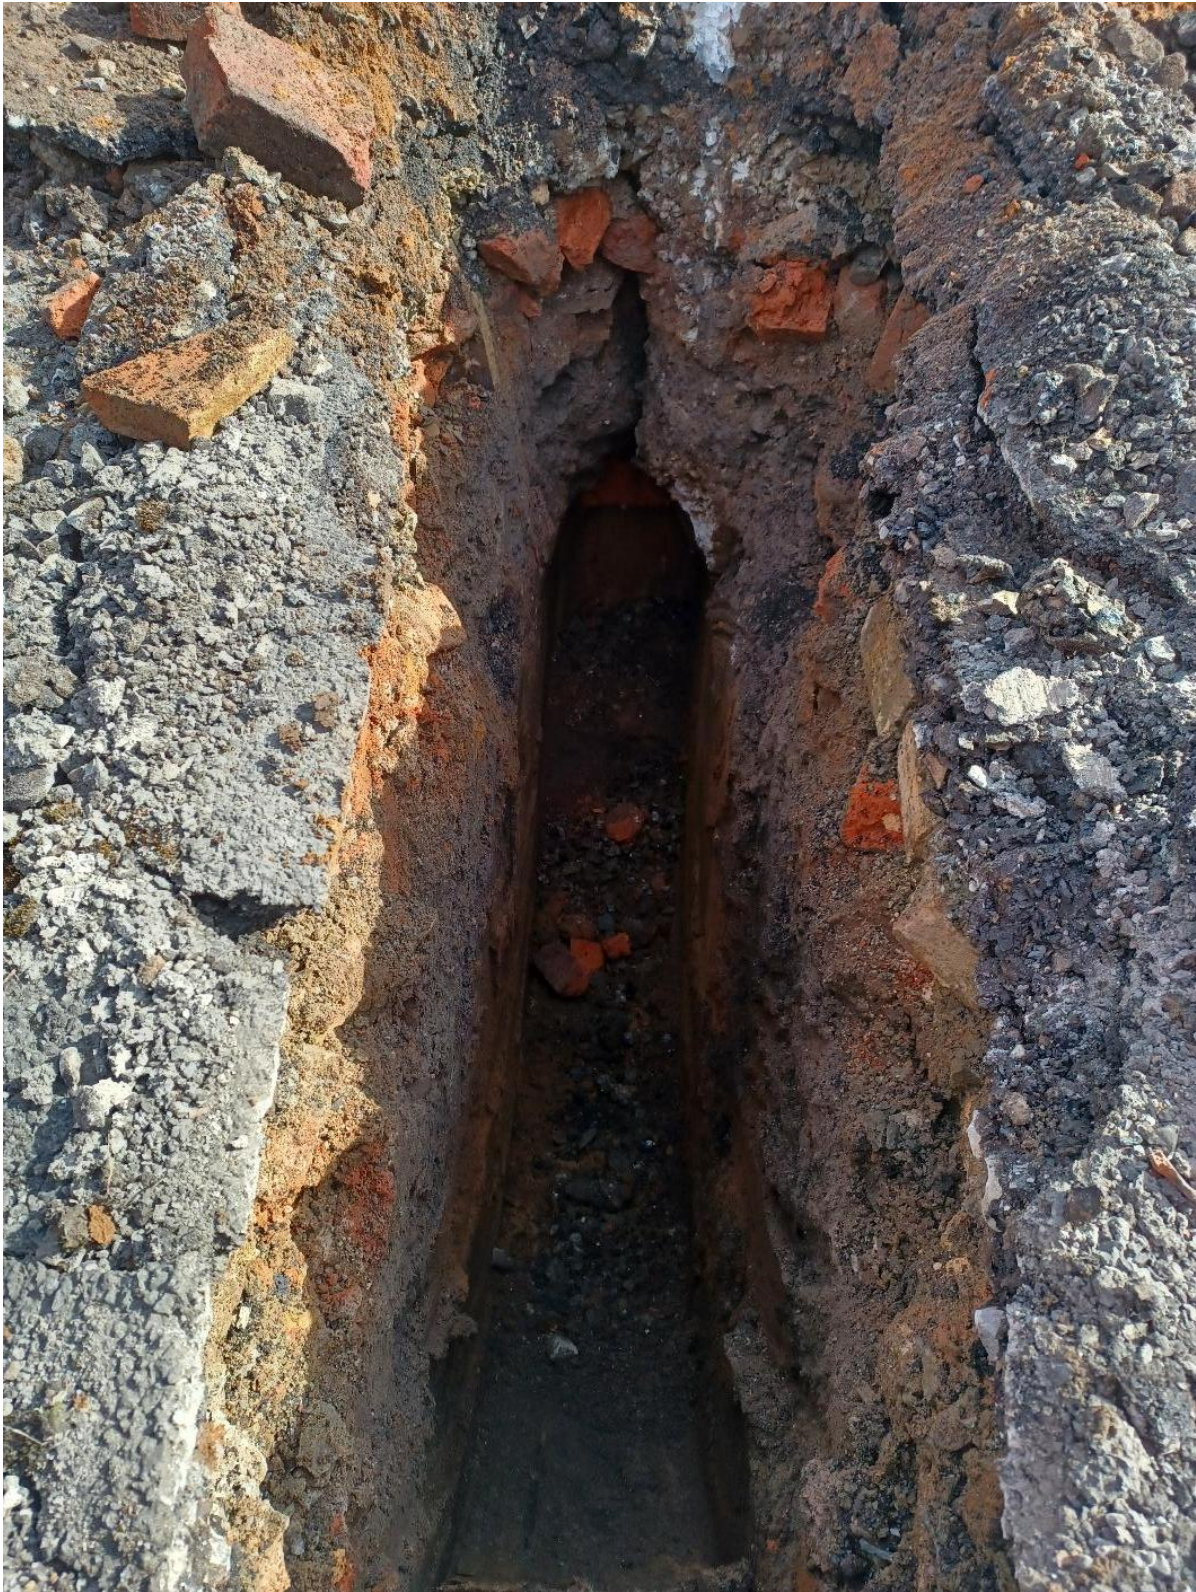
| Remarks<br>PURPOSE: Targeting are immediately north of former forecourt. TERMINATION: Engineer decision, target depth achieved. LOCATION: Surveyed using freeware on Site. GL: Estimated off topographical survey. STABILITY: Stable. GROUNDWATER: None encountered. OTHER: No evidence of potentially harmful or polluting material. | Method, Plant, Stability, Dimensions<br>0.00 - 1.60m TP - Trial Pit tonne tracked<br>Stable<br>L = 2.20m<br>W = 0.60m | Logger<br>RB |
