# Ground Investigation Report [intrusive]

Land off Oldham Road, Rochdale

Soil and Structures Ltd were instructed by Metalcraft Group Ltd (*the Client*) in January 2025 to prepare a Ground Investigation Report (*this Report*) in support of a planned development of a parcel of land located off Oldham Road, Rochdale (the Site).

Development proposals include for the construction of a single-storey retail unit and associated hard standing (parking and goods yard).

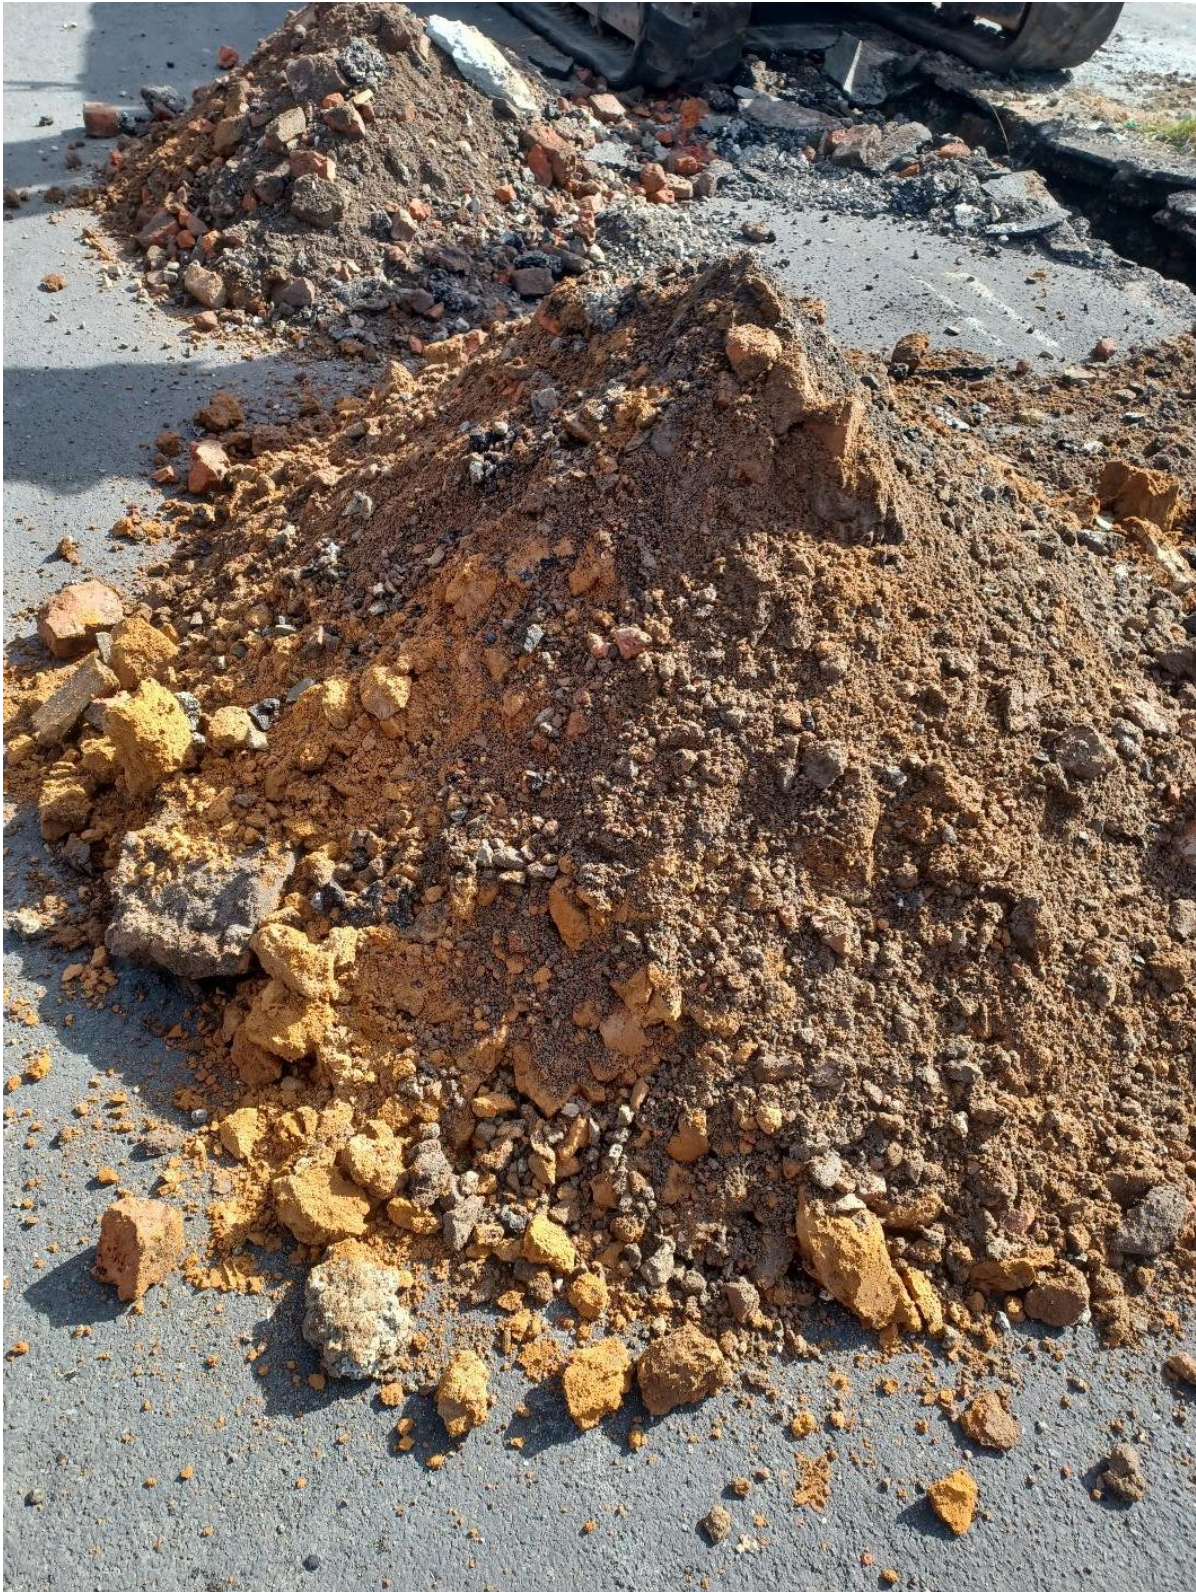
| Remarks<br>PURPOSE: Targeting are immediately north of former forecourt. TERMINATION: Engineer decision, target depth achieved. LOCATION: Surveyed using freeware on Site. GL: Estimated off topographical survey. STABILITY: Stable. GROUNDWATER: None encountered. OTHER: No evidence of potentially harmful or polluting material. | Method, Plant, Stability, Dimensions<br>0.00 - 1.60m TP - Trial Pit tonne tracked<br>Stable<br>L = 2.20m<br>W = 0.60m | Logger<br>RB |

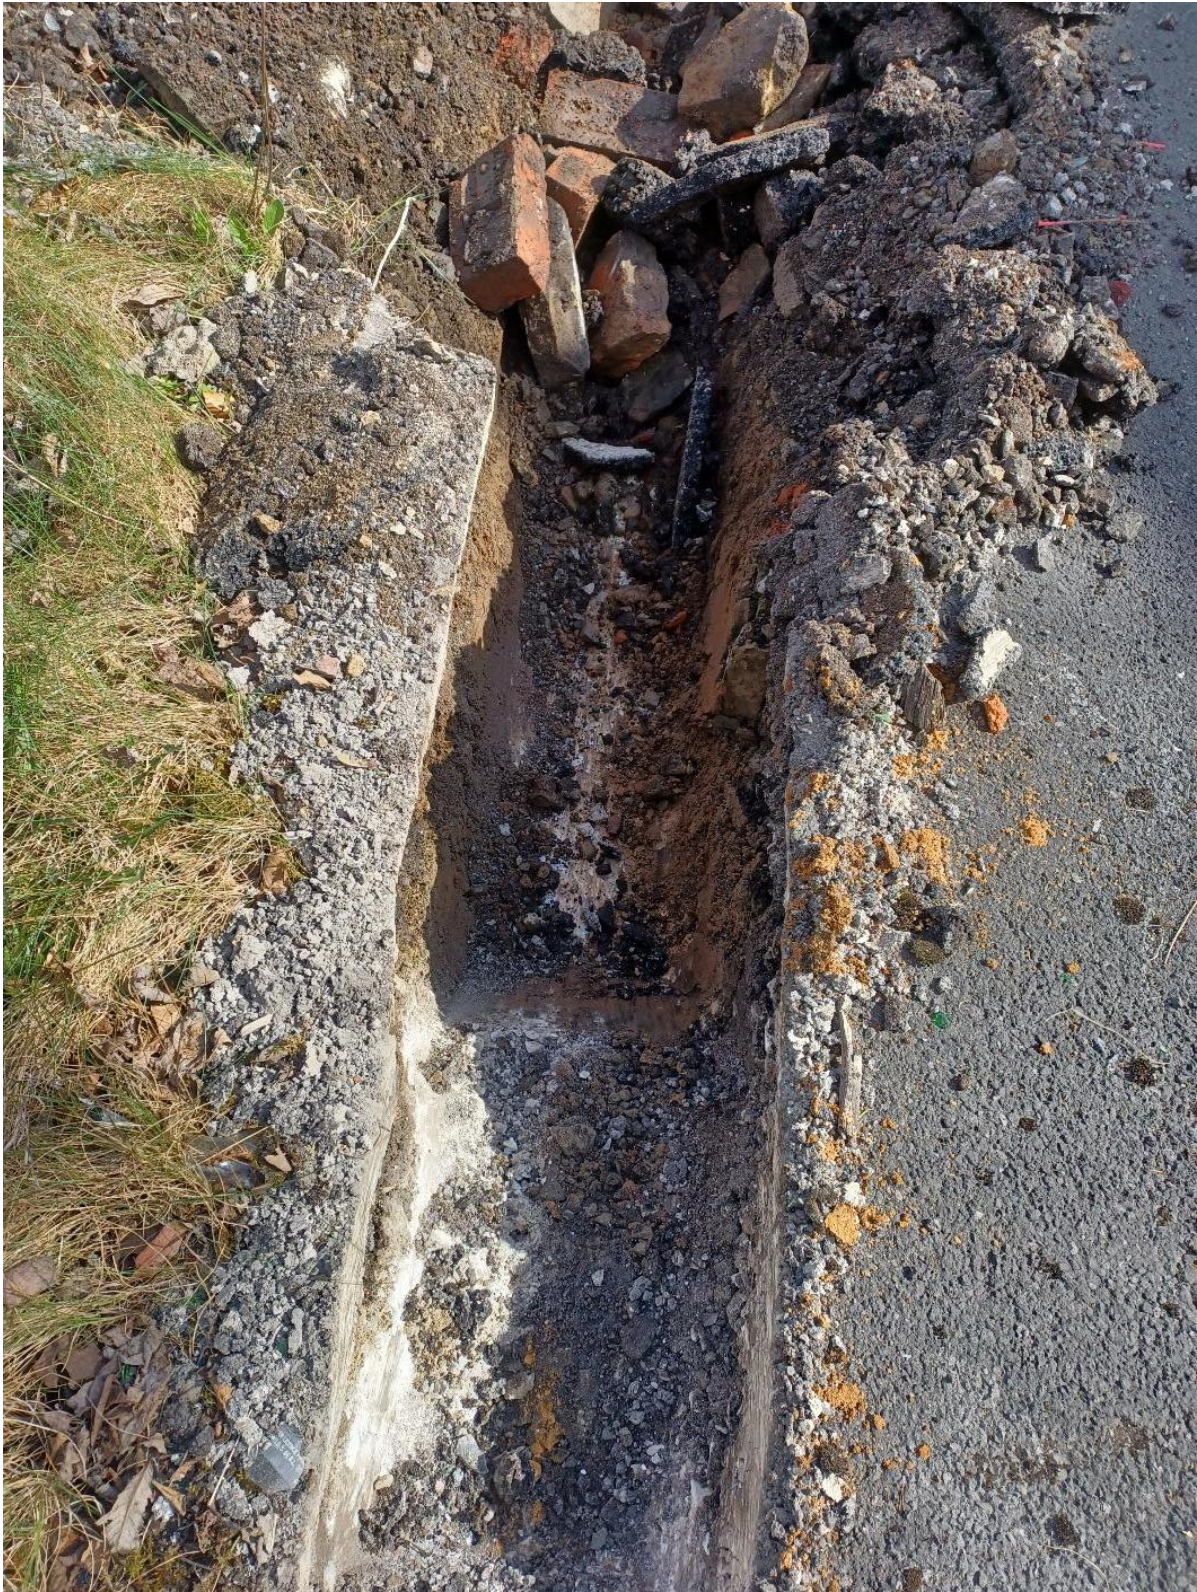
| PURPOSE: Targeting are immediately south of former forecourt. TERMINATION: Refusal on concrete slab. | 0.00 - 0.40m TP - Trial Pit tonne tracked | RB |

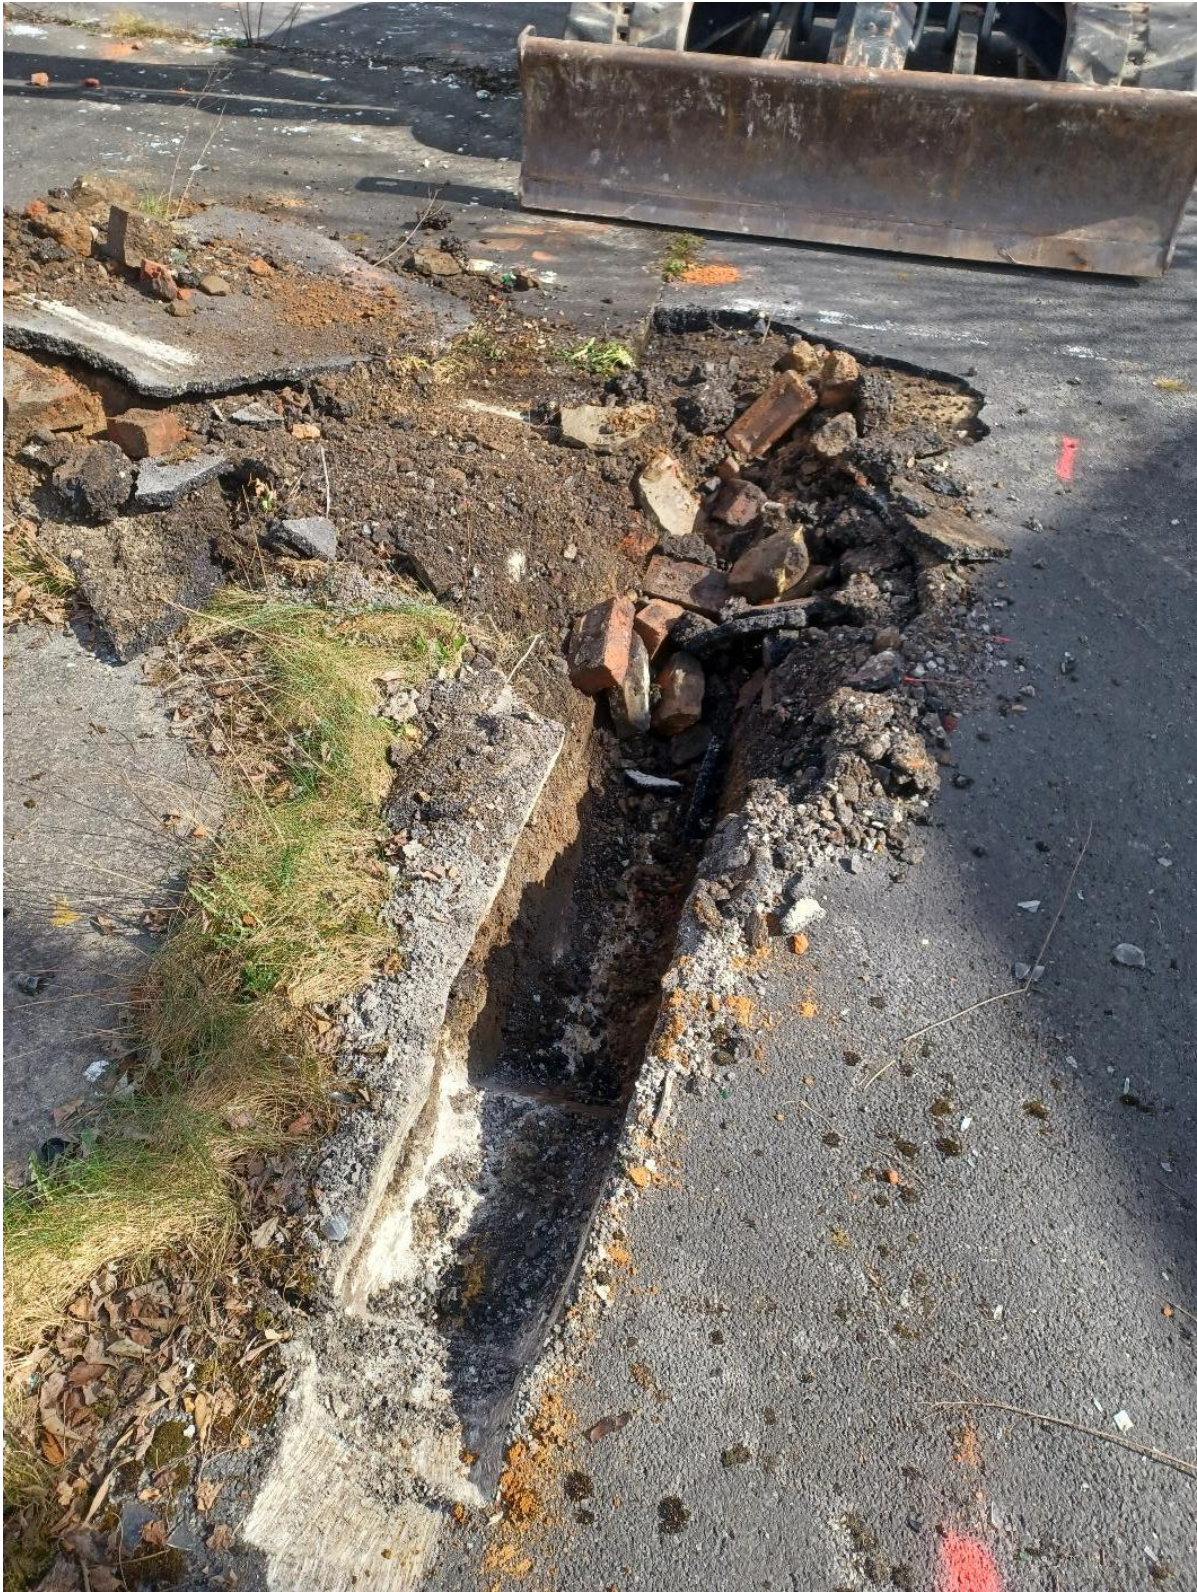
| PURPOSE: Targeting are immediately south of former forecourt. TERMINATION: Refusal on concrete slab. | 0.00 - 0.40m TP - Trial Pit tonne tracked | RB |

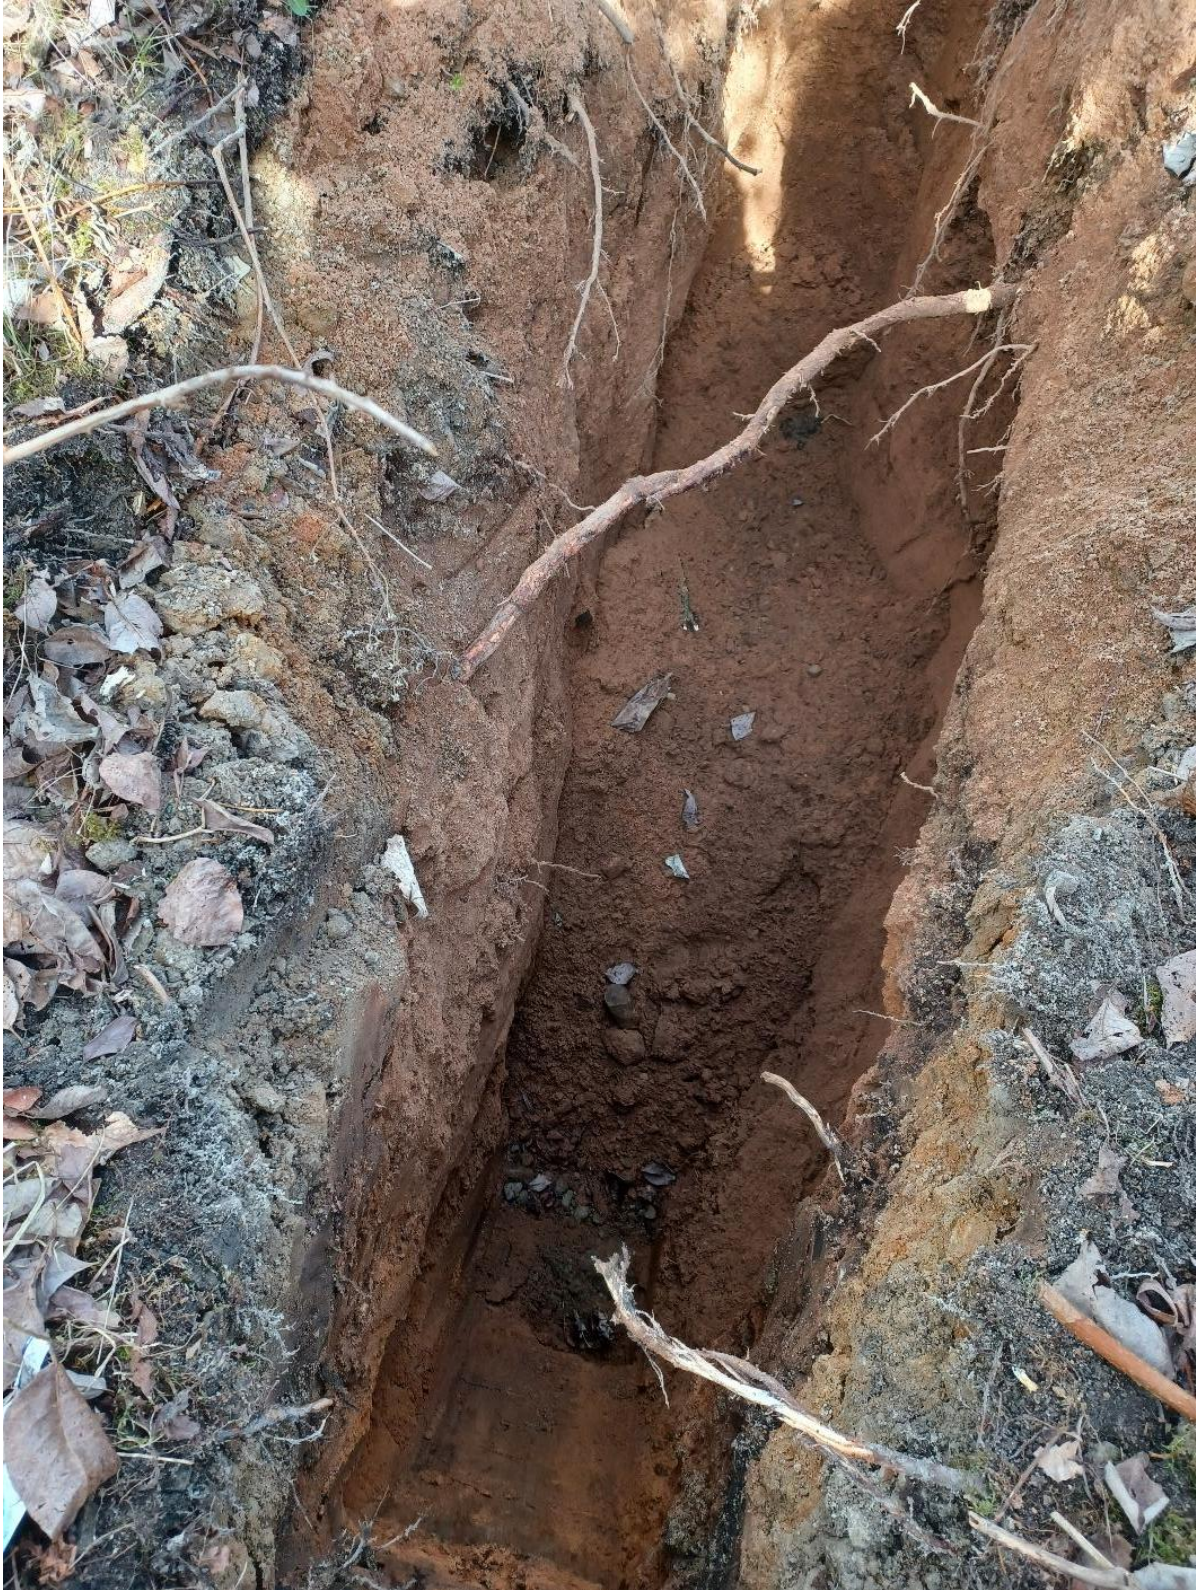
| <b>Remarks</b><br>PURPOSE: GEneral coverage of the Site and to permit in-situ testing. TERMINATION: Engineer decision, target depth achieved to permit infiltration testing. LOCATION: Surveyed using freeware on Site. GL: Estimated off topographical survey. STABILITY: Continual collapse within Made Ground deposits. GROUNDWATER: None encountered. OTHER: No evidence of potentially harmful or polluting material. | | | <b>Method, Plant, Stability, Dimensions</b><br>0.00 - 1.40m TP - Trial Pit<br>Stable | | |

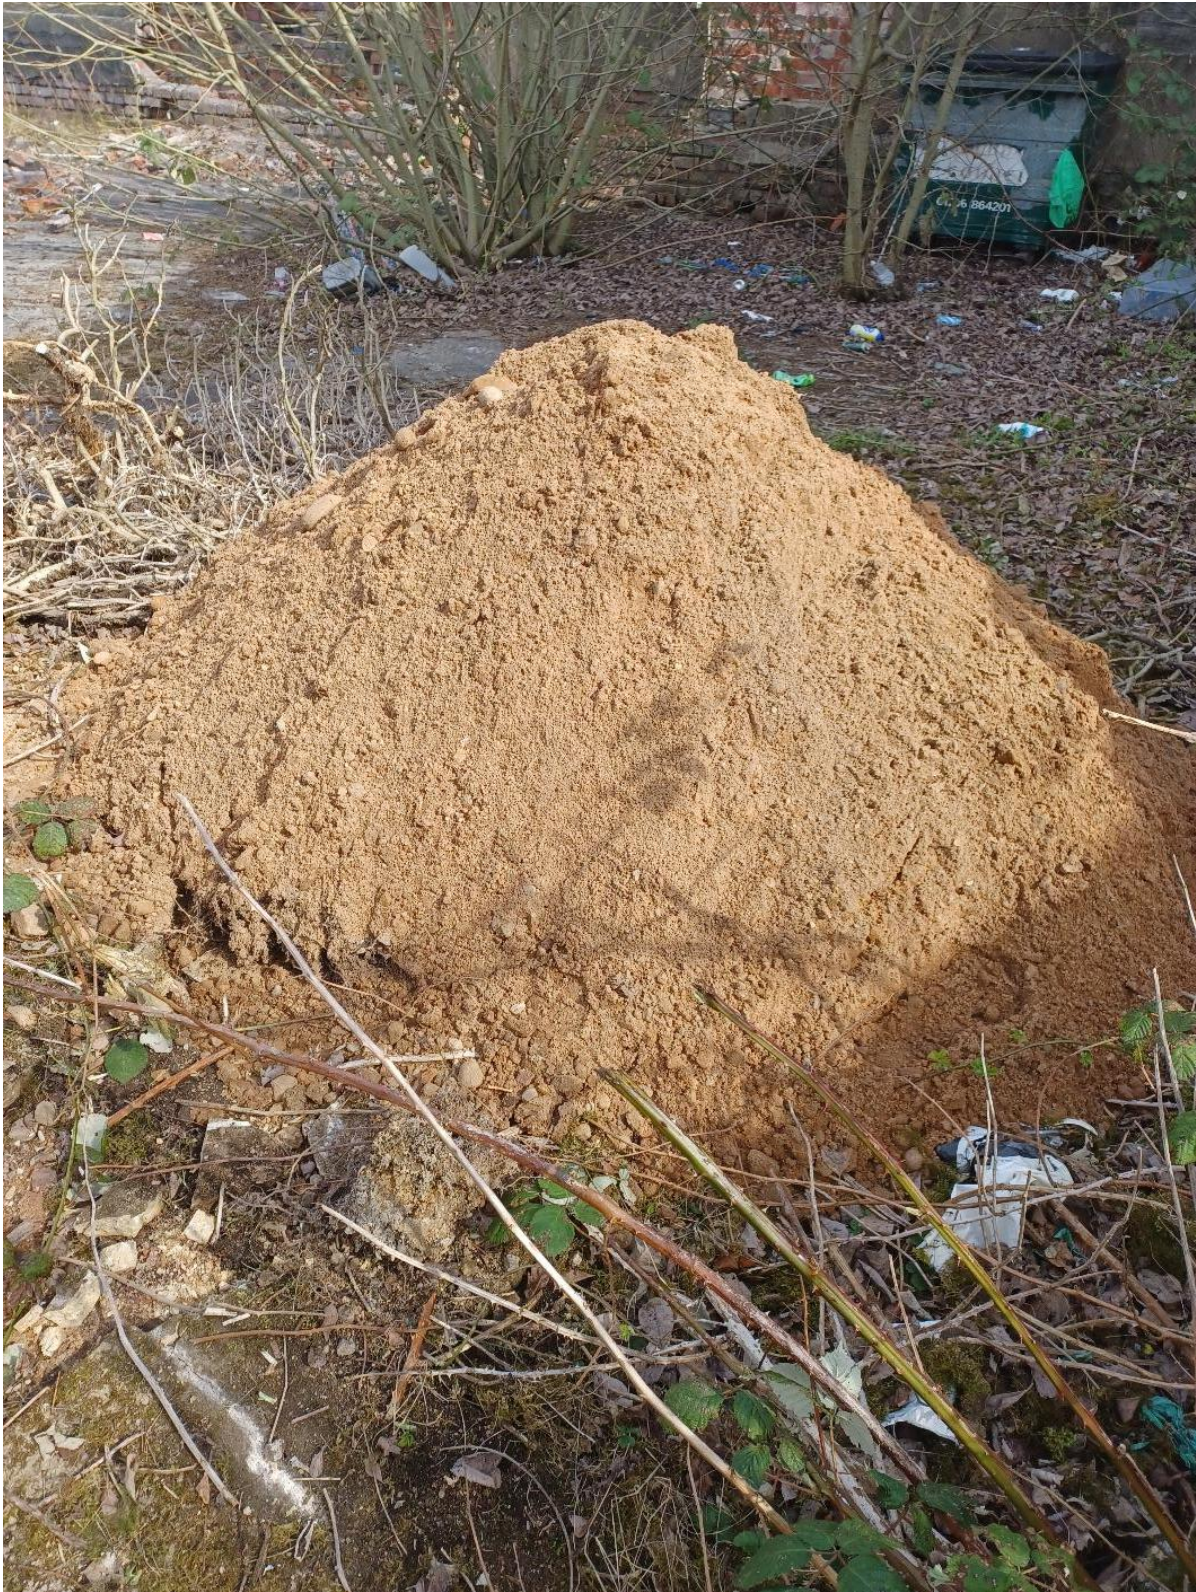
| <b>Remarks</b><br>PURPOSE: GEneral coverage of the Site and to permit in-situ testing. TERMINATION: Engineer decision, target depth achieved to permit infiltration testing. LOCATION: Surveyed using freeware on Site. GL: Estimated off topographical survey. STABILITY: Continual collapse within Made Ground deposits. GROUNDWATER: None encountered. OTHER: No evidence of potentially harmful or polluting material. | | | <b>Method, Plant, Stability, Dimensions</b><br>0.00 - 1.40m TP - Trial Pit tonne tracked<br>Stable | | |

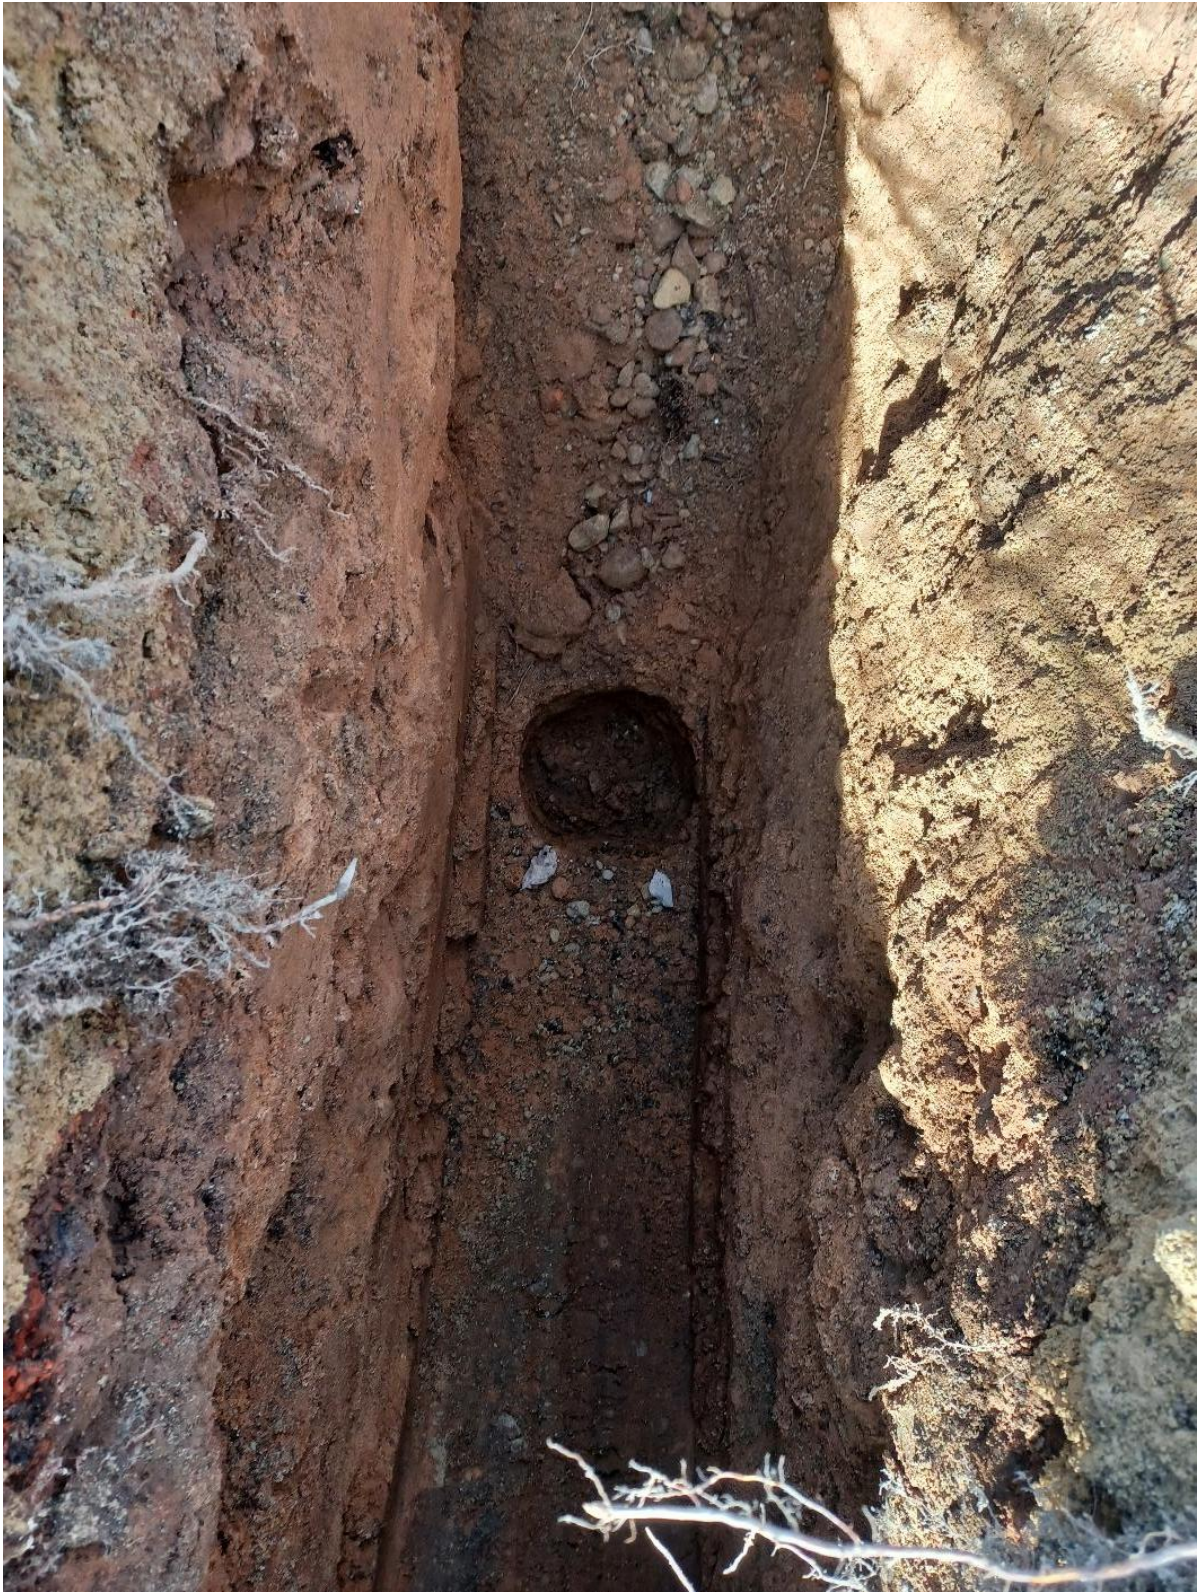
| Remarks<br>PURPOSE: GEneral coverage of the Site and to permit in-situ testing. TERMINATION: Engineer decision, target depth achieved to permit infiltration testing. LOCATION: Surveyed using freeware on Site. GL: Estimated off topographical survey. STABILITY: Continual collapse within Made Ground deposits. GROUNDWATER: None encountered. OTHER: No evidence of potentially harmful or polluting material. | Method, Plant, Stability, Dimensions<br>0.00 - 1.40m TP - Trial Pit 7 tonne tracked<br>Stable | Logger<br>RB |

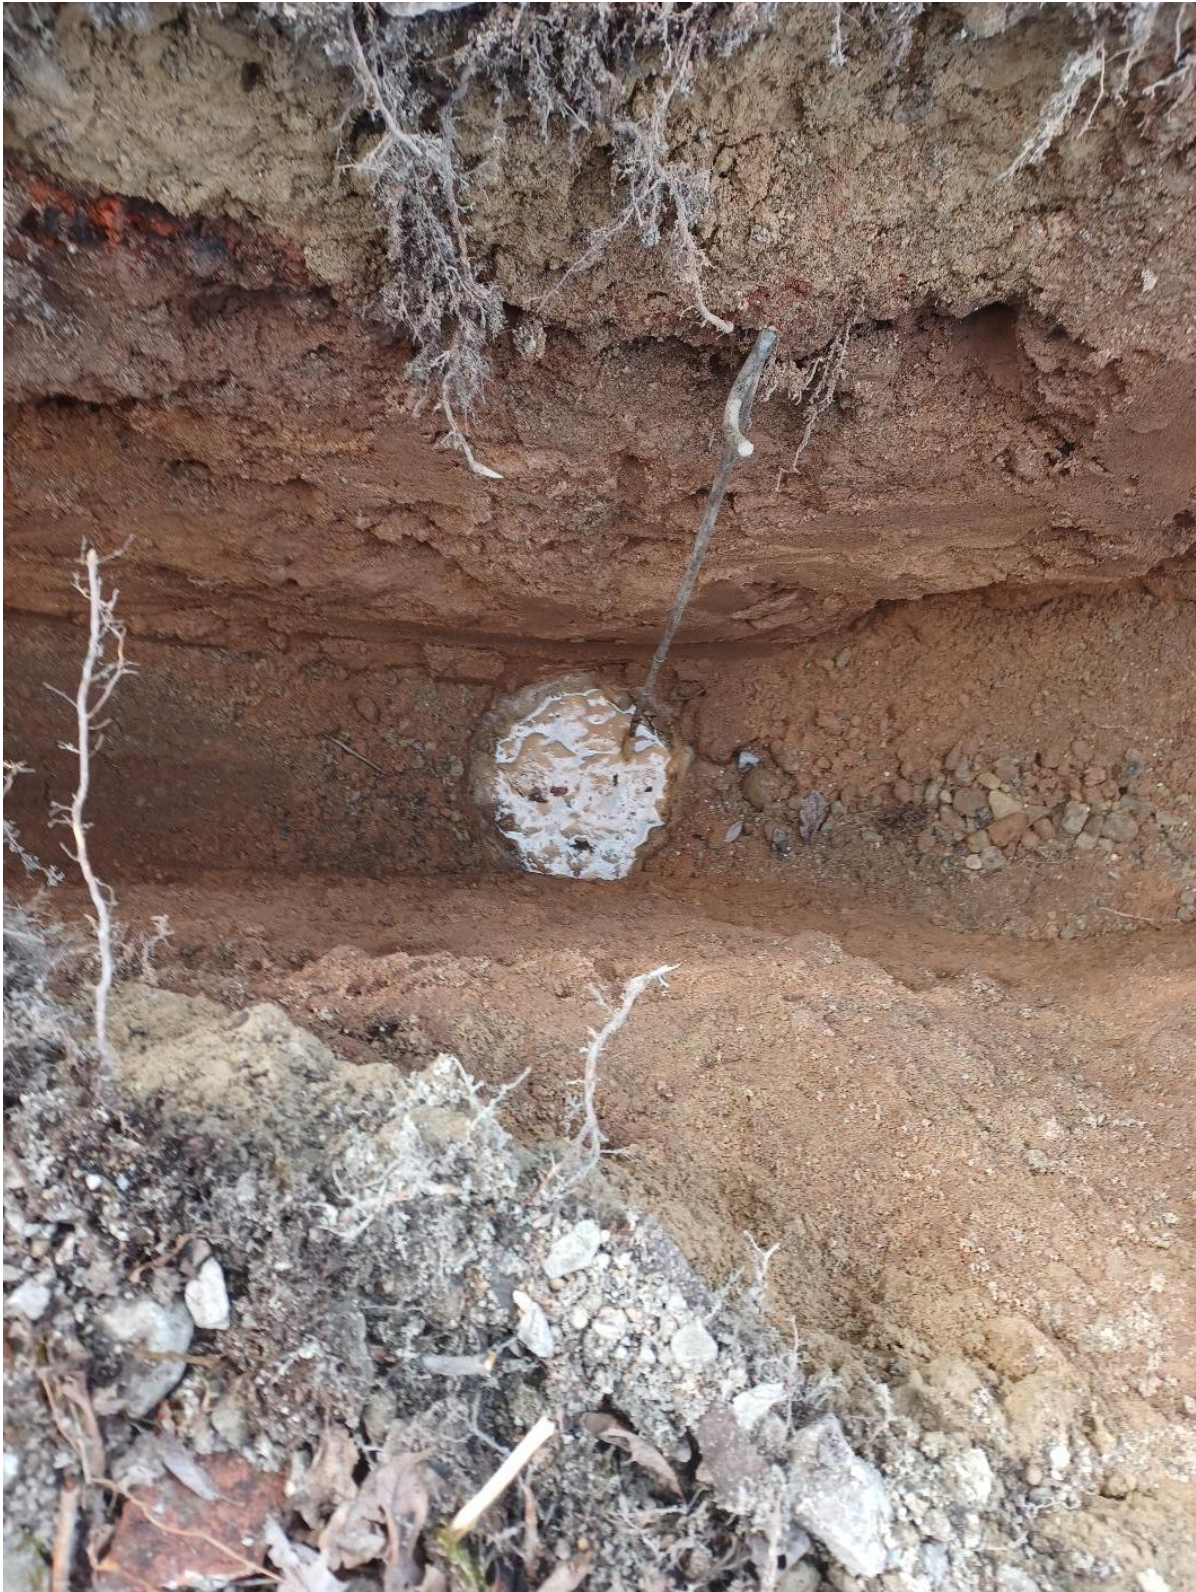
| Remarks<br>PURPOSE: GEneral coverage of the Site and to permit in-situ testing. TERMINATION: Engineer decision, target depth achieved to permit infiltration testing. LOCATION: Surveyed using freeware on Site. GL: Estimated off topographical survey. STABILITY: Continual collapse within Made Ground deposits. GROUNDWATER: None encountered. OTHER: No evidence of potentially harmful or polluting material. | Method, Plant, Stability, Dimensions<br>0.00 - 1.40m TP - Trial Pit 7 tonne tracked<br>Stable | Logger<br>RB |

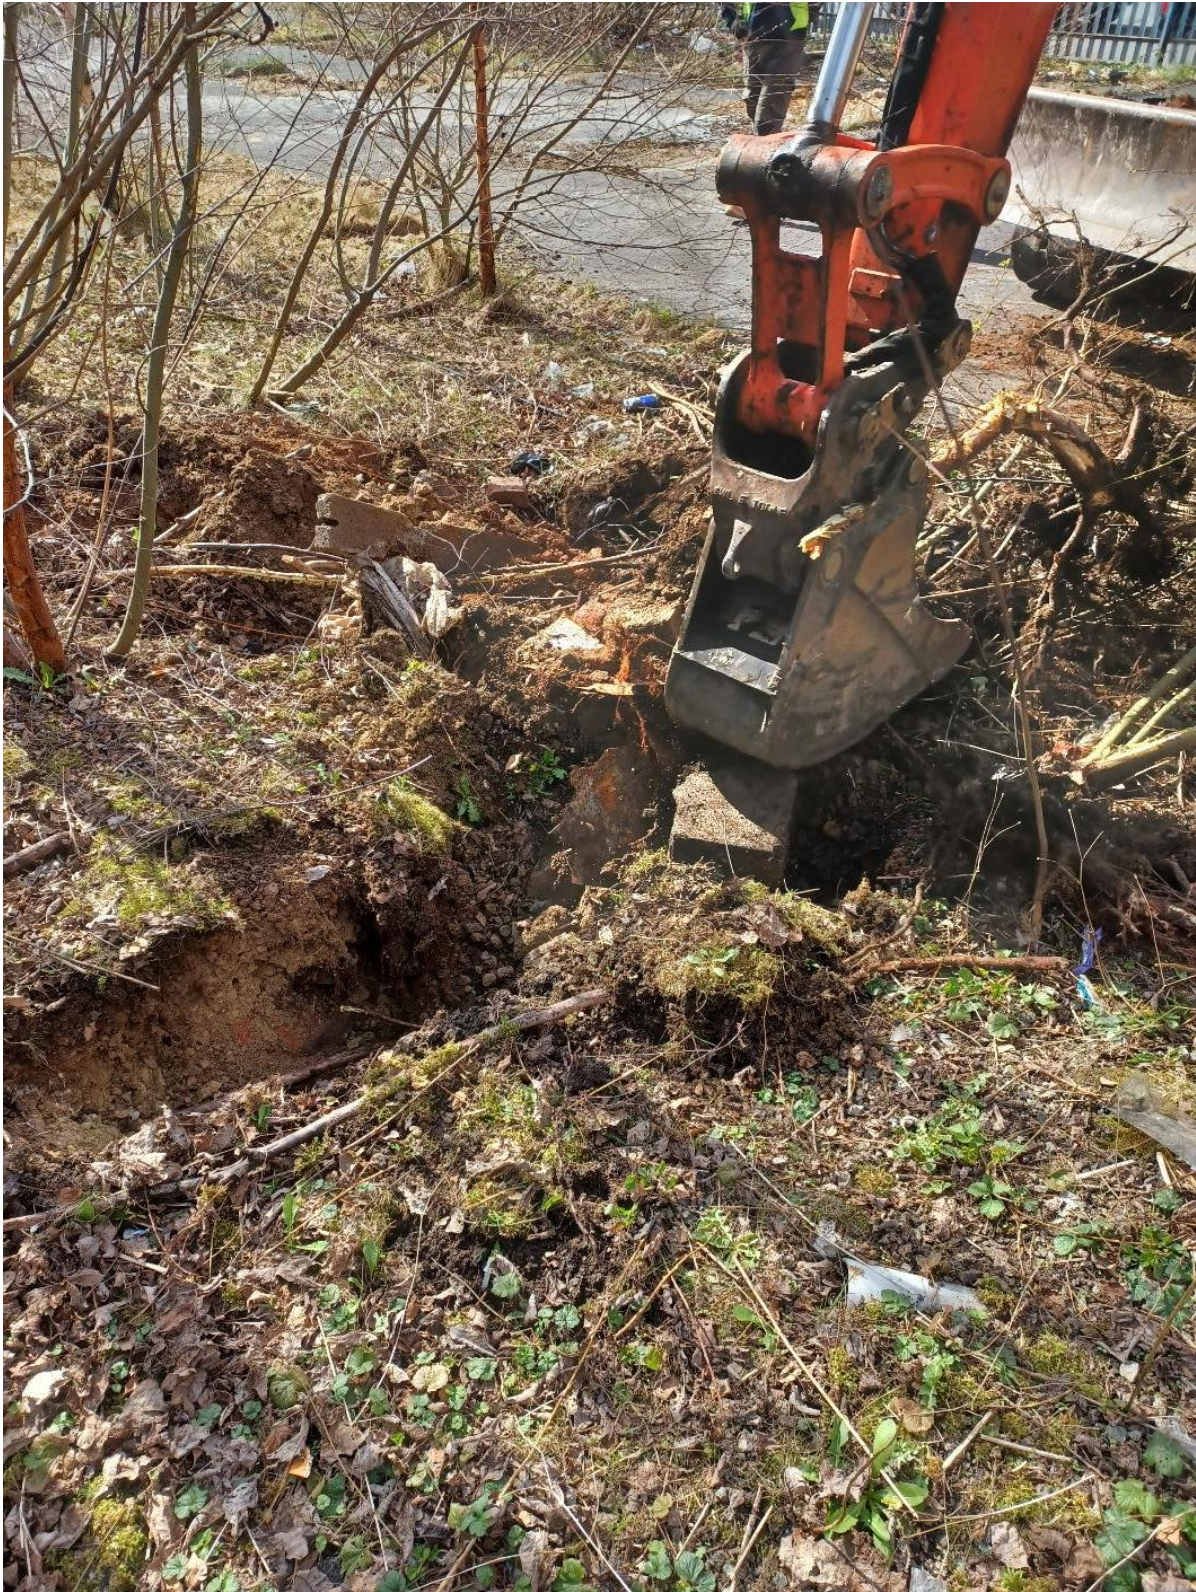
| PURPOSE: Targeting former location of underground storage tank (UST) as indicated by neighbour. TERMINATION: Engineer decision, target depth achieved - relic concrete footing (base of former UST) encountered and dug through. LOCATION: Surveyed using freeware on Site. GL: Estimated off topographical survey. STABILITY: Continual collapse within Made Ground deposits. GROUNDWATER: None encountered. OTHER: No evidence of potentially harmful or polluting material. | 0.00 - 2.00m TP - Trial Pit tonne tracked<br>Unstable | RB |

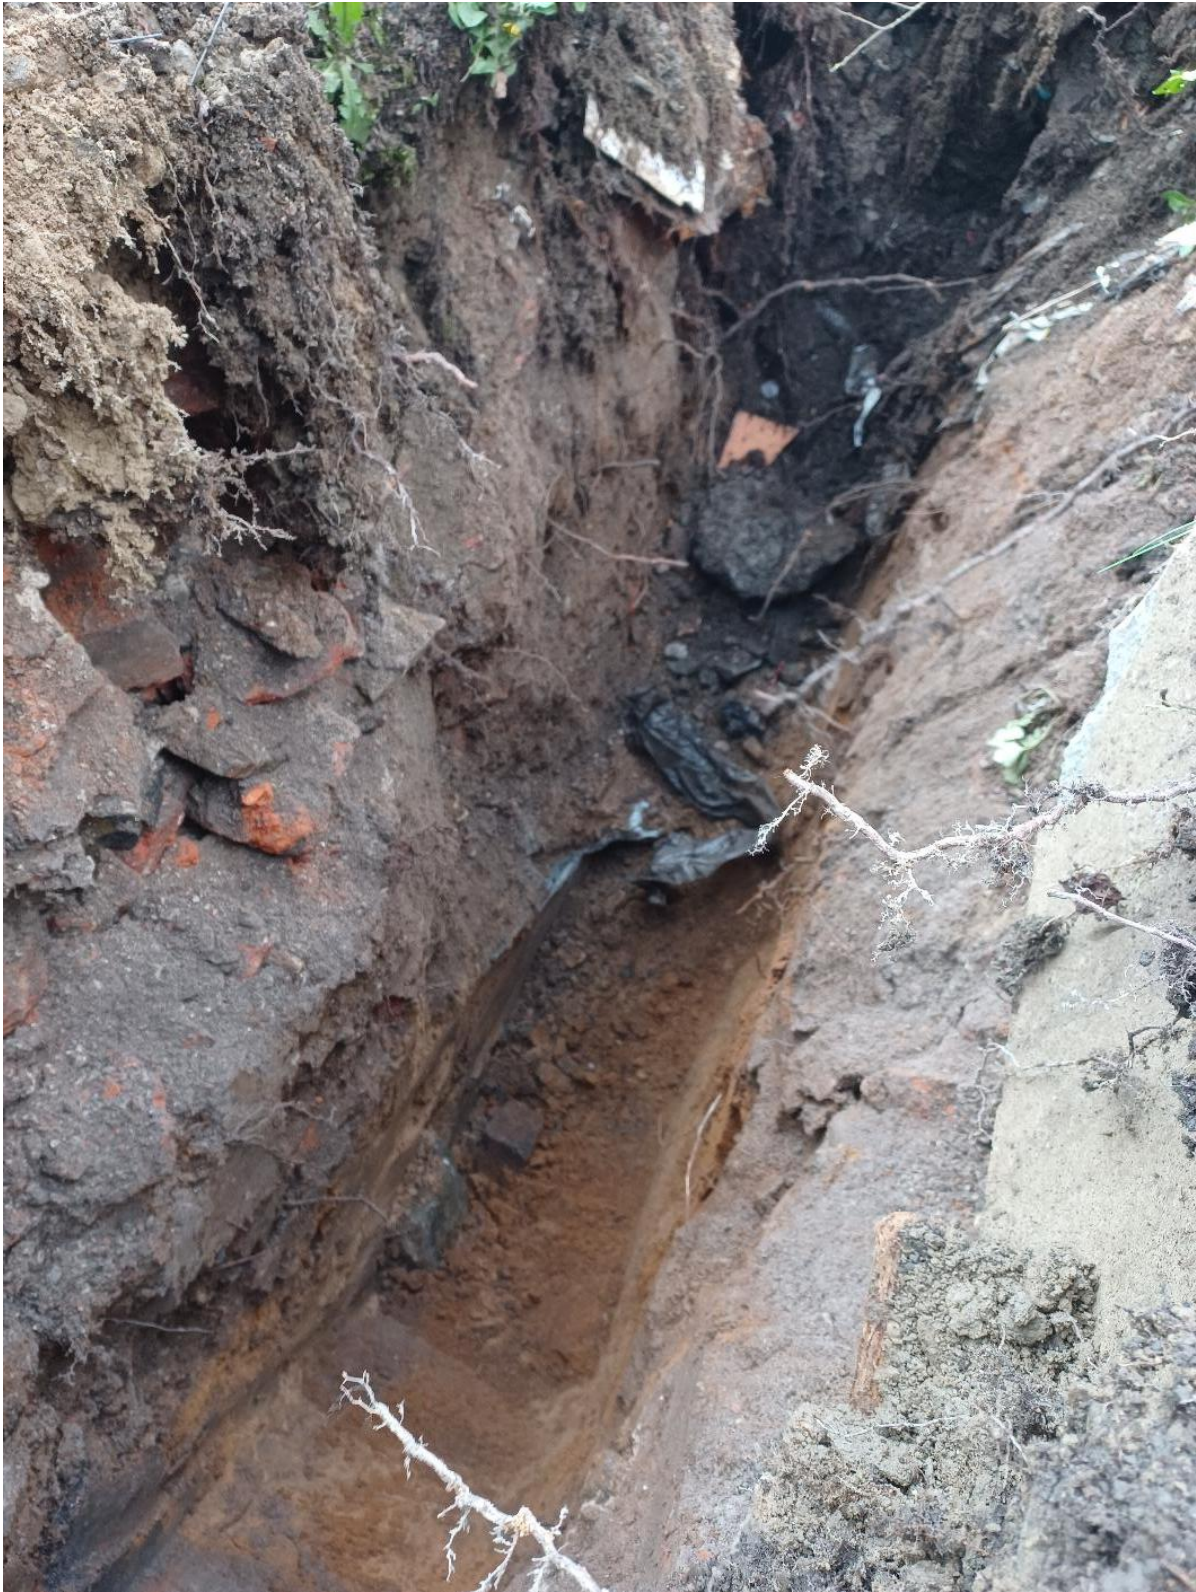
| Remarks<br>PURPOSE: Targeting former location of underground storage tank (UST) as indicated by neighbour. TERMINATION: Engineer decision, target depth achieved - relic concrete footing (base of former UST) encountered and dug through. LOCATION: Surveyed using freeware on Site. GL: Estimated off topographical survey. STABILITY: Continual collapse within Made Ground deposits. GROUNDWATER: None encountered. OTHER: No evidence of potentially harmful or polluting material. | | | Method, Plant, Stability, Dimensions<br>0.00 - 2.00m TP - Trial Pit tonne tracked<br>Unstable | | |

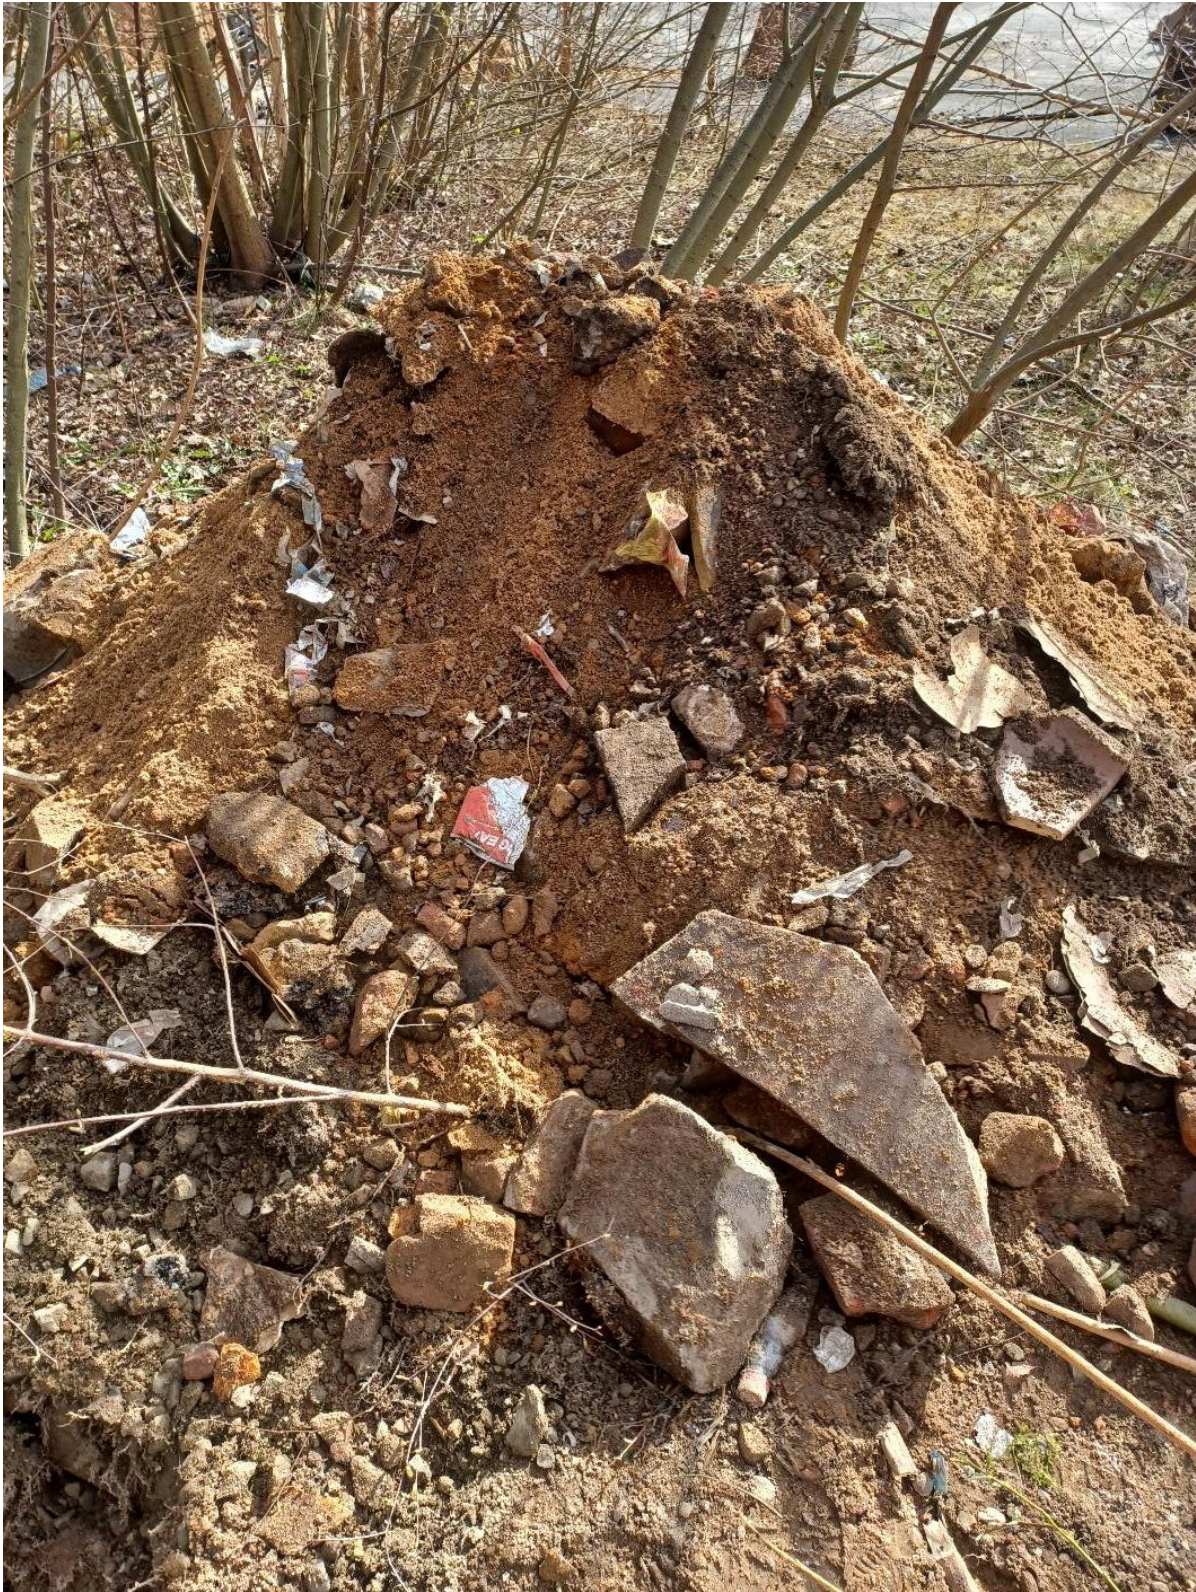
| PURPOSE: Targeting former location of underground storage tank (UST) as indicated by neighbour. TERMINATION: Engineer decision, target depth achieved - relic concrete footing (base of former UST) encountered and dug through. LOCATION: Surveyed using freeware on Site. GL: Estimated off topographical survey. STABILITY: Continual collapse within Made Ground deposits. GROUNDWATER: None encountered. OTHER: No evidence of potentially harmful or polluting material. | 0.00 - 2.00m TP - Trial Pit tonne tracked<br>Unstable | RB |

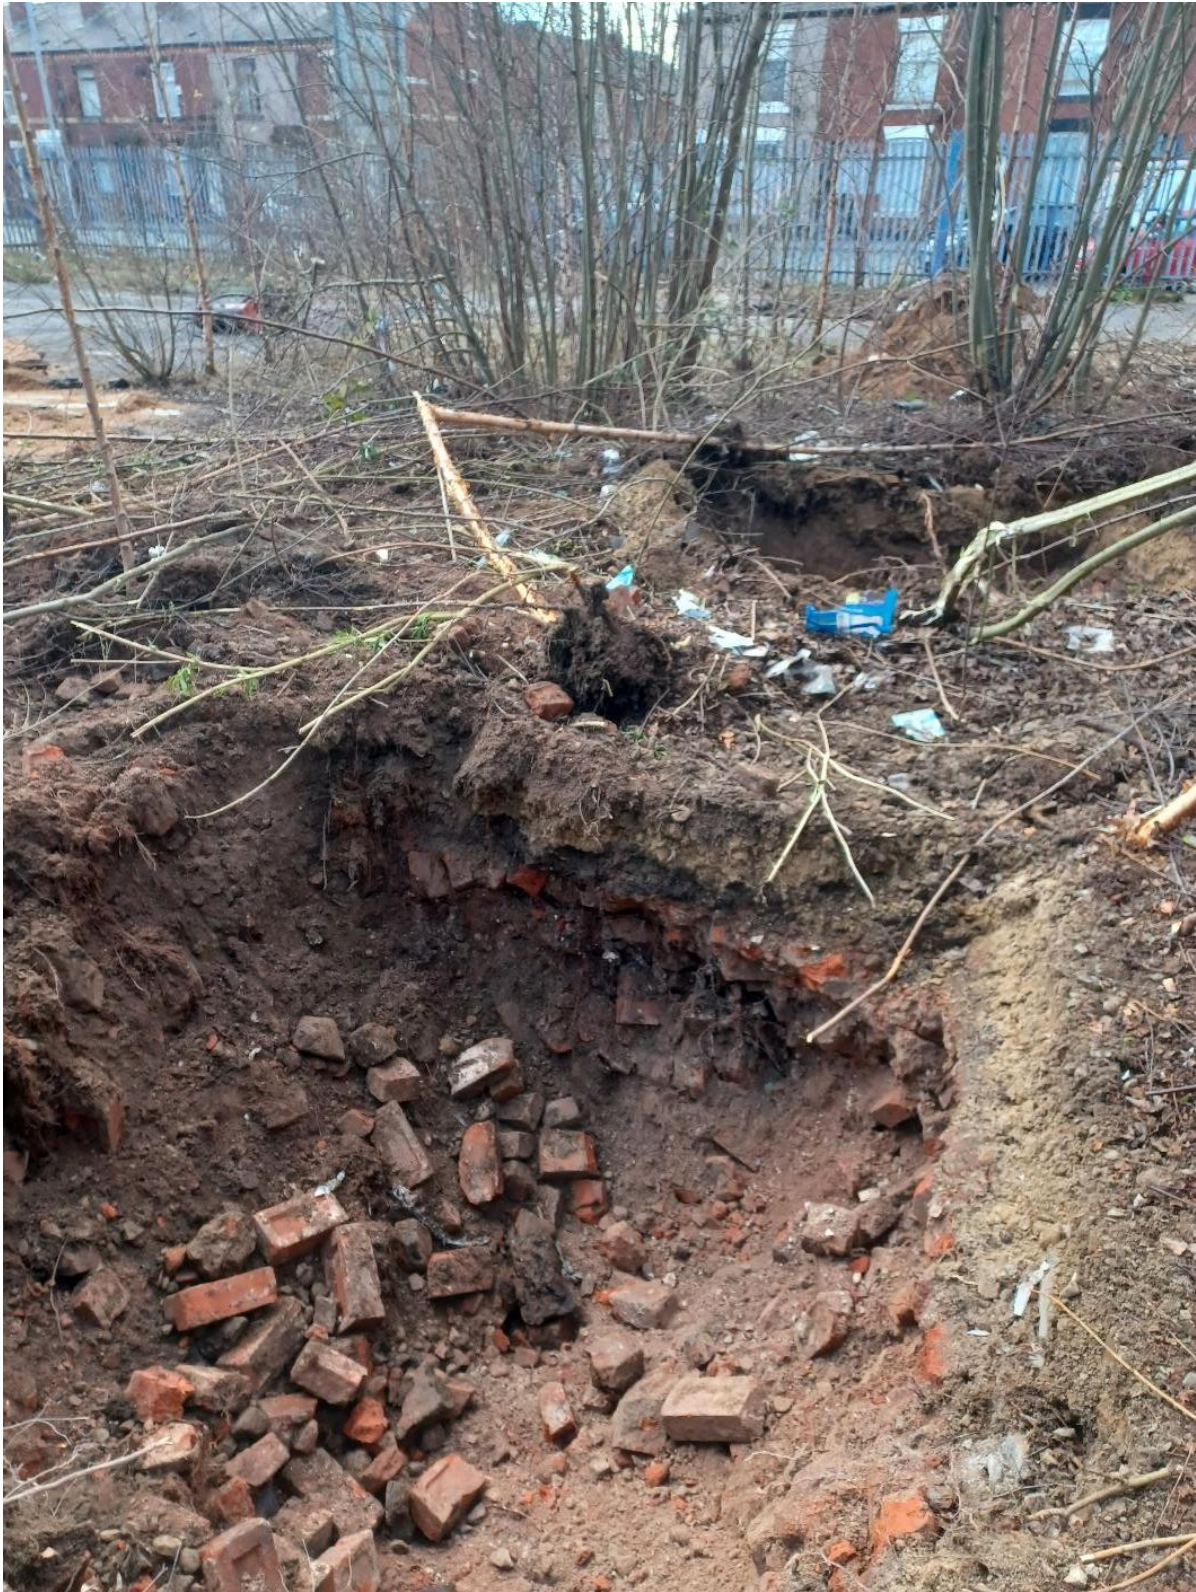
| Remarks<br>PURPOSE: Targeting location of remaining underground storage tank (UST) as indicated by neighbour.<br>TERMINATION: Engineer decision, target depth achieved - no evidence of relic USTs. LOCATION: Surveyed using<br>freeware on Site. GL: Estimated off statellite imagery. STABILITY: Localised collapse within Made Ground<br>deposits. GROUNDWATER: None encountered. OTHER: No evidence of potentially harmful or polluting material. | Method, Plant, Stability, Dimensions<br>0.00 - 1.40m TP - Trial Pit tonne tracked<br>Unstable | Logger<br>RB |
