# Ground Investigation Report [intrusive]

Land off Oldham Road, Rochdale

Soil and Structures Ltd were instructed by Metalcraft Group Ltd (*the Client*) in January 2025 to prepare a Ground Investigation Report (*this Report*) in support of a planned development of a parcel of land located off Oldham Road, Rochdale (the Site).

Development proposals include for the construction of a single-storey retail unit and associated hard standing (parking and goods yard).

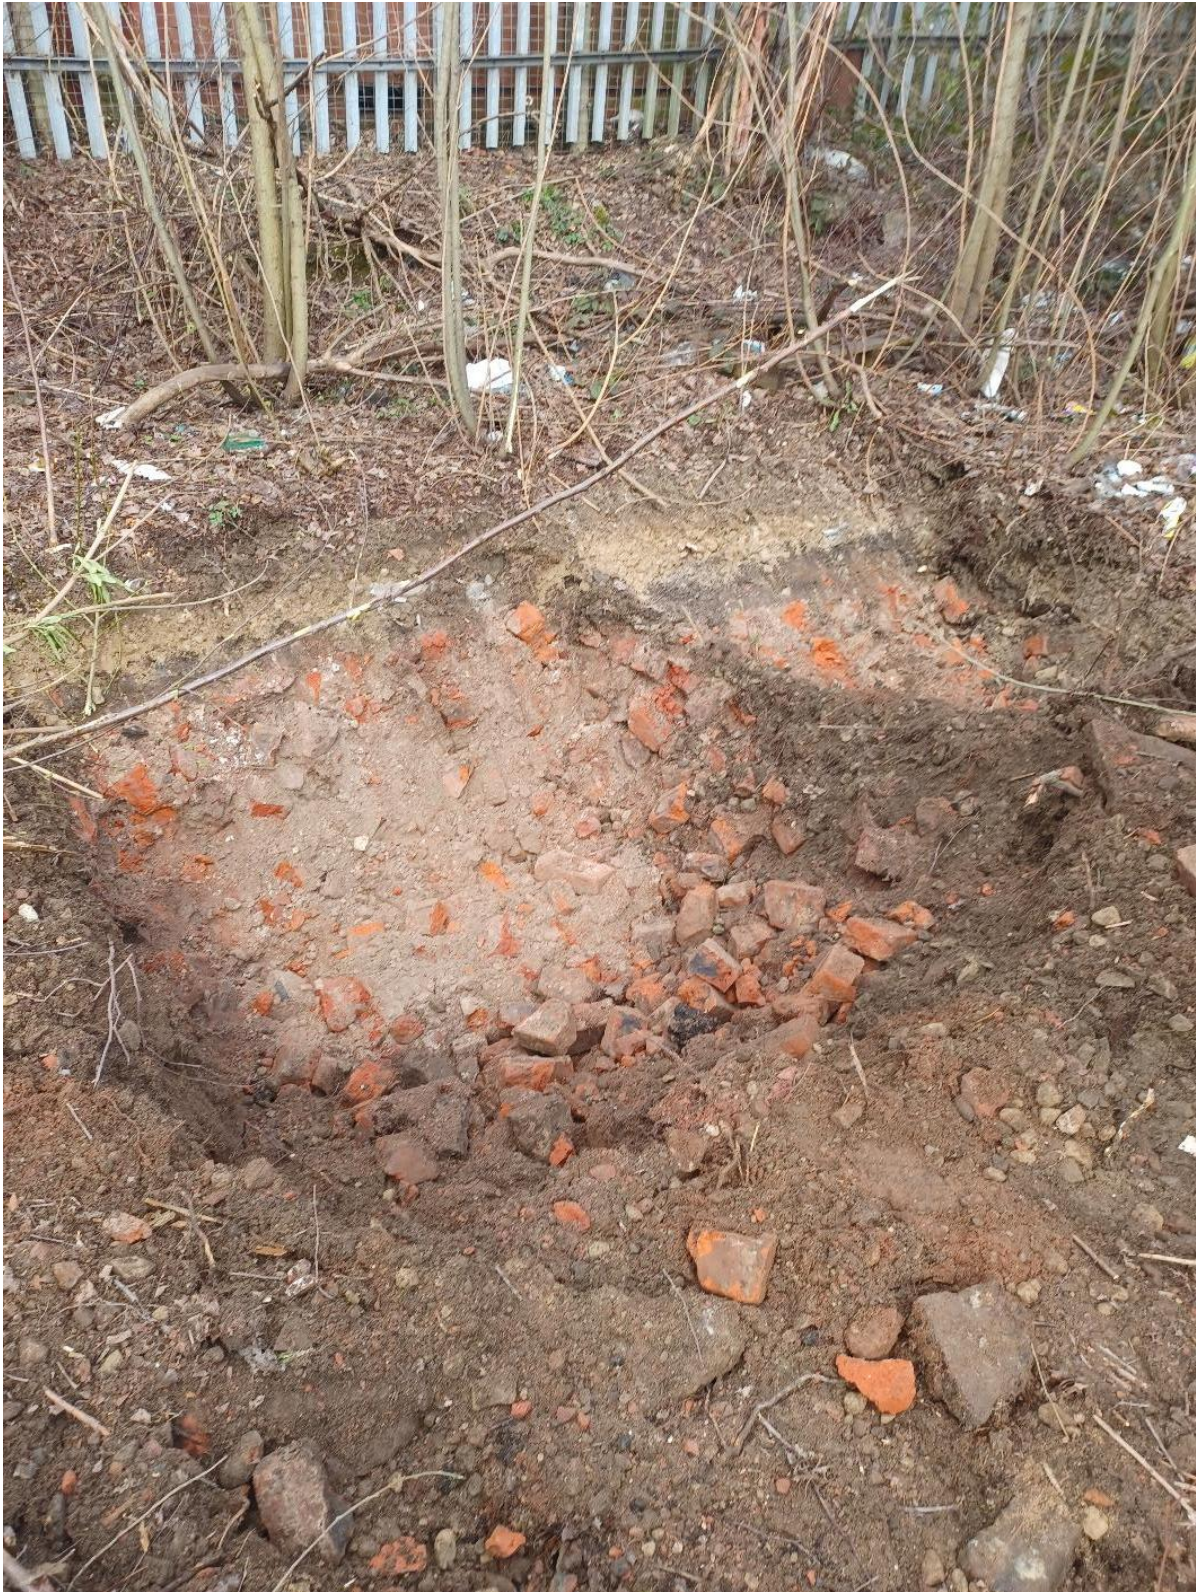
| <b>Remarks</b><br>PURPOSE: Targeting location of remaining underground storage tank (UST) as indicated by neighbour.<br>TERMINATION: Engineer decision, target depth achieved - no evidence of relic USTs. LOCATION: Surveyed using freeware on Site. GL: Estimated off satellite imagery. STABILITY: Localised collapse within Made Ground deposits. GROUNDWATER: None encountered. OTHER: No evidence of potentially harmful or polluting material. | | | | <b>Method, Plant, Stability, Dimensions</b><br>0.00 - 1.40m TP - Trial Pit tonne tracked<br>Unstable | |

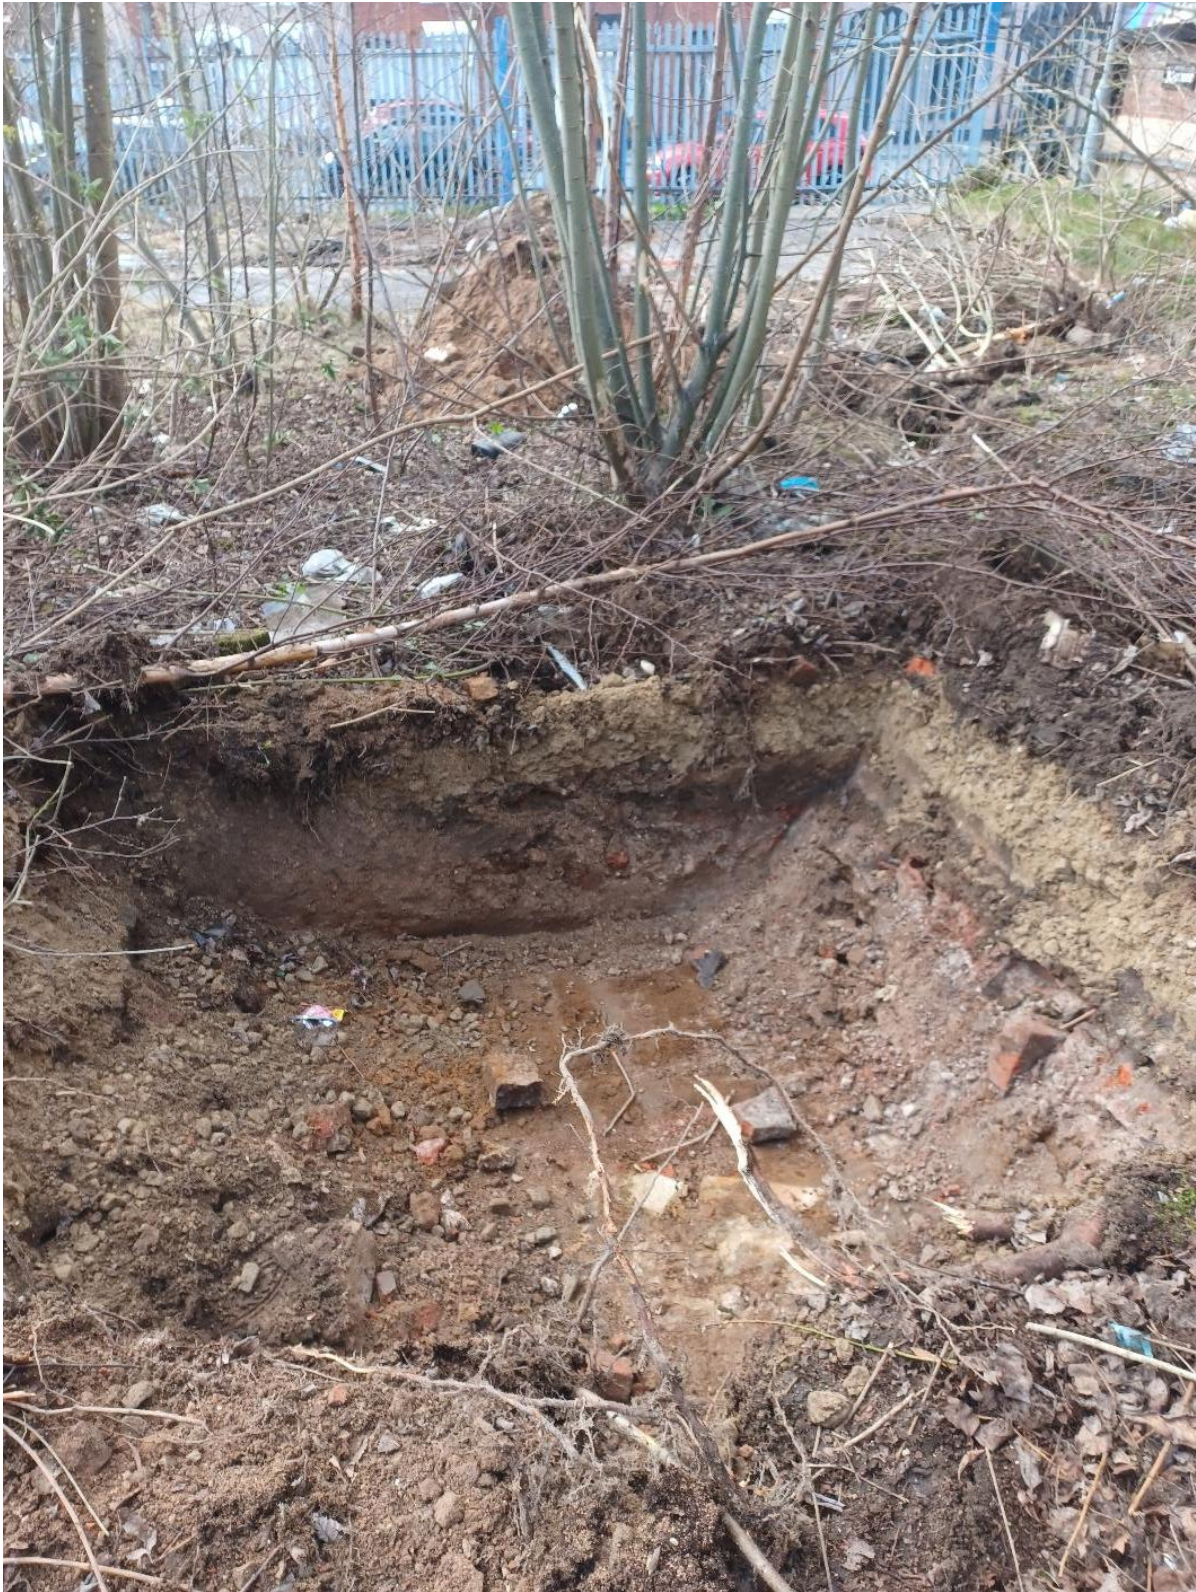
| Remarks<br>PURPOSE: Targeting location of remaining underground storage tank (UST) as indicated by neighbour.<br>TERMINATION: Engineer decision, target depth achieved - no evidence of disturbed ground or evidence of relic USTs. LOCATION: Surveyed using freeware on Site. GL: Estimated off topographical survey. STABILITY: Stable.<br>GROUNDWATER: None encountered. OTHER: No evidence of potentially harmful or polluting material. | | | Method, Plant, Stability, Dimensions<br>0.00 - 0.90m TP - Trial Pit tonne tracked<br>Stable | | |
