**Hopwood Hall College, Rochdale**  
**Remediation Strategy & Build Phase Verification Plan**

Job Number  
**LKC251085**

Report Date  
**21<sup>st</sup> July 2025**

| <b>Report Title</b> | Remediation Strategy & Build Phase Verification Plan |

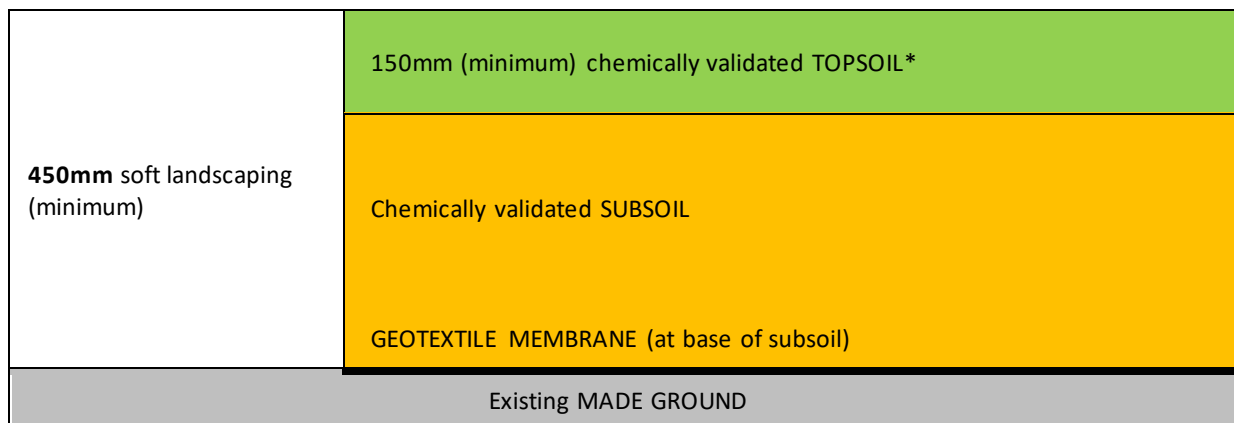
Plate 2-1: Typical Environmental Cover System Construction.

- **Shared Landscaping: 450mm thick environmental cover system comprising:**  
Geotextile membrane and at least 300mm comprising clean inert fill and sufficient topsoil for a growing medium.

A diagram of a typical environmental cover system is shown in Plate 2-1 below.

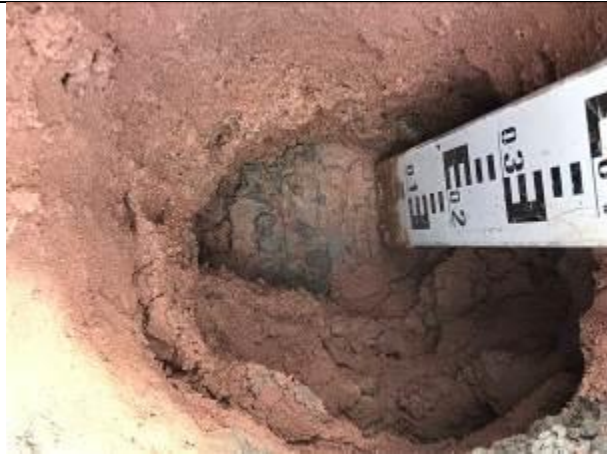
View of soil in capping layer excavation.

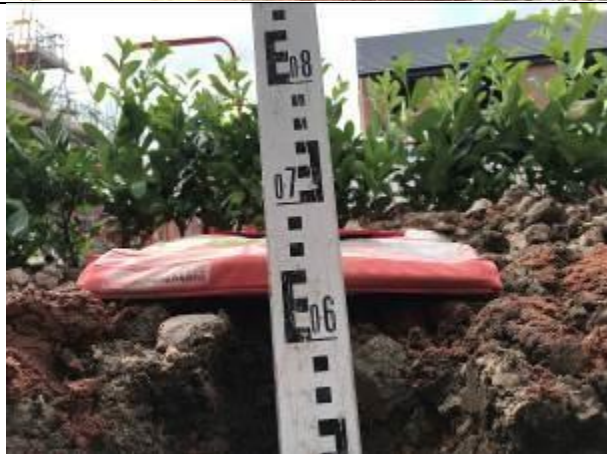
Depth measurement in garden area to the front of Plot 1 (*circa* 640mm).
