# HISTORIC BUILDING RECORD

Client: Hopwood Hall College  
Project: Conversion of Former Chapel  
Reference: HCO-SEV-XX-XX-RP-A-09104  
Date: July | 2025

| DOCUMENT TITLE | HISTORIC BUILDING RECORD |

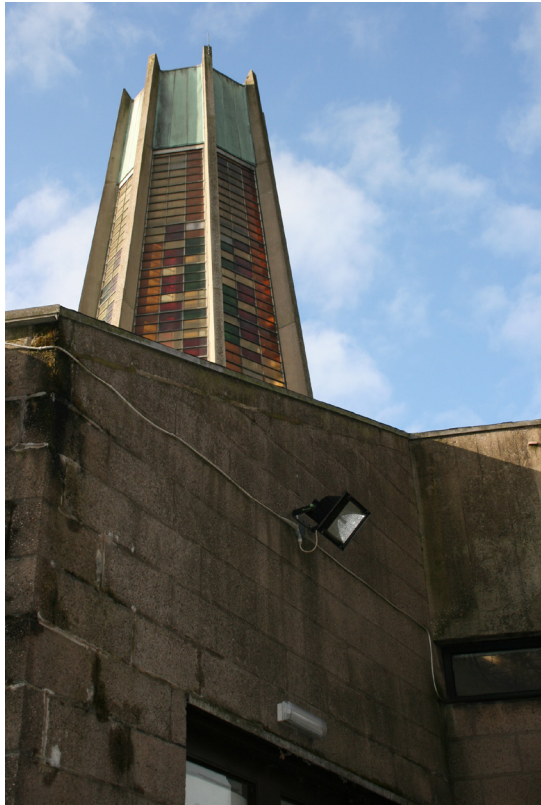
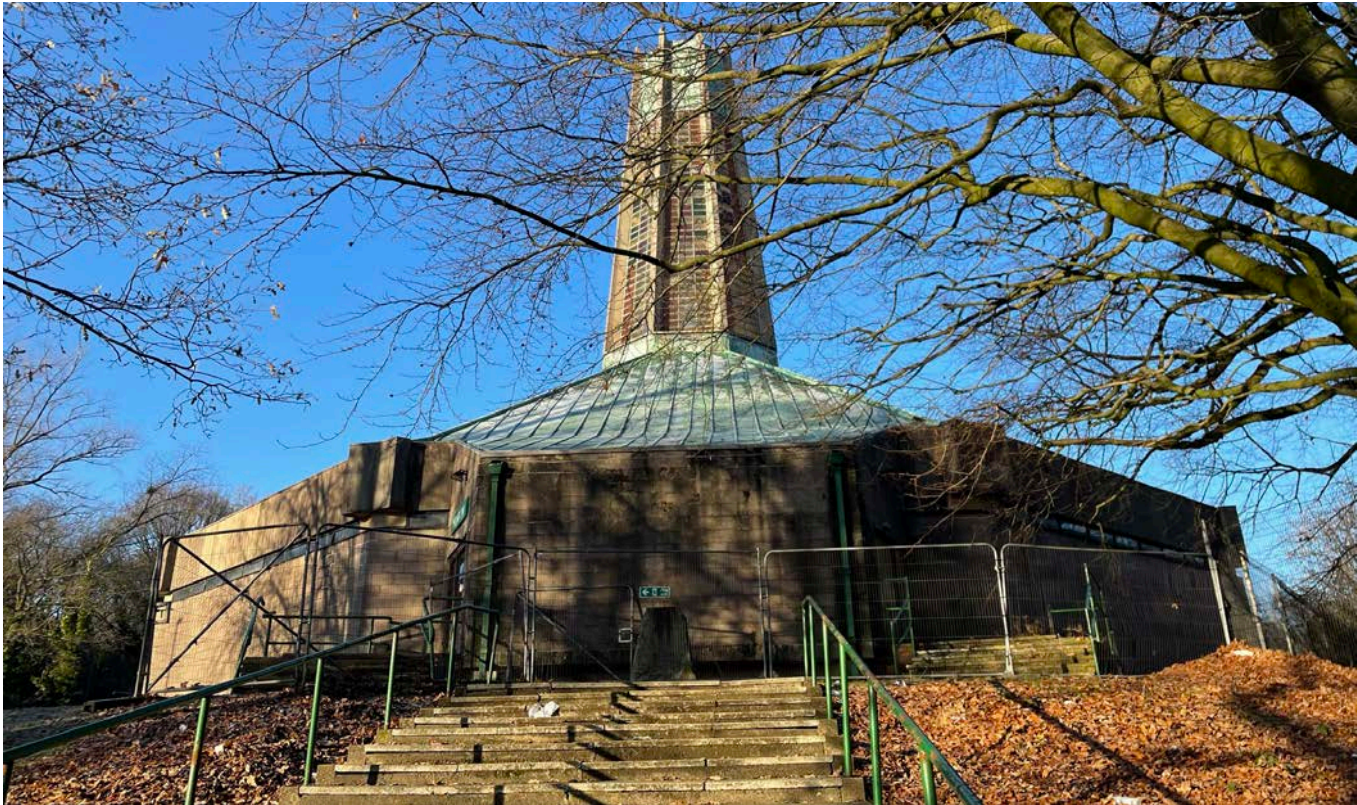
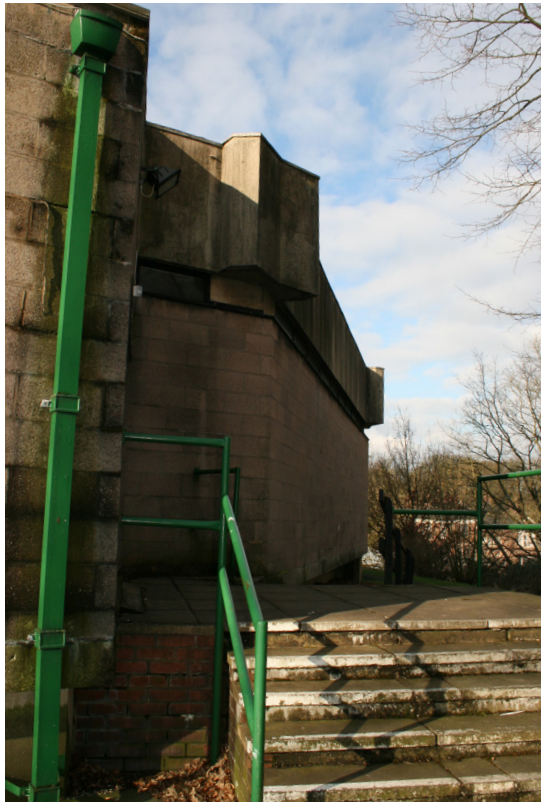
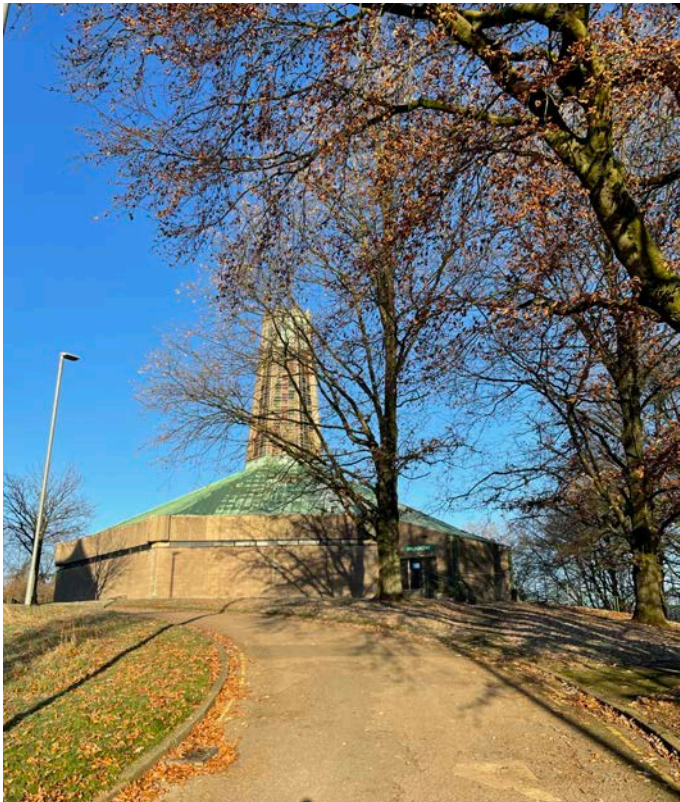
Figure 3.4 The Existing Site - External Photographs (Source: Seven Architecture)

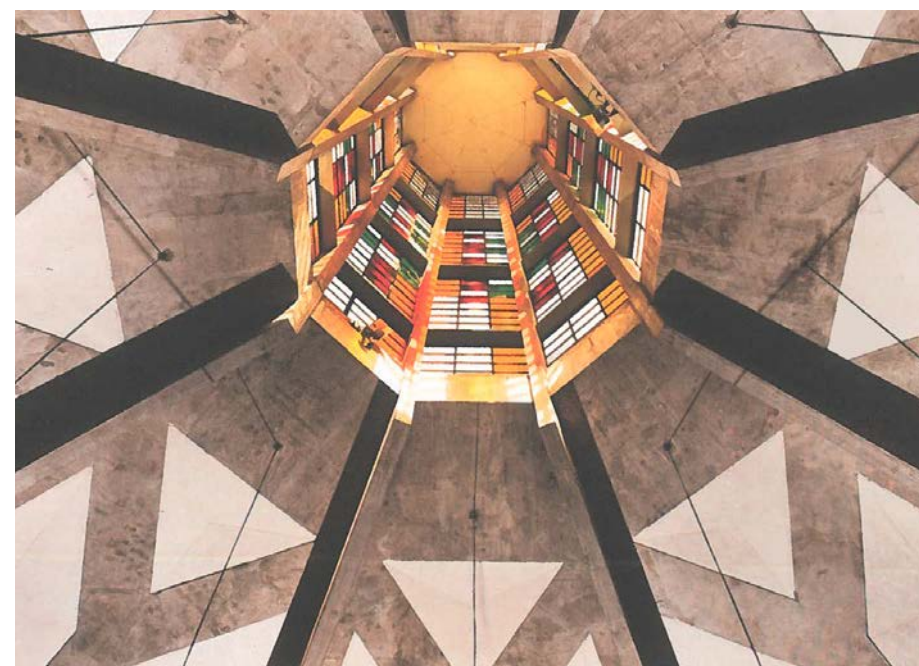
Figure 4.21  
Hopwood Hall Chapel, interior view of tower and coloured glass  
(Source: 'Twentieth Century Architects: Frederick Gibberd' by Christine Hui Lan Manley. Published by Historic England, 2017)

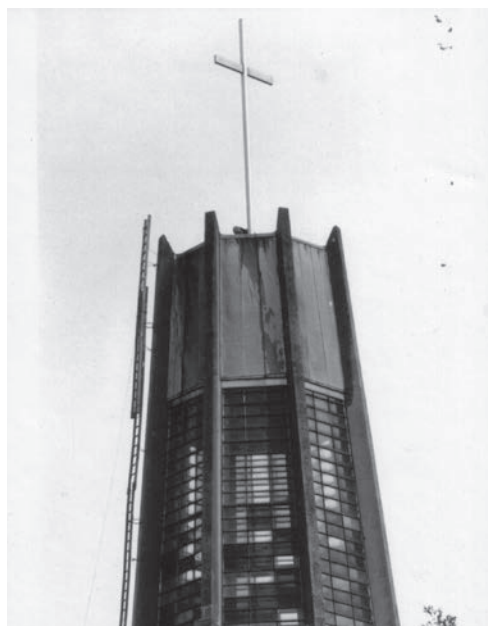
Figure 4.22  
The Chapel spire  
(Source: Rochdale Archives)

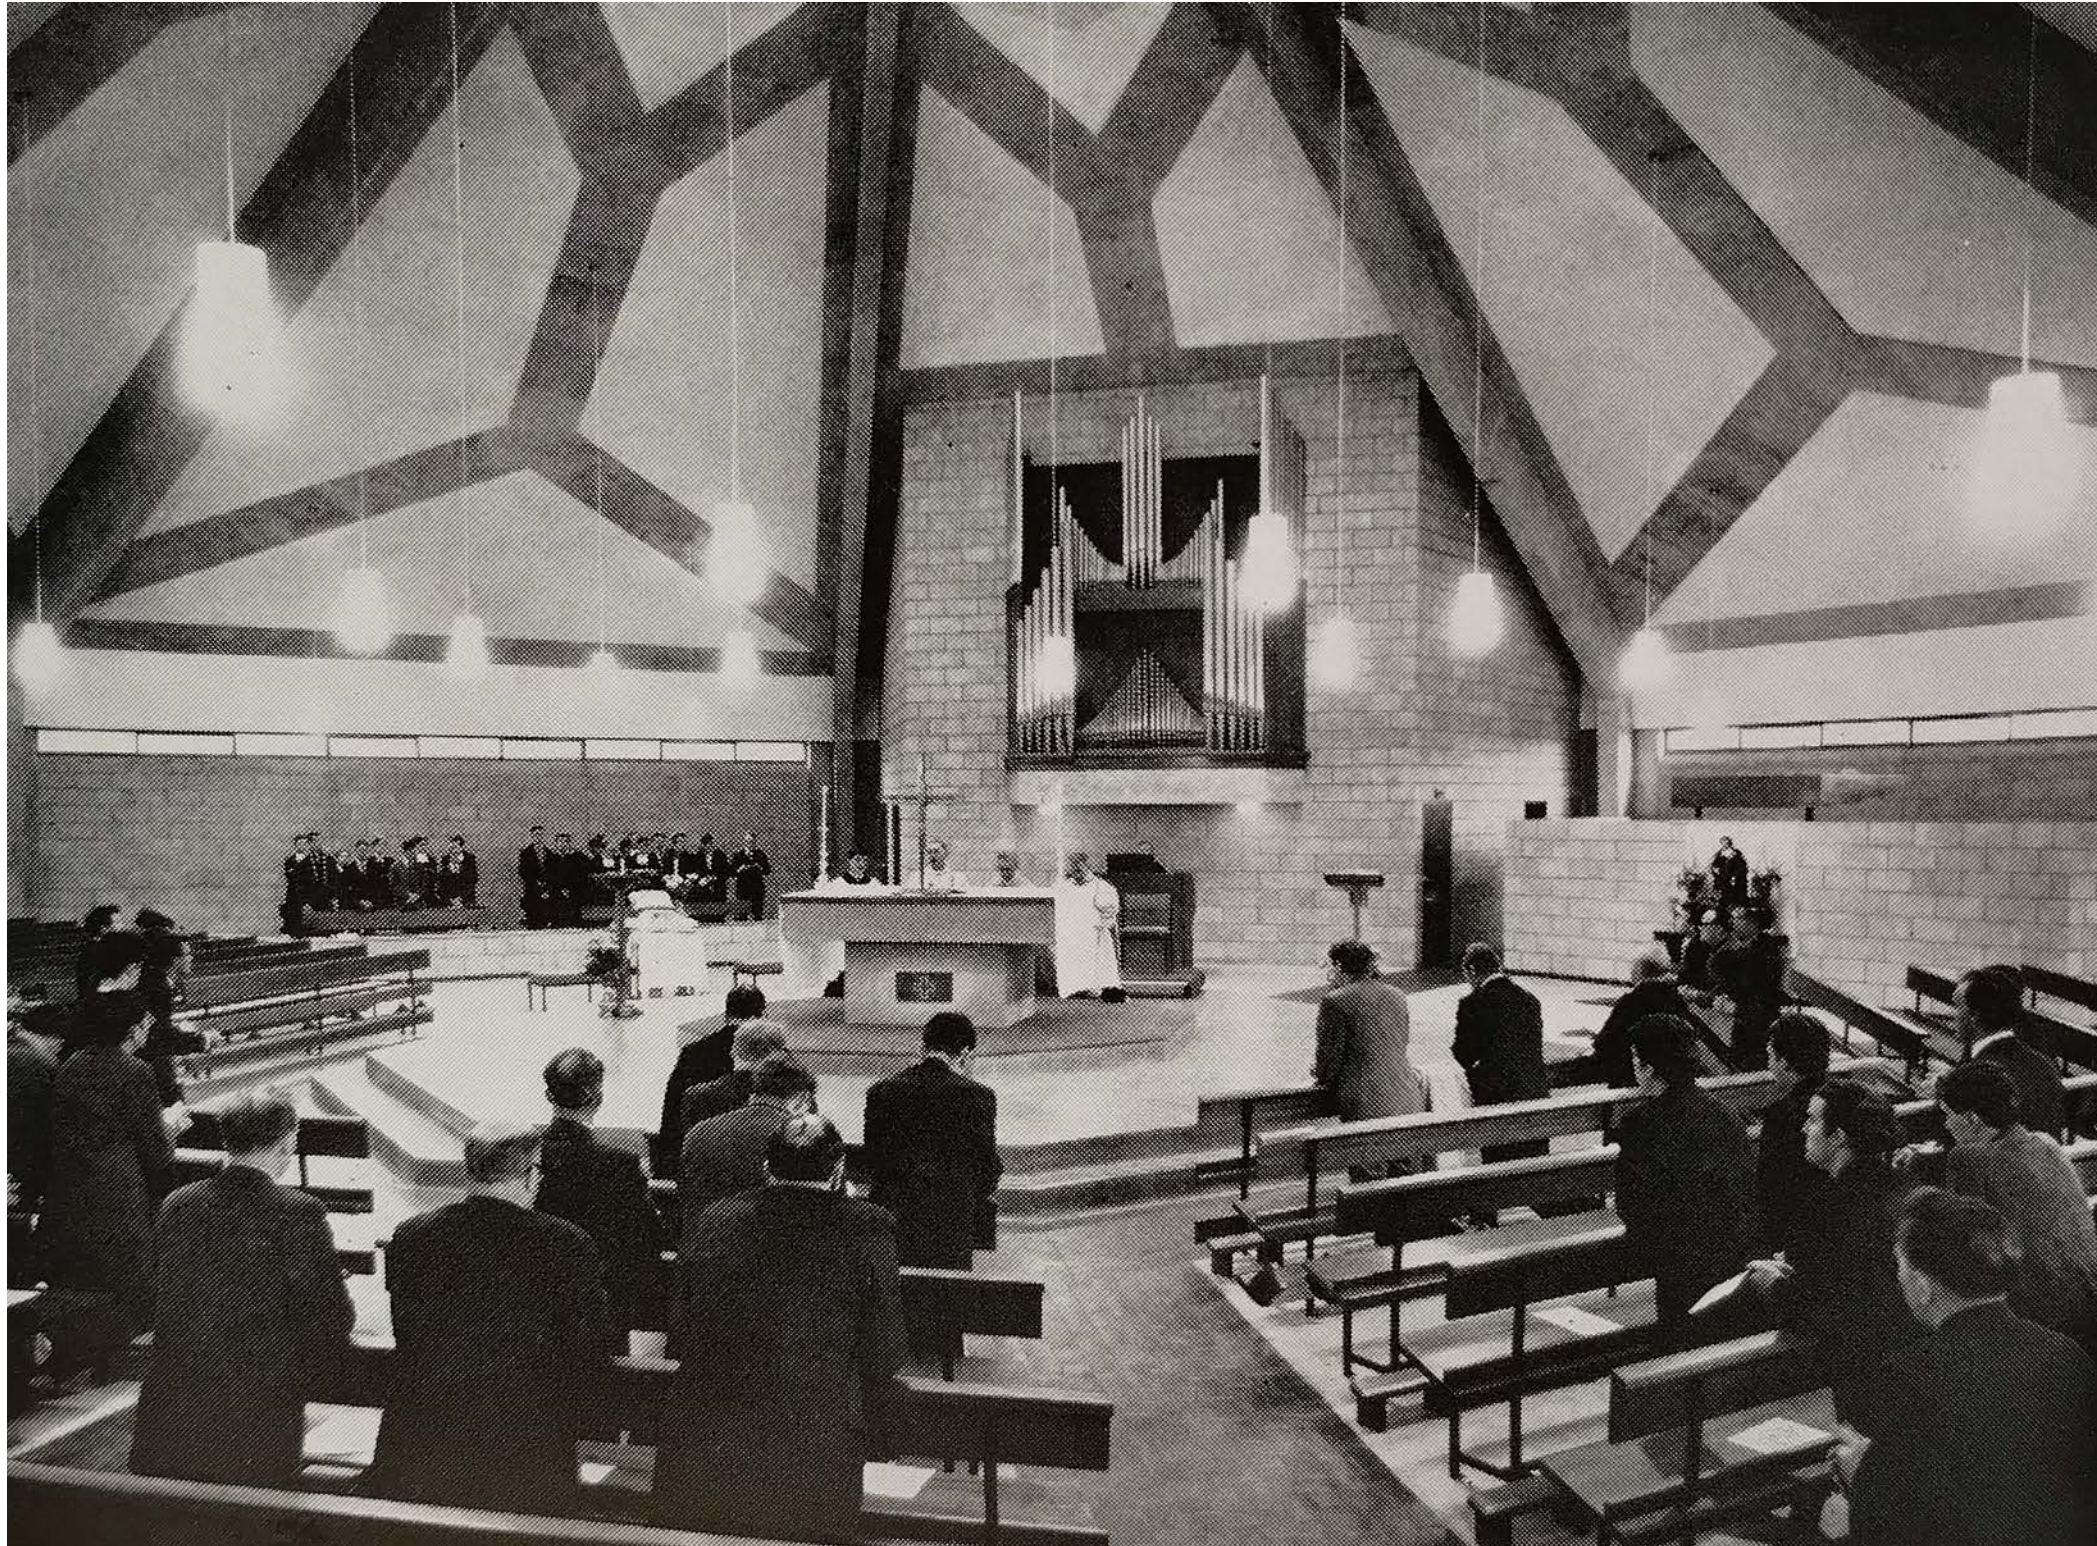
Figure 4.28  
The Chapel interior  
(Source: Rochdale Archives)

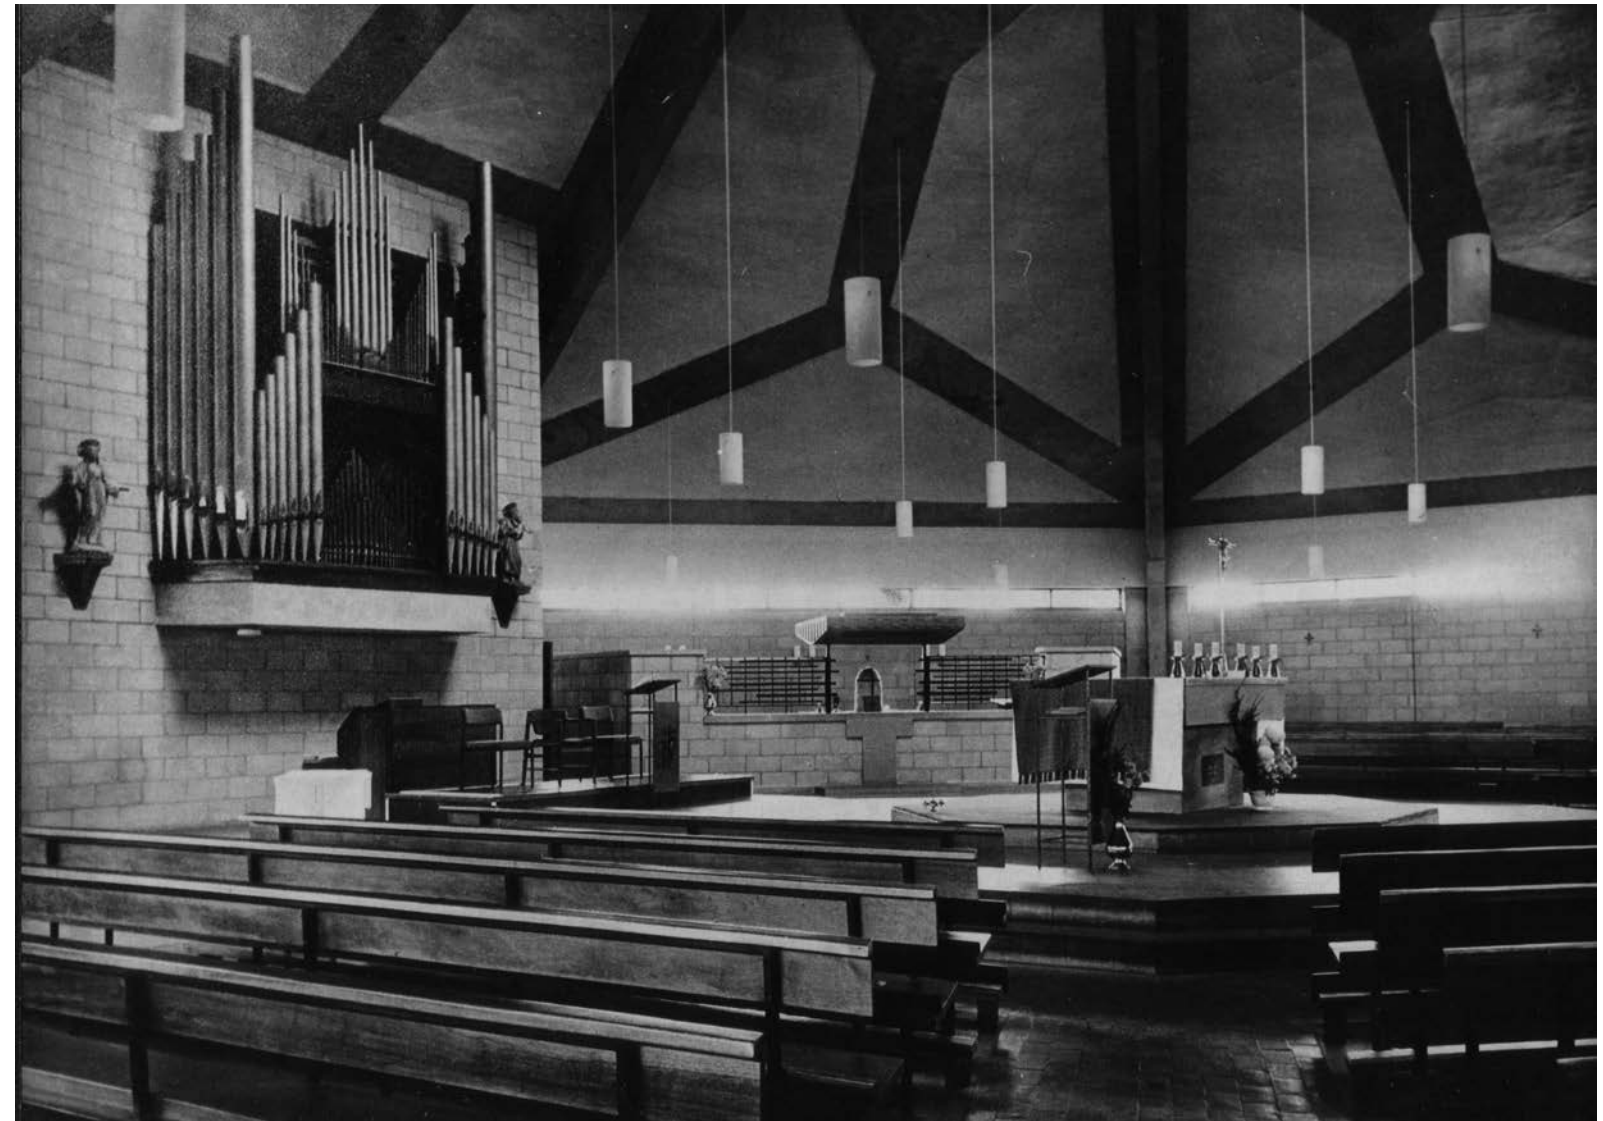
Figure 4.30  
Chapel interior  
(Source: Rochdale Archives)

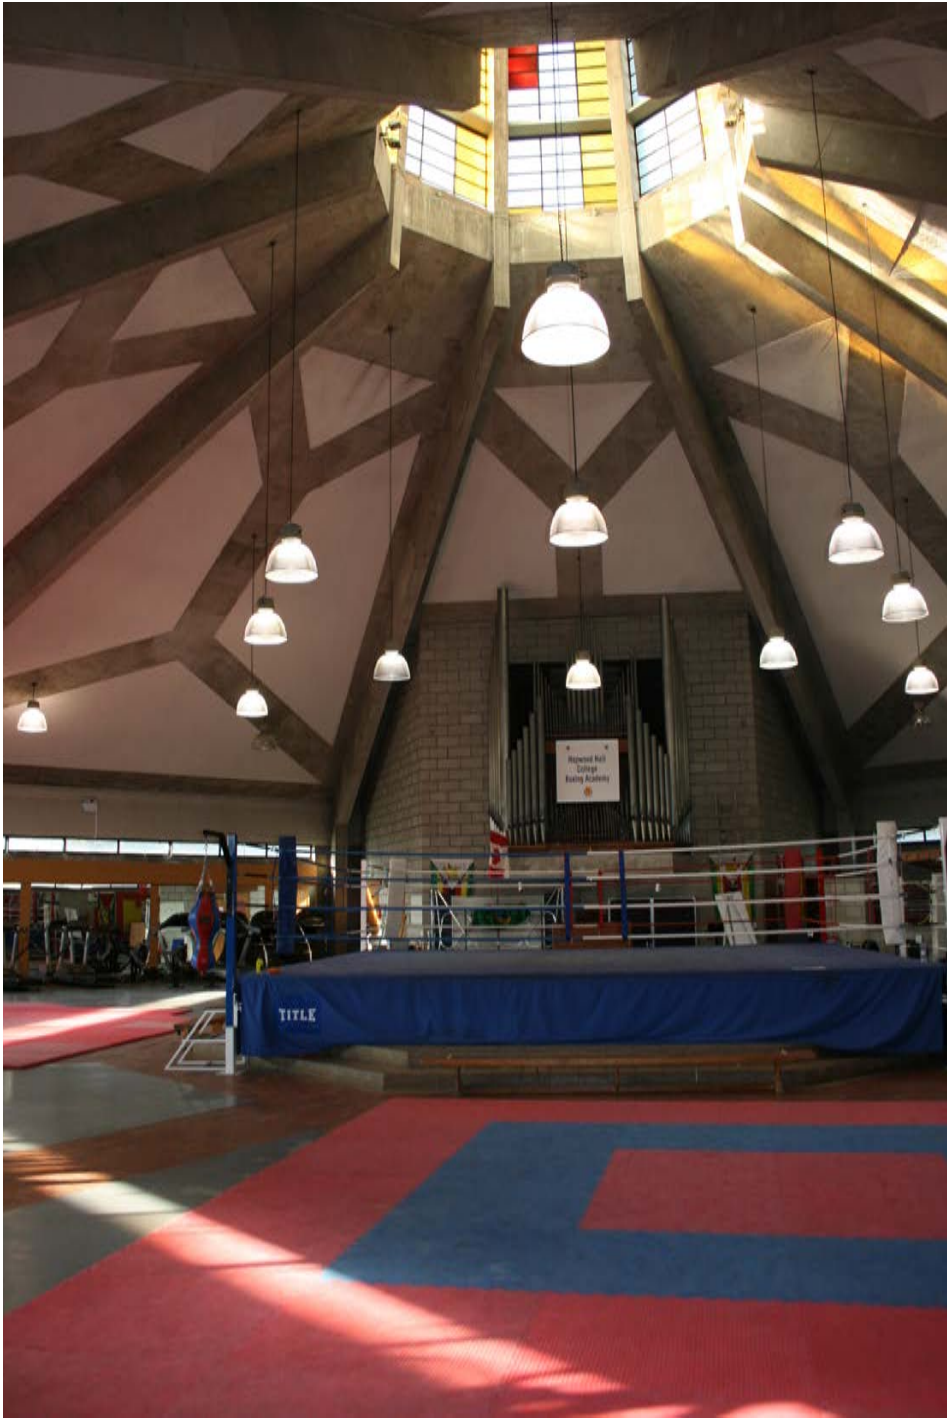
Figure 4.31  
Photographs from 2011 showing the Chapel in use as a sports facility  
(Source: Seven Architecture)

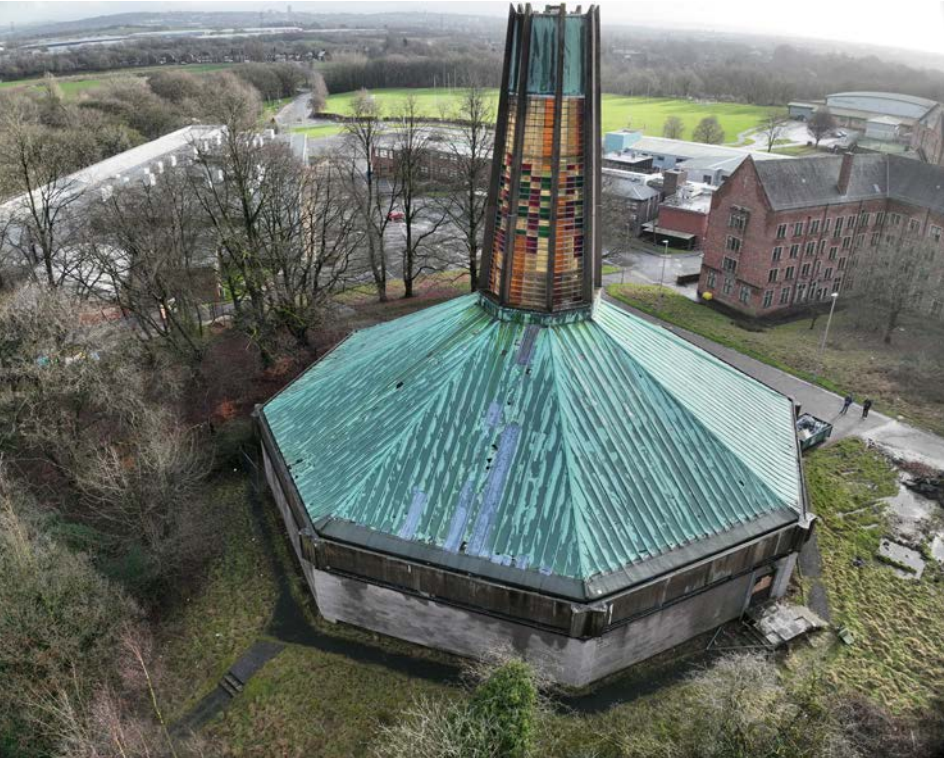
1 Aerial View  
(Image credit - Castle Keep Surveys)

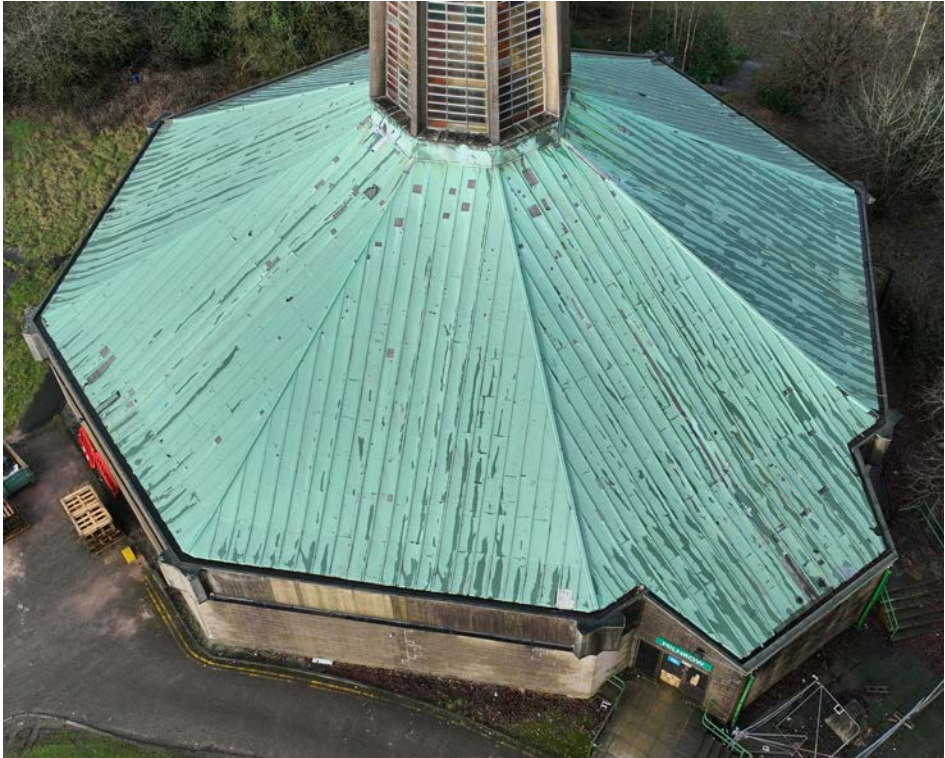
2 Aerial View  
(Image credit - Castle Keep Surveys)

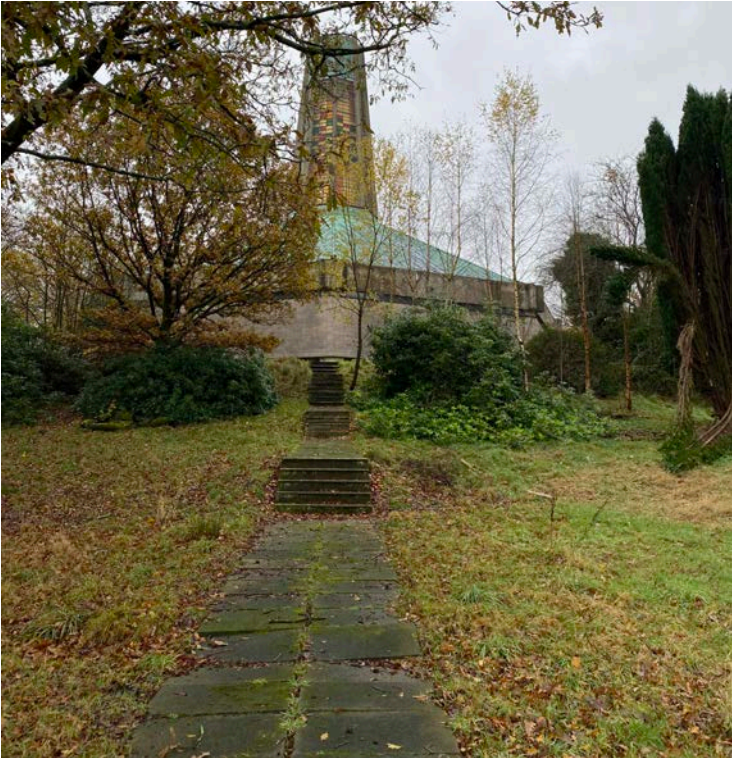
3 View from the Existing Stepped Access towards the building from the North

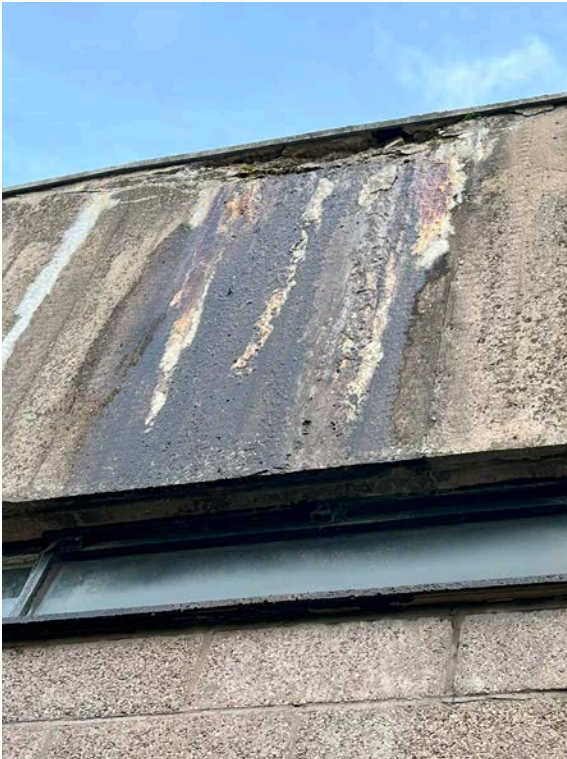
The concrete is left in it's natural state throughout and in places the ring beam appears heavily stained and water damaged. This appears to have been caused by defective rainwater goods failing to adequately shed water combined with a lack of suitable drip projection to the parapet capping.

23 View of Damaged Concrete Ring Beam

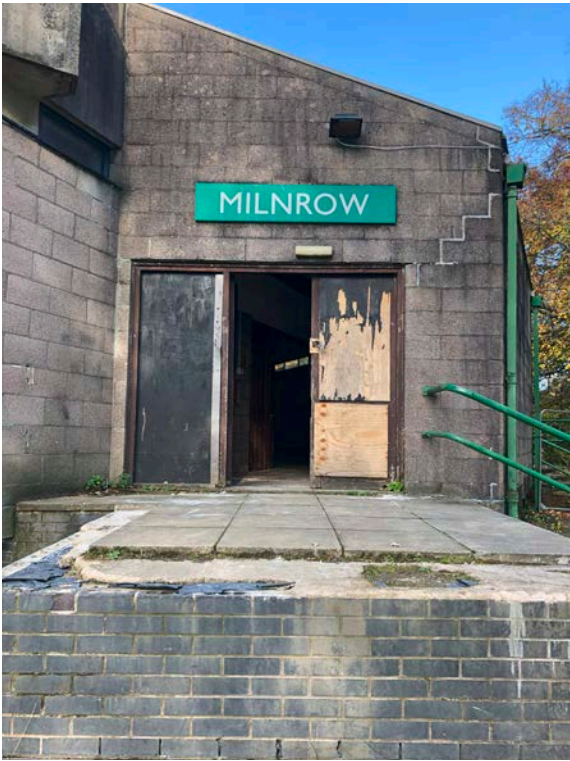
24 External Doors (South Entrance to Narthx)

The concrete blockwork to the Narthex is heavily stained and appears to have been saturated by water for a prolonged period.

To each side of the Narthex, the building is entered through a double door set within a larger opening with side screen. The existing doors are timber framed and in poor condition with the glazed areas boarded over. These are noted on the 1962 plan (number 1) as 'Glazed Al. Screen and Doors' and appear in the 1965 photos to be a plain design with dark frames and simple horizontal cross bar.

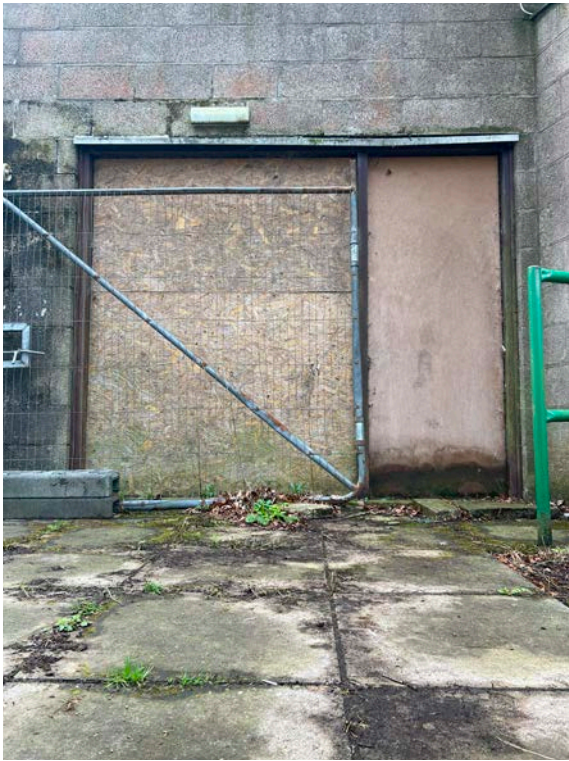
25 External Doors (North Entrance to Narthex)

The primary access to the building is via the Narthex, through two sets of double doors with side screen. The existing doors are timber framed and in poor condition with the glazed areas boarded over. These are noted on the 1962 plan (number 1) as 'Glazed Al. Screen and Doors' and appear in the 1965 photos to be a plain design with dark frames and simple horizontal cross bar.

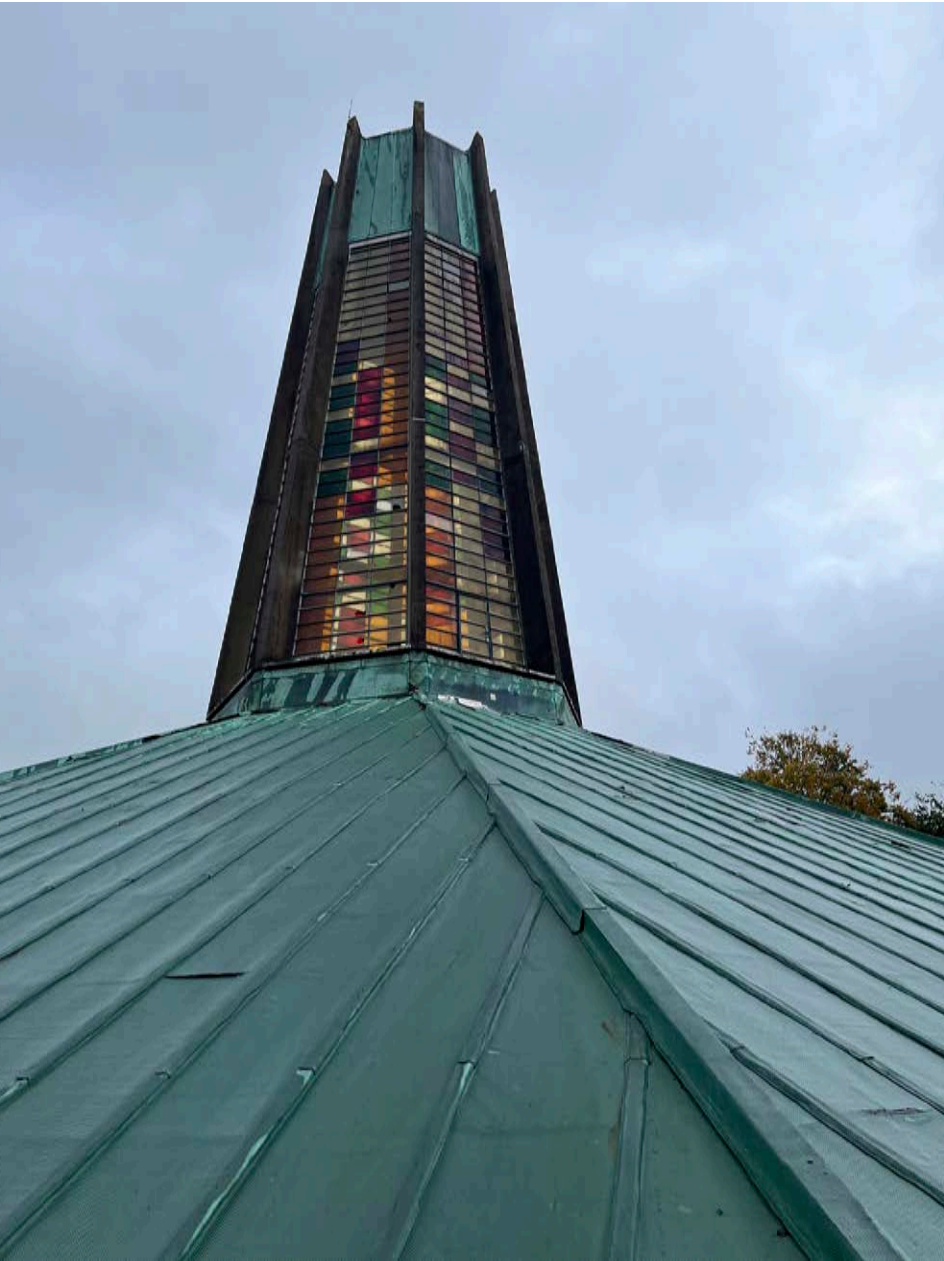
The copper faced bituminous felt incorporates timber battens placed at regular intervals to form a 'standing seam' effect which emphasises the octagonal geometry. The felt is adhered to a wood fibre board on a further bituminous roofing membrane placed directly above the concrete roof panels. The roof has been patch repaired over a number of years, and upon inspection the substrate was found to be saturated indicating the failure of the copper faced roofing felt.

The roof drains into a concealed parapet gutter lined using bitumen roofing felt with a metal capping to the concrete parapet. Rainwater outlets at each column position indicate concealed downpipes embedded within the concrete frame. Upon inspection the parapet gutter was found to have standing water, indicating that the outlets have become blocked.

30 View of Copper Faced Roof and Glazed Lantern

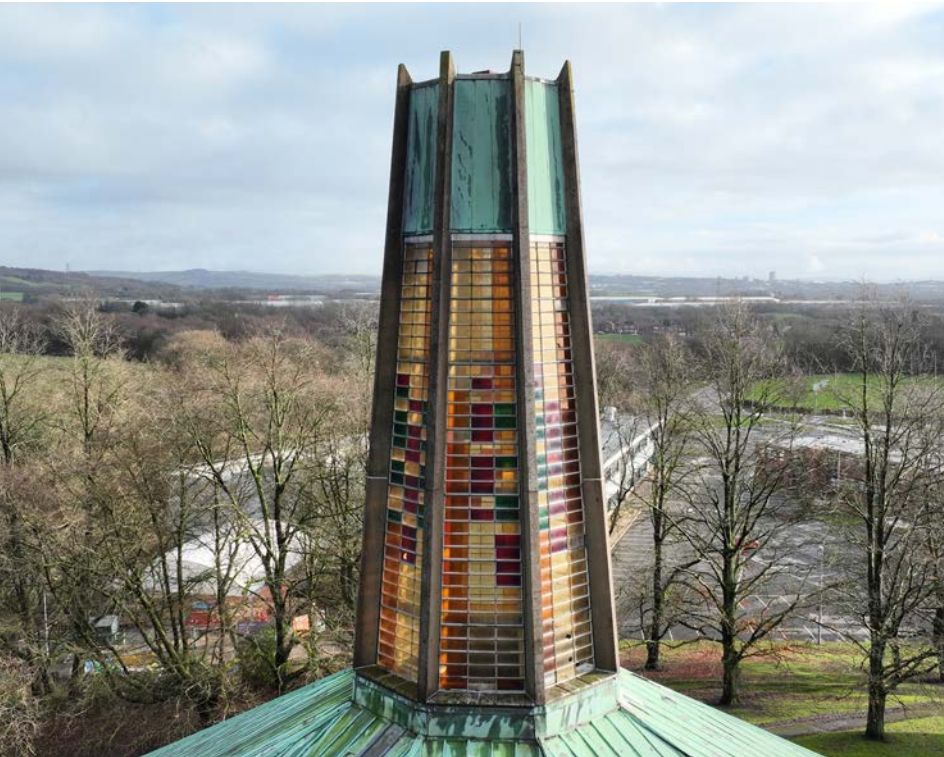
35 View of Glazed Lantern  
Image credit - Castle Keep Surveys

The glazing is noted in the 1965 Architectural Review article as "French Antique glass" designed by David Atkins, an artist who was a member of the Gibberd practice who had also been responsible for the marble floor pattern at Liverpool Cathedral. It is understood that the 1964 drawing (number 8 - unseen by the author) that the specification for French antique glass was eventually changed to 'West German Antique Glass obtained only from Messrs Claritude Ltd, 19 Dunraven St, Park Lane, London WC1'. The glazing is primarily yellow and acid-etched white with seemingly random clusters of red, white and green.

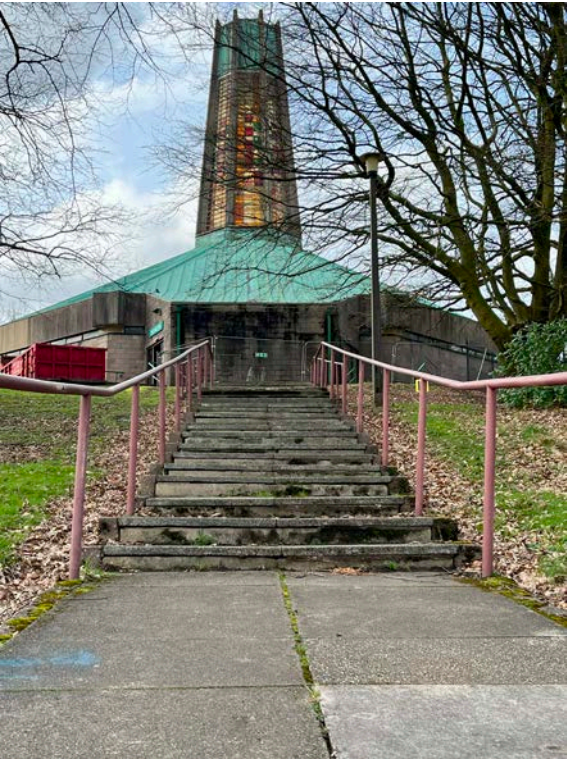
43 View of External Steps to East

The Chapel is accessed from the main College campus via a set of paved steps leading towards the eastern facade of the building. These steps did not form part of the original landscape design since the Chapel was designed to respond to Hopwood Hall. The steps are in poor condition with a utilitarian style handrail not suited to the original design detailing of the Chapel.

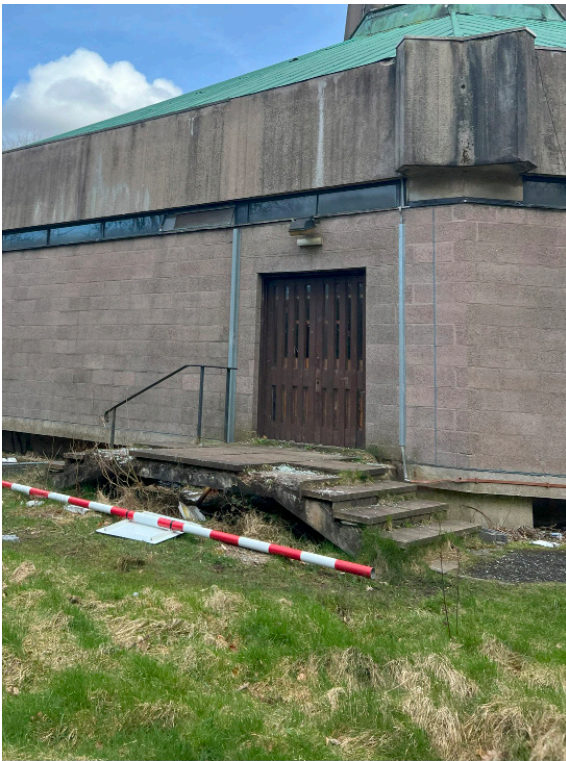
48 View of Steps to West Porch

External access into the west porch to the rear of the building is via a set of flying concrete steps which, although in poor condition, appear to have been little altered from the original design.

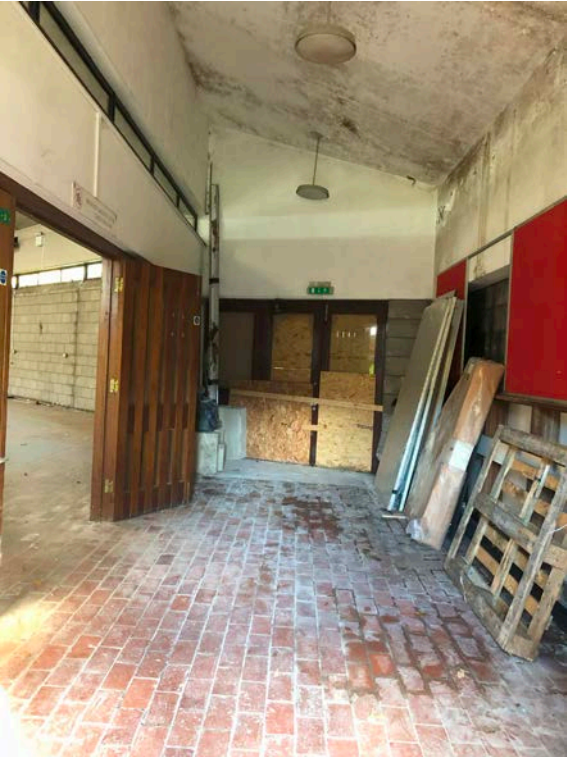
100 View of Narthex

The building is entered from the east through a small Narthex which is plain in decoration with a sloping soffit and featuring a red brick paved floor. The walls are exposed blockwork with a band of painted white plaster above door head height. A band of internal clerestorey windows, matching the size and appearance of the exterior windows, are positioned in the wall between the Narthex and main chapel. The Narthex has suffered from water ingress and is currently in poor condition.

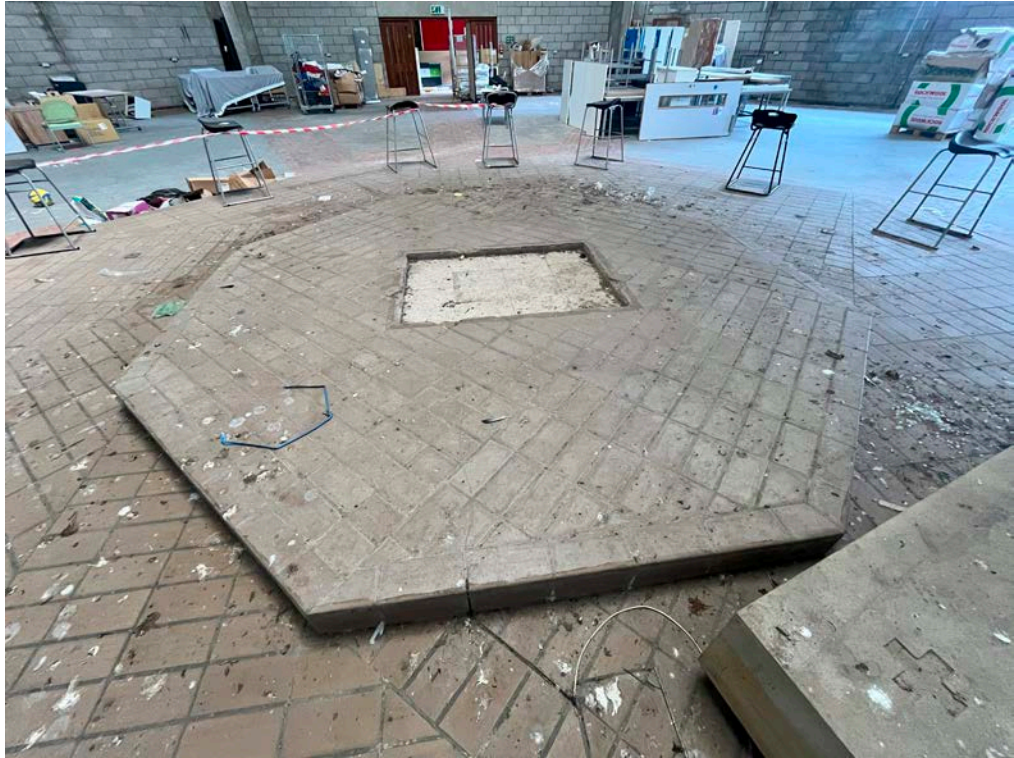
The raised dais to the Sanctuary features two outer steps with a central raised area with a recess for the base of the Altar stone which have been previously dismantled and set aside. The dais features buff coloured brick pavements set out in a decorative radial pattern, as shown on the original drawings. The paving is in fair condition with a few areas of damage and a previous services channel cut out of the floor with flush steel edging. The altar stone features four carved inset crosses, one in each corner, which are still legible.

123 View of Sanctuary raised Dias

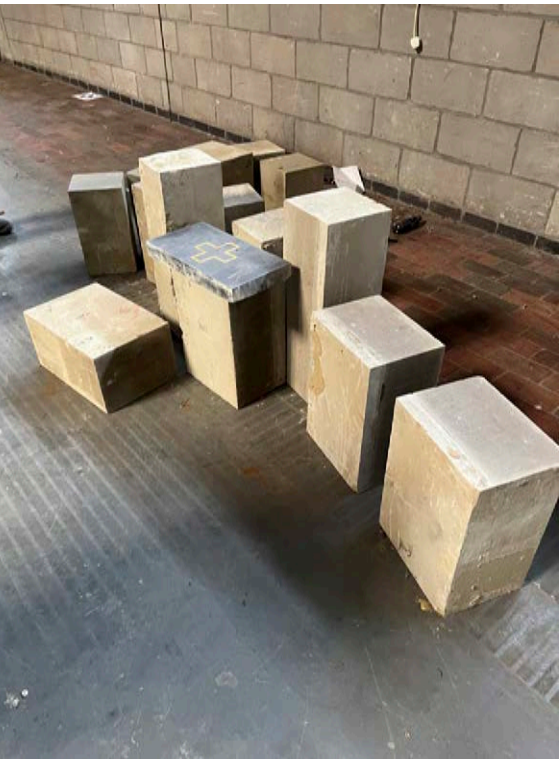
126 View of displaced base to Sanctuary Altar stone

The central raised dais to the Sanctuary is still in place with the original radial brick paving in tact. There is a small amount of damage to the paving where previous services appear to have been installed. The altar stone and supporting plinth has been dismantled but are retained within the building and could be reinstated in the original position.

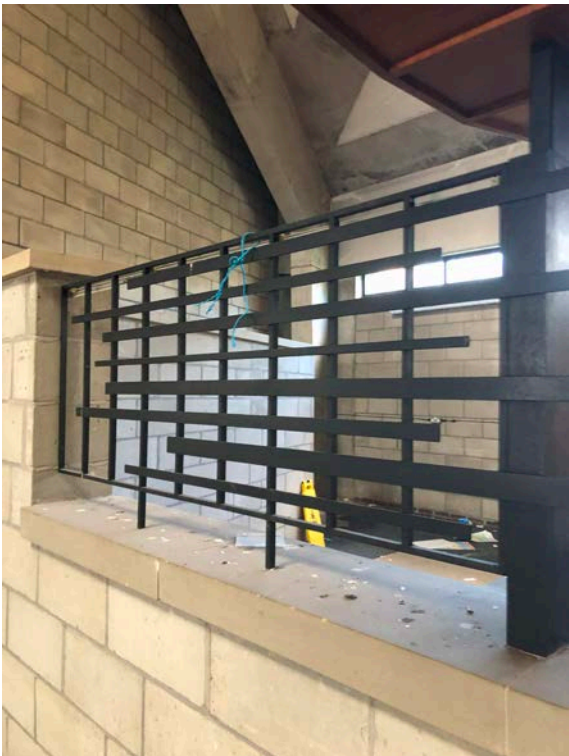
138 View of Metal Screen to Blessed Sacrament Chapel

The Blessed Sacrament Chapel was altered during the late 1960s, with the high blank walls to the front lowered and the introduction of a new black metal screen to allow the altar to be visible from within the main body of the Chapel. This alteration is thought to be reflective of liturgical change during this period, providing evidential value associated with considerable changes across the Catholic Church. Since this original change, the Blessed Sacrament Chapel appears to have been largely retained and remains in good condition.

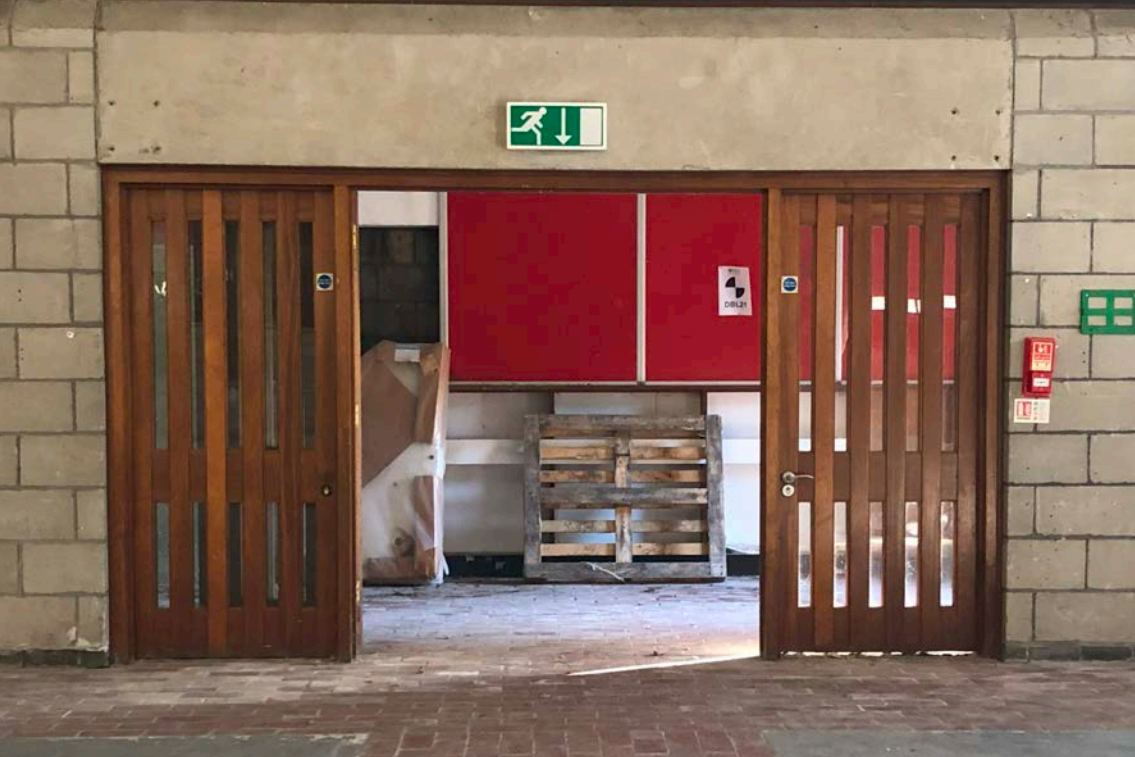
155 Internal Doors between Narthex and Chapel

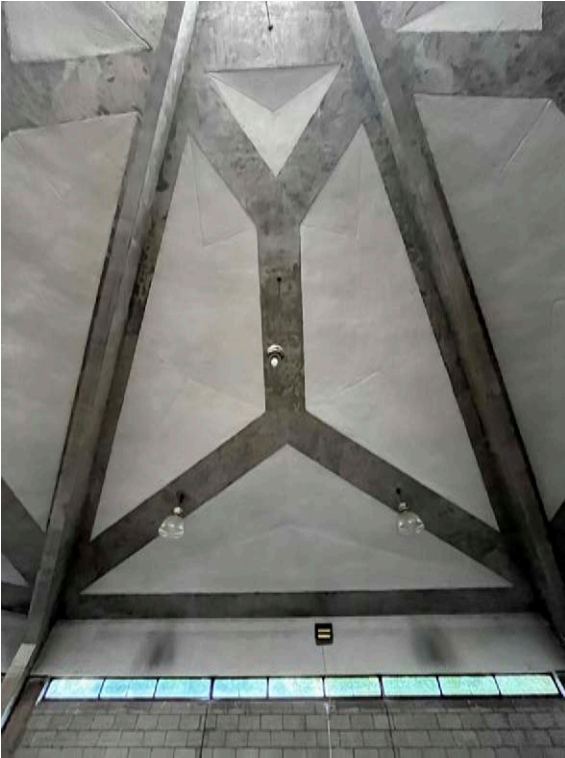
163 View of Soffit

The sprayed asbestos was removed from the soffit in 2025 and the concrete panels above have been treated with an asbestos encapsulation paint. This work was considered necessary for the future health and safety of the building occupants and also allows the concrete soffit panels to dry out following water penetration owing to the poor condition of the copper roof covering. The approved proposals will reinstate an acoustic plaster coating to the soffit which will replicate as closely as possible the appearance of the original material.
