# **GEO-ENVIRONMENTAL AUDIT PHASE 1 PRELIMINARY RISK ASSESSMENT**

**PROPOSED MIXED COMMERCIAL & RESIDENTIAL  
DEVELOPMENT**

**BOARSHAW RD & CLOUGH STREET  
MIDDLETON  
MANCHESTER  
M24 2WQ**

Author: Daniel Slattery  
Client: Mr Zulqurnain Shah  
Reference: rep-tjba-shah-boarshaw rd & clough st-Phs1Env-070825.docx

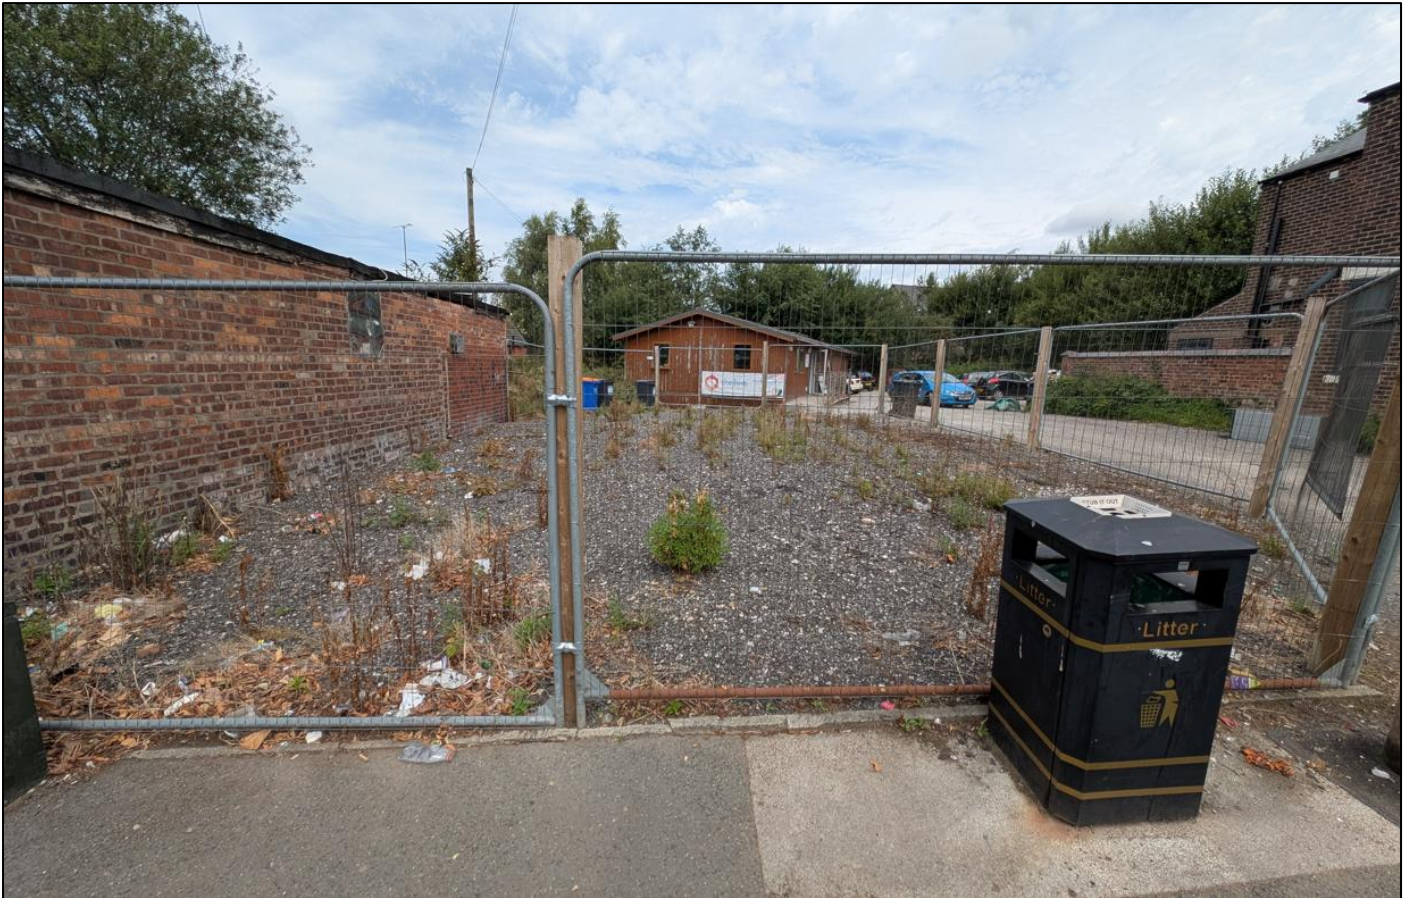
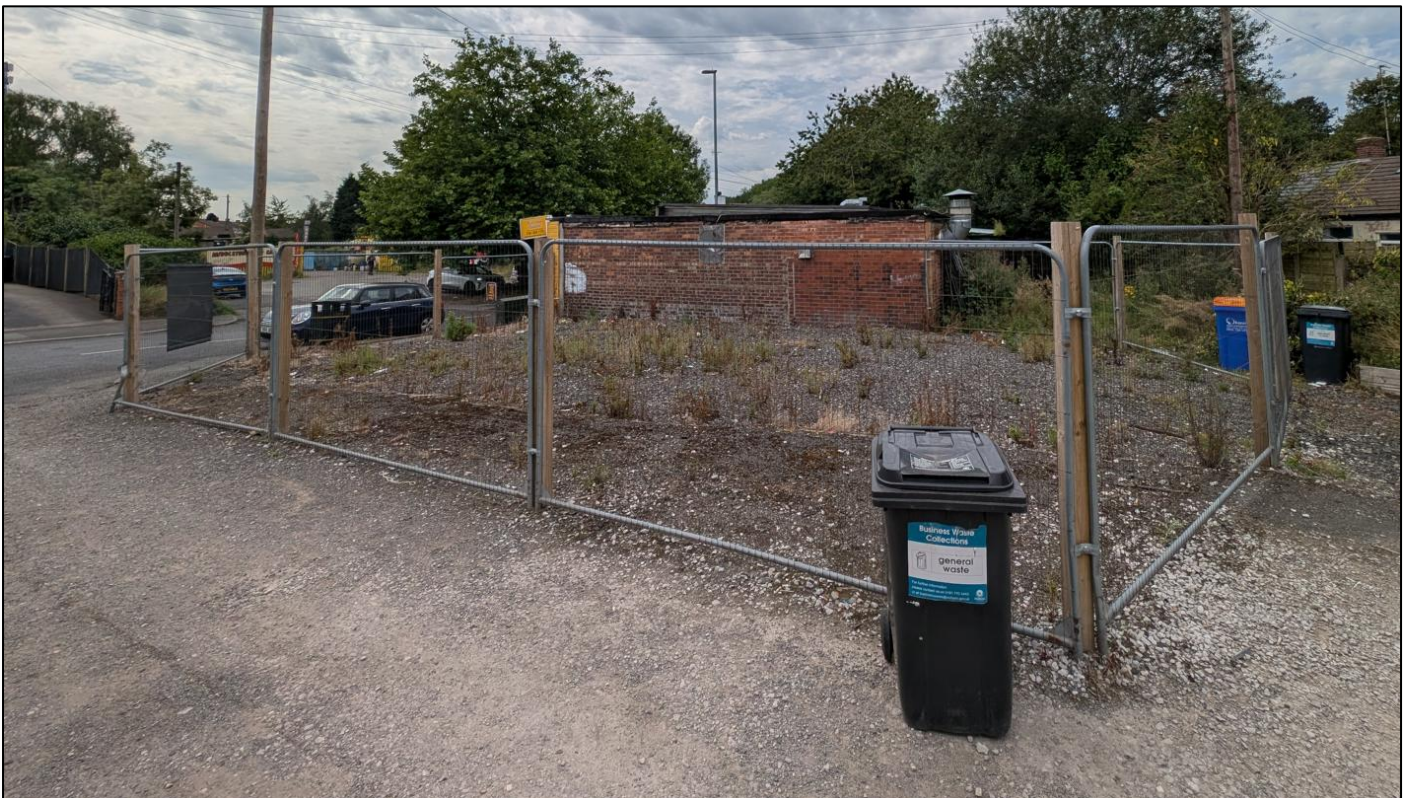
#### 4. APPENDIX B: SITE WALKOVER PHOTOS.

| Areas of discoloured soil, polluted water, vegetation, and significant odours: | Made ground only noted on the site surface. |

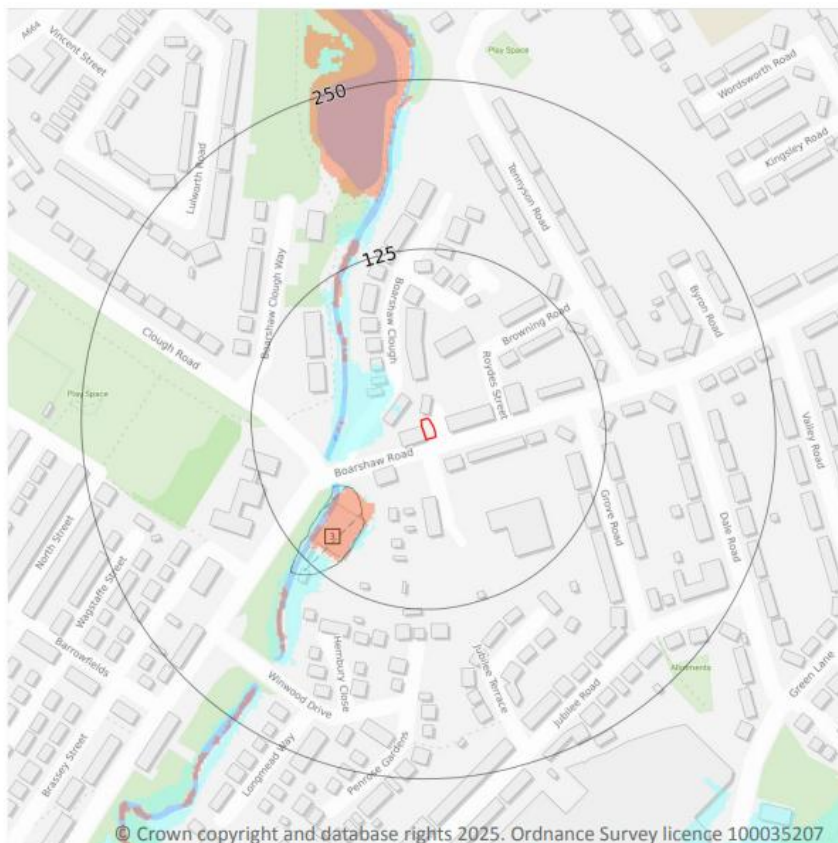
## 7 River and coastal flooding

The chance of flooding from rivers and/or the sea in any given year, based on cells of 50m within the Risk of Flooding from Rivers and Sea (RoFRaS)/Flood Risk Assessment Wales (FRAW) models. Each cell is allocated one of four flood risk categories, taking into account flood defences and their condition. The risk categories for RoFRaS for rivers and the sea and FRAW for rivers are; Very low (less than 1 in 1000 chance in any given year), Low (less than 1 in 100 but greater than or equal to 1 in 1000 chance), Medium (less than 1 in 30 but greater than or equal to 1 in 100 chance) or High (greater than or equal to 1 in 30 chance). The risk categories for FRAW for the sea are; Very low (less than 1 in 1000 chance in any given year), Low (less than 1 in 200 but greater than or equal to 1 in 1000 chance), Medium (less than 1 in 30 but greater than or equal to 1 in 200 chance) or High (greater than or equal to 1 in 30 chance).

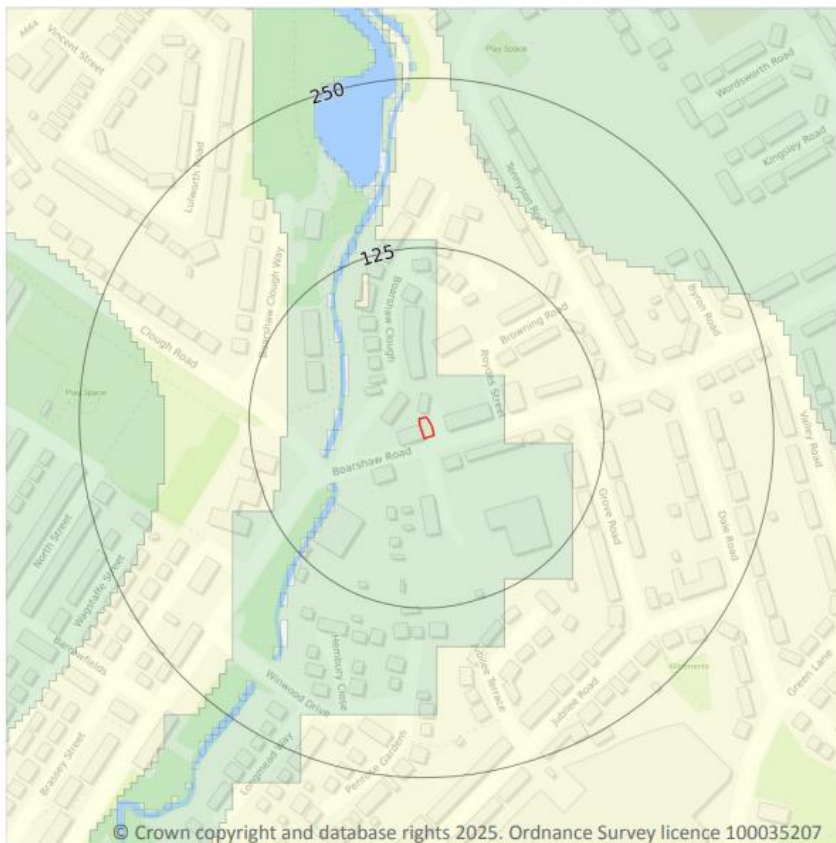
## 9 Groundwater flooding

Groundwater flooding is caused by unusually high groundwater levels. It occurs when the water table rises above the ground surface or within underground structures such as basements or cellars. Groundwater flooding tends to exhibit a longer duration than surface water flooding, possibly lasting for weeks or months, and as a result it can cause significant damage to property. This risk assessment is based on a 1 in 100 year return period and a 5m Digital Terrain Model (DTM).

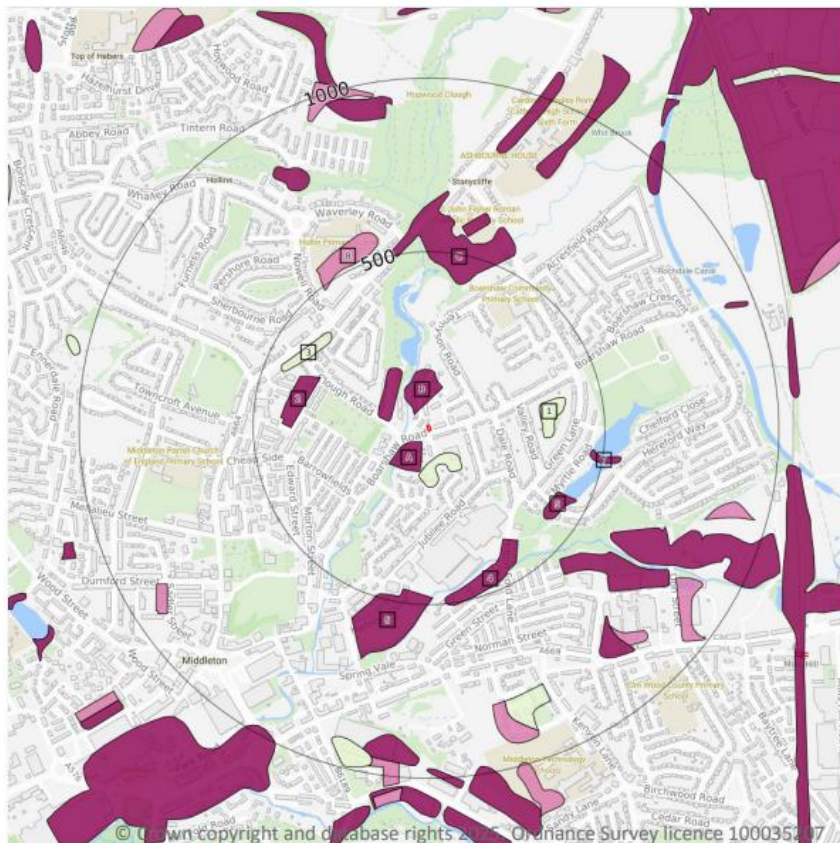
## Geology 1:10,000 scale - Artificial and made ground

Details of made, worked, infilled, disturbed and landscaped ground at 1:10,000 scale. Artificial ground can be associated with potentially contaminated material, unpredictable engineering conditions and instability.
