**Cassel and Fletcher**

No.1 Drake Street

**Building Recording: Level 2**

21 November 2025

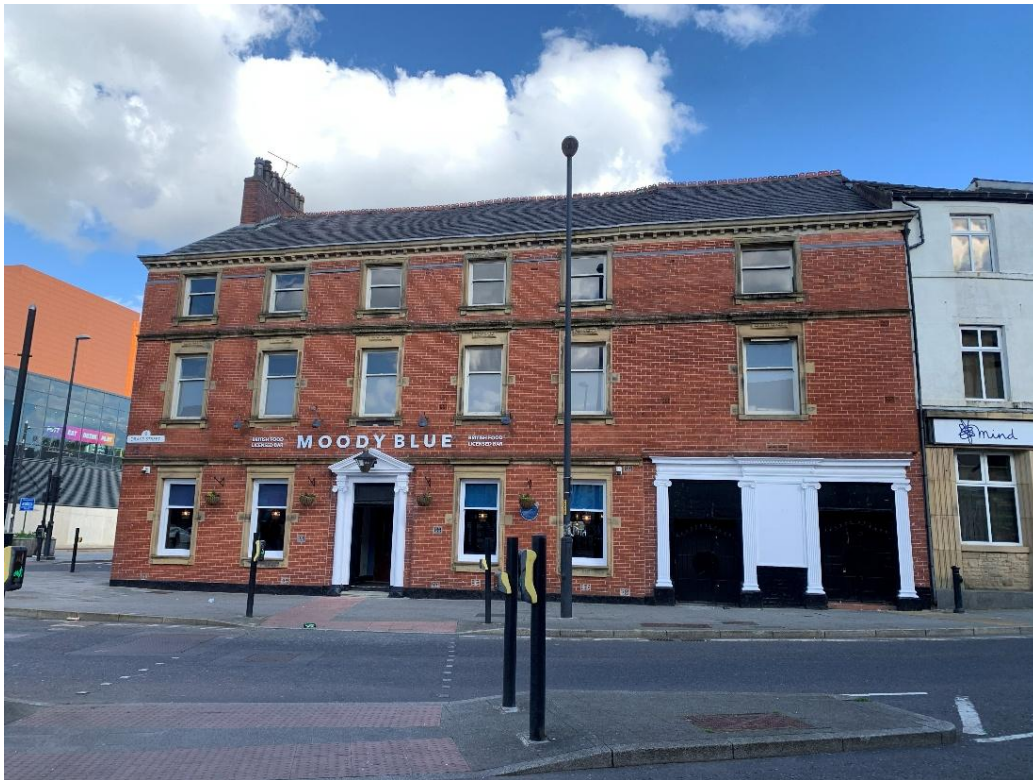
Figure 4.1: Site exterior as viewed from Drake Street

- 4.2 This element of the building fronting Drake Street retains a good degree of architectural integrity; it is constructed of red / orange brick with a slate roof, and features including a classical stone surround with a pediment to the main entrance, moulded stone window surrounds, projecting stone string courses, and a modillion eaves cornice. Windows are one over one sliding sash, frames are timber with horns and possibly a reproduction of a Victorian style window frame. The listing notes that the brick frontages may have been refaced, this is corroborated by the stretcher bond to the front elevation, while the return of the gable to Smith Street is in Flemish bond. The gable elevation also indicates previous alterations where there are variances in brickwork, inserted windows and visible gauged brick arches with keystones where former openings have been bricked up.

- 4.3 The roof is steeply pitched with a slate covering and bargeboards to either side of a central chimney stack that projects from the gable. The roof undulates and raises significantly along the southern element of the building, and the slates do not meet flush in this area. This could be due to later structural movement, the nature of hand-cut timbers or that that this represents an extension. There are no obvious signs of joints within the brickwork, however, as the building has likely been re-faced in the 19<sup>th</sup> century this would make analysis difficult. The chimney stack has eight glazed bishop chimney pots. Historic photos also show a stack has been removed in the location of the raised roofline.

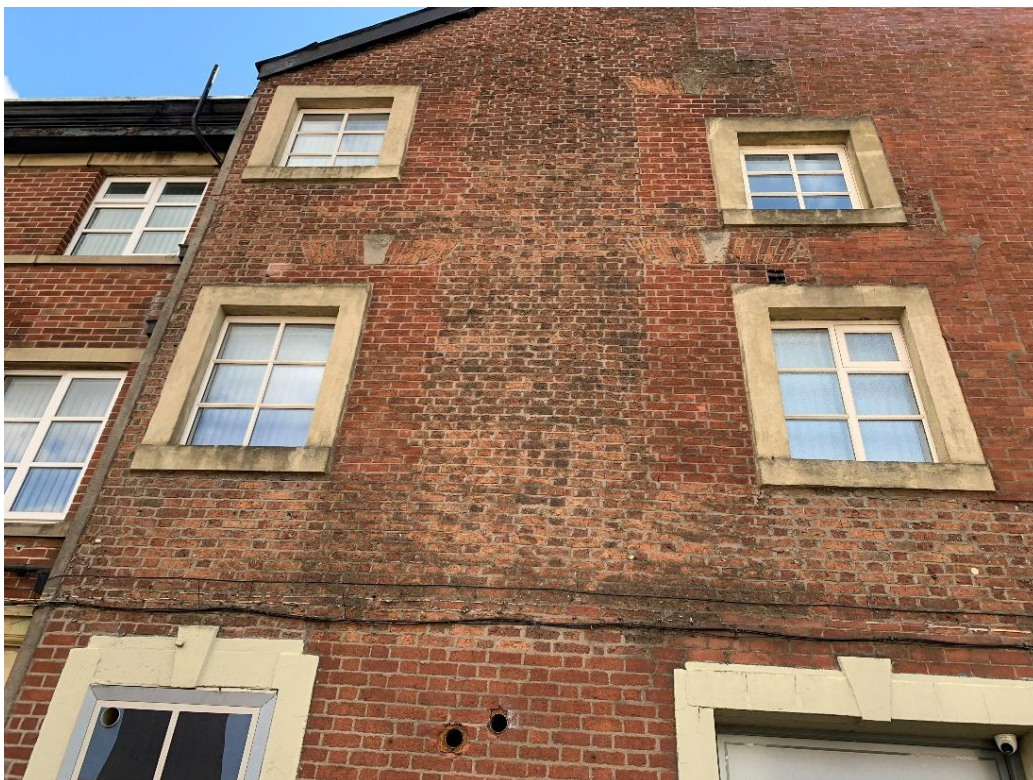
Figure 4.2: Site exterior from Smith Street

- 4.5 The element of the building fronting Smith Street (not described within the listing) is a later phase of construction, and likely dates from the around the mid-20th Century. This is evident from the more contemporary appearance of the brickwork. Nonetheless, a traditional design approach has been adopted with the use of buff stone dressings and traditional glazing pattern to the uPVC windows. This element of the building is occupied by Rochdale Housing Solutions on the ground floor, and residential apartments on the upper floors.

- 4.7 The side elevation (Smith Street) gives the best evidence for the likely form of the building before the re-facing. Sections are in an older handmade red brick, currently there are plain stone window surrounds but slightly off-set from these are bricked up openings with gauged brick heads and stone keystones (now cemented over).

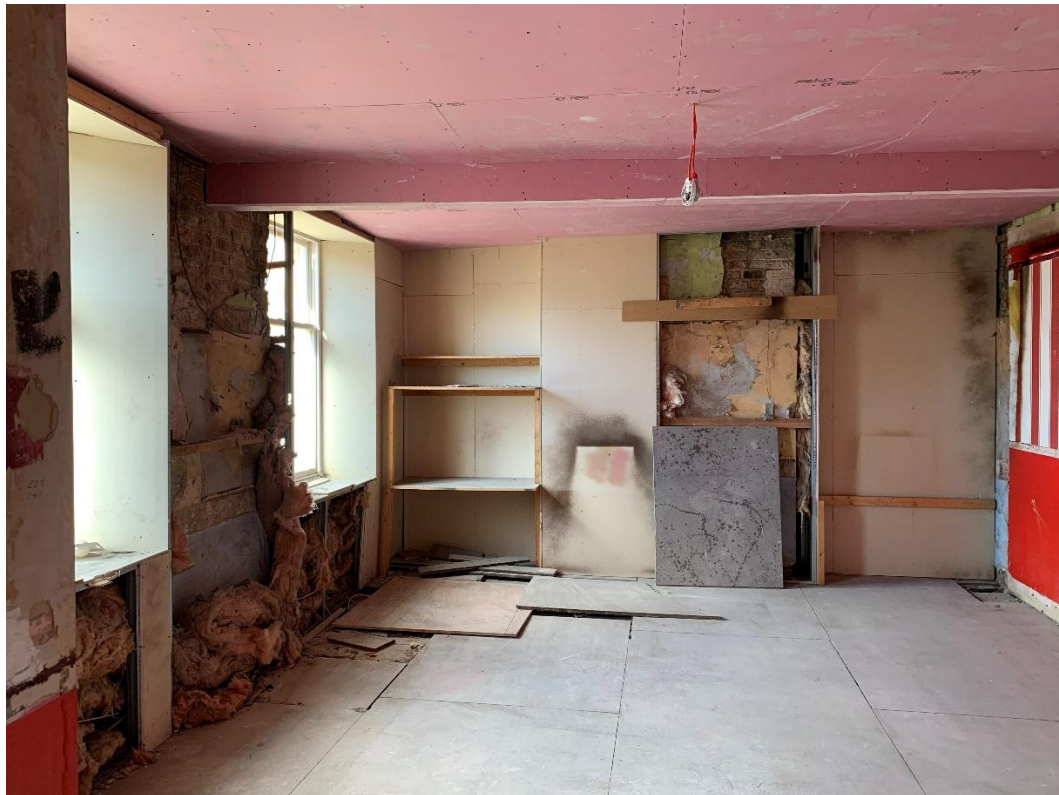
Figure 4.3: Room FF1

Floorboards are visible in some locations but are covered by modern boarding. There are modern plasterboard finishes throughout with some areas of exposed brickwork. Windows are modern replacement sashes with modern surrounds.

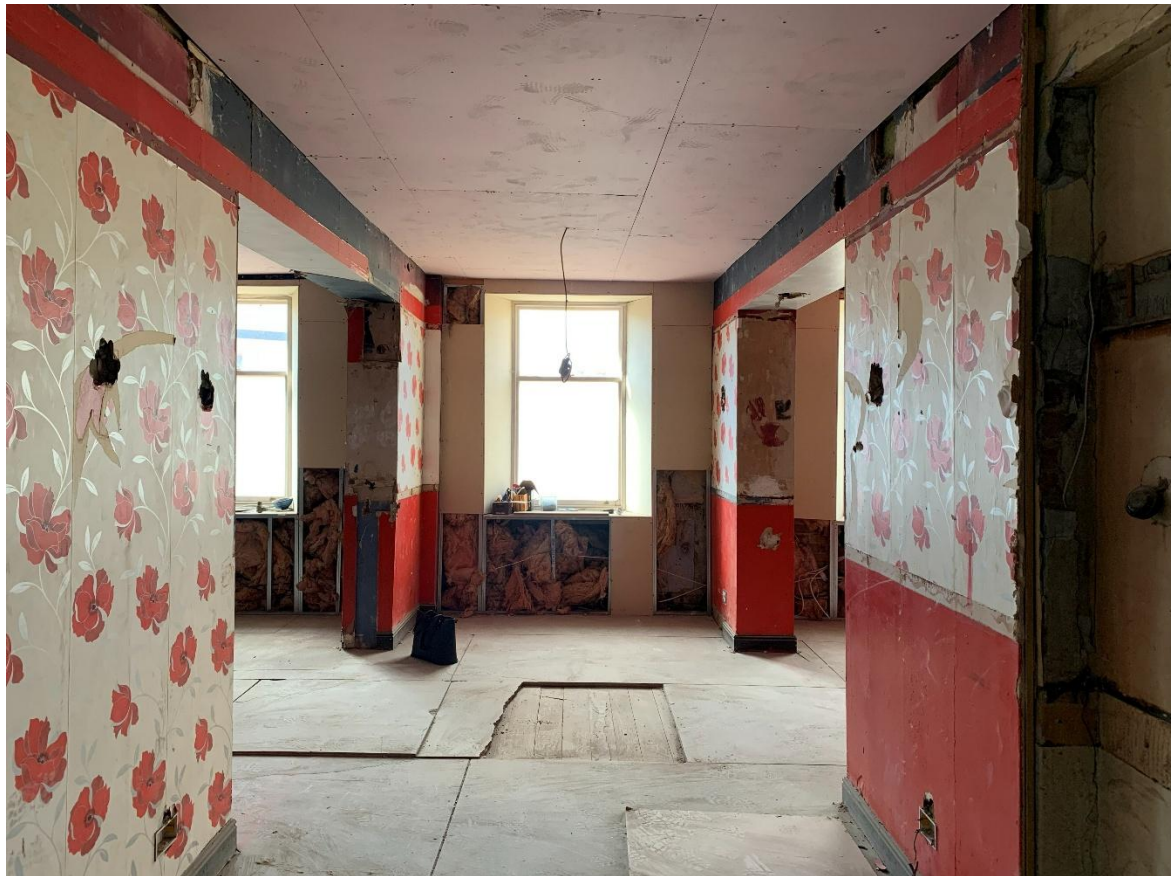
Figure 4.4: Room FF2

- 4.12 Floorboards are visible in some locations but are covered by modern boarding. Modern plasterboard finishes throughout with some areas of exposed brickwork. Modern replacement sash with modern surround.

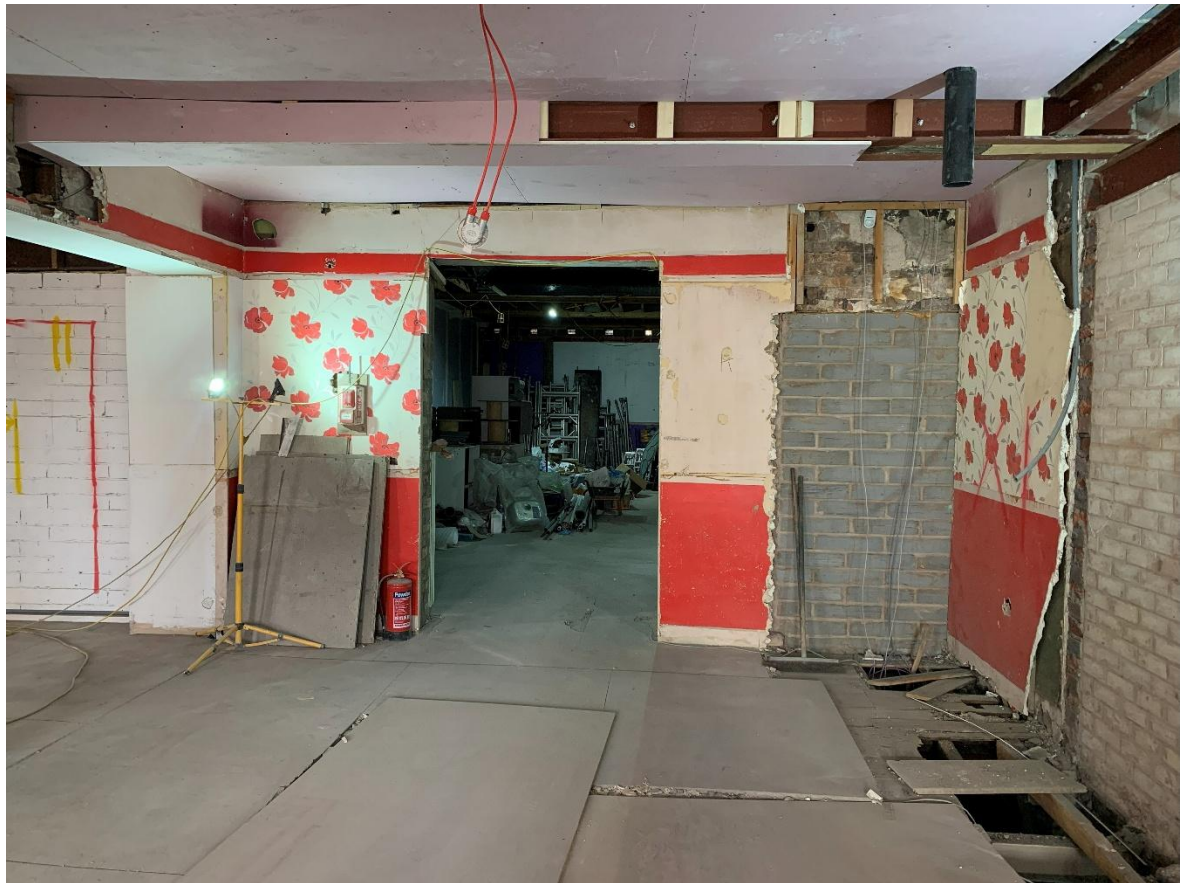
Figure 4.5: Room FF3

- 4.13 Floorboards are visible in some locations but are covered by modern boarding. Modern plasterboard finishes throughout with some areas of exposed breeze block walls and painted brickwork. Some skirting in place but on plasterboard walls and sitting on the modern floor finishes so assumed to be modern.
- 4.14 Some historic floor joists above are visible that are partly boxed in. Several have been reinforced with later steel beams.
- 4.15 Modern replacement sashes with modern surrounds.

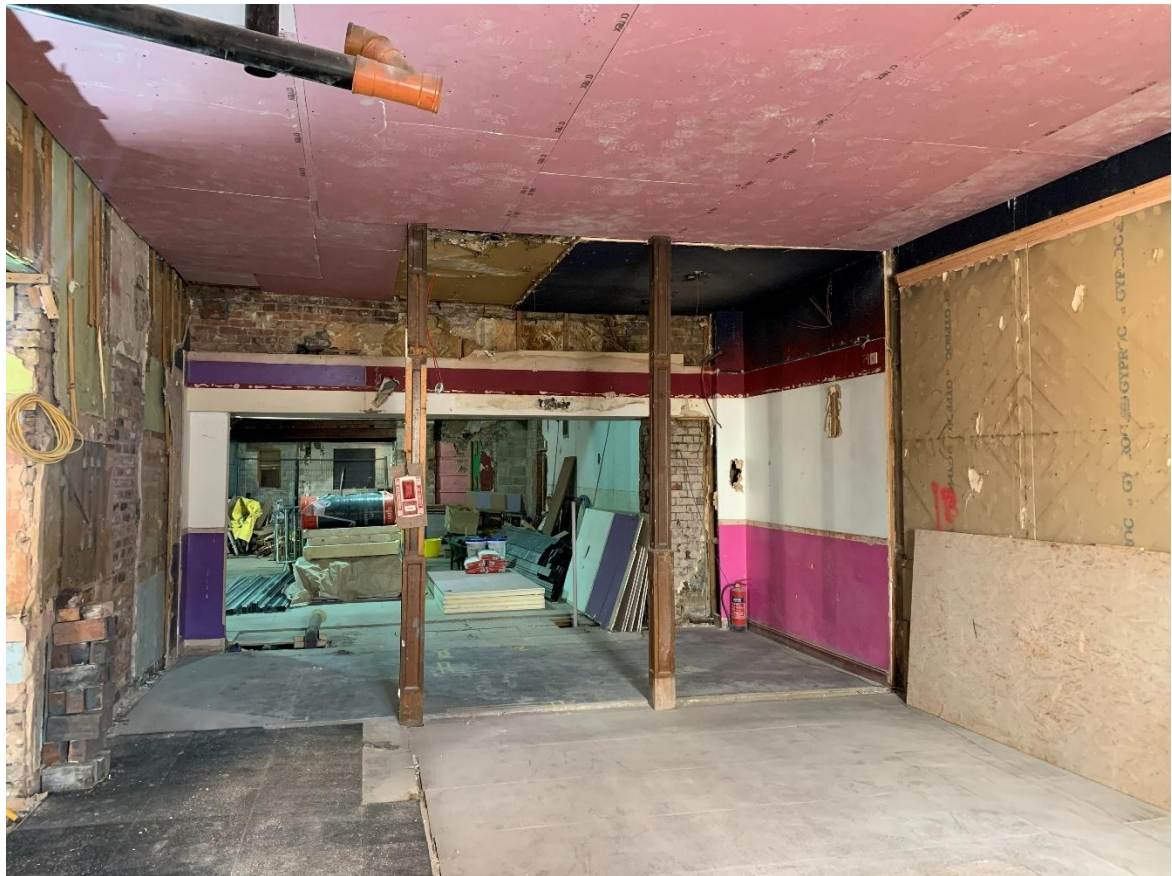
Figure 4.1: Room FF4

- 4.16 Floorboards are visible in some locations but are covered by modern boarding. Modern plasterboard finishes some with picture rails but again assumed to be modern.
- 4.17 The room has two timber columns of varnished panelling fixed to an internal timber. One has 'lounge' painted onto the panel.
- 4.18 Some isolated areas of ceiling plaster, however, it is applied to metal mesh sheets so likely 20<sup>th</sup> century in date.
- 4.19 Modern replacement sash with modern surrounds.
- 4.20 Opening in the wall between FF4 and FF5 crudely formed so likely to be a fairly recent alteration.

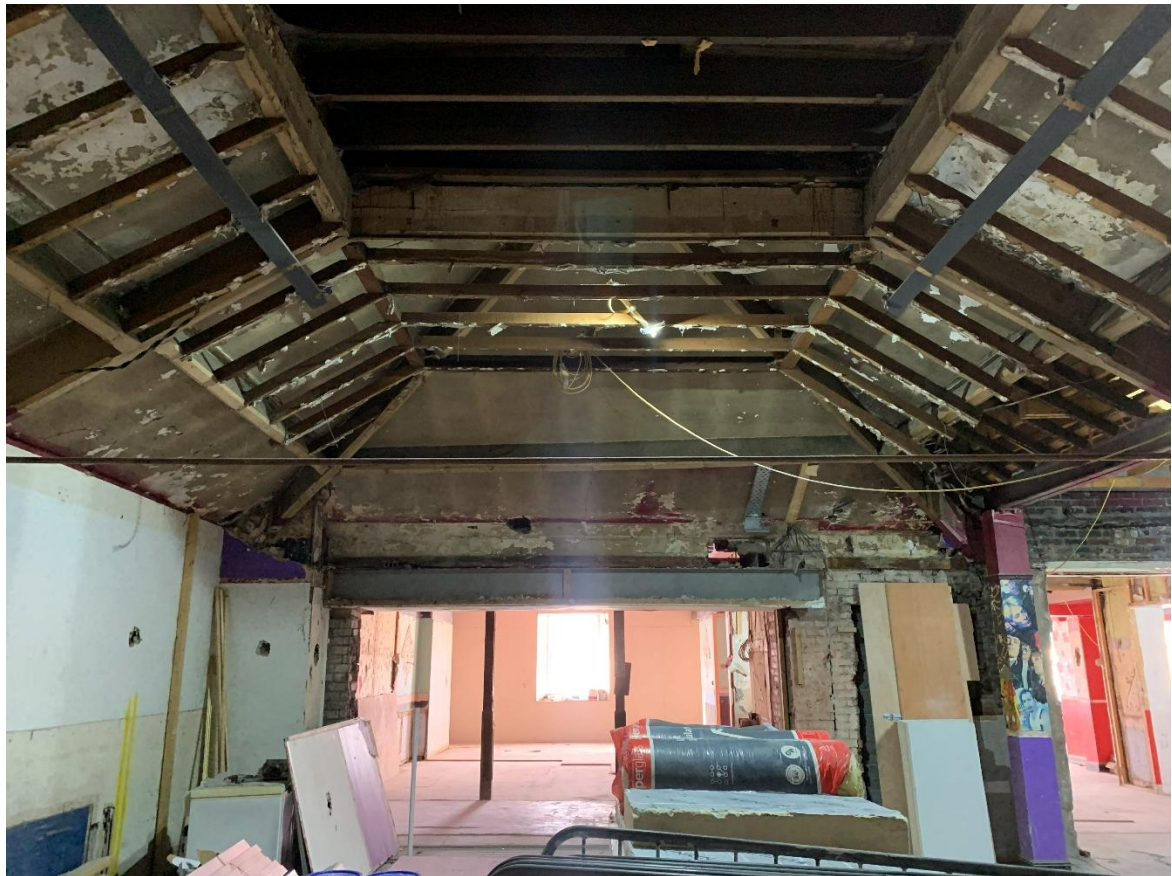
Figure 4.5: Room FF5

- 4.21 Lath and plaster applied above the rafters with evidence that there was also a ceiling below the rafters that has been removed.
- 4.22 Timber mansard roof structure with steel collars and ties where end wall has been removed following the later extension of room FF6. Principal timbers have chamfered edges suggesting they were likely exposed.
- 4.23 Central section of the roof appears later in date and is assumed to have been a roof lantern.
- 4.24 Walls a mixture of bare brick, breeze block and plasterboard.

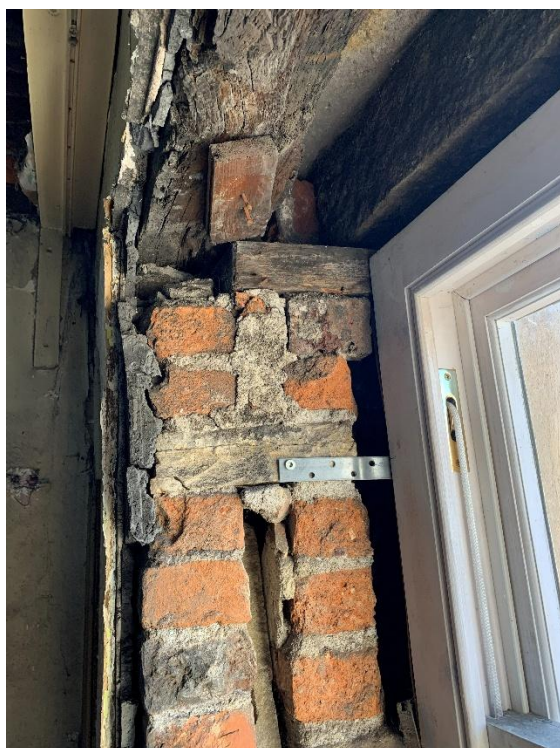
- 4.28 There is a sash window with timber surround to the rear where the glazing survives but this is bricked up with breeze blocks externally.
- 4.29 Historic timber dog-leg stair leading to attic level with wide timber panels on walls.

Figure 4.6: Window reveal in Room SF7.

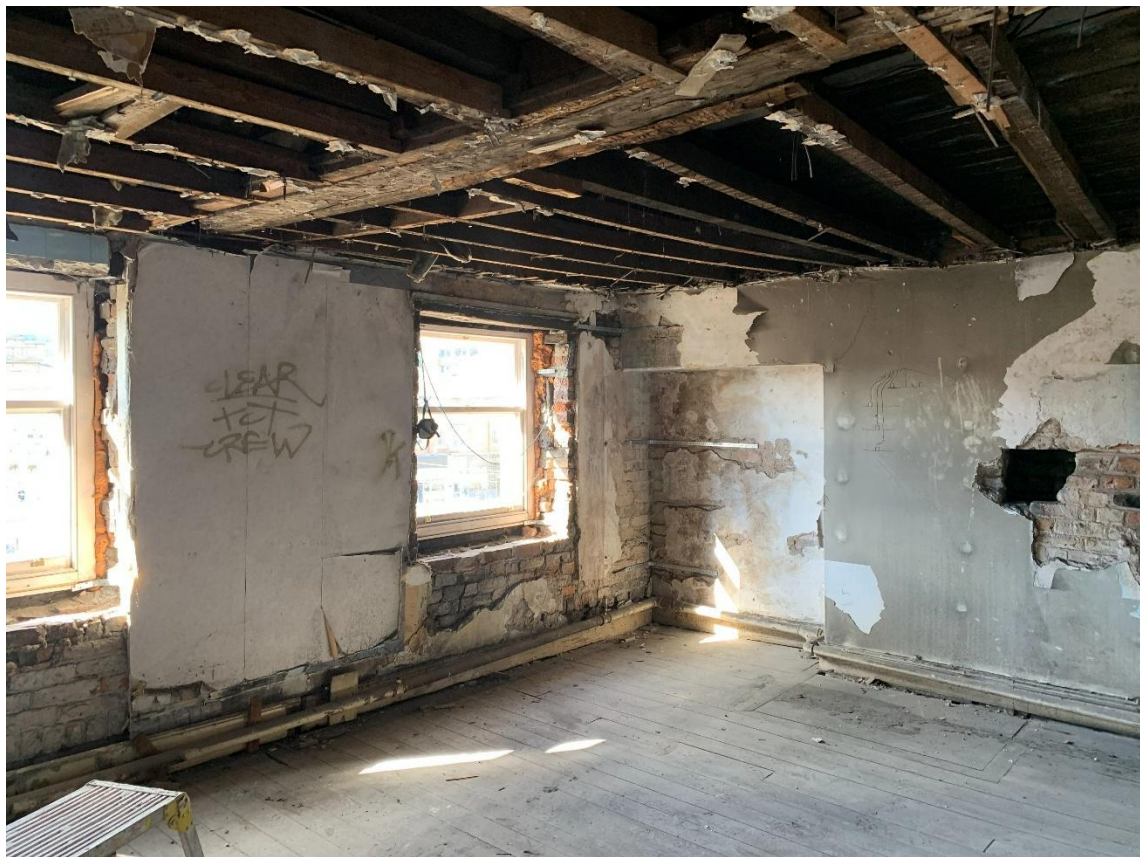
Figure 4.8: Room SF8

- 4.30 Evidence of a hearth in the floor adjacent to chimney breast although no fireplace or surround remains.
- 4.31 Timber cupboard door to the back of the stairs with evidence of strap hinges. The door now appears to be un-openable and forms a fix panel with no handle or hinges.
- 4.32 Timber floorboards visible throughout with timber skirting.
- 4.33 Timber lintel above window to the front elevation set slightly back from the main façade with modern replacement sashes to the front elevation with missing surround / exposed brick.

- 4.34 Ceiling missing / removed although joists for the attic space above still survive in part.

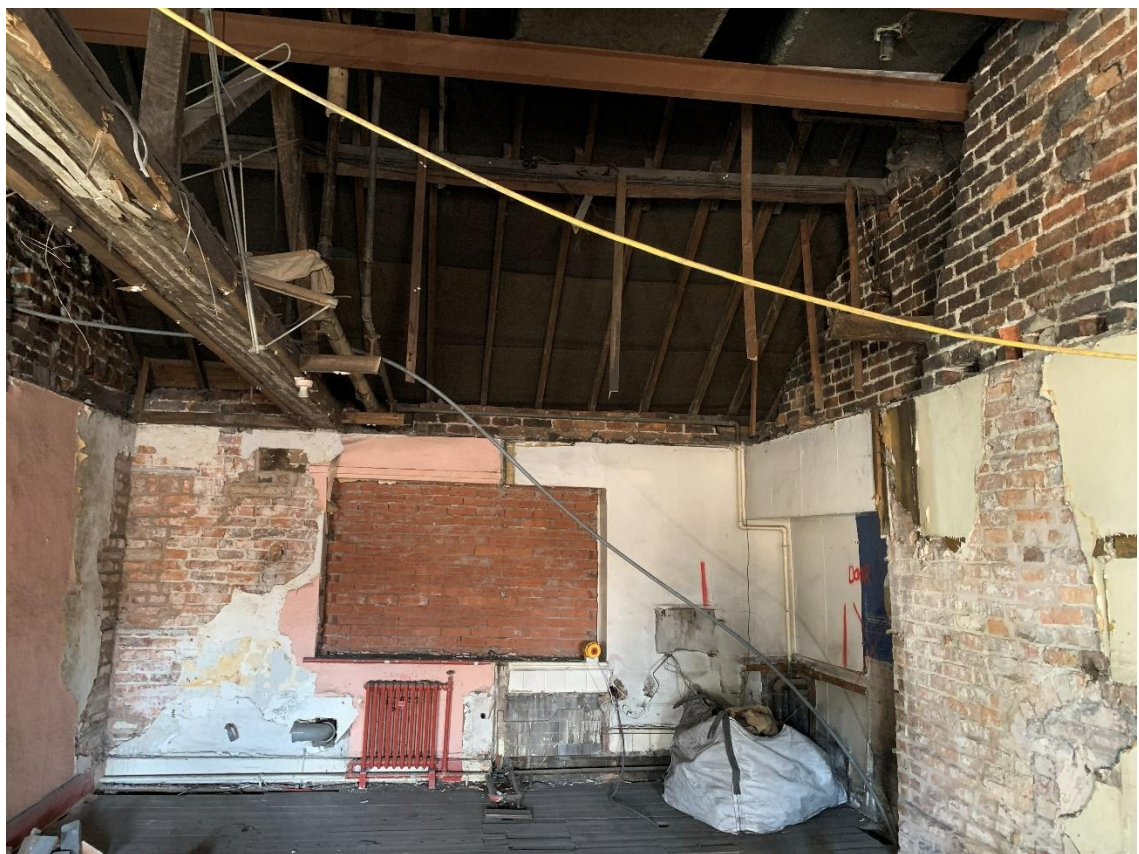
Figure 4.9: Room SF9

- 4.35 Ceiling has been removed and the room is currently open to the attic level. Underside of the roof is visible which shows modern felt, the roof timbers appear machine cut and are likely later replacements suggesting a re-roofing has taken place. 20th century steel supports with water tanks within the attic level are also visible.
- 4.36 Hearth and bricked up fireplace in dividing wall, the chimney stack externally has since been removed.
- 4.37 Timber floorboards throughout with isolated areas of skirting.

- 4.38 Cast iron radiator beneath a large opening in the rear wall that has been bricked up with modern brickwork. The size and horizontal shape of the opening suggest this was likely not a historic opening or was widened before infilling.
- 4.39 Areas of plaster applied to brick. Exposed brick in lime mortar to the attic space above.
- 4.40 Three timber steps into adjacent room SF10, again possible suggesting this formed a later extension or was connected to the main building at a later point due to the level change.
- 4.41 Modern replacement sashes to the front elevation with missing surround / exposed brick.

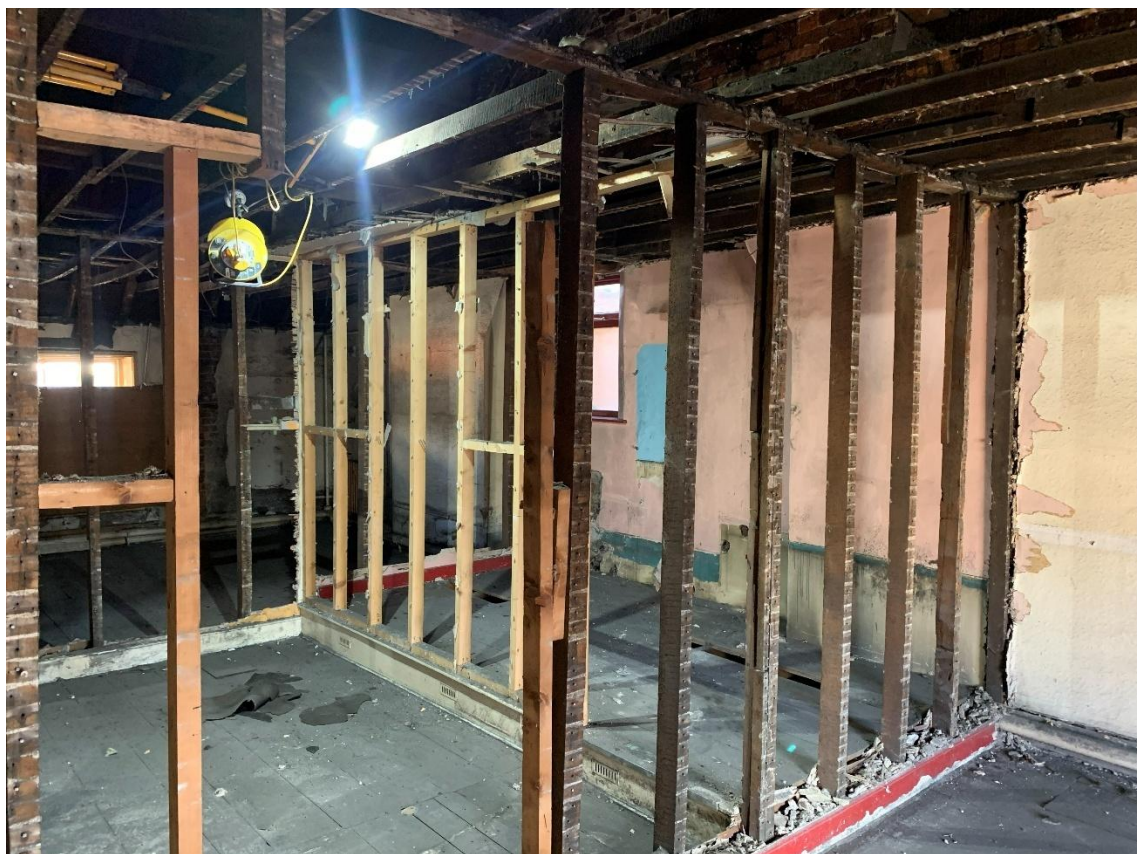
Figure 4.10: Room SF10

- 4.42 Room comprises various dividing timbers for partitions, some are clearly modern but others with evidence of studs and laths likely older. These demark various level changes across the floor in this room. Small subdivided former WC with white tiling.

- 4.43 Ceiling has been removed and room is currently open to the attic level, although evidence of a ceiling structure still remains.
- 4.44 Sash window in rear wall partly boarded over, 20th century casement side window. Modern replacement sash to the front elevation with timber surround and cill.
- 4.45 Timber floorboards slightly wider than those elsewhere possibly suggesting they are likely older. Timber skirting survives in places.
- 4.46 Cast iron radiator.

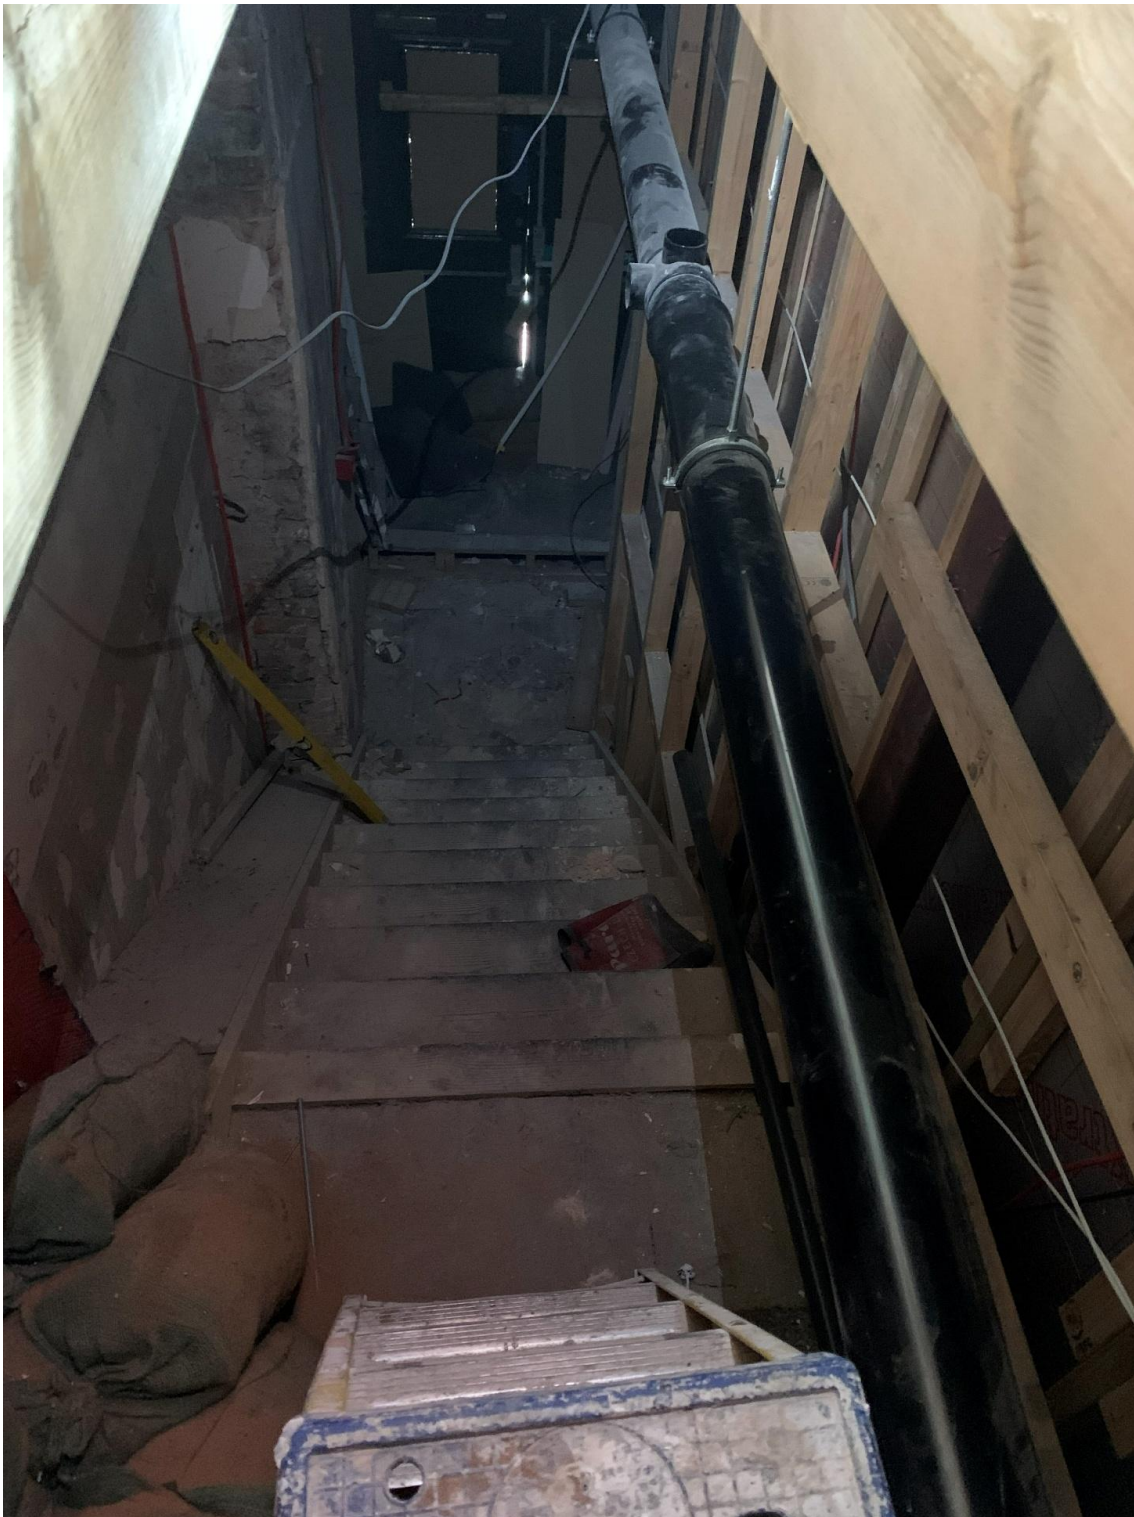
**GF Lobby**

- 4.11 This space was partly inaccessible but was viewed from above. There is a timber stair between ground and first floor that no longer meets the first-floor level with the floor covered over.
