Reference: 16-218-L2

## GREEN LANE – HEYWOOD VALIDATION LETTER REPORT

This letter report details the remediation and enabling works operations that were undertaken by The Challenger Group to facilitate the preparation of the site for the construction of a four-storey apartment block on a parcel of land intersected by Green Lane and Roeacre Street, Heywood, herein referred to as the site.

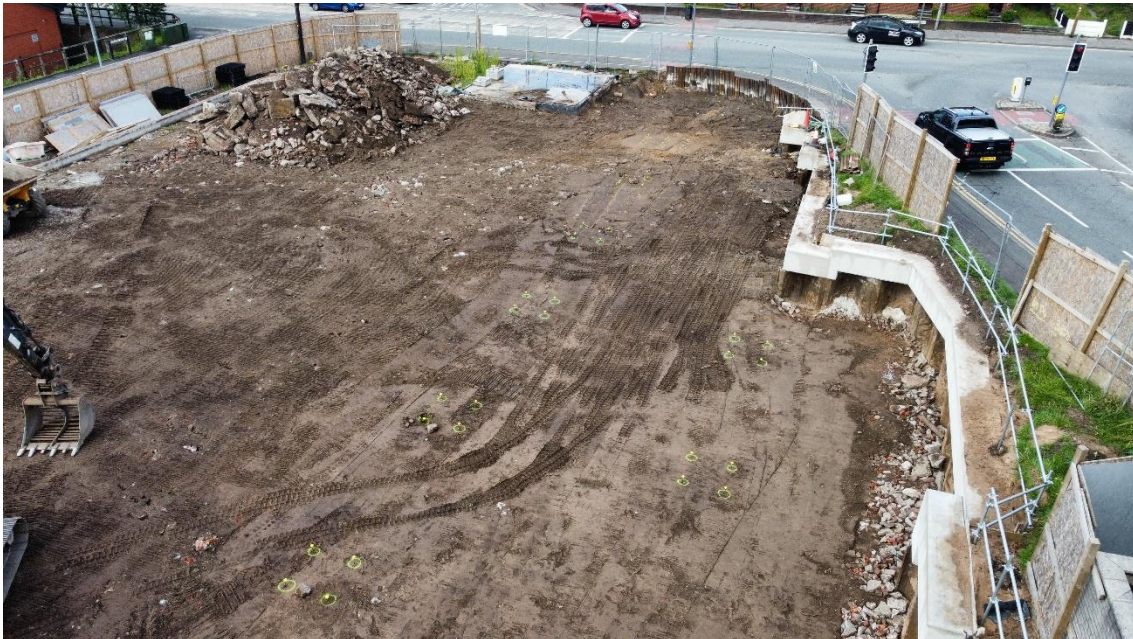
| RE – Point | Detailed Discussion |
|---|---|
| RE-8 | <p>All obstructions and relic foundations were grubbed out and removed in their entirety as part of the cut enabling works undertaken on site.</p> <p>The oversized obstructions were removed and stockpiled to be removed from the site. E3P have been provided the waste transfer note, which can be made available on request.</p> <p>Plate 3 indicates a stockpile of oversized hardcore in the northern sector of the site awaiting removal.</p> |

**PLATE 3 – OVERSIZED HARDCORE STOCKPILE NORTHERN SECTOR OF THE SITE**

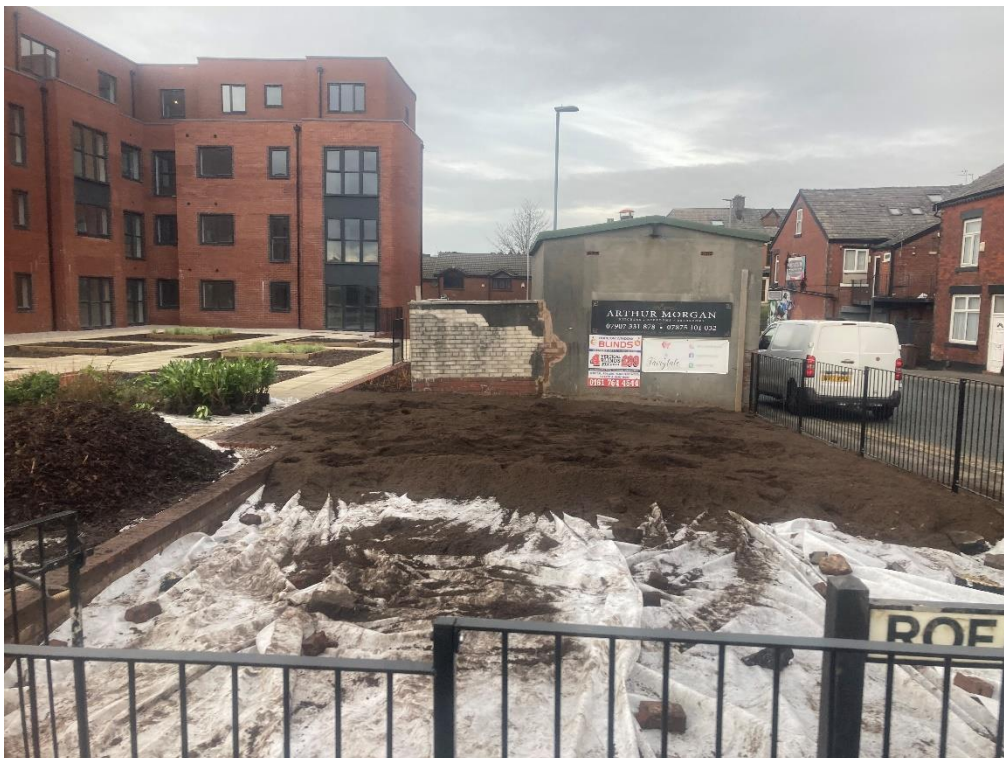
| RE – Point | Detailed Discussion |
|---|---|
| RE-13 | <p>Peripheral landscaped areas are present on site, with these areas being constructed via the placement of clean material and consist of:</p> <ul style="list-style-type: none"> <li>✿ Geotextile Membrane or aggregate break layer;</li> <li>✿ 300 mm of imported topsoil.</li> </ul> <p>E3P have attended the site, following the construction of the clean cover system in these areas, to ensure they have been placed in line with the agreed remediation strategy.</p> <p>Plates 4 and 5 show the placement of the geotextile membrane and an example of the depth of the clean cover system placed.</p> |

**PLATE 4 – PLACEMENT MEMBRANE BELOW COVER SYSTEM**

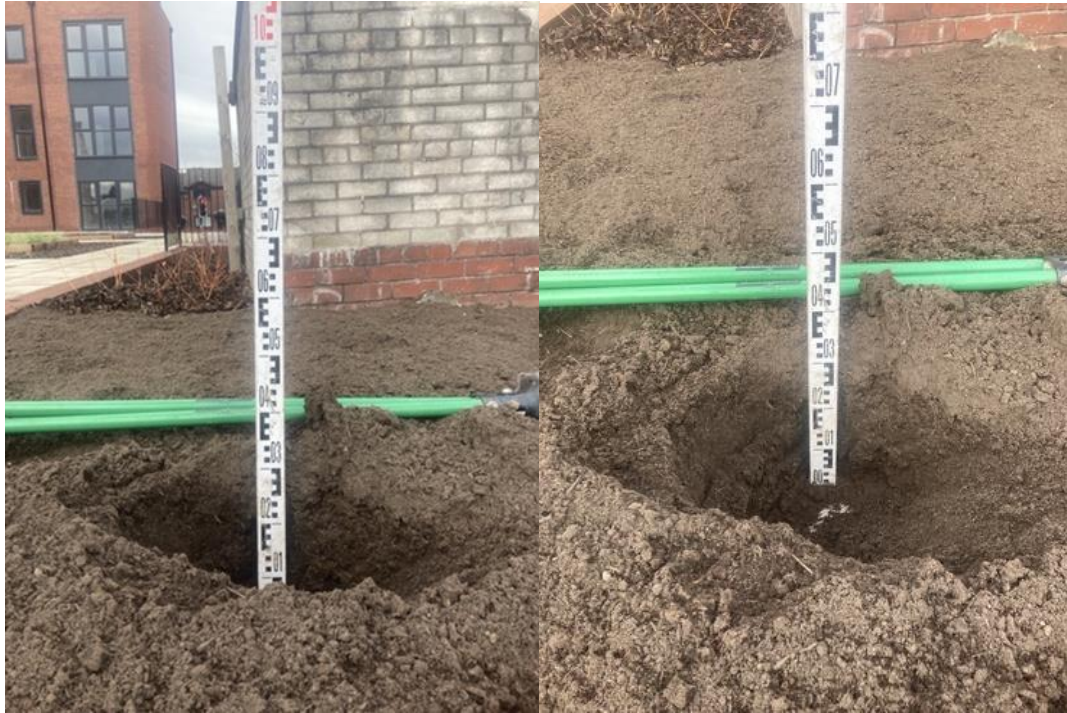
| RE – Point | Detailed Discussion |
|---|---|
| RE-15 | <p>Given the limited area occupied by the POS on site, Challenger Building Services Ltd opted to form the full depth of the cover system (300 mm) utilising imported topsoil. As such, no subsoil deposits have been utilised on site.</p> |

E3P attended the site in November 2025 to advance four hand excavated trial pits across the POS area, with the resulting strata and validation information attached to this letter. E3P can confirm that the POS area has been prepared in accordance with the agreed Remediation Strategy for the site.

**Plate 5 – Depth validation check of public open space**
