# LEOPOLD COURT ROCHDALE

## Preliminary Ecological Appraisal Report

*December 2025*

*Project Name:* Leopold Court, Rochdale  
*Project Reference:* CW20-1836  
*Report Title:* Preliminary Ecological Appraisal Report  
*Report Reference:* CW20-1836 RPT 001  
*Printing Instructions:* Print at A4 Portrait, Double Sided.

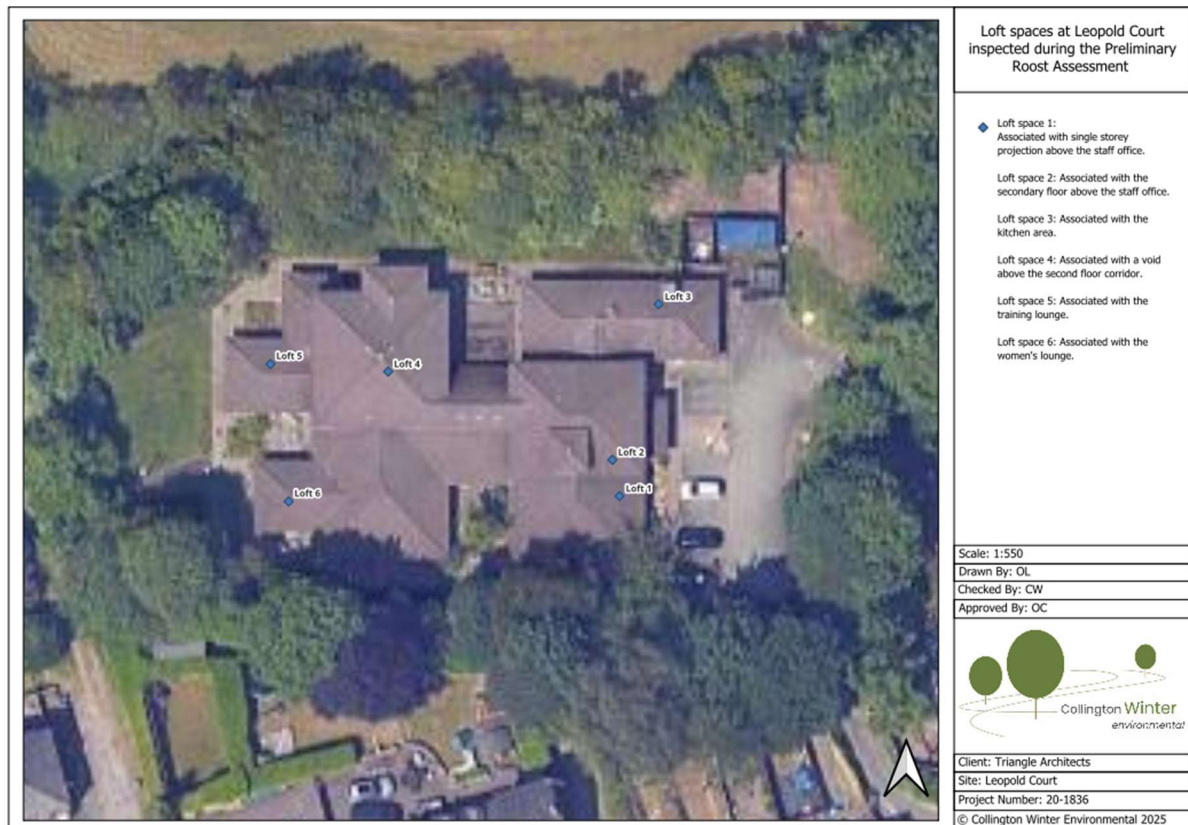
Figure 3.2. Loft spaces at Leopold Court inspected during the Preliminary Roost Assessment.

- 3.5.23. The building exhibits a complex roof structure comprising multiple loft voids, accessed via a series of entry hatches. During the survey, six loft spaces were inspected, with their approximate locations illustrated in Figure 3.2. Several additional lofts could not be accessed due to their location within occupied rooms, the absence of keys, or health and safety constraints. In particular, lofts situated above the two main stairwells were not entered due to restricted access and potential fall hazards which prevented safe inspection. The lofts that were inspected share a consistent structural form, consisting of timber roof trusses, predominantly arranged in triangular or leaning frameworks, and lined with what appears to be bitumen-based felt.

- 3.5.24. The internal roof voids were of modern construction and remain intact throughout. Potential roosting opportunities may exist between the felt and roof lining where gaps or access points are present on the external roof. Each loft contained building service equipment, including insulated ventilation ducting, electrical cabling, and insulation wool, which together create warm, stable microclimates.

- 3.5.25. The loft spaces vary in size, with one inspected space being under 1m in height; however, the majority provide sufficient volume and shelter to offer potential roosting opportunities for void-dwelling bats. However, no bats or evidence of bat activity were recorded within any of the lofts during the inspection.

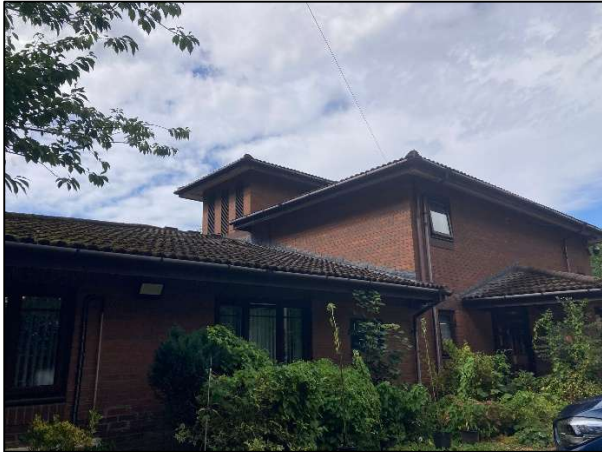
3.5.15. The roof is finished with concrete double Roman interlocking tiles. These tiles overlap tightly, and provide minimal crevice-roosting potential. From ground level inspections, the roof covering appeared to be in reasonable condition throughout, with no missing tiles and very few displaced tiles visible, and only very small

Western roof elevations

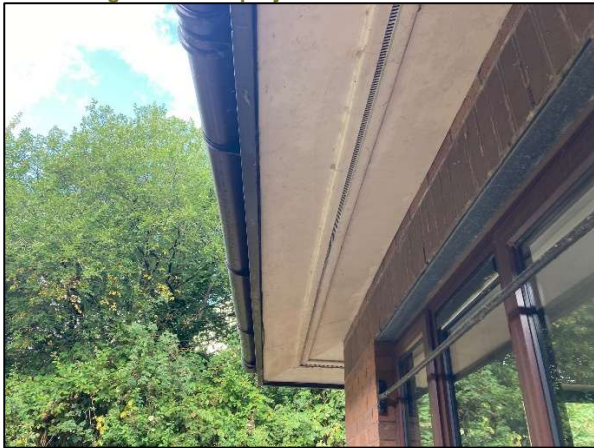
Soffits on ground floor projections

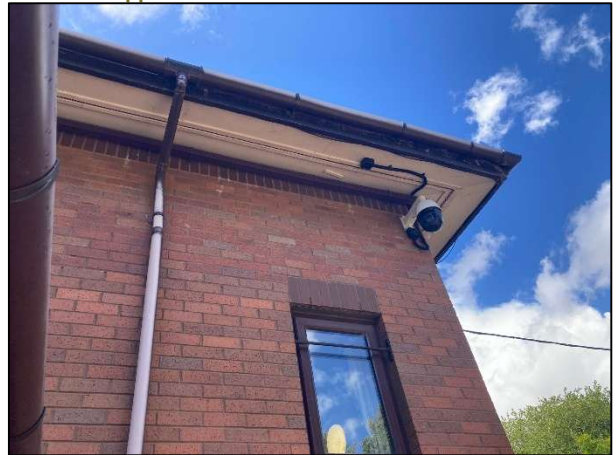
Soffits on upper elevations

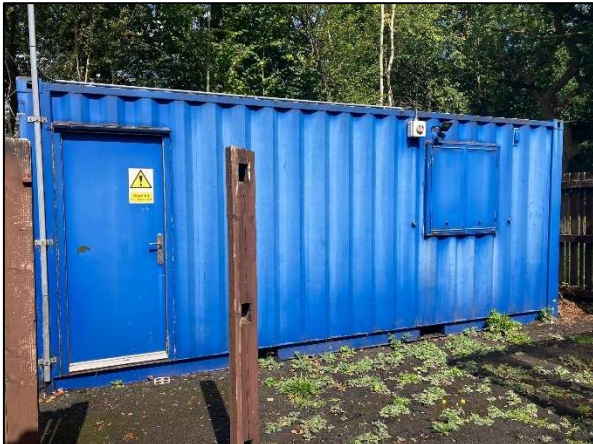
- 3.5.22. In addition to the main building, a metal shipping container is present at the front of the property. This structure is considered to offer negligible suitability for bats due to its construction, which provides thermally unstable conditions. Furthermore, the container lacks structural features that could provide shelter or concealment, such as crevices or voids.

Shipping container located to the front of the building

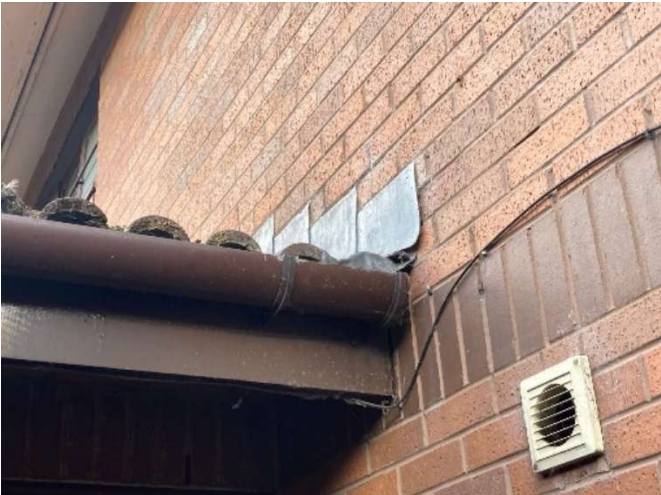
- 3.5.17. Lead flashing is present at junctions where the ground-floor roof projections meet the main body of the building. Small gaps were noted along some sections of this flashing, which may provide minor crevice features with suitability for small or individual numbers of crevice-roosting bats.

| Description | Photos |
|---|---|
| <p>Example of gaps under lead flashing which may provide minor crevice features with suitability for small or individual numbers of crevice-roosting bats.</p> | |

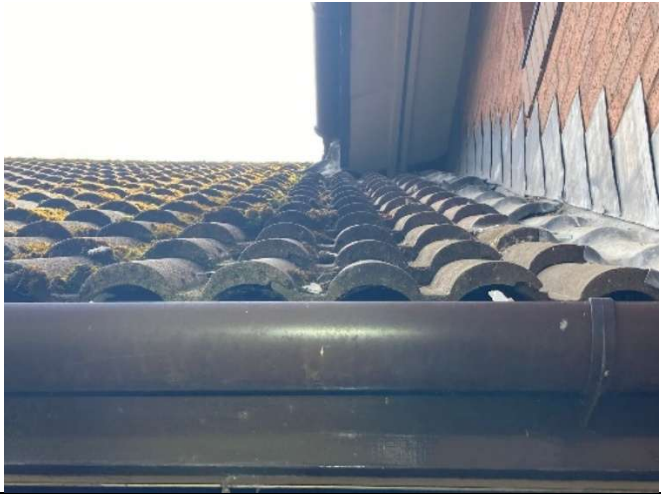
| Description | Photos |
|---|---|
| <p>Photo shows open ends of ground floor imbrices, creating shallow voids which may lead to crevice-roosting opportunities associated with structural supports or internal roof voids (not visible from ground level)</p> | |

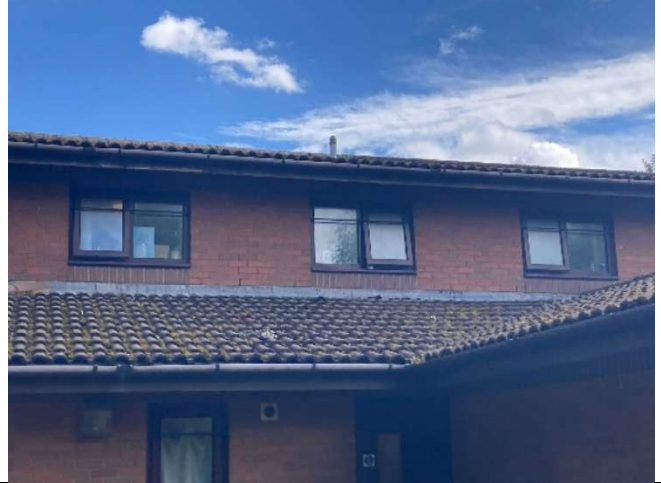
3.5.14. The external walls are constructed from brick and are generally intact and well-maintained. However, vertical gaps were observed in the mortar above the single-storey lean-to roof on the northeastern elevation. These gaps may constitute potential crevice-type features or provide access to cavity wall spaces or loft voids.

| Description | Photos |
|---|---|
| <p>Vertical gaps in mortar above single storey projection which may provide crevice-type features or provide access to cavity wall spaces or loft voids.</p> | |

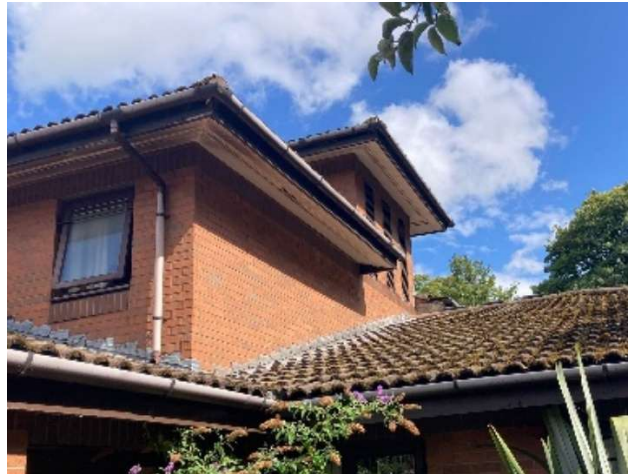
- 3.5.19. A tower structure is present to the east of the main building, containing vents that may provide potential access points to internal spaces. The suitability of these vents for entry is influenced by both their design and the characteristics of the spaces to which they lead. Unsealed or louvered vents may allow access to the interior if the internal space provides suitable conditions, such as being undisturbed, dry, and enclosed. Conversely, vents fitted with mesh are less likely to serve as entry points. Due to the limitations of ground-level inspection, it was not possible to confirm whether the vents provide actual access points.

Louvre vents on the tower structure which may provide access points to internal spaces. Suitability not able to be defined due to limitations of ground level inspection.

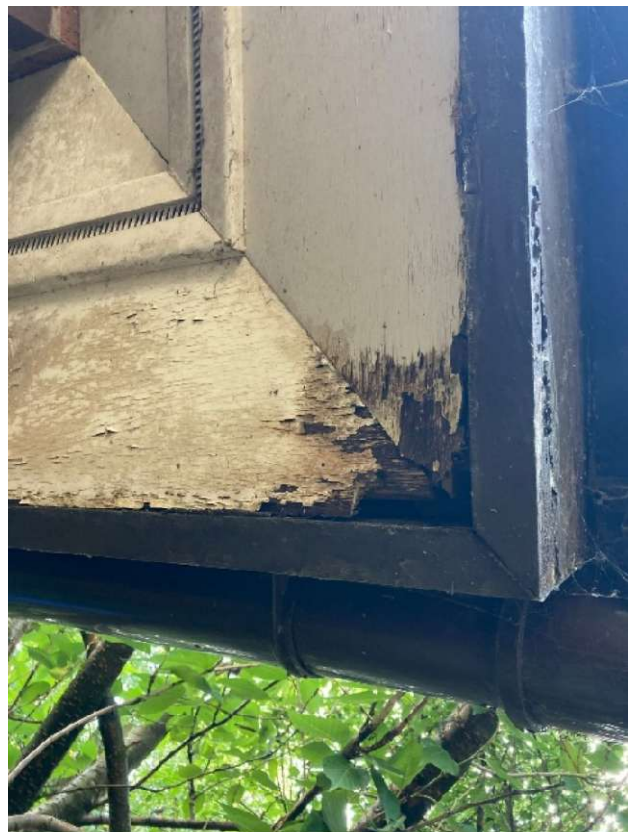
- 3.5.18. The soffits and fascia boards are primarily timber and are generally sound and well-fitted across most elevations, with some minor areas of superficial damage noted. Two small holes were observed on the northwestern and southeastern single storey sections of the building respectively. While these defects could theoretically provide a point of ingress for bats, they are assessed as having low suitability due to the likely impact on this feature from ground floor external lighting.

Defects on soffits. Considered to be of low suitability due to likely impact of external lighting on ground floor elevations.

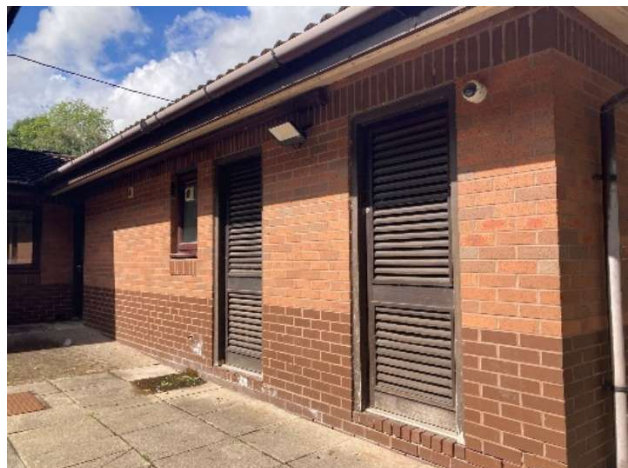
Louvre doors may provide ingress/egress. However, internal spaces were found to comprise well-sealed spaces used for storage and/or building service machinery.
