# LEOPOLD COURT, ROCHDALE

## Bat Survey Report

*December 2025*

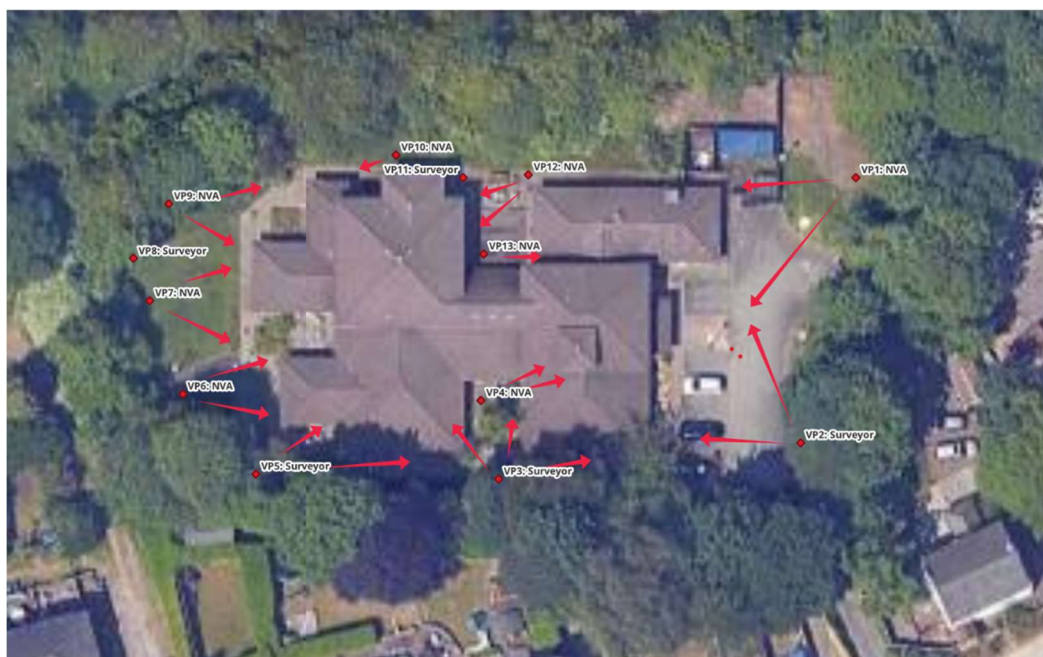
Figure 2.1. Surveyor and NVA locations.

- 2.1.3. Suitable vantage points were established around the building to ensure full coverage of all elevations and to observe identified PRF's, as well as any discrete features not noted during the PRA.

- 2.1.5. The survey was supplemented with eight Night Vision Aids (NVAs), each consisting of a Night Fox Whisker unit with LED torch components providing infrared illumination for low-light observation. Representative screenshots captured at the darkest points of the survey are provided in Appendix I. All footage was reviewed using appropriate media players and tracking software supplied by Wildlife Imaging Systems.

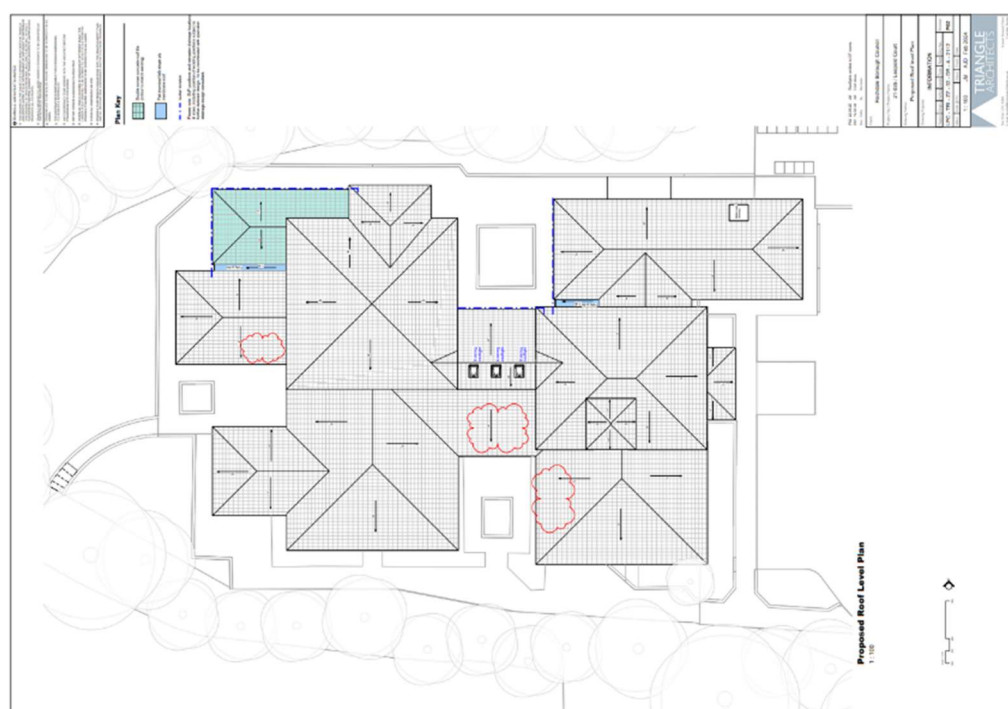
Figure 2.2. Proposed roof level plan produced by Triangle Architect Ltd.

- 2.2.2. The endoscope survey targeted external areas of the building that are likely to be affected by the proposed extension works. Based on the architectural plans provided by Triangle Architects Ltd. (ref. Figure 2.2), the proposed extensions, highlighted in blue, consist of two primary areas, comprising a rectangular addition to the existing single storey lean-to projection, and a smaller extension linking the central northeast projection to the main structure. The northwestern extension incorporates a gable roof finished with double roman tiles, which ties into the adjacent roof projection via a short section of flat roof. The northeastern connecting extension is designed with a flat roof profile.

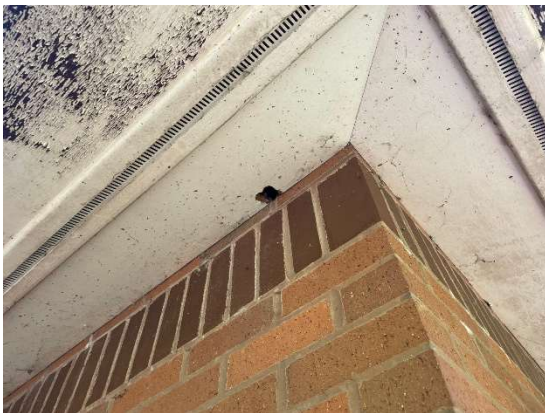
| Feature | Description | Photographs |
|---|---|---|
| Hole in soffit | <p>A small hole was identified in the soffit of the neighbouring projection. Endoscopic inspection of the feature found that it provides ingress into the internal loft space.</p> <p>Endoscopic and visual inspections of the interior found no evidence of bat use, and no staining or wear was observed around the entrance.</p> <p>The feature is assessed as having low suitability for roosting due to the influence of external lighting on the lower elevations.</p> | |

- 3.2.4. Other features, including partially lifted tiles, small gaps around lead flashing, and the hole in the soffit, are considered to be of low suitability for bats due to their limited size and shelter. If occupied, these features are likely to support only individual bats or small numbers of crevice-dwelling species. External lighting is likely to further reduce the suitability of features at lower elevations.

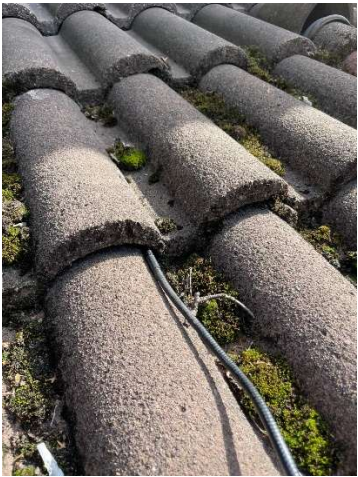
| Lifted tiles | <p>Three partially lifted roof tiles were identified on the west-facing roof slope. The features create small gaps of sufficient size to permit access for crevice-dwelling bat species. These openings lead only into shallow voids beneath the roof tiles, which are considered too exposed to provide suitable or stable roosting conditions. However, concealed features under the roof tiles may be present. No evidence of bat use was recorded during inspection.</p> | |

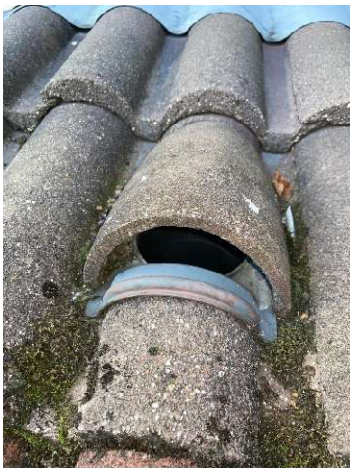
| Ventilation pipe | <p>A ventilation pipe located beneath a roof tile was identified on the west-facing roof slope. The opening provides a direct access route into the internal loft void. The surrounding area is sheltered by overlying tiles, offering some protection from the elements; however, the entrance remains partially exposed and subject to light and temperature fluctuations. Endoscopic inspection of the internal loft space revealed no evidence of bat use.</p> | |

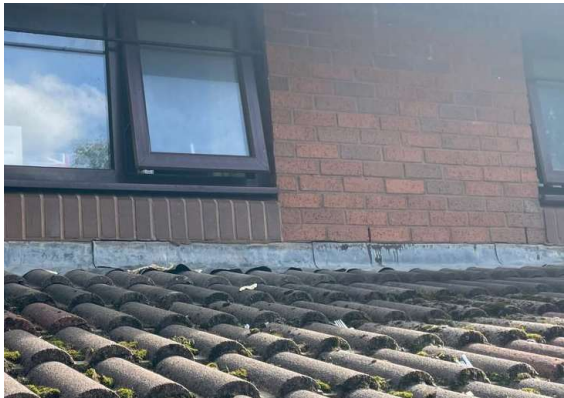
| Gaps along lead flashing | <p>Approximately ten small gaps were identified along sections of lead flashing which may provide potential crevice roosting opportunities for bats. No evidence of bat use was recorded during inspection and several contained spider webs, indicating no recent usage.</p> | |

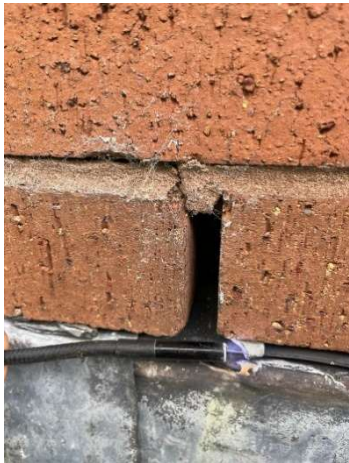
| Vertical gaps in mortar between brickwork | <p>Four gaps in the mortar were identified in the brickwork of the main building above the flashing of the west-facing roof pitch. All crevices lead into a cavity wall, which appeared to contain insulated Styrofoam boarding. These gaps may serve as potential ingress or egress points into internal cavity wall spaces or roof voids. No evidence of bats was observed during the inspection.</p> | |

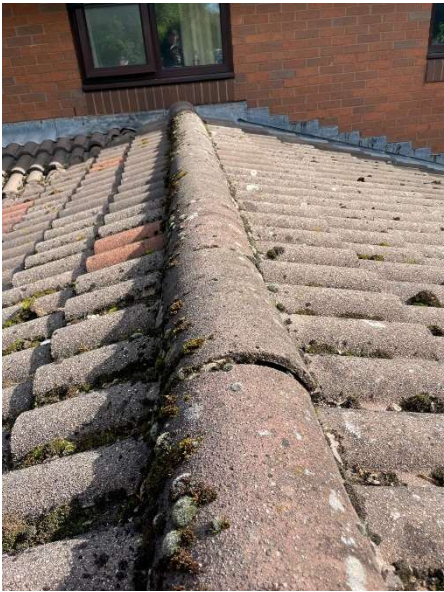
| Slipped ridge tile | <p>A slipped ridge tile on the adjacent roof has created a gap of sufficient size to provide potential crevice ingress. The ridge was found to be hollow along its full length and may potentially offer sheltered and warm conditions. No evidence of bat activity was observed in the visible areas accessed via endoscope.</p> | |

- 3.2.3. The most notable potential roosting feature is the hollow ridge on a projection of the neighbouring structure, which would become adjoining once the proposed extension is constructed. This area offers shelter and may provide relatively stable microclimatic conditions. Additional features of note include horizontal timber joints with potential deeper crevices beneath roof tiles, and gaps in mortar providing ingress into cavity walls or internal loft spaces. While no evidence of bats was observed, detailed inspection of such discrete spaces associated with these features was limited.

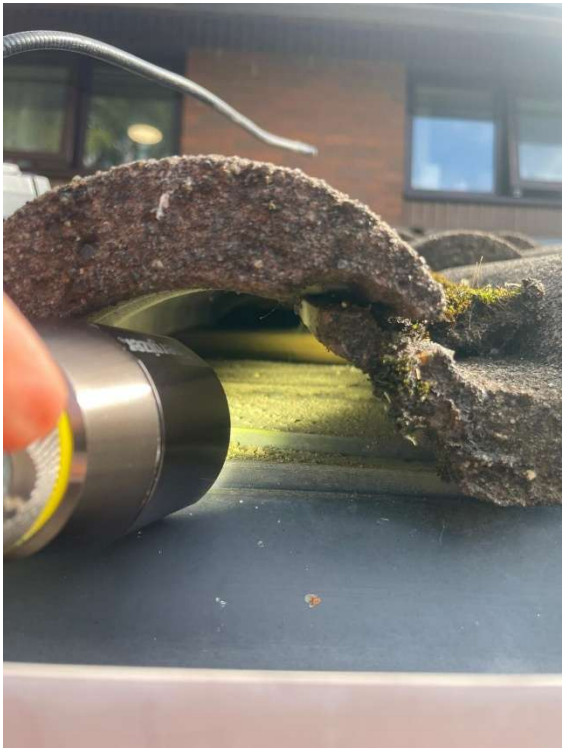
| Under roof tiles | <p>A shallow void beneath roof tiles provides some shelter but is relatively exposed. Horizontal timber joints within the roof structure may create crevices that could offer roosting opportunities for crevice-dwelling bats, particularly deeper within the structure where visibility was restricted. No evidence of roosting bats was found during inspection.</p> | |

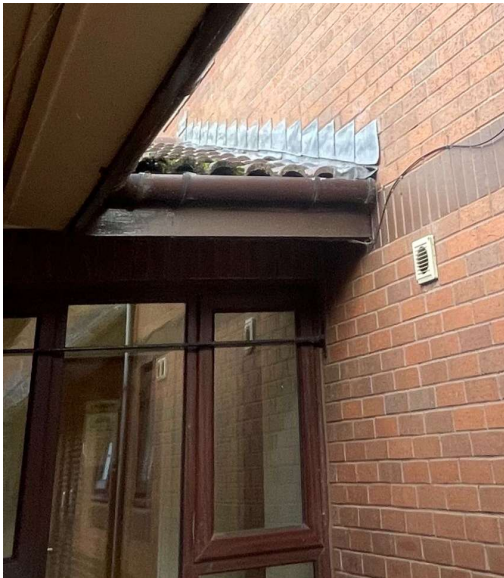
| Feature | Description | Photographs |
|---|---|---|
| Gap under lead flashing | A small gap is present beneath the lead flashing at the roof edge, consistent with flashing elsewhere on the building. The feature could potentially provide roosting opportunities for crevice-dwelling bats; however, no evidence of bat activity was observed, and intact spider webs suggest the feature has not been recently used. | |

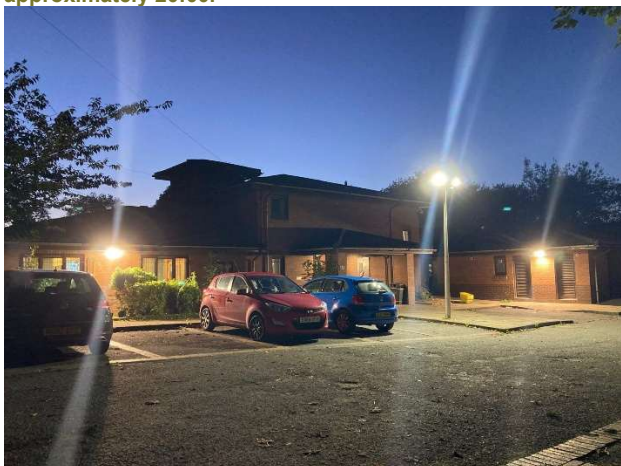
- 3.1.4. External lighting came on at approximately 19:15, comprising streetlamps in the car park to the east of the site and external wall-mounted lights on the lower elevations of the building. This lighting is likely to have caused some disturbance to bats, particularly around the illuminated areas, and may have reduced the likelihood of bats roosting on or near these locations. Photographs of external lighting taken during the survey is provided in Appendix II.

**Photograph A: Eastern elevations; photo taken at approximately 20:00.**

4.3.1. As bats are known to be utilising the site for foraging and commuting purposes, any additional lighting to the building should be designed and installed to comply with current legislation and to minimize the impact on any bats in the locale, with current lighting retrofitted where possible. Guidance outlined in the Institute for Lighting Engineers document “Guidance for the Reduction of Obtrusive Lighting” (2005) and BCT’s “Bats and Artificial Lighting in the UK” (2018) suggests the following:

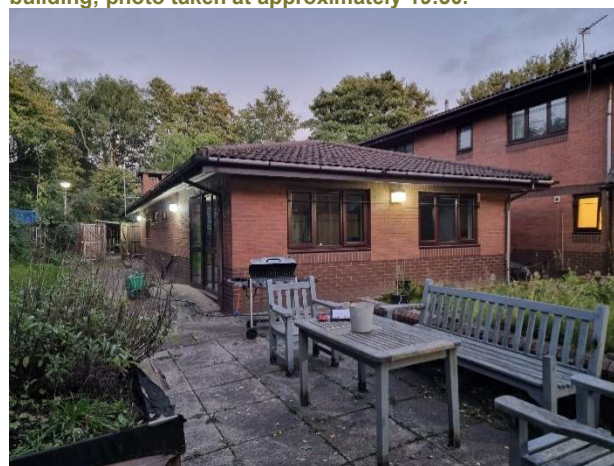
**Photograph B: Projection on north-east section of building; photo taken at approximately 19:30.**

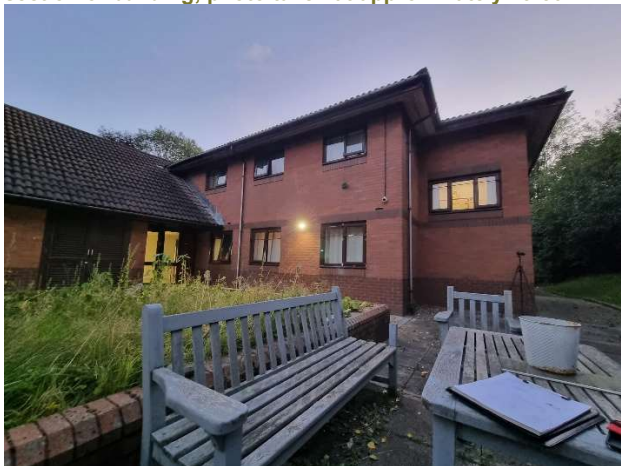
**Photograph C: Photograph B: Projection on central north section of building; photo taken at approximately 19:30.**

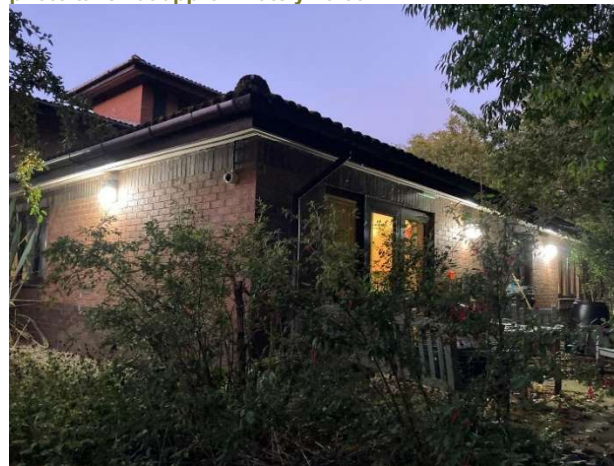
**Photograph D: South-eastern section of building; photo taken at approximately 20:00.**

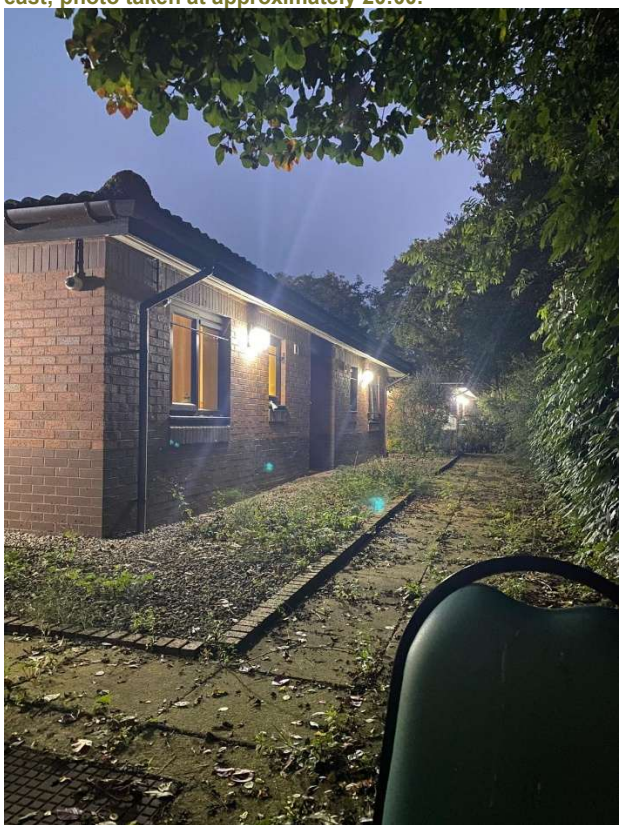
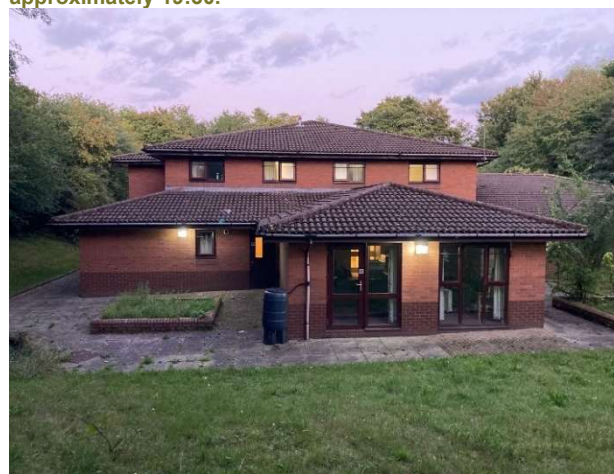
**Photograph E: Western elevations; photo taken at approximately 19:30.**

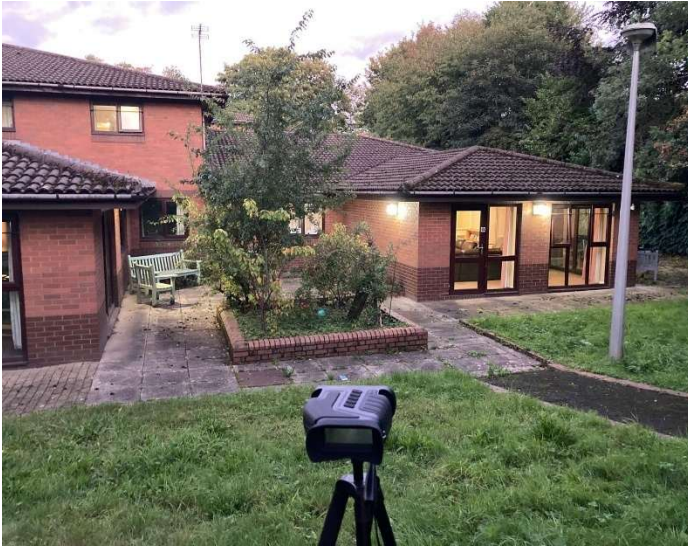
**Photograph G: Western elevations; photo taken at approximately 19:30.**
