# 299 BOARSHAW ROAD, MIDDLETON

## Preliminary Bat Roost Assessment Report

*December 2025*

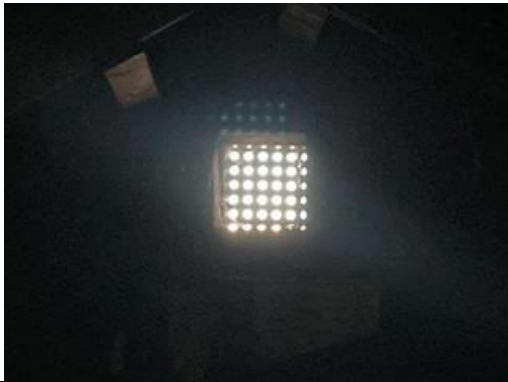
3.2.4. An airbrick was located on the eastern wall located near the apex; this was blocked by an inactive wasp nest limiting this potential access points. A second airbrick was located on the western aspect also at the apex, this was found to consist of small gaps providing potential access point into the loft.

| Reference | Photographs |
|---|---|
| Western Airbrick | |

- 4.1.1 B1 was found to provide roosting potential and therefore, in accordance with Best Practice guidance (Collins, 2023) further nocturnal surveys should be undertaken between May-September (inclusive) to determine usage by roosting bats. The building was assessed as providing **Low bat roosting potential**; therefore, a minimum of one further survey is recommended, completed between May-August.

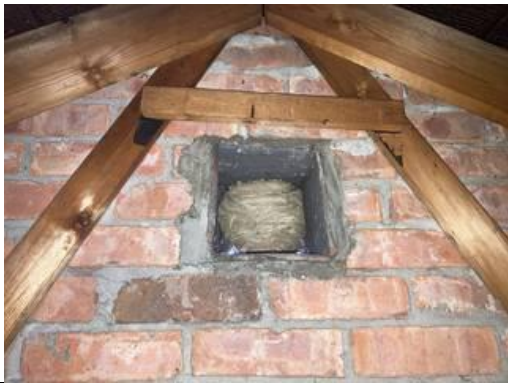
| Reference | Photographs |
|---|---|
| Eastern Airbrick covered by wasp nest. | |

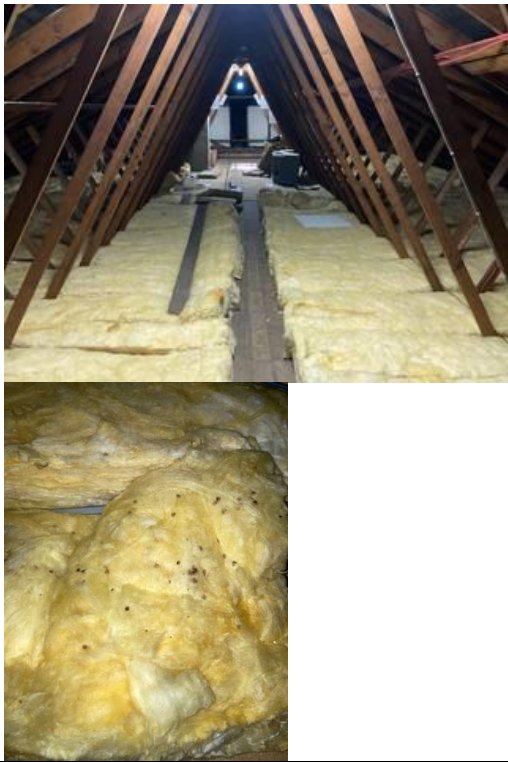
3.2.3. Some small areas of staining were located on the insulation on the western aspect located near the loft hatch. However, due to the age of the stains it's unconfirmed what the cause of this was, there was no confirmed evidence of bats located onsite.

| Reference | Photographs |
|---|---|
| Loft space with staining marks on the insulation. | |

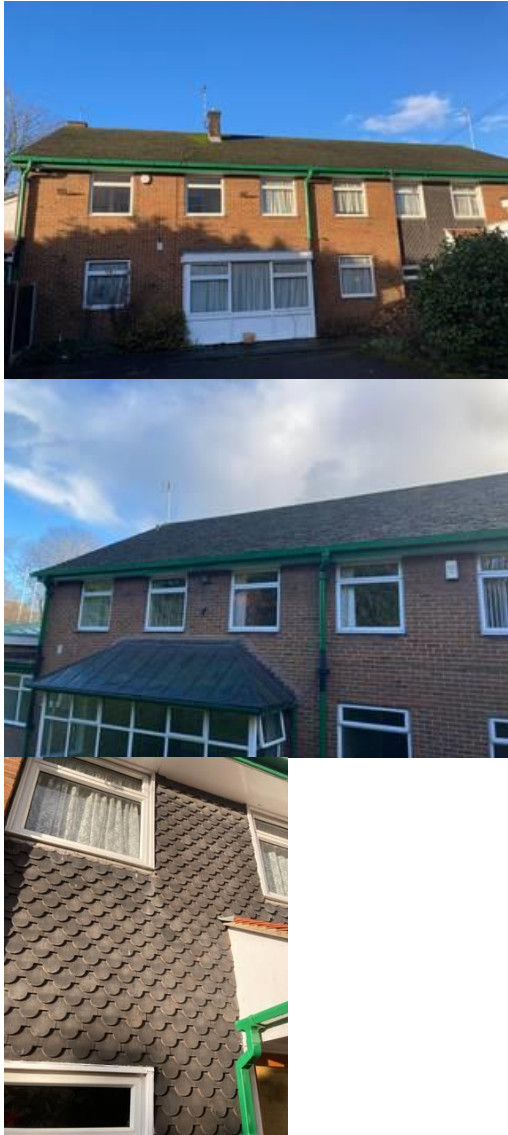
- 3.2.7. Externally, the building was made up of redbrick walls which were in good condition throughout the full extent of the building. The windows and doors were all also found to be in good condition with no access points or roosting features located along these aspects. A section of hanging tiles is located around the front door on the southern aspect of the building, these were all found to be in good condition with no gaps creating PRF's. The roofing tiles and ridge tiles were all found to be in good condition with no PRF's or access points identified along the full extent of the roof.

| <p>Main Building</p> | |

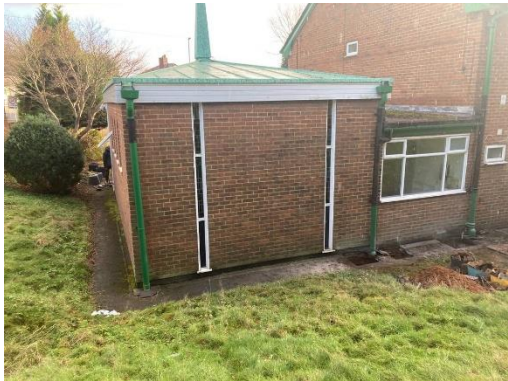
- 3.2.8. A single-story extension was located on the western aspect of the building. The structure features a pyramid-shaped, low-pitched roof finished with green-coated sheet material (likely metal or a similar waterproof panel system). The roof slopes evenly from all sides toward a central vertical spire or vented pinnacle. There were no gaps or crevices along the roof that could support a roosting bat. Plastic eaves were located on the bottom of the roof along the brick walls which were also in good condition.

| <p>Single story extension</p> | |

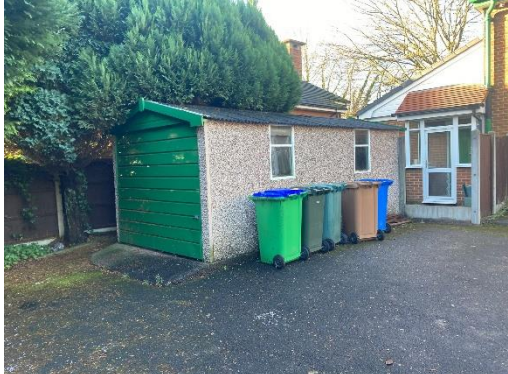
- 3.2.11. A single-story pebble dashed garage was located adjacent to B1 with a single layered corrugated metal roof. There were small gaps between the corrugated metal sheets and the walls however they did not lead to any further cracks or crevices that would support a roosting bat. Internally the building was fully exposed with no loft spaces within the building. All windows and doors were well sealed providing no access points or crevices anticipated to be utilised by roosting bats. The building did not provide features suitable to support a roosting bat and there was evidence of bats identified. The building was found to provide **“None” bat roosting potential.**

| <p>Single story garage</p> | |

- 4.1.3 B2 was found to provide “None” bat roosting potential and therefore there are no further surveys recommended on B2 only.
